Atlanta Property Inspections, Inc.

HOME INSPECTION REPORT

310 Marshy Pointe, Johns Creek, GA 30097
Inspection prepared for: Greg Smith & Natalie Smith
Date of Inspection: 2/26/2020 Time: 1:30 PM
Age of Home: 20 Years Old (2000) Size: 8460 SF
Weather: Cloudy, Damp Soil, 50 Degrees

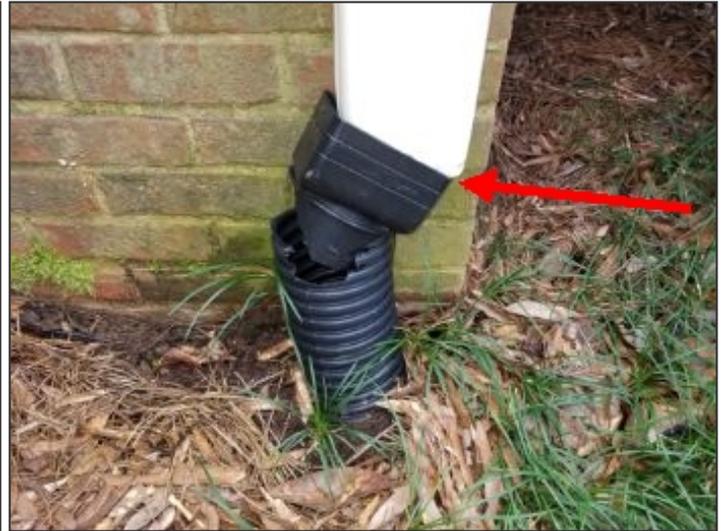
EXTERIOR GROUNDS:		
Page 14	EXTERIOR DRAINAGE:	<ul style="list-style-type: none"> • A disconnected downspout was found at an underground drain pipe located at the front left garage corner (see photo). A minor repair is suggested to prevent possible water intrusion into foundation.
Page 16	EXTERIOR STAIRS:	<ul style="list-style-type: none"> • SAFETY CONCERN: The metal hand railing at the end of the right side deck stairs is loose at the rail post connection to the brick patio (see photo). This condition is a safety concern. Repair is advised to fully secure the loose railing.
EXTERIOR WALLS:		
Page 17	EXTERIOR TRIM:	<ul style="list-style-type: none"> • Damaged wood trim was noted at the lower portions of the rear unfinished basement room entry door (see photo). Replacement of the affected wood trim is recommended.
Page 18	FASCIA / SOFFIT:	<ul style="list-style-type: none"> • Damaged wood was observed at the fascia board located at the front left side roof above the living room / office, and at the left side master bathroom roof (see photo). The damaged wood appears to be from carpenter bee activity. Repair / replacement of the affected wood is recommended. • Damaged wood was observed at the soffit board located at the front left corner roof (see photo). Replacement of the damaged wood is recommended, further evaluation is recommended to determine the source of the water damage and to make necessary repairs.

Disconnected downspout at left garage corner

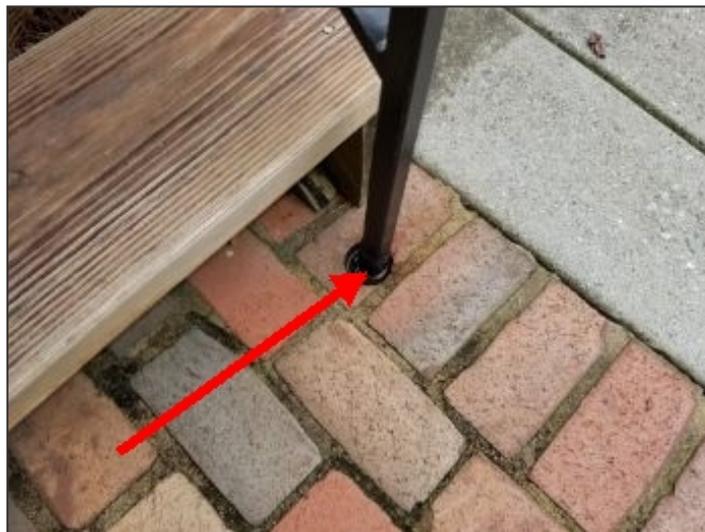
- The metal hand railing at the end of the right side deck stairs is loose at the rail post connection to the brick patio (see photo). This condition is a safety concern. Repair is advised to fully secure the loose railing.

Loose metal railing at patio connection

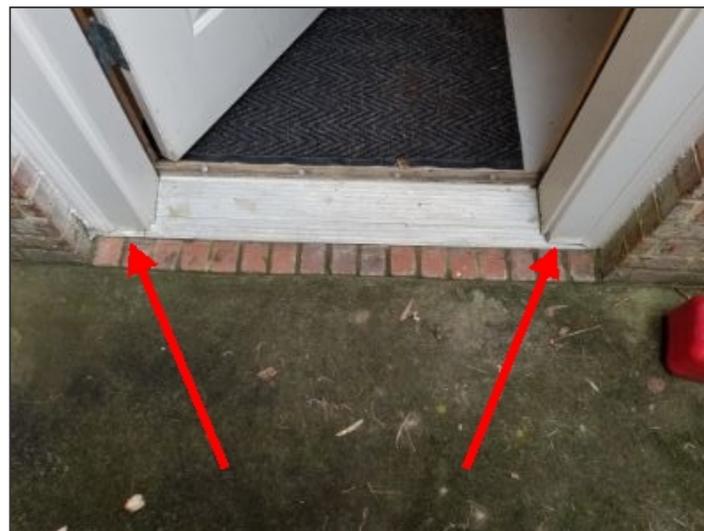
- **Damaged wood trim was noted at the lower portions of the rear unfinished basement room entry door (see photo). Replacement of the affected wood trim is recommended.**

Damaged wood trim at basement entry door

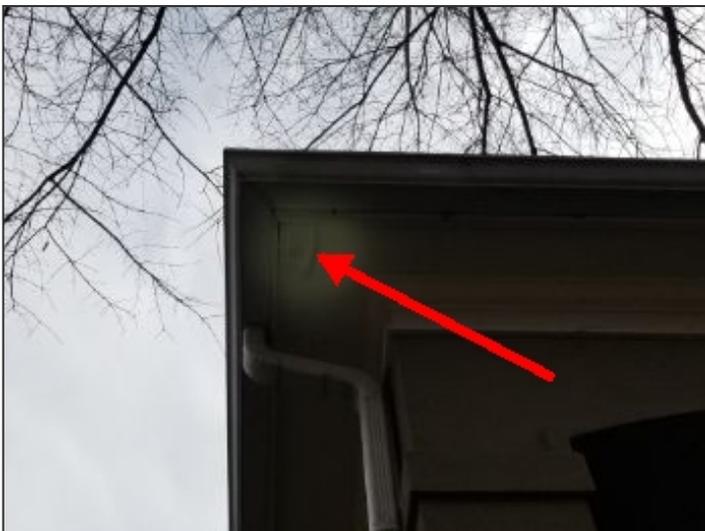
• **Damaged wood was observed at the soffit board located at the front left corner roof (see photo). Replacement of the damaged wood is recommended, further evaluation is recommended to determine the source of the water damage and to make necessary repairs.**

Damaged soffit at front left corner roof

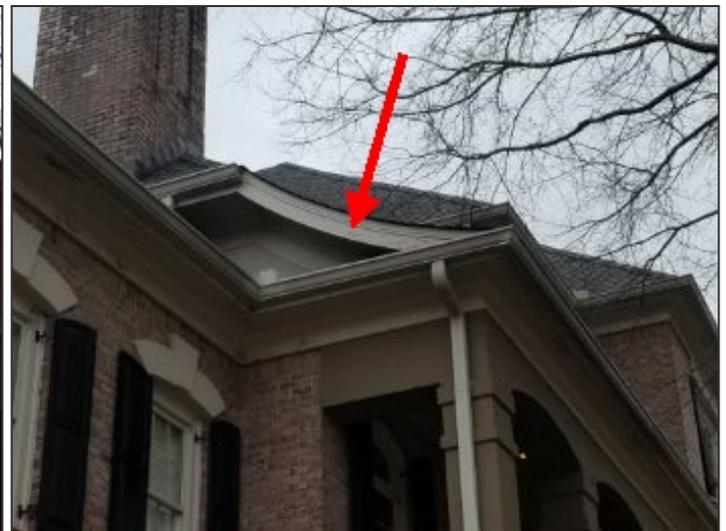
• **Damaged wood was observed at the fascia board located at the front left side roof above the living room / office, and at the left side master bathroom roof (see photo). The damaged wood appears to be from carpenter bee activity. Repair / replacement of the affected wood is recommended.**

Damaged fascia at front left corner roof

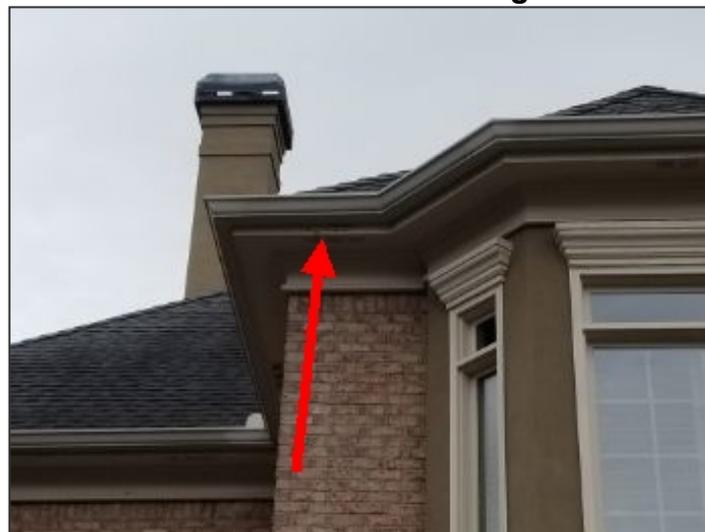
Damaged fascia at left side master bathroom roof

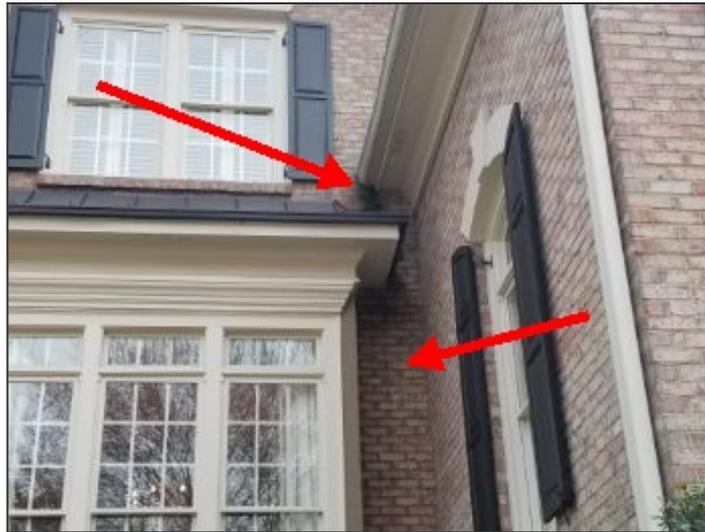
• **Water staining was found at the front dining room wall just below the intersecting garage gutter (see photo). This is an indication that water is bypassing the gutter and running down the wall. This roof intersection is missing the diverter flashing or kickout flashing just above the gutter. Further evaluation by a professional roofing contractor is recommended to determine repair needs and costs.**

Water staining at dining room brick wall below gutter

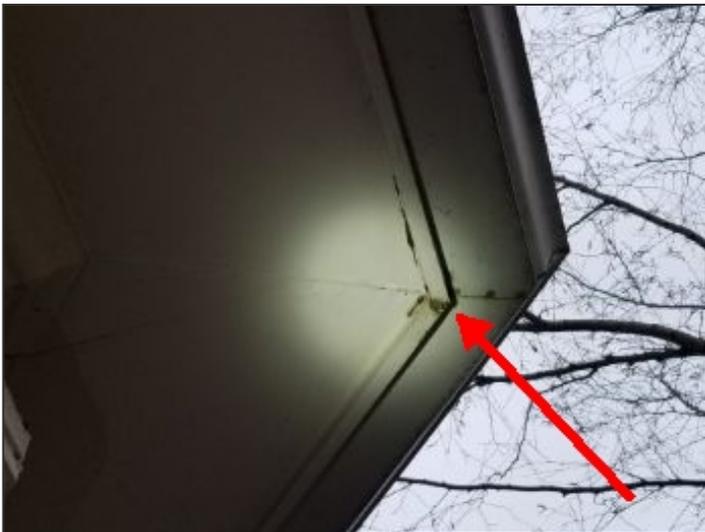
- A gutter seam leak was noted at the rear deck roof near the upper stair landing (see photo). This condition can lead to water damage at the roof fascia and soffit if not corrected. Repair is recommended.
- The gutters are full of debris at the front porch and rear covered deck roof (see photo). Gutter cleaning is recommended, at all needed areas, so that the gutters can drain correctly.
- A gutter is improperly sloped at the front porch roof, and right side garage roof and are holding water (see photos). Repair / adjustment is recommended so that the gutter is properly sloped and water flows to the downspout.

Gutter seam leak at rear deck roof

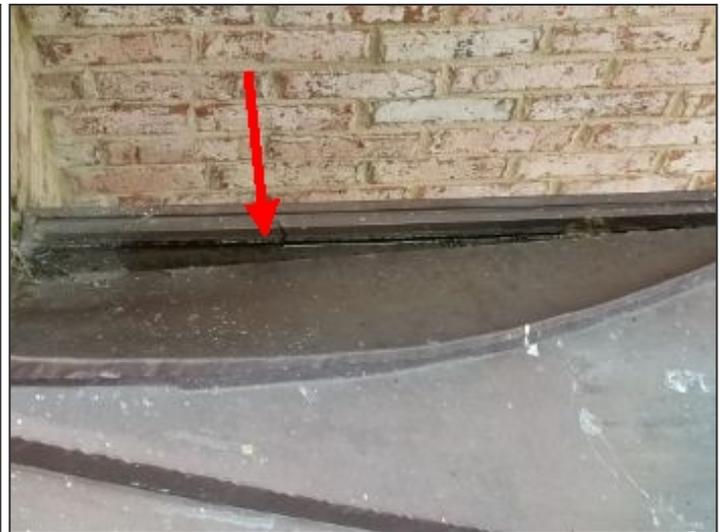
Front porch roof holding water - right side

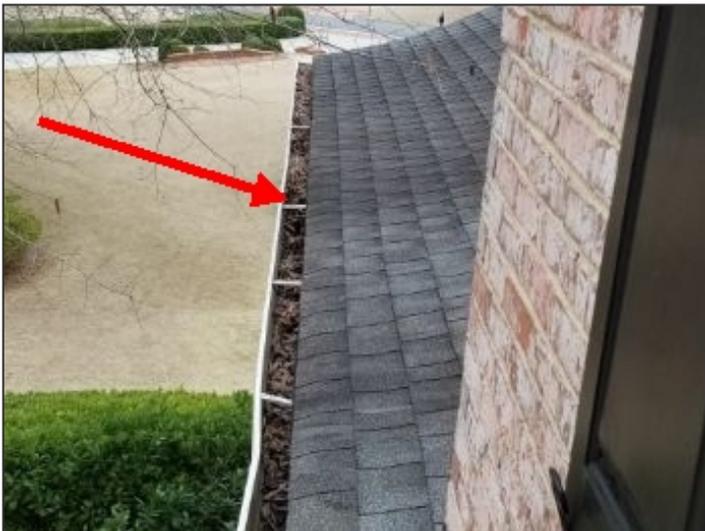
Gutter debris at front roof

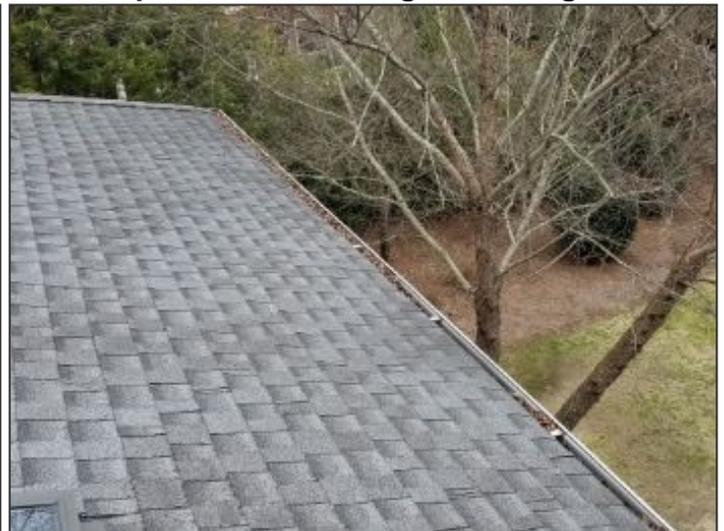
Gutter debris at rear roof

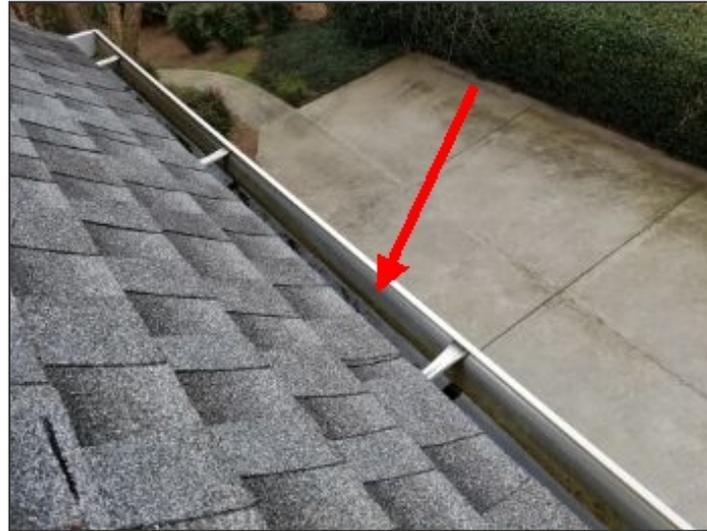
Garage gutter holding water

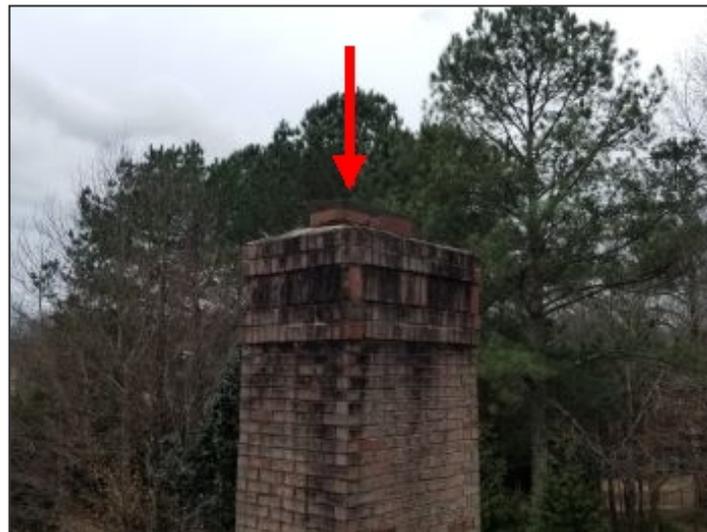
- **Two brick masonry chimneys are present.**
- **A wood frame chimney is present with stucco coating.**
- **The chimneys appear serviceable; no concerns were observed except as mentioned below.**
- **The rear kitchen keeping room chimney is missing the flue caps. This condition is leaving the flues open to the exterior which is not recommended. Correction is suggested to install properly sized flue caps at the masonry chimney flues.**

Missing flue caps at masonry chimneys

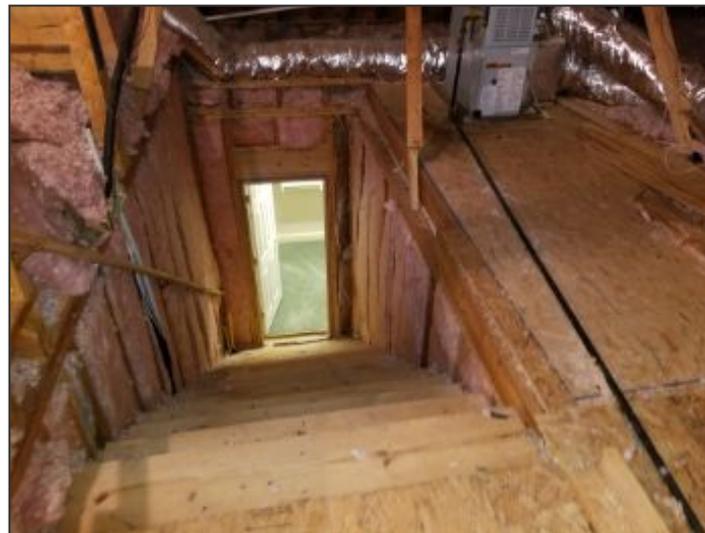
The floored attic does not have any safety guard railing as needed around the staircase opening (see photo). This condition is a safety concern. Correction is recommended.

No guard railing at top of attic staircase

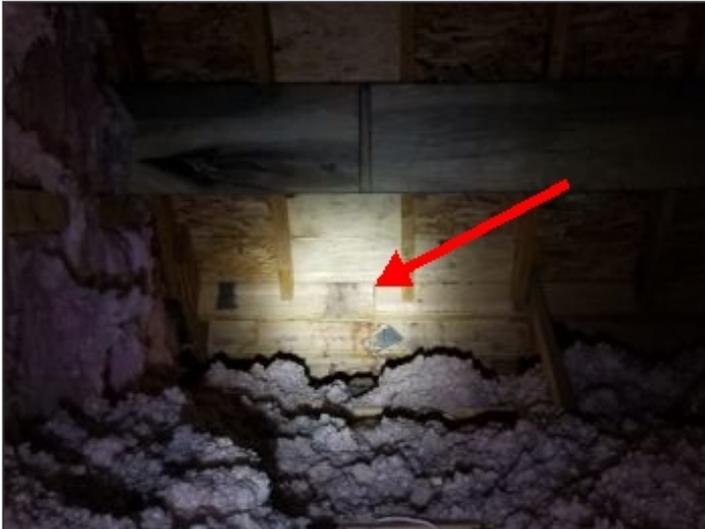
• **Water stains were noted in the attic at the front roof above the office / living room, the front corner of the family room chimney, and at the intersecting roof behind the family room chimney (see photos). This condition may be the result of previous roof leaks from the older roof that has since been replaced but this could not be verified during this limited visual inspection. There were no signs of active leaks during this inspection period and after recent rains. Ask seller for disclosure information regarding any past roof leaks. Continue to monitor, future repair may be needed.**

Evidence of an old leak at front roof above office

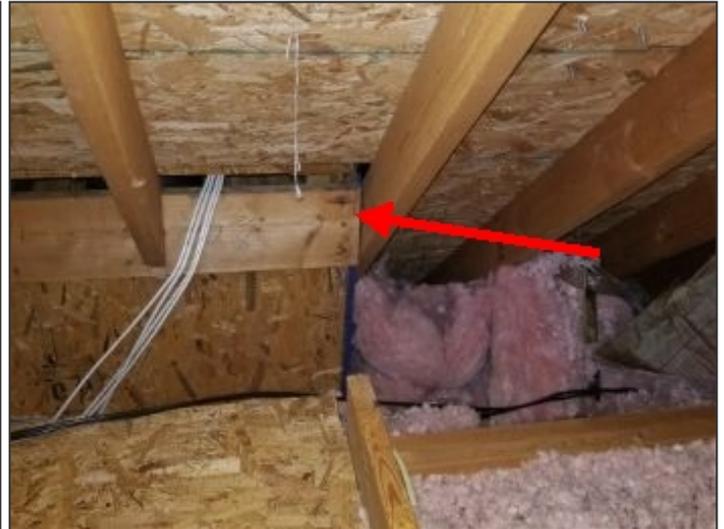
Evidence of a previous leak at corner of family room chimney - dry at time of inspection

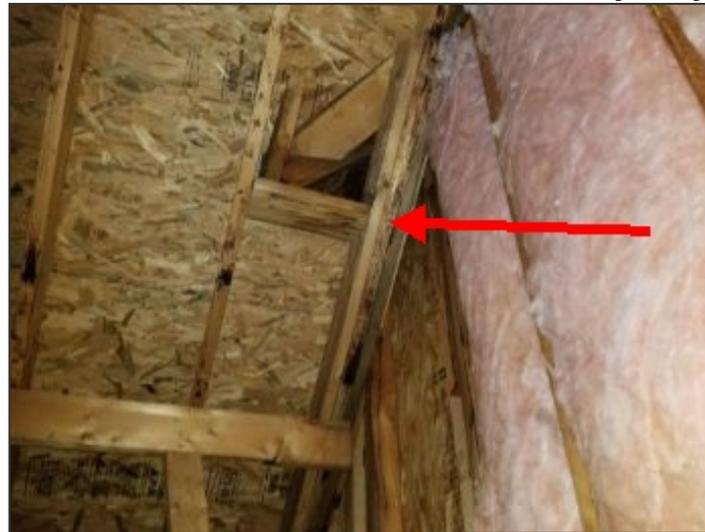
Evidence of a previous leak at rear roof intersection behind family room chimney

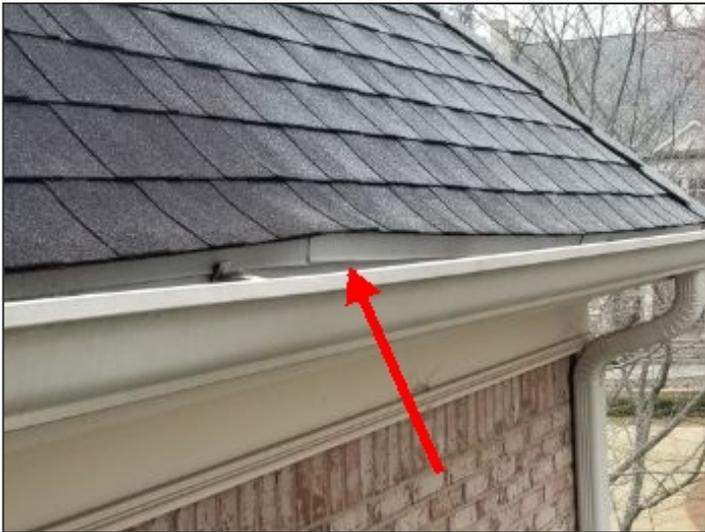
• Rodent exclusion methods (**drip edge** flashing) were observed at the lower eaves of the roof location which is an indication of rodent exclusion work (see photo). Ask seller for more information regarding rodent proofing work and any remaining warranty coverage.

Rodent exclusion methods at eaves of roof

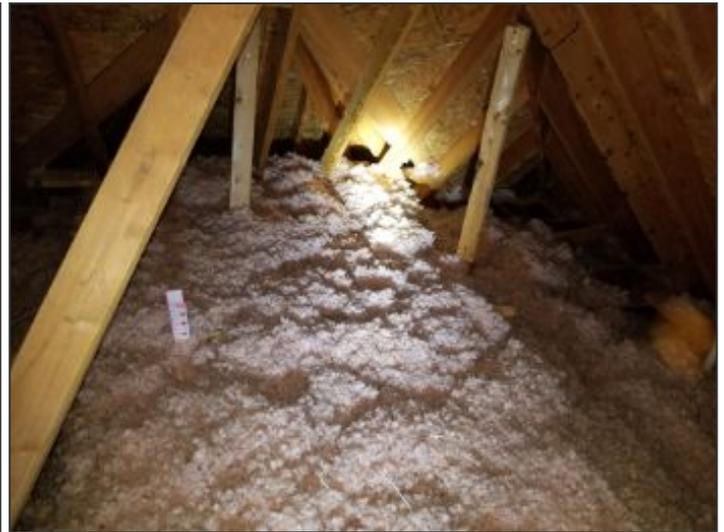
• **RODENT ACTIVITY NOTED:**
There is evidence of rodent activity in the attic:

Rodent trails in attic insulation

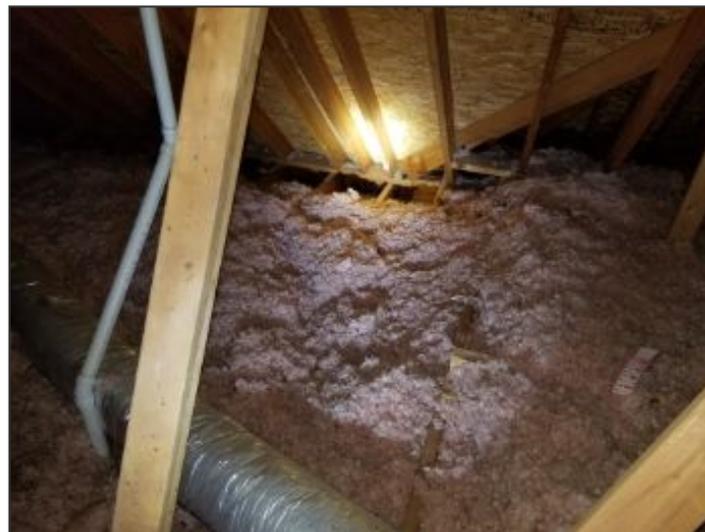
Rodent trails in attic insulation

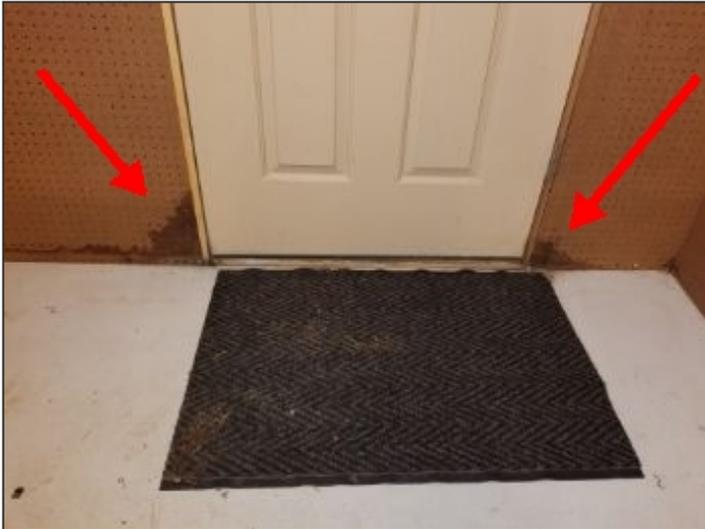
- Evidence of water entry was observed at the basement unfinished rear entry door - the wall board has elevated moisture levels when measured with a Tramex moisture meter (see photo). Further evaluation is recommended by a professional door contractor to determine repair needs and costs.

Evidence of water entry at rear basement door

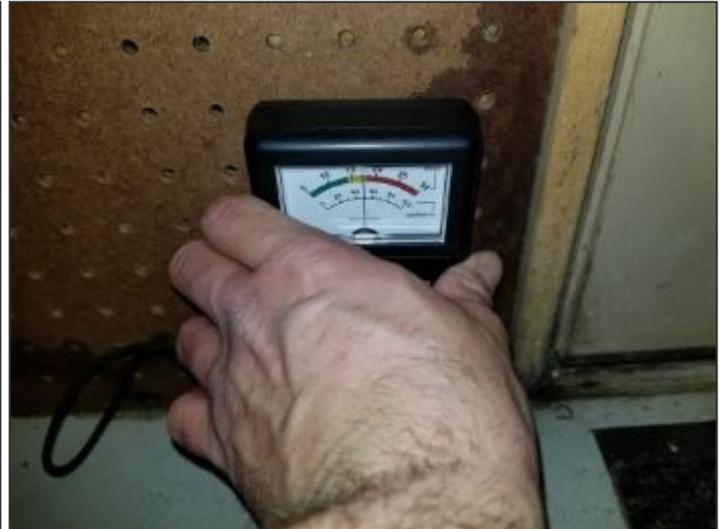
Elevated readings at left side of basement entry door

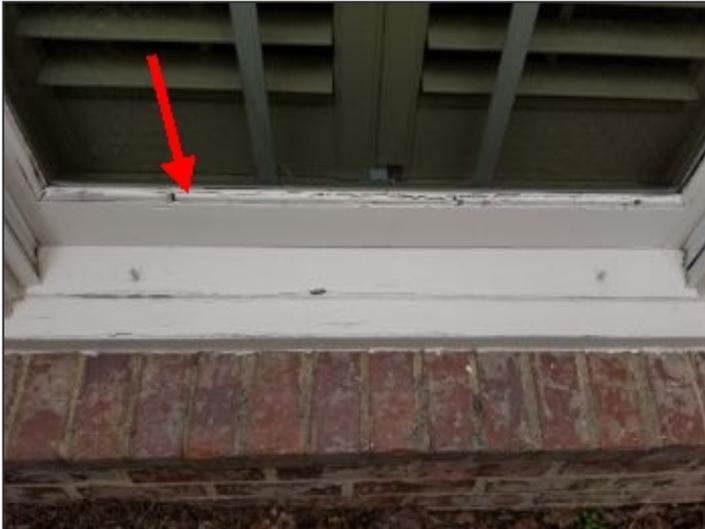
Damaged window frame at rear right basement window

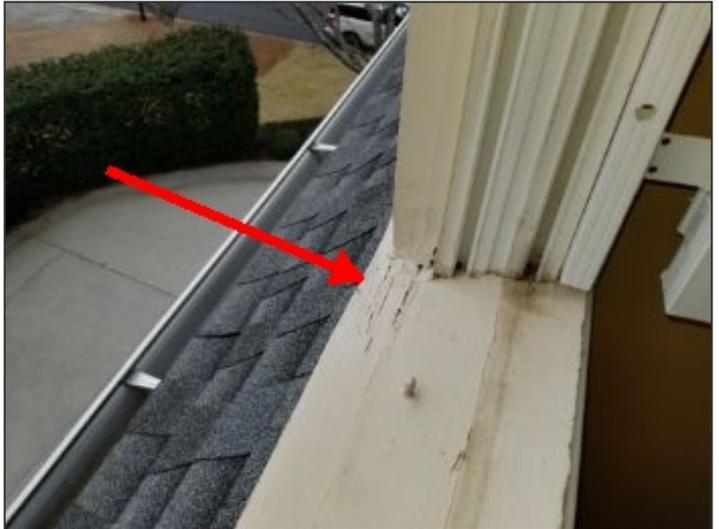
- Minor water damage was noted to the window sill at the window above the overhead garage doors (see photo). The damaged area appears to be isolated to the "nose" of the sill only which is often a relatively easy and inexpensive repair. Replacement of the damaged wood is recommended; continue to keep this window well sealed.
- Water damage was noted to the window frame at the rear right corner basement window (see photo). The damaged frame is difficult to repair and may require full window replacement. Further evaluation is recommended by a professional window contractor to determine the full extent of repair or replacement needs and costs.

Damaged window sill at side window in bonus room above garage

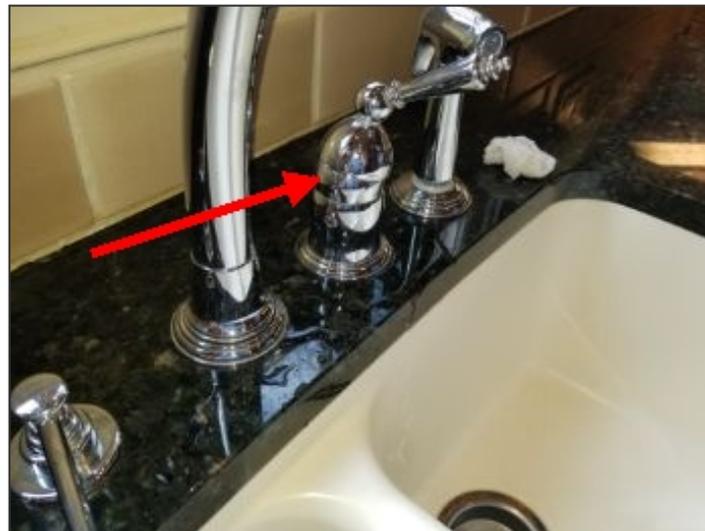
- **A porcelain sink is present;**
- **The kitchen sink faucet handle has an active leak when put into the cold water position (see photo). Further evaluation and correction is recommended by a professional plumber.**

Active leak at kitchen sink faucet handle

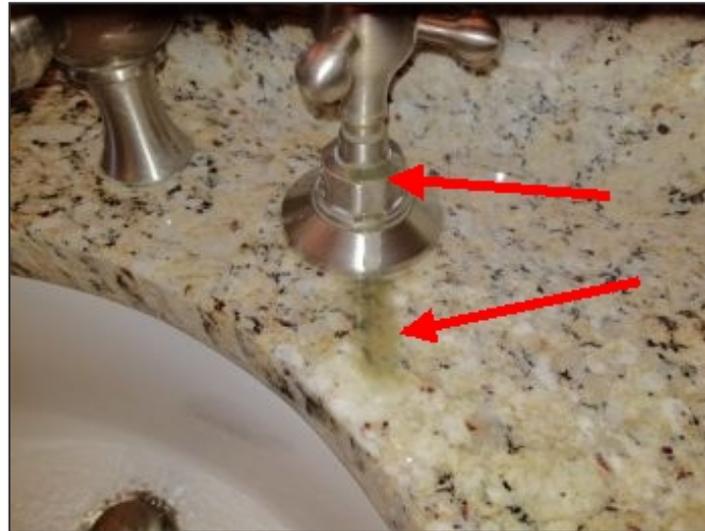
Active leak at cold water master bathroom sink handle

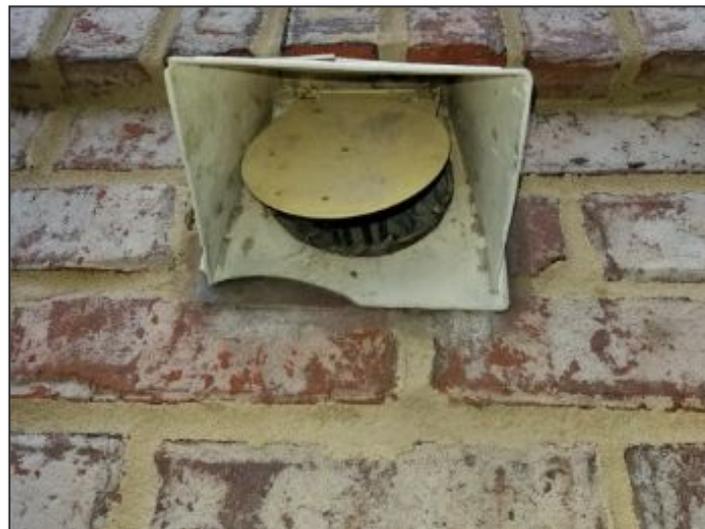
• **The dryer exhaust vent cover is damaged / disconnected at the top of the flapper that does not allow the vent cover to fully close (see photo). Cleaning is recommended, continue to monitor and clean as needed.**

Dryer vent flapper not fully close

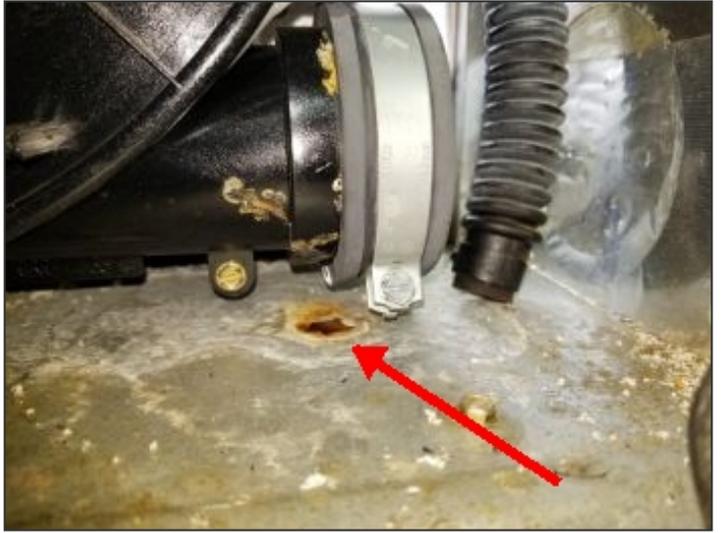
- An active condensate leak was observed at the rubber cap at the right side of the inducer fan (see photo). Repair is recommended by a professional HVAC contractor.

Small drip leak inside of basement furnace

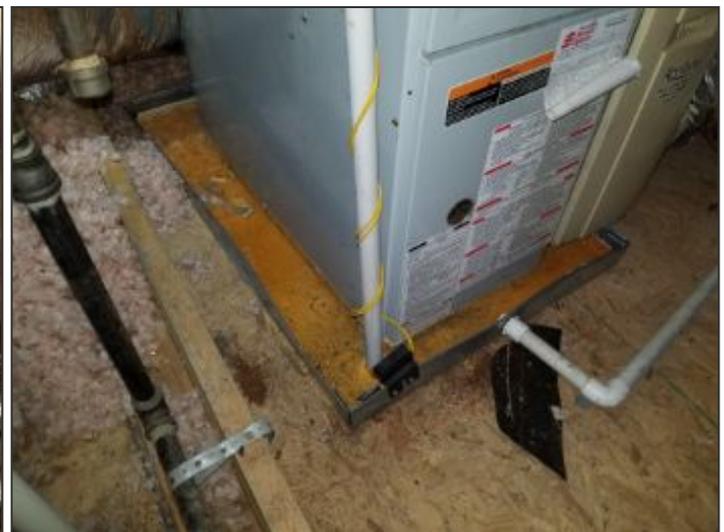
• Rust and corrosion are visible inside the condensate drain pan on the floor below the furnace. This condition is an indication that the primary condensate drain line has been previously clogged or is currently clogged. Ask seller for any history of repairs regarding this issue. If no repair information is available, further evaluation is recommended by a professional HVAC contractor to determine repair needs.

Rust staining in drain pan below master furnace

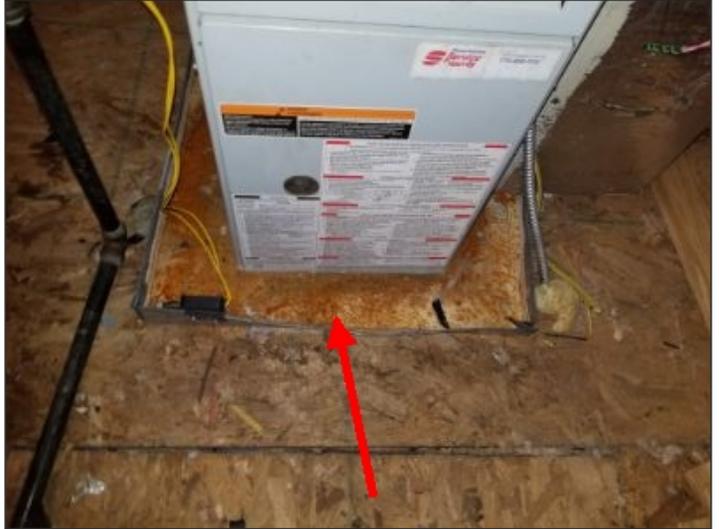
Rust staining in drain pan below second floor furnace
