**Amerispec**  
**PO Box 350**  
**Loganville, GA 30052**  
**Jess.Hodges@AmeriSpec.biz**

Doc #:	202002-16978	Inspector:	Zach Flory
Date:	2/25/2020		
Dwelling Address:	1250 Spring Oak Way Cumming GA 30041		
Client Name:	Alexander Garland		
Client's Agent:	Leiah Clark

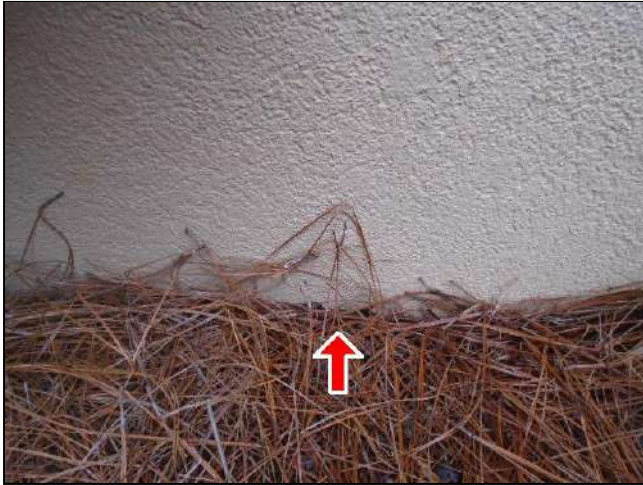
(1) Portions of the siding at the front of the home are very close to or in direct contact with the ground. This can cause accelerated deterioration and a higher probability of pest infestation. Recommend further evaluation by a licensed contractor for corrections to prevent potential damage.

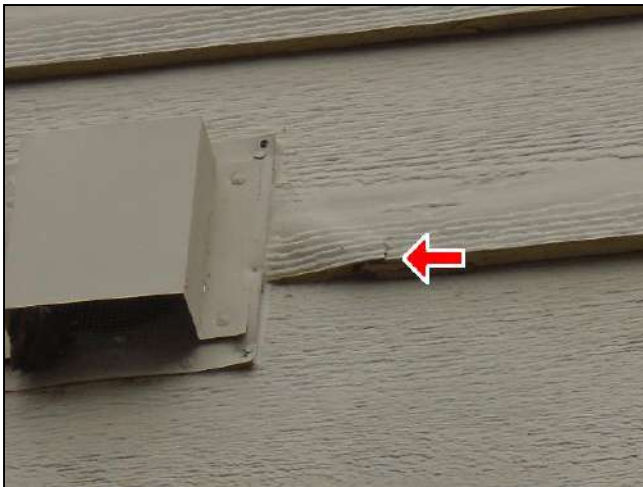
(2) Deterioration and/or swelling observed in sections of the hardboard siding located at the left side of the home. This material is subject to water absorption and should be regularly painted/sealed to prevent moisture damage. Suggest further evaluation by a qualified contractor for maintenance and/or repairs to prevent further damage/deterioration or replacement as needed.

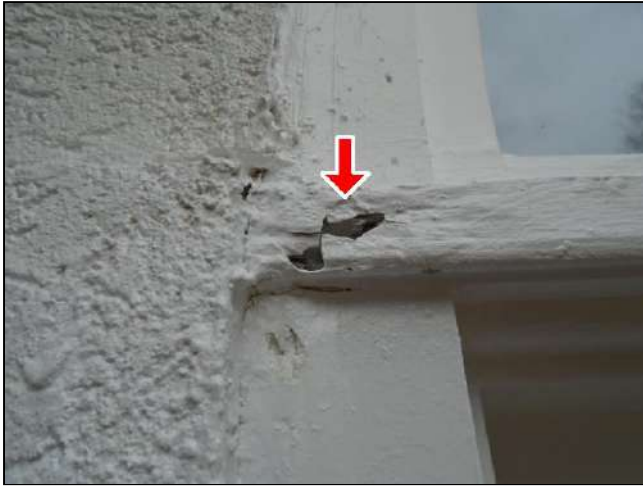
Damaged/deteriorated trim observed at the main entry door. Recommend review by a qualified contractor for repairs to prevent further damage or replacement as needed, prior to close.

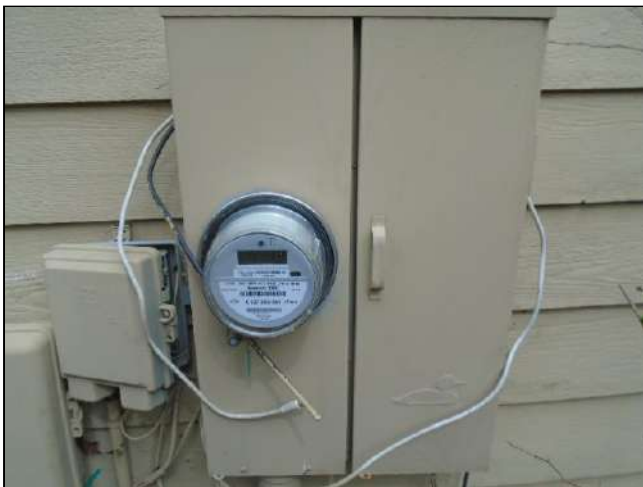
(1) GFCI located at the deck did not trip when tested (defective); suggest review by licensed electrician for repairs or replacement prior to close.

(2) The electric meter is located at the left side of the home. The main shut off is located at the meter.

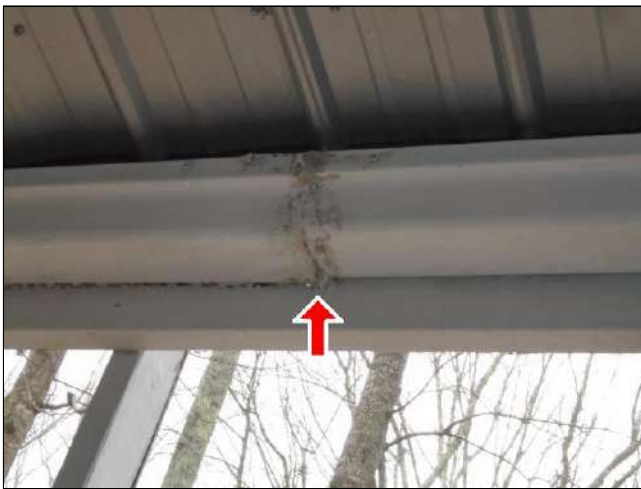
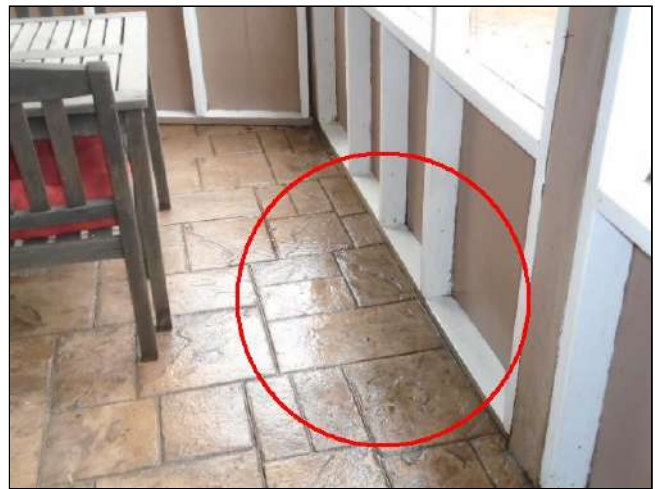
(1) Drainage system at the basement patio area appears to be leaking. Recommend review by a qualified contractor for corrections to prevent damage and deterioration of construction materials at these areas.

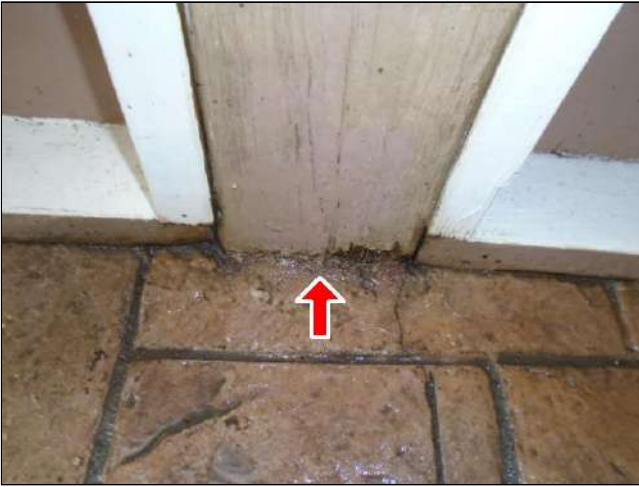
(2) The deck support posts are resting in concrete. This limits the inspectors ability to determine proper footings under the posts, limits the review of potential damage/deterioration at the base of the posts, and may cause wood deterioration/moisture damage. it is typically advised that support posts rest on cleats that allow air-flow around and under the posts. Recommend further evaluation for corrections as needed by a licensed contractor prior to close.

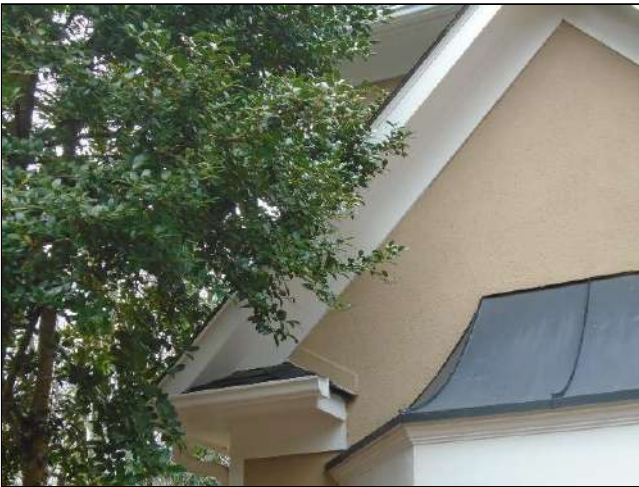
A tree at the front of the home is in contact with or very close to the dwelling. Trees this close can cause damage during winds or as the tree continues to grow. Removal by a qualified arborist or other options to prevent such damage is recommended.

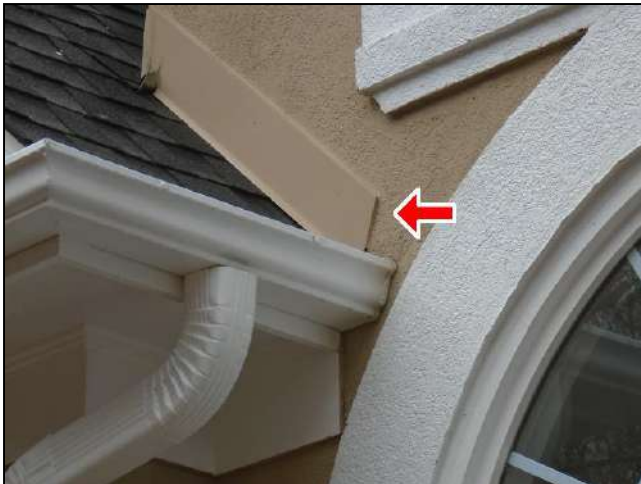
(1) No kick-out flashing is present at the bottom of the roof-to-wall flashing. Normally, a diagonal piece of flashing should be present to divert water running down the roof off the wall of the house and into a gutter or to the ground. Water running onto the siding and trim can create an excessive moisture condition which can lead to deterioration of these materials. We recommend kick-out flashing be installed by a qualified professional.

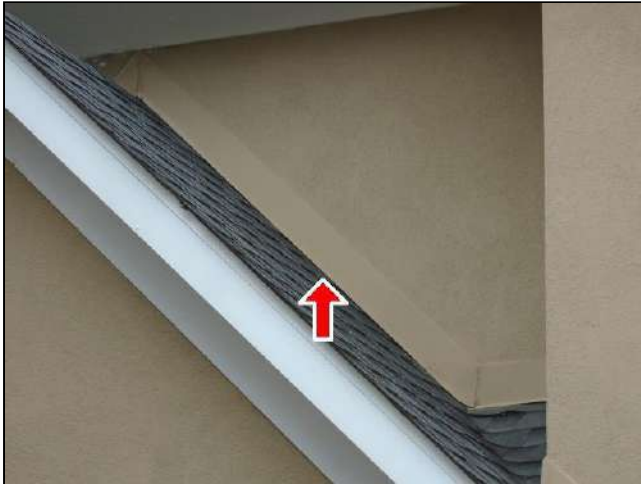
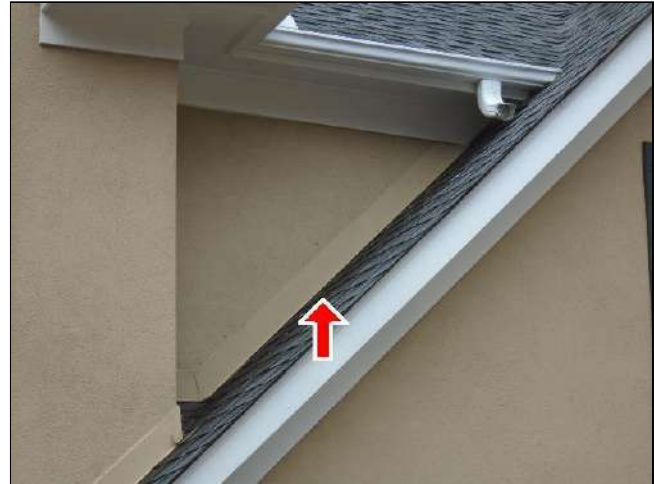
(2) Inspector is unable to determine if step flashing is present. Visible flashing observed installed over the shingles whereas step flashing is installed beneath the shingles. Recommend further evaluation by a licensed roofer to verify proper installation of the flashing or for corrections as needed prior to close.

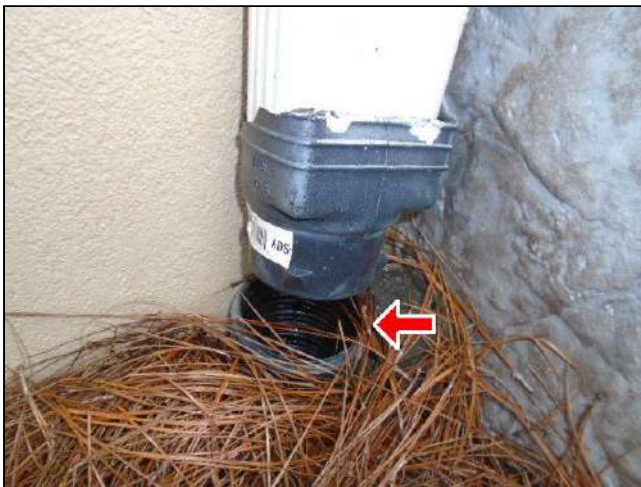
(1) Gutter downspouts were detached and may not drain as intended. Recommend review by a qualified professional for corrections as needed.

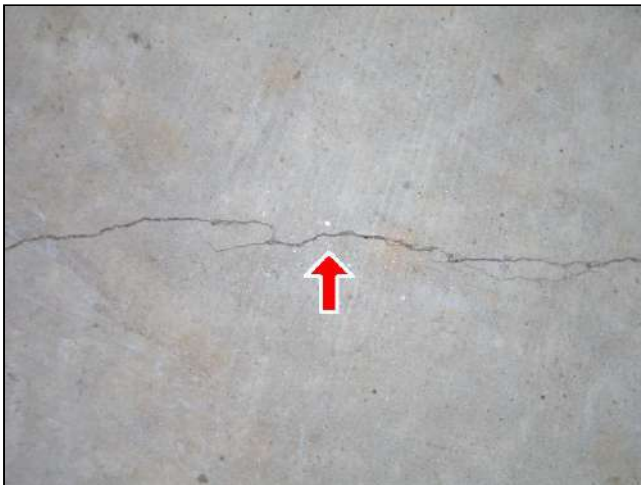
Minor cracking observed, recommend maintenance and repairs by a qualified contractor as needed.

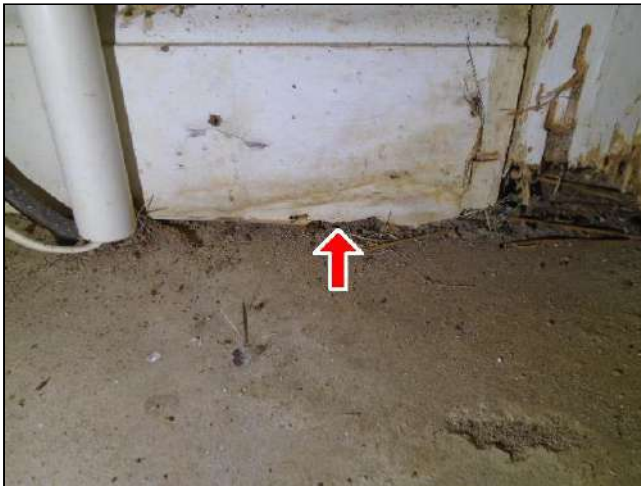
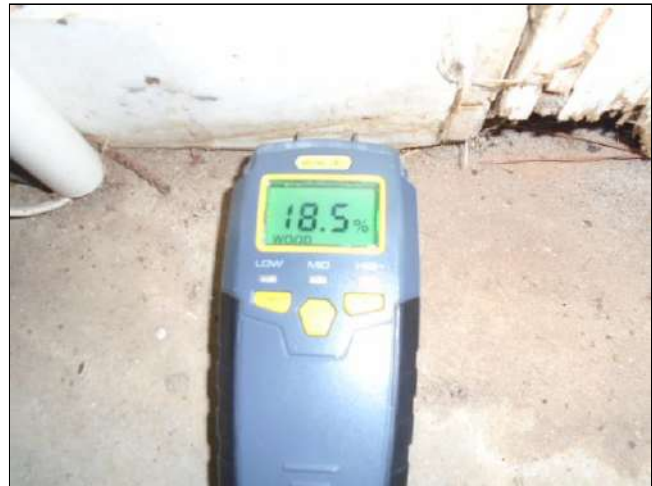
(1) Stains observed on the garage posts. An elevated level of moisture was detected using an electronic moisture meter. A qualified contractor is needed for further review to determine the source of the moisture and to perform necessary corrections prior to close.

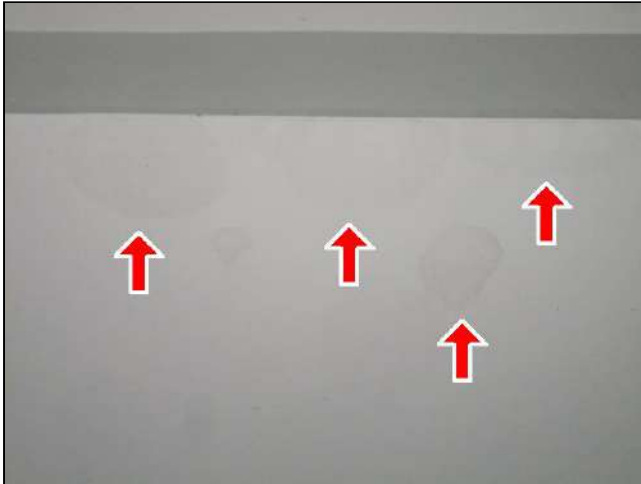
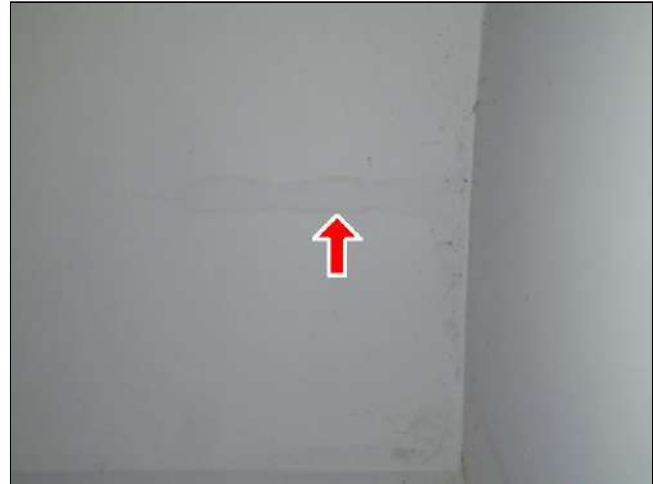
Stains observed on ceiling in the garage ceiling, inaccessible with a moisture meter. Client is advised to consult seller to determine the source of staining and verify that corrections have been made or have reviewed by a qualified contractor for corrections as needed.

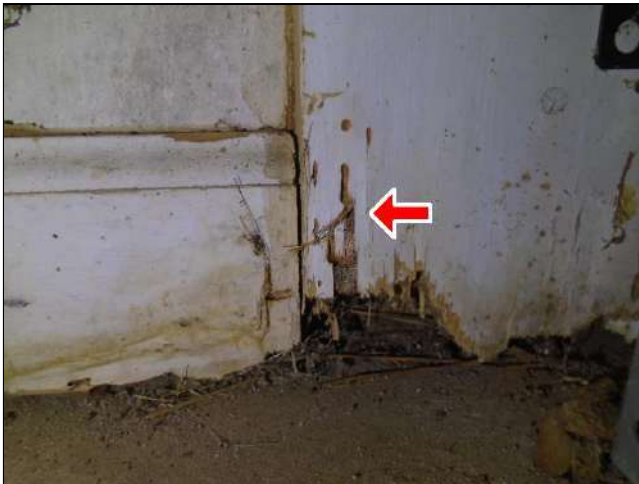
(1) Although identification of termites is beyond the scope of a general home inspection, mud tubes or damaged areas indicative of possible termite activity were observed at the garage door post. We are unable to determine if it is currently active or the extent of any potential damage. We suggest consulting with homeowner regarding any past history of treatment. We recommend arranging for further review by a licensed pest control specialist prior to close and review by a qualified contractor for repairs of any potential damage.

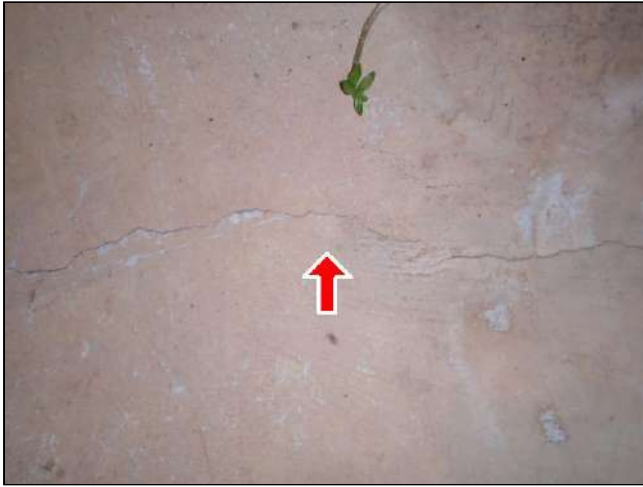
Minor settlement cracking observed in the slab at the front. Inspector is unable to determine when settlement occurred or if additional settlement is likely. It is suggested to seal all cracks in the slab to prevent moisture or pest intrusion. Settlement does not appear to be affecting the serviceability of the structure. Recommend review by licensed contractor for corrections prior to close.

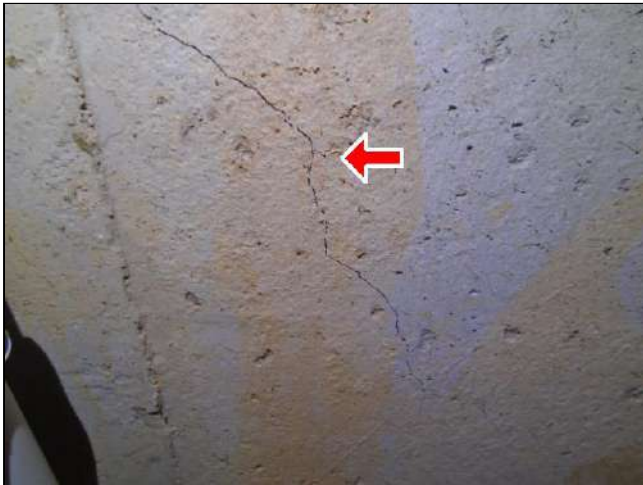
(1) Minor settlement cracking observed at the front wall. This is an indication that previous settlement has occurred at this location. The inspector is unable to determine when settlement occurred or if additional settlement is likely. Settlement does not appear to be affecting the serviceability of the structure. It is suggested to seal all cracks to prevent moisture or pest intrusion. Recommend review by a licensed contractor for further evaluation and corrections as needed prior to close.

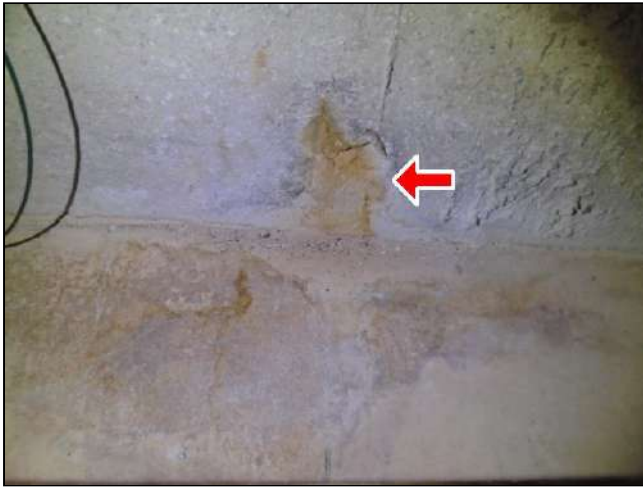
(2) Efflorescence is present on the front foundation wall in the basement at an area of cracking. Efflorescence is the salts left behind from moisture soaking into or passing through a masonry product. This moisture could adversely affect the foundation and/or the basement environment. Recommend review by a licensed contractor specializing in moisture control to determine the source of moisture and recommend or make necessary corrections to prevent further moisture intrusion.

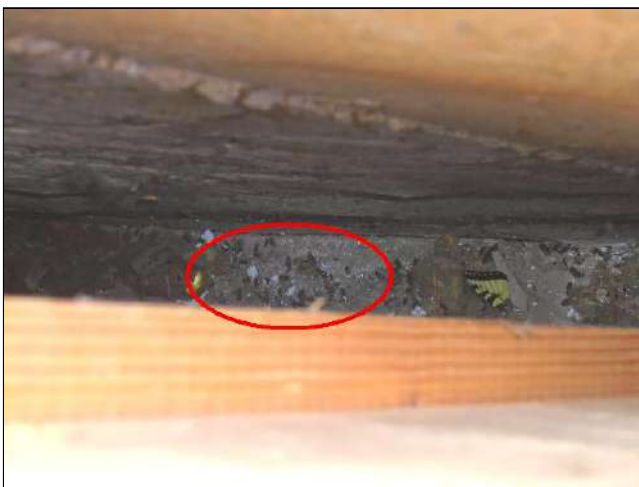
Wildlife droppings or other evidence of wildlife activity observed. Suggest review by licensed pest control specialist for treatment as needed.

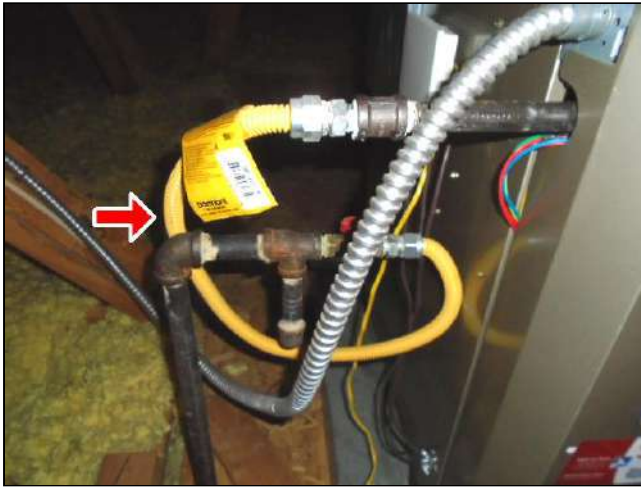
The gas piping system of this home includes corrugated stainless steel tubing (CSST). This flexible gas line system has specific installation requirements related to electrical bonding, designed to reduce the potential for lightning related electrical arcing that can perforate the tubing and result in gas leaks or fires. During the home inspection, the CSST could not be verified to be integrally bonded or to have a bonding attachment. An electrical contractor should be consulted for a complete evaluation of the CSST installation to ensure the presence of an electrical bonding path.

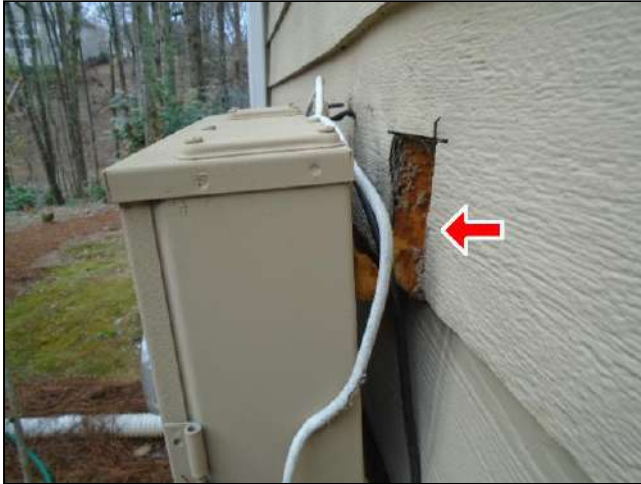
Electrical meter is pulled away from the home. Recommend review by a qualified professional for corrections prior to close to ensure safe, proper function of all electrical components.

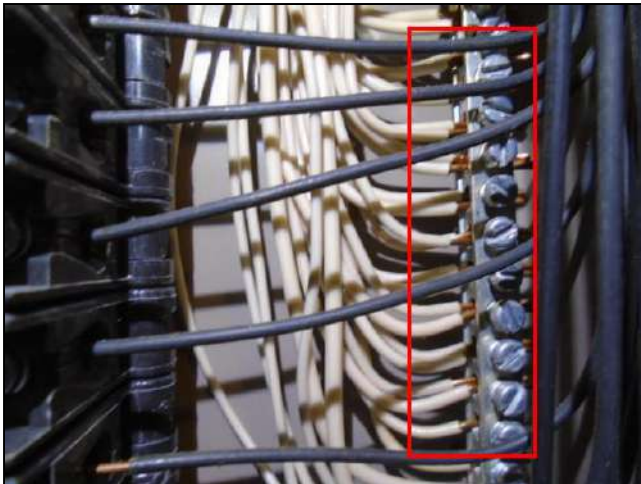
(1) Doubled up neutral were noted in the main panel. Doubling up on the neutrals creates a significant problem when the circuit needs to be isolated. Each neutral conductor should terminate within the panel board in an individual terminal. Each neutral conductor shall terminate within the panel board in an individual terminal that is not also used for another conductor. In order to isolate the circuit, the branch breaker is turned off and removing the neutral conductor from the terminal and re-locating to an open neutral bus terminal and securing the neutral wire. A licensed electrician is needed to review this panel and make all corrections necessary to ensure safe and proper operation of the system.

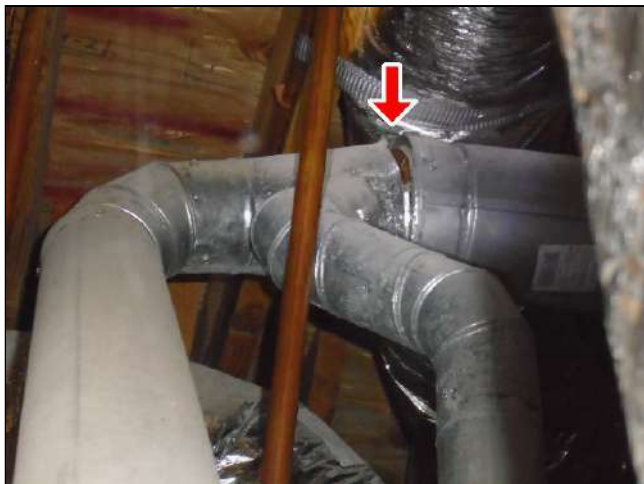
Gap observed in vent pipe, which is a serious safety concern. Recommend review by a licensed heating contractor for repair or replacement, prior to close.

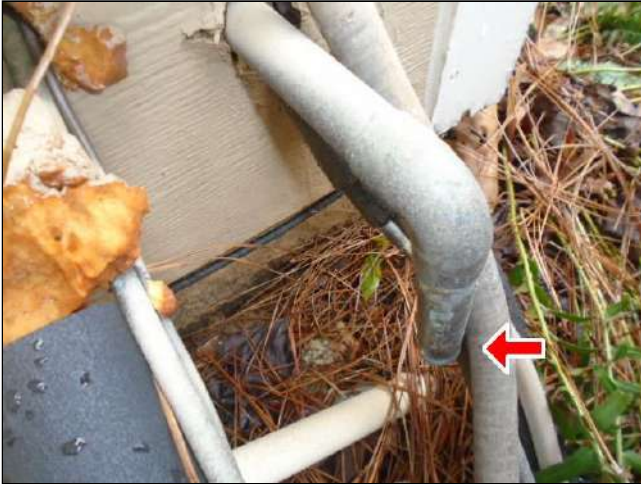
(3) Condensate drainpipe from the AC unit terminates near the foundation of the house. Condensate drainpipe should be extended away foundation wall.
