Inspection Report

Property Address:
2567 Briars N Dr
Atlanta GA 30360

Avalon Home Inspections

Date: 1/27/2020	Time: 10:00:00 AM	Report ID: 28737TS
Property: 2567 Briers N Dr Atlanta GA 30360	Customer: Craig Dixon	Real Estate Professional: Barbara Neuman Keller Williams Peachtree Road

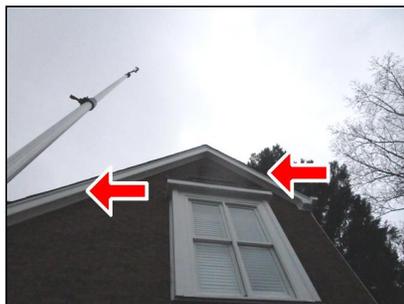
1.1 Item 1(Picture)

The metal drip edge is missing along rake/eaves. Moisture or water could leak in to attic when raining. A qualified roofing contractor should inspect and repair as needed.

Recent changes in code require installation of drip edge flashing when roof is replaced. This change is not retroactive on shingles installed prior to 2012.. This also supports edge of roof shingles and covers the "builder gap" between fascia board and roof sheathing.

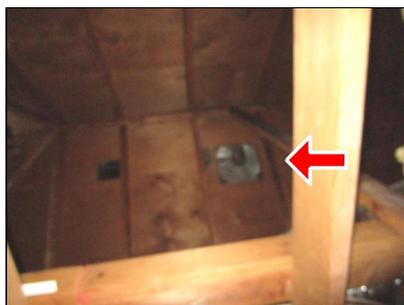
1.6 Item 1(Picture)

Thermostatically controlled vent fan in the attic is too high to test and not hot enough for it to come on. This is for your information. A qualified contractor should inspect and repair as needed.Item 1(Picture)

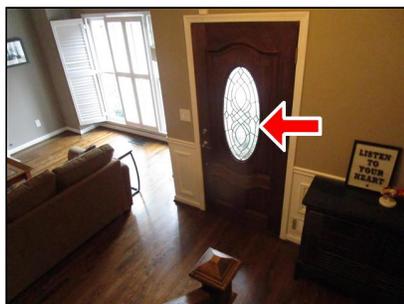
2.1 Item 1(Picture)

(2) The entry door front of home has a cracked glass pane. A repair or replacement is needed. A qualified contractor should inspect and repair as needed.Item 1(Picture) Item 2(Picture)

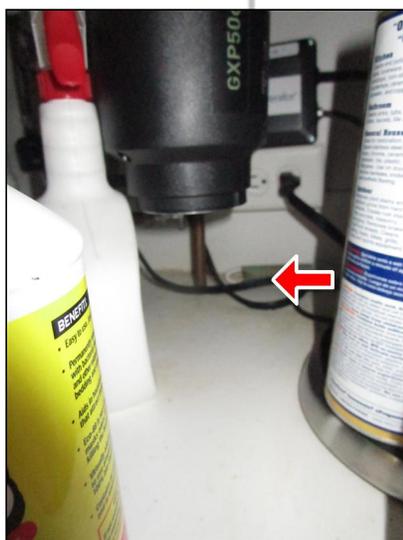
4.12 Item 1(Picture)

The food disposer wiring is improper(not in conduit). Repairs are needed. A qualified electrician should correct as needed. Item 1(Picture)

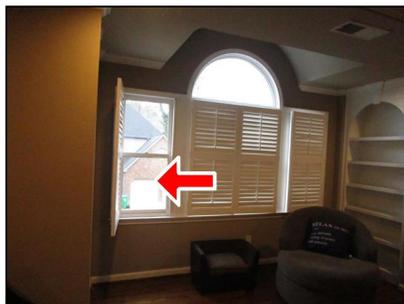
5.5.B Item 1(Picture)

(1) One window stuck or painted shut at the master bedroom. A repair may be needed. A qualified contractor should inspect and repair as needed. Item 1(Picture) Item 2(Picture) Item 3(Picture)

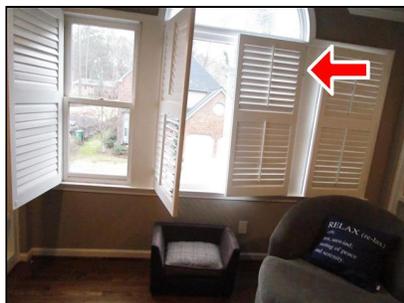
5.5.B Item 4(Picture)

(2) One window plantation shutter has pulled loose at window frame at the master bedroom. A repair may be needed. A qualified contractor should inspect and repair as needed. Item 4(Picture) Item 5(Picture)

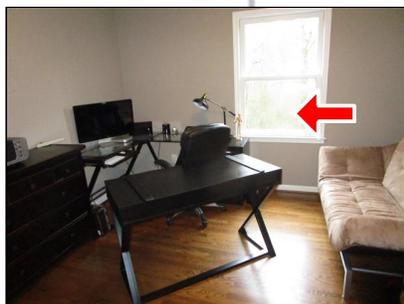
5.5.B Item 6(Picture)

(3) One window is cloudy (lost seal) at the guest bedroom. In order to correct the cloudy appearance of glass, a replacement of glass pane or the unit will be necessary. A qualified contractor should inspect and repair as needed. Item 6(Picture) Item 7(Picture)

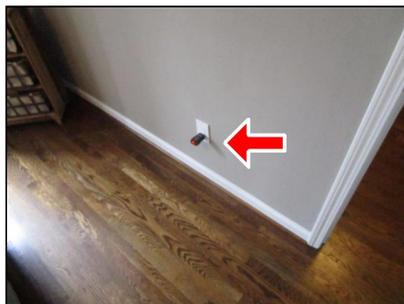
5.6.B Item 1(Picture)

At least one "three-prong" outlet is not grounded in the guest bedroom. Electrical issues are considered a hazard until repaired. A qualified licensed electrical contractor should perform repairs that involve wiring. Item 1(Picture) Item 2(Picture)

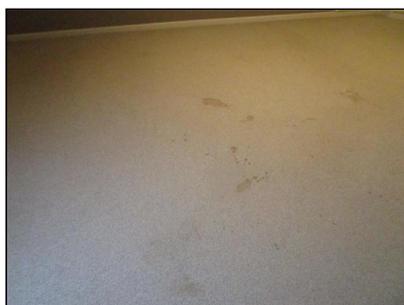
5.2.D Item 1(Picture)

The Carpet is stained at the bonus room. While this damage is cosmetic, the repair cost should be considered due to the amount of damage. A qualified contractor should inspect and repair as needed.Item 1(Picture) Item 2(Picture)

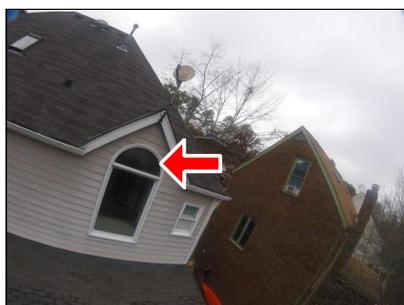
6.3.A Item 1(Picture)

One window is cloudy (lost seal) at the master bath. In order to correct the cloudy appearance of glass, a replacement of glass pane or the unit will be necessary. A qualified contractor should inspect and repair as needed.Item 1(Picture)

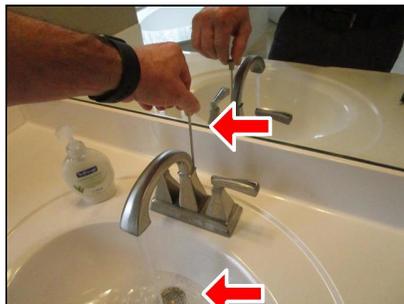
6.4.A Item 1(Picture)

The stop-valve linkage for sink is disconnected at the master bath. Repairs are needed. A qualified licensed plumber should repair or correct as needed. Item 1(Picture)

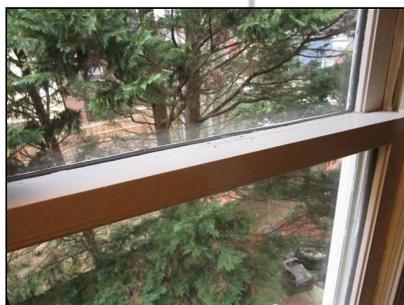
6.3.B Item 1(Picture)

One window is missing lock hardware at the hall bath. This is a small repair. A qualified contractor should inspect and repair as needed. Item 1(Picture) Item 2(Picture)

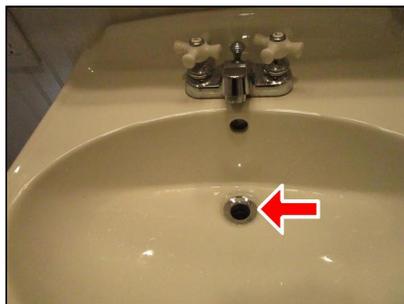
6.4.B Item 1(Picture)

The stop-valve for sink is missing at the lower level bath. Repairs are needed. A qualified licensed plumber should repair or correct as needed. Item 1(Picture)

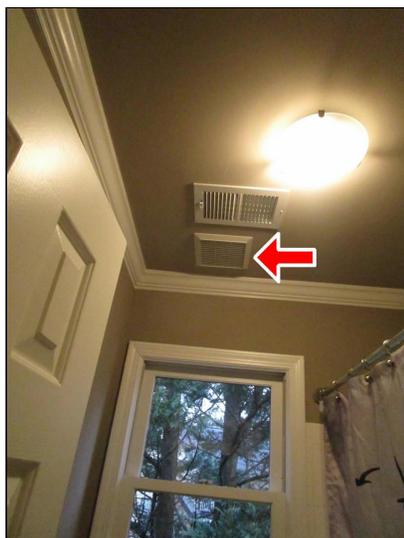
6.7.B Item 1(Picture)

The exhaust fan did not work at the upstairs hall bath. This is a safety issue that needs repair. A qualified contractor should inspect and repair as needed. Item 1(Picture)

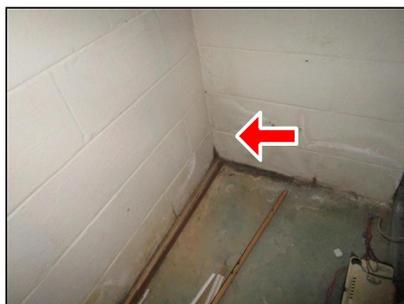
7.0 Item 1(Picture)

(2) Evidence of prior water intrusion was found in one or more sections of the basement. For example, water stains or rust at support post bases, efflorescence on the foundation, etc. Accumulated water is a conducive condition for wood-destroying organisms and should not be present in the basement. Recommend reviewing any disclosure statements available and ask the property owner about past accumulation of water in the basement. The basement should be monitored in the future for accumulated water, especially after heavy and/or prolonged periods of rain. If

water is found to accumulate, then recommend that a qualified contractor who specializes in drainage issues evaluate and repair as necessary. Typical repairs for preventing water from accumulating in basements include:

Ideally, water should not enter basements, but if water must be controlled after it enters the basement, then typical repairs include installing a sump pump. Item 2(Picture) Item 3(Picture) Item 4(Picture) Item 5(Picture)

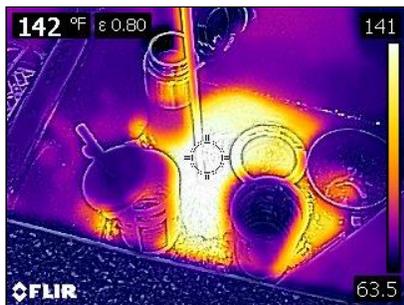
8.2 Item 2(Picture)

(2) The hot water temperature was greater than 120 degrees Fahrenheit. This is a safety hazard due to the risk of scalding. The thermostat should be adjusted so the water temperature doesn't exceed 120 degrees. If the water heater is powered by electricity, a qualified person should perform the adjustment, since covers that expose energized equipment normally need to be removed. Item 3(Picture) Item 2(Picture)

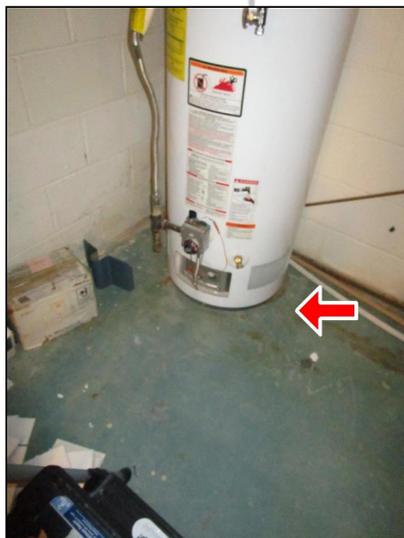
8.2 Item 4(Picture)

(3) The water heater is missing over flow pan with drain line. Leaks can cause damage to unit or home. A qualified licensed plumber should repair or correct as needed.

If it is not possible to install a gravity flow pan due to location of water heater, it is recommended to at least install a moisture sensor that will alert you by cell phone or have your monitored alarm company install one for you. This is FYI. Item 4(Picture)

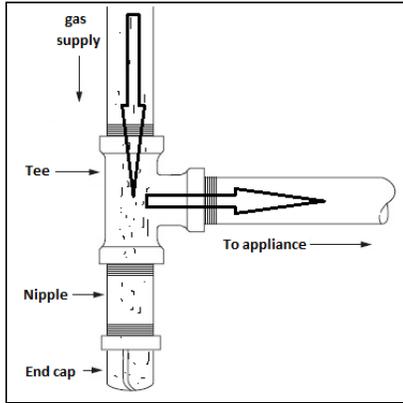
8.4 Item 1(Picture)

(1) The gas line's sediment trap is installed improperly(does not change directions) at furnace. This can cause damage to the unit or shorten its life span. A qualified contractor should inspect and repair as needed. Item 1(Picture) Item 2(Picture)

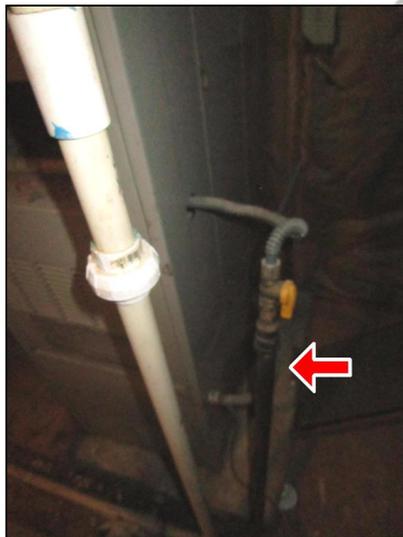
8.4 Item 3(Picture)

(2) The gas line is missing sediment trap at furnace. This can cause damage to the unit or shorten its life span. A qualified contractor should inspect and repair as needed. Item 3(Picture)

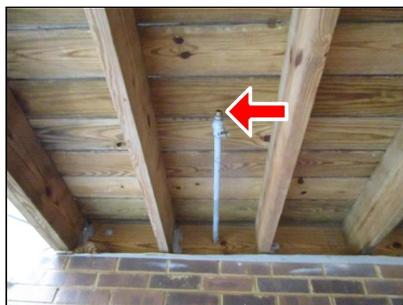
8.4 Item 4(Picture)

(3) The gas line is missing a cap and can be turned on inadvertently at the rear deck. This is a safety issue and should be repaired. A qualified contractor should inspect and repair as needed. Item 4(Picture) Item 5(Picture)

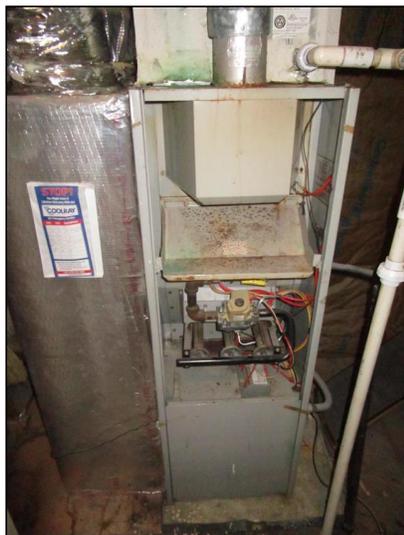
8.4 Item 6(Picture)

(4) The gas line was installed improperly using soft copper or CSST pipe through wall instead of hard piping at the furnace. This is a safety issue and should be repaired. A qualified contractor should inspect and repair as needed.

IRC R2422.1.2. Item 6(Picture)

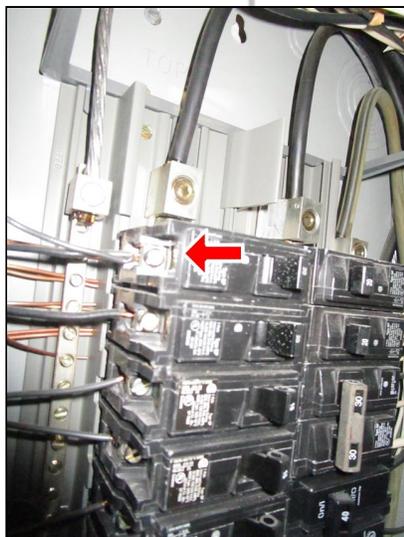
9.1 Item 1(Picture)

(1) The problem(s) discovered in the sub and main panels such as doubled wiring at circuit(s), and any other problems that an electrical contractor may discover while performing repairs need correcting. I recommend a licensed electrical contractor inspect further and correct as needed. Item 1(Picture) Item 2(Picture)

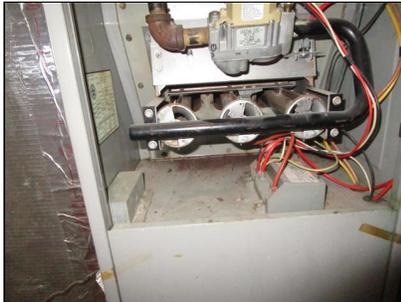
10.0 Item 2(Picture)

(2) The gas furnace will fire, but carbon deposits on burners or jets indicate the need to service. A more thorough inspection by a qualified contractor is needed. A qualified HVAC person should inspect further and repair or replace as needed. Item 2(Picture)

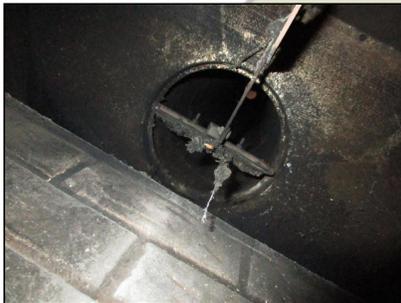
10.8 Item 1(Picture)

The liner was partially visible and appeared good, but due to creosote build-up we could not inspect for cracks. I recommend a licensed chimney sweep clean and inspect for safety. Item 1(Picture)

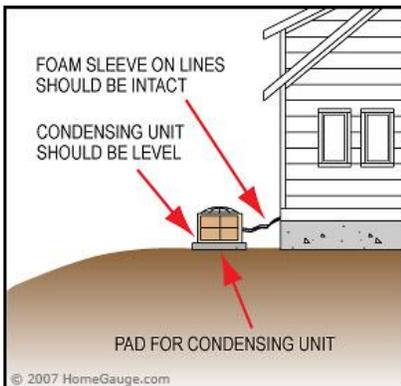
10.10 Item 2(Picture)

(2) The foam sleeve on suction line is missing foam sleeve in area(s) at outside unit. Missing foam on suction line can cause energy loss and condensation. I recommend service or repair as needed. Item 2(Picture) Item 3(Picture)

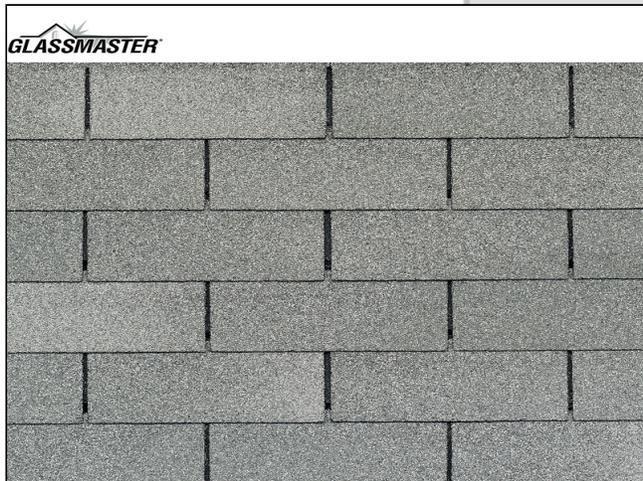
1.0 Item 1(Picture)

i (2) The roof covering appears to be the over 10 years old. This is the inspectors "reasonable estimate" based a visual review on what appears to be normal granular deterioration of the roof covering. If an exact age and future useful life of the roof is needed I would recommend that a licensed roofing contractor evaluate and verify the age of the roof and estimate its future useful life. This is for your information

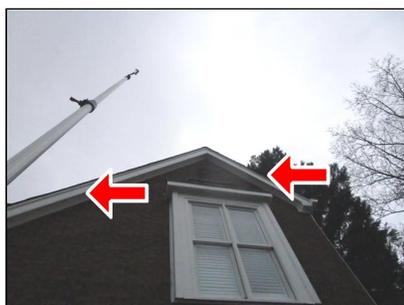
1.1 Item 1(Picture)

🔨 The metal drip edge is missing along rake/eaves. Moisture or water could leak in to attic when raining. A qualified roofing contractor should inspect and repair as needed.

i Recent changes in code require installation of drip edge flashing when roof is replaced. This change is not retroactive on shingles installed prior to 2012.. This also supports edge of roof shingles and covers the "builder gap" between fascia board and roof sheathing.

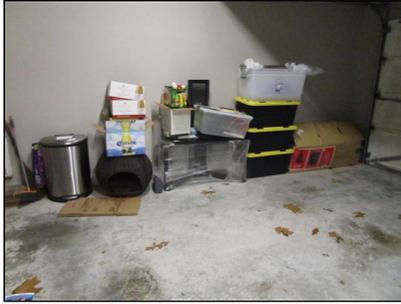
3.1 Item 1(Picture)

Some walls were obstructed with stored items. Stored items can obstruct damage that would of been otherwise noticed. This is FYI. Item 1(Picture) Item 2(Picture)

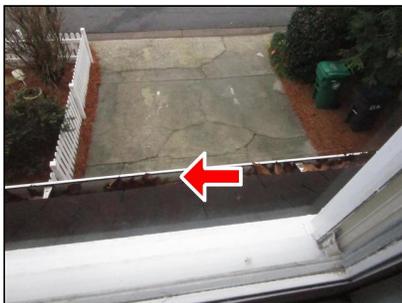
1.4 Item 3(Picture)

(2) The gutters need cleaning of debris at virtually all areas where gutters are installed. Gutters that drain poorly or clogged can lead to many costly problems such as deterioration of fascia, soffit or roof edge. It can also cause gutters to pull loose and lead to possible water intrusion. A qualified person should clean as needed. Item 3(Picture) Item 4(Picture)

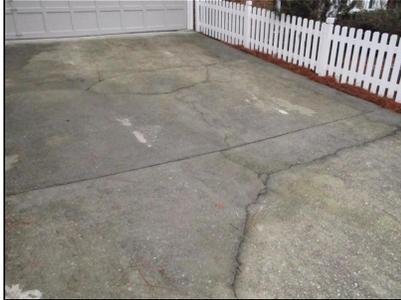
2.4 Item 1(Picture)

(2) The concrete drive at the front of home has typical expansion cracks. Water can cause further deterioration if not sealed properly. I recommend prep and seal using a qualified contractor. Item 1(Picture)

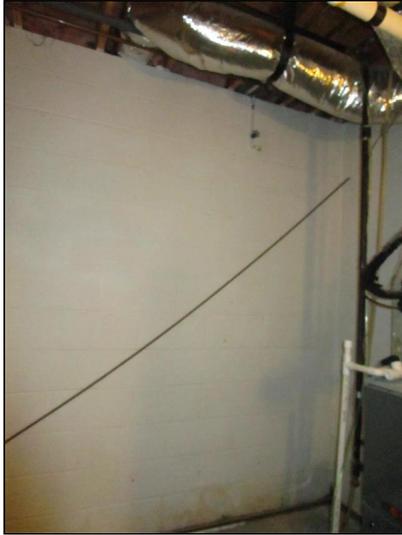
7.0 Item 5(Picture)

(3) The basement has a fresh coat of paint, i was unable to detect any signs of water intrusion. Paint is often used to mask defects that this inspector cannot be held responsible for as our standards limit us to visual inspections only. Please be advised that interior walls cannot be treated with water sealant after they have been painted with conventional paint. Item 3(Picture)

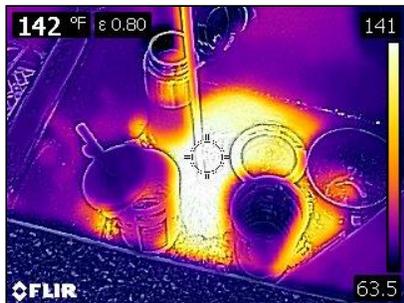
8.2 Item 2(Picture)

(2) The hot water temperature was greater than 120 degrees Fahrenheit. This is a safety hazard due to the risk of scalding. The thermostat should be adjusted so the water temperature doesn't exceed 120 degrees. If the water heater is powered by electricity, a qualified person should perform the adjustment, since covers that expose energized equipment normally need to be removed. Item 3(Picture) Item 2(Picture)
