**House Smart**

**865 Autumn Close  
Alpharetta GA 30004**

Client(s): Blythe  
Inspection Date: 2/17/2020  
Inspector: Keith Cook , ASHI 202558

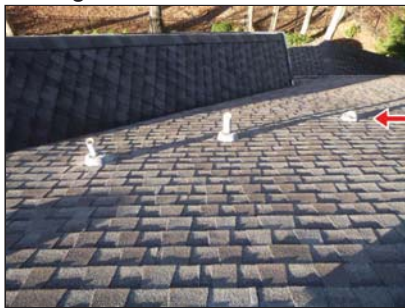
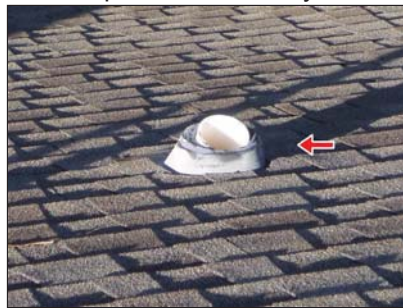
**✘ 17. SERVICE / REPAIR:** Low plumbing vent pipe noted above Master bedroom. All vent pipes should extend at least six inches above the roof level to prevent blockage in the event of snow. Most repairs can easily be performed by adding an extension from the attic level. Repair as needed by roofer or plumber.

extend - may be 6" pipe

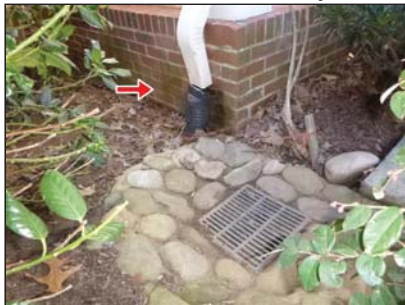
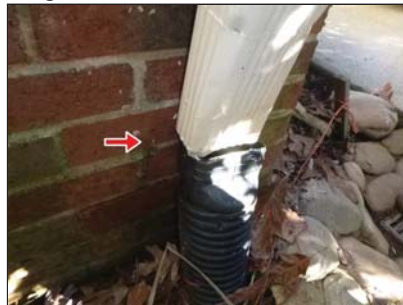
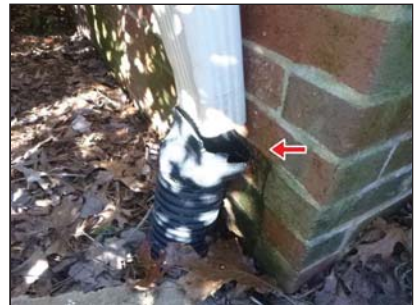
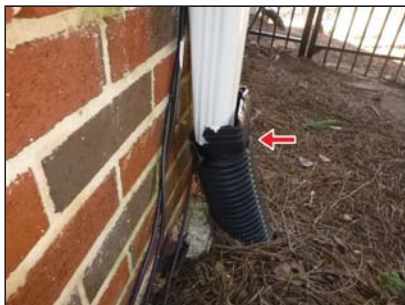
**✘ 18. SERVICE / REPAIR:** Downspouts not adequately connected to drain extensions. Have properly fitted or have connectors installed. Verify that drainage line is clear.

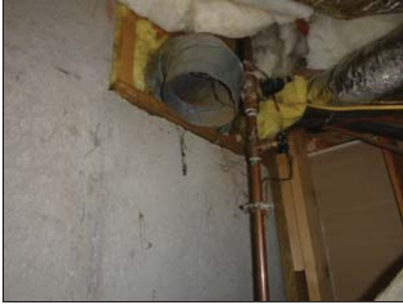
Item 19 - Picture 1

- ❌ 19. **SERVICE / REPAIR:** Recommend having water line insulation near the combustion make up air supply on outside wall.

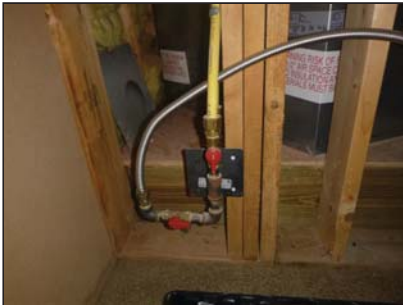
Item 20 - Picture 1

- ❌ 20. **GENERAL NOTE:** Remote gas lines found that are not labeled. Recommend having each identified to aid in locating as necessary.

unsure of termination of yellow pipes - label

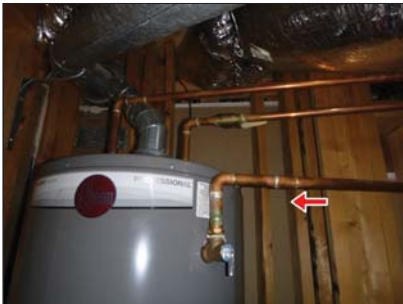
Item 21 - Picture 1

- ❌ 21. **SAFETY / HEALTH:** Bleeder valve required for temperature and pressure discharge drain lines that are not installed to gravity drain. This prevents standing water on safety device which could become rusted stuck rendering it ineffective. Recommend a licensed plumber to correct.

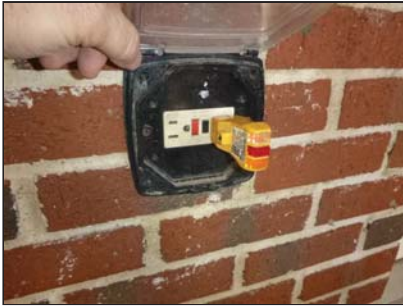
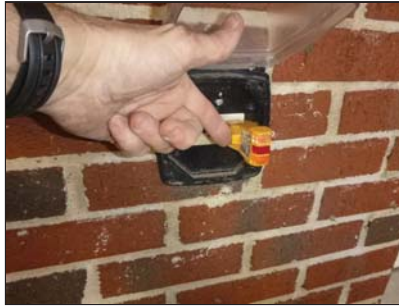
- ❌ 22. **SAFETY / HEALTH:** GFCI device failed to trip when tested with pocket tester or when test button used at: 1) Patio rear. While it will still appear to function, it does not provide the required level of safety. Required to be GFCI protected at this location. Replacement with a functional GFCI is necessary by qualified electrician.

under deck

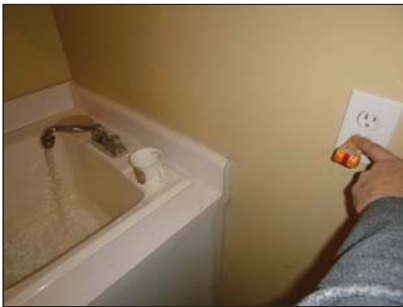
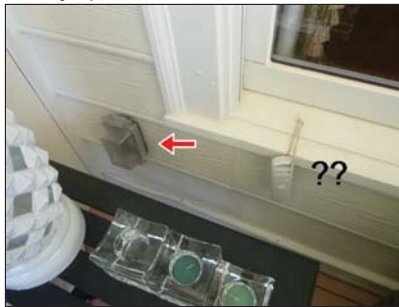
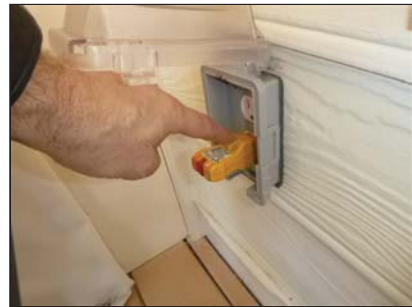
- ❌ 23. **SAFETY / HEALTH:** GFCI protection is missing at Laundry room, Back Porch. GFCI (ground fault circuit interrupter) protected devices required to be installed at this/these location(s) when originally built for protection from electrical shock. Have corrected by qualified electrician.

porch at  
north  
behind  
end table

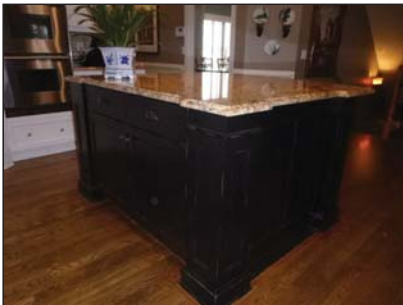
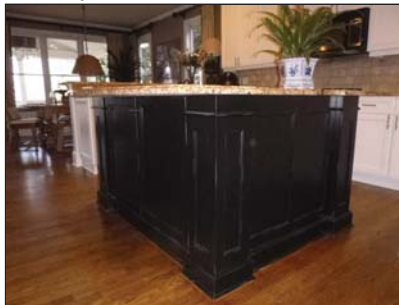
- ❌ 24. **SAFETY / HEALTH:** Insufficient receptacles observed in the kitchen island system. Current standards state that all counter tops 12 inches wide should have at least one receptacle and there be no more than four feet between receptacles and no more than two feet from an end, appliance or sink. Recommend a licensed electrician to evaluate the condition and correct for compliance.

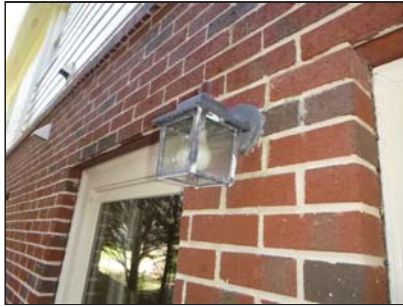
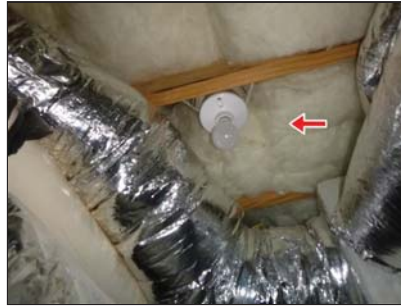
- ❌ 25. **SERVICE / REPAIR:** Inoperable lights observed at the time of inspection at: 1) Basement side door sconce, 2) Mechanical room. Replace bulbs and verify that the fixture is operational. If not, consult an electrician for repairs.

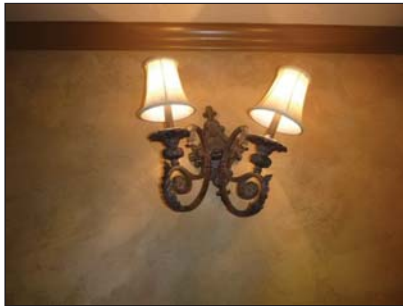
Item 26 - Picture 1

- ☒ 26. **SERVICE / REPAIR:** Recommend having damaged sconce repaired or replaced to match.

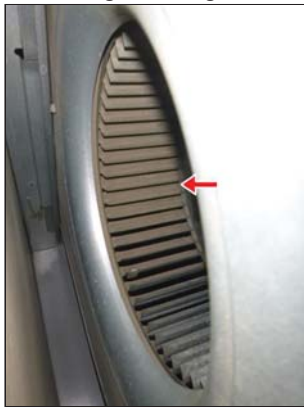
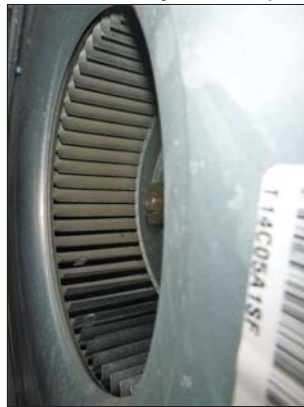
- ☒ 27. **SERVICE / REPAIR:** Blower fins and motor have visible dust on surfaces seen from return plenum and would encourage having HVAC service clean system especially if occupants have allergies or respiratory health issues.

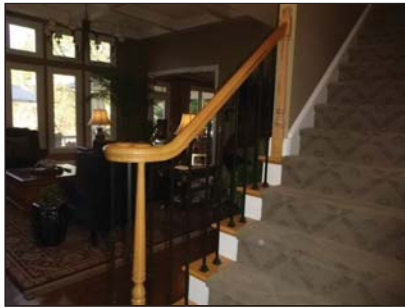
Item 47 - Picture 1

- ❌ 47. **SAFETY / HEALTH:** Guard rail on side of stair is loose. Should be able to withstand 200 pounds of lateral force. Railing should be repaired to provide required safety. Consider the cosmetics of this system and recommend having carpenter experienced with this type of work to correct.

note: one spindle on 2nd or 3rd step is cut short. Appears to have been glued.

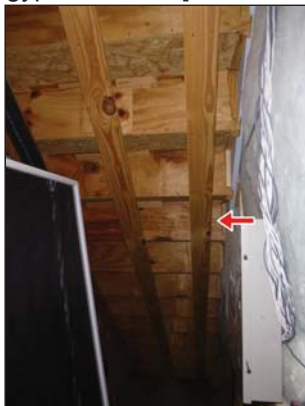
Item 48 - Picture 1

- ❌ 48. **SAFETY / HEALTH:** Storage space below the stairs is presently unfinished but accessible for storage and technically should be protected for safety. [2000 IRC Section R314.8 Under Stair Protection. Enclosed accessible space under stairs shall have walls, under stair surface and any soffits protected on the enclosed side with 1/2 inch gypsum board.]

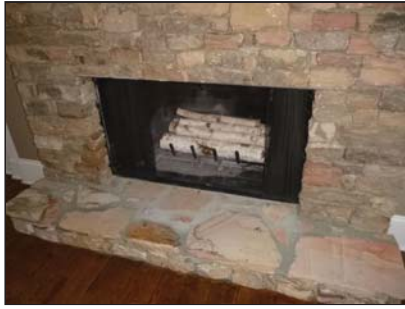
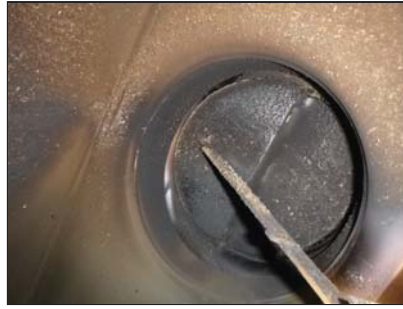
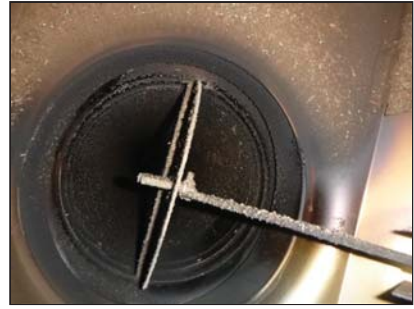
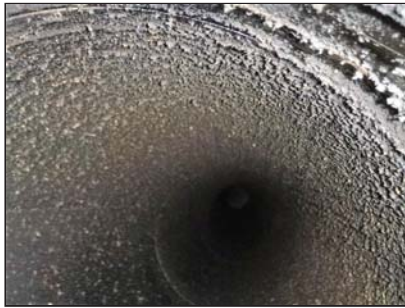
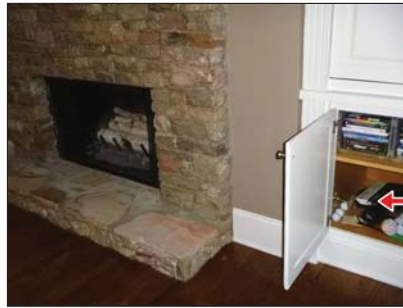
- ❌ 49. **SAFETY / HEALTH:** The chimney flue is dirty at Family room. Have a professional chimney sweep clean the flue for proper operation. **ALSO,** Distance between gas valve and fireplace is excessive. The location might allow too much gas to be released before match is struck. Recommend modifying for operational safety. If not modified, consider having two person light to reduce risk of large fire flash.

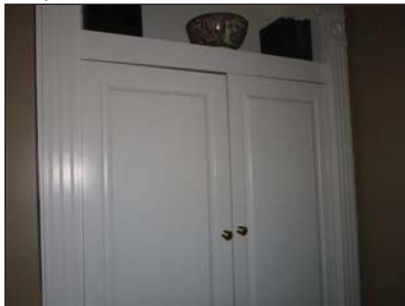
Item 50 - Picture 1

- ❌ 50. **SERVICE / REPAIR:** Cabinet doors need adjustments made to avoid conflicting when closed right of Family room fireplace.

doors on tracks. No longer need to be recessed. Former TV space

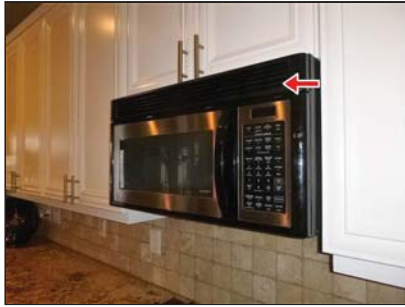
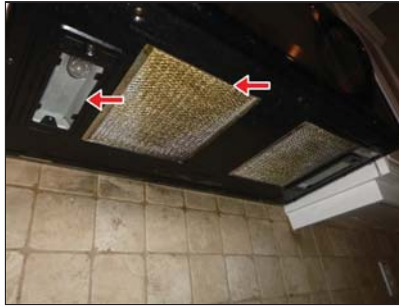
- ❌ 51. **SERVICE / REPAIR:** Exhaust fan filter is somewhat dirty with deposits of grease and should be either cleaned or replaced for safety. Glass missing on light bulb space. ALSO, The exhaust fan fails to have air flow through top grill when tested and not extended to outside. Unit should have internal dampers repositioned to deliver air through system as designed unless planning to convert to exterior exhausting system.

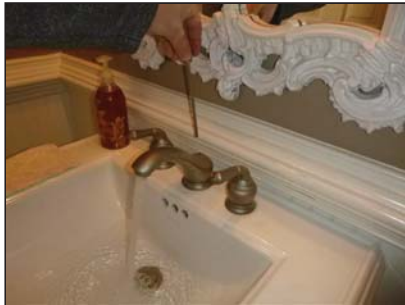
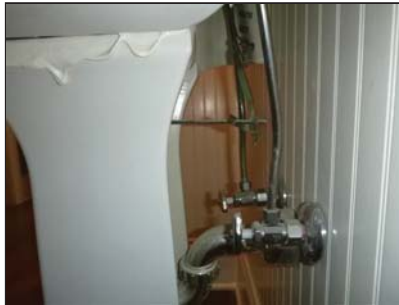
- ❌ 52. **SERVICE / REPAIR:** Pop up drain assembly not functional should be repaired or replaced at Living level bathroom vanity sink(s).

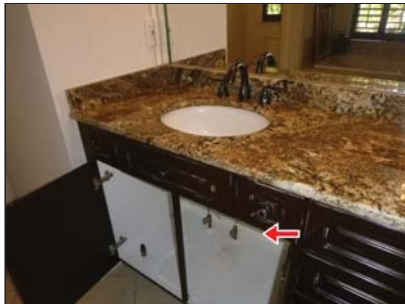
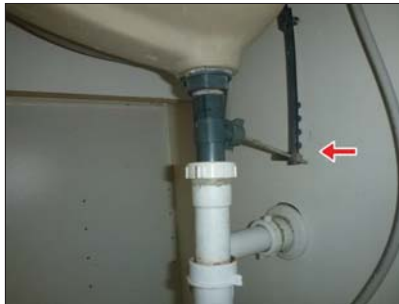
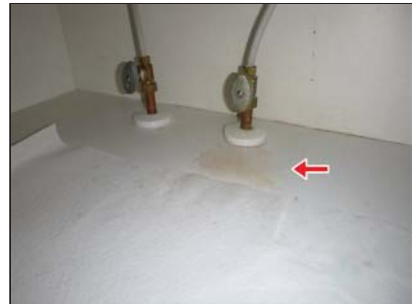
- ❌ 53. **SERVICE / REPAIR:** Drain assembly found to leak below Master bathroom sink when filled with water and then drained. Recommend a licensed plumber to correct.

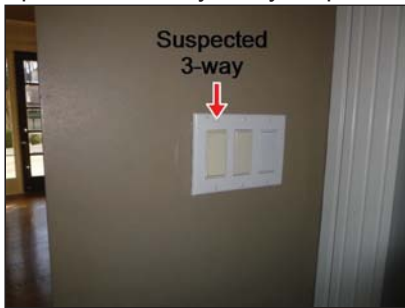
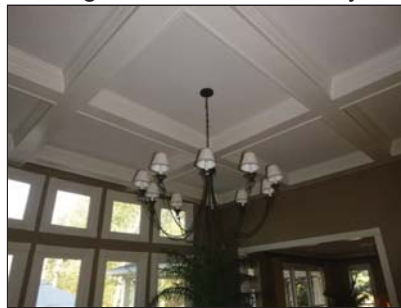
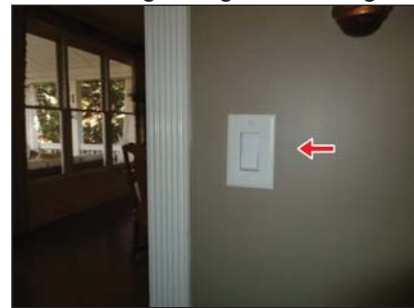
81. **GENERAL NOTE:** Switches either side of Family room possibly wired for 3-way switching but light fixture currently installed may have been connected to switch that was intended to serve a fan (if it were installed) which means the one near Breakfast side does not operate lights. Recommend having electrician review wiring conditions to operate as 3-way. May be possible from light switch box, but may require correcting wiring from ceiling level.

installing electrician indicated solution may be connecting additional wire at fixture per phone conversation with wife

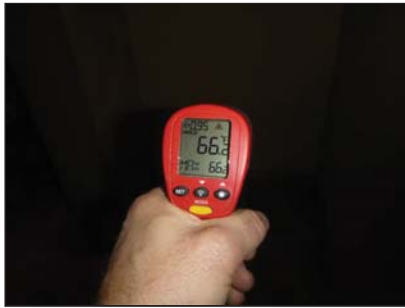
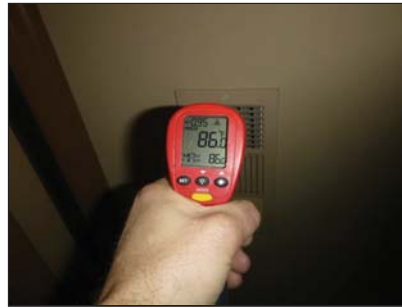
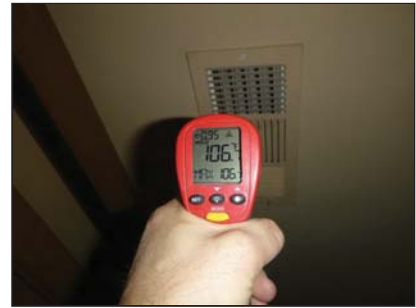
90. **GENERAL NOTE:** Heat pump tested and found providing heat between 15 to 20 degrees above room temperature and Emergency Heat Between 105 to 120+ degrees. Designed to be economical in standard mode and more costly in emergency mode.

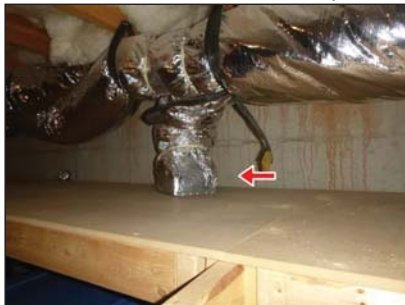
Item 91 - Picture 1

91. **GENERAL NOTE:** One supply in mechanical room is simply set on top of storage shelf. Recommend having directed to serve area or cap off.

cap off. Opening is rectangular
