**National Property Inspection, Cumming GA DBA  
National Property Inspections**

**Sally , 10620 Montclair Way, Johns Creek, GA, 30097**

Inspection Date:  
02/25/2020

## GENERAL INFORMATION

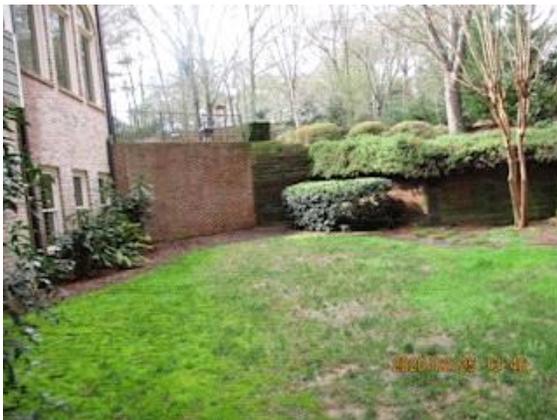
Negative slope noted at rear perimeter of the home. May cause drainage problems/water intrusion during rainfall. The current condition may contribute to water intrusion.

Water puddling in the yard. Ponding water could cause moss in summer and/or ice in winter, both of which are slip hazards. It could also lead to damage to the surfaces themselves, particularly freeze/thaw damage. Ponding against the house could lead to water penetration into the building and damage to the foundation and sub grade areas.

Grading / Drainage: Near level grading at the back of the property, may pose slow drainage problem, water ponding noticed

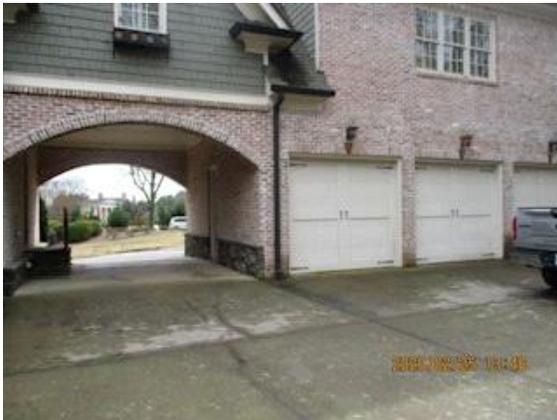
Excessive cracks observed. These cracks were common and were due to normal ground settlement. Recommend filling cracks with a driveway caulk/sealant to prevent any further damage due to water penetration.

Driveway: cracked driveway surface

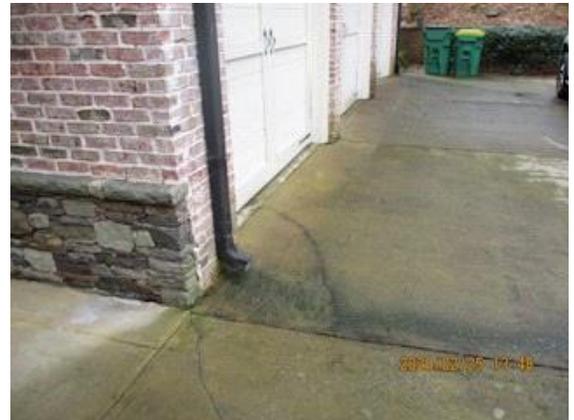
Driveway: cracked driveway surface

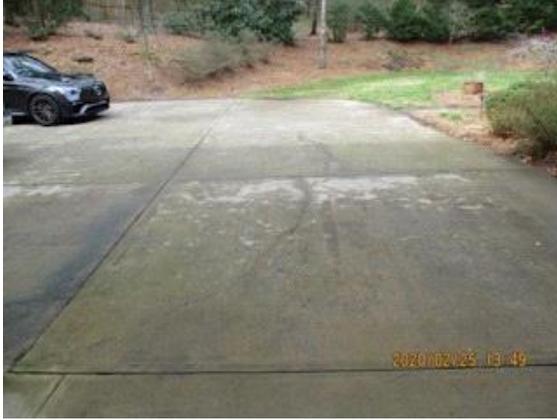
Driveway: cracked driveway surface

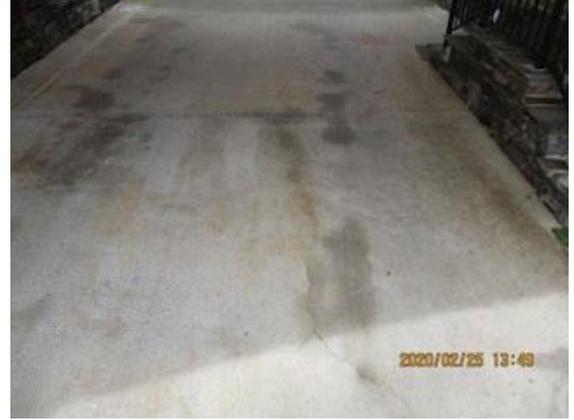
Driveway: cracked driveway surface

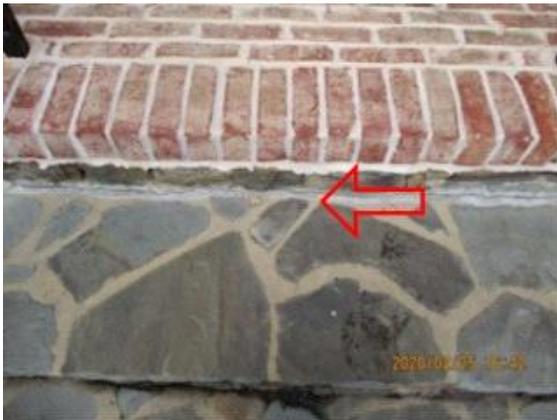
Walks / Steps: slight separation at the front stoop

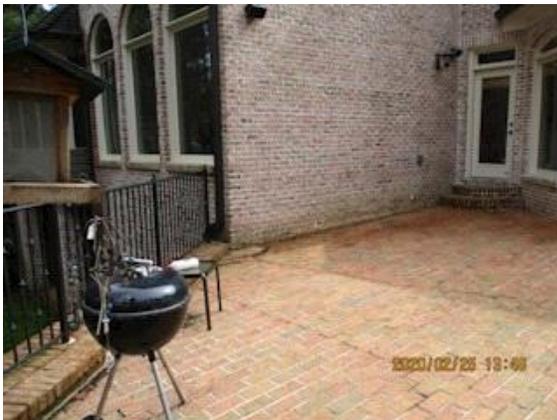
Patio: cracks and settlement noticed

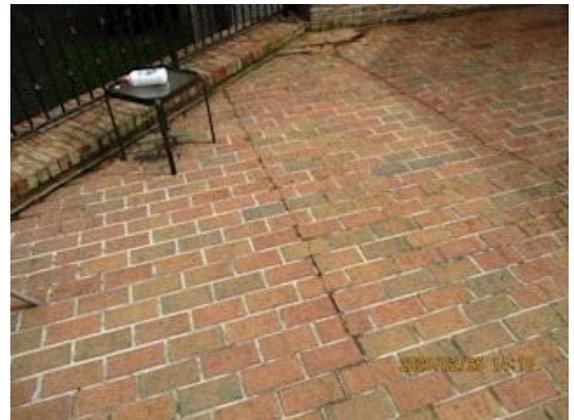
Patio: cracks and settlements

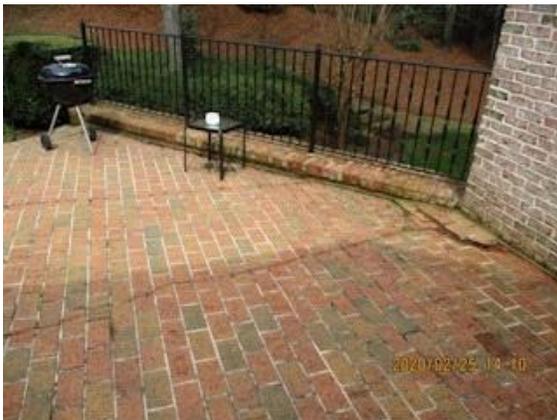
Patio: cracks and settlement

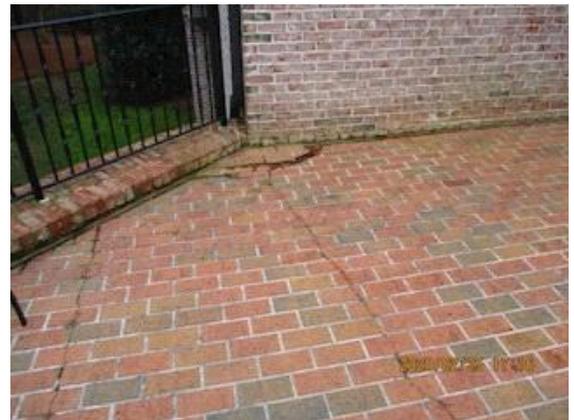
The brick patio outside the kitchen have settled and it may allow water penetration into the lower basement level. Recommend filling the cracks with an approved concrete sealant to prevent any future water damage/deterioration.

Patio: sign of settlement at the patio

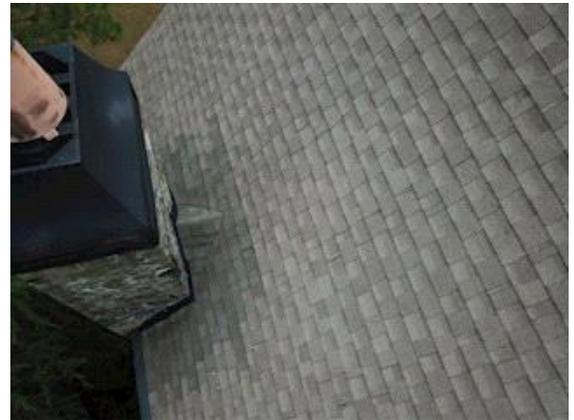
Roofing: previous roof repair behind the chimney

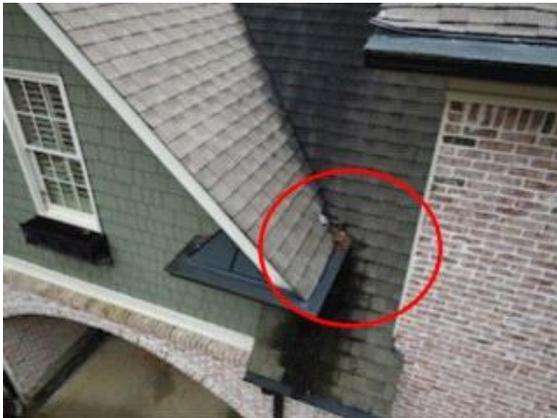
Downspouts noted from upper roof discharging onto lower roof. Recommend extending downspouts to gutter(s) to reduce the risk of premature deterioration and water intrusion.

Gutters/Down Spouts: Gutter draining to the lower roof directly which could result in leakage

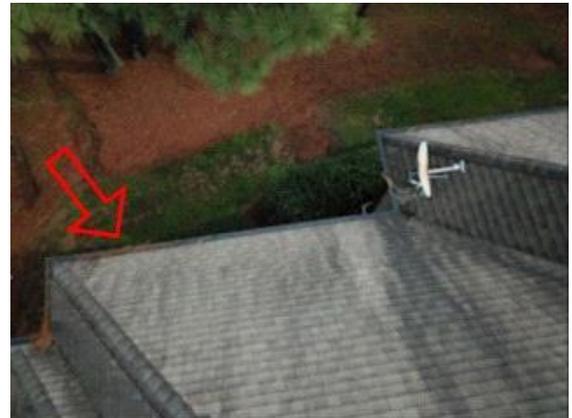
The gutters were filled with debris which was inhibiting water to drain off the roof and flow through the gutters and downspouts properly. Gutter not draining properly could further lead to soil erosion or foundation water intrusion. Recommend regular cleaning to allow proper water flow

Gutters/Down Spouts: Gutter was full of debris

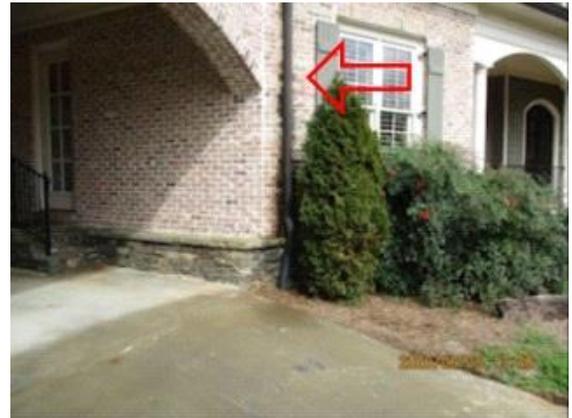
Gutters/Down Spouts: Gutter / downspout was overflow and was leaking water

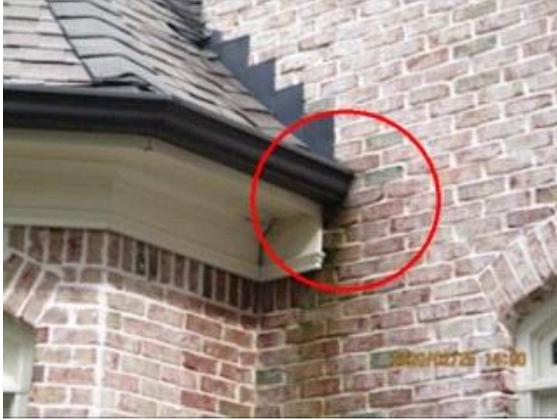
Gutter was leaking water at the end and leaving water stain on the wall at various locations

Gutters/Down Spouts: gutter leaking water at the end

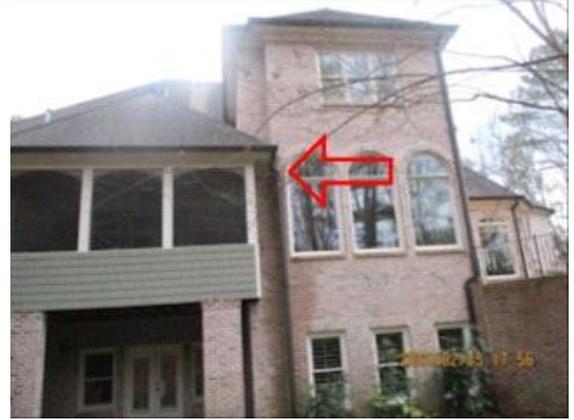
Gutters/Down Spouts: Gutter appear leaking water

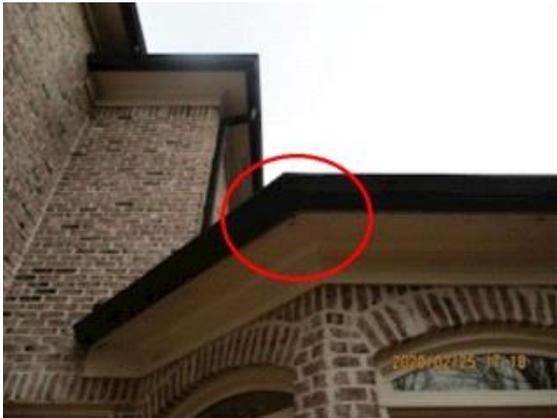
Gutter outside the kitchen breakfast room was leaking at the seam and was causing water damages to the fascia board behind

Gutter : gutter outside the kitchen leaking water at the seam

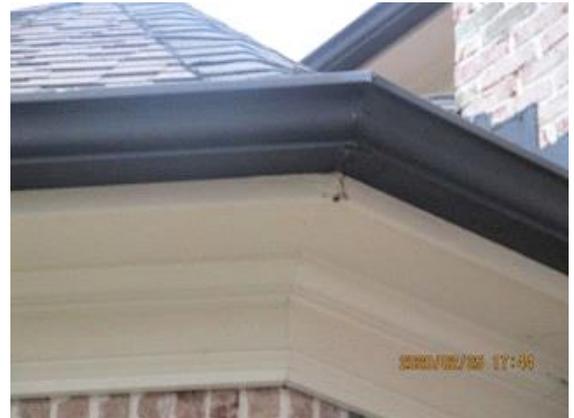
Gutter : gutter leaking water at the seam

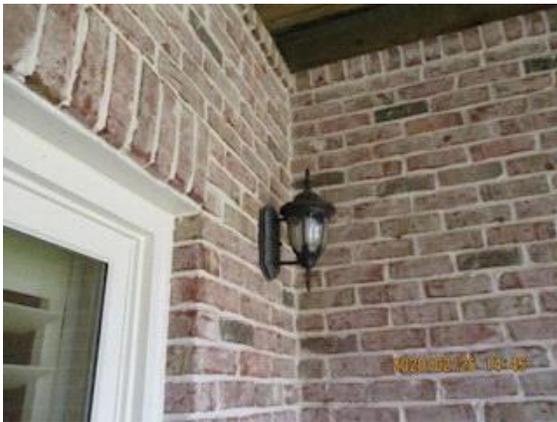
Basement patio light fixtures were not responding

Exterior Surface: A few of exterior light fixture on the basement patio not responding

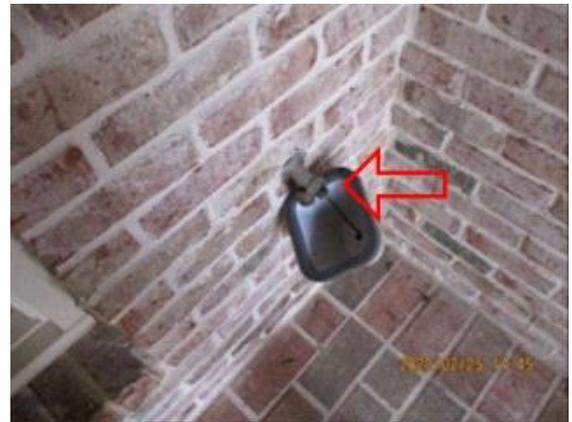
Basement exterior faucet missing a handle

Exterior Surface: Basement exit faucet handle missing

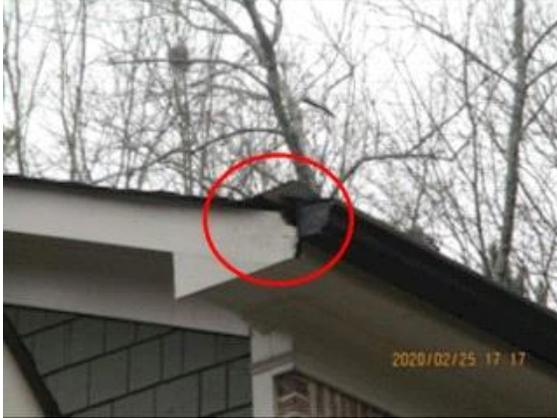
Exterior Surface: trim board damages

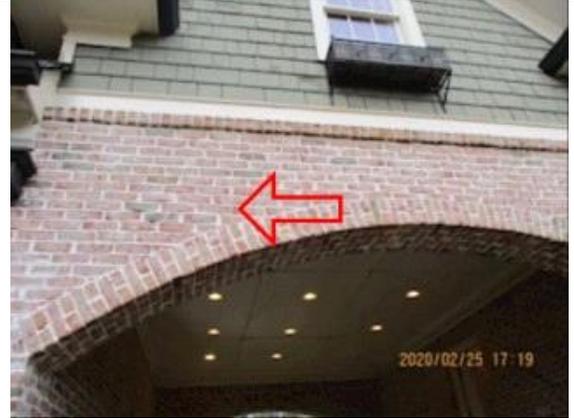
Brick appeared in good condition with some minor, localized mortar deterioration apparent. Recommend re-pointing (removing loose mortar, replacing with new) to prevent additional deterioration. A few localized cracks noticed on the brick surface. Recommend refill the cracks to prevent water penetration

Exterior Surface: cracks on brick wall

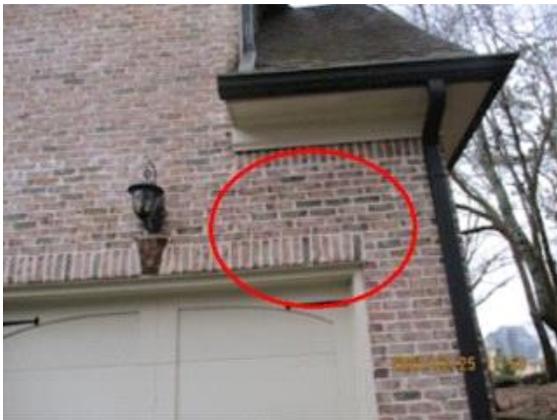
Exterior Surface: cracked brick wall

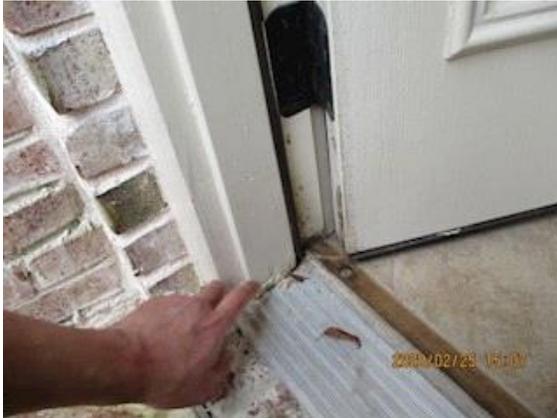
Lower corners of door jambs were deteriorated and should be repaired and sealed along bottom edges to keep water from "wicking up".

Exterior Doors: door jamb damaged near the bottom

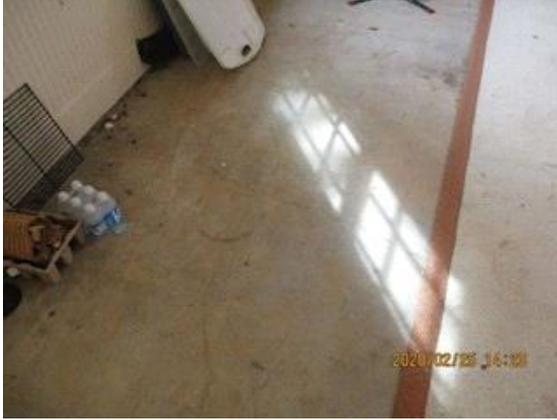
The concrete floor of the garage had cracks typical of slab construction. Recommend sealant of cracks and monitor for further cracking and settlement.

Garage/Carport: Typical cracks on the garage floor on slab construction

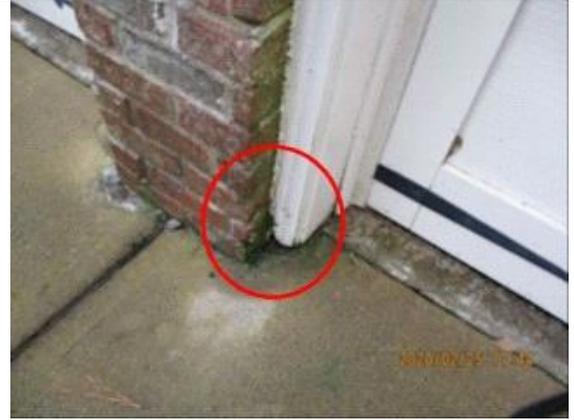
Wood trim outside the overhead door have water damages near the bottom

Garage/Carport: exterior wood trim rotten near the bottom

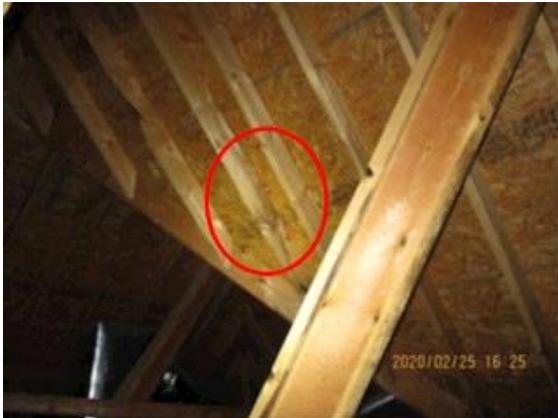
Evidence of previous roof leak(s) was noted. Since it was dry at the time of the inspection, it could not determine whether the leak(s) was active.

Attic Framing/Sheathing: Water stain on the attic deck

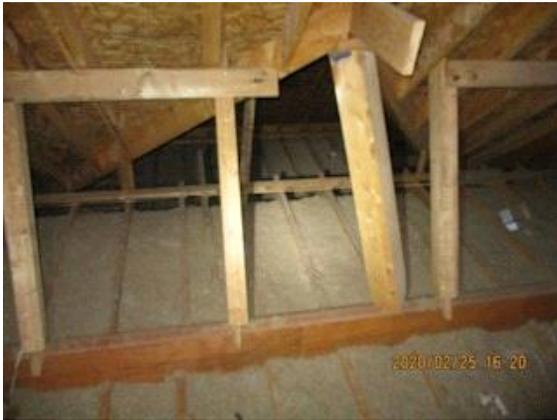
Loose-fill Cellulose insulation present, approximately 5-6 inches deep, estimated R value 17-21. Current standard for attic insulation is recommended to be R40 in value. You may wish to look at upgrading the insulation level in the near future.

Attic Insulation: insufficient blown in insulation materials

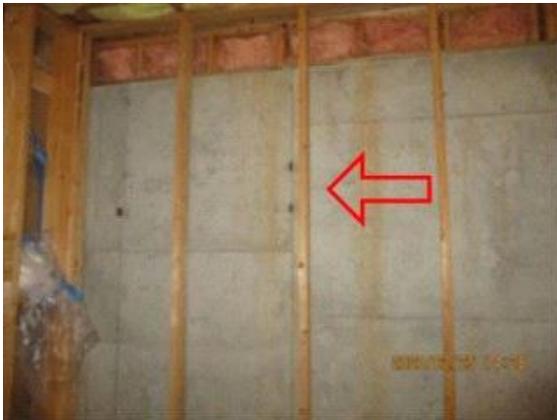
Vertical crack at foundation. Monitor this area for possible future movement and water intrusion. .

Interior Foundation: basement foundation wall cracks

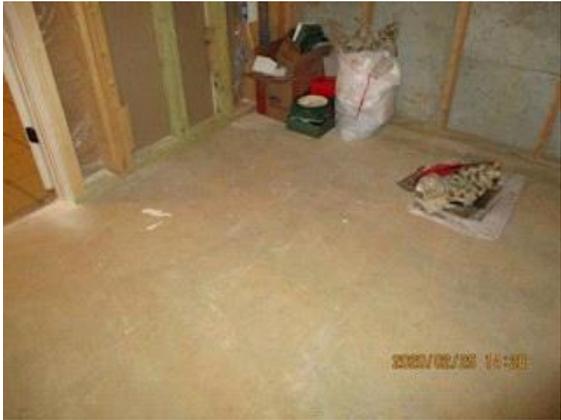
Floor cracks observed. Appeared to be more than typical cracking. Recommend further evaluation by a qualified contractor

Floor/Slab: concrete cracks on the basement floor

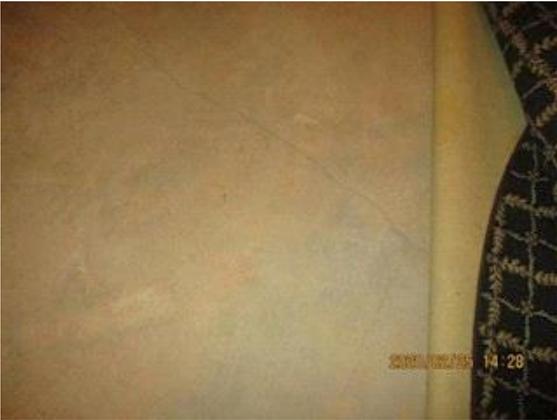
Floor/Slab: Basement floor cracks

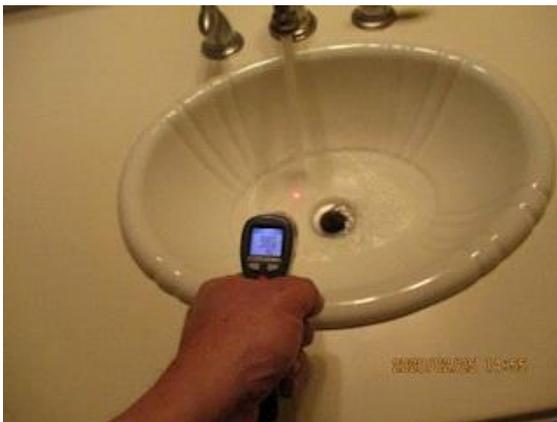
Sink drainage stopper was missing

Basment full bathroom : Sink drainage stopper assembly missing

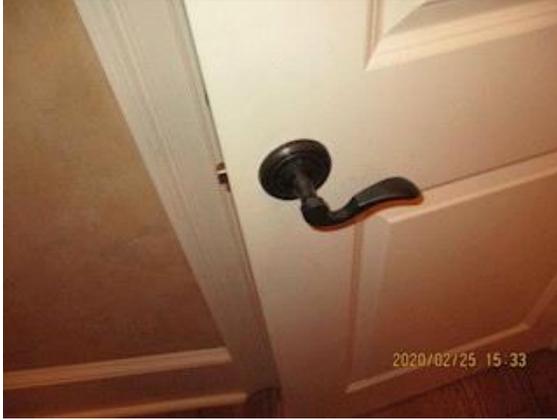
main level half bathroom : door missing a lock

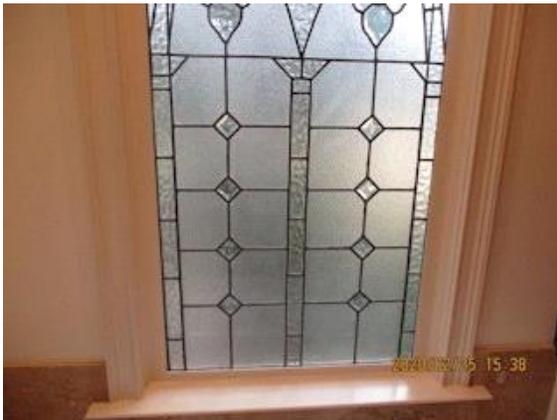
master bathroom : Window near bathtub should be composed of tempered glass for safety

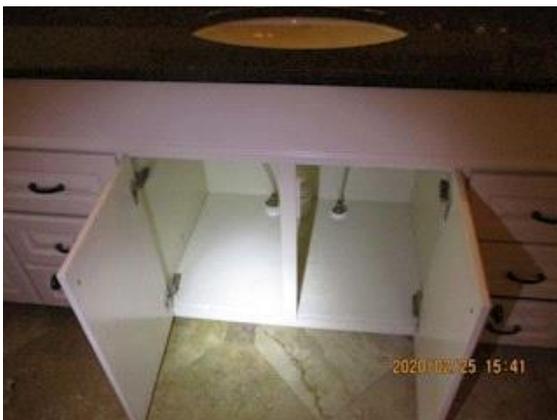
Leaking connections at plumbing pipes beneath sink. This should be repaired to avoid future/additional damage to the cabinet floor and possibly the wall/floor structures below.

master bathroom : Sink was leaking water

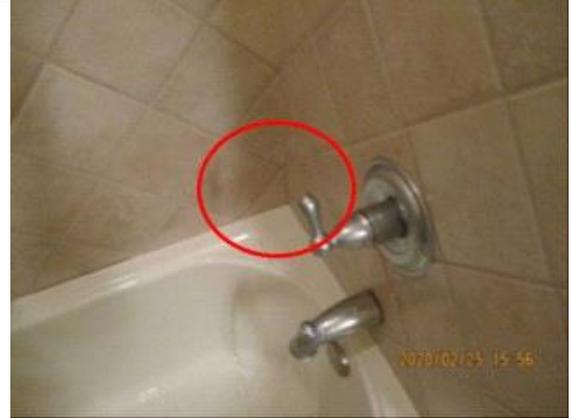
upper front left bathroom : Defective grout at the shower enclosure

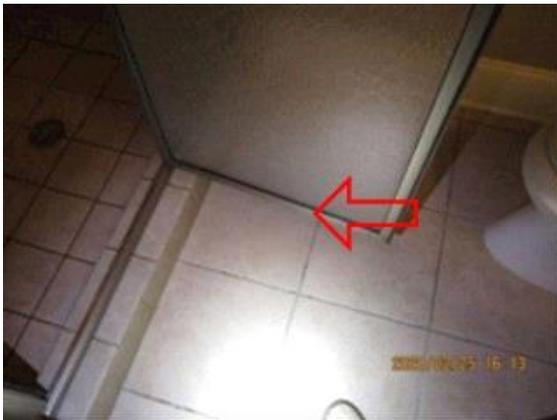
upper rear bathroom : Shower door rubber seal was torn / missing

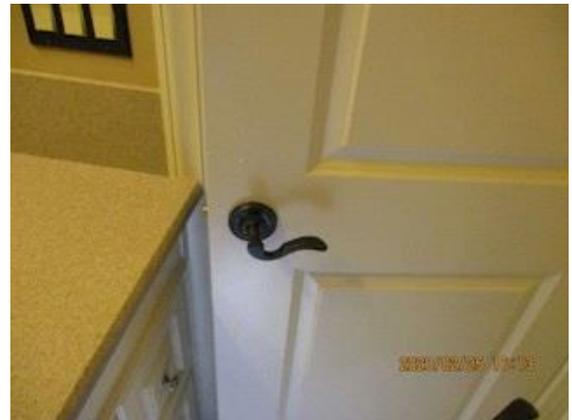
upper rear bathroom : door could not closed properly

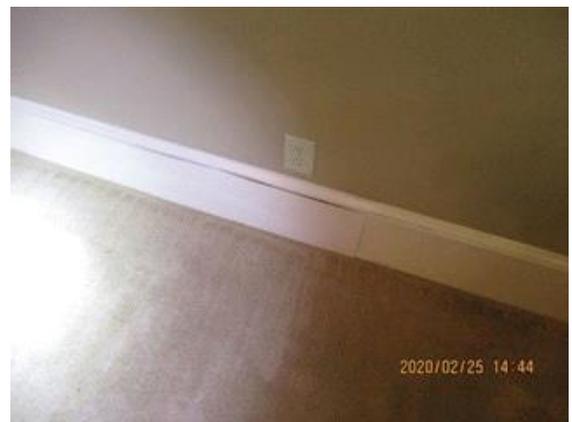
Basement grand room : water damages on the baseboard

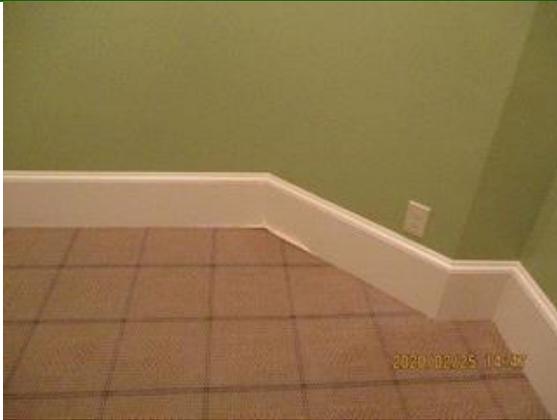
Basement grand room : water damages on the baseboard

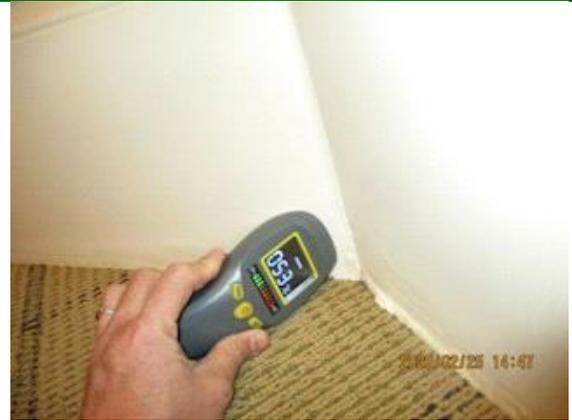
Water damages noticed at the baseboard and elevated moisture was presented. Recommend further evaluation by a qualified contractor

Basement grand room : Elevated moisture detected at the baseboard

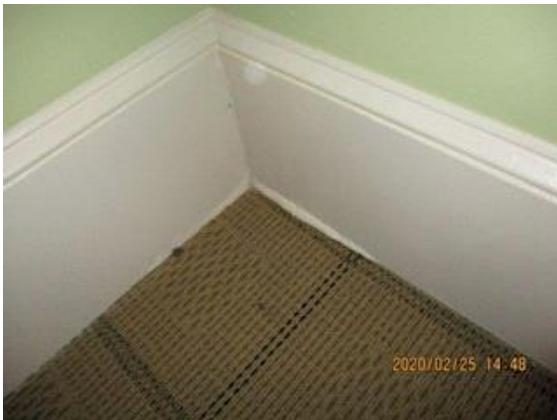
Basement grand room : baseboard water damages

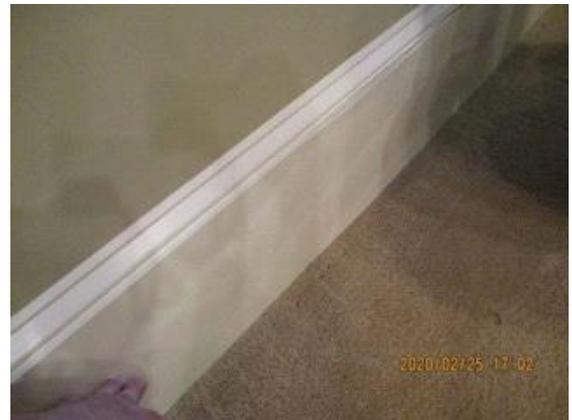
Basement grand room : water damages at the baseboard

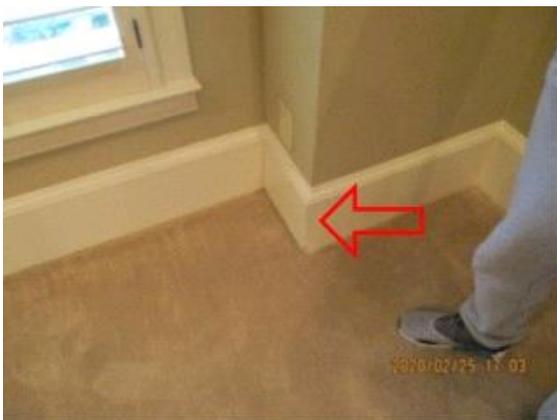
Basement grand room : water damages at the baseboard

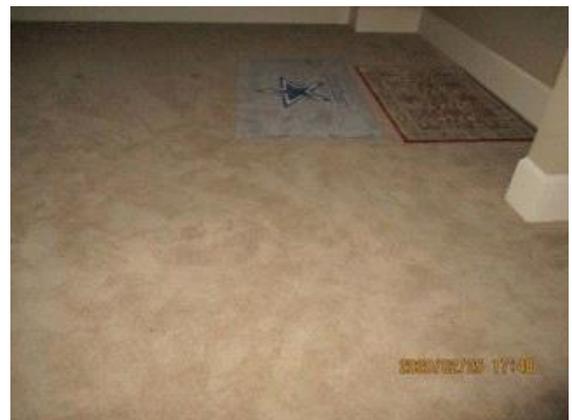
Carpet was buckled. Recommend re-stretching to prevent trip/fall hazard.

Basement grand room : carpet buckled

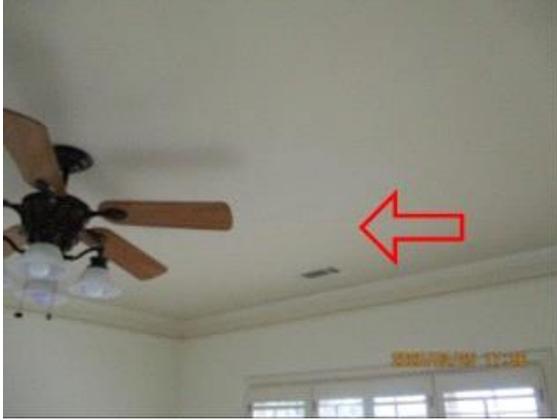
Ceiling repair noticed. Suspected previous roof leakage. Recommend further evaluation by a qualified contractor

upstair front left room : ceiling repair noticed

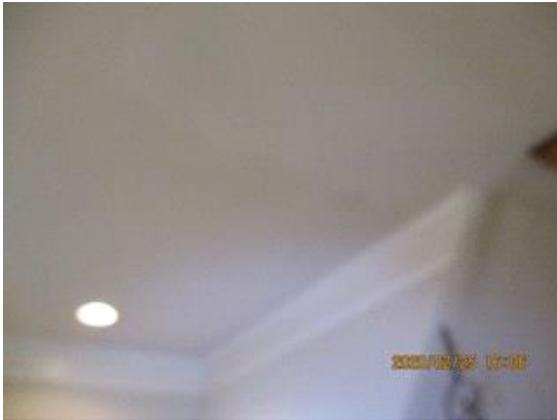
upstairs front right room : water stain on ceiling

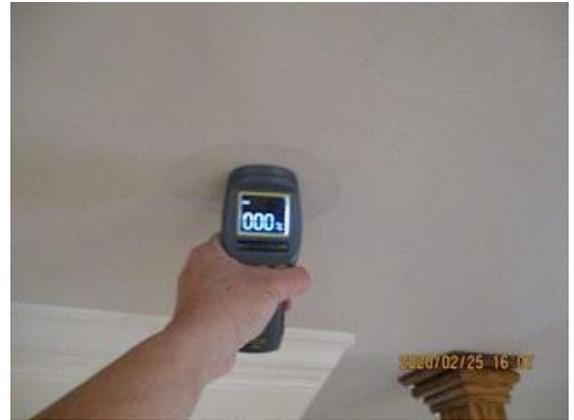
Stain(s) at ceiling tested dry on day of observation. Monitor for moisture related deterioration.

upstairs front right room : ceiling stain test dry

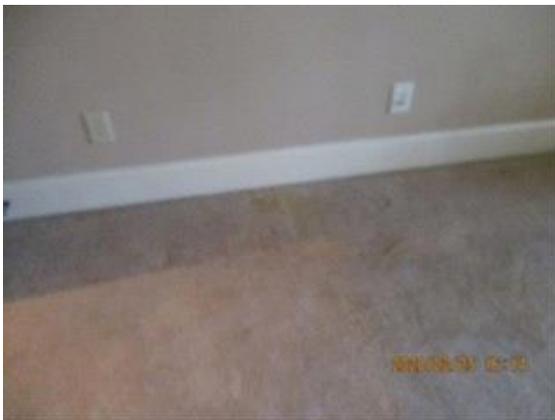
upstairs rear room : carpet stain
