# Inspection Report

**Property Address:**  
4850 Stratford Ln  
Johns Creek GA 30022

**Residential Inspector of America, Inc**

**Date:** 2/15/2020

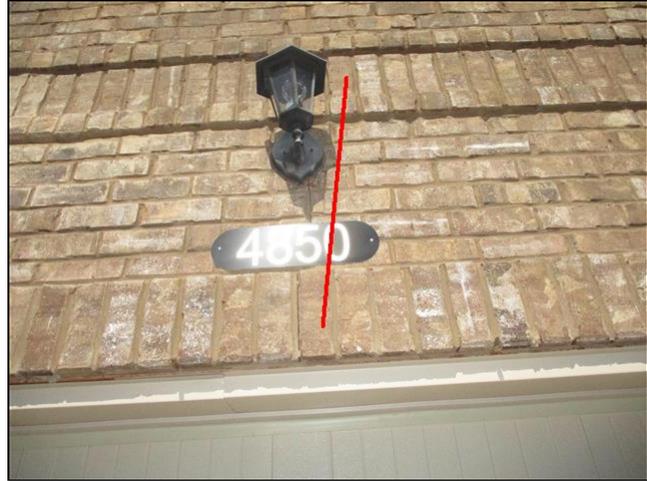
Small step crack(s) found in the brick veneer over the garage door opening(s). Crack(s) are not wide enough to be considered a structural concern and is due to settlement. It cannot be determined if crack(s) will continue to progress, but due to the age of the house, it is likely the movement is complete. Have patched as needed. See photo(s)

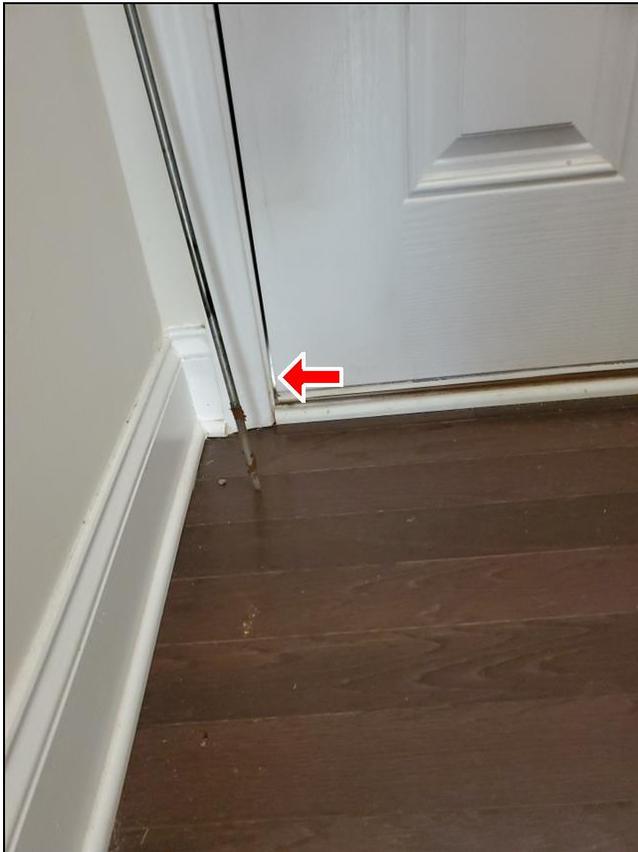
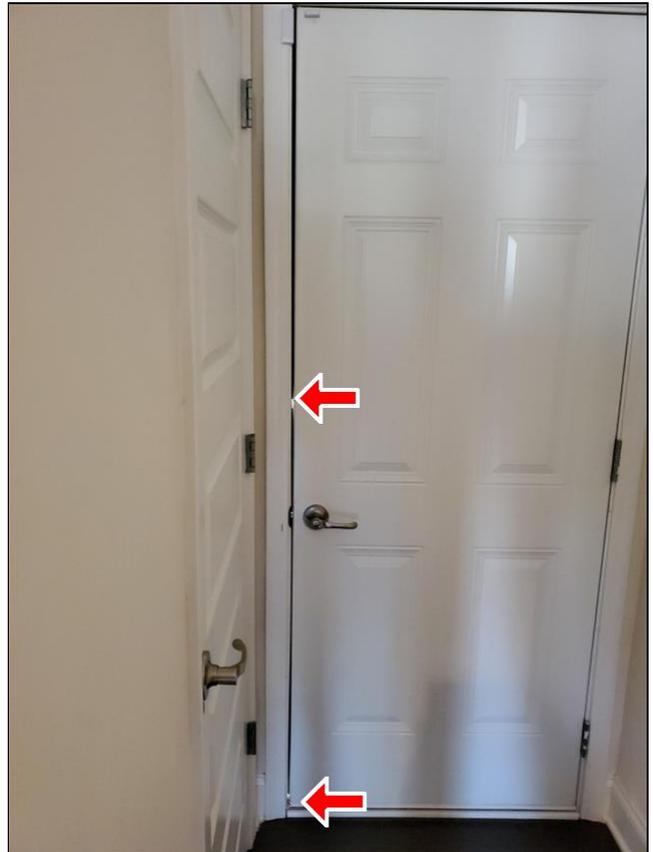
(1) Small gaps at weather stripping observed; daylight visible at closed doors. Recommend extending weather stripping to prevent drafts at the front and garage egress door(s). See photo(s)
-

(1) Small gaps at weather stripping observed; daylight visible at closed doors. Recommend extending weather stripping to prevent drafts at the front and garage egress door(s). See photo(s)

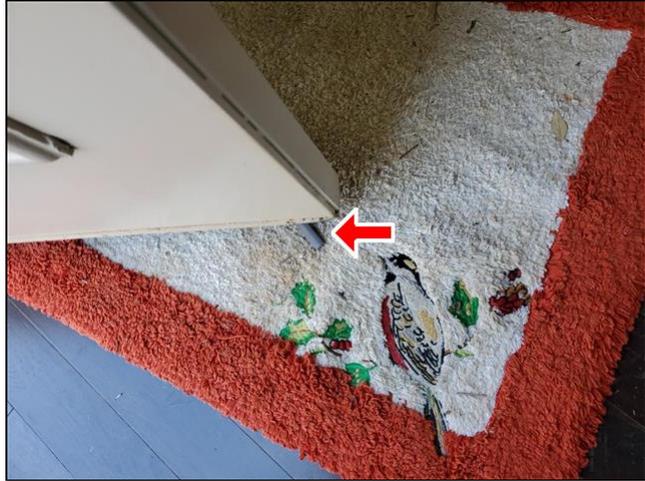
(2) Replace or re-attach torn weather strip at the underside of patio door.

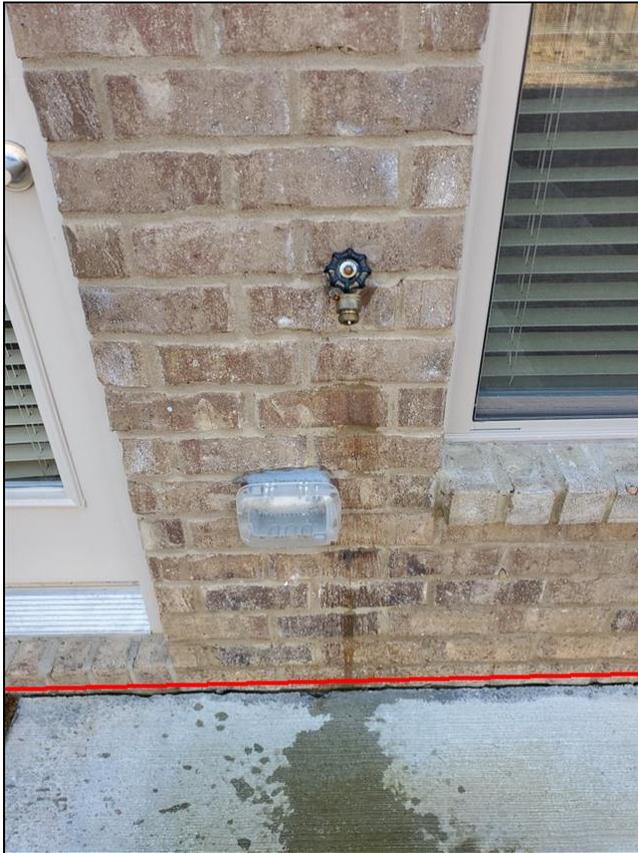
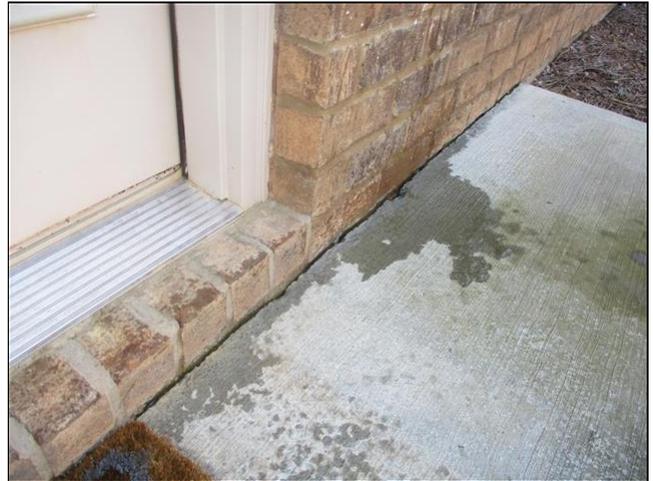
(1) Recommend sealant at gap where patio meets house brick. See photo(s)

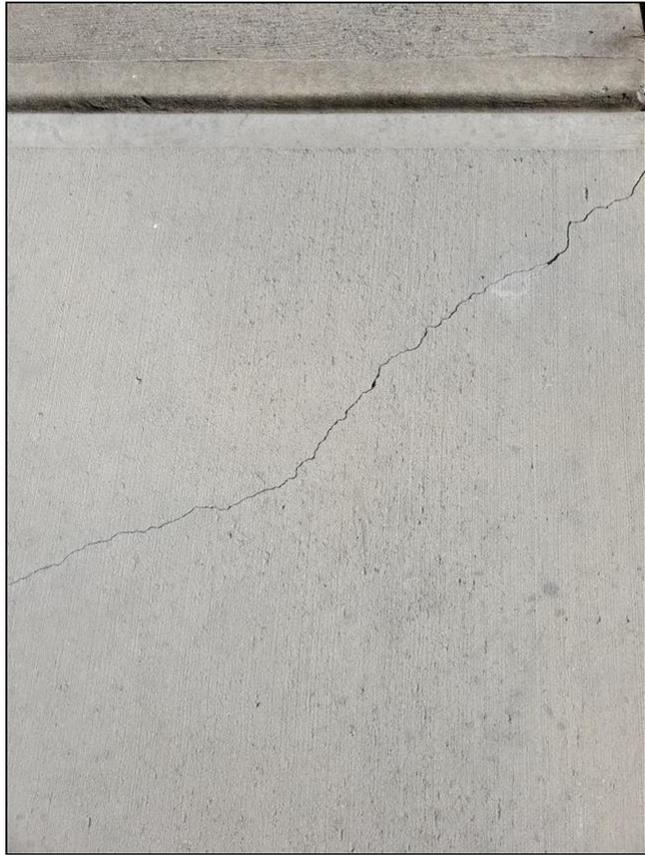
(2) Minor cracking in driveway. Patch as needed.

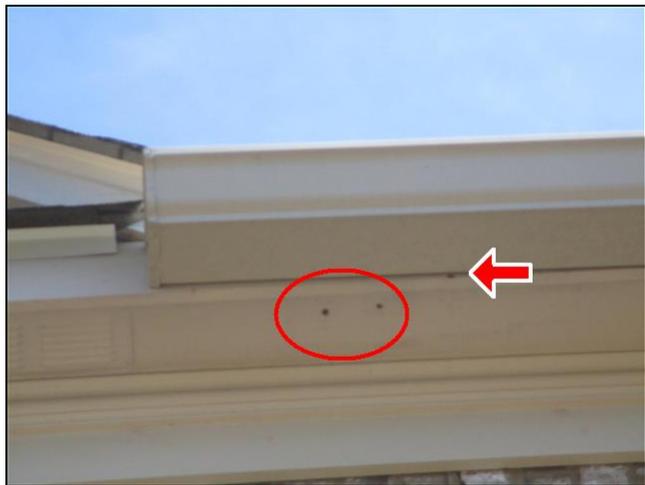
Carpenter bee damage found on the wood eve trim at the left side of house. Have damaged areas replaced as needed. It is impractical to control these insects, and they are not considered to be wood destroying type since they are not known to eat the wood. Have all affected trim replaced.

🐝 Carpenter bee damage found on the wood eave trim at the left side of house. Have damaged areas replaced as needed. It is impractical to control these insects, and they are not considered to be wood destroying type since they are not known to eat the wood. Have all affected trim replaced.

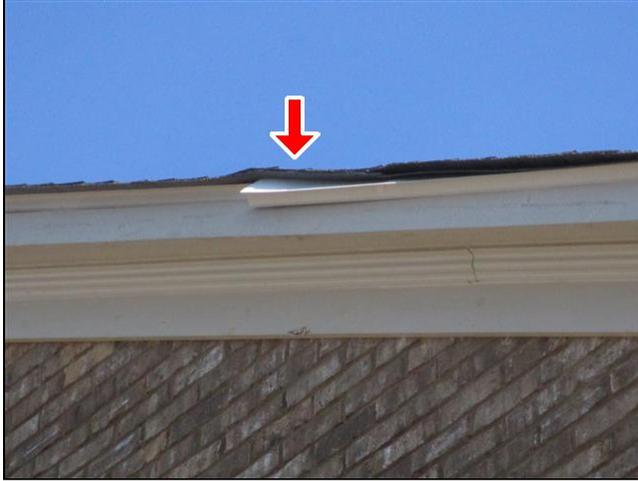
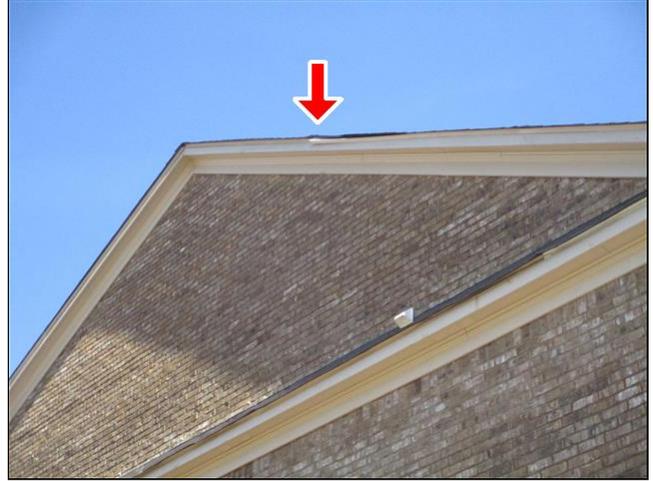
Refit loose hanging drip edge flashing at left side fascia. See photo.

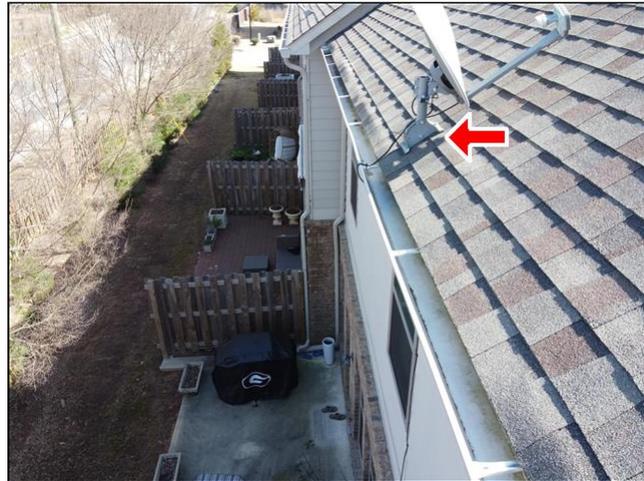
(1) Recommend to remove satellite dish if not in use and use roof tar at fastener entry into roof decking. If kept, sealant will need to be maintained where dish attaches to the roof.

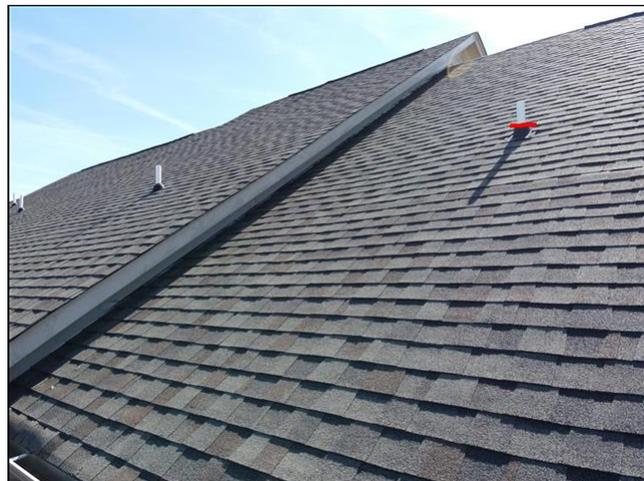
(2) Boot flashing around plumbing vents on the roof are ok now, but these last about 5-7 years before needing replacement. They crack and split and allow rain water to leak into attic. Check roof decking periodically for leaking into the inside the attic.

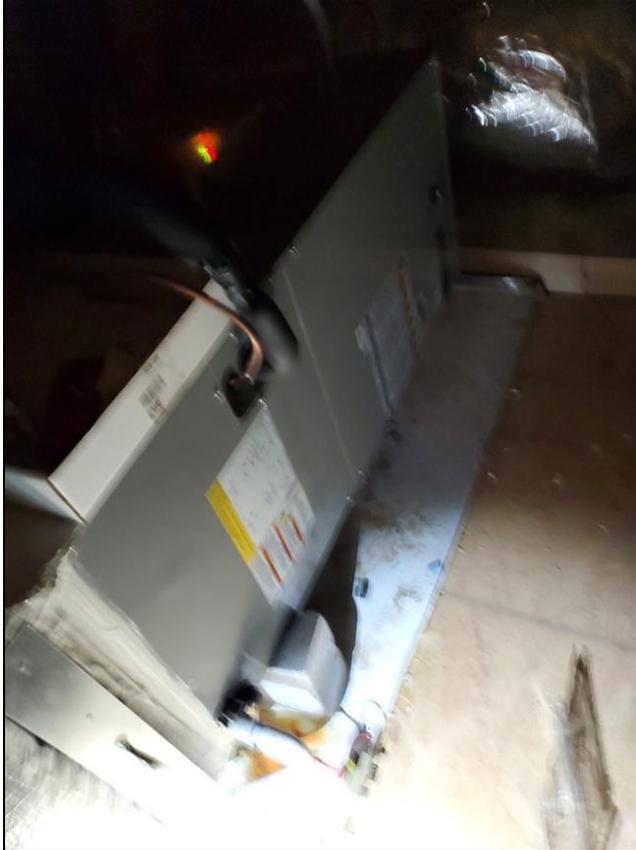
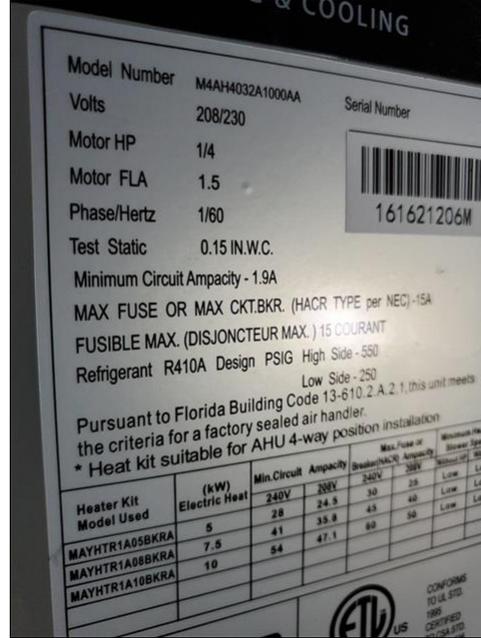
Have an hvac tech service the heating and cooling equipment to clean the blower motor, the evaporator coils, the condensing coils, the electrical contacts, check refrigerant levels, check size of units compared to size of home and ascertain that the equipment is operating properly and efficiently. Much of internal parts of the hvac system is concealed from view, and our inspection is mostly visual. Therefore, an hvac tech should evaluate for any concealed defects or hazards in the system. Furthermore, manufacturers recommend annual maintenance and servicing to keep the system working at peak efficiency.

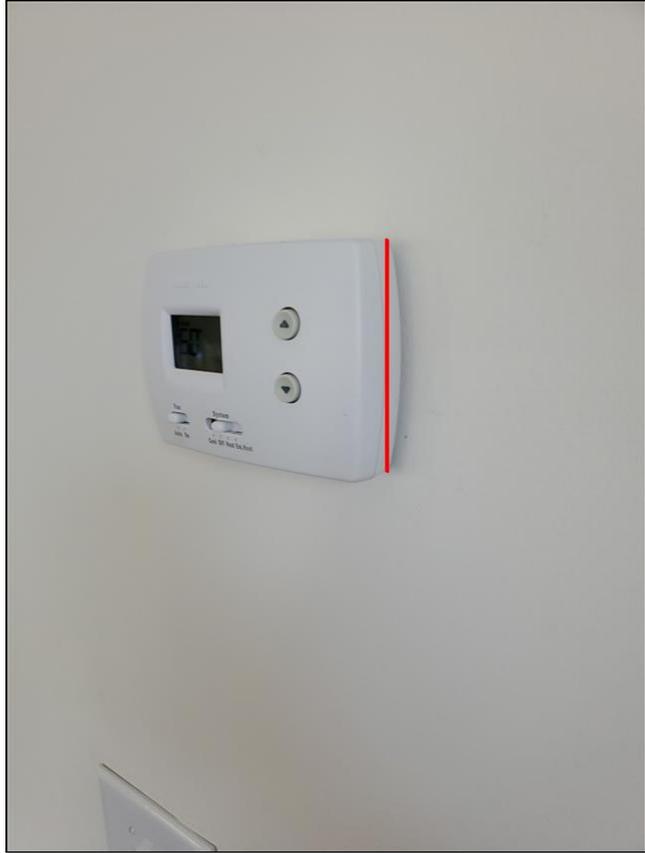
Affix loose thermostat to wall on the main floor.

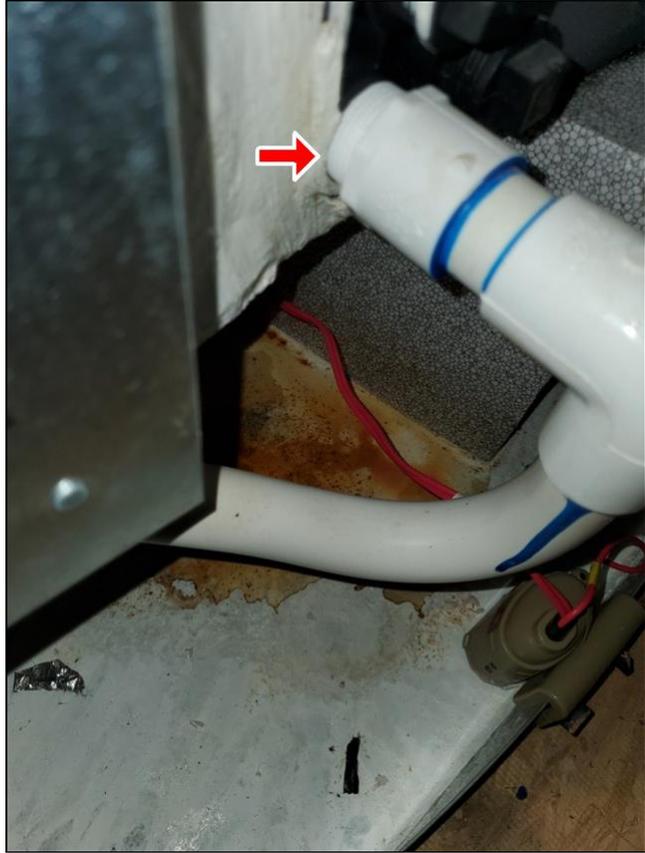
(1) Rust observed in overflow pan underneath the attic air handler. Have Hvac tech repair small leak at the evaporator coil shroud and condensate drain.
-

🔧 (1) Rust observed in overflow pan underneath the attic air handler. Have Hvac tech repair small leak at the evaporator coil shroud and condensate drain.

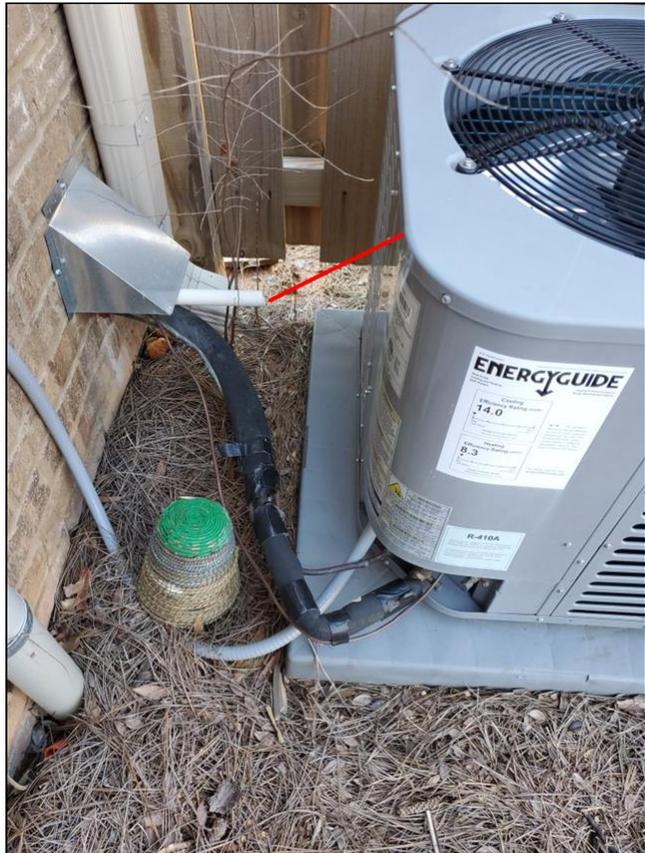
(2) Have the condensate drain line for the heat pump unit extend out and away from the home.
-

🔧 (2) Have the condensate drain line for the heat pump unit extend out and away from the home.

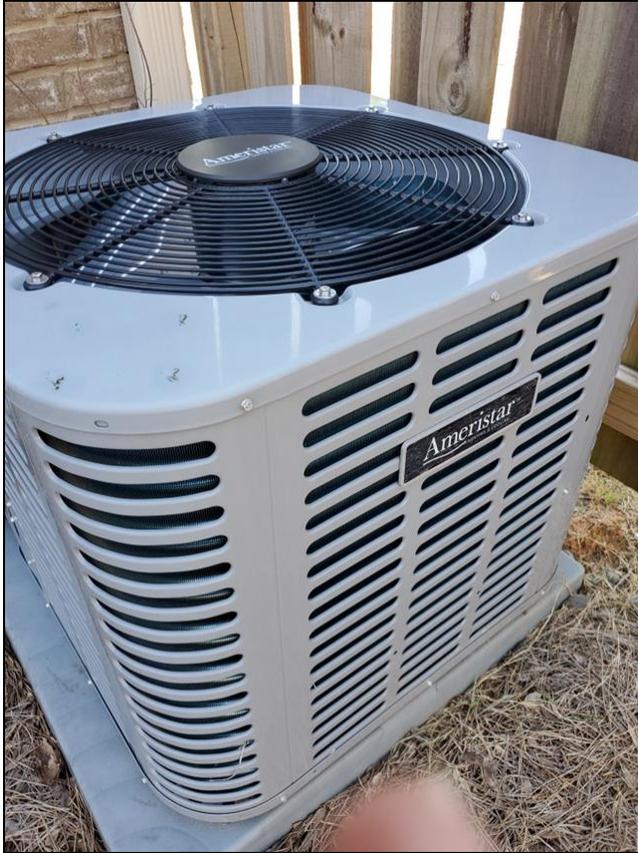
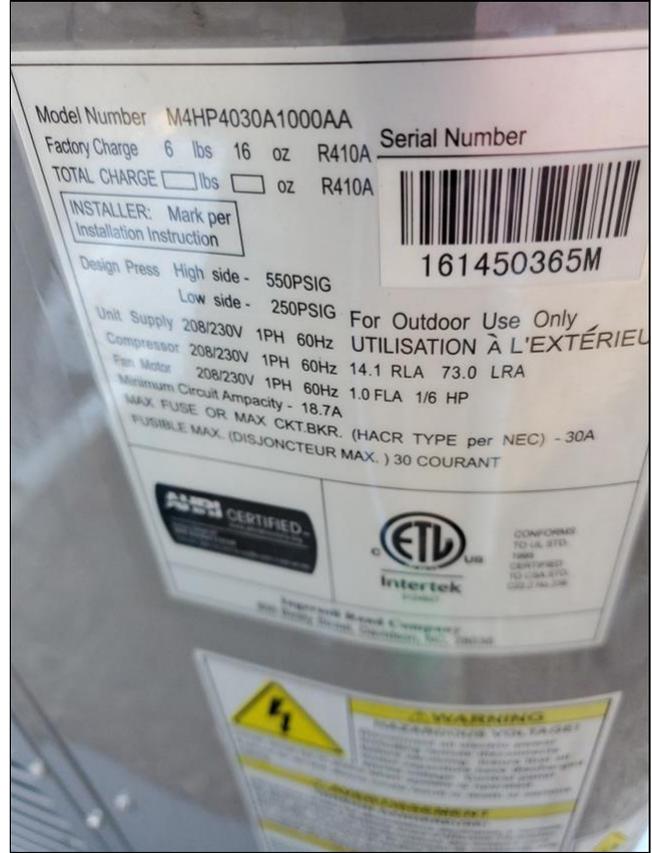
(3) After repairs and along with servicing the heating unit(s), hvac tech should check refrigerant levels in the a/c system to ensure that the systems are working at peak efficiency.

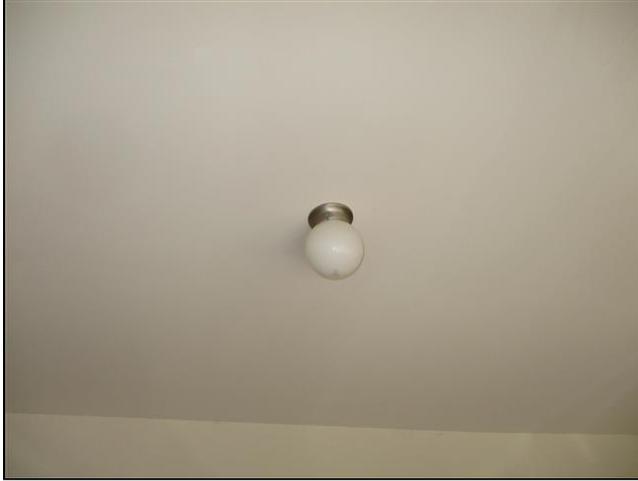
garage

Several lights are out in the house. See photos for locations.

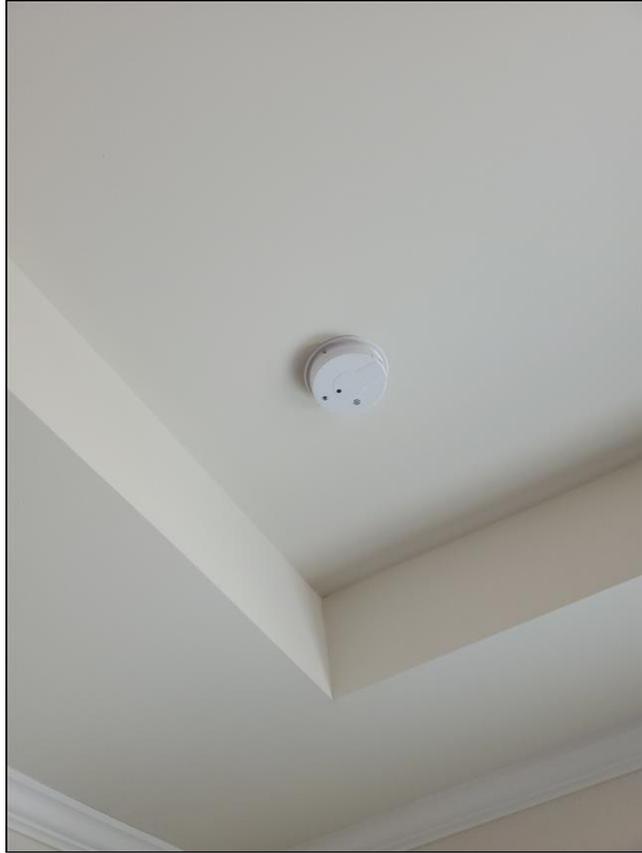
Smoke detectors can last 10 years before needing replacement. Smoke detectors in this house work, but it is recommended that they be replaced.

🔧 Smoke detectors can last 10 years before needing replacement. Smoke detectors in this house work, but it is recommended that they be replaced.

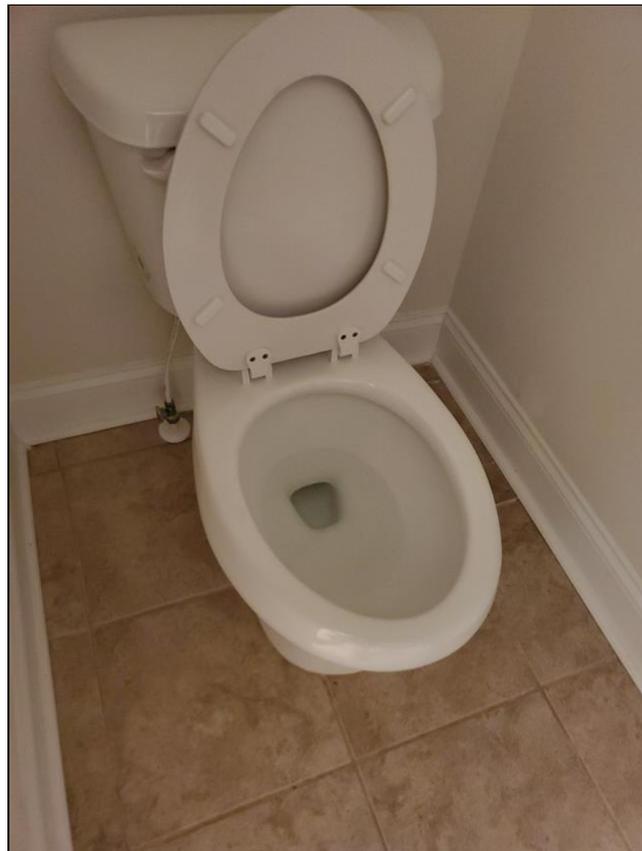
(1) "Running" toilet found in master bath. Have filling mechanism adjusted or repaired.
-

🔧 (1) "Running" toilet found in master bath. Have filling mechanism adjusted or repaired.

water valve shut off at toilet after discovery

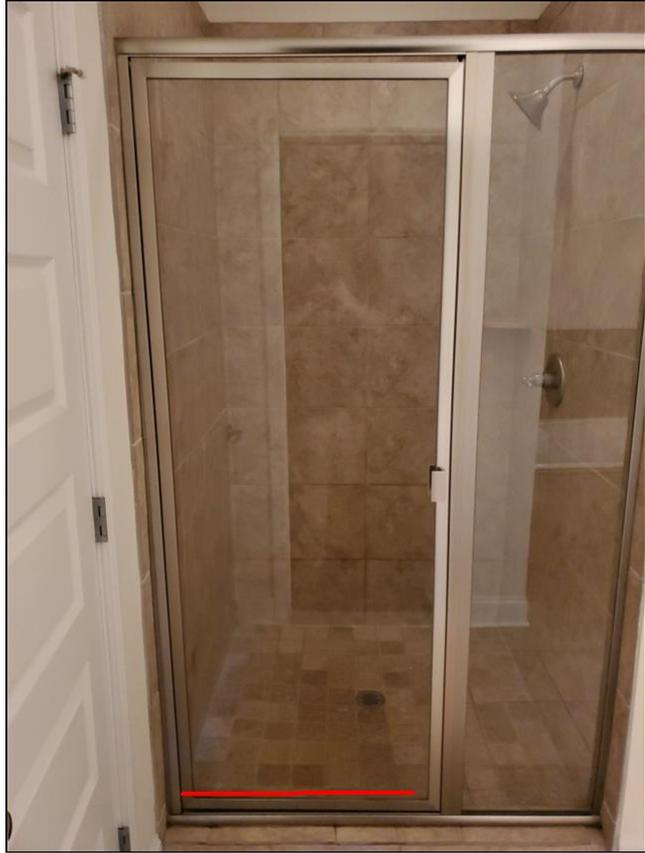
(2) Master shower door sticks to frame and is hard to open and close. Recommend adjustment.
-

🔧 (2) Master shower door sticks to frame and is hard to open and close. Recommend adjustment.

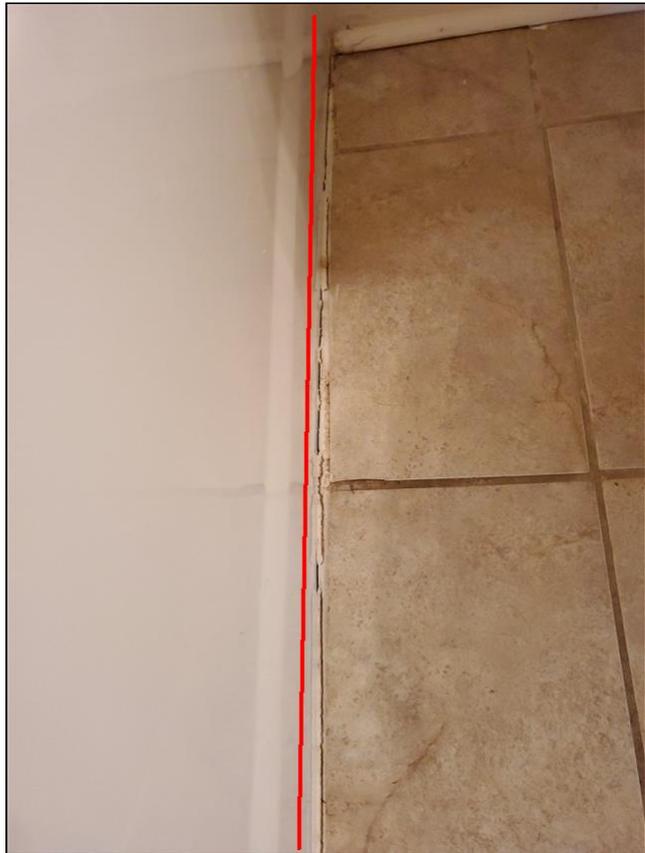
(3) Seal gap / re-grout between tile floor and bathtub in the upstairs bathroom.

🔧 (3) Seal gap / re-grout between tile floor and bathtub in the upstairs bathroom.

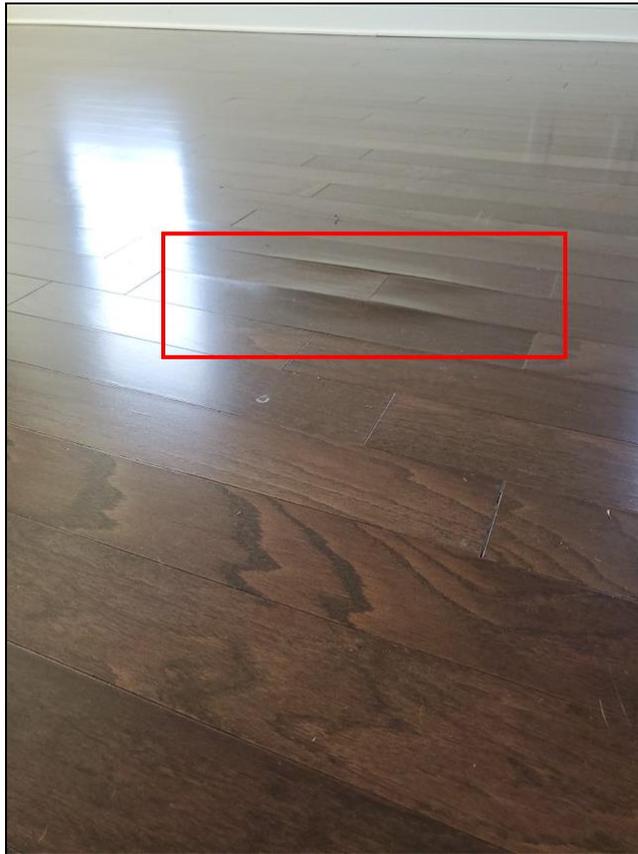
master bedroom

Pre-engineered flooring is delaminating, forming ridges, at several places upstairs. See photo(s). Recommend repairs by flooring installation tech.

🔧 Pre-engineered flooring is delaminating, forming ridges, at several places upstairs. See photo(s). Recommend repairs by flooring installation tech.

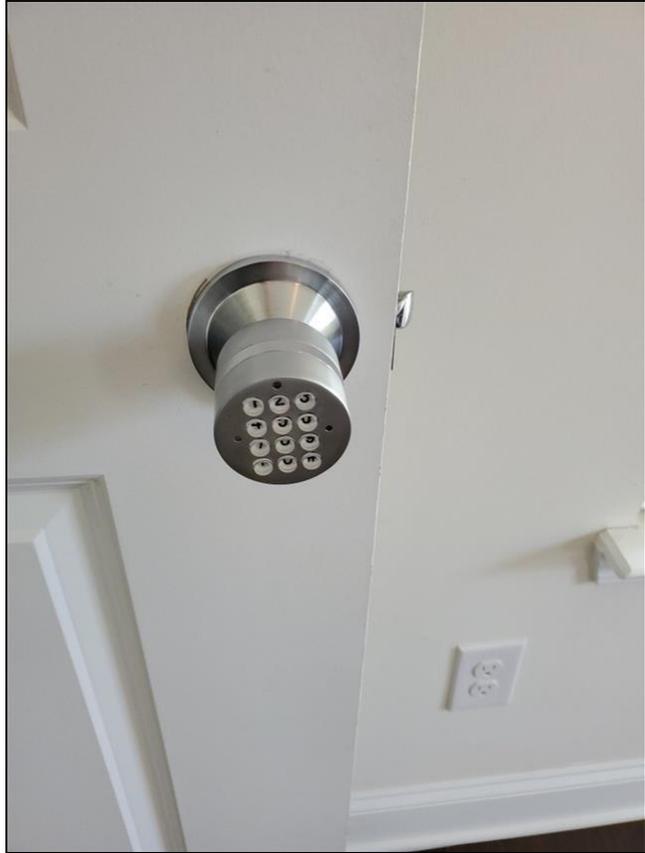
(1) Inquire with seller for information (product document and code) for the key pad door lock on the master bedroom entry door.
-

👉 (1) Inquire with seller for information (product document and code) for the key pad door lock on the master bedroom entry door.

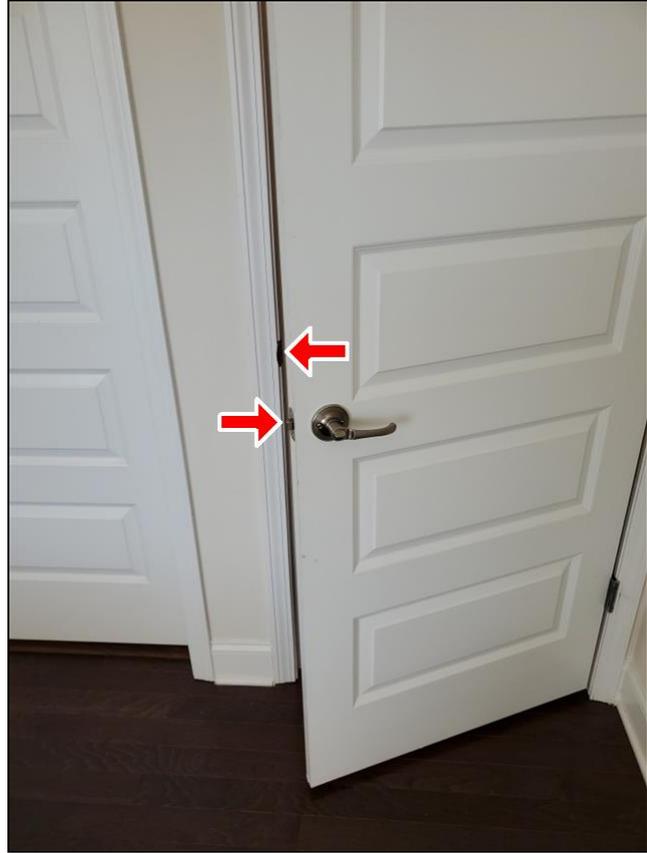
(2) Some interior doors are out of square in the opening and rub on the frames. Adjust as needed so that they will close and latch. This is common in older homes that have had some settlement. See photos(s)

👉 (2) Some interior doors are out of square in the opening and rub on the frames. Adjust as needed so that they will close and latch. This is common in older homes that have had some settlement. See photos(s)

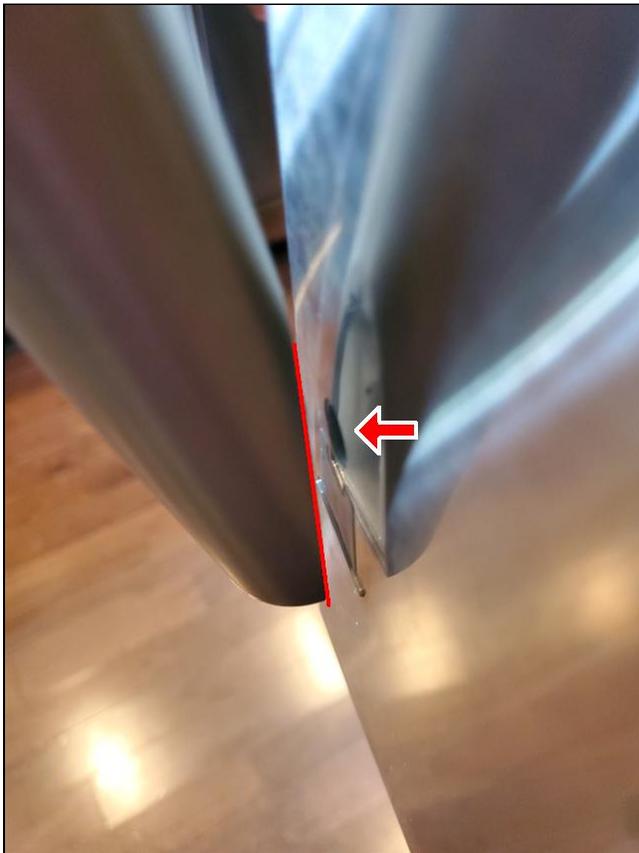
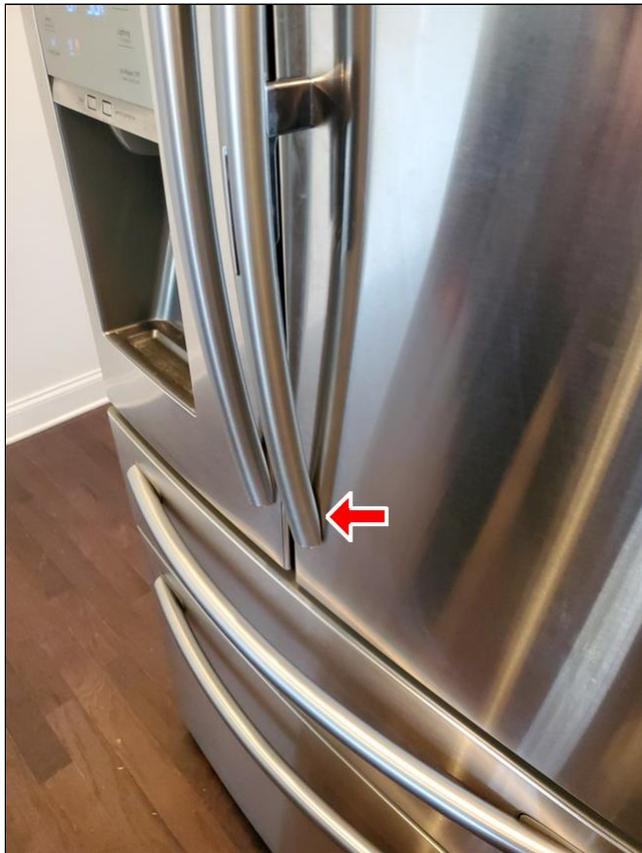
The Refrigerator handle is not fully attached the door. Recommend repair. See photo(s)

🔧 The Refrigerator handle is not fully attached the door. Recommend repair. See photo(s)
