Property Inspection Report

Property address: **1741 Liberty Pkwy NW
Atlanta GA 30318**

Inspection date: **Friday, January 24, 2020**

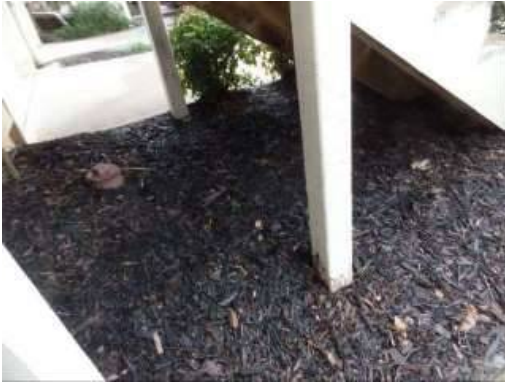
Photo 2-1

Soil was in contact with one or more wooden deck, porch or balcony support posts. This is a conducive condition for wood destroying organisms. Even if posts are made of treated wood, the cut ends below soil may not have been field treated. Recommend grading soil or repairing as necessary to prevent wood-soil contact.

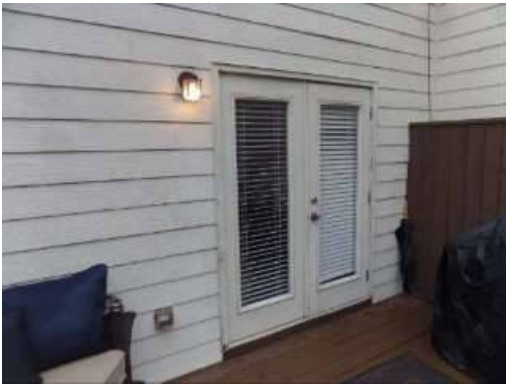
Photo 5-1

The paint or stain finish in some areas was failing (e.g. peeling, faded, worn, thinning). Siding and trim with a failing finish can be damaged by moisture. Recommend that a qualified contractor prep (e.g. clean, scrape, sand, prime, caulk) and repaint or restain the building exterior where necessary and per standard building practices. Any repairs needed to the siding or trim should be made prior to this.

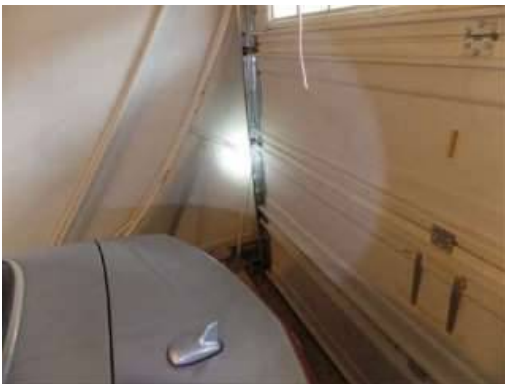
Photo 10-1

One or more garage vehicle doors were DIFFICULT or unable to open or close. Vehicle doors should open and close smoothly and easily. A qualified person should evaluate and repair as necessary. This may require lubrication or repair to hardware such as rollers or brackets.

THE LEFT VERTICAL TRACK (AS VIEWED FROM INSIDE) WAS BENT AT A SPOT ABOUT 3 FEET HIGH. A QUALIFIED CONTRACTOR SHOULD INSPECT/EVALUATE AND REPAIR OR REPLACE AS NECESSARY.

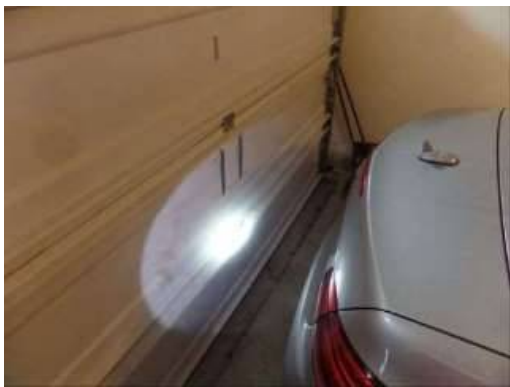
Photo 11-1

THE GARAGE DOOR WAS FUNCTIONAL ALTHOUGH IT APPEARED TO BE PUSHED/BENT IN AT THE TIME OF INSPECTION. IT IS RECOMMENDED TO ASK THE SELLER FOR DETAILS ABOUT THE DOOR. EVALUTE AND MONITOR AS NECESSARY.

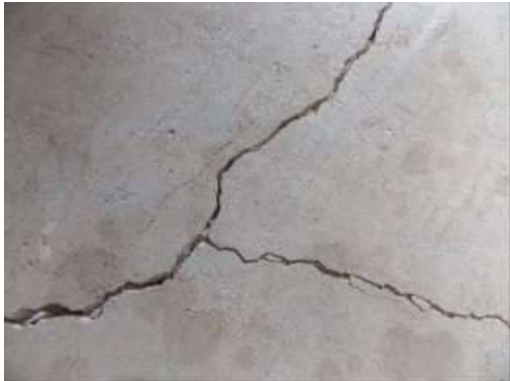
Photo 12-1

12) **i** Minor cracks were found in the concrete slab floor. These are common and appeared to be only a cosmetic issue.

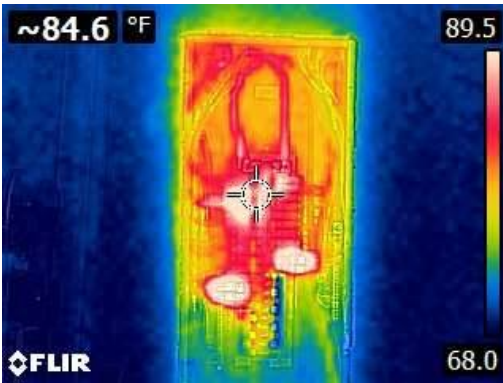
Photo 15-1

Thermal imaging infrared camera revealed ELEVATED HEAT SIGNATURE AT THE TOP RIGHT BREAKER (FURNACE) at the time of inspection. (LAST TWO PHOTOS)
 A QUALIFIED CONTRACTOR SHOULD INSPECT/EVALUATE AND REPAIR OR REPLACE AS NECESSARY.

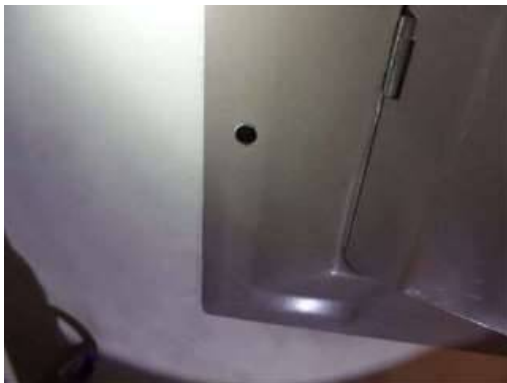
Photo 16-1

Missing screws in the panel should be replaced with the stock panel screws from the manufacturer or their equivalent.

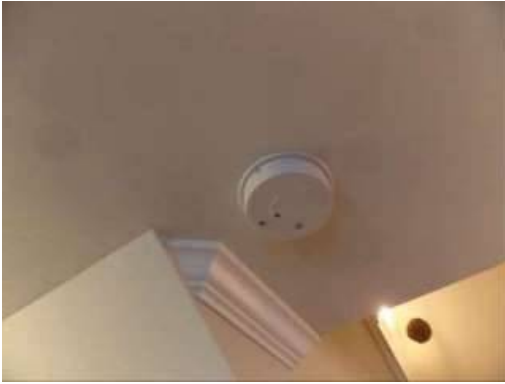
Photo 17-1

Based on the age of this structure and the appearance of existing smoke alarms, the alarms may have been installed more than 10 years ago. According to [National Fire Protection Association](https://www.nfpa.org/101), aging smoke alarms don't operate as efficiently and often are the source for nuisance alarms. Older smoke alarms are estimated to have a 30% probability of failure within the first 10 years. Newer smoke alarms do better, but should be replaced after 10 years. Unless you know that the smoke alarms are new, replacing them when moving into a new residence is also recommended by NFPA. For more information, visit: <https://www.reporthost.com/?SMKALRMLS>

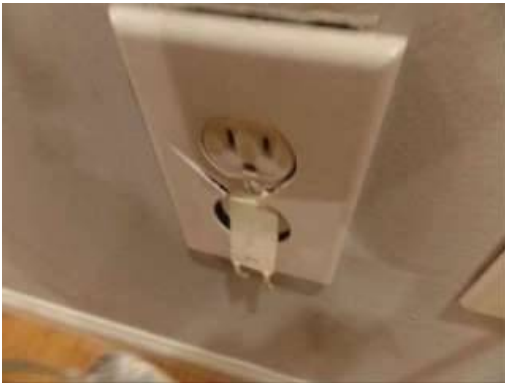
Photo 18-1

One or more cover plates for switches, receptacles (outlets) or junction boxes were missing or broken or loose. These plates are intended to contain fire and prevent electric shock from occurring due to exposed wires. Recommend that a qualified person install cover plates where necessary.
FOR EXAMPLE AT LOWEST LEVEL

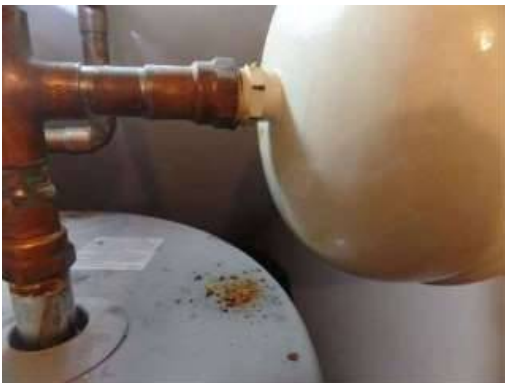
Photo 21-1

Significant corrosion or rust was found at the supply pipes or fittings. This can indicate past leaks, or that leaks are likely to occur in the future. Recommend that a qualified plumber evaluate and replace components or make repairs as necessary.

FOR EXAMPLE AT EXPANSION TANK AT TOP OF UNIT

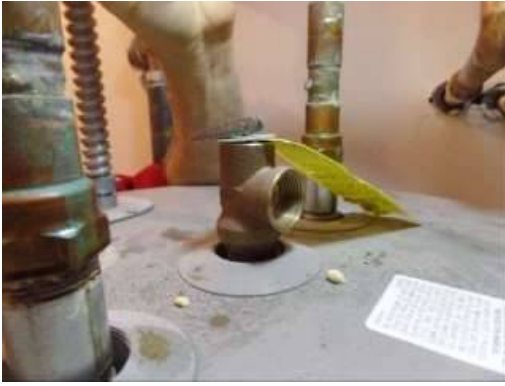
Photo 22-1

No drain line was installed for the temperature-pressure relief valve. Drain lines are normally installed to prevent water from accumulating if/when the valve eventually leaks, and to prevent scalding if someone is standing next to the water heater when the valve opens. Recommend that a qualified plumber install a drain line so it drains outside and per standard building practices. WHAT WAS LIKELY THE PREVIOUSLY CONNECTED DRAIN LINE IN 2ND PHOTO.

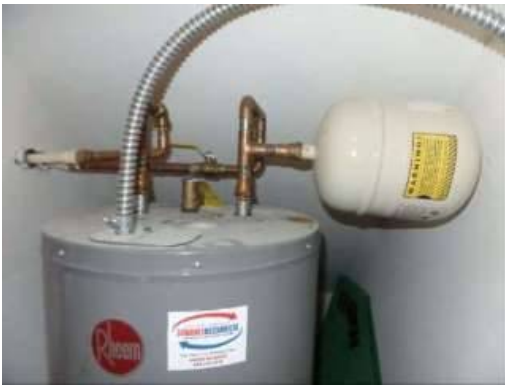
Photo 23-1

23) Expansion tank should be supported to prevent stress on the plumbing.

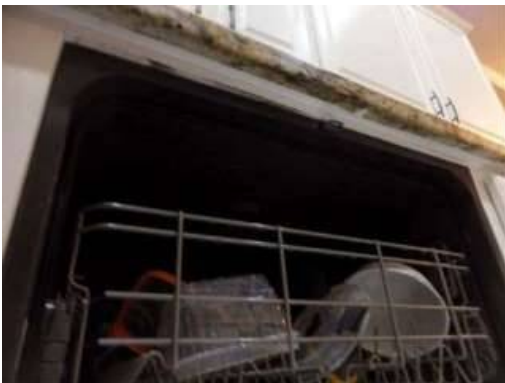
Photo 26-1

The bracket that attaches the dishwasher to the underside of the countertop is loose, missing or installed in a substandard way. Repairs should be made as necessary, such as installing or reinstalling the bracket, and by a qualified contractor if necessary.

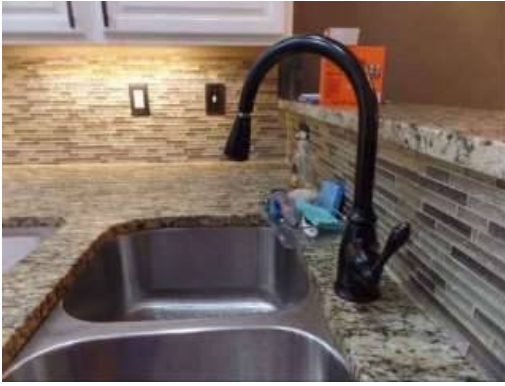
Photo 27-1

Gaps, no caulk, or substandard caulking were found between countertops and backsplashes. Water may penetrate these areas and cause damage. Recommend that a qualified person repair as necessary. For example, by installing caulk.

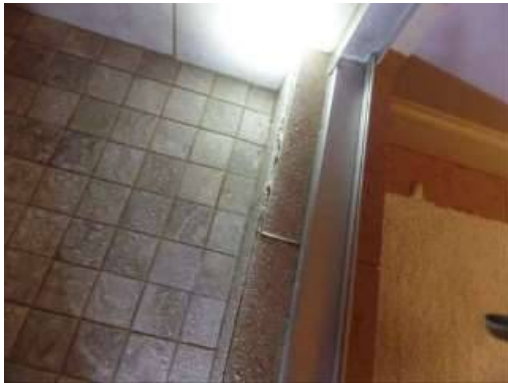
Photo 31-1

THE FIRST FLOOR SHOWER HAD MULTIPLE SHARP TILE EDGES AT THE ELEVATED BASE OF THE SLIDING GLASS DOORS. THESE SHARP EDGES ARE HAZARDOUS AND COULD CAUSE INJURY TO BARE FEET. A QUALIFIED CONTRACTOR SHOULD INSPECT/EVALUATE AND REPAIR OR REPLACE AS NECESSARY.

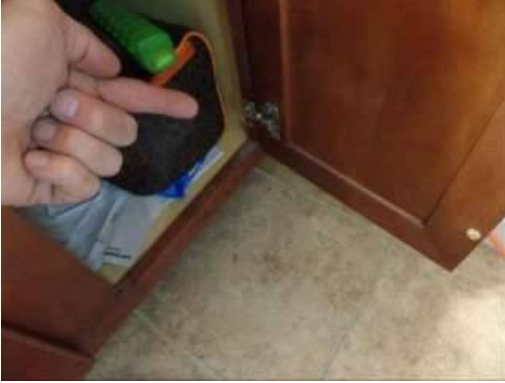
Photo 32-1

One or more cabinets, drawers and/or cabinet doors at location(s) #A and/or MASTER were damaged or deteriorated. Recommend that a qualified person repair or replace as necessary.

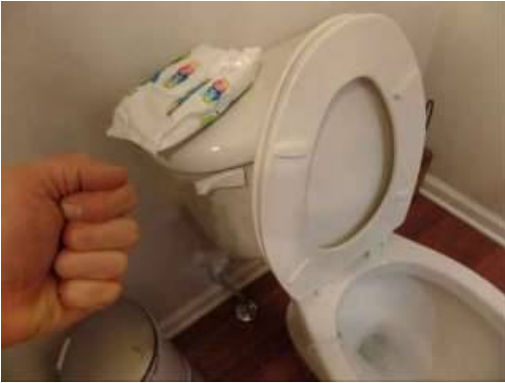
Photo 33-1

The toilet at location(s) #C and/or 1/2 BATH POWDER ROOM ran water continuously or didn't shut off after being flushed, and water leaked from the tank into the bowl. Significant amounts of water can be lost through such leaks. If this system uses a septic system, the septic system can be overloaded and cause significant and potentially expensive damage. A qualified person should repair or replace components as necessary.

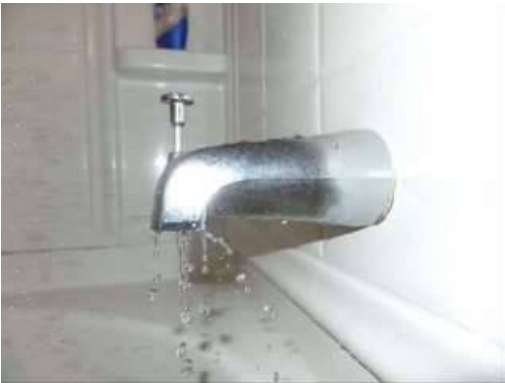
Photo 34-1

Diverter valve for the shower at location # A MASTER was defective. Recommend replacing to prevent the wasting of water. A qualified contractor should inspect/evaluate and repair or replace as necessary.

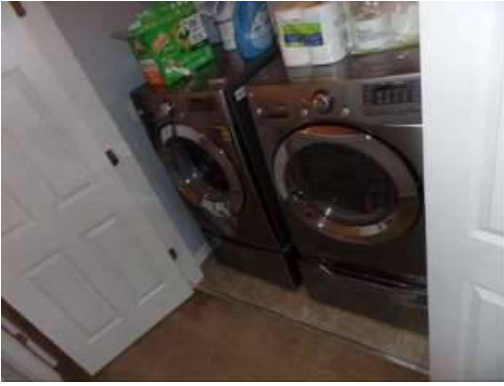
Photo 35-1

THE LAUNDRY WASHING MACHINE WAS LOCATED ABOVE OR NEAR FINISHED LIVING SPACE AT THE TIME OF INSPECTION AND SHOULD BE POSITIONED INSIDE A PROPER EMERGENCY DRAIN PAN. A QUALIFIED CONTRACTOR SHOULD EVALUATE AND REPAIR AS NECESSARY.

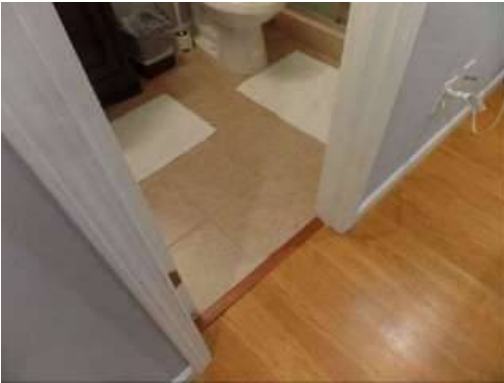
Photo 36-1

Tile, stone and/or grout in the flooring at location(s) #D and/or 1ST FLOOR was deteriorated (e.g. loose or cracked tiles, missing grout) or substandard. Water can damage the sub-floor as a result. Recommend that a qualified contractor repair as necessary.

THRESHOLD WAS LOOSE AT THE TIME OF INSPECTION

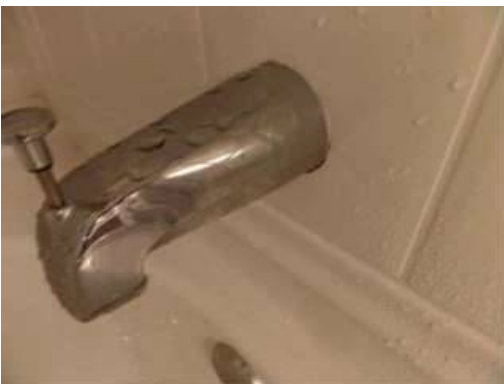
Photo 37-1

Caulk was missing around the base of the bathtub spout, or there was a gap behind it, at location(s) #A, B and/or BOTH TOP BATHROOMS. Water may enter the wall structure behind the bathtub. Recommend that a qualified person repair as necessary to eliminate the gap. For example, by installing or replacing caulk if the gap is small enough. For larger gaps, a shorter spout nipple or an escutcheon plate can be installed.

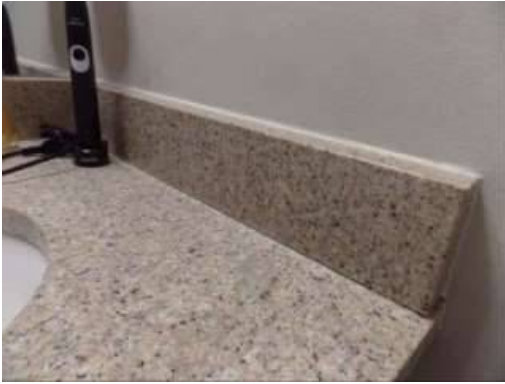
Photo 38-1

Gaps, no caulk, or substandard caulking were found between countertops and backsplashes at location(s) #B and/or FRONT. Water can penetrate these areas and cause damage. Recommend that a qualified person repair as necessary. For example, by installing or replacing caulk.

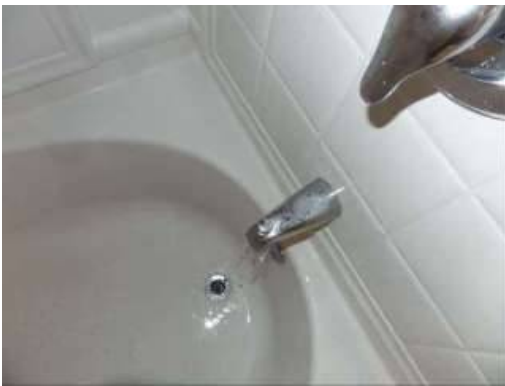
Photo 39-1

The bathtub drain stopper mechanism at location(s) #A and/or MASTER was missing. Recommend that a qualified person repair or replace as necessary.

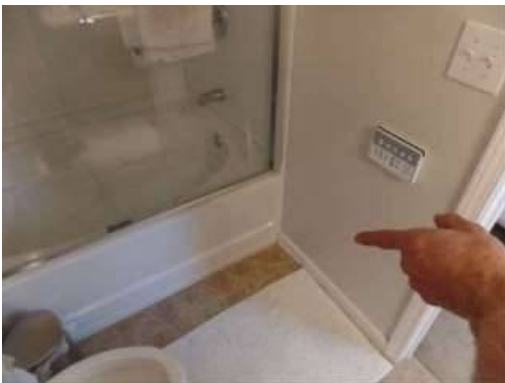
Photo 40-1

The wall by the shower at location(s) #A, B, D, MASTER, FRONT and/or 1ST FLOOR was water-damaged. Recommend that a qualified person repair as necessary.

TRIM DETERIORATED AND/OR DISCOLORED WHICH INDICATES PROLONGED WATER EXPOSURE. AT SLIDING DOORS CAULK/SEALANT SHOULD BE APPLIED AT METAL FRAME. REPAIR MAINTAIN AS NECESSARY.

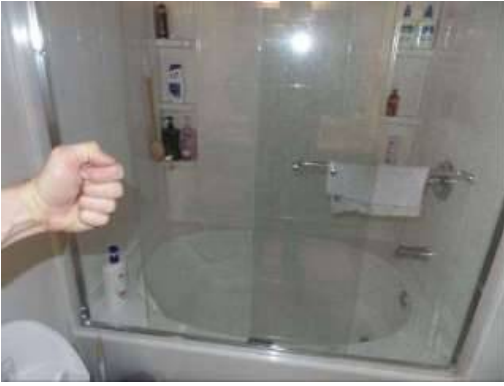
Photo 41-1

THE LEFT SLIDING GLASS DOOR AT MASTER BATHROOM #A WAS DIFFICULT TO OPERATE AT THE TIME OF INSPECTION AND MAY HAVE DAMAGED TRACKS. A QUALIFIED CONTRACTOR SHOULD INSPECT/EVALUATE AND REPAIR OR REPLACE AS NECESSARY.

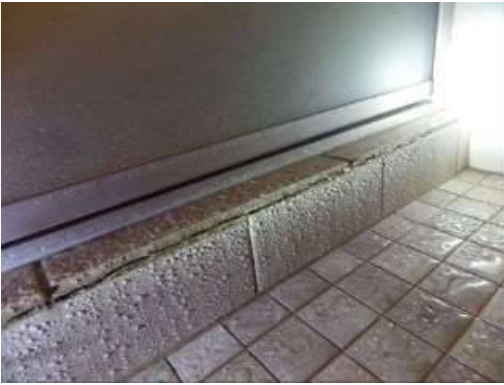
Photo 42-1

ONE OR MORE GAPS WERE PRESENT AT THE TILE GROUT AT THE FIRST FLOOR SHOWER AT THE TIME OF INSPECTION. WATER COULD ESCAPE THE SHOWER ENCLOSURE POSSIBLY CAUSING WOOD ROT AND POTENTIAL BIOLOGICAL GROWTH (MOLD). A QUALIFIED CONTRACTOR SHOULD INSPECT/EVALUATE AND REPAIR OR REPLACE AS NECESSARY.

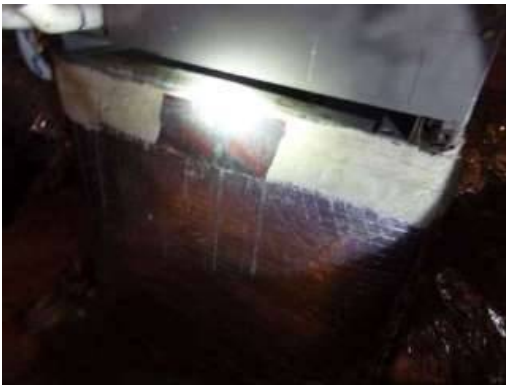
Photo 48-1

Recommend **INSTALLING, REPLACING** or **WASHING** HVAC filters upon taking occupancy depending on the type of filters installed. Regardless of the type, recommend checking filters monthly in the future and replacing or washing them as necessary. How frequently they need replacing or washing depends on the type and quality of the filter, how the system is configured (e.g. always on vs. "Auto"), and on environmental factors (e.g. pets, smoking, frequency of house cleaning, number of occupants, the season).

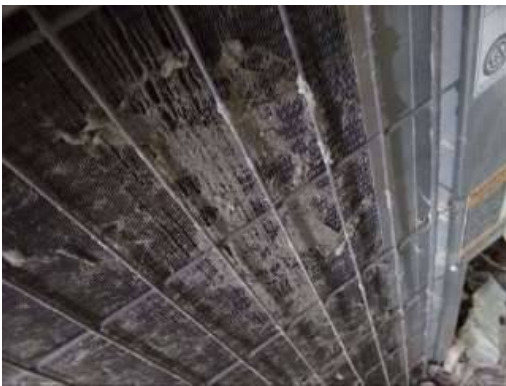
Photo 49-1

The cooling fins at the air handler evaporator coils were EXTREMELY dirty. Recommend that a qualified person clean fins as necessary.

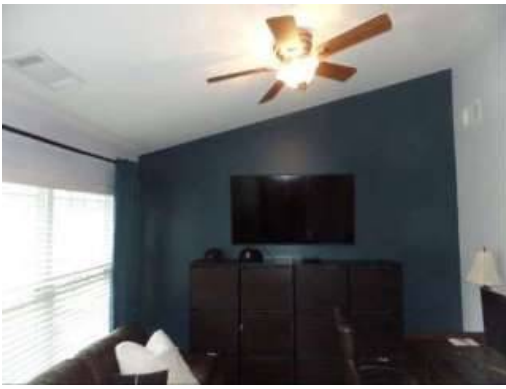
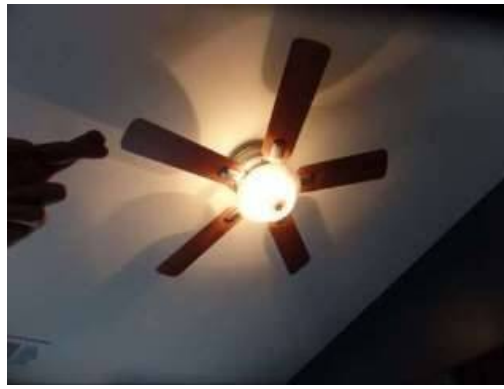
One or more ceiling fans appeared to be inoperable, or the inspector was unable to find normal controls with which to operate the fan(s). Recommend asking the property owner about their operation, and if necessary, that a qualified electrician evaluate and repair.

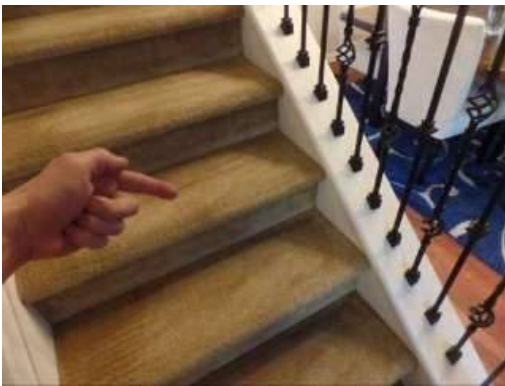
Photo 58-1

Carpeting in one or more areas was damaged or deteriorated. Recommend that a qualified contractor replace as necessary. FOR EXAMPLE AT STAIRS

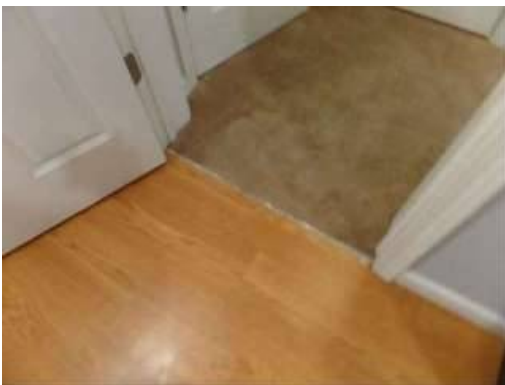
Photo 59-1

LAMINATE FLOOR AT LOWEST LEVEL WAS MISSING A DOORWAY THRESHOLD AT THE TIME OF INSPECTION. A QUALIFIED CONTRACTOR SHOULD INSPECT/EVALUATE AND REPAIR OR REPLACE AS NECESSARY.

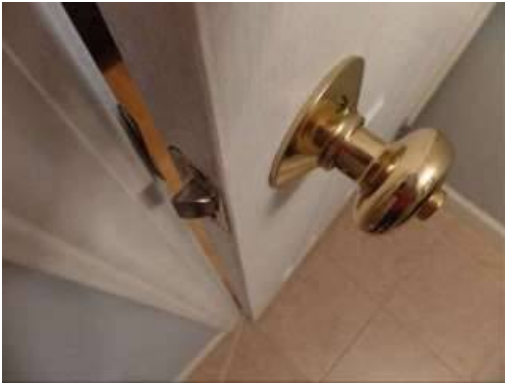
Photo 60-1

One or more interior doors wouldn't latch or were difficult to latch. Recommend that a qualified person repair as necessary. For example, by adjusting latch plates or locksets. FOR EXAMPLE AT MULTIPLE

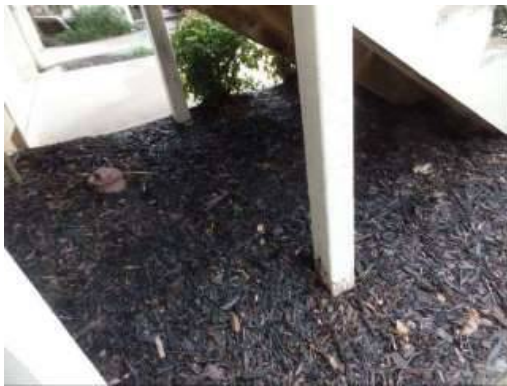
Photo 2-1

Soil was in contact with one or more wooden deck, porch or balcony support posts. This is a conducive condition for wood destroying organisms. Even if posts are made of treated wood, the cut ends below soil may not have been field treated. Recommend grading soil or repairing as necessary to prevent wood-soil contact.

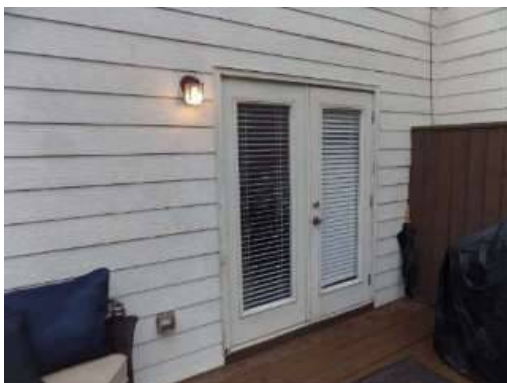
Photo 5-1

The paint or stain finish in some areas was failing (e.g. peeling, faded, worn, thinning). Siding and trim with a failing finish can be damaged by moisture. Recommend that a qualified contractor prep (e.g. clean, scrape, sand, prime, caulk) and repaint or restain the building exterior where necessary and per standard building practices. Any repairs needed to the siding or trim should be made prior to this.

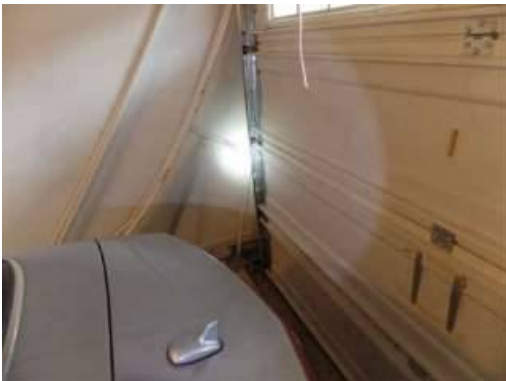
Photo 10-1

THE LEFT VERTICAL TRACK (AS VIEWED FROM INSIDE) WAS BENT AT A SPOT ABOUT 3 FEET HIGH. A QUALIFIED CONTRACTOR SHOULD INSPECT/EVALUATE AND REPAIR OR REPLACE AS NECESSARY.

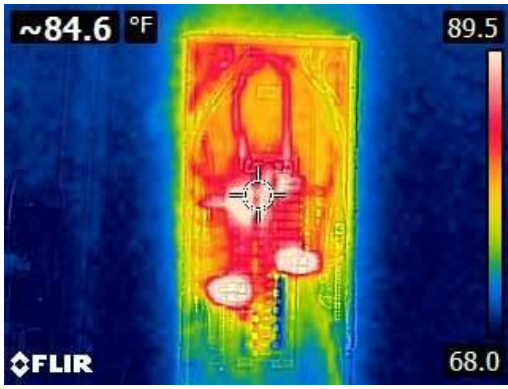
Photo 15-1

Thermal imaging infrared camera revealed ELEVATED HEAT SIGNATURE AT THE TOP RIGHT BREAKER (FURNACE) at the time of inspection. (LAST TWO PHOTOS)
A QUALIFIED CONTRACTOR SHOULD INSPECT/EVALUATE AND REPAIR OR REPLACE AS NECESSARY.

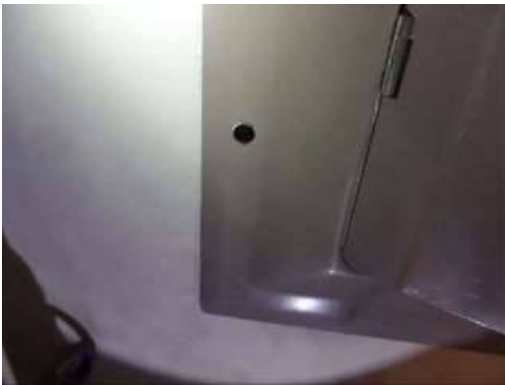
Photo 16-1

Missing screws in the panel should be replaced with the stock panel screws from the manufacturer or their equivalent.

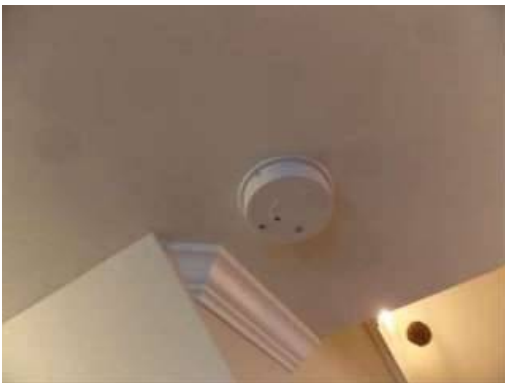
Photo 17-1

Based on the age of this structure and the appearance of existing smoke alarms, the alarms may have been installed more than 10 years ago. According to [National Fire Protection Association](https://www.nfpa.org), aging smoke alarms don't operate as efficiently and often are the source for nuisance alarms. Older smoke alarms are estimated to have a 30% probability of failure within the first 10 years. Newer smoke alarms do better, but should be replaced after 10 years. Unless you know that the smoke alarms are new, replacing them when moving into a new residence is also recommended by NFPA. For more information, visit: <https://www.reporthost.com/?SMKALRMLS>

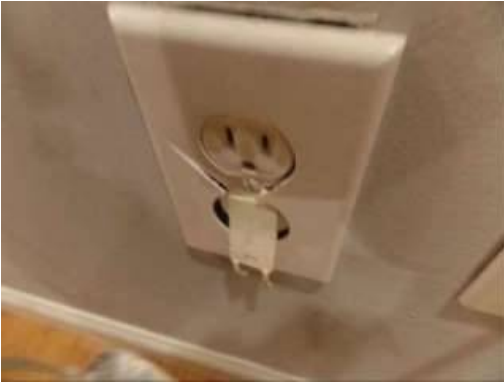
Photo 18-1

One or more cover plates for switches, receptacles (outlets) or junction boxes were missing or broken or loose. These plates are intended to contain fire and prevent electric shock from occurring due to exposed wires. Recommend that a qualified person install cover plates where necessary.
FOR EXAMPLE AT LOWEST LEVEL

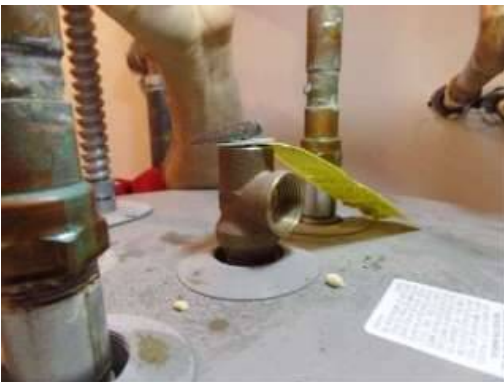
Photo 22-1

22) 🔧🔍 No drain line was installed for the temperature-pressure relief valve. Drain lines are normally installed to prevent water from accumulating if/when the valve eventually leaks, and to prevent scalding if someone is standing next to the water heater when the valve opens. Recommend that a qualified plumber install a drain line so it drains outside and per standard building practices.
WHAT WAS LIKELY THE PREVIOUSLY CONNECTED DRAIN LINE IN 2ND PHOTO.

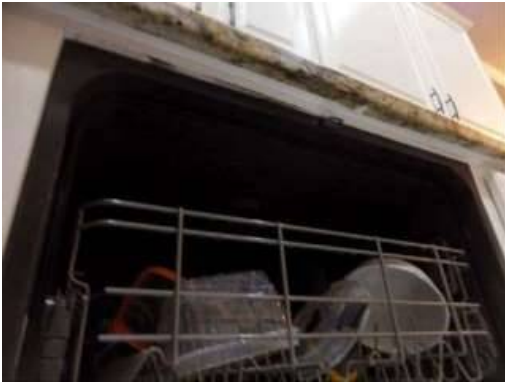
Photo 26-1

The bracket that attaches the dishwasher to the underside of the countertop is loose, missing or installed in a substandard way. Repairs should be made as necessary, such as installing or reinstalling the bracket, and by a qualified contractor if necessary.

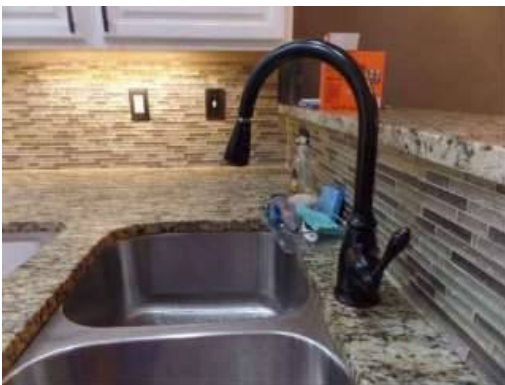
Photo 27-1

Gaps, no caulk, or substandard caulking were found between countertops and backsplashes. Water may penetrate these areas and cause damage. Recommend that a qualified person repair as necessary. For example, by installing caulk.

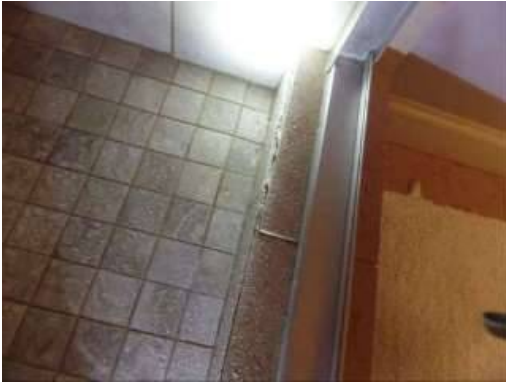
Photo 31-1

THE FIRST FLOOR SHOWER HAD MULTIPLE SHARP TILE EDGES AT THE ELEVATED BASE OF THE SLIDING GLASS DOORS. THESE SHARP EDGES ARE HAZARDOUS AND COULD CAUSE INJURY TO BARE FEET. A QUALIFIED CONTRACTOR SHOULD INSPECT/EVALUATE AND REPAIR OR REPLACE AS NECESSARY.

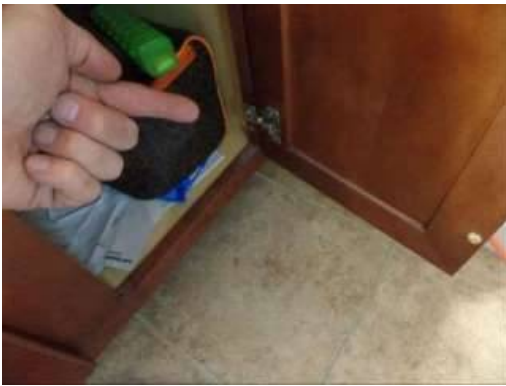
Photo 32-1

One or more cabinets, drawers and/or cabinet doors at location(s) #A and/or MASTER were damaged or deteriorated. Recommend that a qualified person repair or replace as necessary.

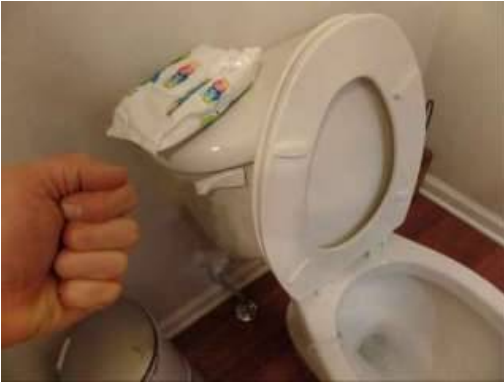
Photo 33-1

The toilet at location(s) #C and/or 1/2 BATH POWDER ROOM ran water continuously or didn't shut off after being flushed, and water leaked from the tank into the bowl. Significant amounts of water can be lost through such leaks. If this system uses a septic system, the septic system can be overloaded and cause significant and potentially expensive damage. A qualified person should repair or replace components as necessary.

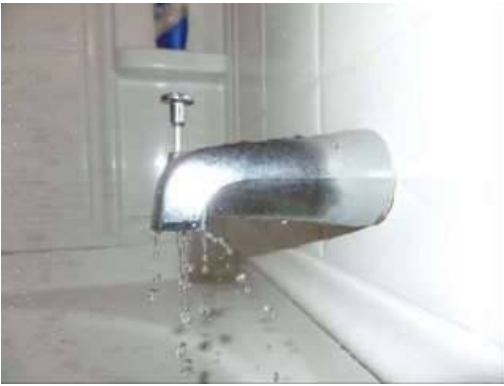
Photo 34-1

Diverter valve for the shower at location # A MASTER was defective. Recommend replacing to prevent the wasting of water. A qualified contractor should inspect/evaluate and repair or replace as necessary.

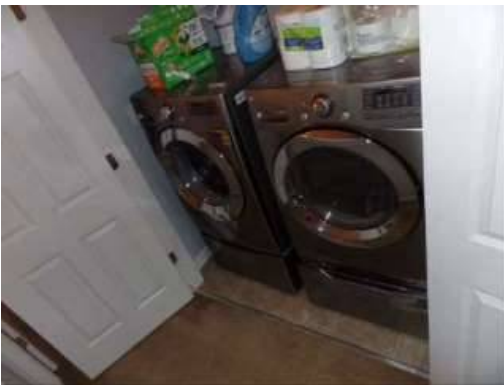
Photo 35-1

THE LAUNDRY WASHING MACHINE WAS LOCATED ABOVE OR NEAR FINISHED LIVING SPACE AT THE TIME OF INSPECTION AND SHOULD BE POSITIONED INSIDE A PROPER EMERGENCY DRAIN PAN. A QUALIFIED CONTRACTOR SHOULD EVALUATE AND REPAIR AS NECESSARY.

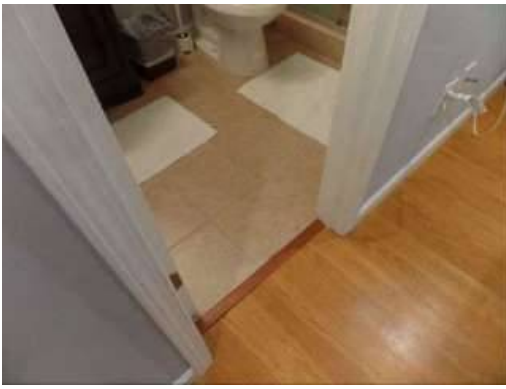
Photo 36-1

THRESHOLD WAS LOOSE AT THE TIME OF INSPECTION

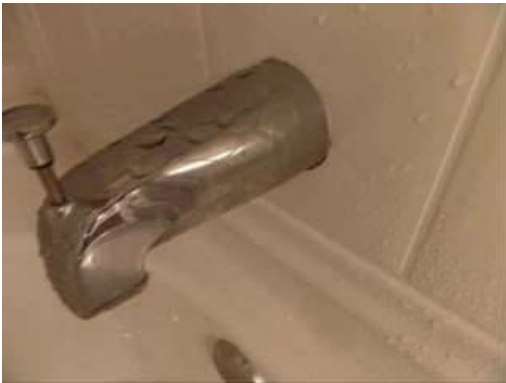
Photo 37-1

Caulk was missing around the base of the bathtub spout, or there was a gap behind it, at location(s) #A, B and/or BOTH TOP BATHROOMS. Water may enter the wall structure behind the bathtub. Recommend that a qualified person repair as necessary to eliminate the gap. For example, by installing or replacing caulk if the gap is small enough. For larger gaps, a shorter spout nipple or an escutcheon plate can be installed.

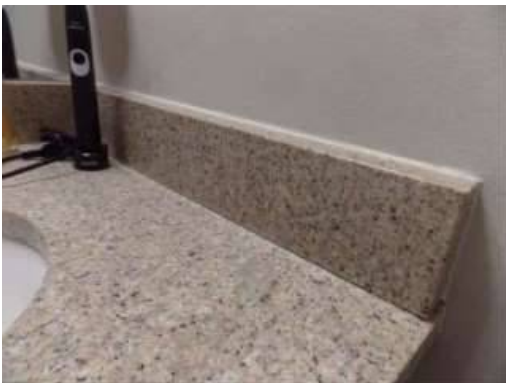
Photo 38-1

Gaps, no caulk, or substandard caulking were found between countertops and backsplashes at location(s) #B and/or FRONT. Water can penetrate these areas and cause damage. Recommend that a qualified person repair as necessary. For example, by installing or replacing caulk.

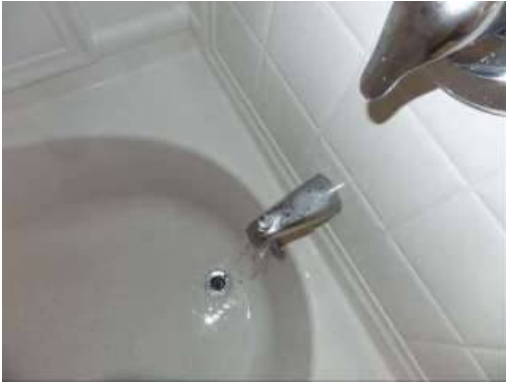
Photo 39-1

The bathtub drain stopper mechanism at location(s) #A and/or MASTER was missing. Recommend that a qualified person repair or replace as necessary.

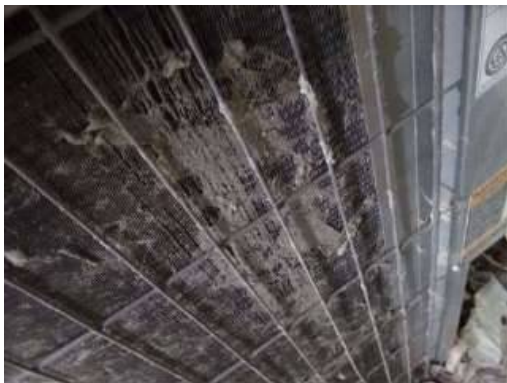
Photo 49-1

The cooling fins at the air handler evaporator coils were EXTREMELY dirty. Recommend that a qualified person clean fins as necessary.
