Castle Inspector

Joey & Katie Raborn
1361 Wesleyan Ct
Marietta, GA 30

Date of Inspection: 3/4/2020

SUMMARY OF INSPECTION

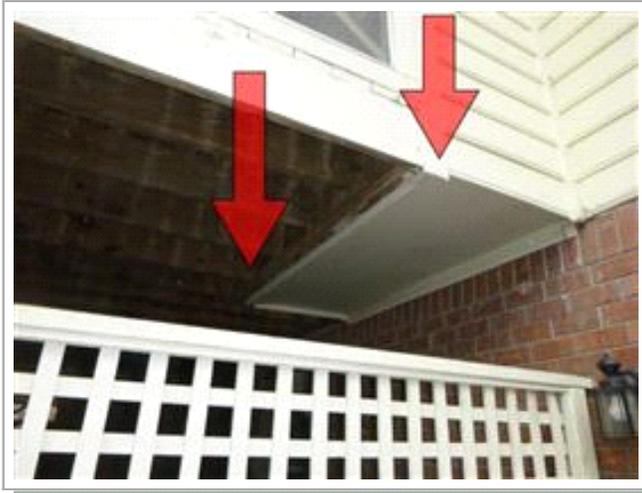
Figure Number 1

The screen porch is partially supported by the cantilevered chimney framing. The chimney has sagged. Recommend installing vertical posts supported by proper footings to prevent further sagging footings not present under walkway.

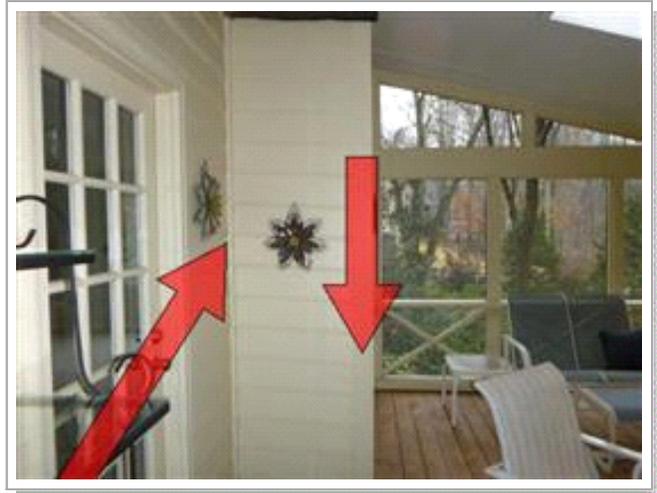
Figure Number 2

The screen porch is partially supported by the cantilevered chimney framing. The chimney has sagged. Recommend installing vertical posts supported by proper footings to prevent further sagging footings not present under walkway.

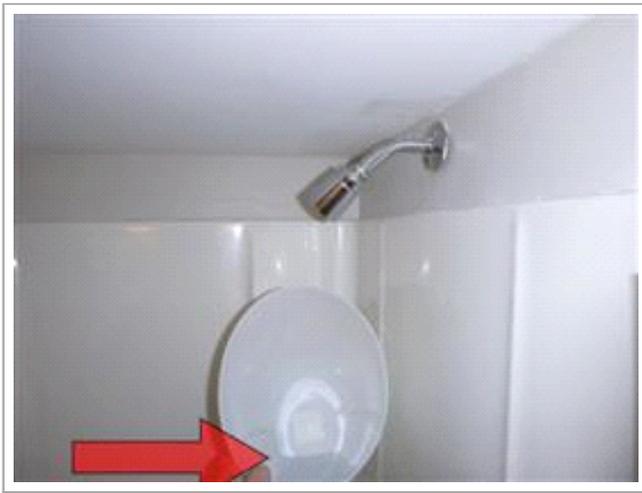
Figure Number 3

The basement shower head drips while the faucet is turned off. The waster supply plumbing for the shower is also leaking. Recommend inspection and repair by qualified plumber.

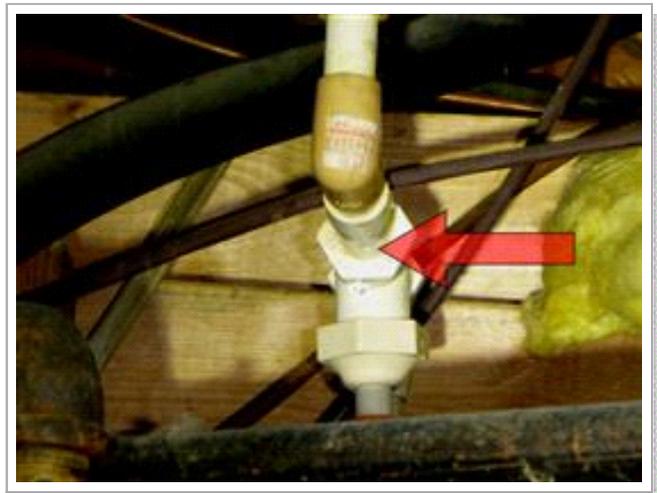
Figure Number 4

The basement shower head drips while the faucet is turned off. The waster supply plumbing for the shower is also leaking. Recommend inspection and repair by qualified plumber.

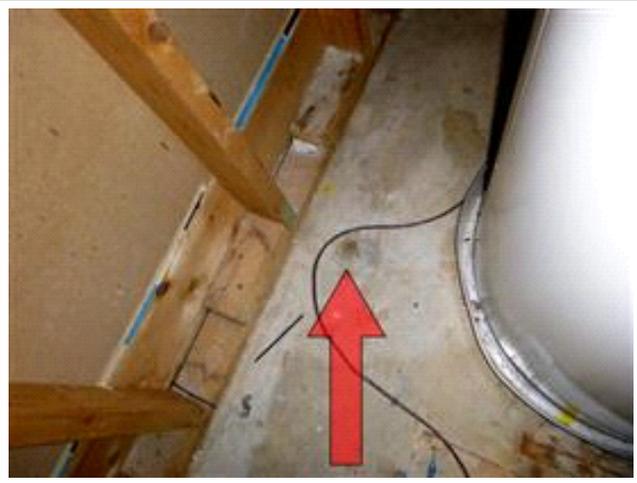
Figure Number 5

The basement shower head drips while the faucet is turned off. The waster supply plumbing for the shower is also leaking. Recommend inspection and repair by qualified plumber.

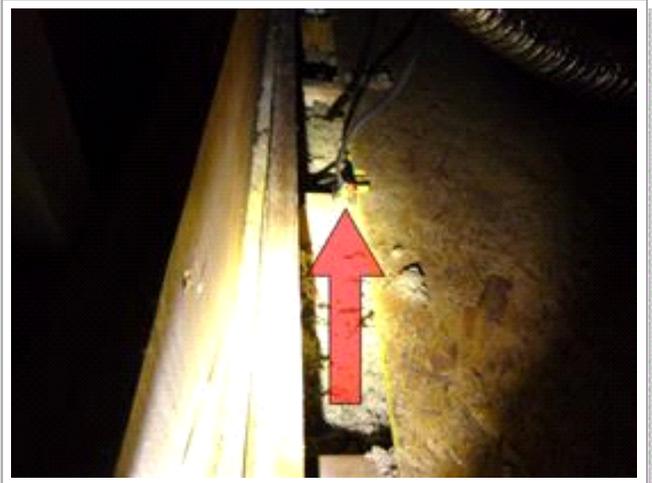
Figure Number 6

Uncovered electrical connections were noted in the attic behind the laundry and under the basement stairs. Recommend placing all electrical connections in covered junction boxes for safety.

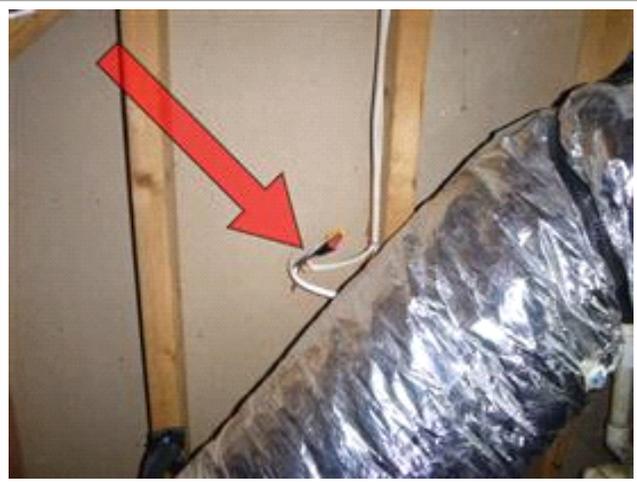
Figure Number 7

Uncovered electrical connections were noted in the attic behind the laundry and under the basement stairs. Recommend placing all electrical connections in covered junction boxes for safety.

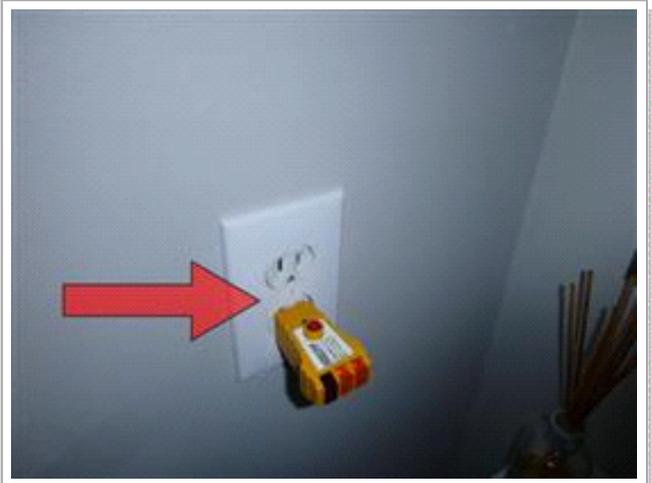
Figure Number 8

The basement bathroom outlet and the unfinished basement outlets are not GFCI protected. GFCI outlets are recommended on the exterior, in the garage, unfinished basement, crawlspace, and within 6 feet of sinks to prevent accidental electrical shock.

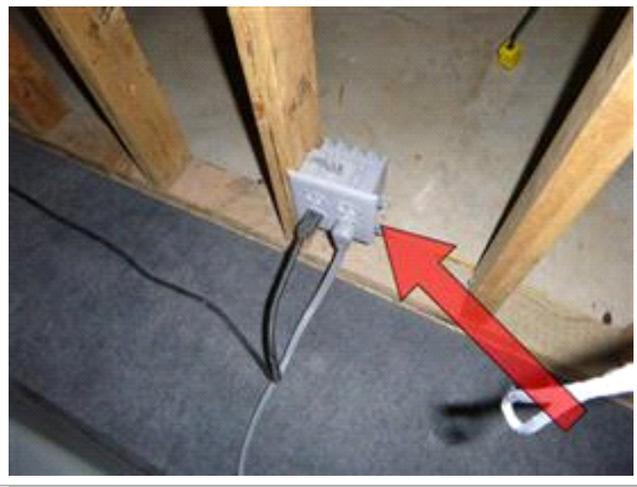
Figure Number 9

The basement bathroom outlet and the unfinished basement outlets are not GFCI protected. GFCI outlets are recommended on the exterior, in the garage, unfinished basement, crawlspace, and within 6 feet of sinks to prevent accidental electrical shock.

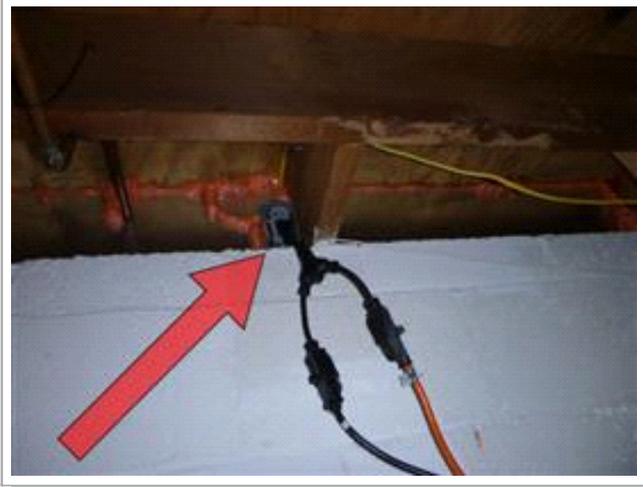
Figure Number 10

The basement bathroom outlet and the unfinished basement outlets are not GFCI protected. GFCI outlets are recommended on the exterior, in the garage, unfinished basement, crawlspace, and within 6 feet of sinks to prevent accidental electrical shock.

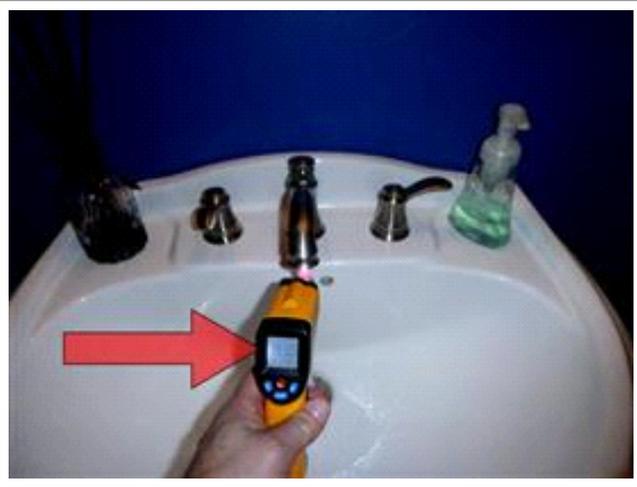
Figure Number 11

The hot water heater temperature exceeds 140 degrees. Recommend turning to a maximum of 125 degrees to prevent scalding.

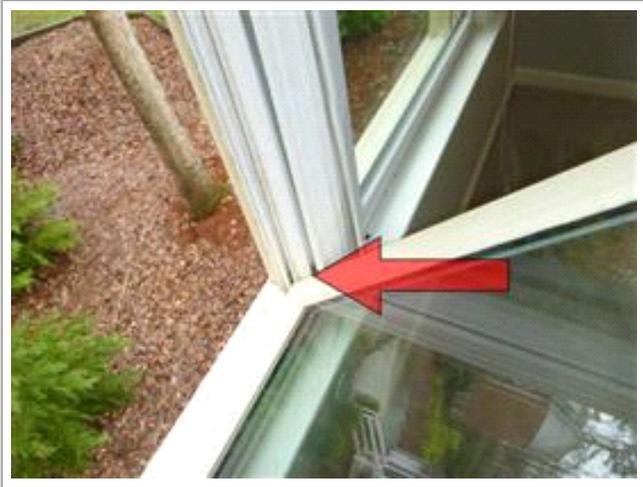
Figure Number 12

The lower rear window sash in the bonus room is not attached to the springs. This will keep the sash from staying up and allow the sash to fall suddenly. Recommend repair for security and safety.

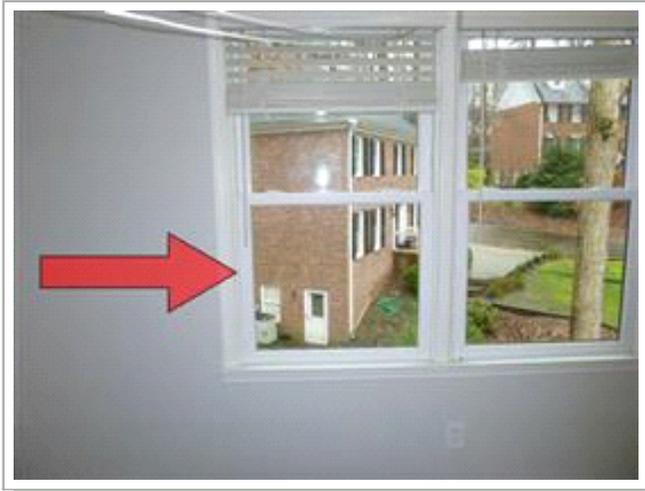
Figure Number 13

The lower rear window sash in the bonus room is not attached to the springs. This will keep the sash from staying up and allow the sash to fall suddenly. Recommend repair for security and safety.

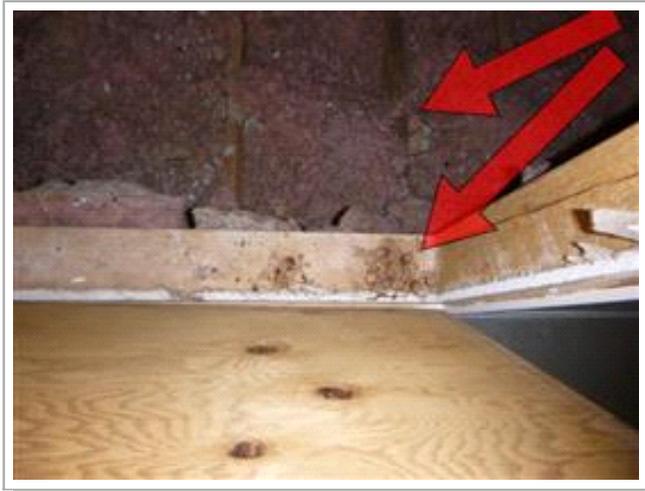
Figure Number 14

Evidence of animal infestation in the attic space above the garage hallway. Heavy wood roach evidence noted in the same space. Recommend consulting an exclusion/extermination service to seal all entry points and eliminate infestation.

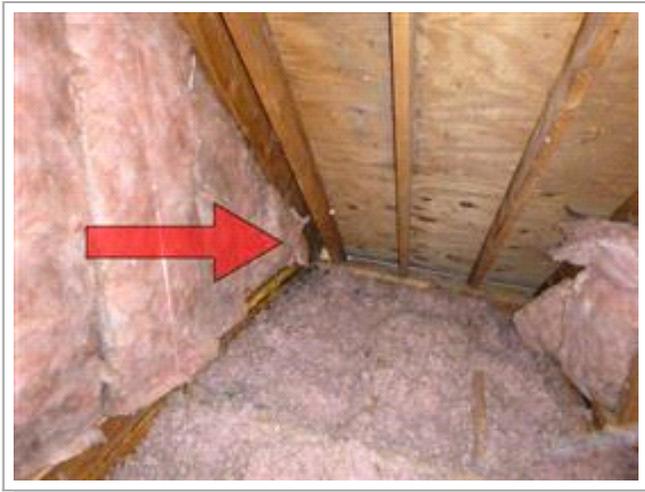
Figure Number 15

Evidence of animal infestation in the attic space above the garage hallway. Heavy wood roach evidence noted in the same space. Recommend consulting an exclusion/extermination service to seal all entry points and eliminate infestation.

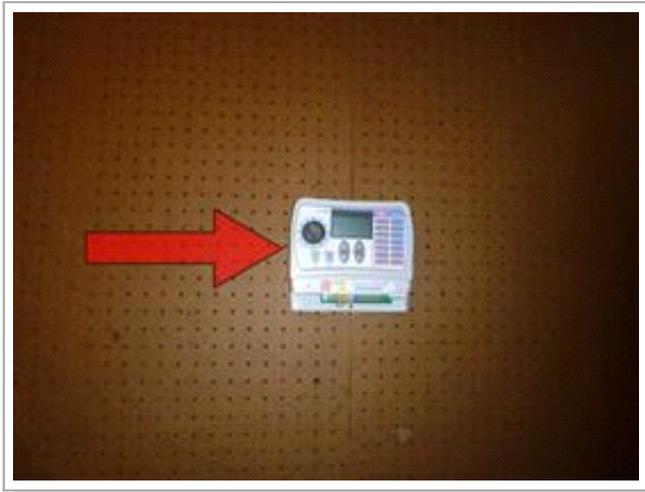
Figure Number 16

The sprinkler system was not operational. The electrical connector has been removed. There is an irrigation pump in the box on the lower patio which has no electrical connection. Recommend further evaluation and repair by qualified contractor.

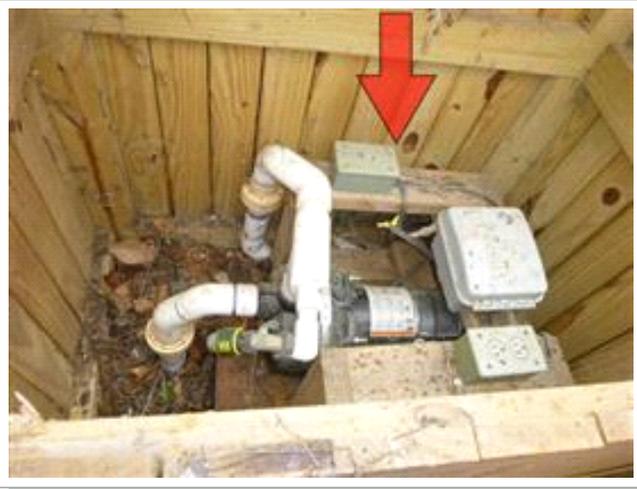
Figure Number 17

The sprinkler system was not operational. The electrical connector has been removed. There is an irrigation pump in the box on the lower patio which has no electrical connection. Recommend further evaluation and repair by qualified contractor.

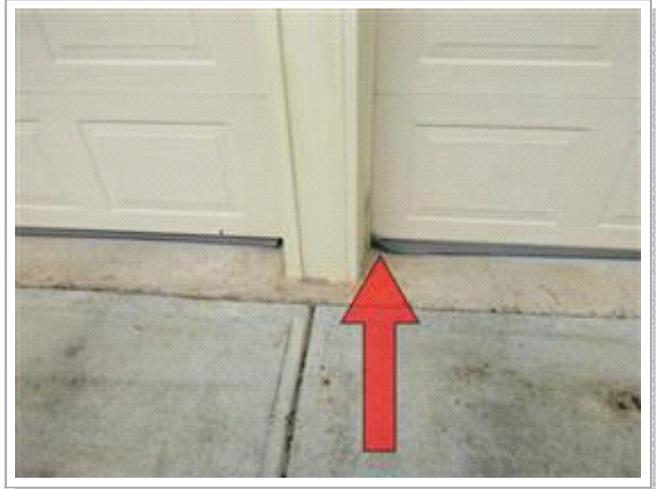
Figure Number 18

Recommend properly trimming and positioning garage door gaskets to prevent animal and insect entry.

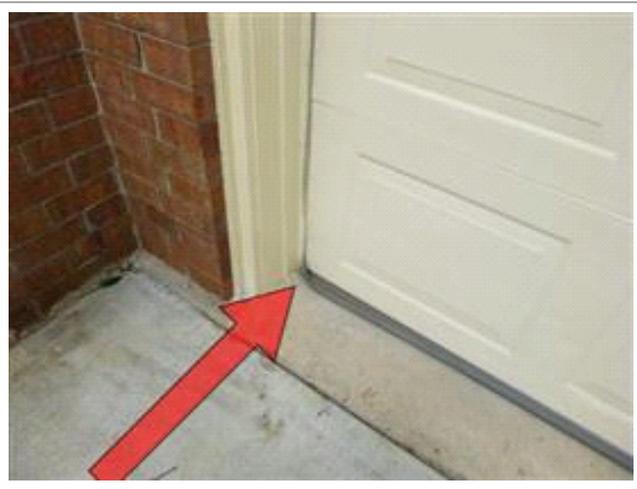
Figure Number 19

Recommend properly trimming and positioning garage door gaskets to prevent animal and insect entry.

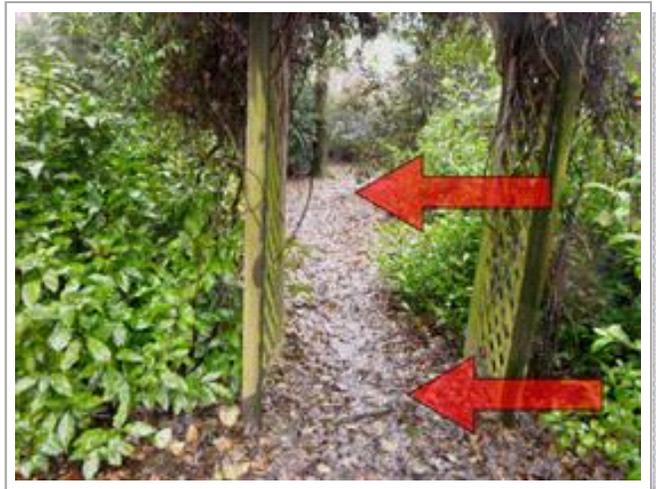
Figure Number 20

The walkway on the left side of the home also serves as drainage from the front yard. The area does not drain properly. Recommend proper grading/landscaping to allow for drainage.

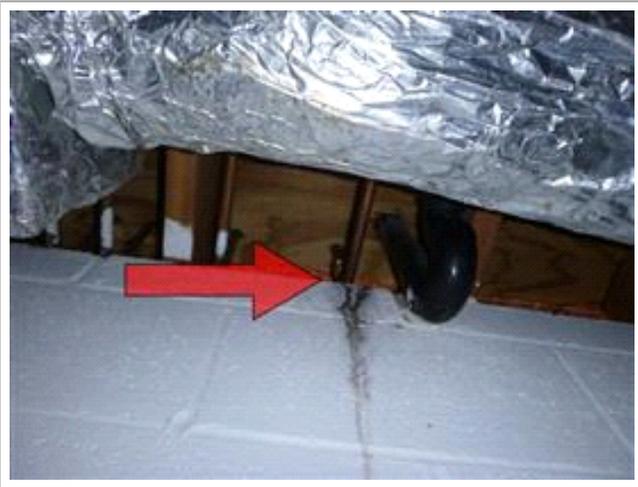
Figure Number 21

Signs of previous leak under the kitchen sink. Repairs noted. No current leakage. Monitor and repair as necessary.

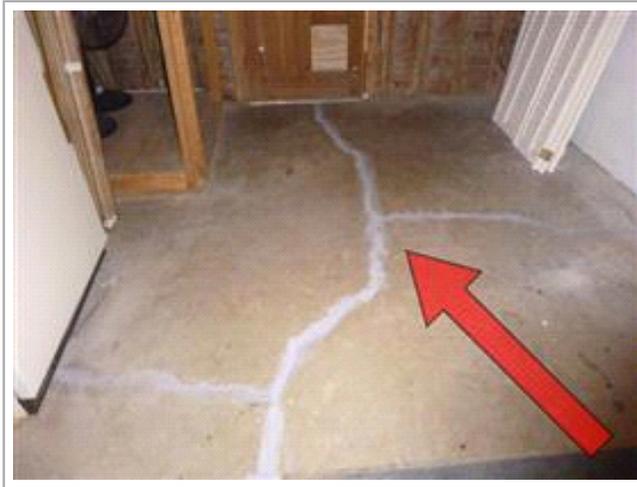
Figure Number 22

Minor slab cracks noted. Typical. Monitor and repair as necessary.

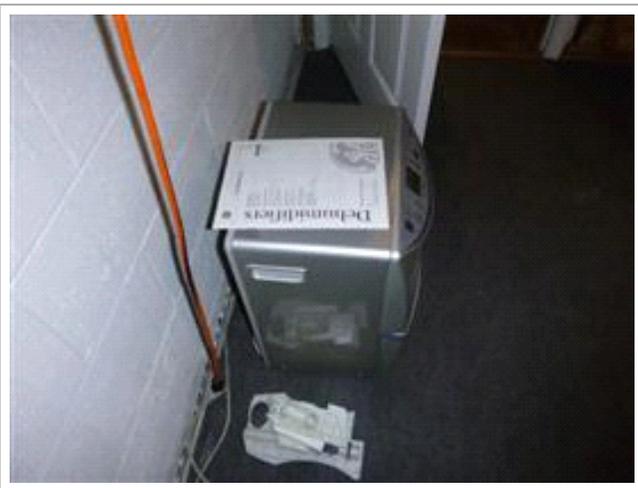
Figure Number 23

The dehumidifier has a bad bearing. Budget for replacement.
