Inspection Report

Property Address:
14080 Crabapple Lake Dr
Roswell GA 30076

Residential Inspector of America, Inc

Date: 2/8/2020

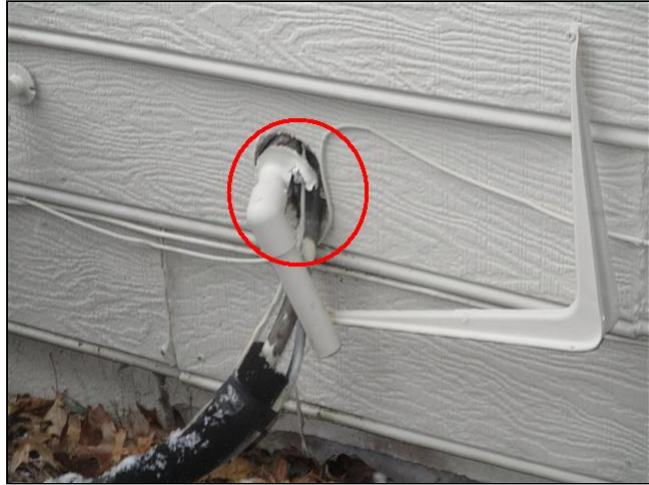
- 🔧 (1) Seal condensate drain to siding on right side of house near HVAC equipment.

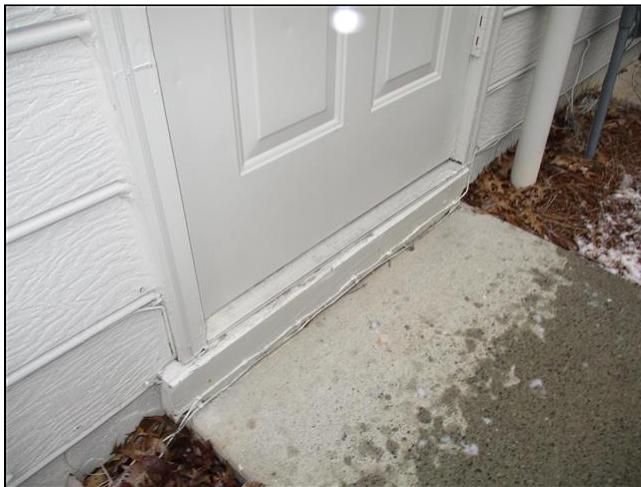
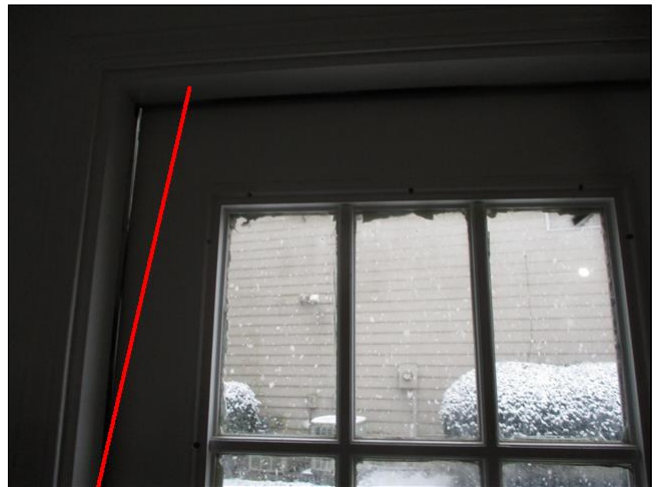
- 🔧 (1) The exterior egress door that leads out of the garage on the right side of house is stuck and would not open. Damage near the top hinge is apparent as the door does not sit flush with frame. Recommend repair.

loose threshold repair is also needed

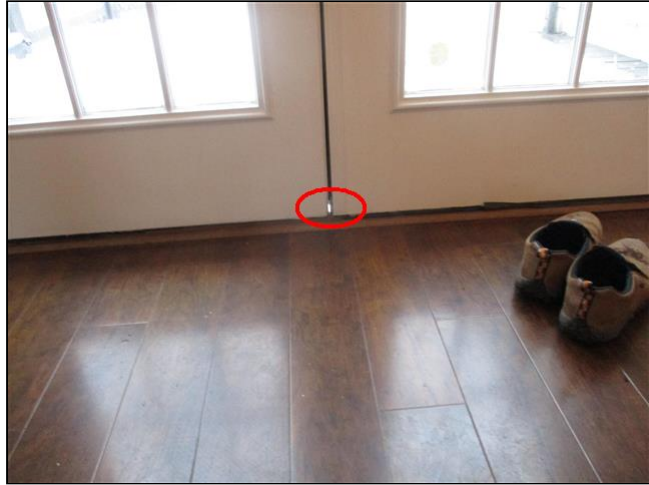
🔧 (2) Weather strip does not fit correctly around the rear deck egress door(s). Adjust or replace to prevent drafts.

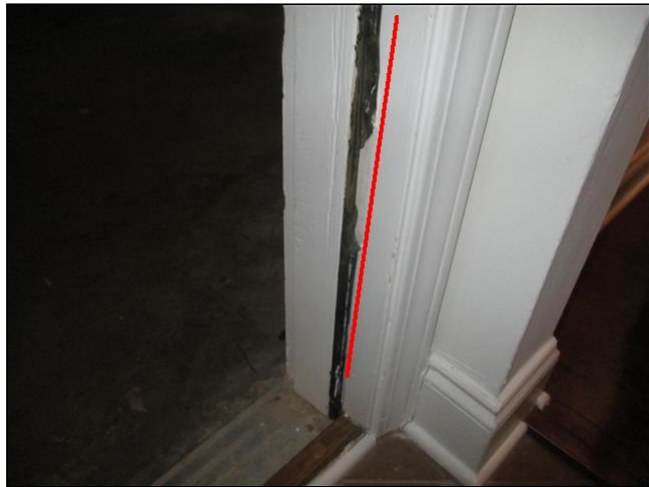
🔧 (3) Recommend replacement of the deteriorated weather stripping and the garage entry into the house door.

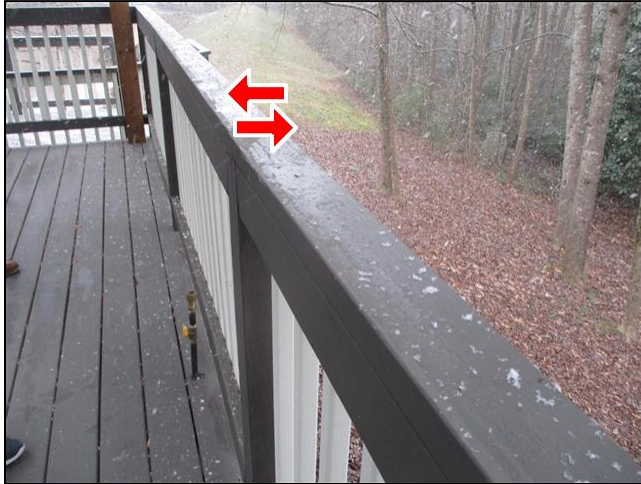
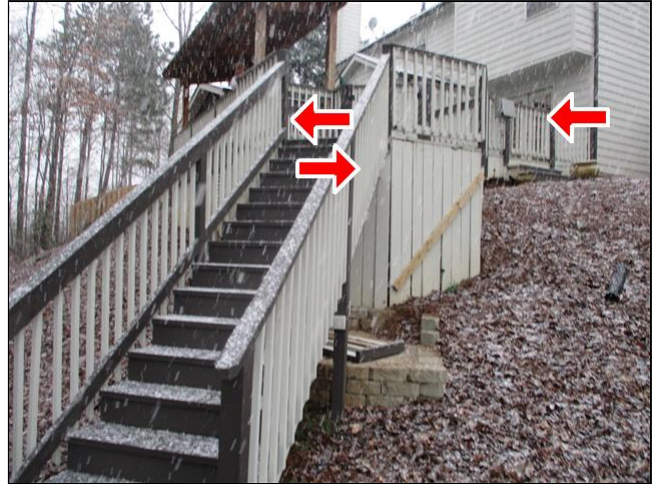
- 🔧 (1) Several guard rails on rear deck are a little loose and need additional bracing and/or fasteners to reduce the amount of movement on the rails. See photo(s) for location(s).

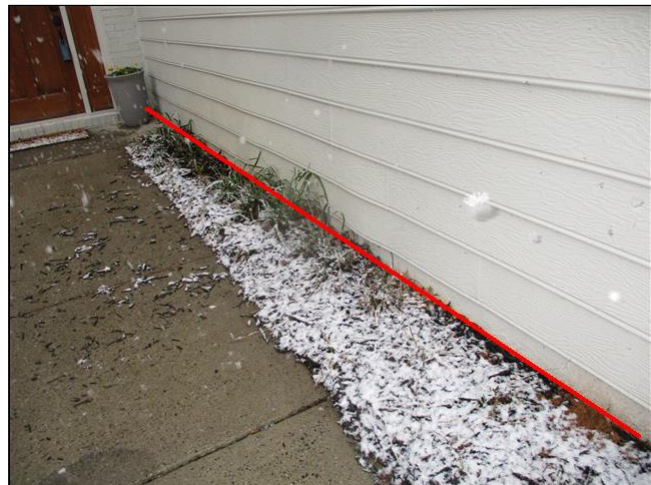
- 🔧 (1) Lower / move vegetation away from siding at grade level around house for termite abatement and to keep moisture retention away from siding. See photo.

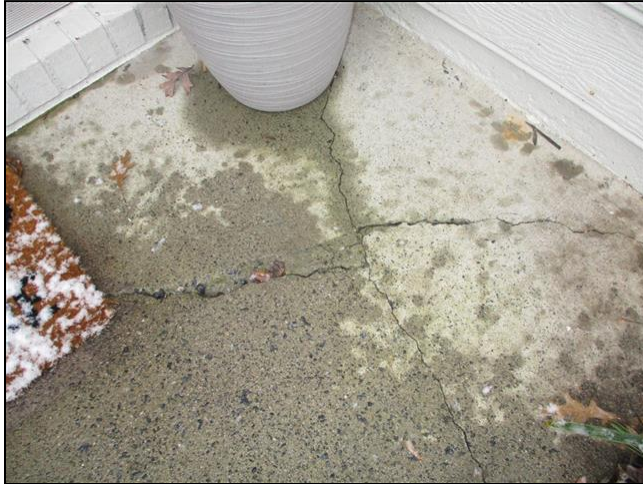
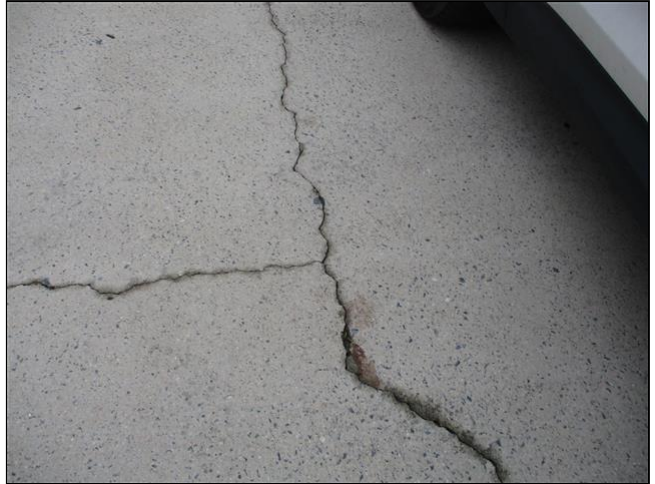
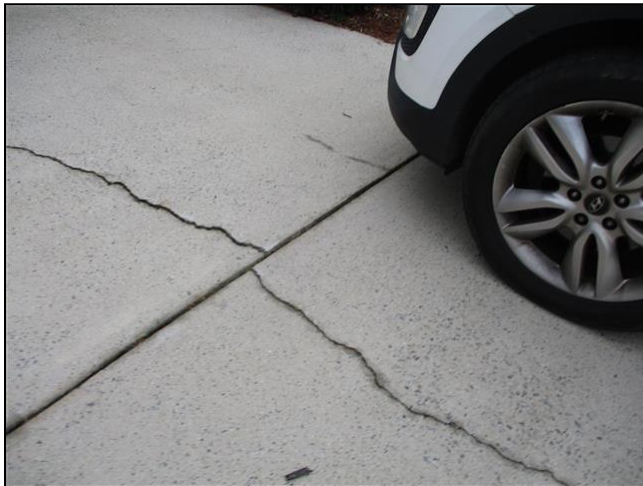
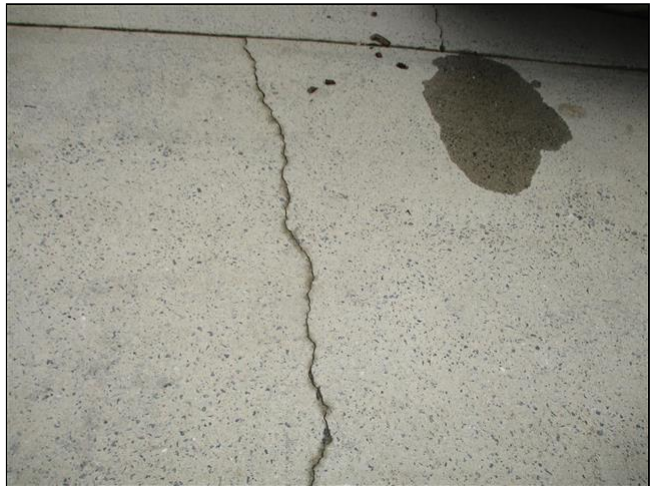
🔧 (2) There are a few cracks in driveway / sidewalk with slight deflection and at or less than a 1/4 inch in width. A small amount of crumbling was observed in several places. Patch and repair as needed.

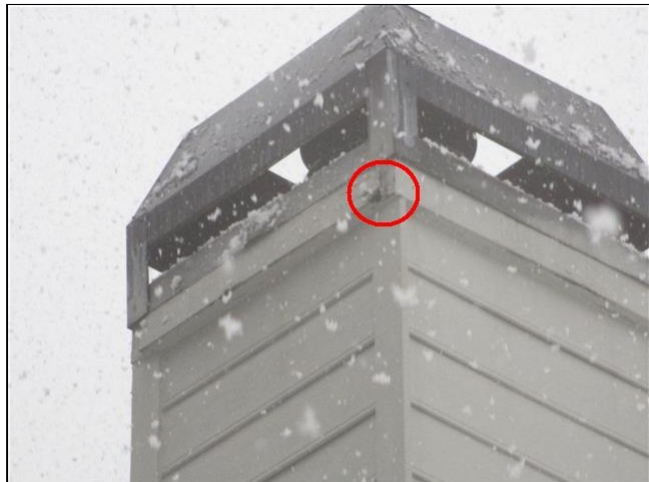
🔧 Recommend repair of the small area of chimney trim rot. See photo for location.

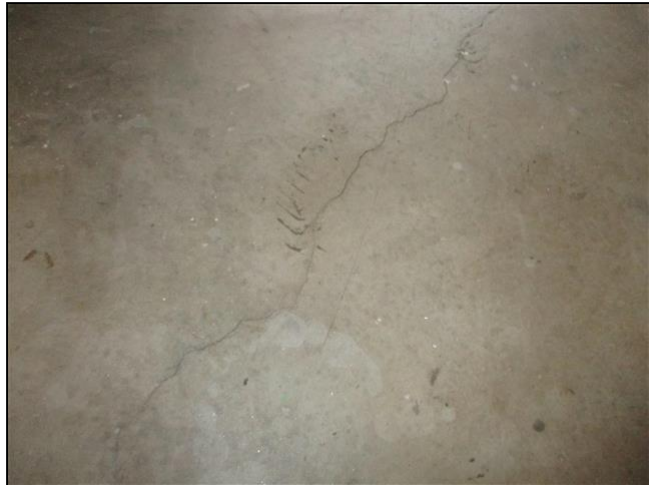
Cracks in garage floor are not wide enough to be considered a structural concern and are due to normal settlement and shrinkage of the concrete.

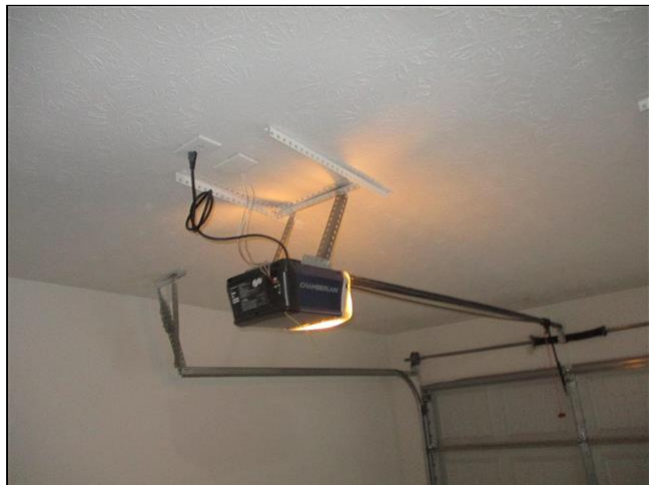
🔧 The right garage door was found non functioning upon testing. Recommend a garage door company diagnose and repair.

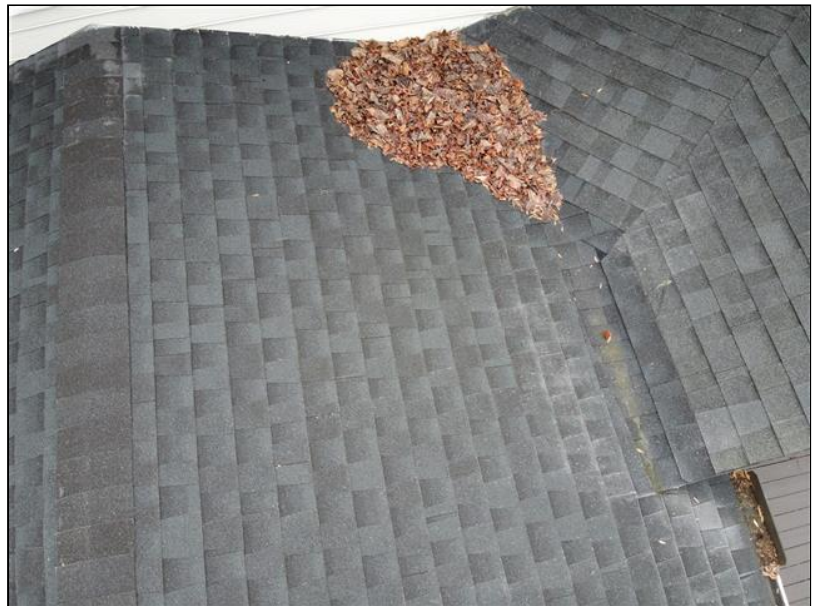
🔧 Remove leaf debris off roof covering above the back porch. See photo.

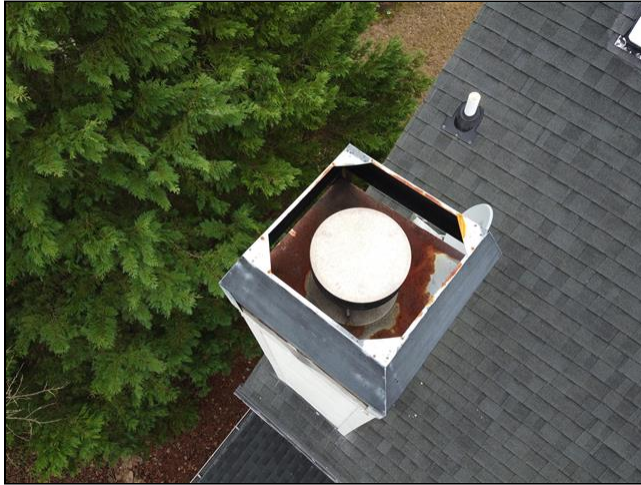
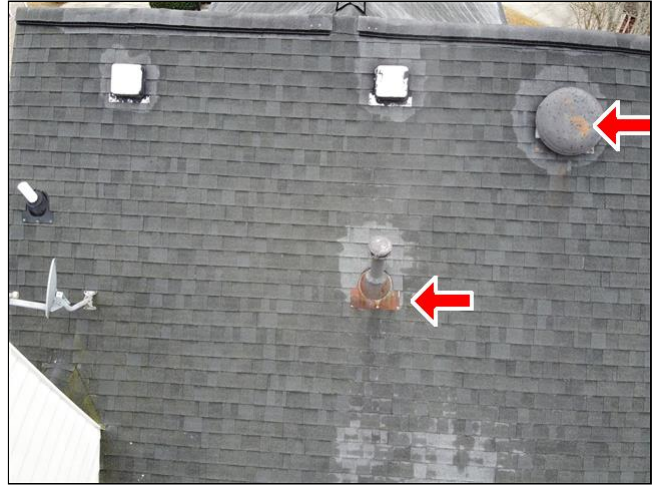
🔧 (1) Rust has developed on the cap on the top of the chimney and other metal vents atop roof. They will soon need to be replaced, but it does not appear to be leaking now. A rust inhibitive paint may salvage the caps if repaired soon.

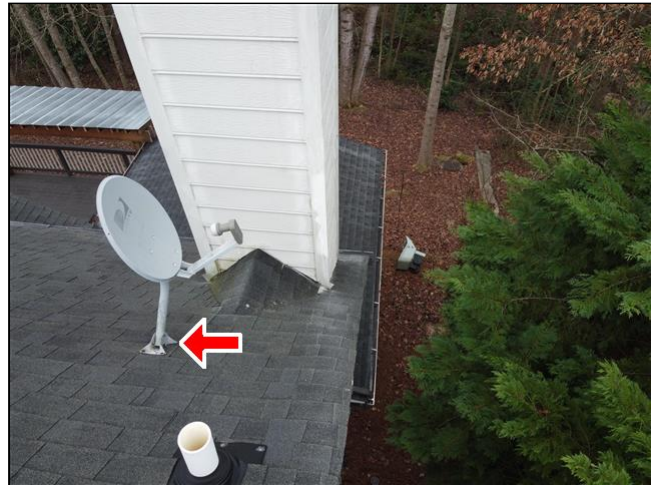
🔧 (2) Recommend to remove satellite dish if not in use and use roof tar at fastener entry into roof decking. If kept, sealant will need to be maintained where dish attaches to the roof.

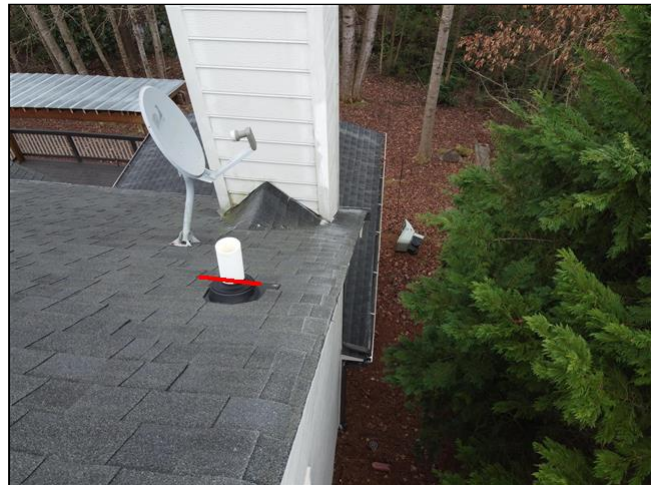
(3) Boot flashing around plumbing vents on the roof are ok now, but these last about 5-7 years before needing replacement. They crack and split and allow rain water to leak into attic. Check roof decking periodically for leaking into the inside the attic.

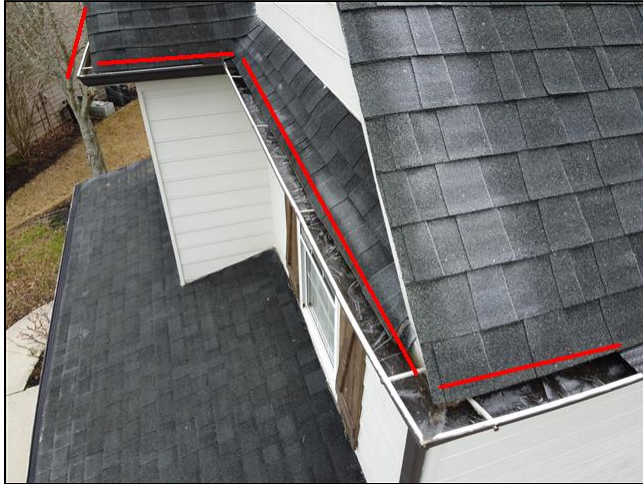
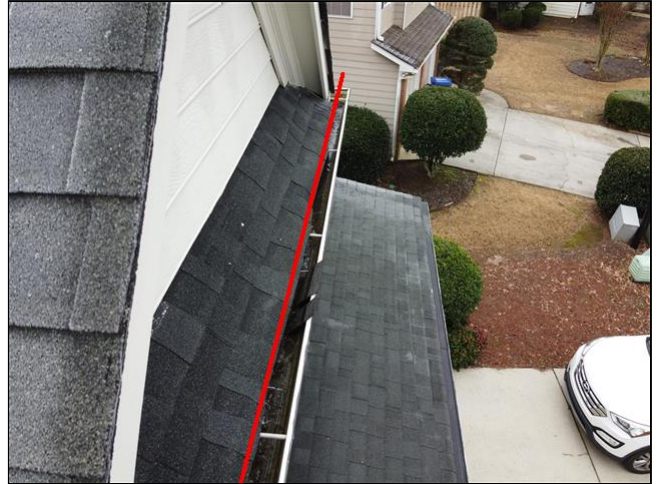
- 🔧 (1) Gutters shown in photo(s) on the front side of house need more slope towards the down spout to ensure adequate roof drainage. They are holding water.

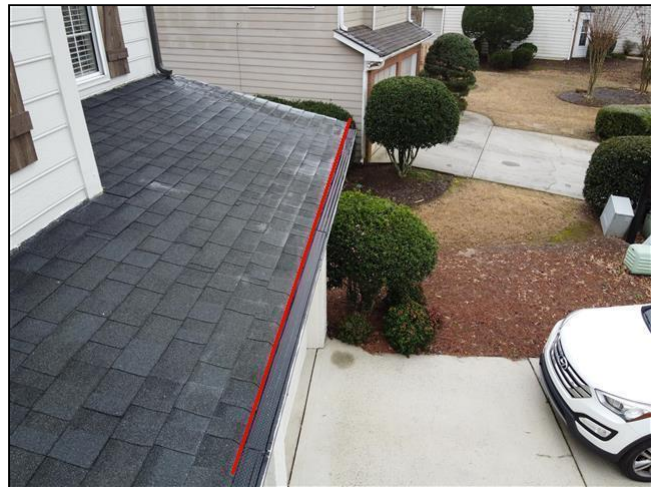
- (2) Most house gutters have guards with the exception of several on the front. Recommend to added guards to remainder.

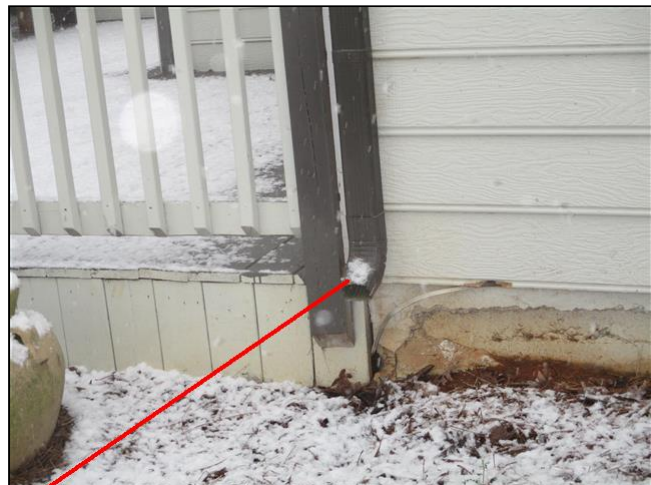
- 🔧 (3) Recommend to add extension to the downspout at the back left corner. It is best to have water draining away from house foundation and deck area.

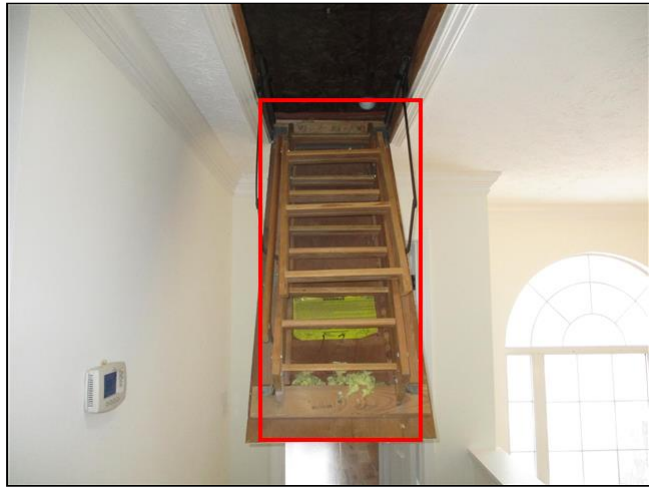
🔧 (1) Weather strip and insulation of some type needed over the attic pull down steps.

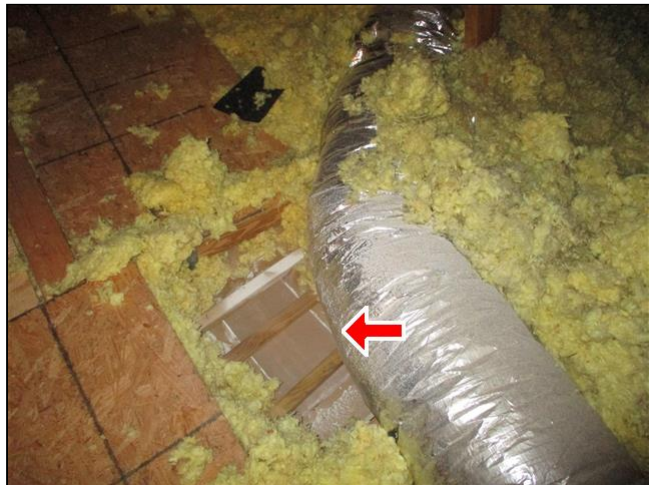
🔧 (2) Spread out insulation evenly over any voids in attic as seen in photo. The open chase is ok as it has batt insulation around the wall area.

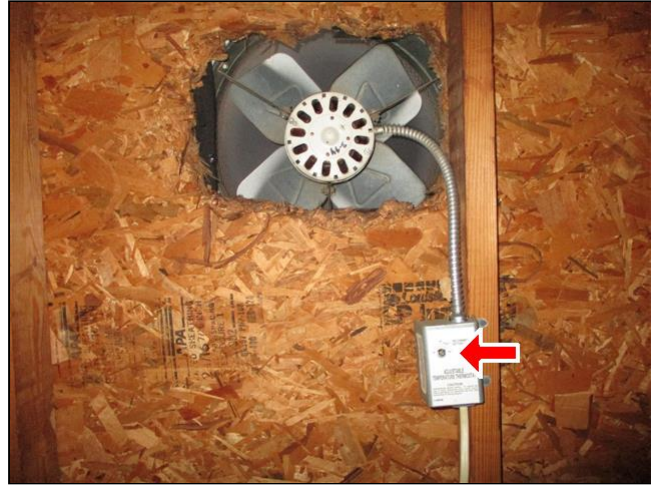
🔧 Too cool in attic for power vent to run by the attached thermostat.

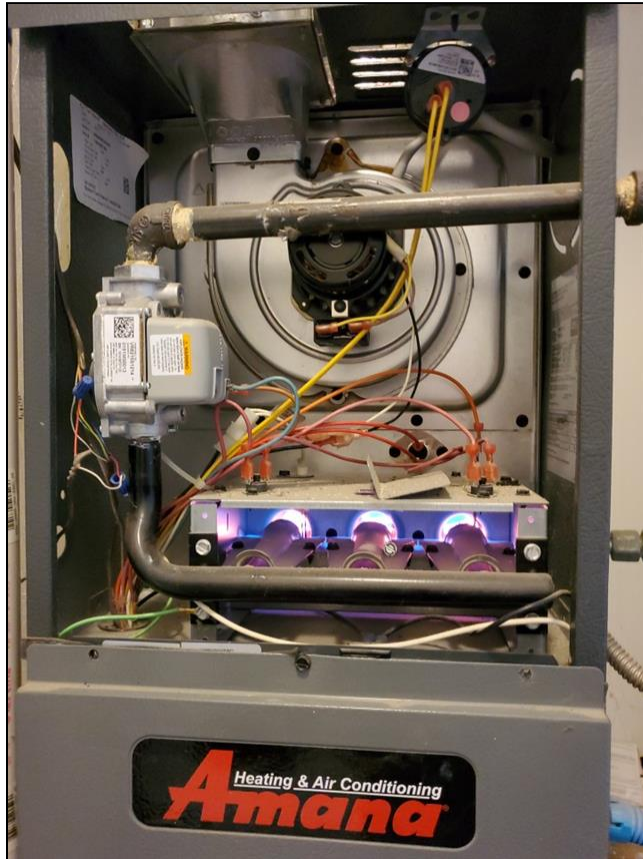
🔧 Have an hvac tech service the heating and cooling equipment to clean the blower motor, the evaporator coils, the condensing coils, the electrical contacts, check refrigerant levels, check size of units compared to size of home and ascertain that the heat exchangers on furnaces are not cracked and the included air handler equipment is safe to operate and functioning properly. Much of internal parts of the hvac system is concealed from view, and our inspection is mostly visual. Therefore, an hvac tech should evaluate for any concealed defects or hazards in the system. Furthermore, manufacturers recommend annual maintenance and servicing to keep the system working at peak efficiency.

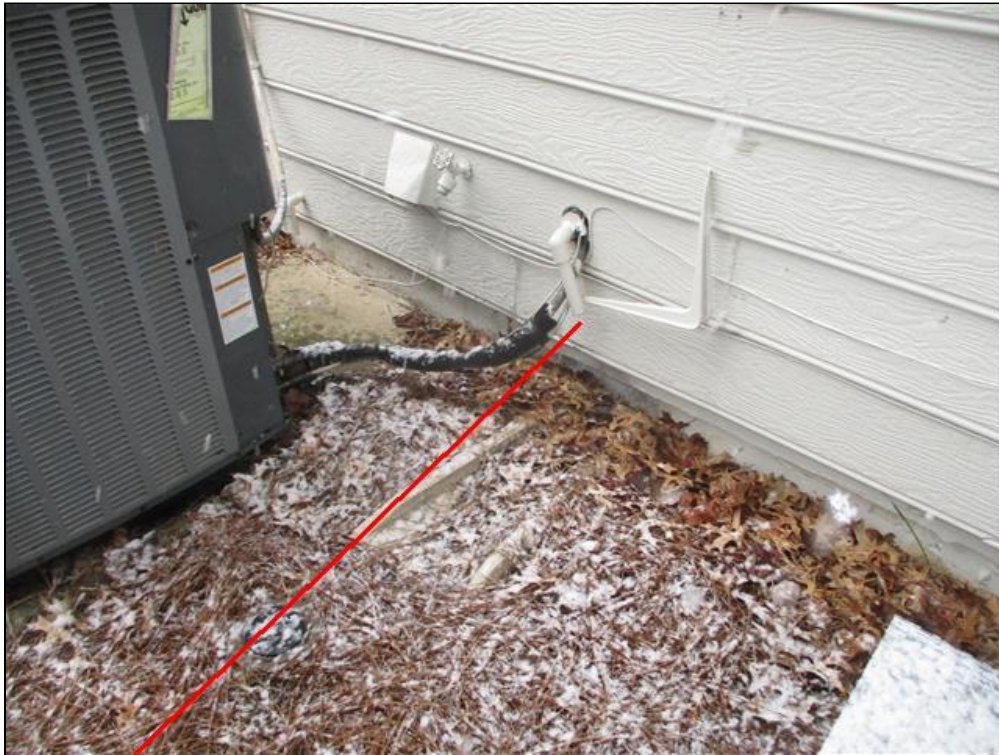
- 🔧 (1) Have the condensate drain line for the a/c unit extended out and away from the home.

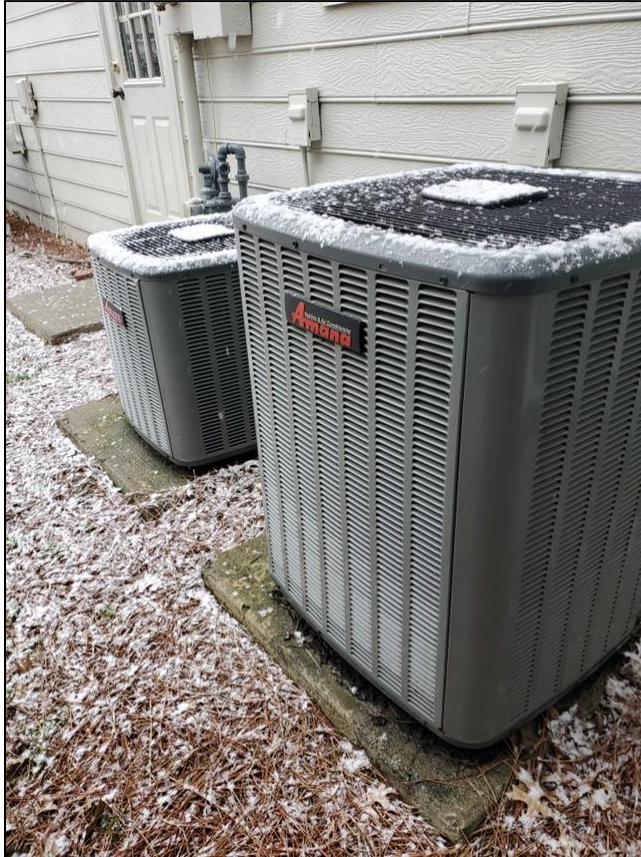
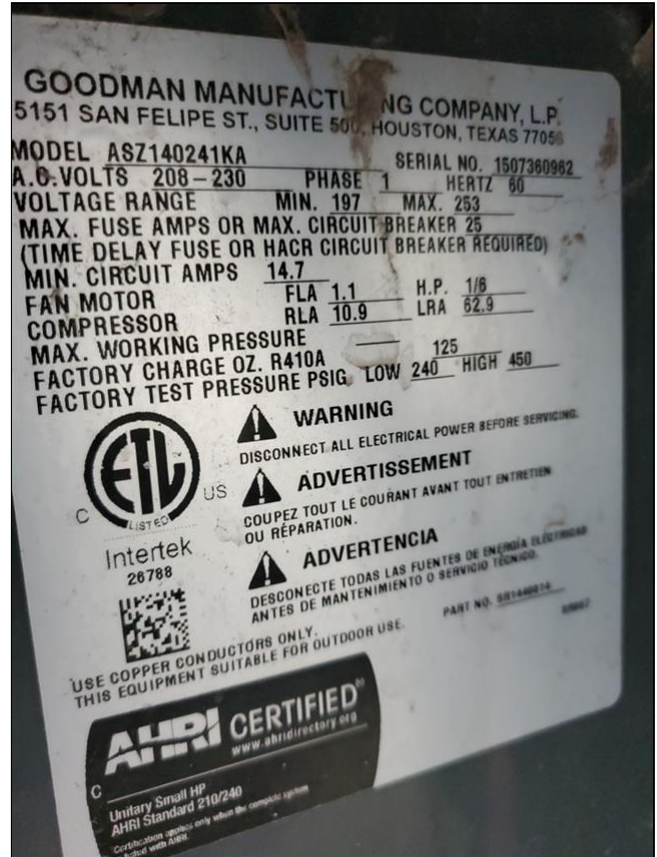
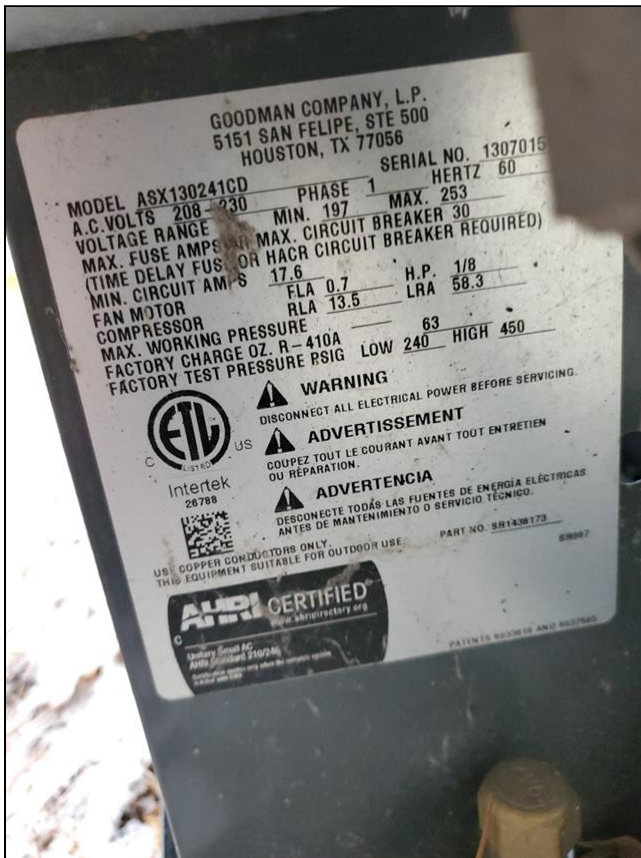
- 🔧 (2) After repairs, and along with servicing the heating unit(s), hvac tech should check refrigerant levels in the a/c system to ensure that the systems are working at peak efficiency.

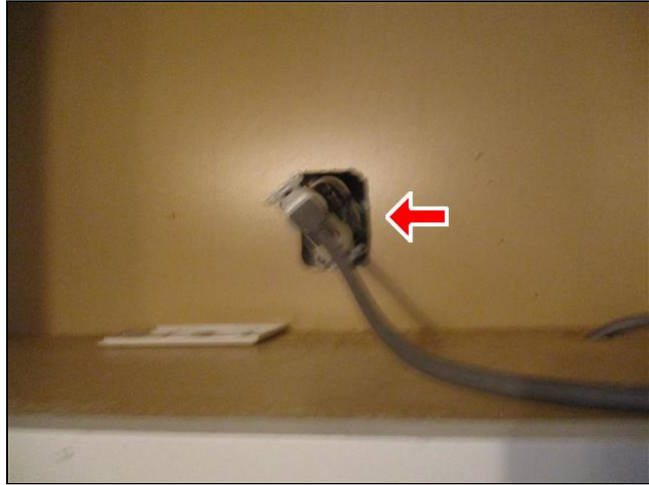
🔧 Cover needed on the open junction box in the cabinet above the cook top area. Covers are used to control sparking.

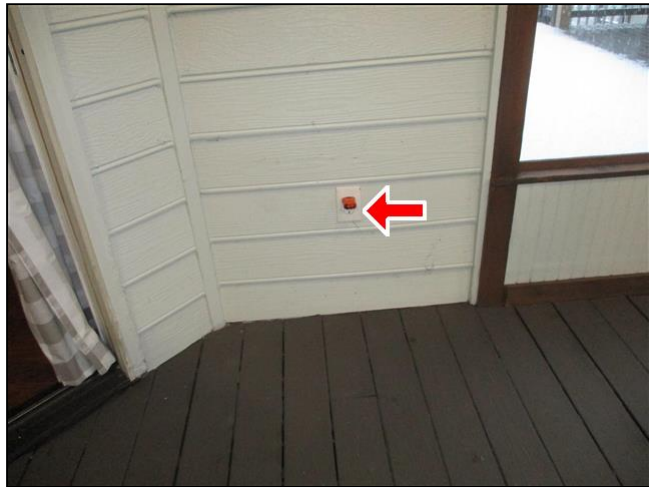
🔧 (1) There is no power to exterior electrical outlet at one back porch receptacle. Recommend electrician diagnose and repair.

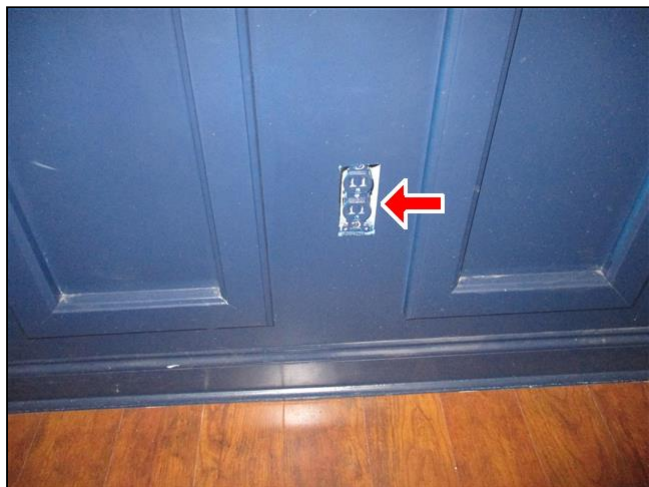
🔧 (2) Add missing face plate to wall outlet at the breakfast bar.

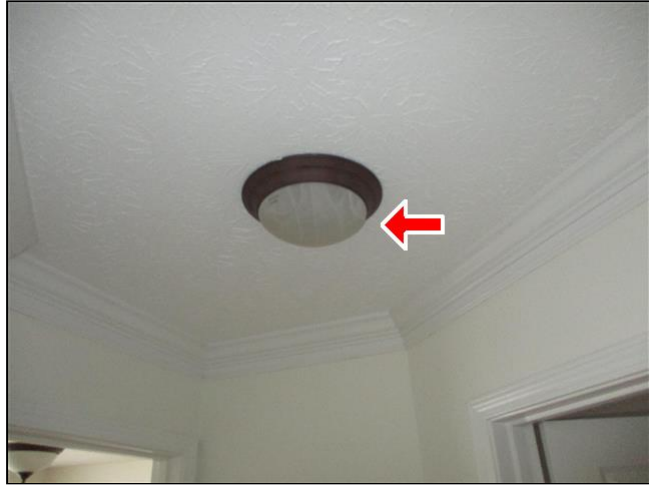
🔧 (3) Change out light bulb in the upstairs left hall ceiling fixture.

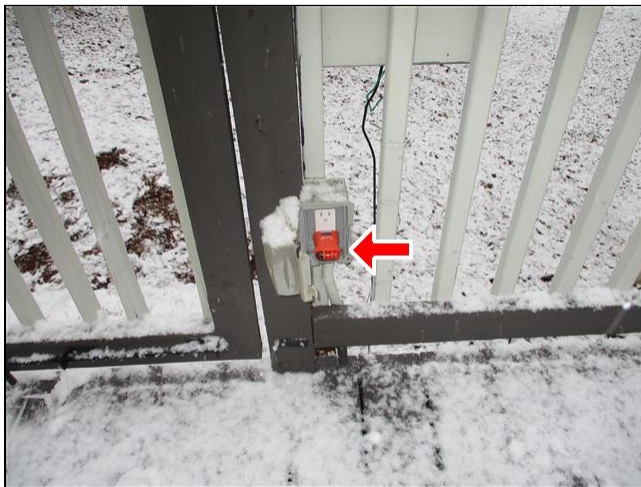
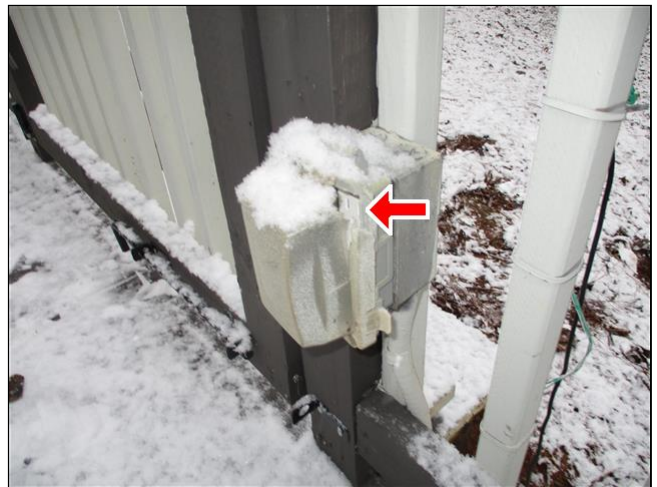
🔧 It is recommended that all exterior outlets be switched to the gfci protected type. This will make the outlets more safe and bring the wiring closer to modern standards. These were not required in older homes.

the cover on the non gfci outlet is damaged also

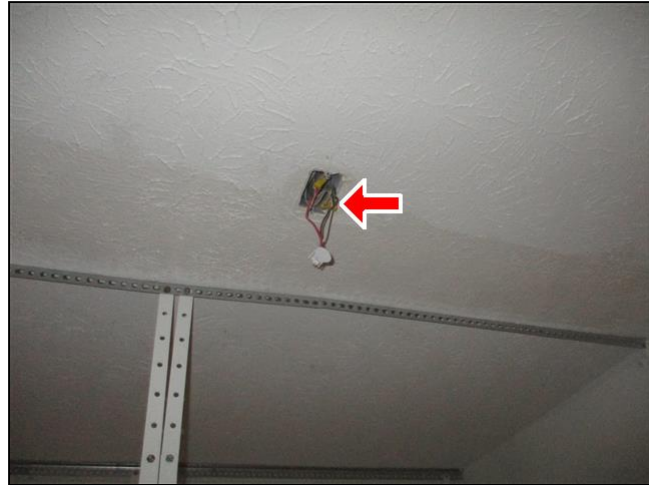
🔧 (2) Replace missing smoke detector at the garage ceiling.

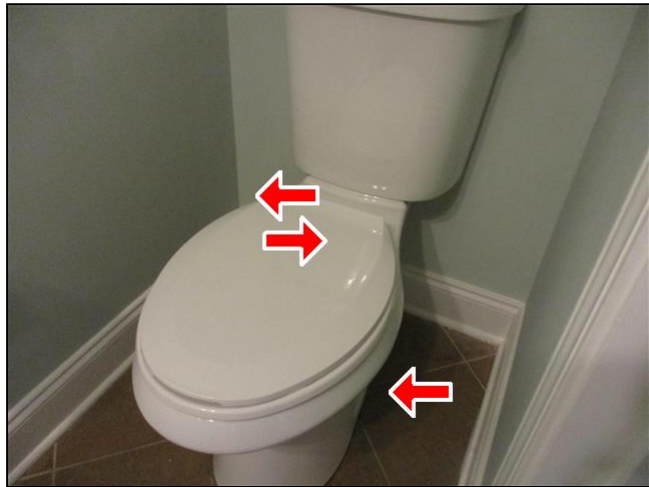
🔧 (1) Secure the loose toilet to the floor in the main floor hall bath. Loose toilets can lead to broken wax seals between toilet and drain pipe that can leak on the floor.

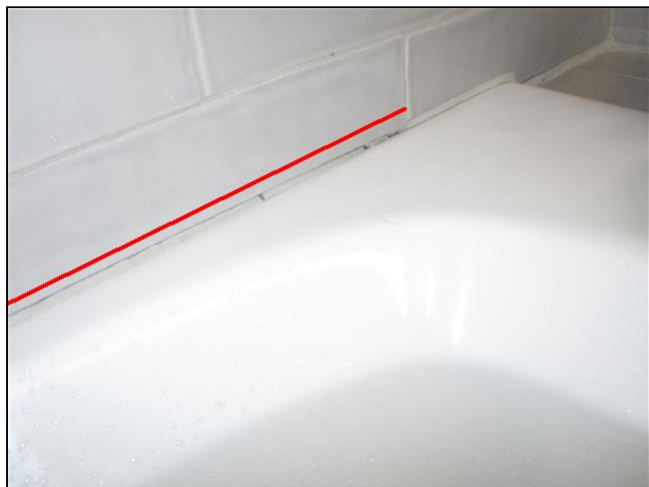
🔧 (2) Touch up grouting needed between tile back splash and the master bath tub. Water can enter into the tile and get into wall.

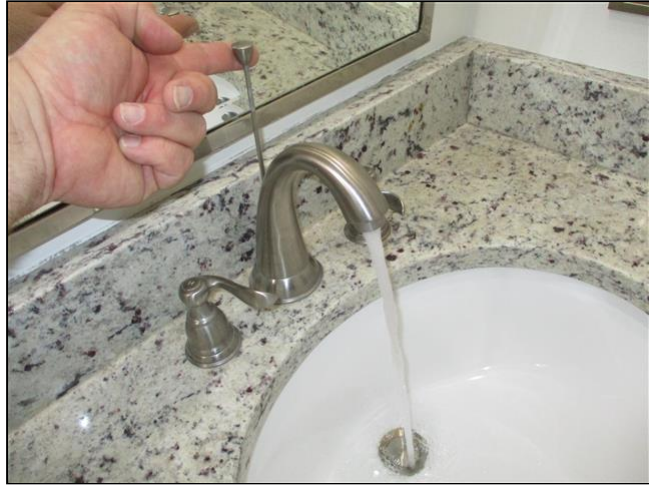
- 🔧 (3) Attach plunger pull rod to stopper under sink for proper functioning at the right master sink.

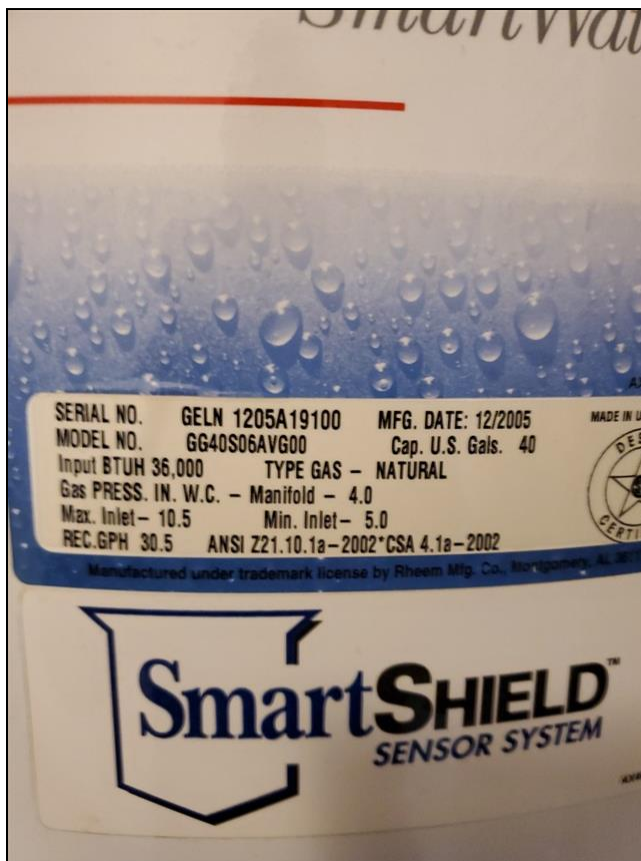
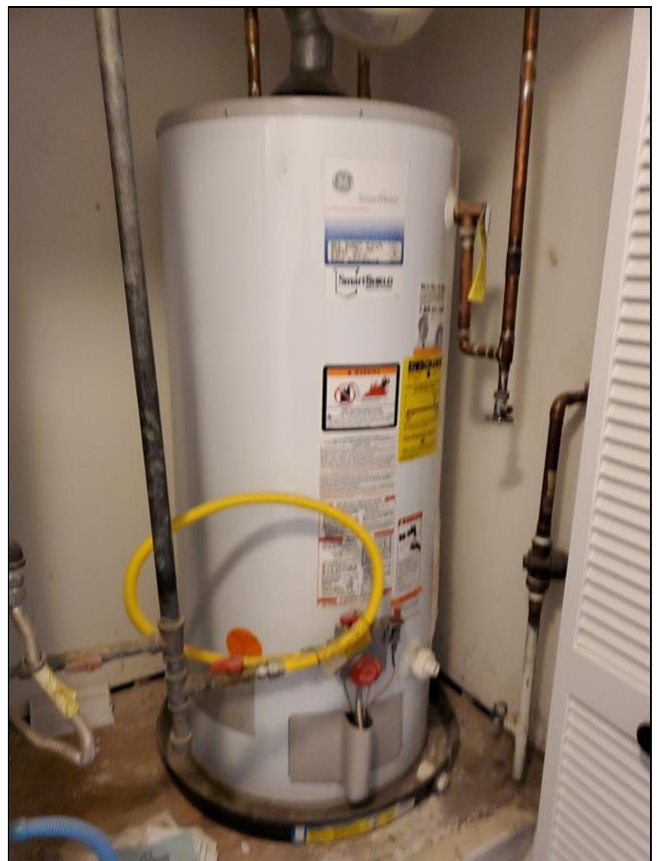
- 🔧 Water heaters generally last about 10-12 years before needing replacement. Current water heater works and makes hot water but will likely need replacement in the near future due to its age. Unit is from 2005.

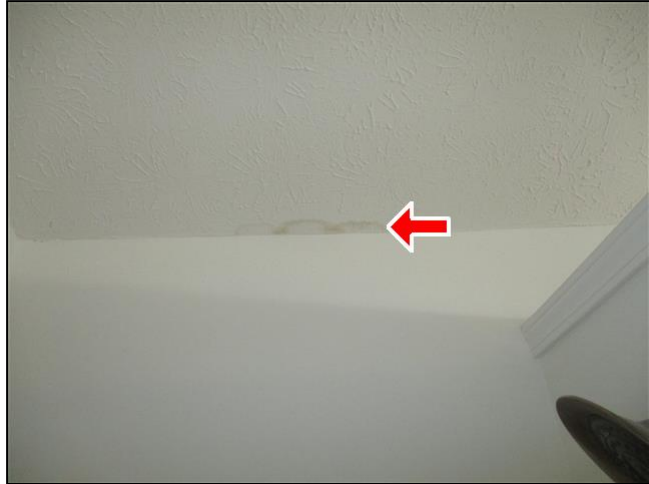
above master shower

🔧 Water stains found on ceiling from past leaks. Stains were not wet at time of inspection, but conditions could change and leaks could become active again. Exact cause of the stain is not clear and it cannot be confirmed that the leak that caused the stain has been repaired. Before stains are sealed and painted over, buyer should resolve all concerns prior to closing. See photo(s).

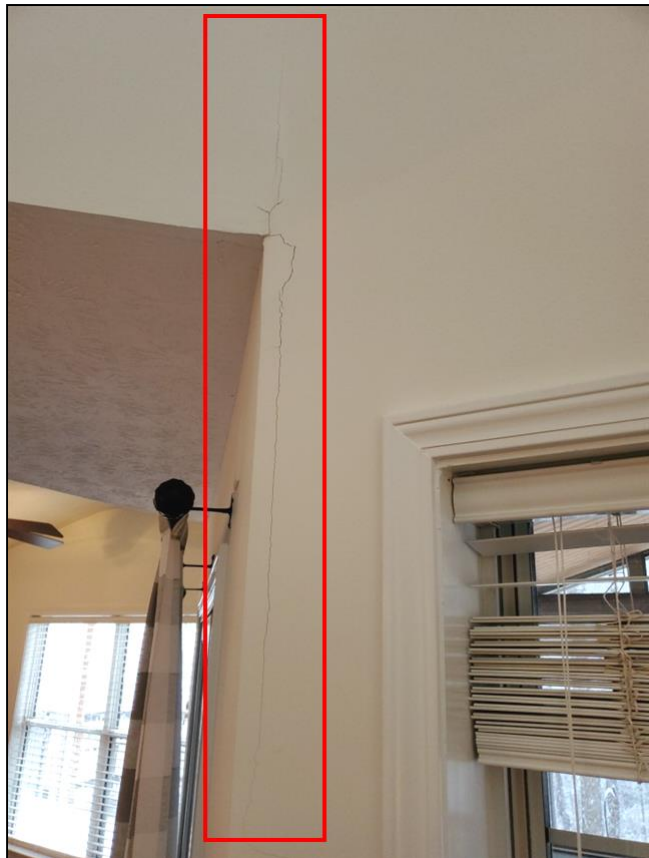
🔧 Drywall repair needed in the living room. Normal house settling has cause cracking at the wall transition. This is not a structural concern. See photo(s)

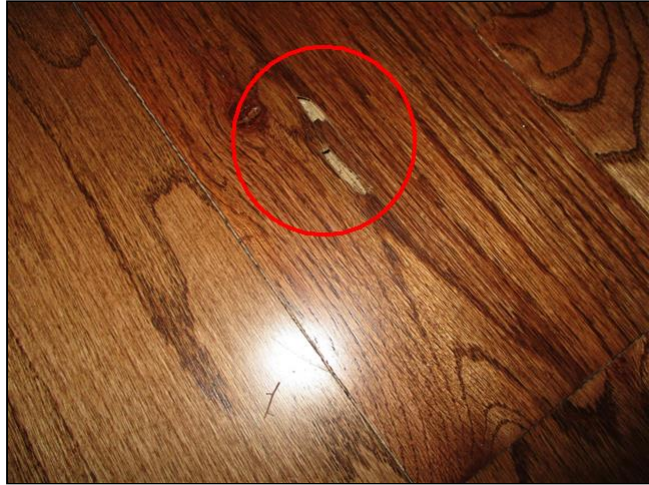
🔧 There is puncture damage to wood flooring inside the master bedroom. Recommend replacement of section, or some type of fill repair.

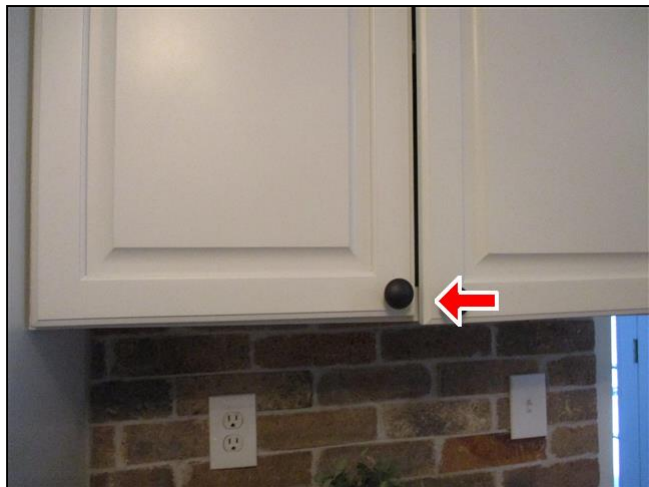
🔧 (1) Several kitchen cabinet doors are a little loose and need to be tightened at the hinge.

also one above the stove

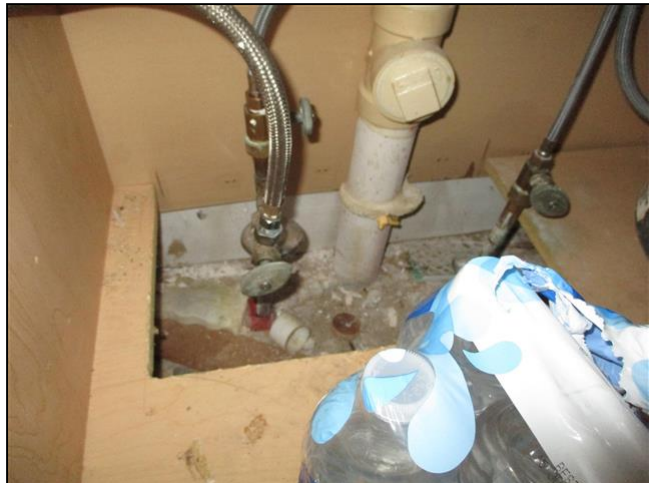
🔧 (2) Recommend covering the open area at kitchen sink cabinet floor. See photo.

stored items will get pushed into void

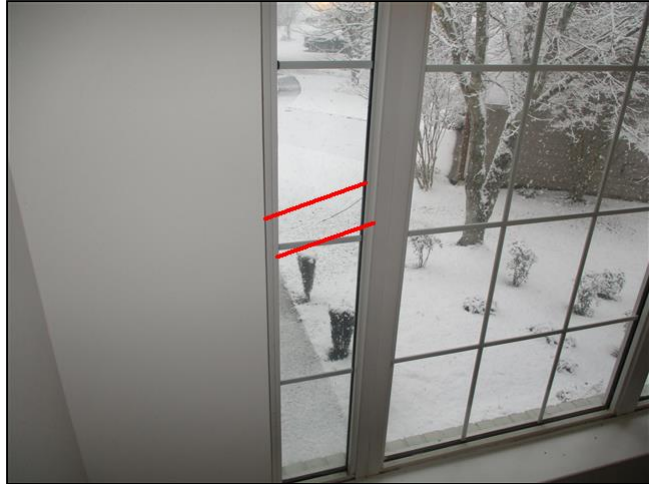
🔧 (1) Replace the cracked glass at the front door atrium window. See photo.

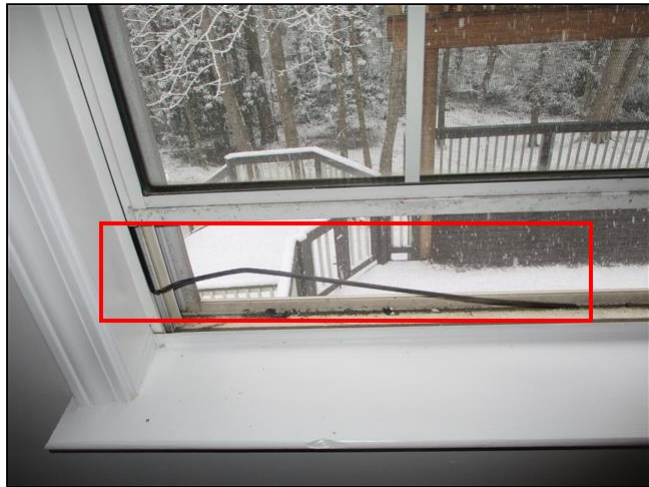
🔧 (2) There is internal damage inside frame at one window at the back left bedroom. Recommend repair or replacement.

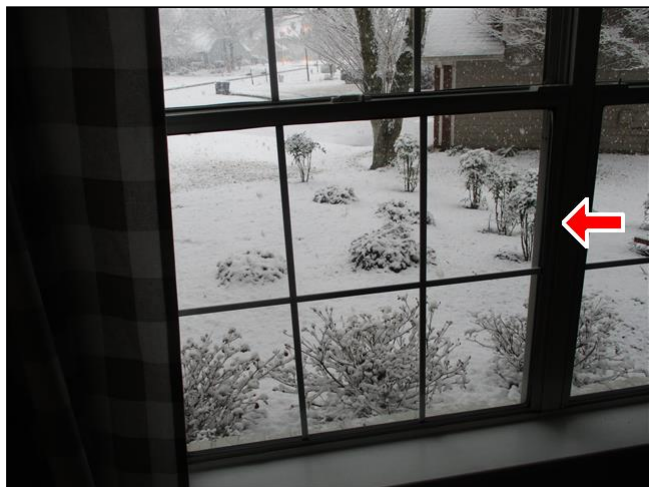
🔧 (3) Most house windows are hard to open. One would not open in the front left room. Have all windows open and close.

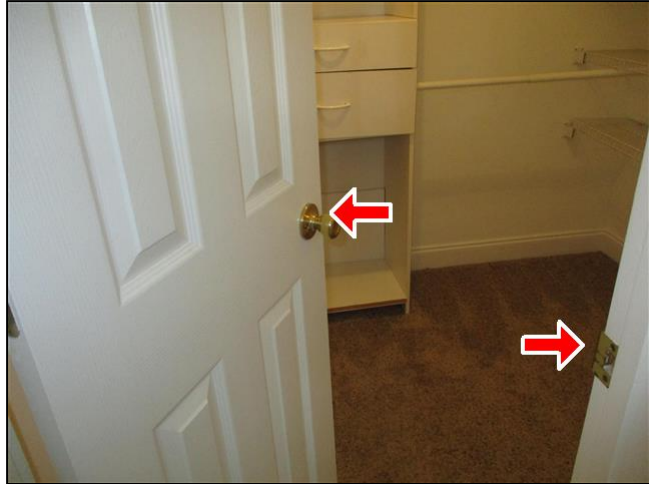
master closet

🔧 Adjust interior door in photo so that it will close and latch.
