Inspection Report

Property Address:
520 Waterview Trail
Alpharetta GA 30022

Champia Real Estate Inspections, LLC

Date: 3/3/2020	Time: 09:02 AM	Report ID: 40838
Property: 520 Waterview Trail Alpharetta GA 30022	Customer: Brett Pancoast	Real Estate Professional: Sherri Godwin Atlanta Communities (Atlanta) InTown Peachtree Rd

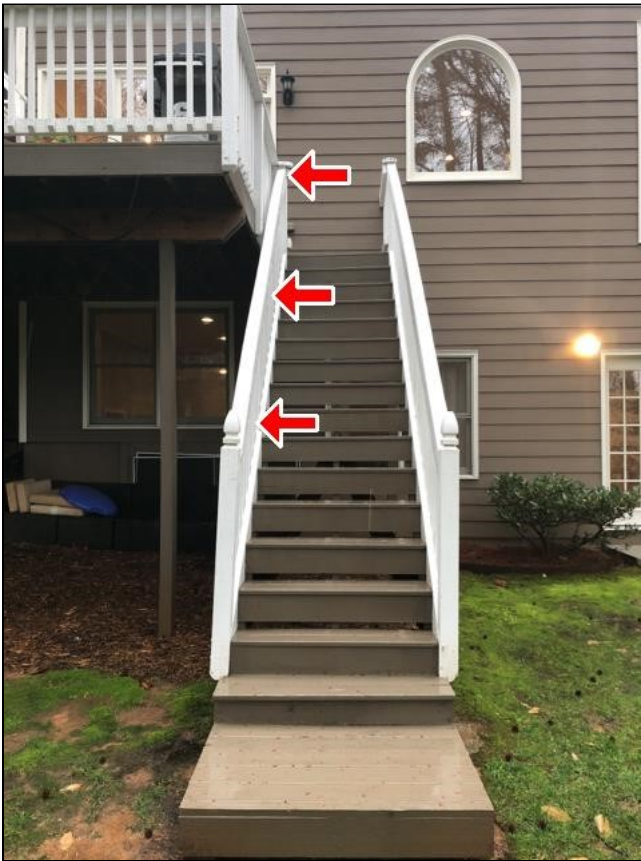
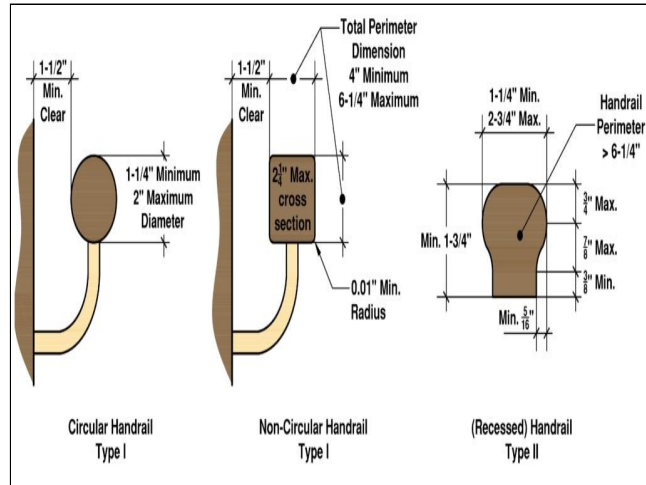
2.2 (1) **Handrail is not graspable at deck stairs** (see pictures for examples). NOTE: Handrails should be graspable per current construction standards. Recommend a qualified contractor assess condition of all stair handrails and make repairs as needed.

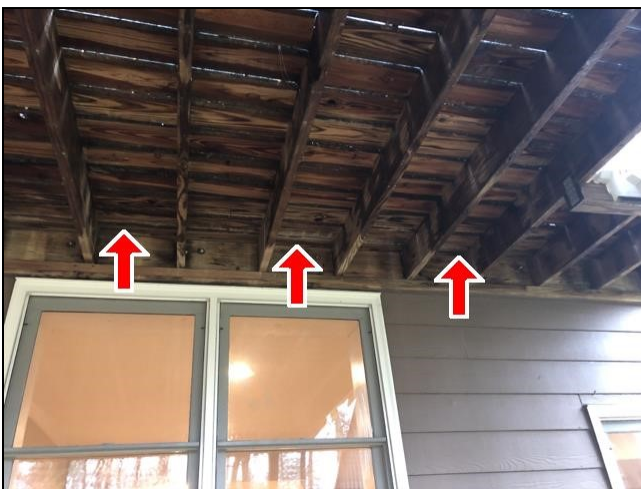
2.2 (2) Missing flashing noted between siding and first deck board at rear deck. Monitor and make repairs as needed.

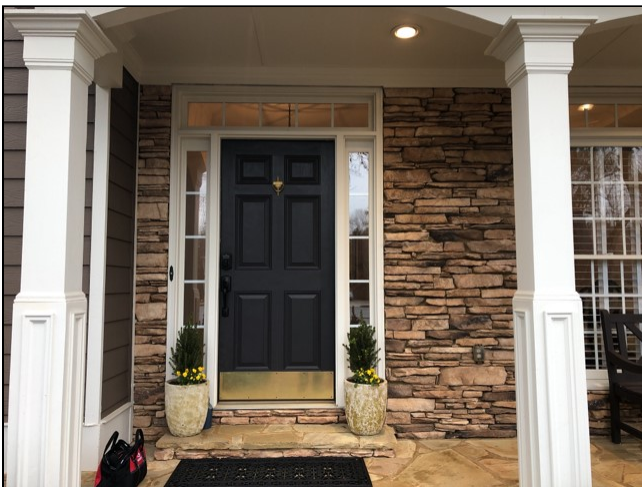
3.1

(1) **Masonry veneer was not installed per the specifications of the masonry veneer manufacturing association.** See their information at the link below.

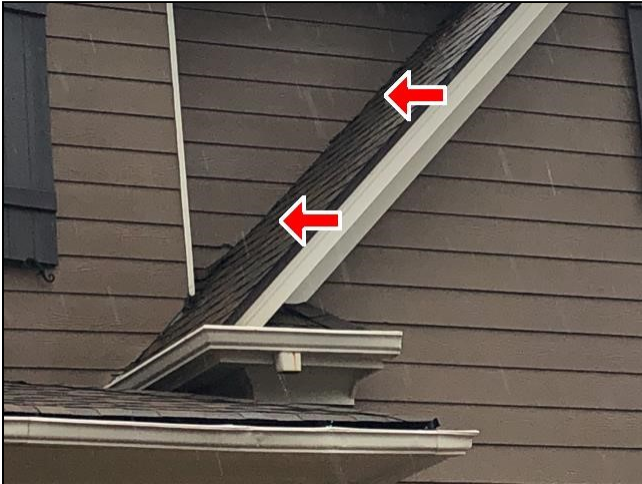
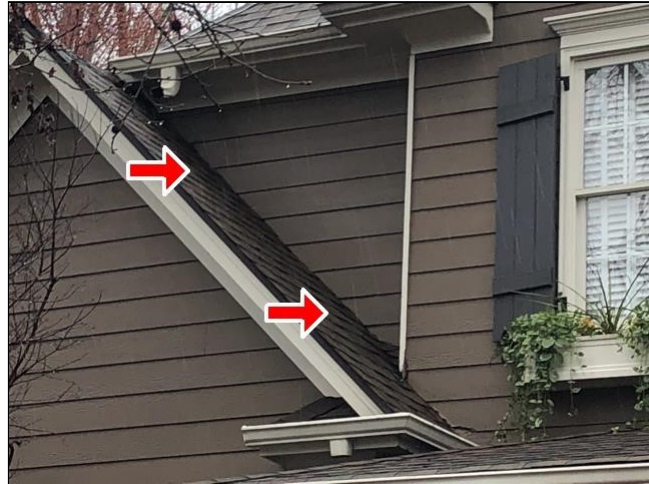
3.1 (2) **Contact of cladding with roof noted.** NOTE: A distance of at least 1" to 2" is recommended between cladding and roof to avoid moisture damage. Recommend that a qualified contractor assess siding at roof and make repair as needed.

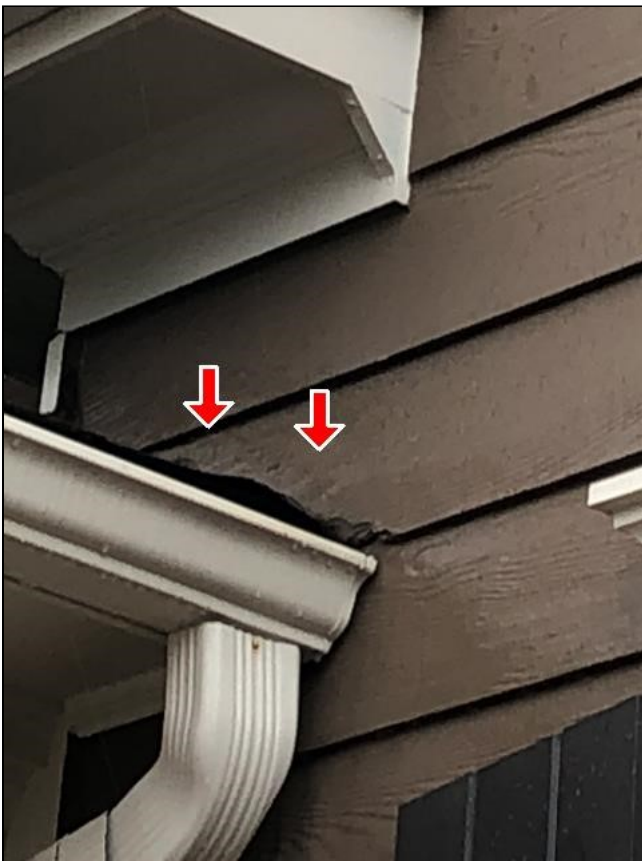
3.1 (3) **Damage noted at cladding boards.** See pictures for examples. NOTE: Damage to siding material or finish could allow pest or moisture entry into wall. Recommend a qualified siding contractor assess all of the siding and make repairs needed.

3.1 Above front porch

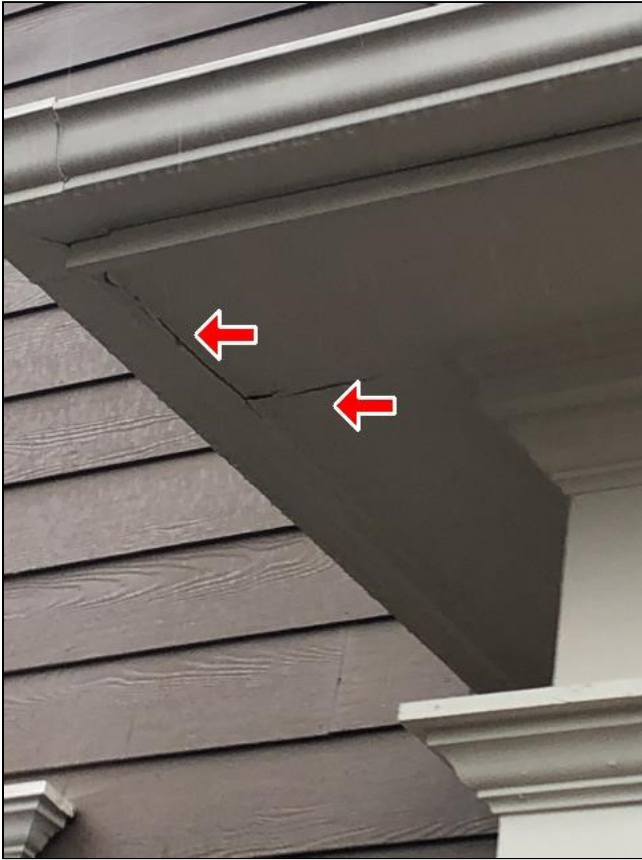
3.3 **Damage/decay noted at numerous facias and/or soffits.** Recommend that a qualified contractor assess damage and make repairs as needed.

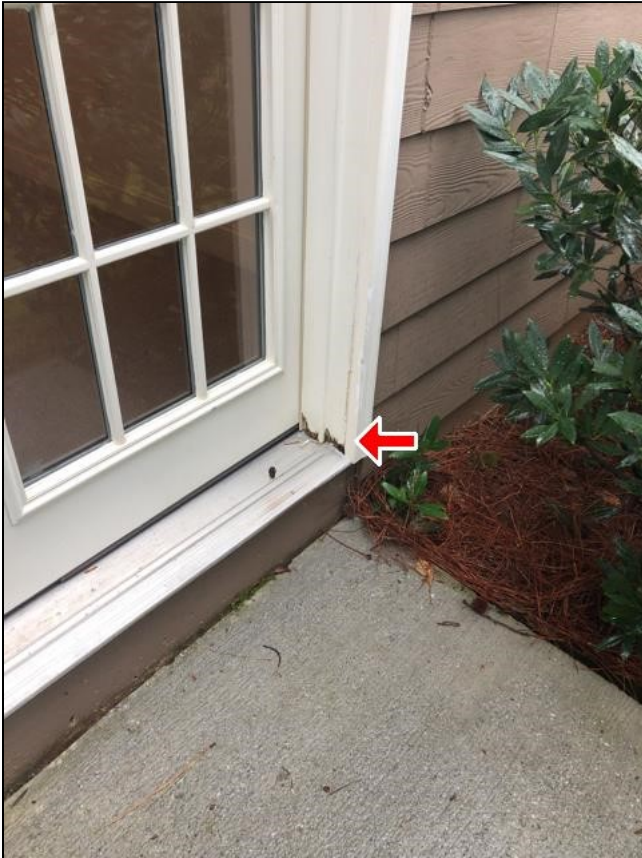
3.4 **Rot present on door and/or frame.** (See pictures for examples) Recommend a qualified contractor assess all doors for similar damage and make repairs as needed.

3.4 Basement door at rear of home

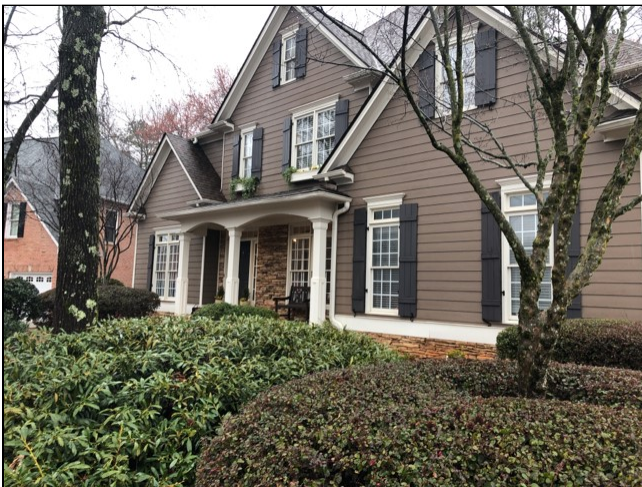
3.5 (1) **Missing screens noted.** Recommend that screens be replaced.

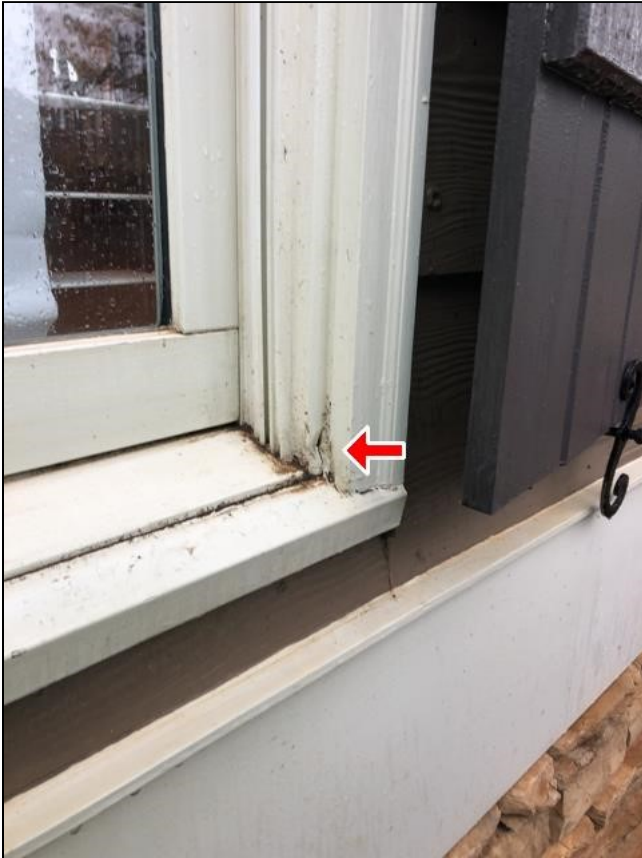
3.5 (2) **Window frame and/or sashes are damaged.** (See pictures for examples) Recommend a qualified contractor assess all windows for similar damage and make repairs as needed.

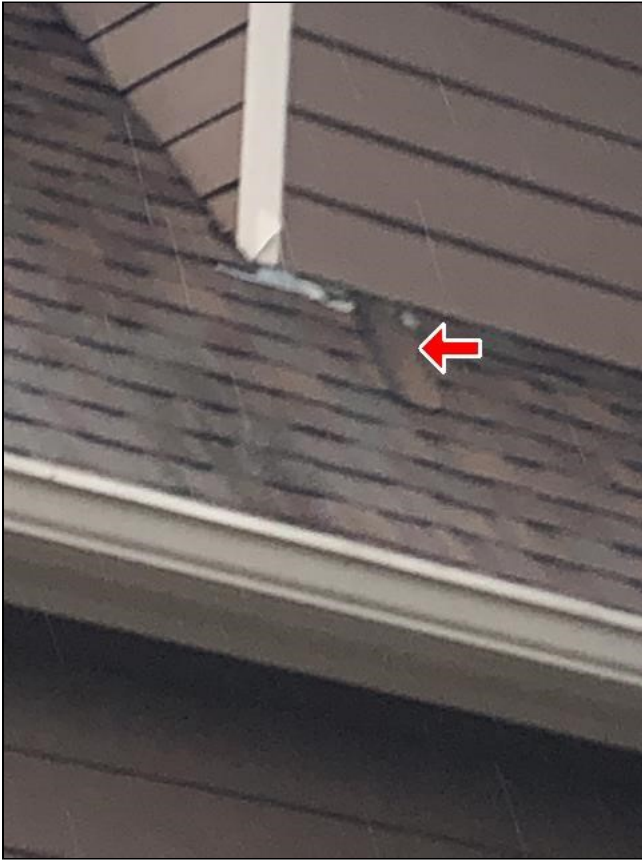
4.1 Signs of shingle damage (slipped shingle above garage) was noted on roof. (See pictures for examples)

Recommend a qualified roofing contractor assess all of the roof for similar damage and make repairs as needed to prevent moisture entry into home.

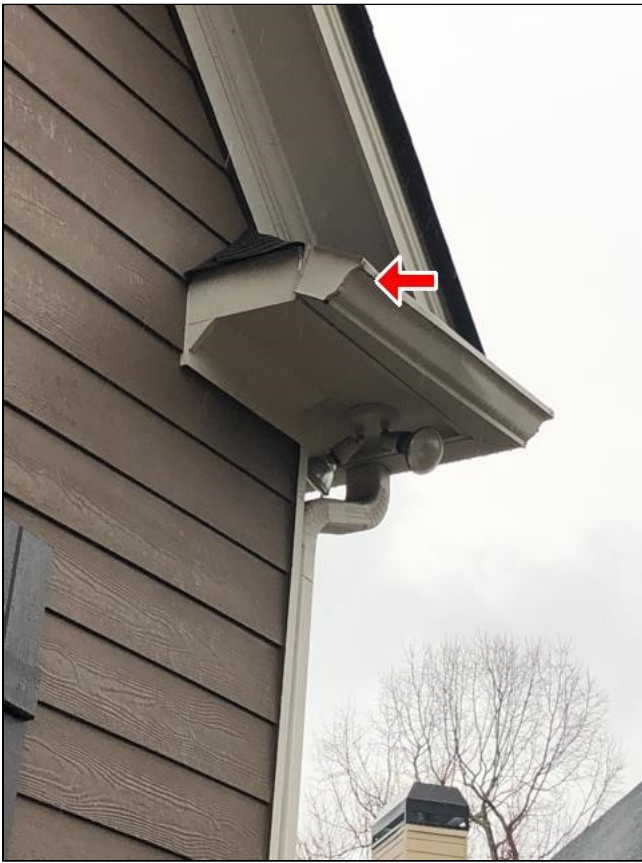
4.3 Gutter is not secure to roof. Recommend a qualified contractor assess gutter and make repairs as needed

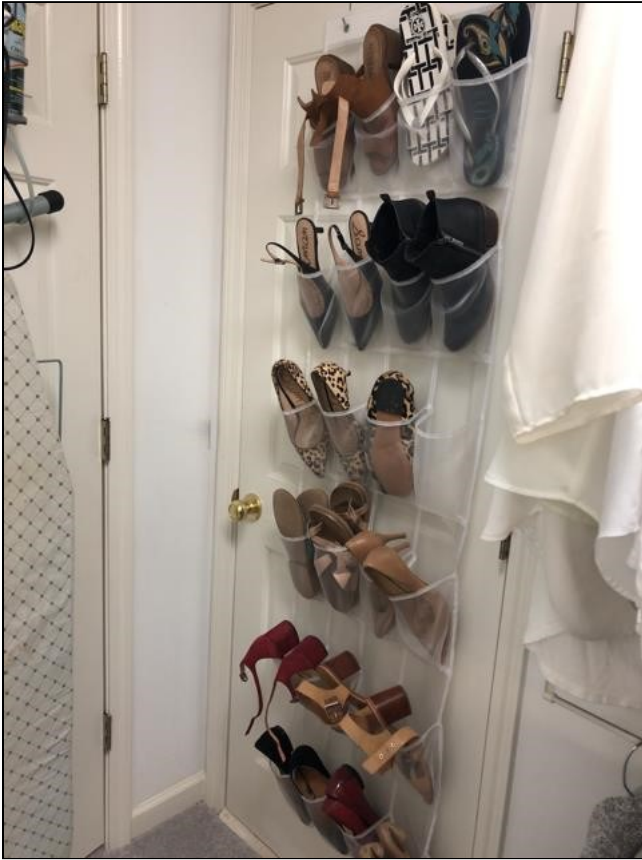
4.5 Hollow core attic door to attic. This door is not a thermal barrier to attic. Recommend a qualified contractor assess door and make repairs as needed to improve thermal envelope.

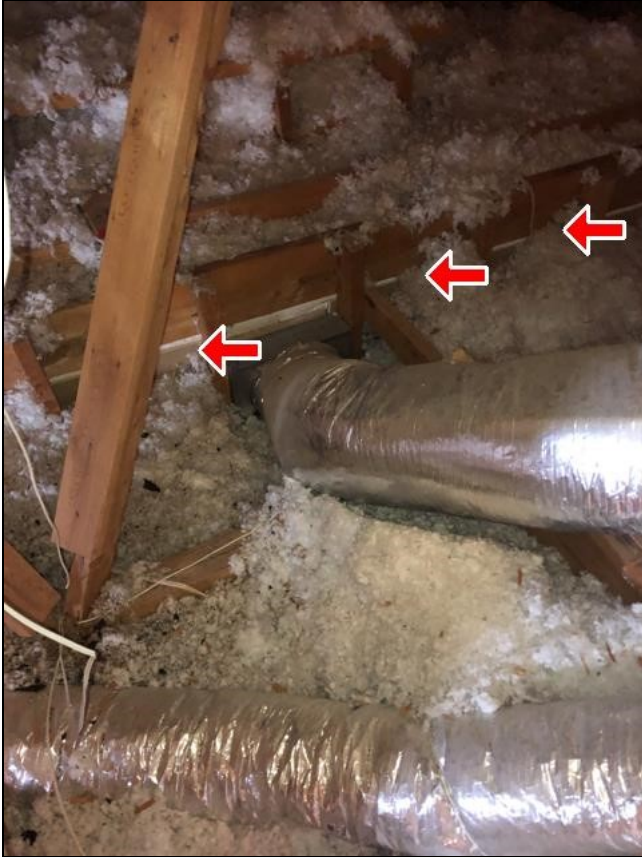
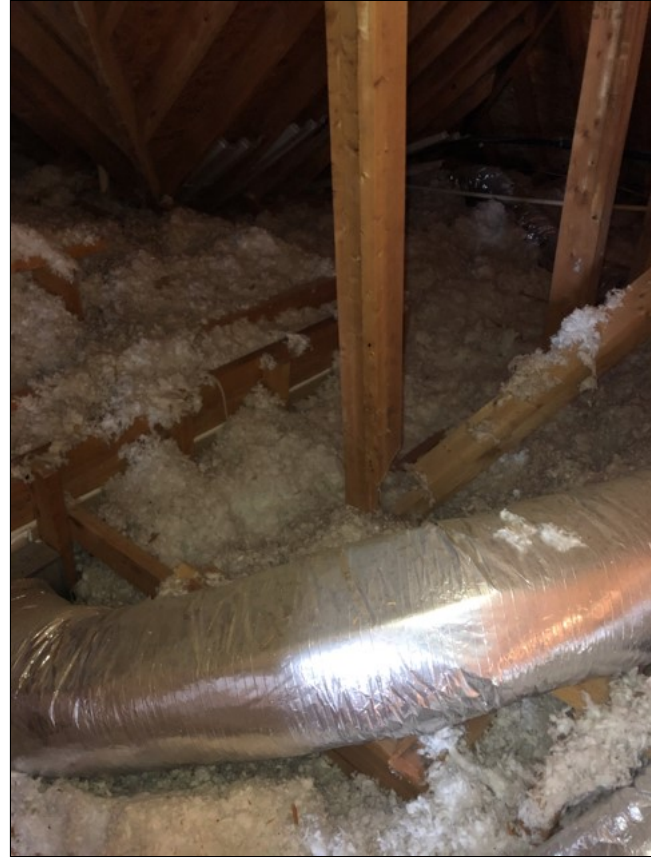
4.7 Missing/thin insulation noted in the attic. (Especially at tray ceiling). Also note that there is partial boards across floor of attic. Do not step on these boards. They will not support your weight. NOTE: 13" of blown-in fiberglass are recommended (can vary by manufacturer) to achieve R30 ceiling insulation. Recommend to amend as necessary to improve thermal envelope.

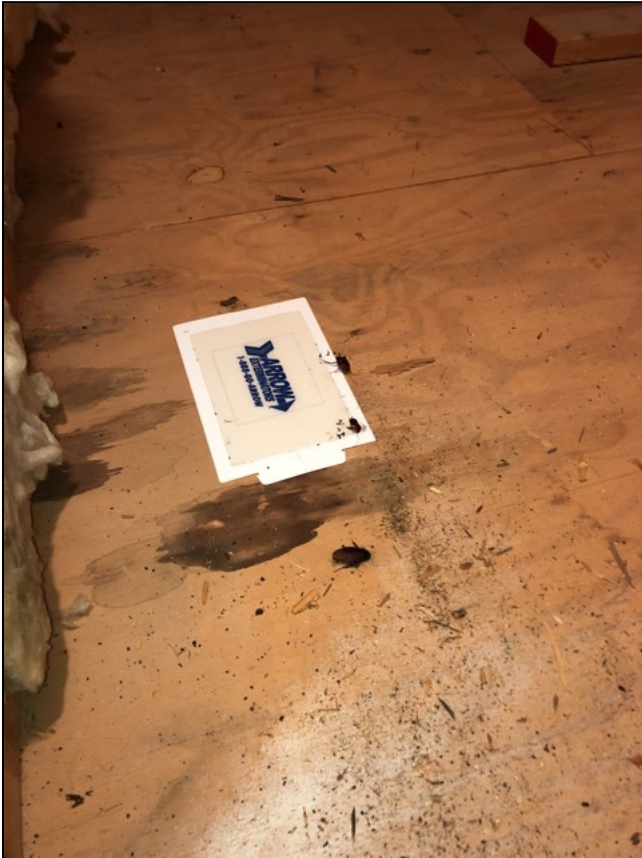
4.9 Signs of animal or insect activity noted in the attic (droppings, tracks, traps, tracks). Recommend to consult with a qualified pest and wildlife exclusion contractor.

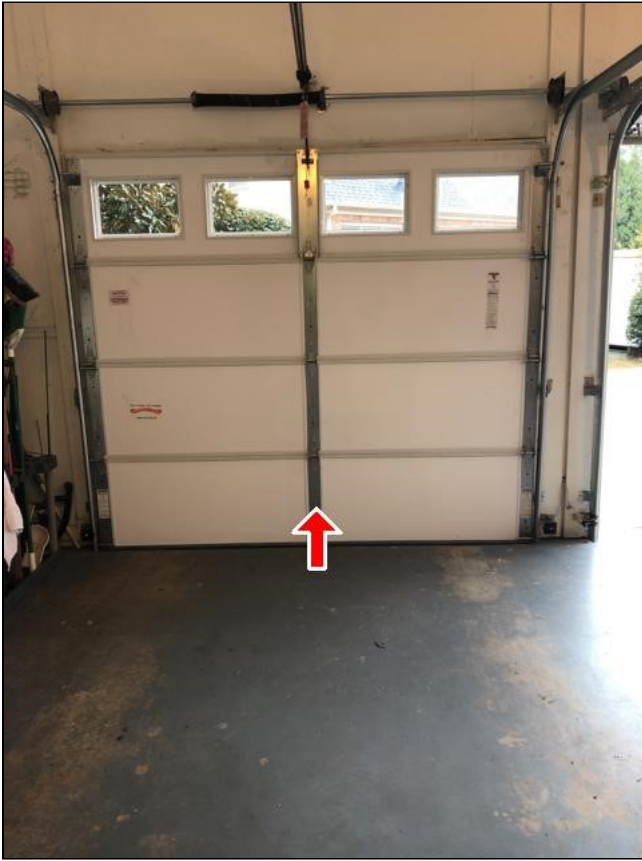
5.5 Garage door did not reverse when met with resistance. (See pictures for locations) Recommend a qualified garage door contractor adjust door opener to reverse per manufacturers recommendations to prevent injury or possible damage to door or property.

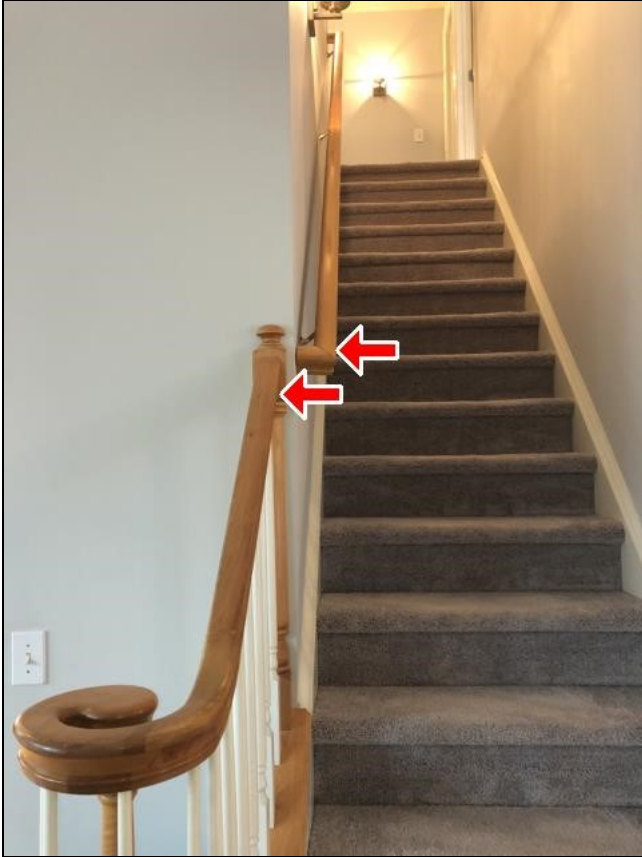
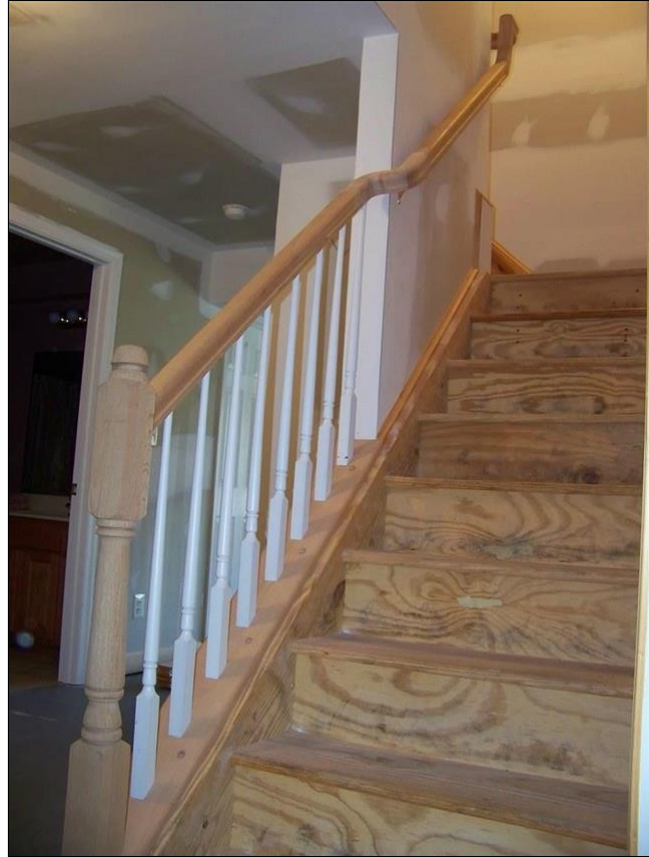
6.4 Handrails are not continuous. . NOTE: Currently accepted construction standards recommend that handrails should be continuous so that ones hand should never leave the handrail while climbing the stairs. The stair rail should also return to the wall to reduce possibility of clothing being caught on handrail. See pictures for examples. Recommend that all stair rails are assessed by a qualified contractor for these conditions and repairs be made as needed.

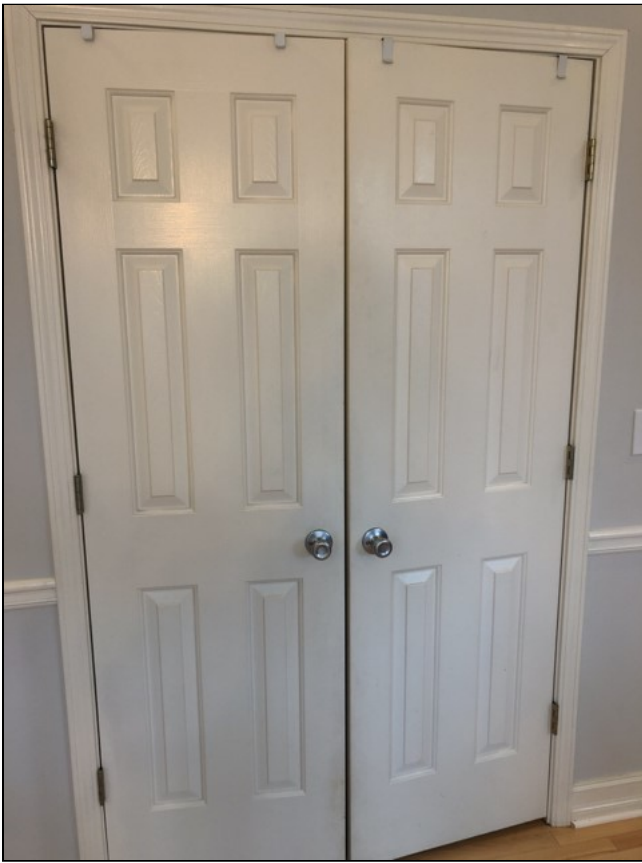
6.5 Door is not latching or locking when closed. Adjust as necessary.

6.5 Kitchen pantry

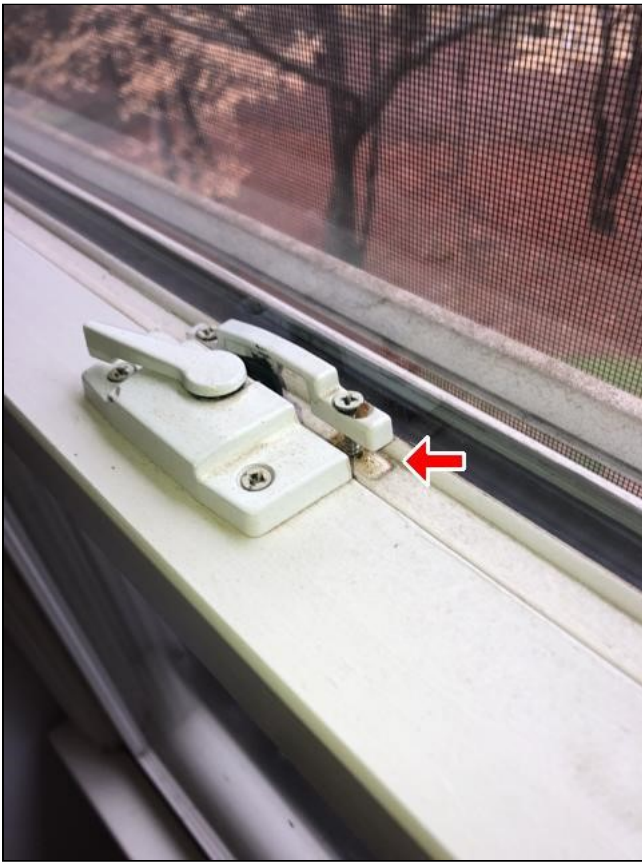
6.6 Hardware missing or damaged. Monitor and repair as needed

6.6 Second floor right rear corner bedroom

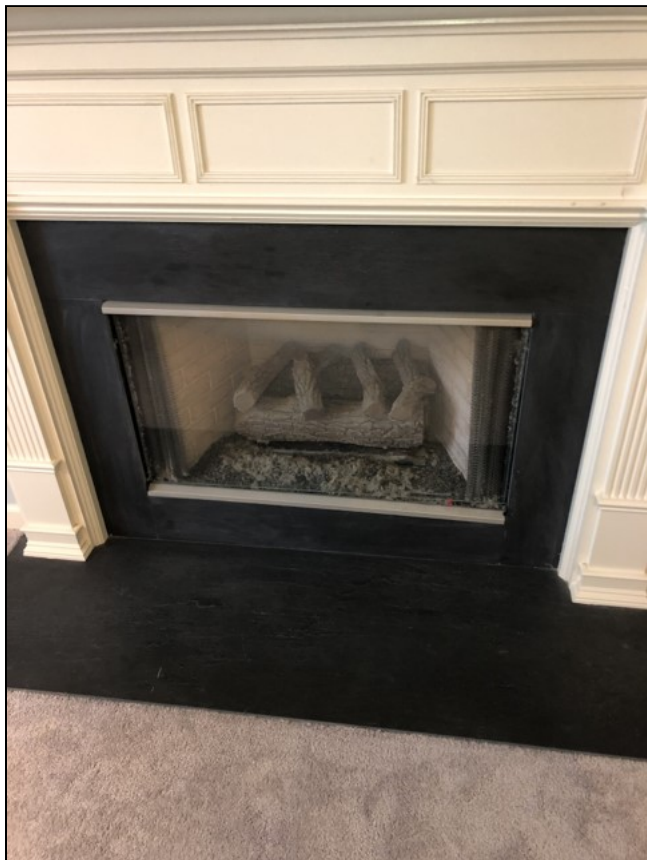
6.7 Second-floor gas fireplace in master bedroom did not light at time of inspection. Recommend a qualified contractor assess gas fireplace and make repairs as needed.

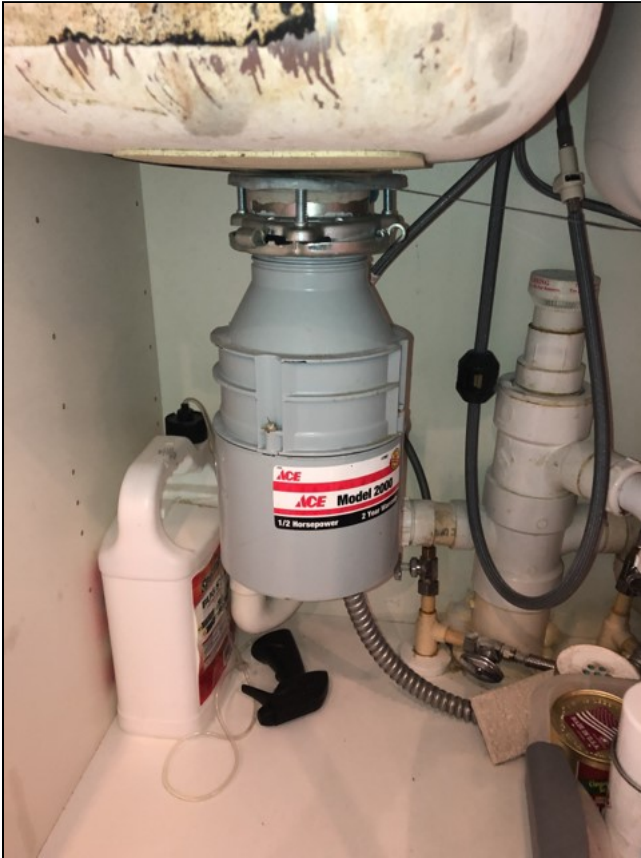
7.5 Excessive noise and vibration noted in disposal under kitchen sink. Recommend a qualified contractor assess disposal and make repairs as needed.

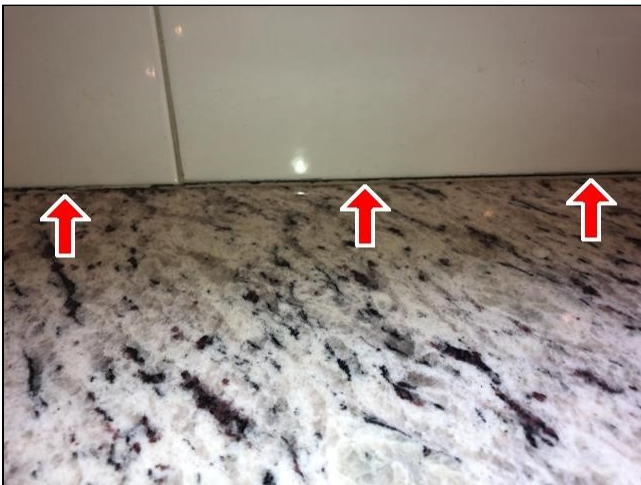
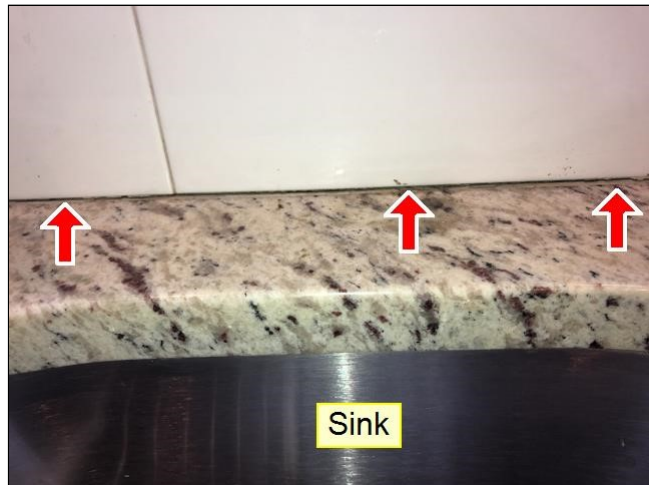
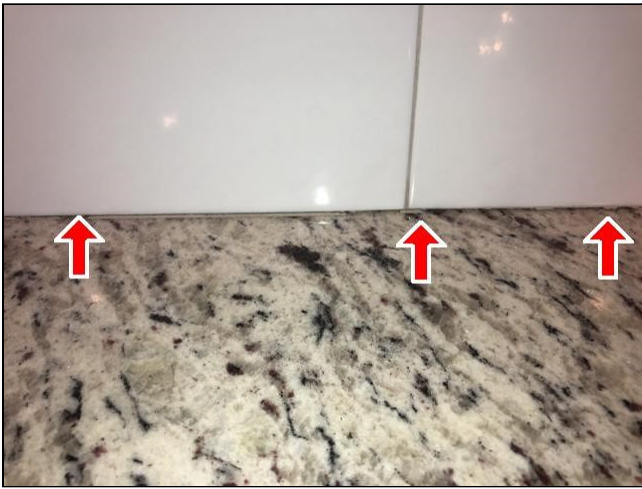
7.8 Gaps noted at counter. Seal/repair as necessary to avoid moisture entry.

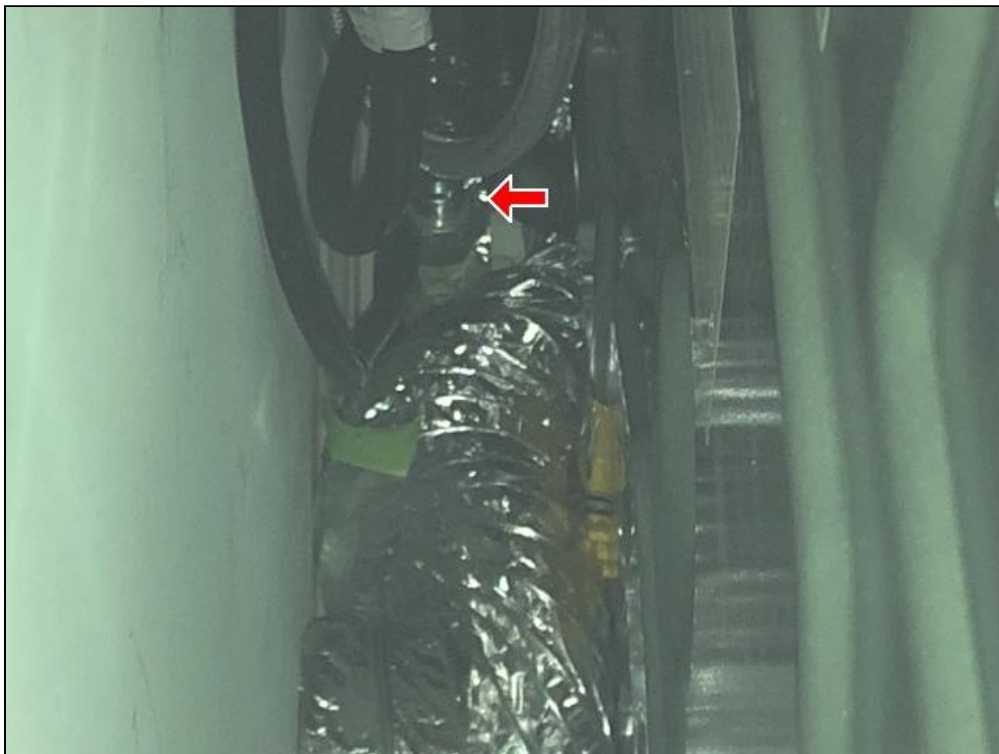
8.1 (2) Missing gas cap at unused gas line behind dryer. Recommend cap be installed for safety.

8.1 Laundry

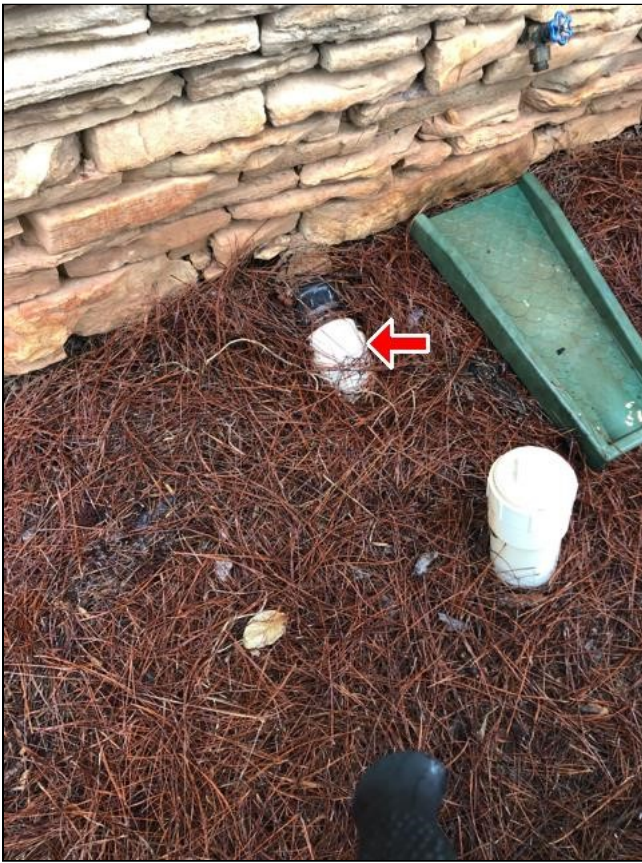
8.4 **Main septic pipe drain is exposed in front of house.** Recommend pipe be protected from frost.

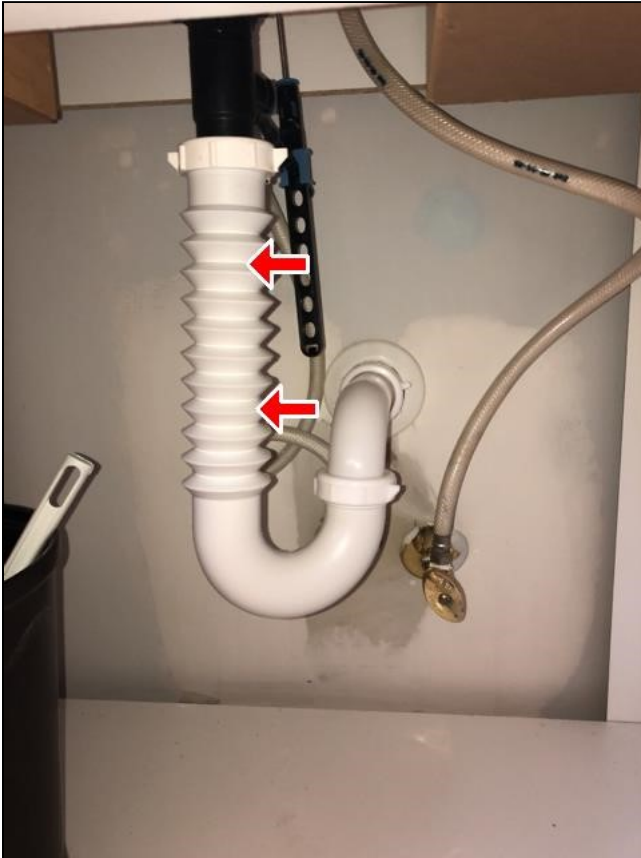
8.6 (1) Corrugated pipe noted. drain. NOTE: Drain pipes should be constructed from smooth materials. Recommend replacement.

8.6 First floor half bath

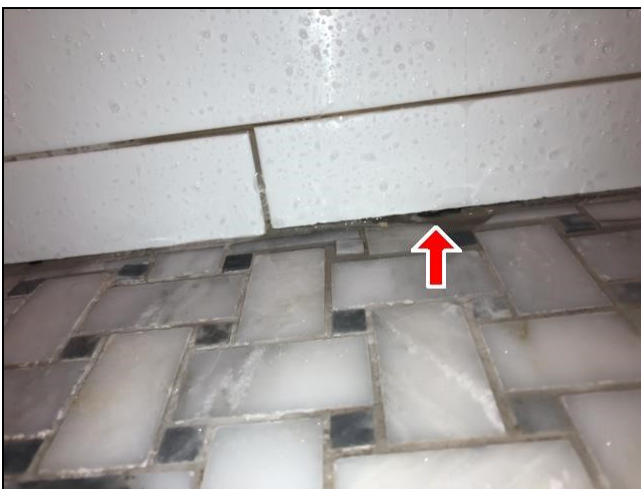
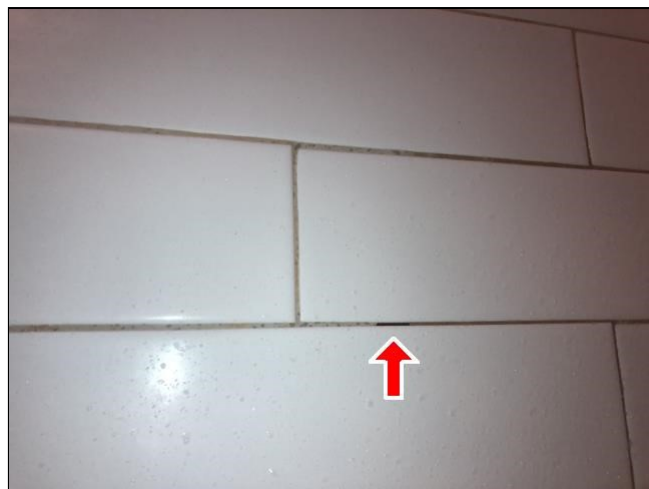
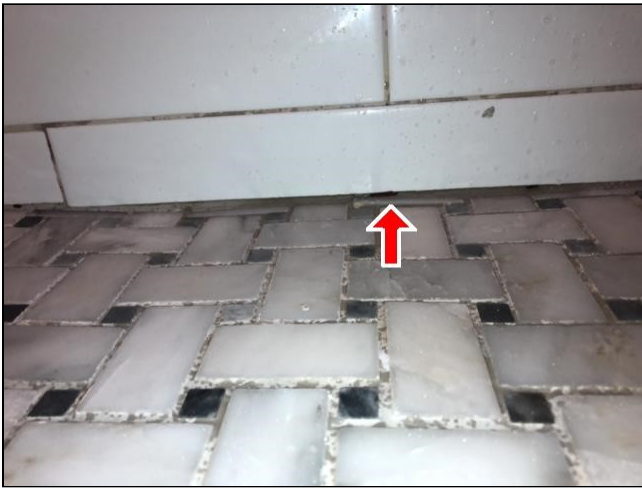
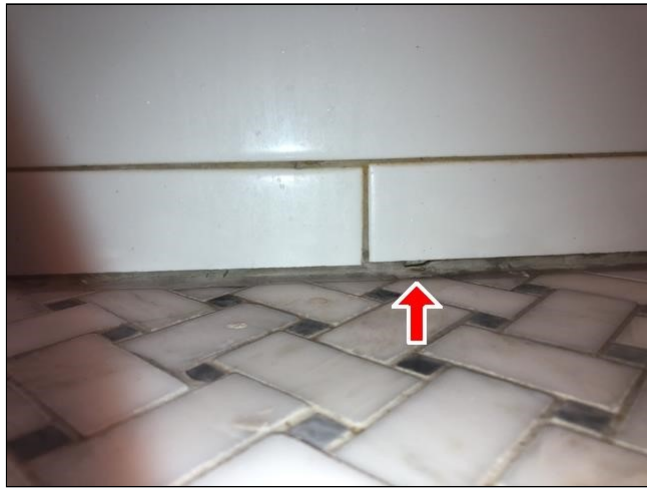
8.6 (2) Cracked grout noted at master bathroom shower walls. Recommend to install an approved flexible sealant to prevent moisture entry.

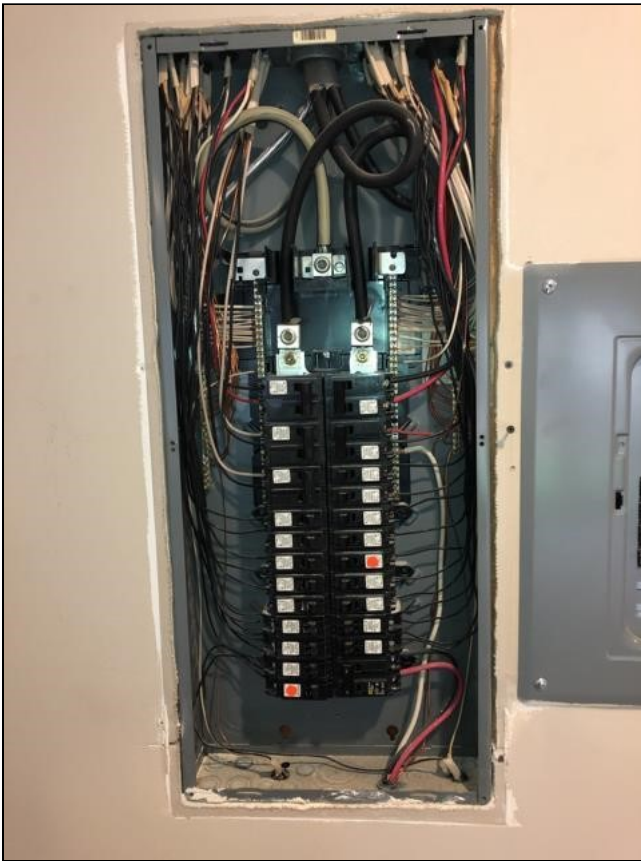
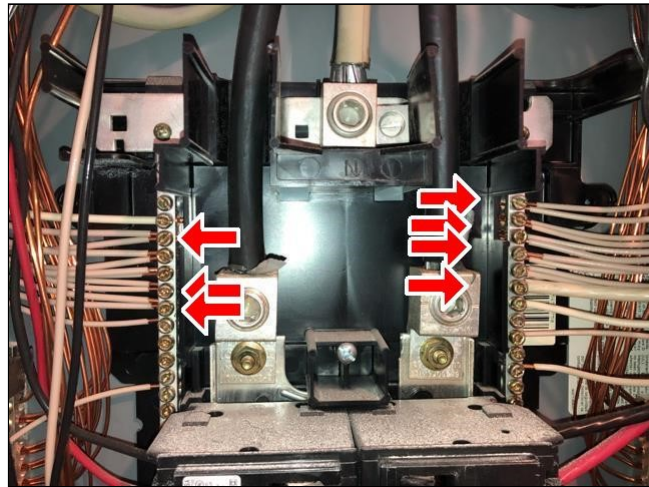
Improper wiring noted with two neutral wires observed under one terminal screw in bus bar. NOTE: Currently accepted construction practices recommends that only one neutral wire per terminal screw at bus bar to ensure circuit can be isolated to work on and to prevent overheating at terminal due to loose connection. Recommend a qualified electrical contractor estimate and make repairs as needed.

9.2 Improper wiring

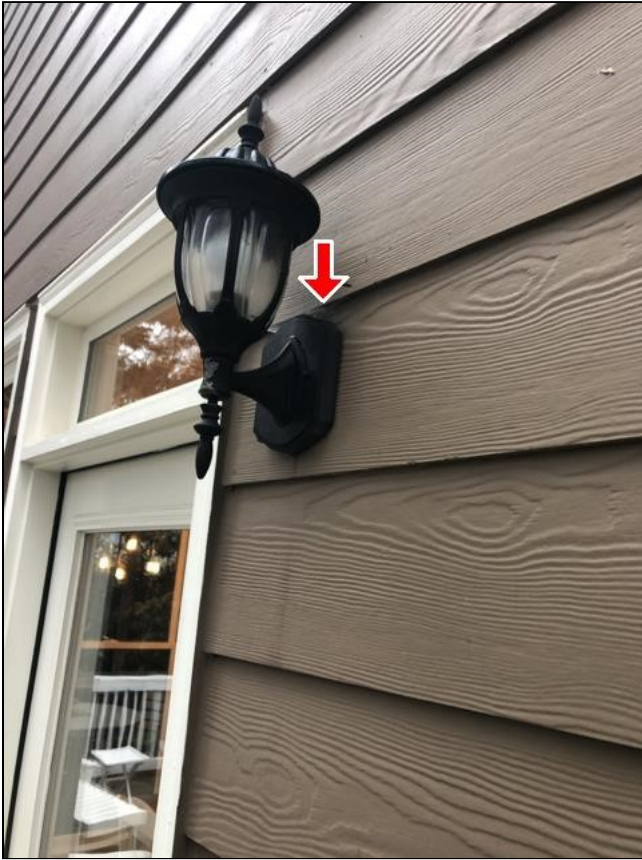
9.4 Missing sealant between light fixture and wall. Recommend light fixture base be sealed to wall to prevent moisture from entering into wall.

9.4 Back Deck

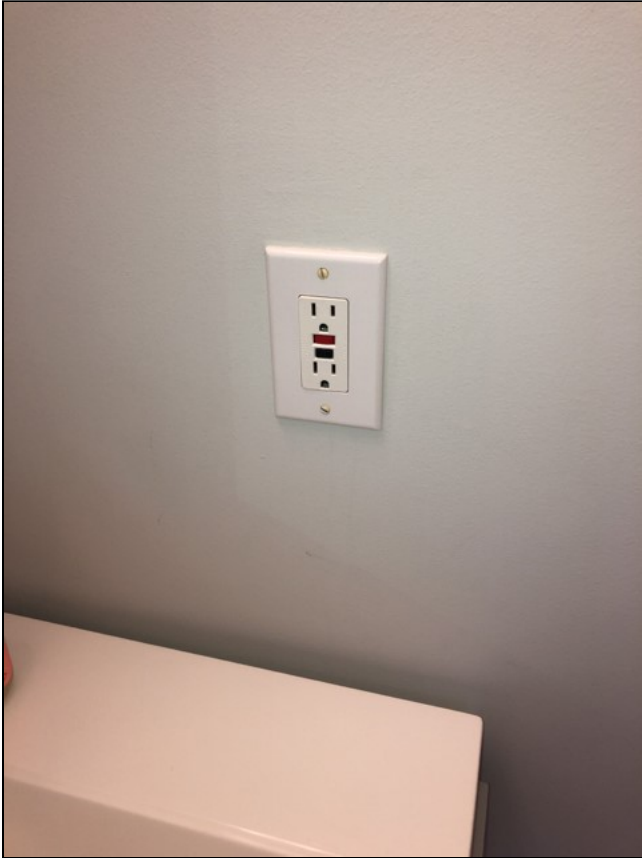
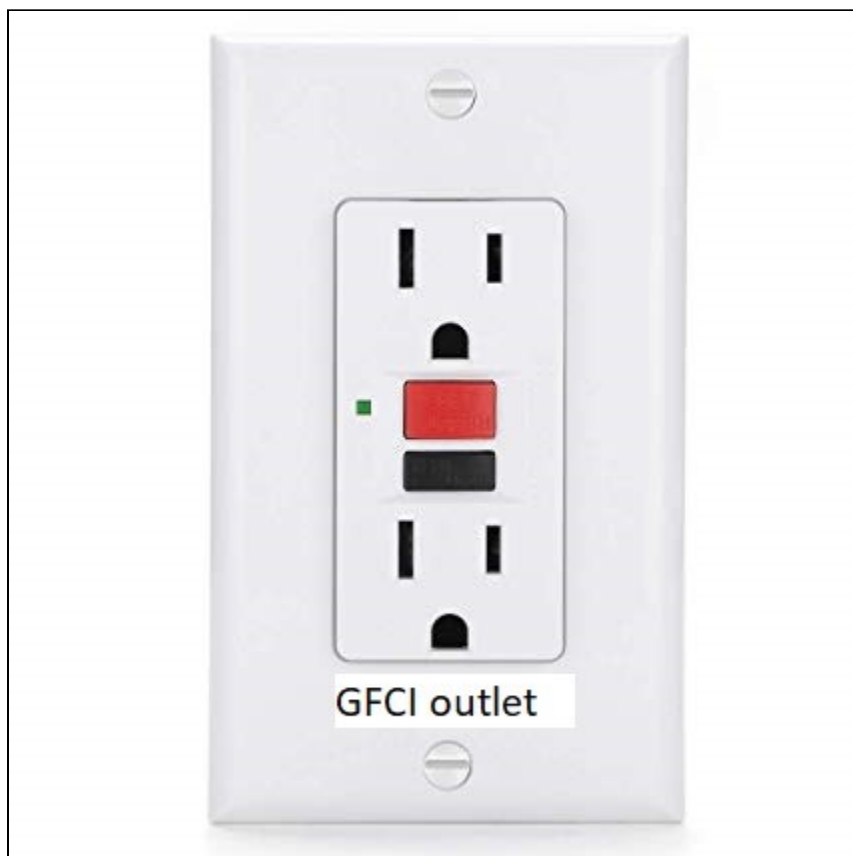
9.6 Ground Fault Circuit Interrupt (GFCI) outlet, breaker, or switch did not trip with test device it did trip with test button. Recommend that a licensed electrician assess condition of all GFCI devices and make repairs as needed. NOTE: GFCI devices are installed where electrical circuits may accidentally come into contact with water. Currently accepted construction practices recommend that GFCI devices be located at the exterior of home, kitchens, bathrooms, spa tubs, laundry rooms, and garages.

9.6 First floor half bath

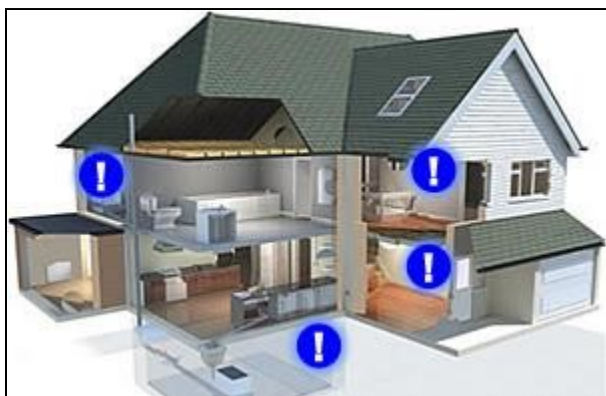
9.9 Missing carbon monoxide detector noted. NOTE: Currently accepted construction practices recommend that CO alarms should be installed in a central location outside each sleeping area and on every level of the home and in other locations where required by applicable laws, codes or standards. For the best protection, interconnect all CO alarms throughout the home. When one sounds, they all sound. Test per manufacturers guidelines.

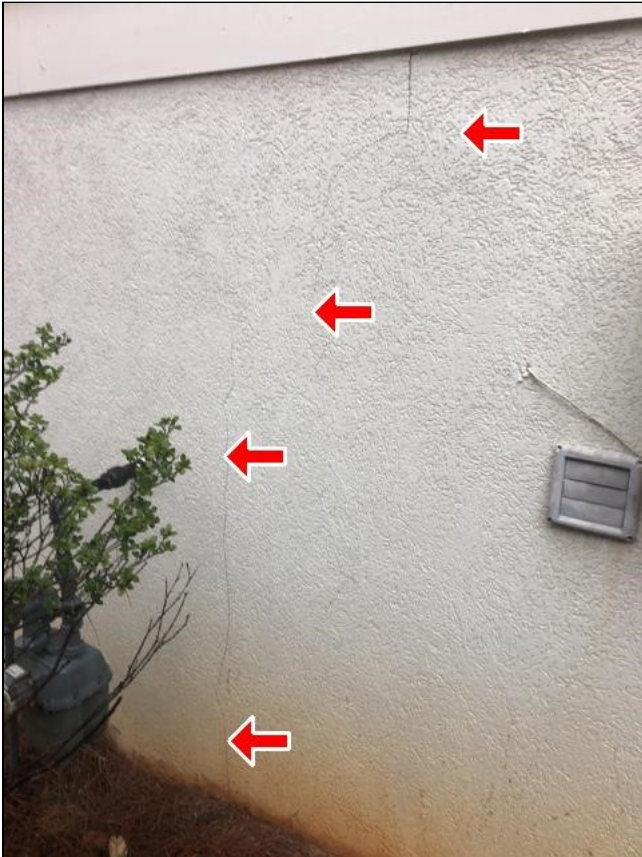
11.1 Crack was noted in the Foundation wall (No matching crack was found on interior surfaces.) Moisture penetration was noted at time of inspection. See picture for example. Recommend that a qualified foundation repair contractor assess foundation and make repair as needed

11.1 Left side by electric meter
