Your Inspection Report

200 Ridge Point Court
Alpharetta, GA 30022

INSPECTION DATE:
Thursday, March 12, 2020

RE: Report No. 33371
200 Ridge Point Court
Alpharetta, GA
30022

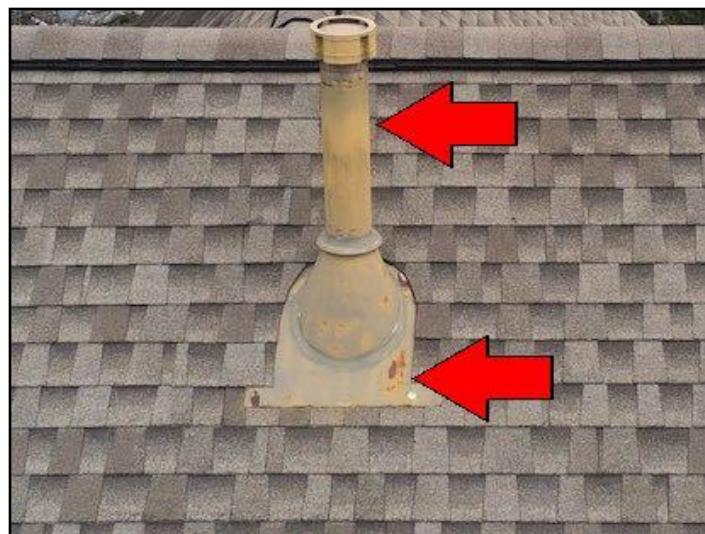
- 1. Condition:** • Damage, loose, rusted or missing

1. Damage, loose, rusted or missing Task:...

Task: Repair or replace

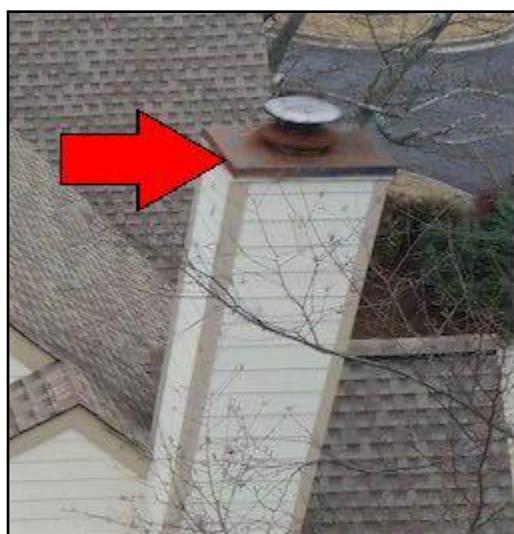
- 2. Condition:** • Chimney cap rusted or ponding

2. Chimney cap rusted or ponding Task: Repair...

Task: Repair or replace

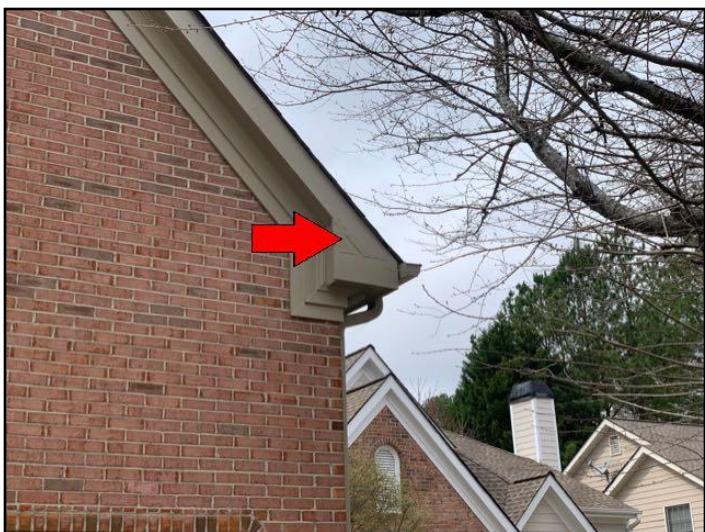
- 3. Condition:** • Rotten/Damaged areas

- 7. Rotten/Damaged areas** Task: Repair necessar...

Task: Repair necessary sections

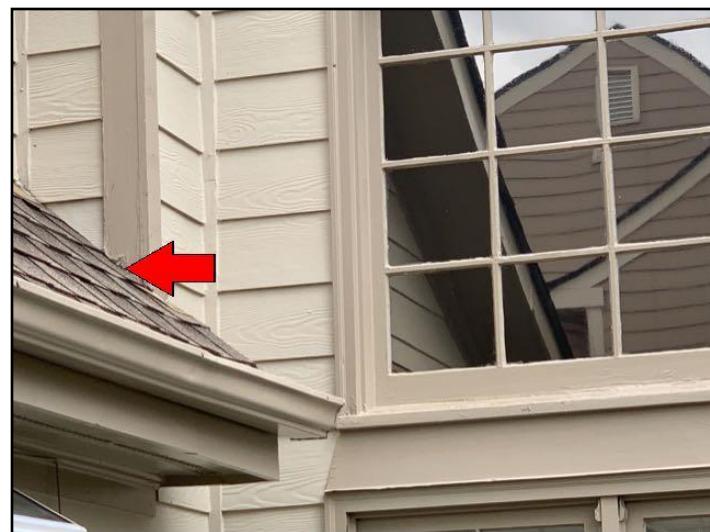
- 8. Rotten/Damaged areas** Task: Repair necessar...

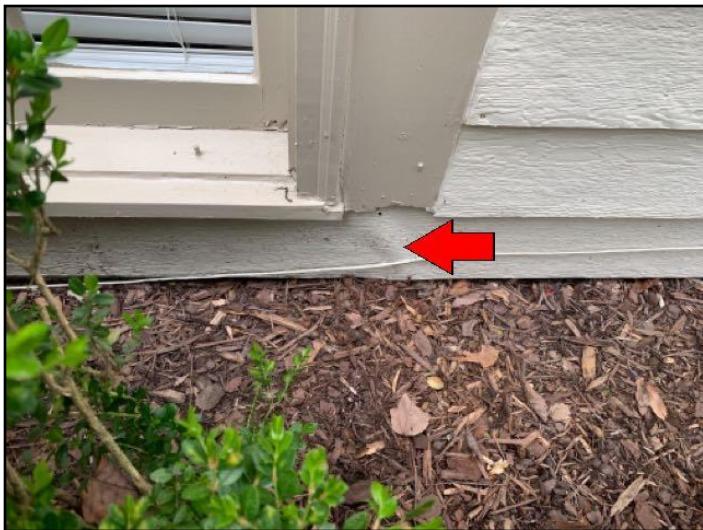
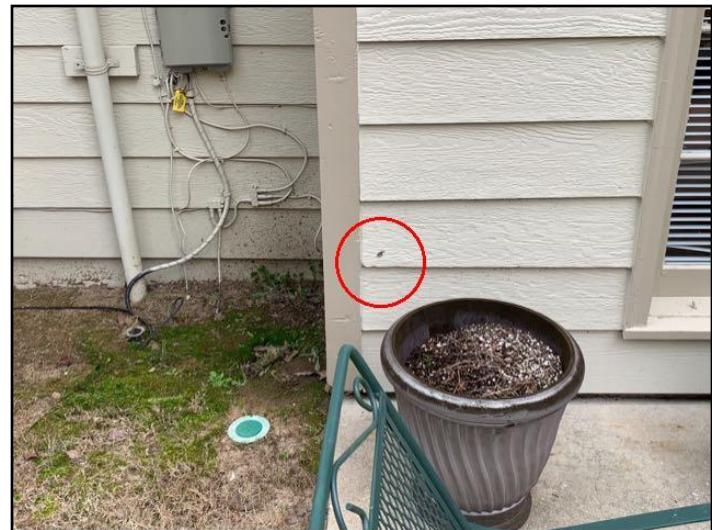
- 5. Condition:** • Damaged siding

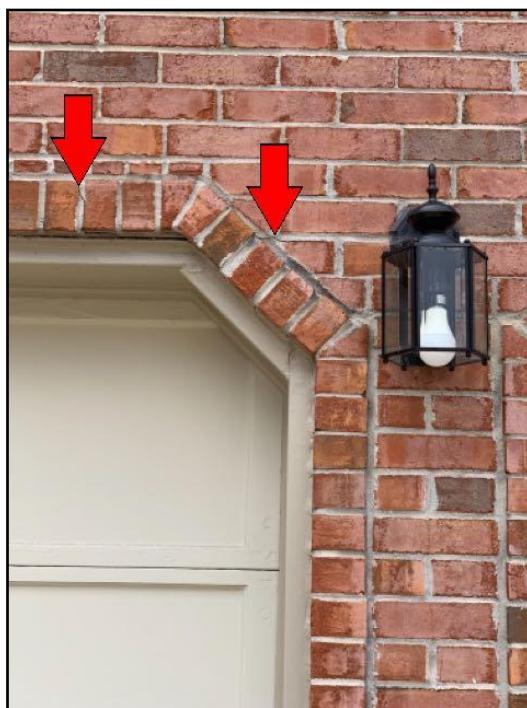
- Mortar deterioration

11. Mortar deterioration Task: Point repairs b...

Task: Point repairs by qualified mason at areas of deterioration

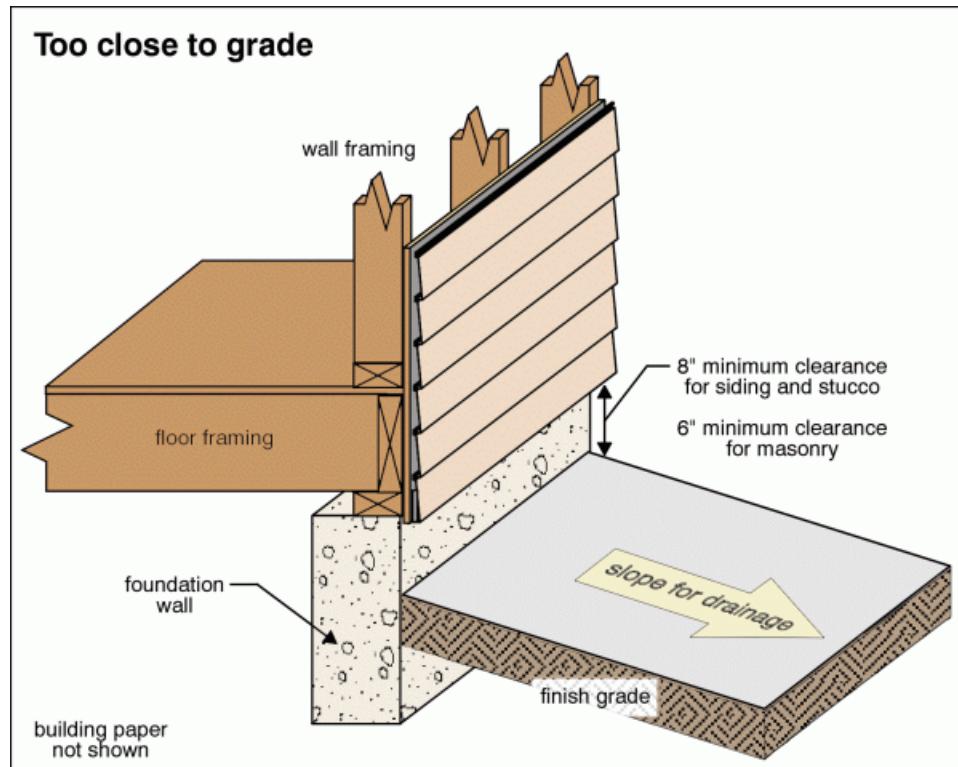
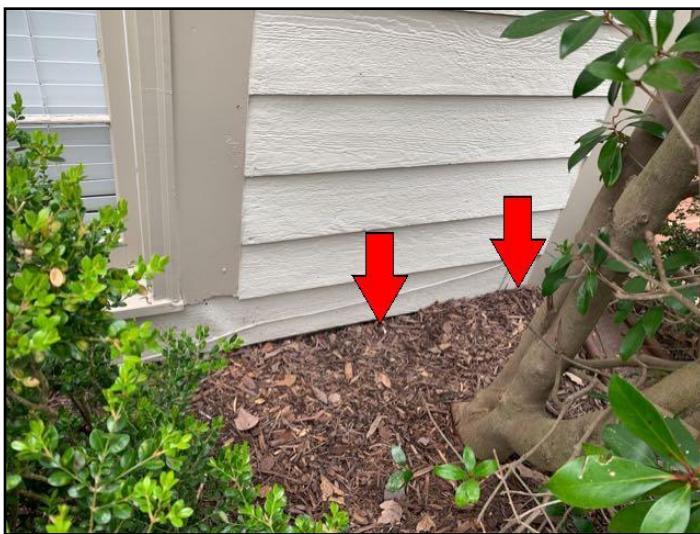
12. Too close to grade Task: Improve...

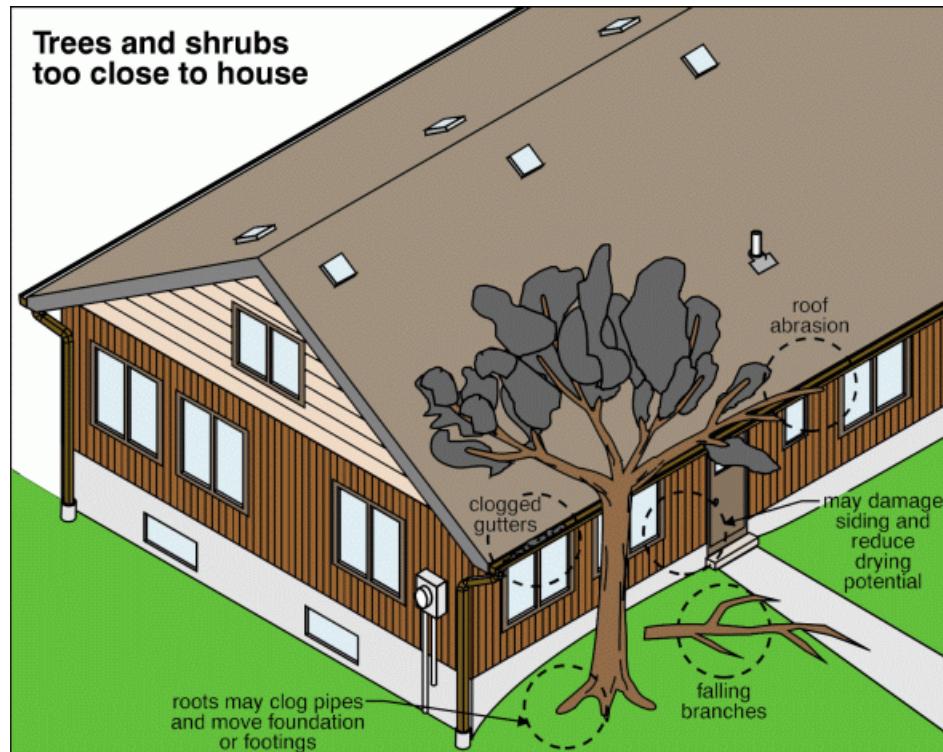
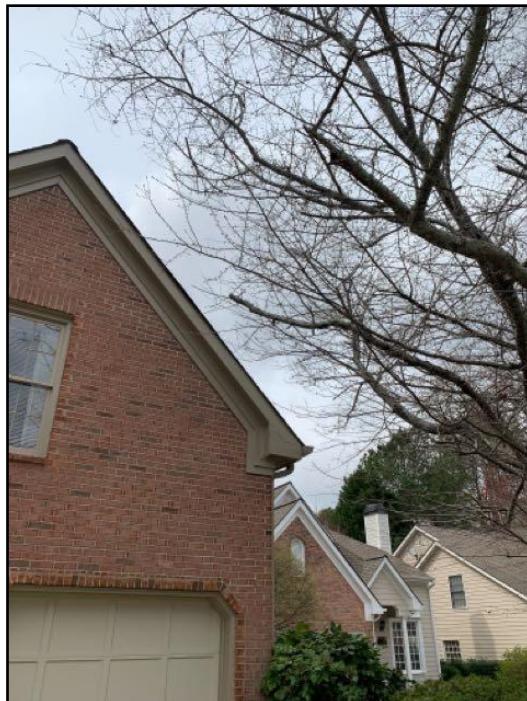
13. Trees or Shrubs too close to building Task...

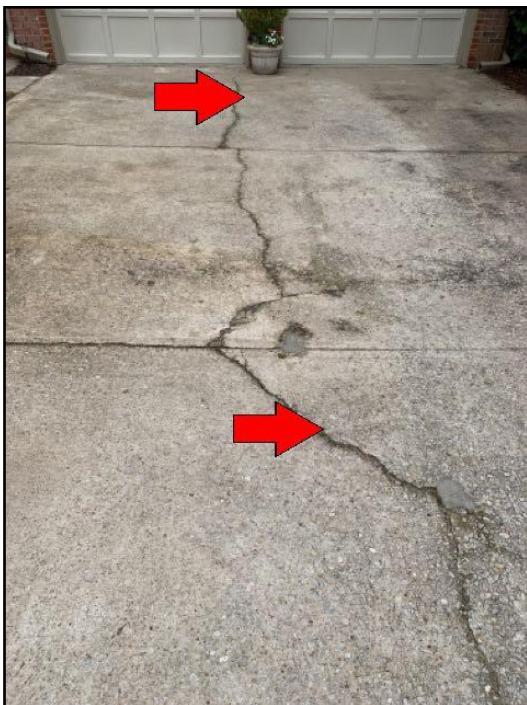
9. Condition: • Cracked or Damaged Surfaces

14. Cracked or Damaged Surfaces Task: Repair a...

Task: Repair as Needed/Be Advised

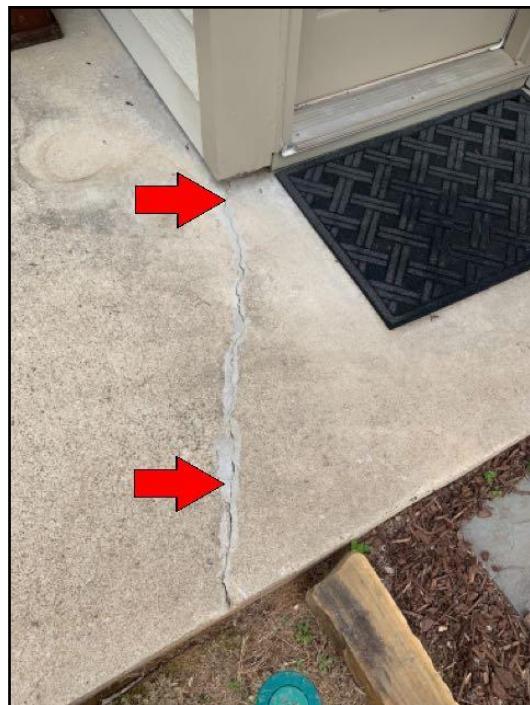
15. Cracked or Damaged Surfaces Task: Repair a...

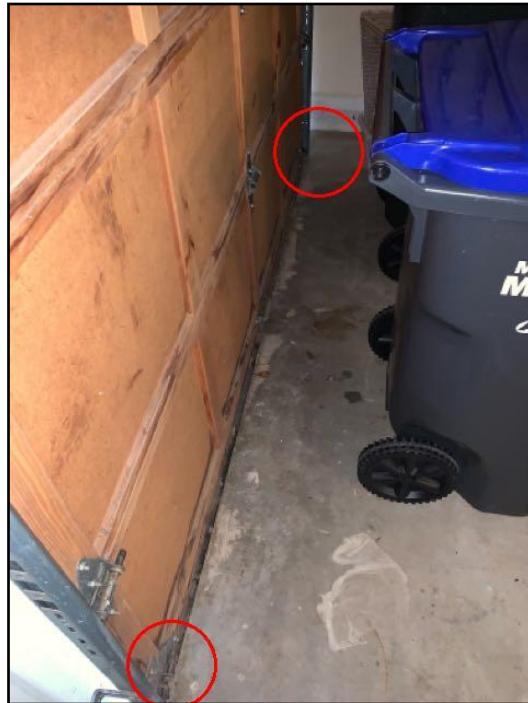
GARAGE \ General notes**10. Condition:** • Sensors/Safety Eyes Missing

16. Sensors/Safety Eyes Missing Location:...

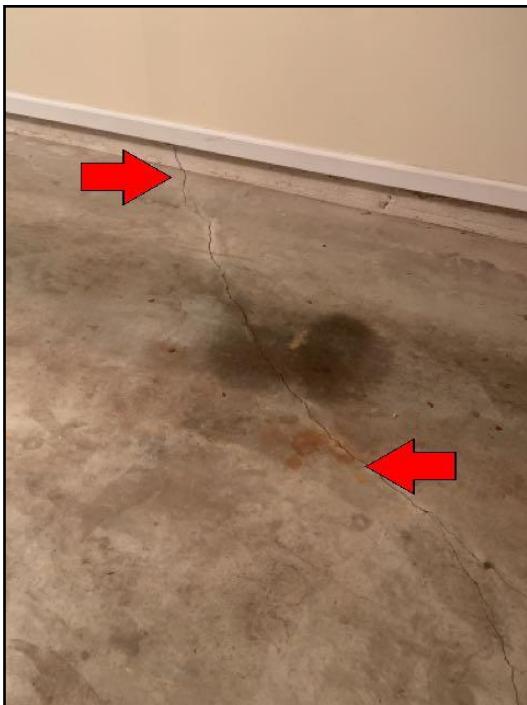
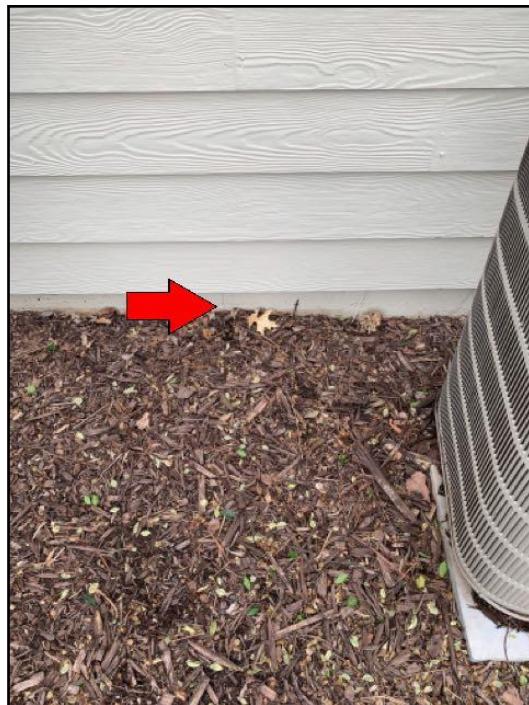
- 11. Condition:** • Crack in masonry

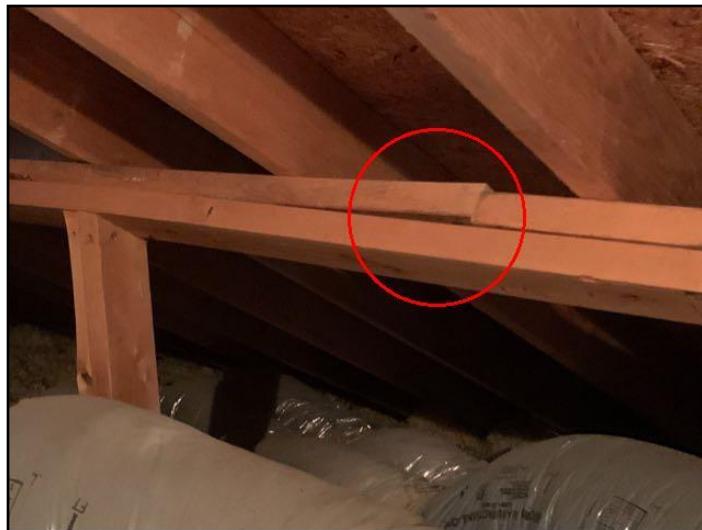
- 12. Condition:** • [Weak connections](#)

19. Weak connections

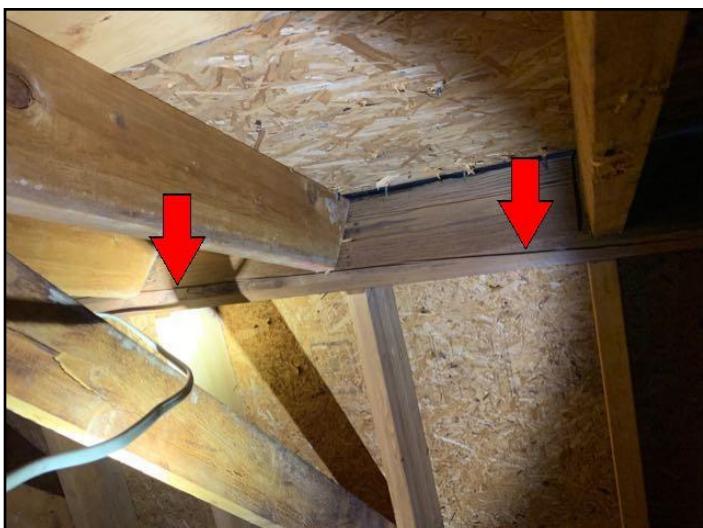
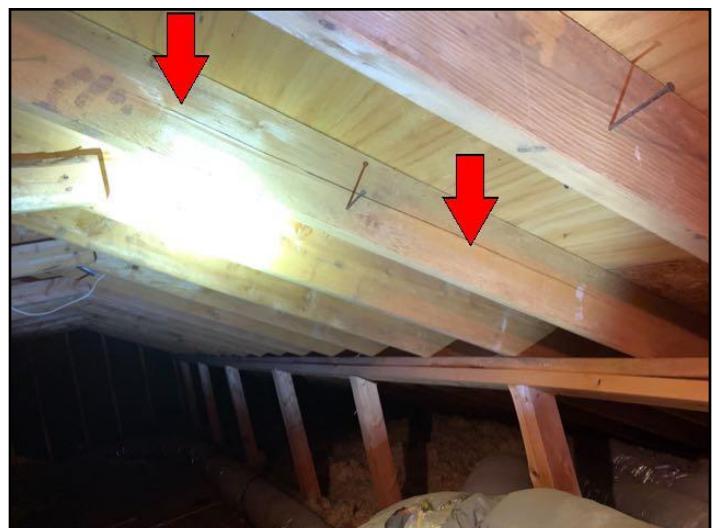
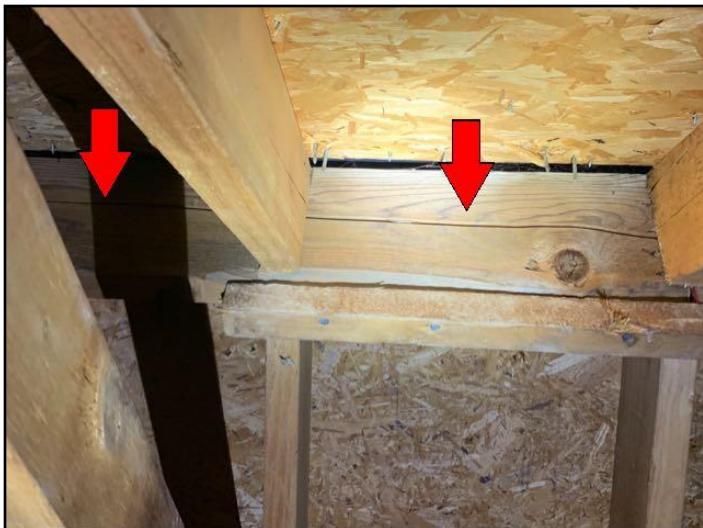
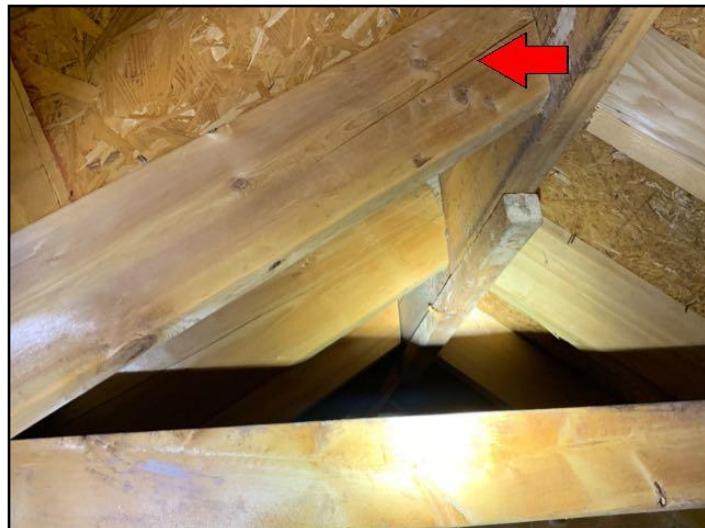
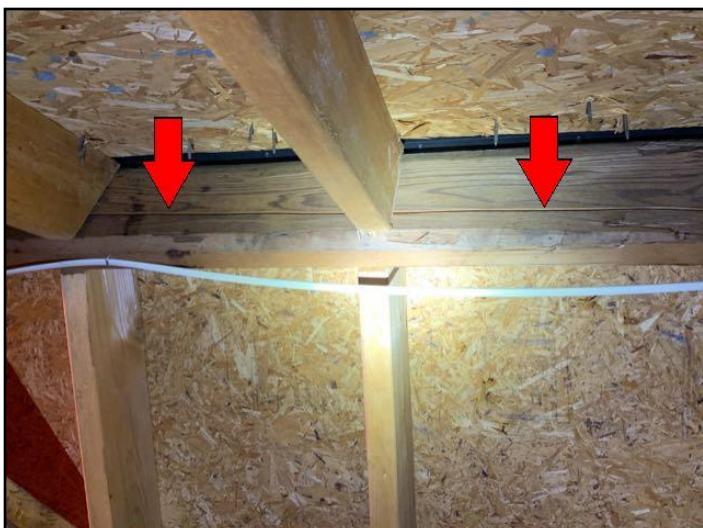
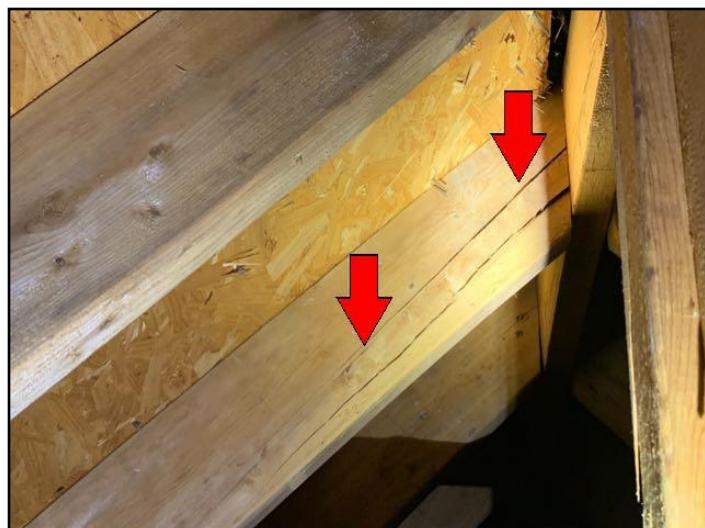
13. Condition: • Split

20. Split

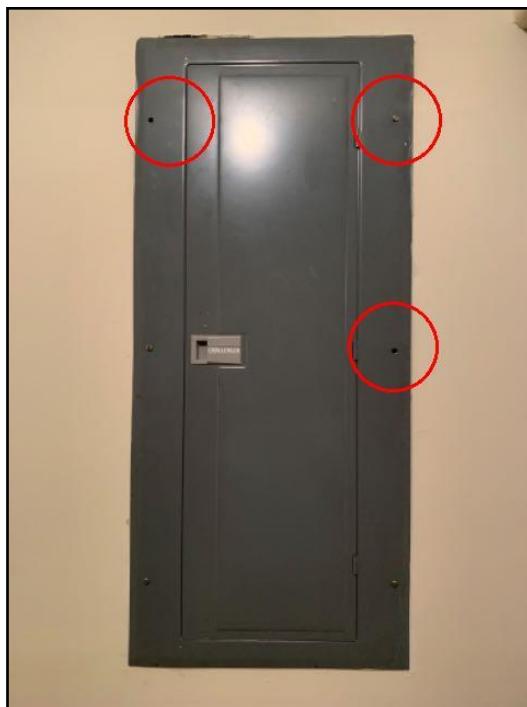
14. Condition: • Cover Screws Missing

26. Cover Screws Missing Location: Panel Task...

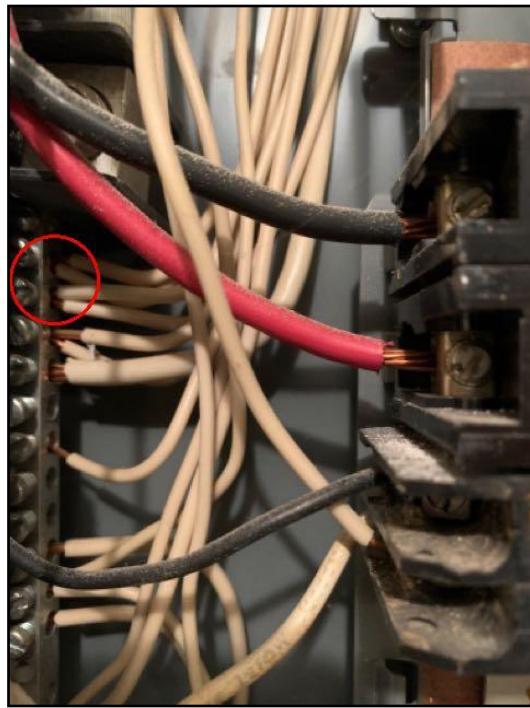
15. Condition: • Bundling of neutral conductors

27. Bundling of neutral conductors Location:...

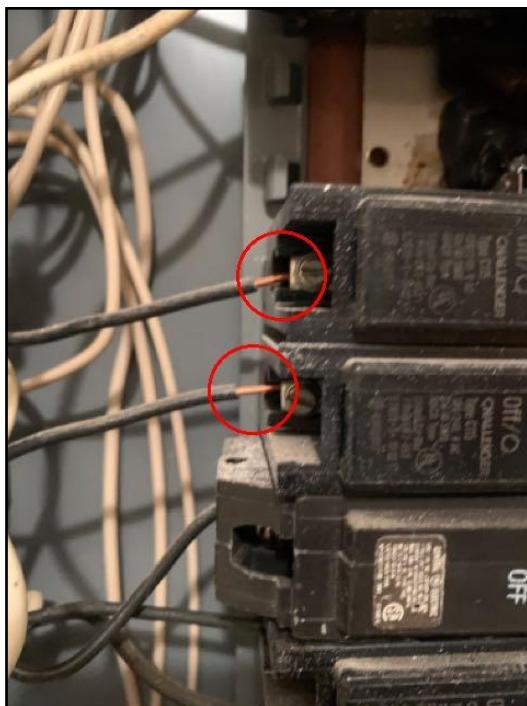
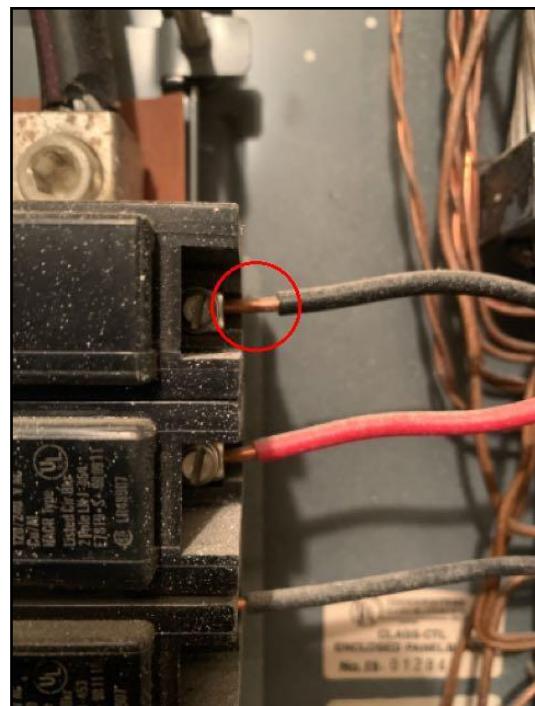
16. Condition: • Not well secured

28. Not well secured Task: Secure Time:...

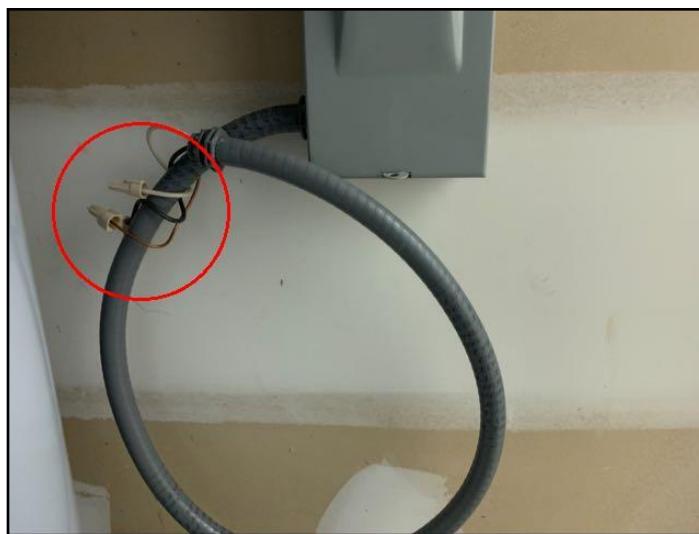
Wire appears to be serving no purpose and should be removed to eliminate any possible safety hazard.

30. Abandoned Wiring Task: Remove Time:...

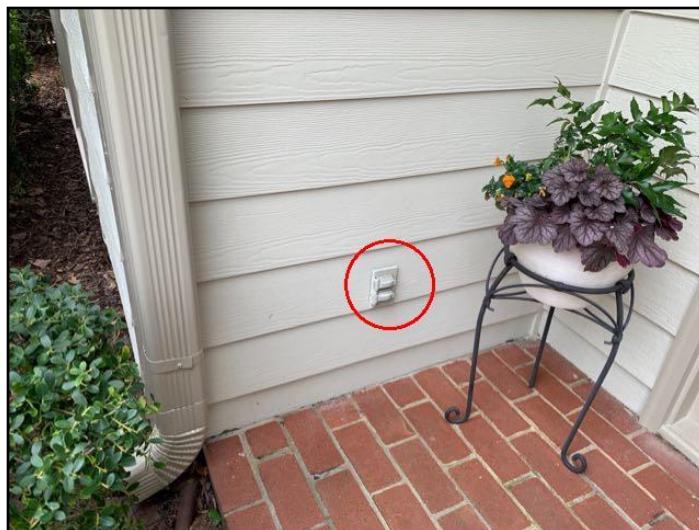
- Loose Receptacles (Outlets) noted

31. Loose Receptacles (Outlets) noted Task:...

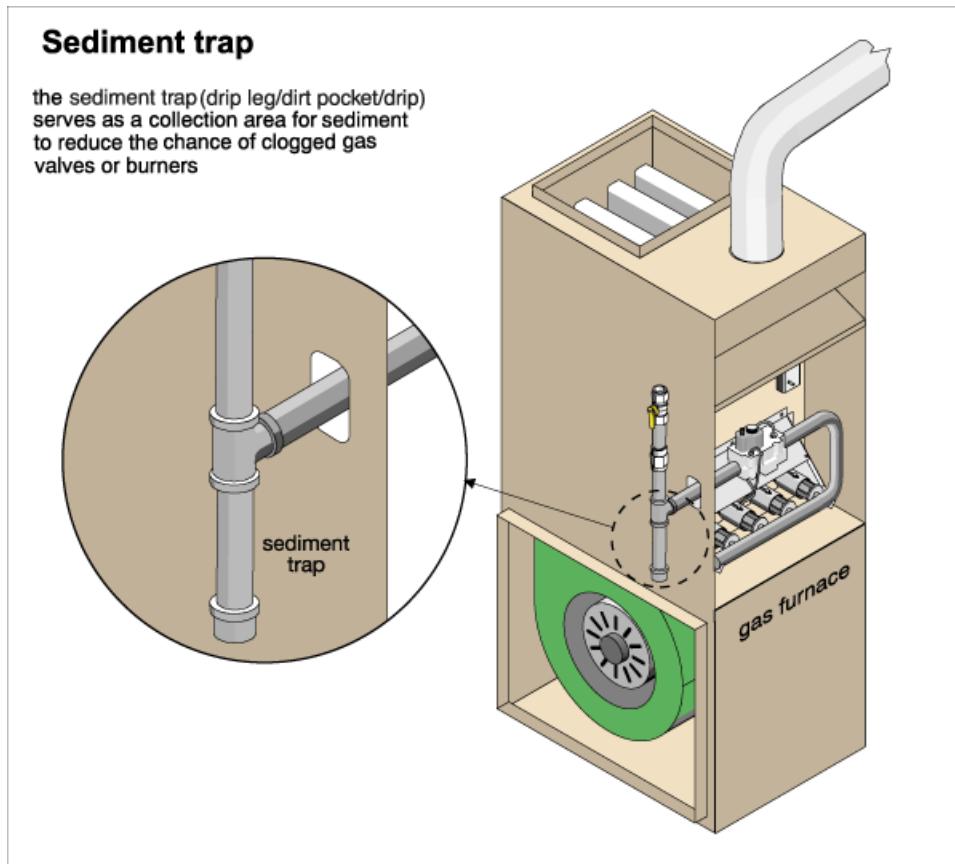
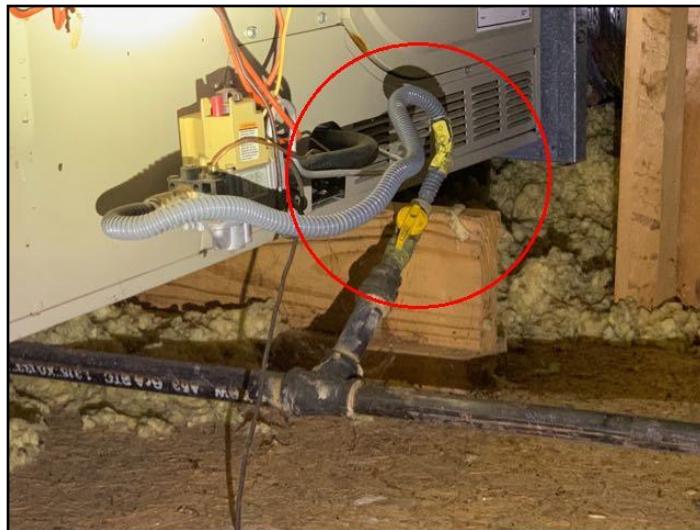
19. Condition: • [No drip leg \(sediment trap, dirt pocket\)](#)

34. No drip leg (sediment trap, dirt pocket)

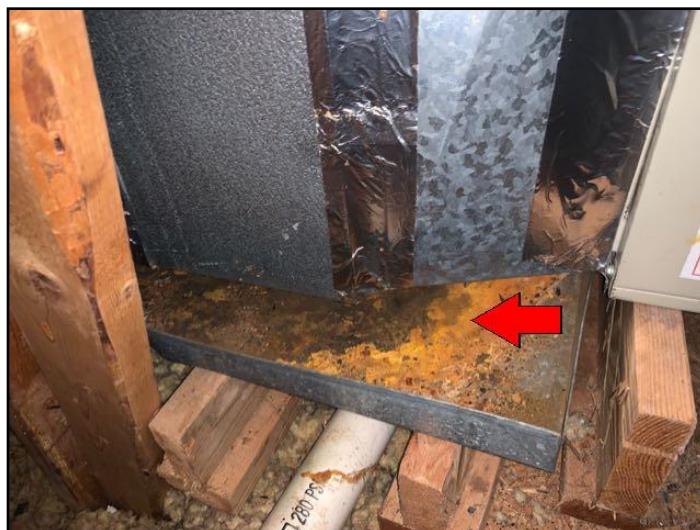
21. Condition: • Auxiliary Pan Rusted

37. Auxiliary Pan Rusted Task: Replace Time:...

Task: Replace

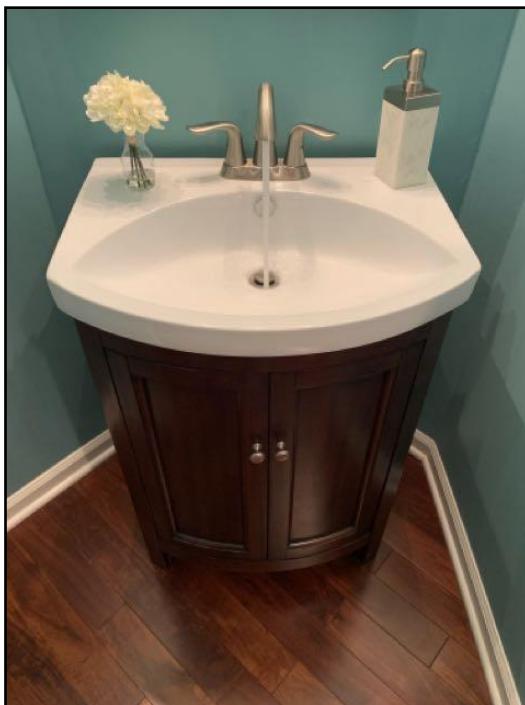
22. Condition: • Pedestal sink not properly attached

38. Pedestal sink not properly...

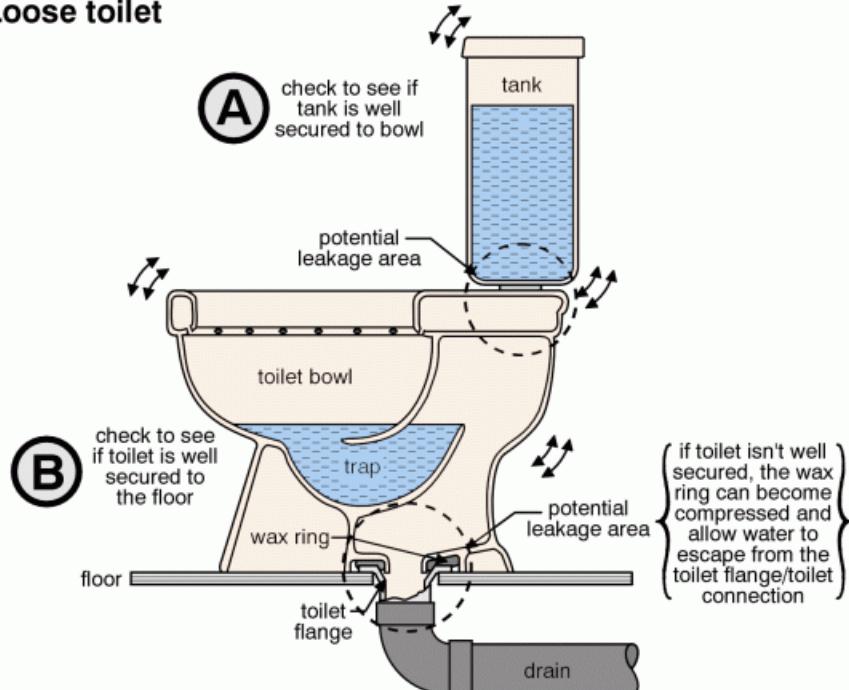
23. Condition: • Loose

Loose toilet

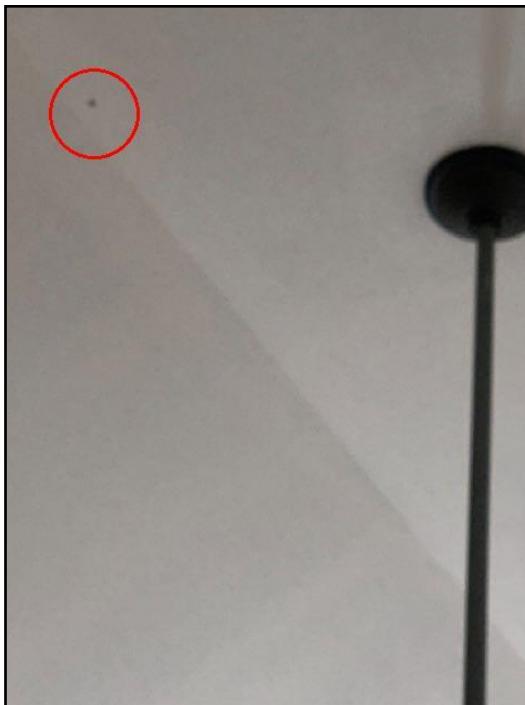
24. Condition: • Nail Pops

40. Nail Pops Task: Be Advised - Repair if...

Task: Be Advised - Repair if Desired

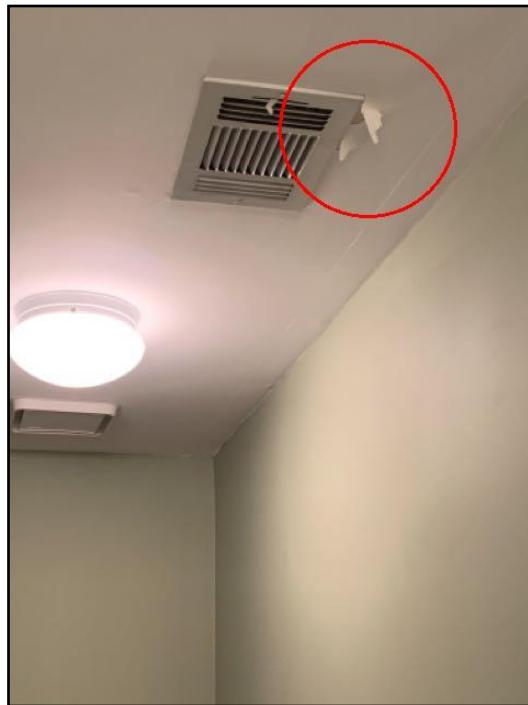
25. Condition: • Typical Flaws

41. Typical Flaws Task: Be Advised and monitor...

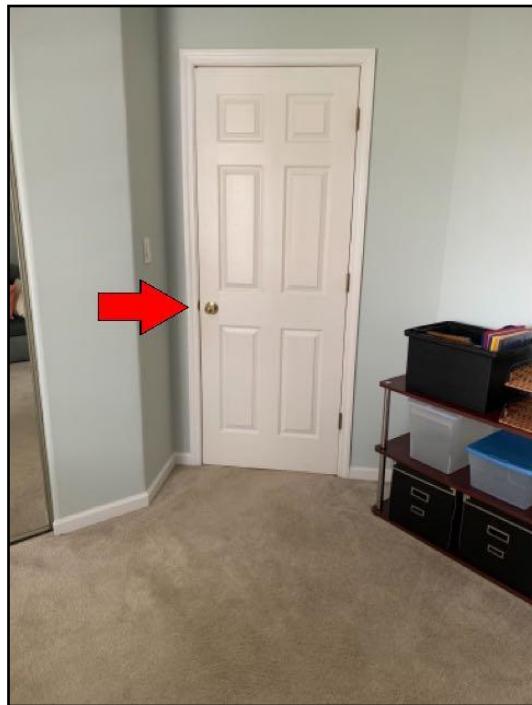
26. Condition: • Does Not Latch Properly

42. Does Not Latch Properly Task: Adjust Time...

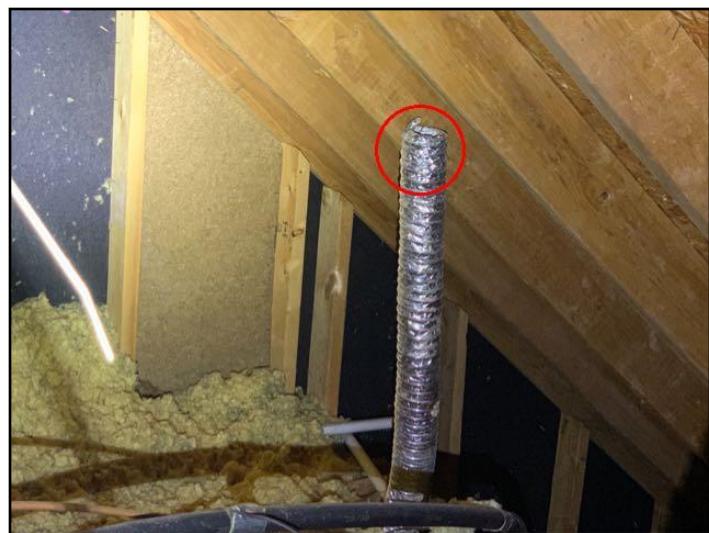
27. Condition: • [Not vented to exterior](#)

43. Not vented to exterior
