**764 Shadowridge Drive Southeast
Atlanta GA 30316**

Client(s): Cole
Inspection Date: 3/18/2020
Inspector: Chuck Turner ,

SECTION I: KEY FINDINGS

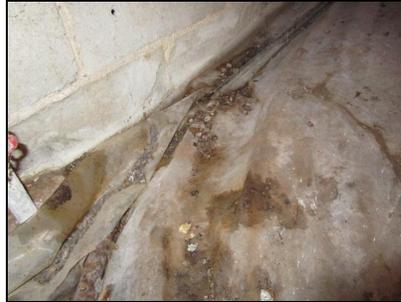
- ❌ 1. **SAFETY / HEALTH:** Although not considered as part of the scope of our inspection, there is ample evidence of pest infestation in the attic and / or crawlspace. A pest report needs to be obtained from a qualified contractor and all repairs made as outlined in the report.

Signs of rodents in the crawlspace

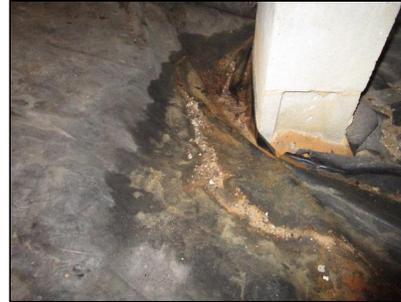
Signs of rodent intrusion in the crawlspace.

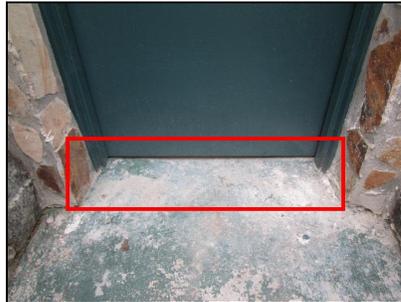
- ❌ 2. **SERVICE / REPAIR:** Add thresholds or sweeps to the crawlspace / basement access doors to prevent rodent intrusion in the crawlspace.

Add threshold or sweep to the basement door

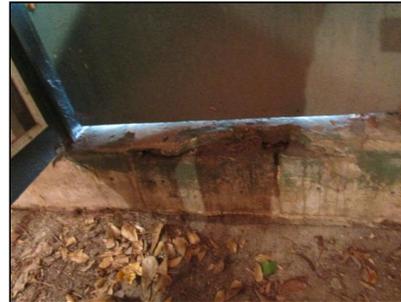
Add threshold or sweep to the crawlspace entry door.

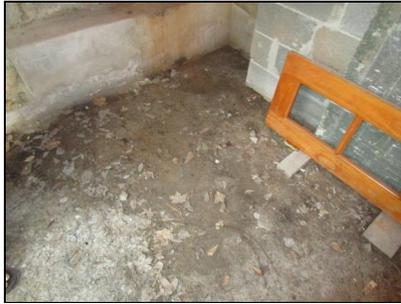
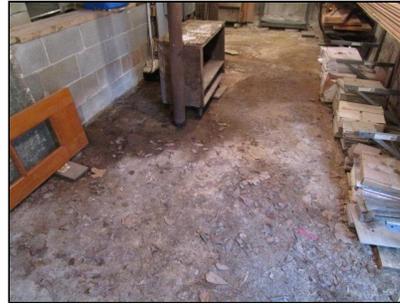
- ❌ 3. **SERVICE / REPAIR:** An inadequate vapor barrier is present in the crawlspace. The installation of a complete vapor barrier is advised to prevent moisture rising from the crawlspace area into the home. Not installing a vapor barrier can lead to high humidity problems in the home and may result in mold growth. A vapor barrier should be placed on the crawl space dirt floor to stop moisture penetration of the floor and sub-floor under any habitable space. The barrier must be taped and sealed at all barrier joints and be extended one foot up the exterior walls and around support columns leaving 3-6 inches minimum at the top for observation of termite tracks. Seal the top to the columns and walls. This approach is approved by the US Department of Energy and building envelope specialists. At a minimum, use 6 mil. polyethylene plastic material. Have a contractor evaluate and add barrier.

Add a complete vapor barrier in the crawlspace.

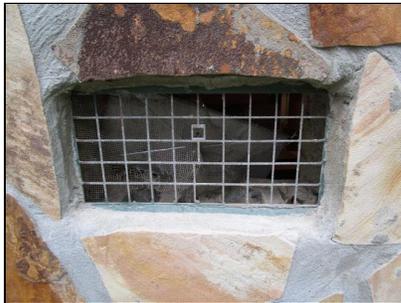
- ✘ 4. **SERVICE / REPAIR:** Damaged and/or missing crawlspace vent screens observed. Repairs or replacement are necessary to prevent further pest entry points.

Replace damaged or missing small screens on the crawlspace vents.

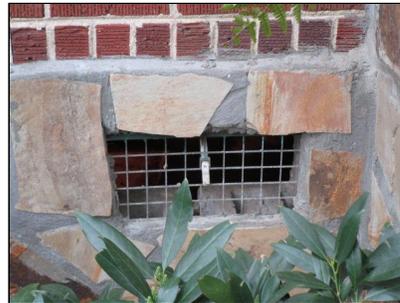
Replace small screens to prevent rodent intrusion.

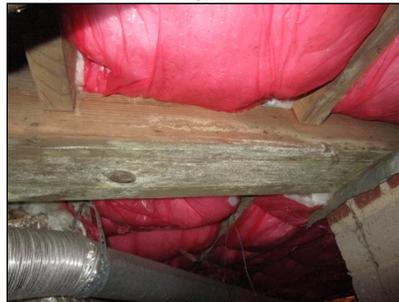
- ✘ 5. **GENERAL NOTE:** Observed an area that may contain mold or fungus (wood destroying organisms) that is common in crawlspaces. Mold does pose a number of health risks. Preventative measures are a home owners best resolve when dealing with mold and its effects. When excessive moisture and humidity accumulates indoors, mold growth will often occur. Water penetration must be addressed and reasonable humidity levels must be maintained. Consider having mold treated professionally to eliminate.

Common fungal growth on the joists in the crawlspace.

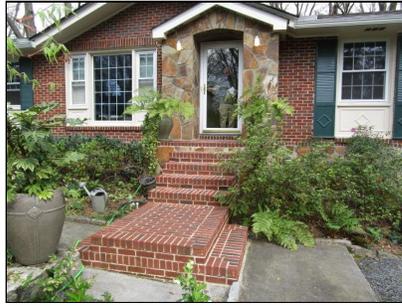
- ✘ 6. **SAFETY / HEALTH:** Missing hand railing on at least one side of stair. Required for any stairway of 30 inches or more in height (more than 4 steps) and a railing around the porch. Recommend install for safety.

Add handrail to the steps and porch

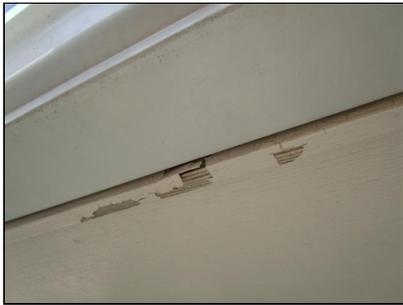
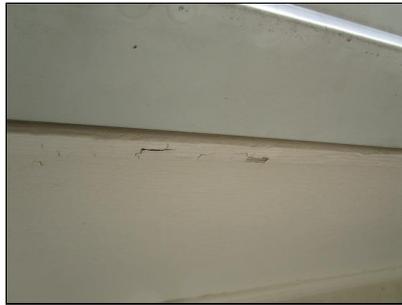
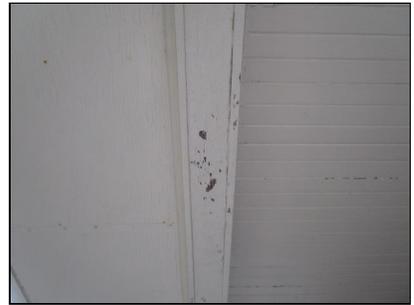
- 7. **MAJOR DEFECT:** Paint on the posts, window and door trim, soffit and fascia found in weathered condition. Sand, prime bare wood, caulk and paint to prevent moisture damage to the affected areas.

Paint weathered and peeling

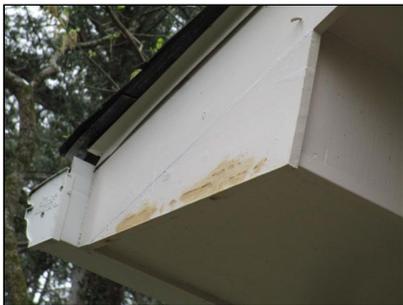
Sand and repaint areas where repaired.

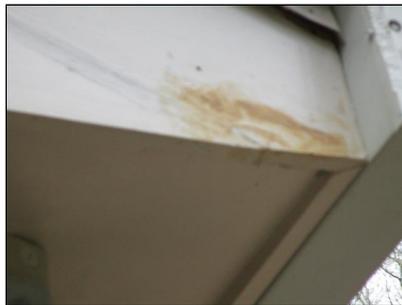
Sand and repaint all trim

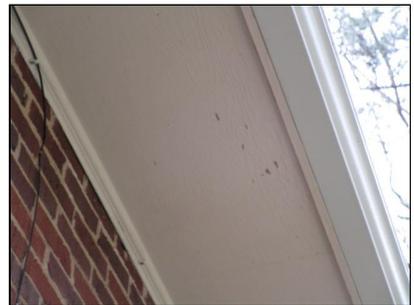
Paint peeling around the entire house

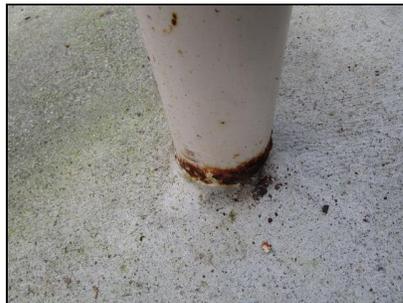
Clean, sand, prime and repaint the metal posts.

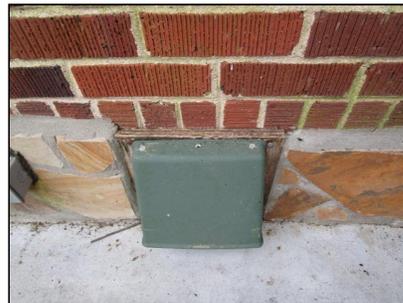
Paint trim around the vent

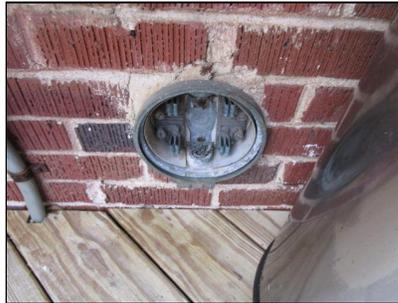
- 8. **SERVICE / REPAIR:** Cap the old meter housing.

Cap the old meter housing at the rear of the house.

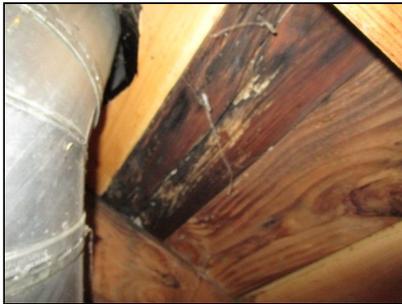
- 9. **MAJOR DEFECT:** Staining noted in attic indicates a roof leak in this area. There are damaged shingles in a couple places. Have the roof evaluated by a professional roofer and repaired as needed.

Stained decking below the flue

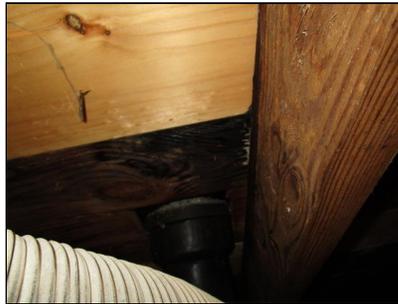
Stained decking below the flue and above the plumbing vent

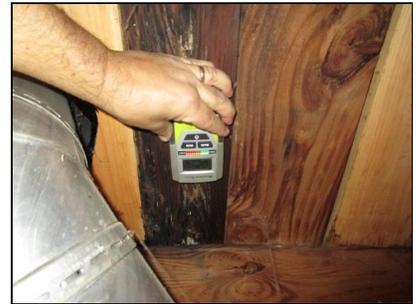
Active leak, moisture meter reads 100%

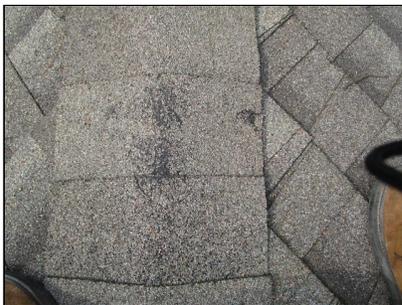
Repair cracked and damaged ridge cap shingles.

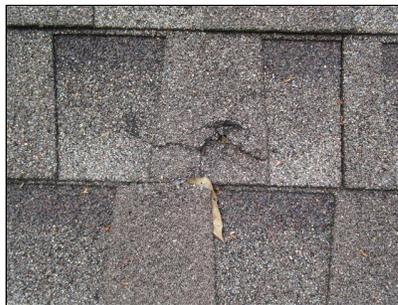
Repair damaged shingles, damaged by tree branches.

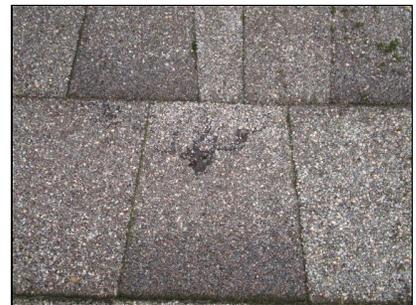
Repair damaged shingles

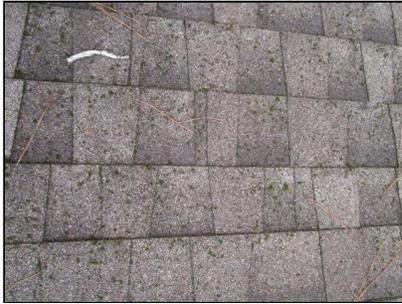
- 10. **SERVICE / REPAIR:** Moss growth on surface of roof. This can adversely affect the condition of roof system and would recommend having professionally treated to kill damaging growth. Zinc or other metals can be used along upper edges to control growth.

Moss growth on the roof.

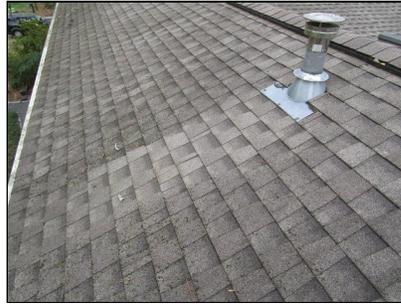
Clean roof of moss and algae.

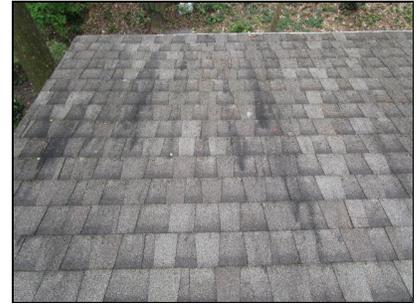
Algae growth on the roof.

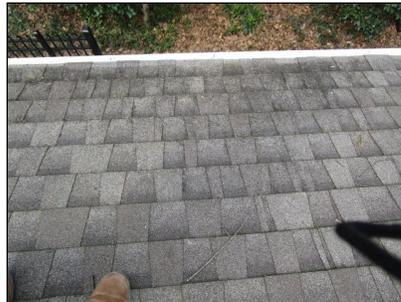
Clean entire roof.

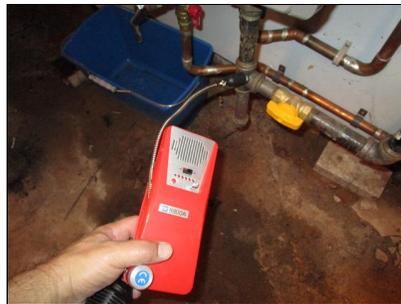
- ❌ 11. **SERVICE / REPAIR:** The house has a tankless water heater system. These water heaters require regular maintenance to maintain proper operation and the warranty. The water heater should be cleaned annually by pumping vinegar through the unit to clean the burner chambers. Recommend cleaning the water heater prior to closing.

Water heater functional, no gas leaks.

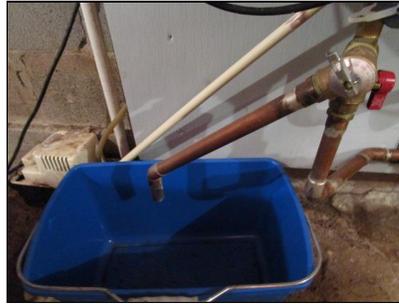
- ❌ 12. **SAFETY / HEALTH:** Temp and pressure valve extension should be extended in heat rated piping in the same diameter pipe as T/P drain line to the exterior of the structure and be turned downward within 6" of the ground. Recommend a licensed plumber inspect further and repair as necessary.

Extend the T/P drain line to the exterior of the house.

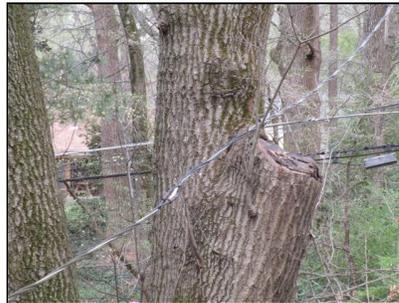
- ❌ 13. **SAFETY / HEALTH:** The overhead electrical wires are being touched by the tree branches. The tree branches need to be trimmed so they do not contact the wires.

Wire cannot be in contact with the tree at the front of the house.

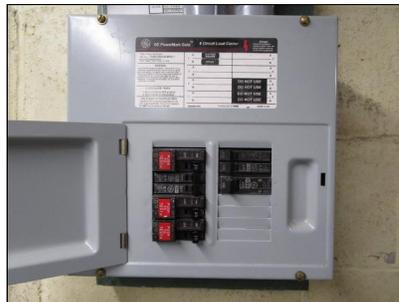
- ❌ 14. **SAFETY / HEALTH:** The panel box is not properly or completely labeled. All electrical disconnects should be clearly labeled so that they can be easily de-energized in case of emergency and for purposes of electrical work. Correct as necessary.

Label the sub-panel.

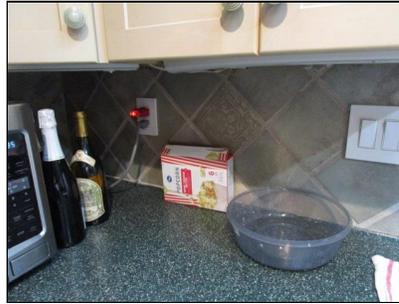
- ❌ 15. **SAFETY / HEALTH:** GFCI protection is missing at required locations. GFCI (ground fault circuit interrupter) protected devices required to be installed at this location when the kitchen was upgraded for protection from electrical shock. Have corrected by qualified electrician.

Add GFCI protection to the receptacle to the left of the sink

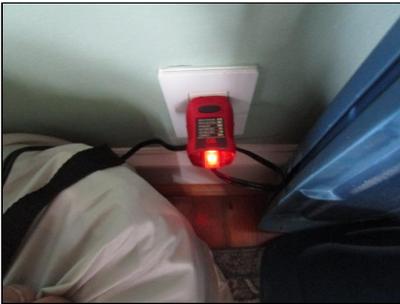
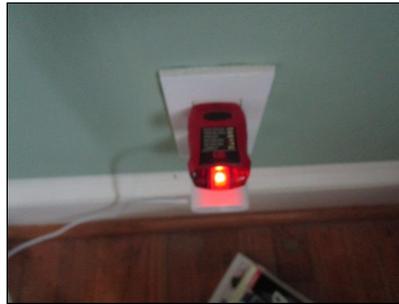
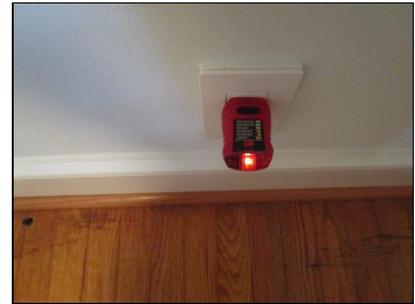
- ❌ 16. **SAFETY / HEALTH:** Open ground reading in receptacles found should be reviewed and corrected by electrician to give proper protection to equipment as code required. **LOCATION: Right front guest bedroom, master bedroom**

Evaluate all receptacles, repair open ground receptacles.

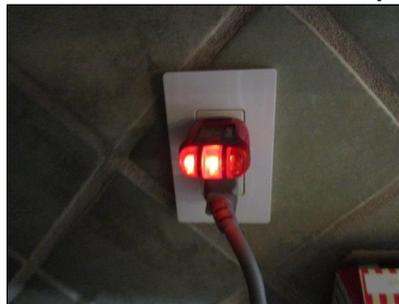
- ❌ 17. **SAFETY / HEALTH:** Reverse polarity at receptacle observed. This is a somewhat common error in wiring where the hot (black wire) and neutral (white wire) are reversed. Recommend a licensed electrician to evaluate the condition and correct for compliance. **LOCATION: Kitchen countertop receptacle to the left of the sink**

One kitchen countertop receptacle is open ground

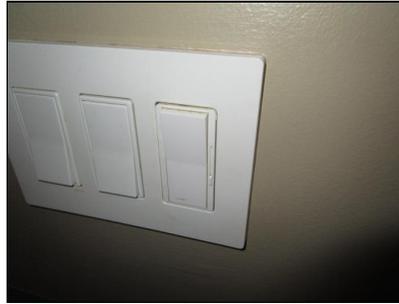
- ❌ 18. **SERVICE / REPAIR:** Dimmer device does not dim lights. Device should be repaired / replaced to operate as intended.

Kitchen dimmer not functional.

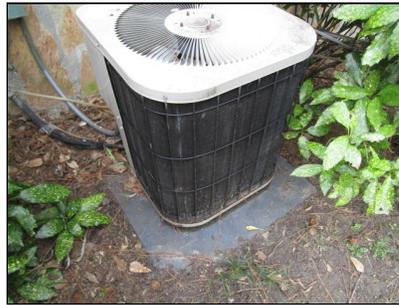
- ❌ 19. **SERVICE / REPAIR:** The AC system is at the end of its expected life span. (20+ years old). Replacement may be necessary in the near future and can be expected to be a significant expense. Recommend a licensed HVAC service technician evaluate unit, repair, clean and return unit to a safe and warrantable condition.

Have the HVAC system serviced and cleaned.

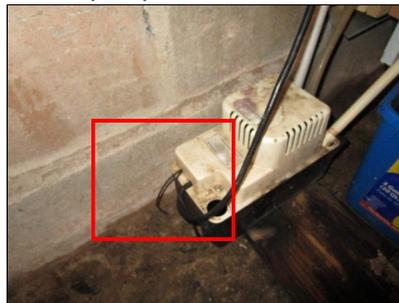
- ❌ 20. **SERVICE / REPAIR:** Condensate pump cut for HVAC system not connected to thermostat wire of unit so that A/C stops working in the event of failure of the condensate pump. Recommend connect pump to unit to prevent flooding of adjacent areas in event of failure of pump.

Connect wires to the thermostat wires.

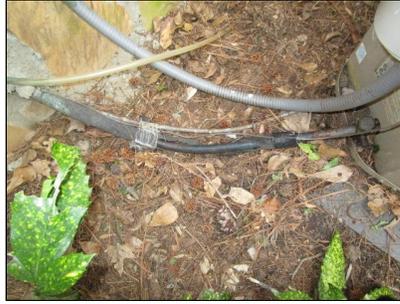
- ❌ 21. **SERVICE / REPAIR:** Freon refrigerant line insulation is damaged / missing. Replace and repair to prevent condensation and energy loss during operation.

Replace the damaged insulation on the condensing unit.

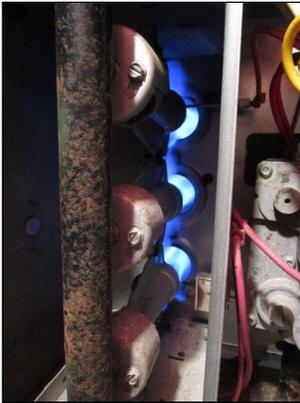
- ❌ 22. **SERVICE / REPAIR:** The furnace is more than 20 years old where the average life expectancy is 17 to 22 years. A visual inspection of the unit and the flame pattern was made with gas and carbon monoxide tests performed - [CO reading within exhaust port of 0 ppm]. Because of the age of the equipment and rust within the unit, a HVAC service technician should evaluate (by partial disassembly) the unit and advise condition (which may include replacing.) If system is determined to still be safe, have full service performed to leave in a warrantable condition. Consider budgeting for replacement or have warranty program established. Also have CO detector installed in sleeping areas where older system serves for added safety.

Good flame pattern at the furnace.

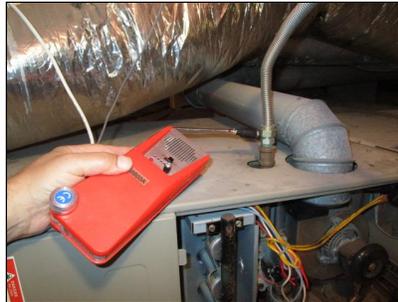
No gas leaks at the furnace.

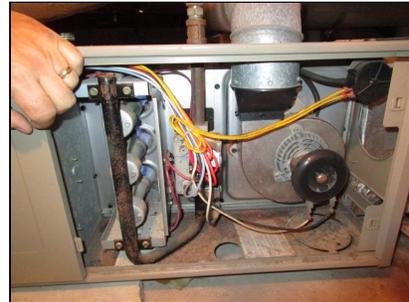
Furnace manufactured in 1999, have unit cleaned and serviced.

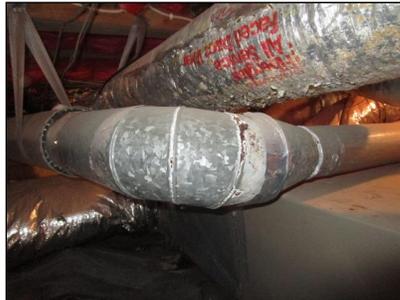
- ❌ 23. **SAFETY / HEALTH:** Rust present on the vent. Have the vent evaluated and repaired or replaced by a licensed HVAC professional.

Rust on the flue in the crawlspace, replace damaged flue.

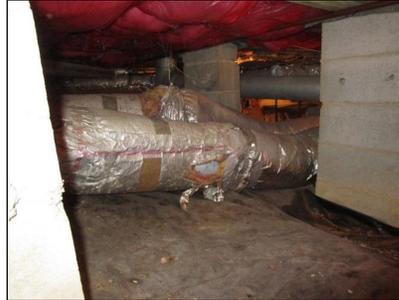
- ❌ 24. **SERVICE / REPAIR:** The duct work is in direct contact with the earth. Over time this will accelerate the deterioration of the insulation covering, encourage pest infiltration, and possibly result in mold growth. Ducts should be supported at manufacturer's recommended intervals, but at no greater distance than five feet. Maximum permissible sag is one-half inch per foot of spacing between supports. Correct as necessary.

Ducts are on the ground

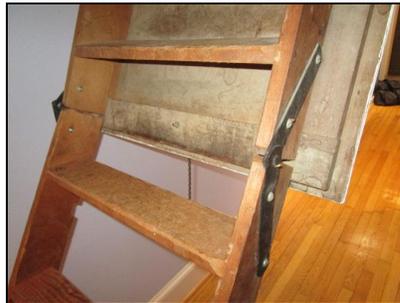
- ❌ 25. **SERVICE / REPAIR:** The pull down ladder leading to the attic area is not cut to the appropriate length. The base of the ladder needs to be cut so that it sits flatly on the ground. One step is damaged. Repair or replace the stairs.

Cut back the attic stairs slightly.

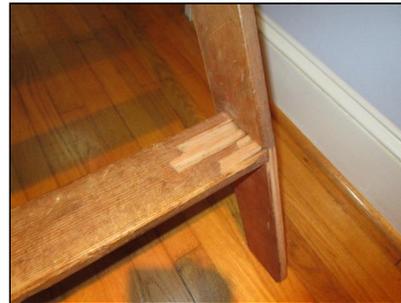
One step is damaged.

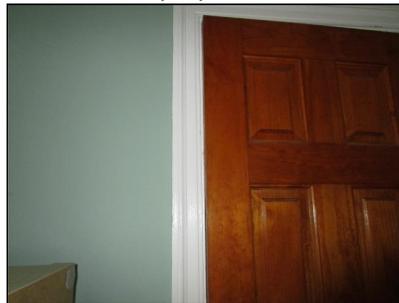
- ❌ 26. **SERVICE / REPAIR:** The door sticks when tested. Evaluate and correct all doors for proper operation. Verify latching when after corrected. Possibly a result in improper installation, settling or misaligned hardware.

Door sticking in the frame.

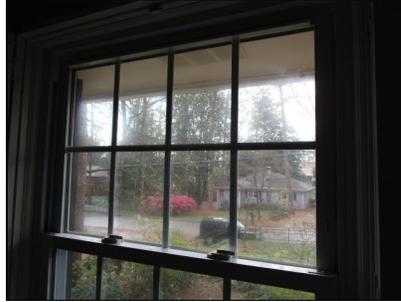
- ❌ 27. **MAJOR DEFECT:** Condensation and / or hazing was noted between insulated window panes. - Location: right front guest bedroom window and the rear entry door - The thermopane insulated glass has lost its vacuum seal and may eventually completely cloud over. Broken seals also reduce the original insulation value of the window. (Dirty windows should be cleaned to assure that conditions do not exist in other units and were not obvious at time of inspection.) Recommend replacement of all damaged windows listed plus any others throughout house that may be identified by glass service.

Failed window in the guest bedroom

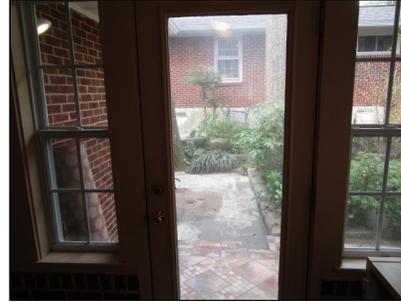
Failed window in the rear of the house

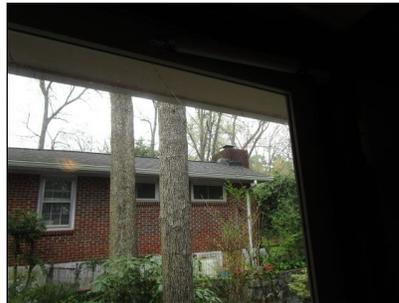
- ❌ 28. **SERVICE / REPAIR:** Cracked window observed. Inspect all windows and replace the affected glass as needed.
LOCATION: Rear storm door window

Rear storm door window is cracked.

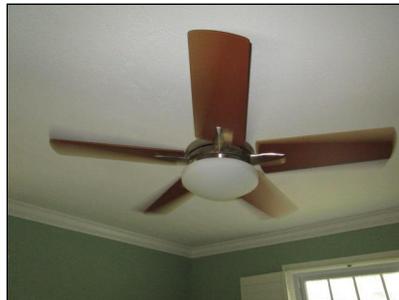
- ❌ 29. **SERVICE / REPAIR:** Ceiling fan found to be noisy when operated. Recommend fan be repaired / replaced to allow normal use.

Guest bedroom ceiling fan is noisy, repair or replace.

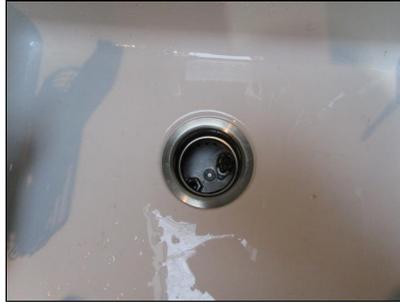
- ❌ 30. **SERVICE / REPAIR:** Splash guard in opening to disposal damaged at kitchen sink and should be replaced.

Replace the missing splash guard at the kitchen sink

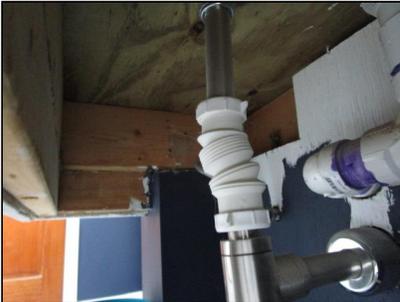
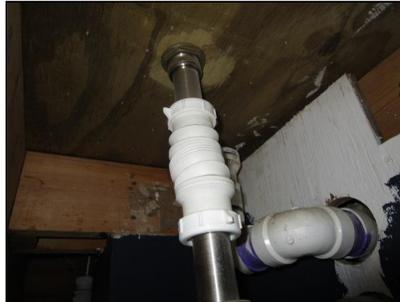
- ❌ 31. **SERVICE / REPAIR:** Trap material used on the master bathroom sinks is designed for temporary repair and uneven interior surfaces may lead to clogging. Plumbing drains are required to have smooth interior surfaces. Have the P-traps checked to ensure they are adequate. Recommend a licensed plumber inspect further and repair as necessary.

Replace temporary trap material

Replace temporary trap material.

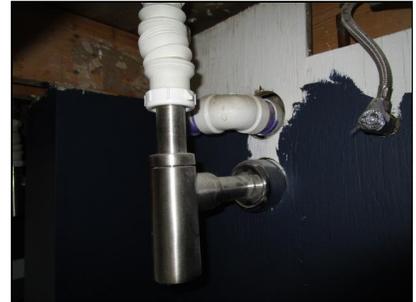
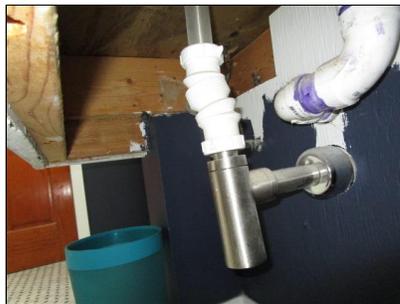
Ensure adequacy of p-traps

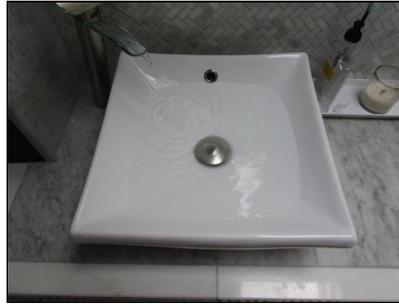
- ❌ 32. **SERVICE / REPAIR:** Slow drain observed at the master bathroom sink and should be cleaned and/or cleared to function normally. May require disassembly of drain line to clear properly.

Slow drains in the master bathroom

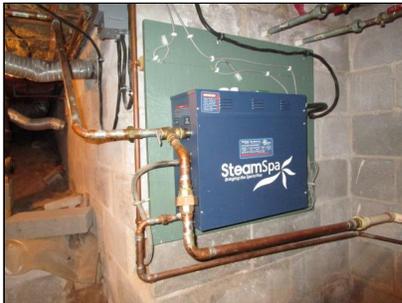
- ❌ 33. **SERVICE / REPAIR:** The steam shower was tested and came on but shut down after several minutes with an EO error code. Have the shower evaluated and repaired as needed by a licensed plumber.

Steam shower in the crawlspace area.

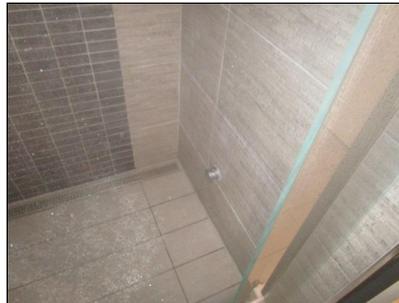
Shower started to operate

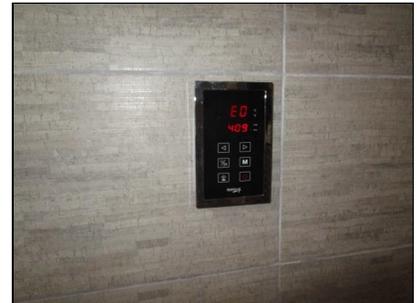
Display indicated an EO error and the unit shut down

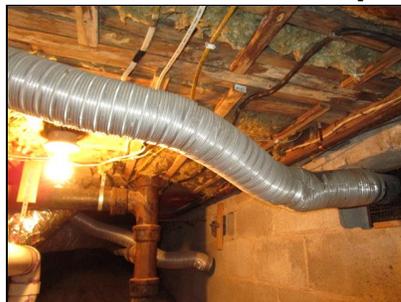
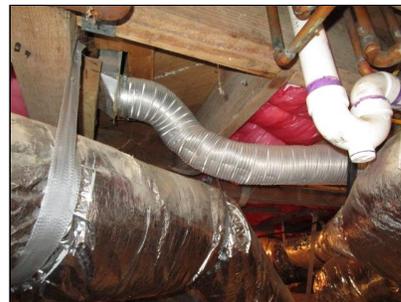
- ❌ 34. **SAFETY / HEALTH:** The dryer exhaust vent uses flexible metal piping running through the crawlspace. This is only to be used as a connector from the dryer to the wall. Large numbers of house fires have been attributed each year to improper dryer exhaust installations. The system should be run through 4 inch metal piping to exterior for safety and manufacturers specifications on dryer units. The line should be a 25 foot maximum run with mechanical tape attachments [NO screw attachment of sections].

Replace flex dryer vents

Replace flex dryer vent with solid pipe.
