# Inspection Report

**Property Address:**  
530 Silver Pine Trail  
Roswell GA 30076

**Residential Inspector of America**  
**Inspector: Todd Rymer**  
**3276 Buford Dr., Ste. 104-306**  
**Buford, GA 30519**  
**770.476.4963**

<b>Date:</b> 3/16/2020	<b>Time:</b> 09:00:00 AM	<b>Report ID:</b> 031620KP567
<b>Property:</b> 530 Silver Pine Trail Roswell GA 30076	<b>Customer:</b> Michael Herzog	<b>Real Estate Professional:</b> Vanessa Westfall Keller Williams

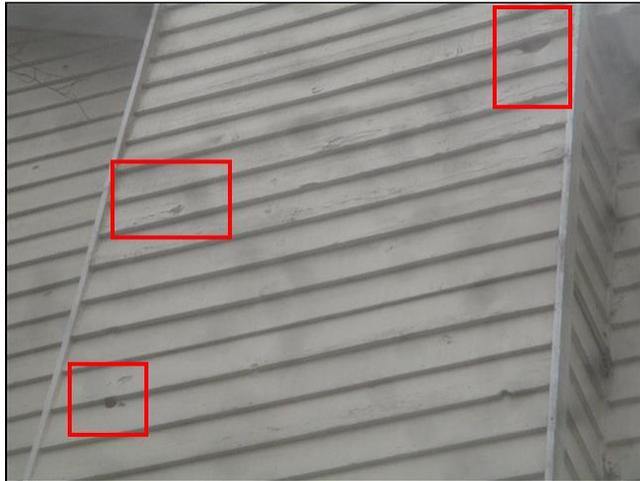
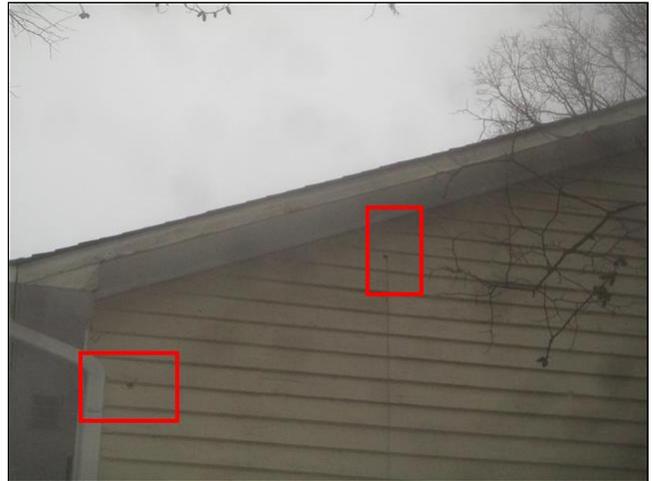
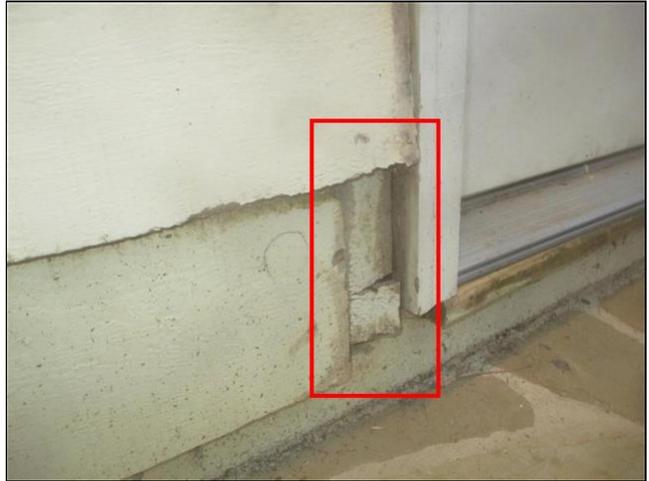
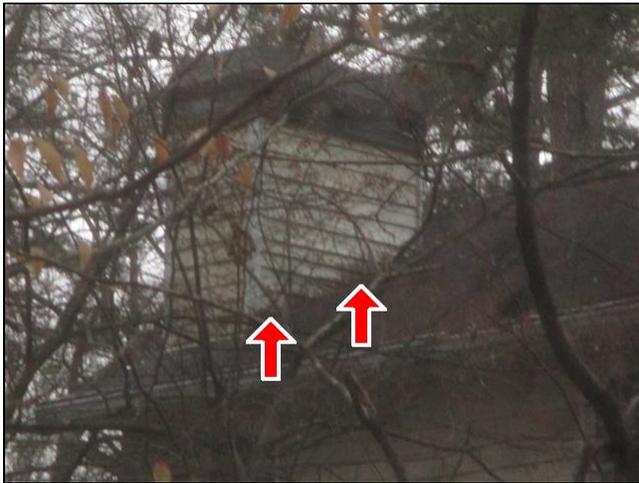
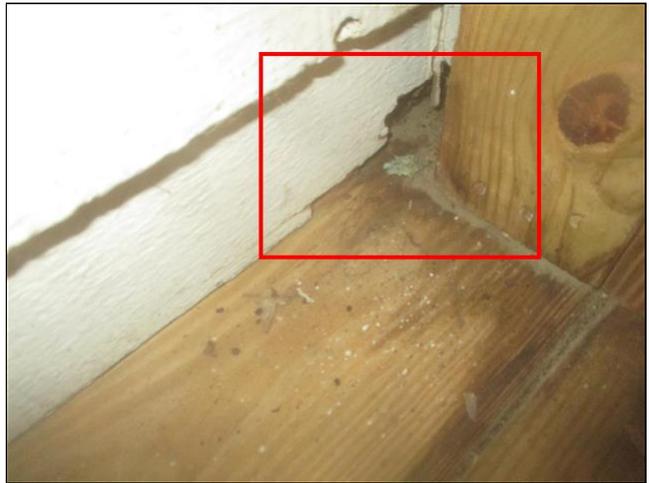
Damaged siding observed at several locations observed around the home. See example photos. Condition of the framing behind the home is unknown. Recommend having the siding of the home further evaluated by a professional siding contractor and all repairs made as required to ensure the siding for the home is completely water tight.

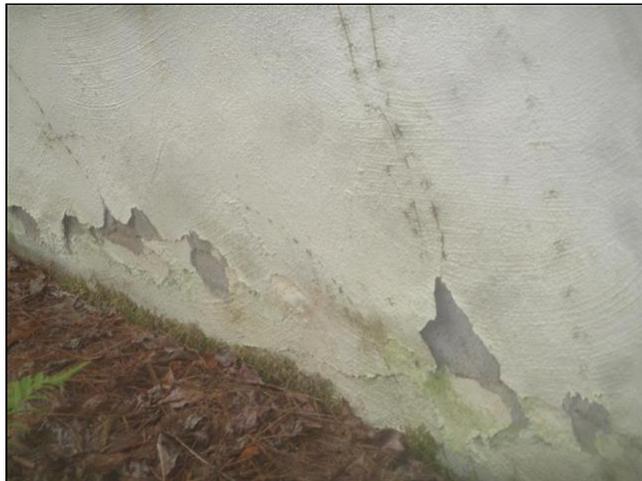
1.0 Item 7(Picture)

🔨 (2) Damage to textured coating on the exterior wall around the home. See example photo. Have repaired/ resurfaced as required.

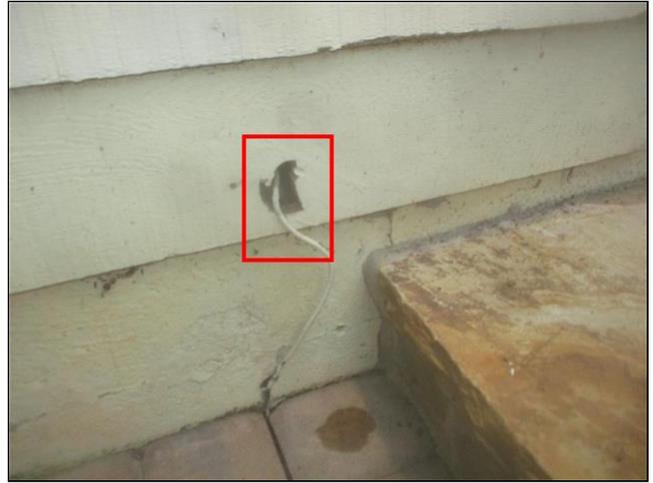
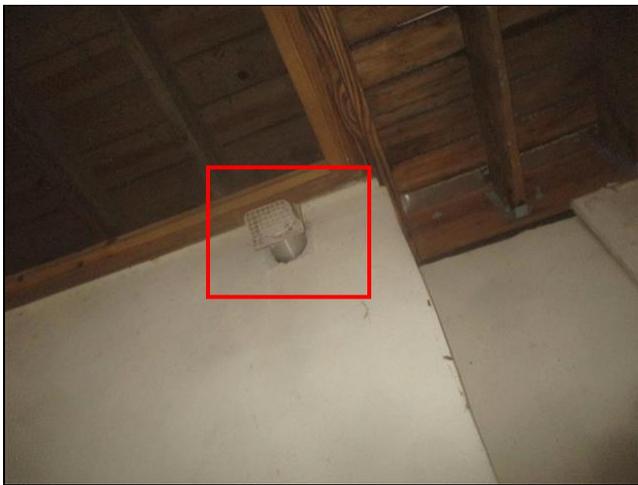
(3) Seal gaps in siding at penetration locations shown in the photos.

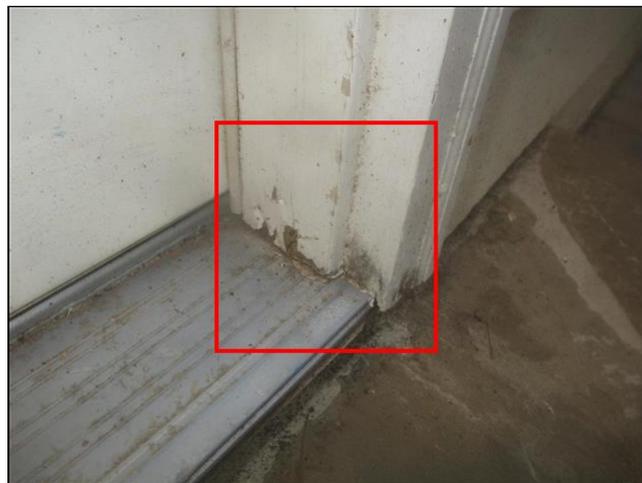
1.1 Item 1(Picture) Rear basement egress door

Minor water damage to door frame at ground level at locations shown in the photo. Have damaged wood repaired/replaced.

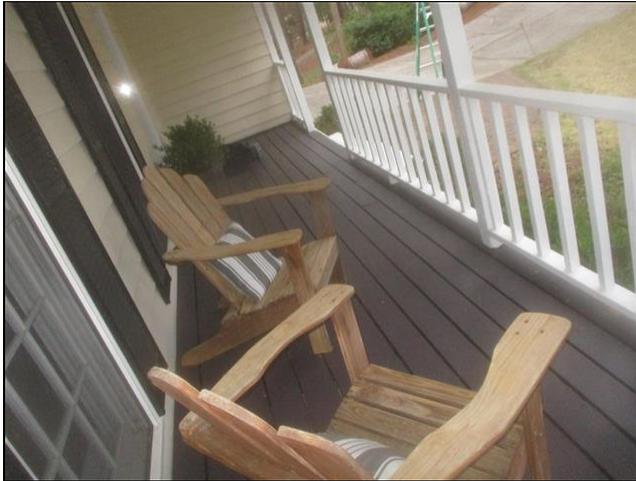
🔧 Decks usually last about 20-25 years (depending on weather conditions) before needing replacement. Older decks were not built to code standards that exist for modern decks. Multiple observed concerns noted with the front porch of the home. See photos. Due to the age and observed concerns associated with the front porch, it is recommended that the front porch be further evaluated by a professional deck contractor and all repairs/corrections made as required to ensure that the front porch is structurally sound and safe to use.

1.3 Item 1(Picture) Front porch has settled and leans downward

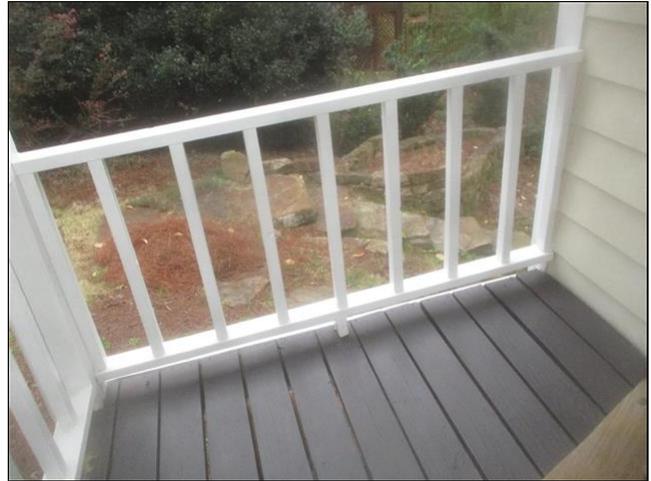
1.3 Item 2(Picture) Spindles for front porch are greater than 4 inches apart (safety concern for small children)

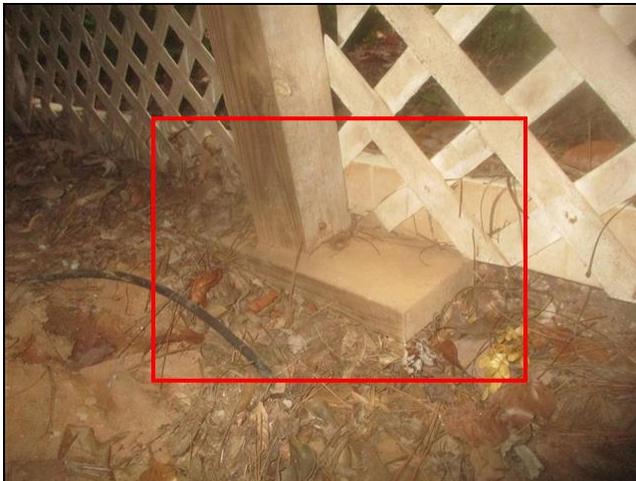
1.3 Item 3(Picture) Most front columns are on loose/above ground wood footings (modern deck columns would have buried concrete footings)

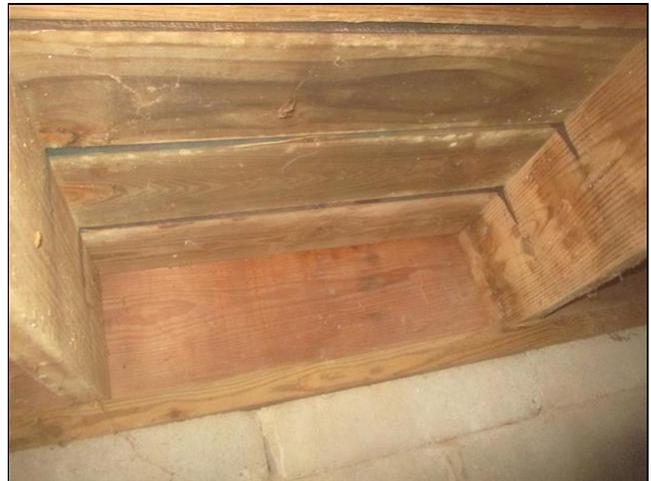
1.3 Item 4(Picture) Front porch is nailed to home, modern deck type installations would be bolted to home

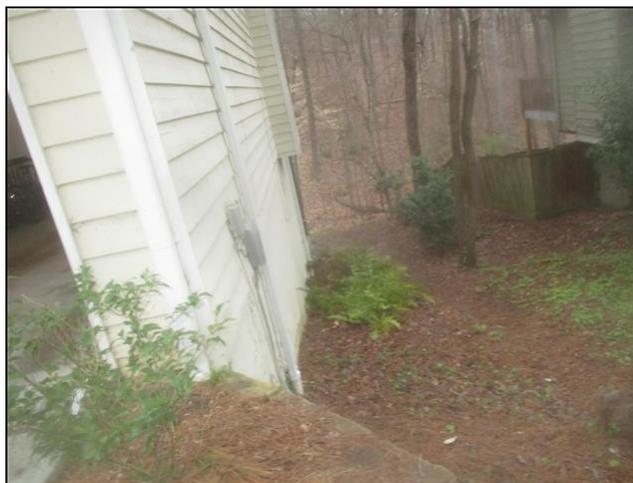
1.4 Item 1(Picture)

👉 (1) House is built on a very steep lot and it will be critical that roof run off always be diverted through gutters and away from the foundation wall to prevent water damage to siding/trim, prevent erosion and settlement, and prevent water entry into the basement. Homes on steep lots tend to settle downhill.

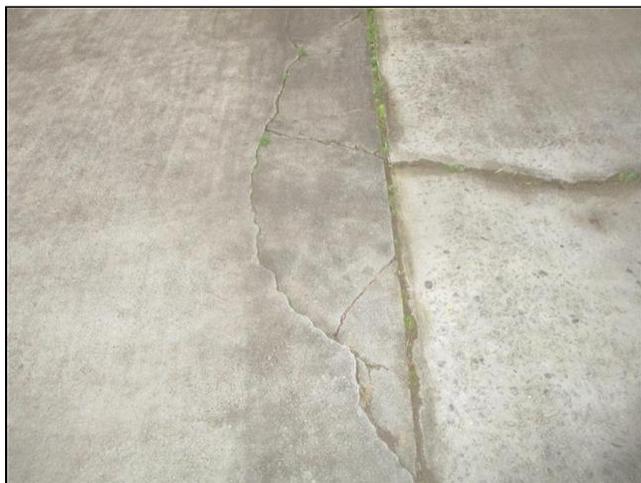
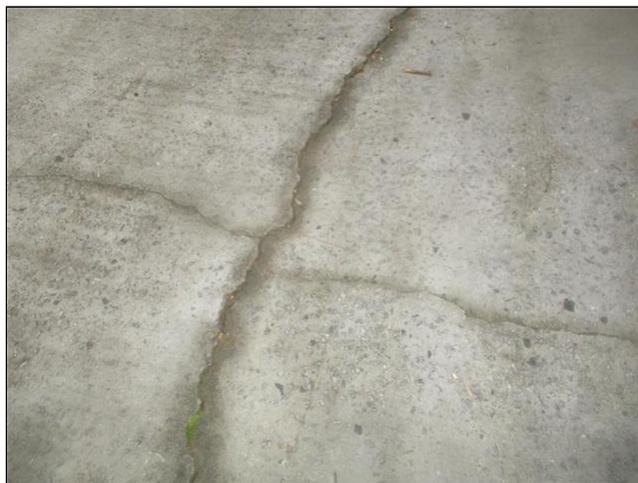
(2) Minor cracking in driveway. Patch as needed. Several areas of larger cracking/damage to the concrete, at these locations repairs would be required in order to achieve a smooth concrete surface. See example photos.

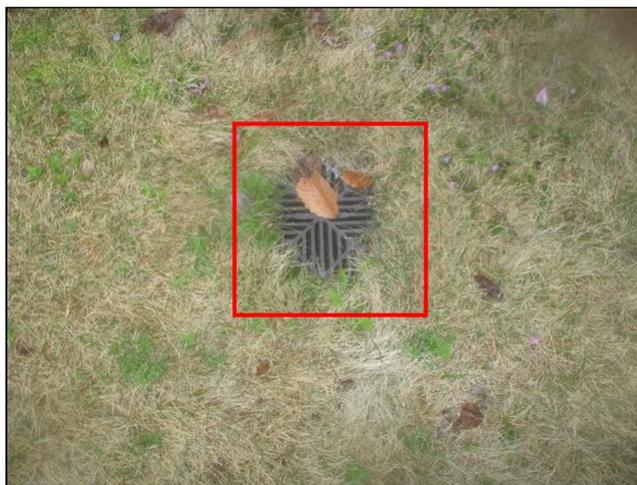
1.4 Item 4(Picture)

(3) Several exterior drains observed around the home. functionality of the drains is unknown.

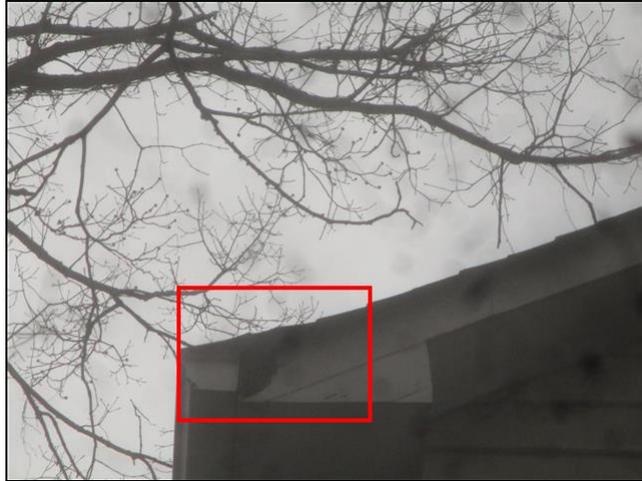
1.5 Item 1(Picture) Rear left corner

🔧 Damage to eave locations as shown in the photo. Determine and resolve cause of water damage (poorly functioning gutters, animal damage, etc.) and repair/replace water damaged wood.

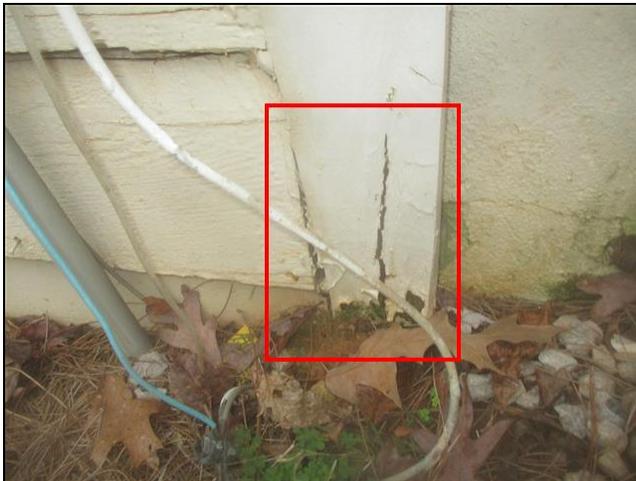
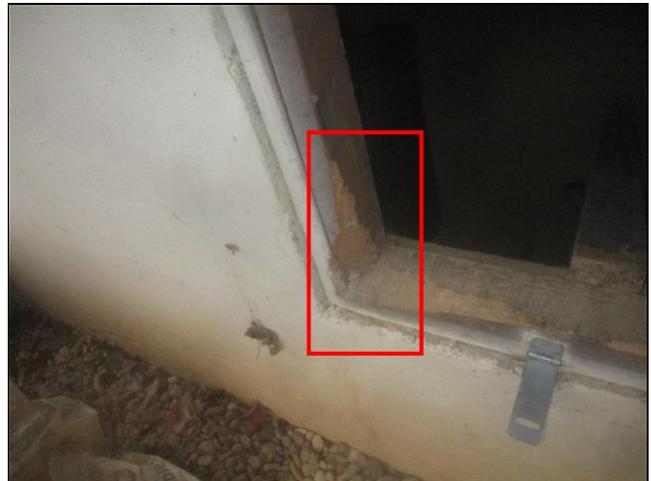
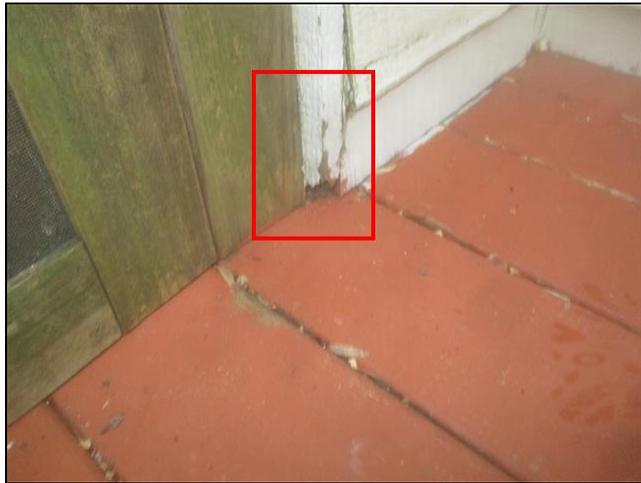
🔧 Rot damage found on the exterior wood exterior components at multiple locations. See photos for examples of these locations. Have all water damaged trim repaired or replaced. It should be understood that more minor water damage may be present on other trim around the house. This type of damage is common and should be expected to occur in the future - if water damaged has occurred in the past it will occur in the future.

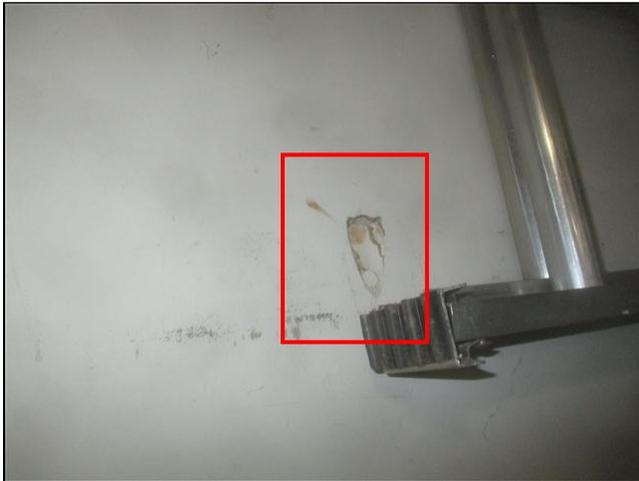
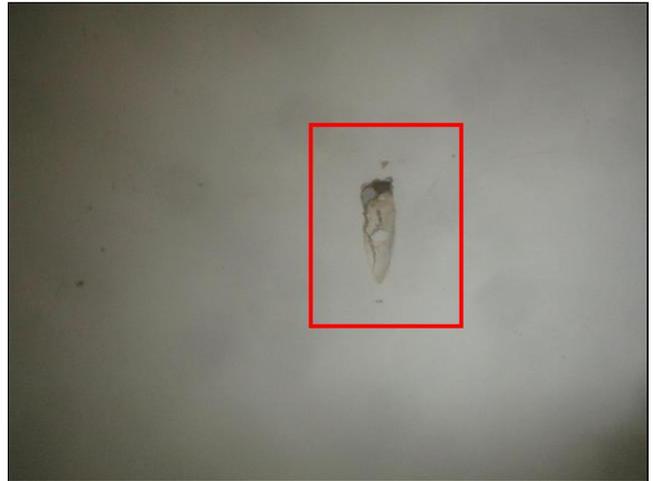
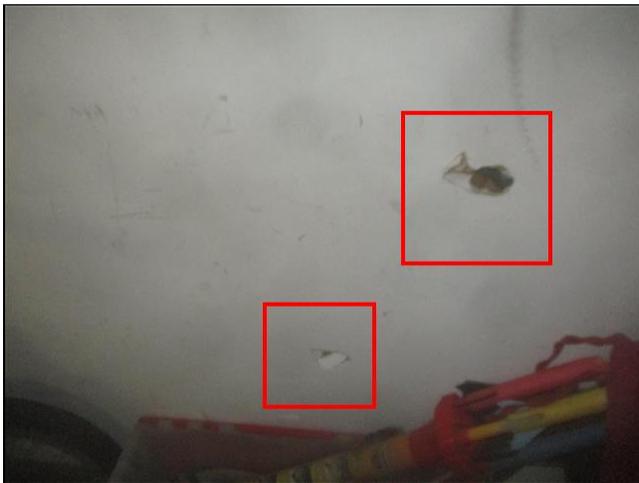
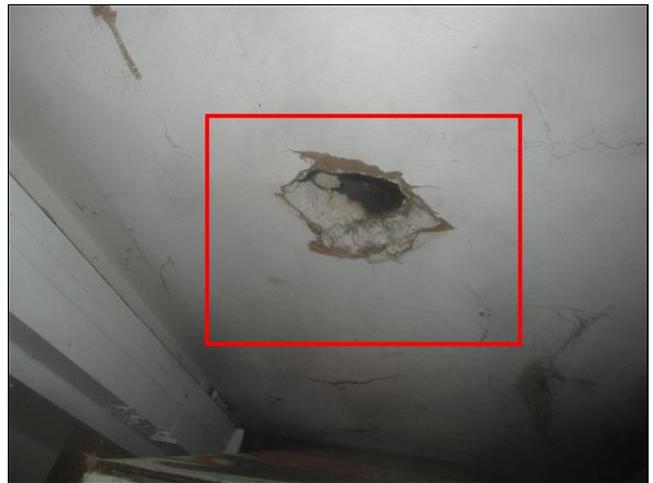
🔧 (1) Repair minor damage to the garage walls. See photos.

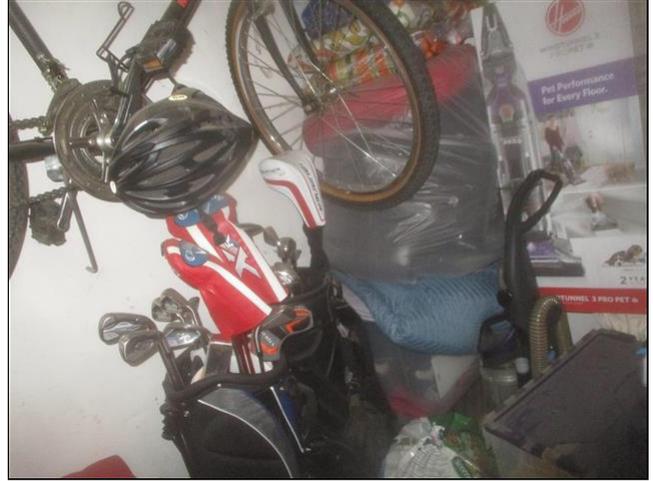
2.1 Item 6(Picture)

(2) The garage inspection was limited due to stored items being in the garage at the time of the inspection.

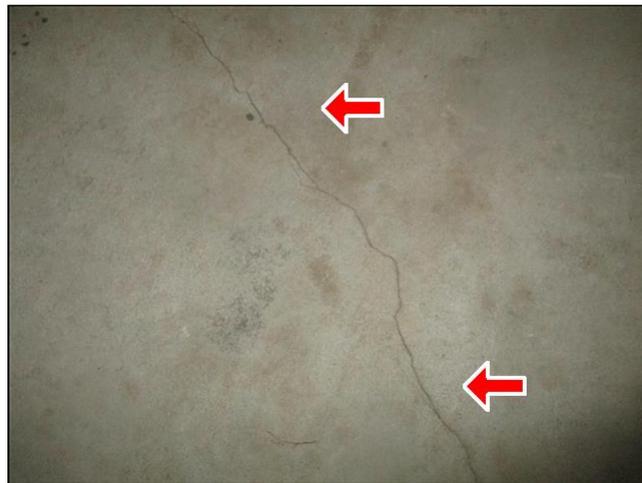
2.2 Item 1(Picture)

Cracks in garage floor are not wide enough to be considered a structural concern and are due to normal settlement and shrinkage of the concrete. Extent of soil compaction under concrete floor is not visible and is not known. Have patched as needed and resolve all concerns.

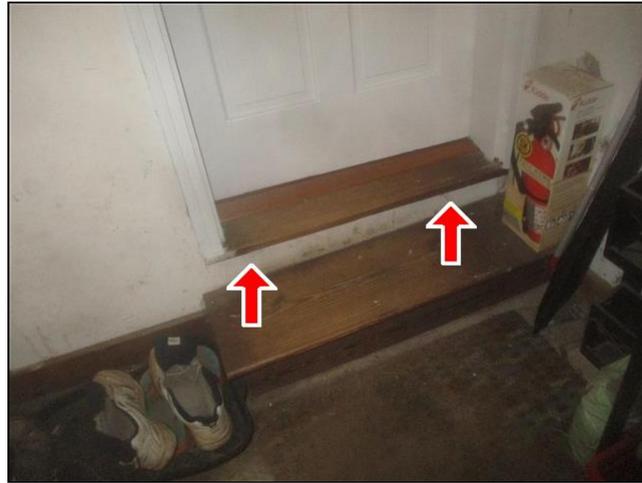
2.5 Item 1(Picture)

🔧 Install a support under the occupant door threshold in the garage. Threshold plate may bend when stepped upon. Support should be pressure treated wood or the equivalent.

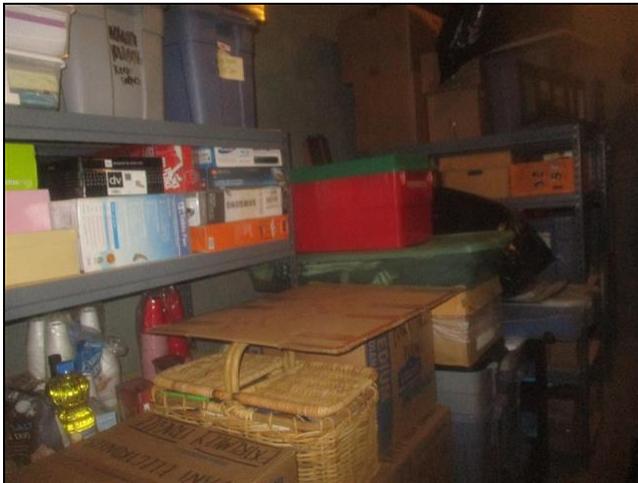
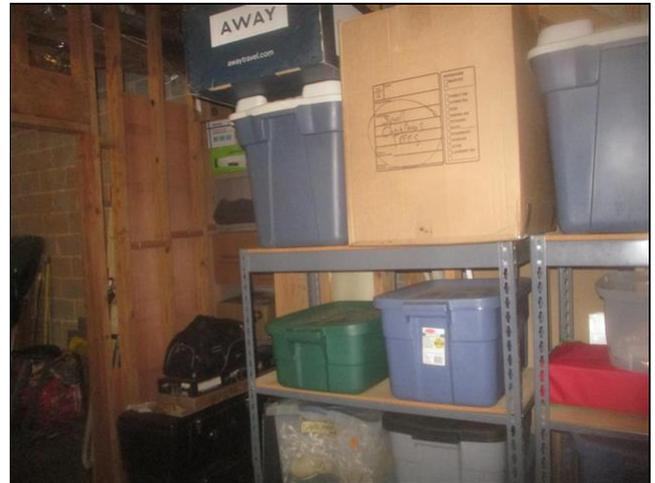
(2) Many stored items in the basement limiting visual inspection of the floor and walls. Insulation was not removed from between all floor and rim joists the crawlspace.

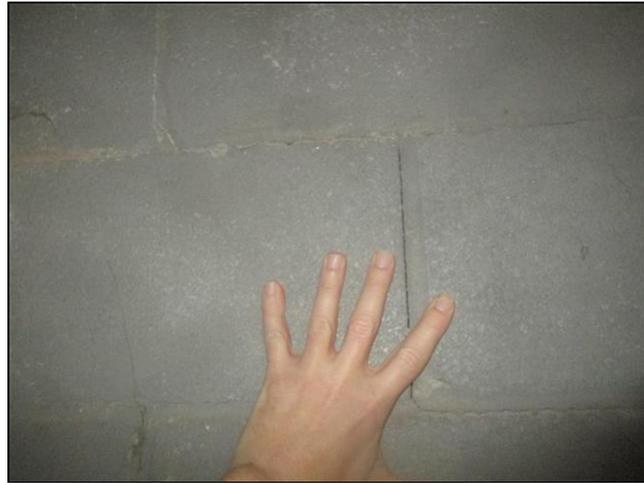
3.1 Item 1(Picture)

The small, hairline cracks in the foundation walls are not a structural concern, but should be patched to prevent any possible future leak. See example photo.

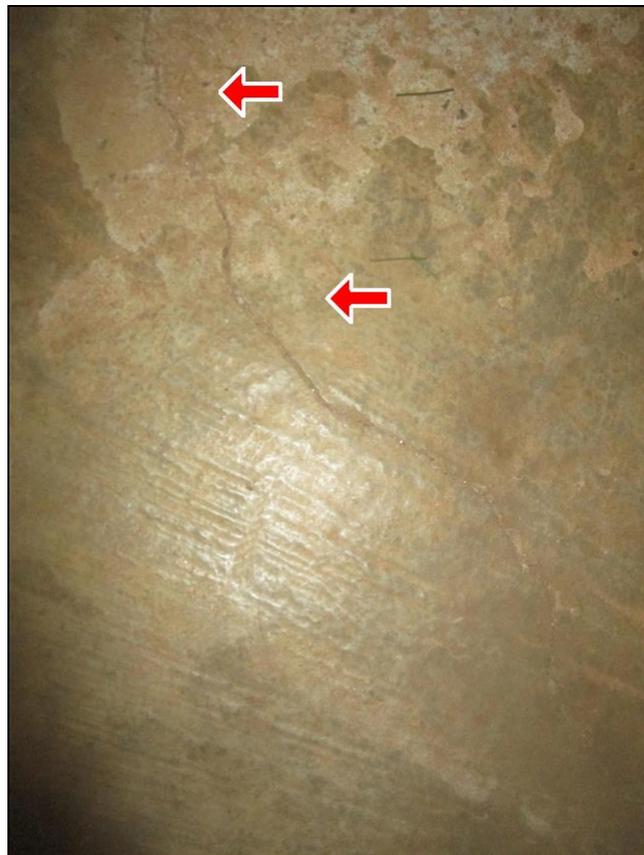
3.3 Item 1(Picture)

Cracks in concrete basement floor are not wide enough to be a structural concern and are likely due to settlement. See example photo. Have patched as needed.

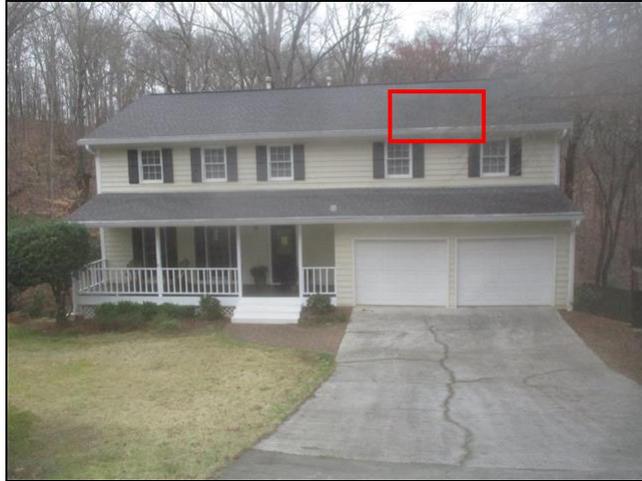
3.5 Item 1(Picture)

🔧 Slight deflection of the roof sheathing/attic framing observed at location shown in the photo. This may be partly due to the 2x4 framing in the attic which would not meet modern standards. No associated concerns noted due to the deflection at the time of the inspection but additional bracing and adjustments should be made as required to correct deflection at this location.

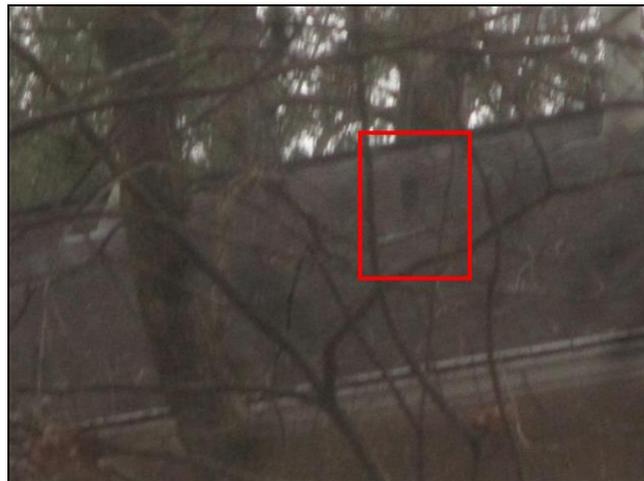
4.2 Item 1(Picture)

Boot flashing around plumbing vents on the roof are ok now, but these last about 5-7 years before needing replacement. They crack and split and allow rain water to leak into attic.

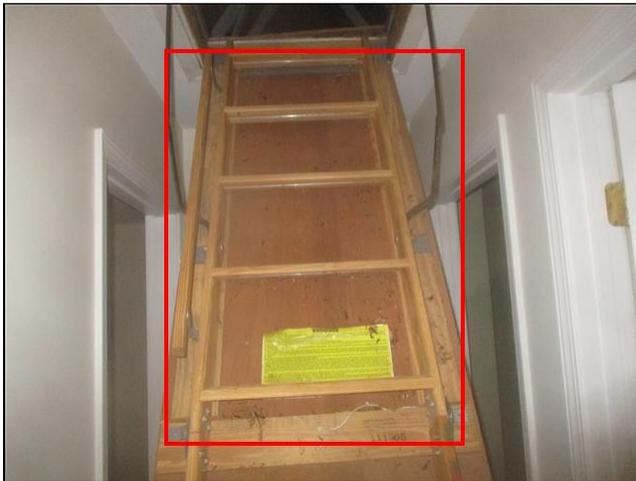
Insulation in the attic is missing or is less than normal in several areas. Have more added to bring levels equal to R-30

5.0 Item 1(Picture) Insulate attic pull down stairs

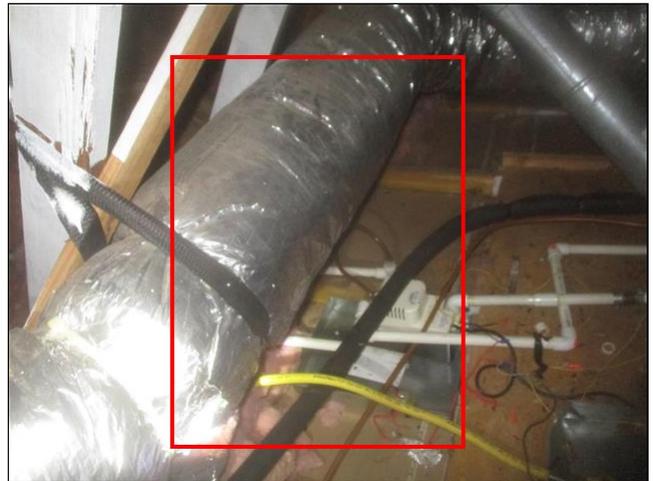
5.0 Item 2(Picture) Missing insulation, central attic location

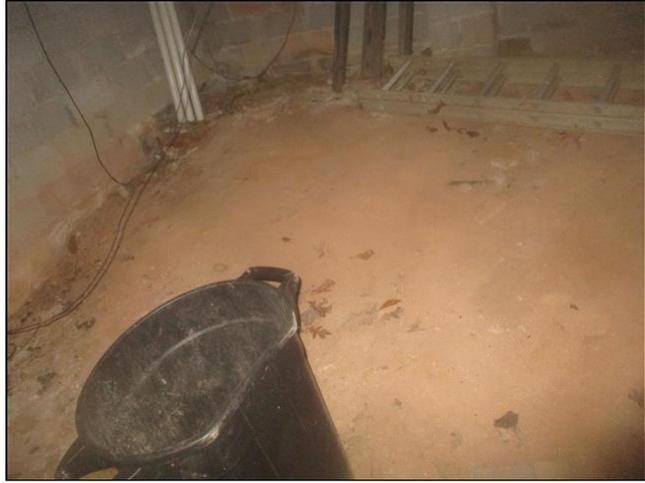
5.2 Item 1(Picture)

🔧 Vapor barrier missing in the crawlspace over the dirt floor. Have a plastic vapor barrier of at least 6 mil thick laid out over the dirt floor.

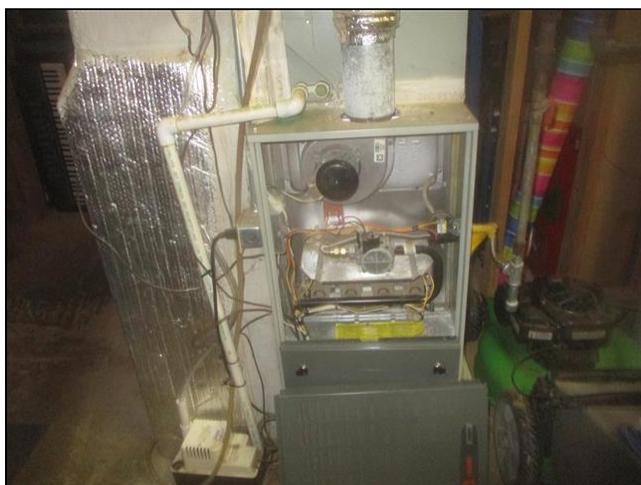
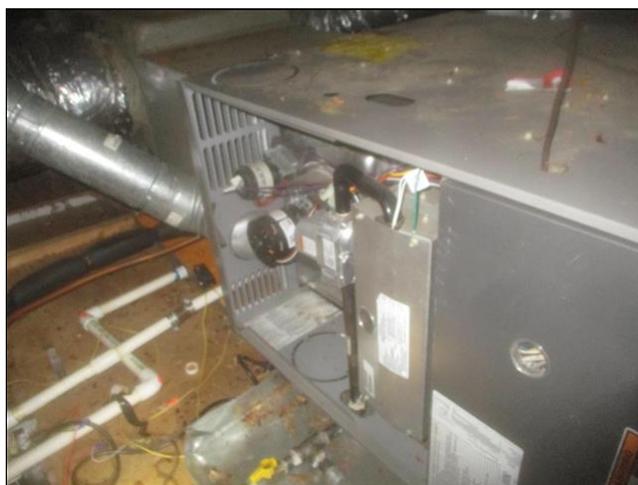
Gas furnaces generally last around 20 years before needing replacement. Furnaces for the home include a 2004 model (services the main floor) and a 2007 model (services the upstairs).

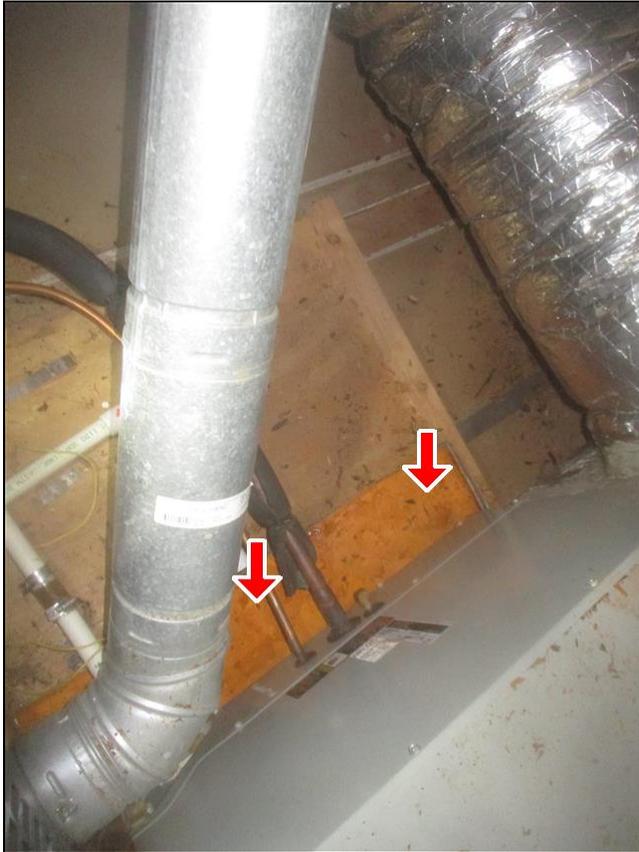
Corrosion observed in the attic furnace drain pan. This is indicative of past/possible ongoing functional concerns with the furnace. Have further evaluated by a hvac service.

6.0 Item 3(Picture) Corrosion in drain pan

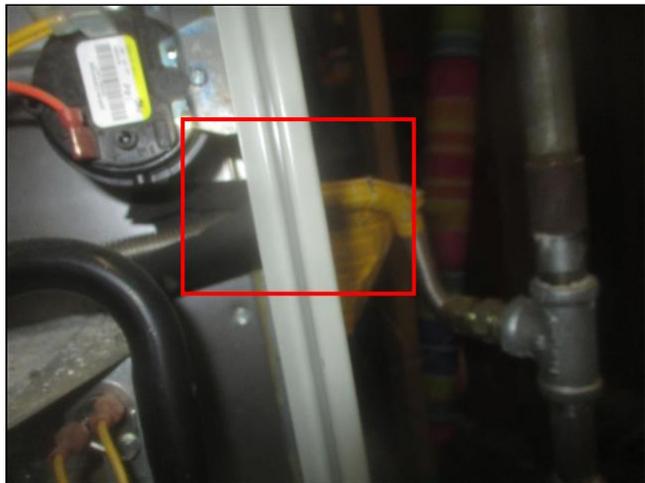
6.0 Item 4(Picture)

🔧 (2) The flex gas connector should not enter the metal side of the basement furnace cabinet. It should be a black steel gas piping where it enters. Have an hvac contractor correct. See photo.

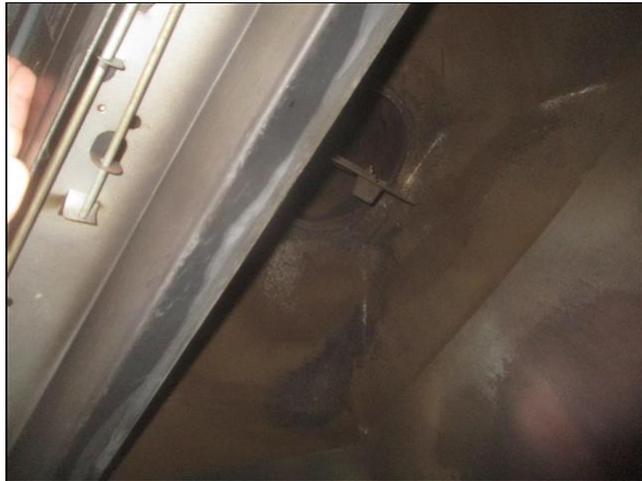
6.5 Item 1(Picture) Damper

🔧 (1) Damper for the fireplace was not fully functional (would not stay shut). Have repaired as required.

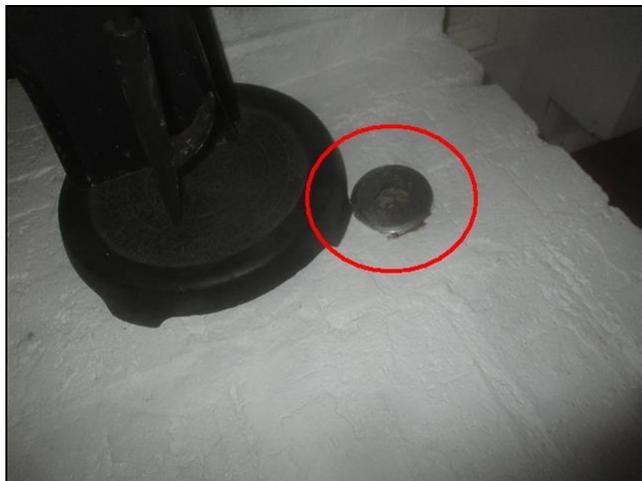
6.5 Item 2(Picture)

🔧 (2) Debris in log lighter valve. Gas could not be turned on to the fire place. Clean debris from opening and ensure gas starter is fully functional prior to closing.

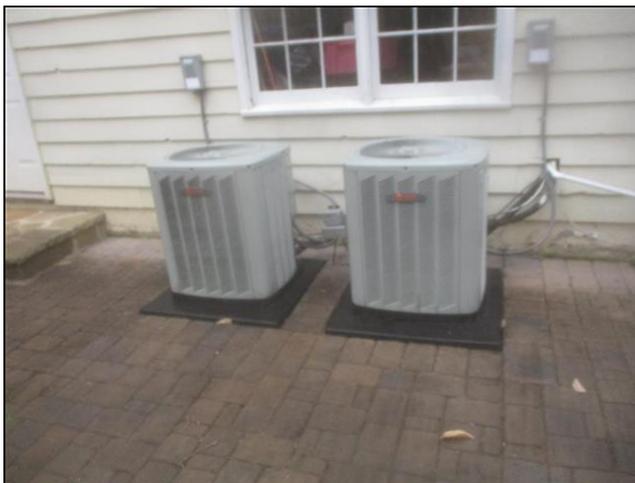
6.6 Item 1(Picture)

A/c units for the home may need replacing in the near future due to its age. A/c units for the home are both 2005 models.

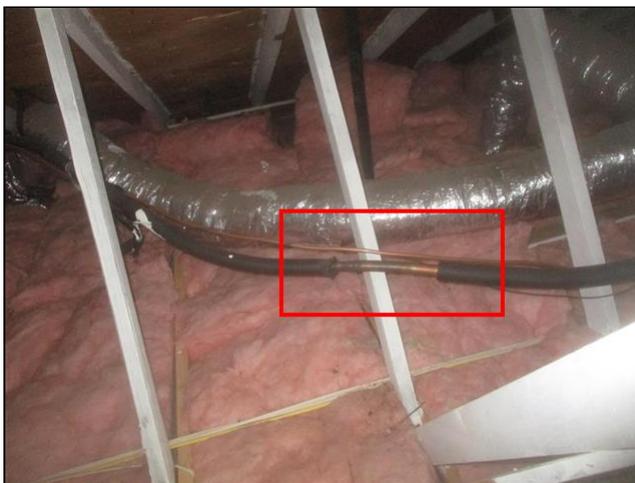
6.6 Item 2(Picture)

🔧 (2) Gaps found in the insulation wrapping around the refrigerant pipes from the a/c units, where these pipes pass through the attic. Have re-wrapped with more insulation to prevent condensate from dripping on the ceiling.

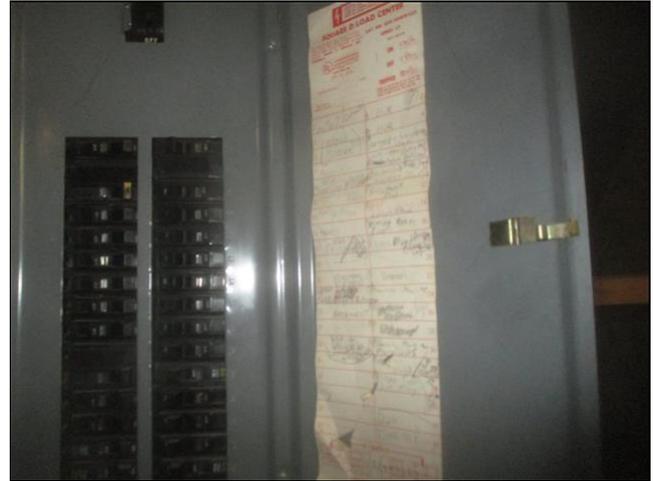
7.2 Item 2(Picture) Not completely/clearly labeled

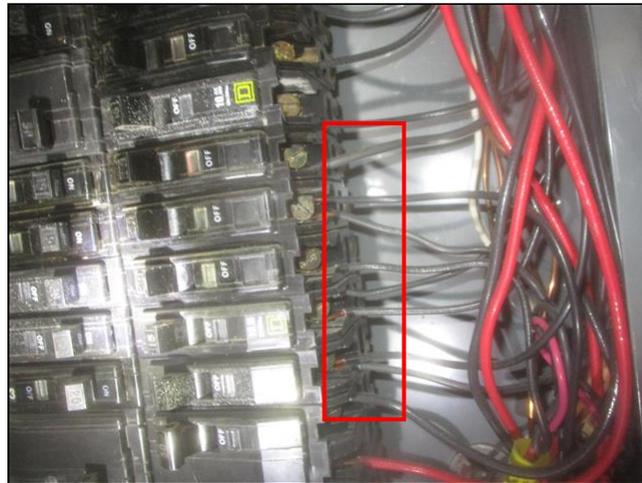
7.2 Item 3(Picture)

(2) Double wired breaker found in the main panel. See photo (~ 3 double tapped breakers). Usual wiring method is to have one wire for one breaker. Have electrician correct.

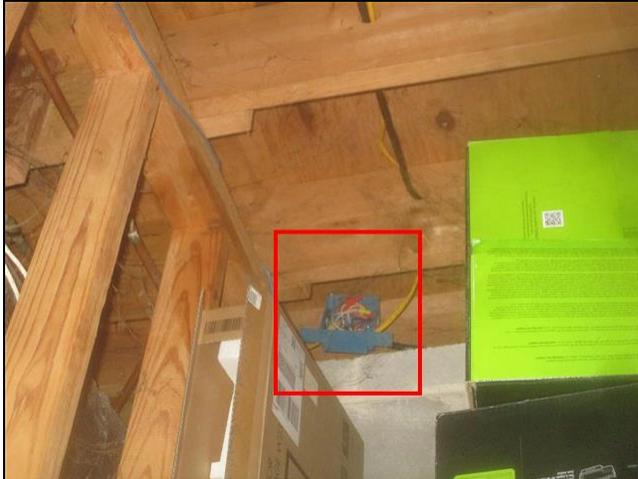
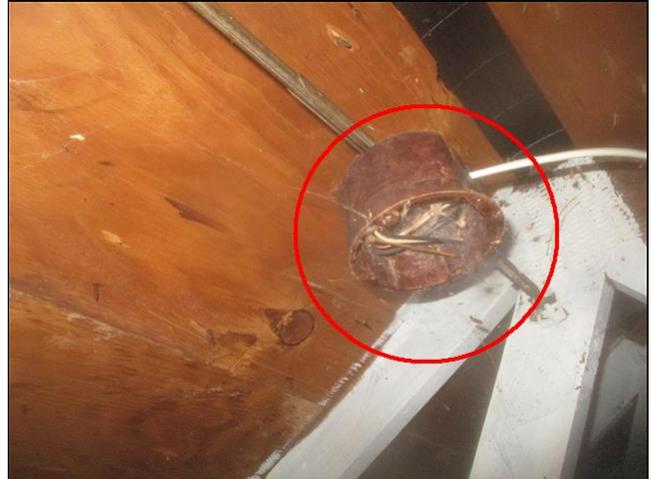
🔧 (1) Covers needed on the open junction boxes at locations shown in the photos. Covers are used to control sparking. Have an electrician correct.

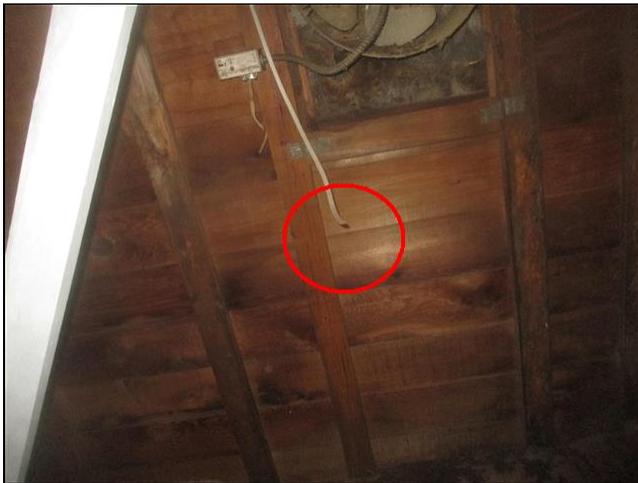
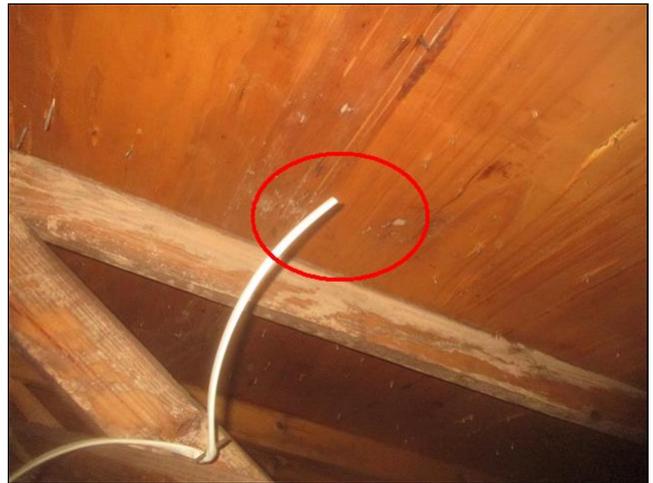
🔧 (2) Open live wires observed near the gable vents at each side of the attic. See photos. This is a safety concern. Wires are associated with past power vent installations at the gable vents that are no longer required. Recommend further evaluation by an electrician and wires professionally removed or terminated so that they are no longer a safety concern.

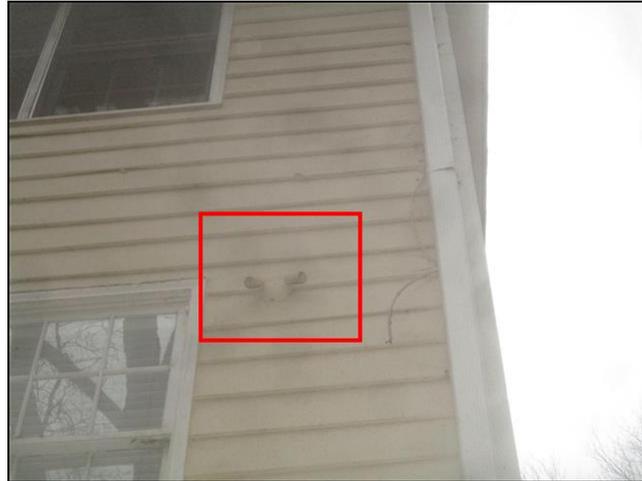
7.4 Item 1(Picture) Rear

🔧 (2) Non-functional security light at the rear of the home. Bulb replacement likely will correct this issue but other electrical concerns may be present preventing the lights to function. Recommend making light functional prior to closing.

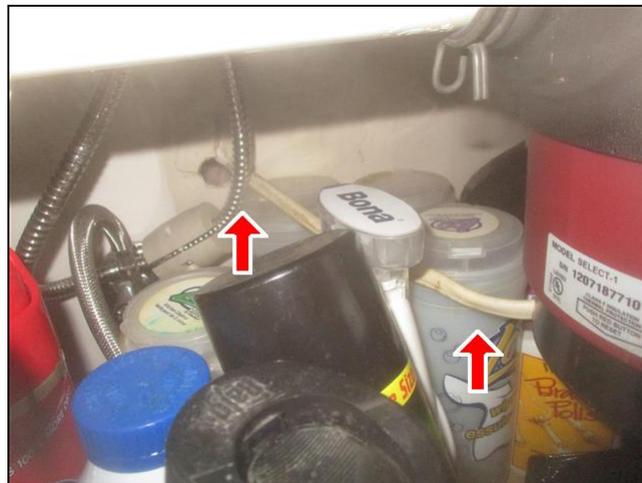
7.5 Item 1(Picture)

🔧 Wiring to garbage disposal under the kitchen sink needs to be in protective conduit.

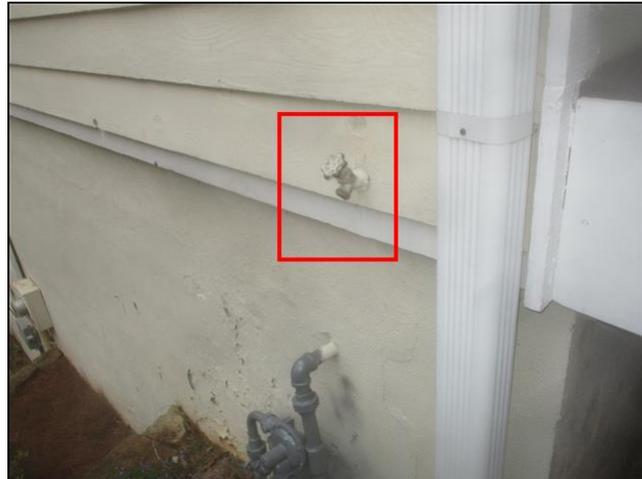
8.1 Item 1(Picture) Left side

🔧 Exterior spigot as shown in the photo was not operational at the time of the inspection. Have owner turn water on to spigot and ensure that the spigot is fully operation with no associated concerns (leaks, etc.) prior to closing.

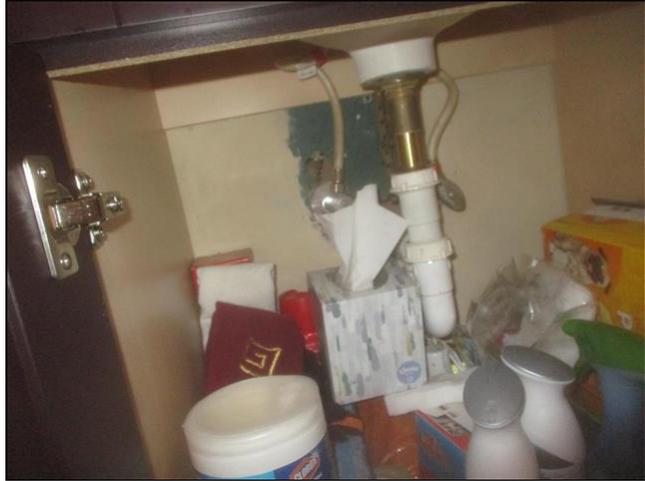
8.2 Item 1(Picture)

🔧 Leak observed associated with the plumbing under the hall bath sink. Have further evaluated by a plumber and repaired as required.

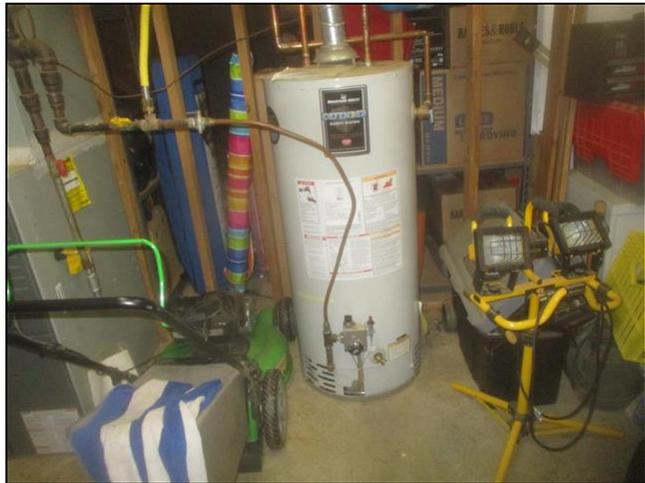
8.3 Item 1(Picture)

🔧 Water heaters generally last 10-12 years before needing replacement. Current water heater works and makes hot water but may need replacing in the near future due to its age. Water heater is a 2007 model.

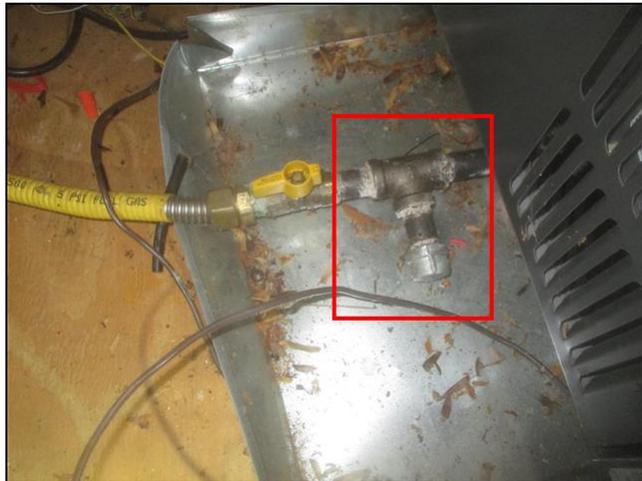
🔧 The "T" fitting, (more commonly known as a drip leg or sediment traps) for the attic furnace gas line is not installed correctly. Hvac tech can evaluate. Gas company may not connect gas for new owner if this is discovered.

8.5 Item 1(Picture) T fitting should be installed in a downward position on a vertical pipe run

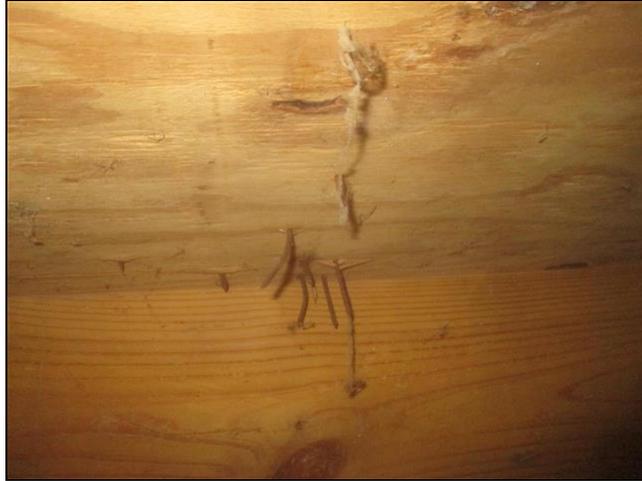
9.0 Item 1(Picture)

🔧 Exposed nails at ceiling of the basement stair landing as shown in the photo. Correct as required to ensure exposed nailing will not be a safety concern.

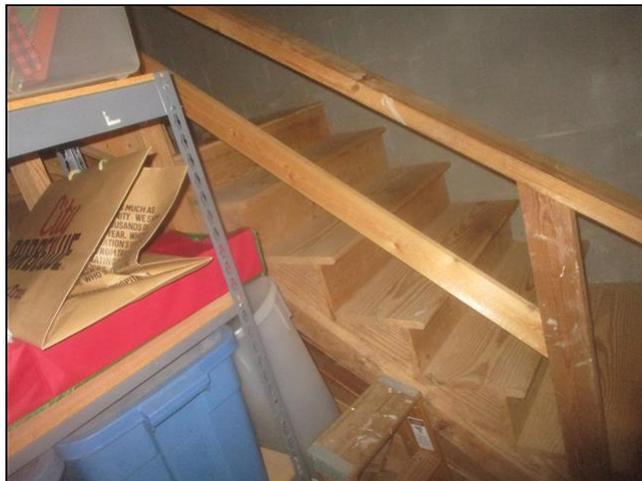
9.3 Item 1(Picture)

🔧 Recommend spindle type guard rails for the basement stairs. Current guard rail would not meet modern standards and is a safety concern for small children.

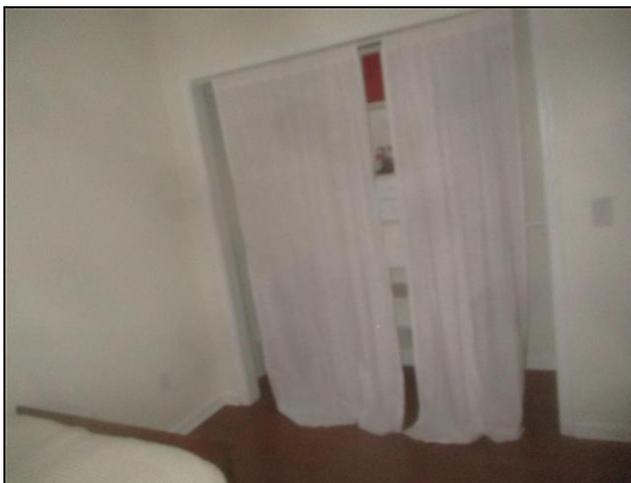
9.7 Item 1(Picture)

Four upstairs closets are missing installed doors (drapes are being used). Resolve any concern prior to closing.

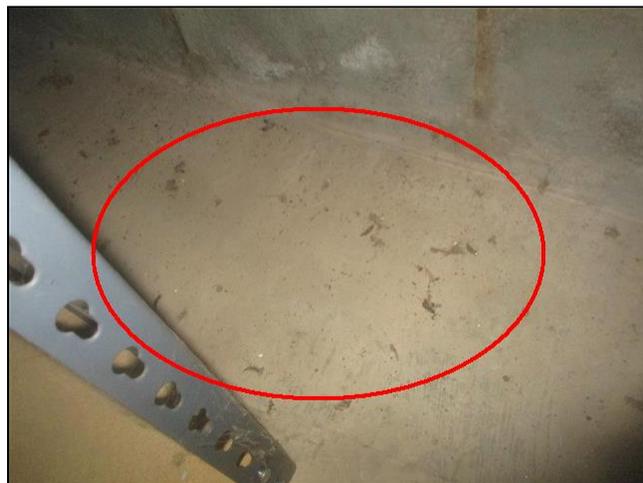
9.8 Item 1(Picture) Rodent droppings, basement

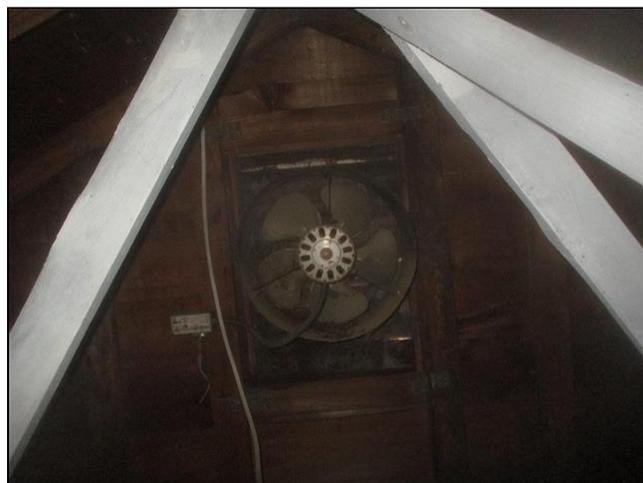
Ten plus bats observed in the gable vent at the left side of the home. A large amount of bat droppings was observed in the attic under this location. Have gable vents sealed off to prevent use by bats and have the bat droppings removed (bat droppings could be a toxic).

9.8 Item 3(Picture) Bats in gable vent
