Inspection Report

Property Address:
5580 Buck Hollow Dr
Alpharetta GA 30005

Date: 2/21/2020	Time: 09:00:00 AM	Report ID: 022120DM612
Property: 5580 Buck Hollow Dr Alpharetta GA 30005	Customer: Riggs Goodman	Real Estate Professional: Julie Barnes Coldwell Banker

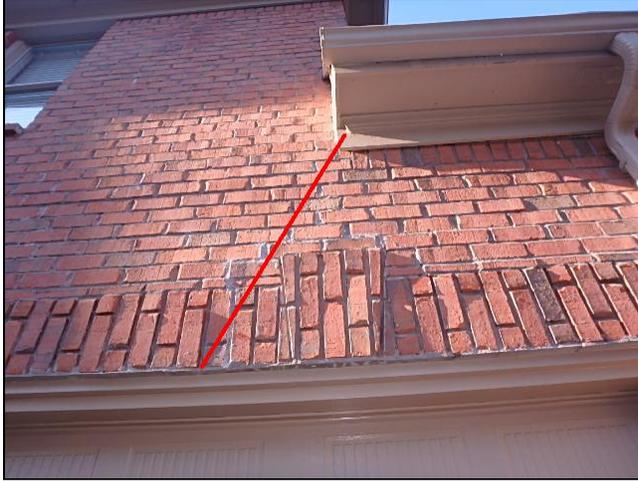
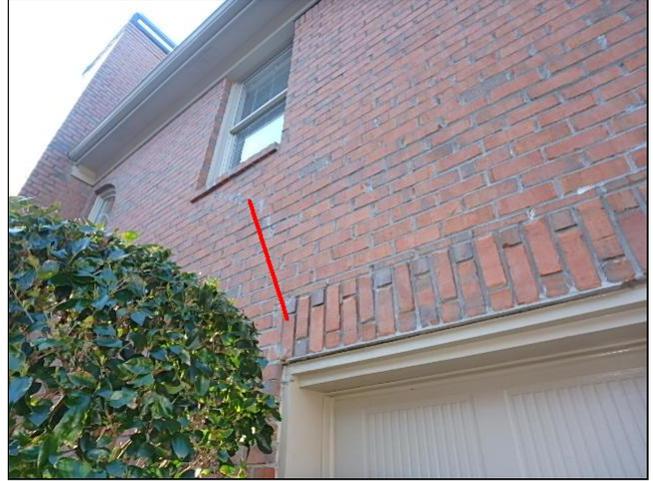
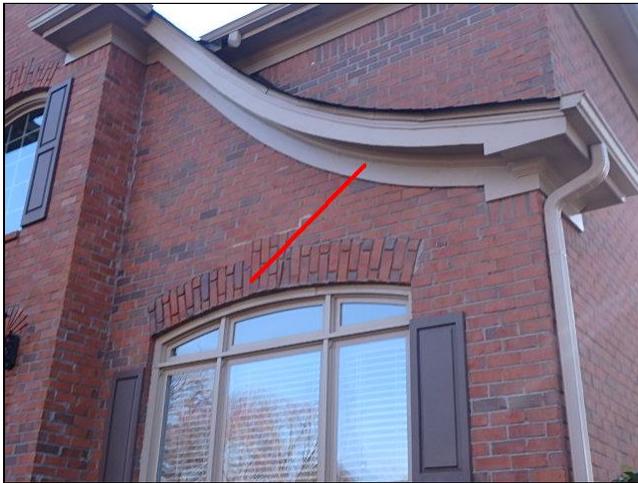
👉 (1) Minor cracking noted at left of house. Monitor for signs of further movement.

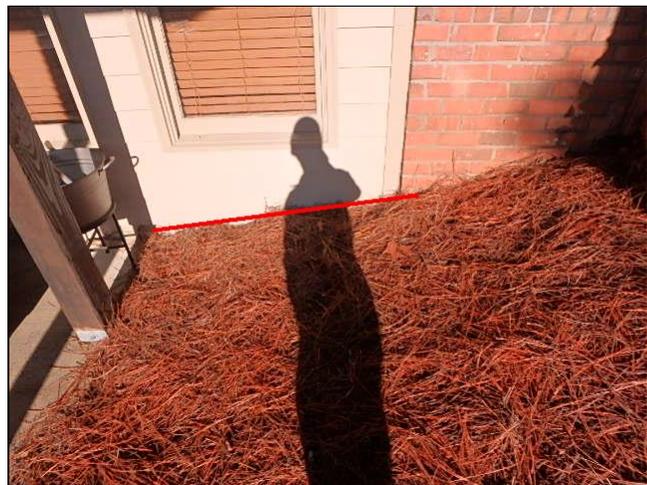
1.1

👉 (2) The soil is too close to the lowest pieces of lap siding on the left side side of the home. This could be an avenue for possible termite infestation. Have all lowered to provide at least 4-6 inches (optimal). See photo(s) for locations.

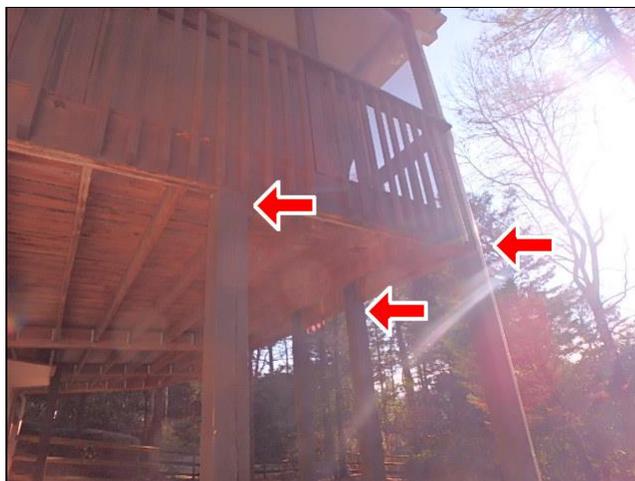
1.4

Weak post connections noted at deck.
Posts should be attached with bolts or metal plates.

🔧 (1) Consult with a deck contractor to evaluate and repair the deck according to current standards.

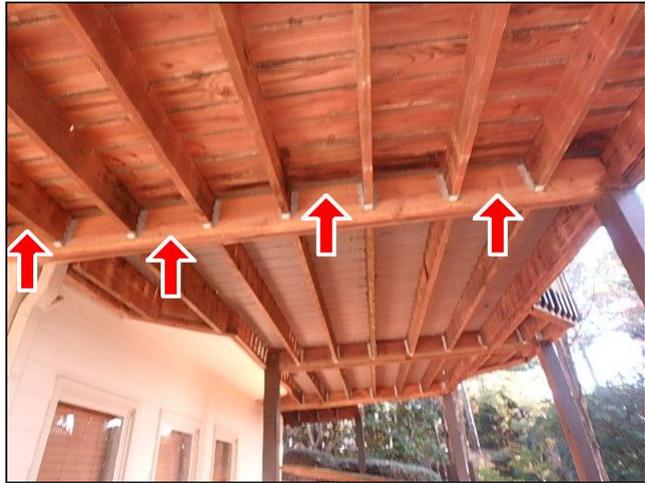
1.4

(2) The beam in the center of the deck should be bolted together.

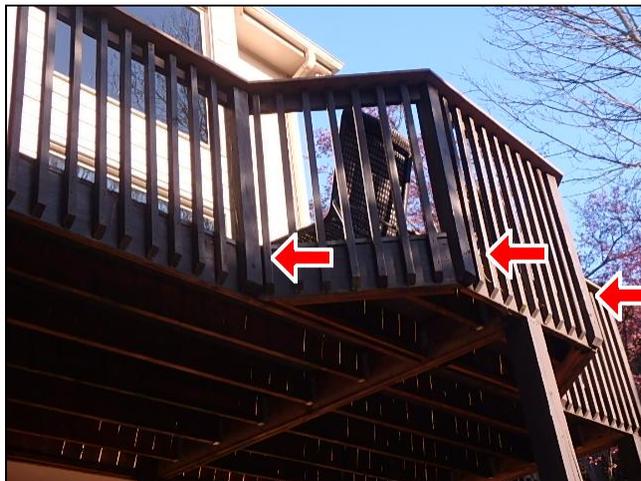
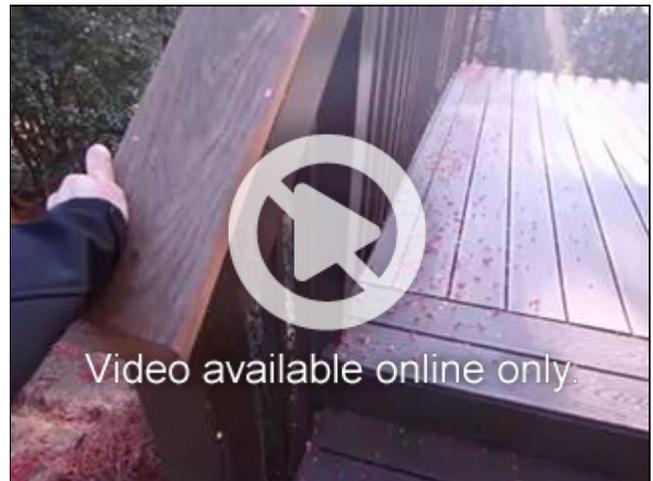
(3) Guard rails on rear deck are loose and need additional bracing and/or fasteners to reduce the amount of movement on the rails. See photo for location.

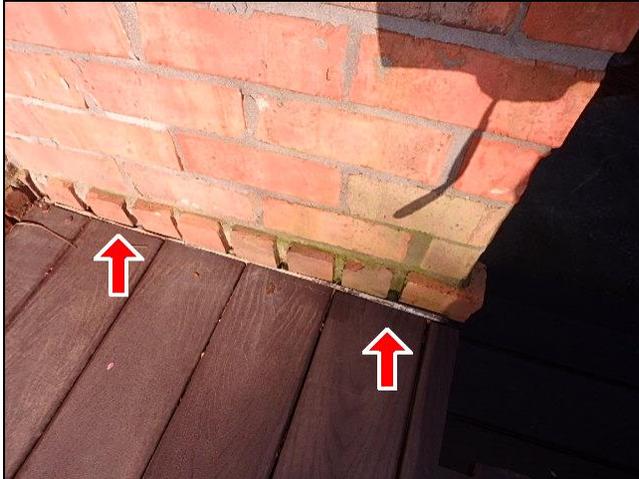
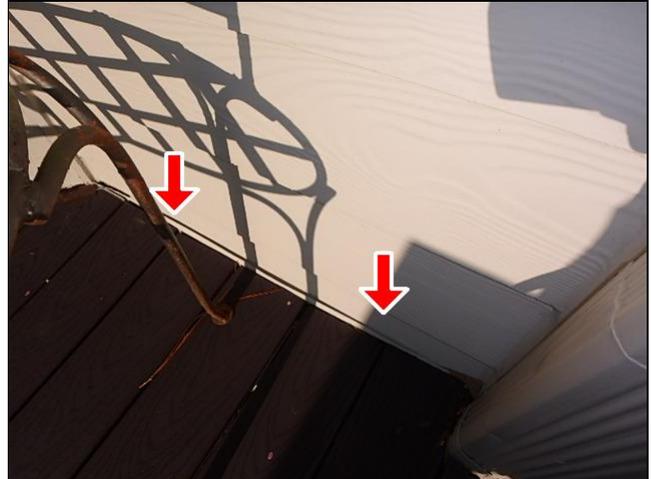
🔧 (4) Improper flashing installation noted at deck. The flashing should be sealed to prevent moisture from reaching the bolts.

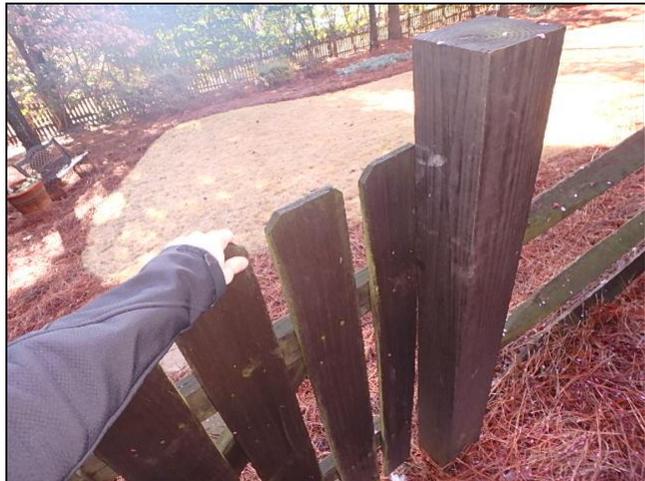
1.4

🔧 (5) Binding gate noted at left of house. Adjust as needed.

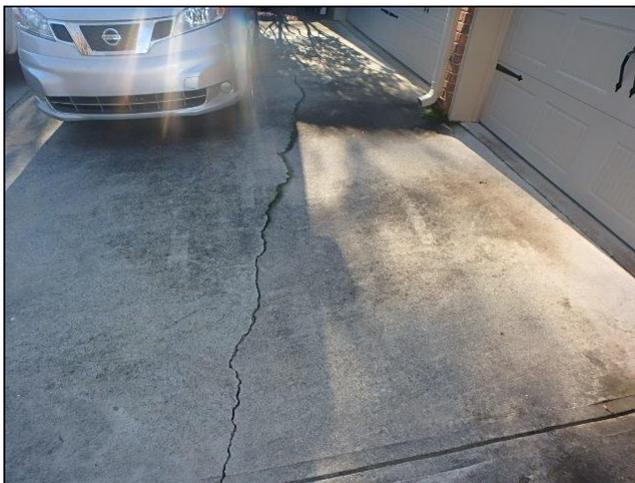
1.5

🔧 (1) Minor cracking in driveway. Patch as needed.

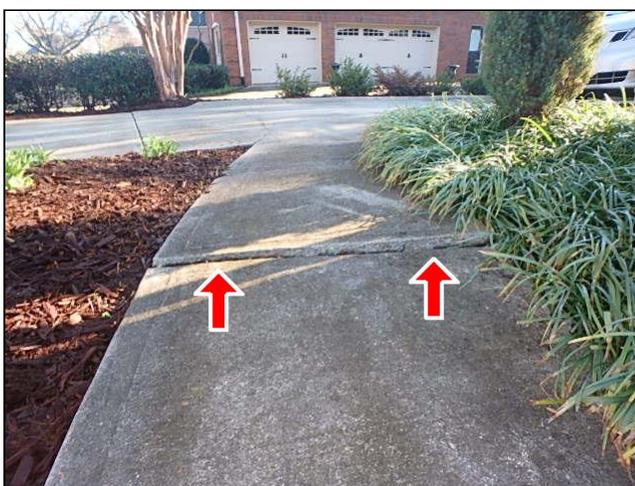
1.5

🔧 (2) Displaced walkway noted at front of house. Repair as needed to remove trip hazard.

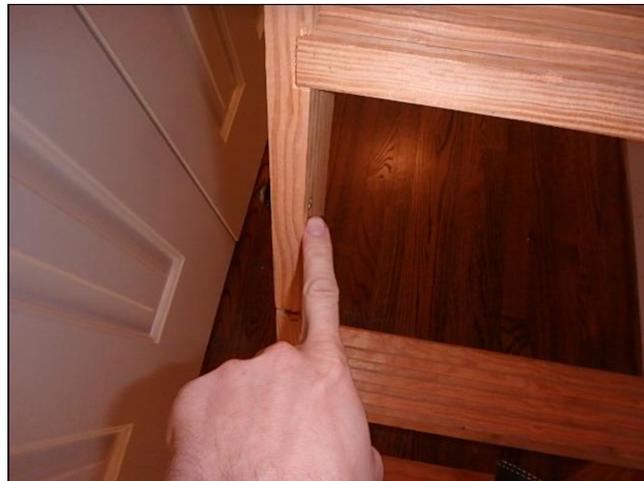
3.4

🔧 (1) Loose and missing hardware noted at pull down stairs. Repair/replace as needed.

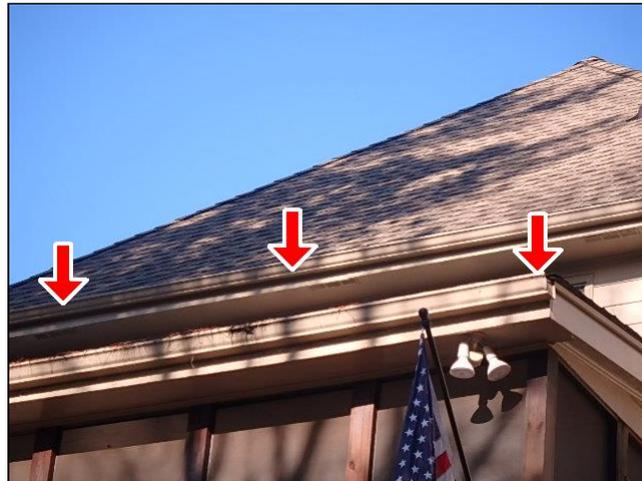
4.3

Clogged gutters noted at various locations. Clean and maintain regularly.

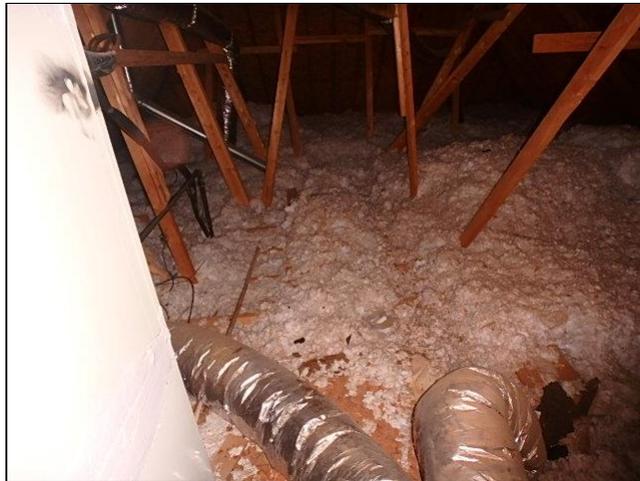
5.0

Additional insulation recommended in the attic to bring the levels up to current standards. Older homes do not have to meet current standards, but a level equaling R-30 is highly recommended.

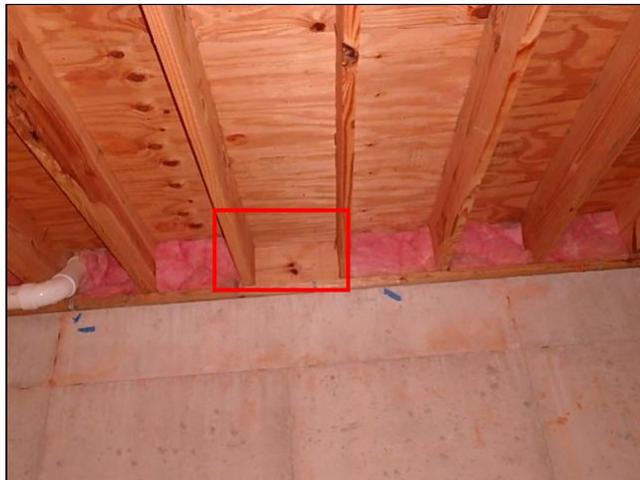
5.1 Right of Basement

Replace missing insulation at right of basement.

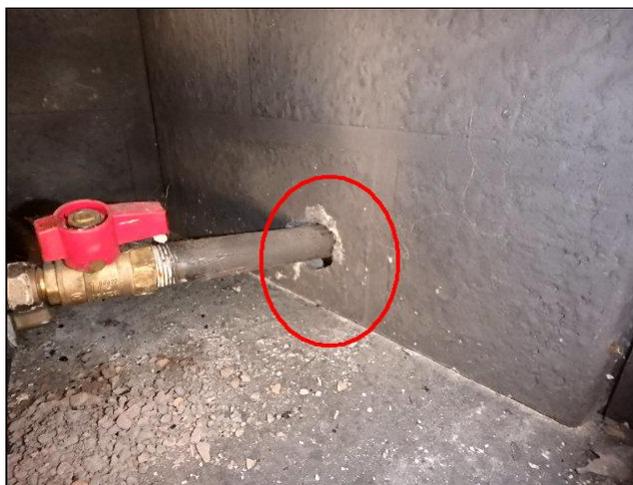
6.5

🔧 (2) Have heat resistant caulk applied around the gas pipe where it enters the fire box in the fireplace. This is needed to prevent any hot embers from entering framing behind fireplace.

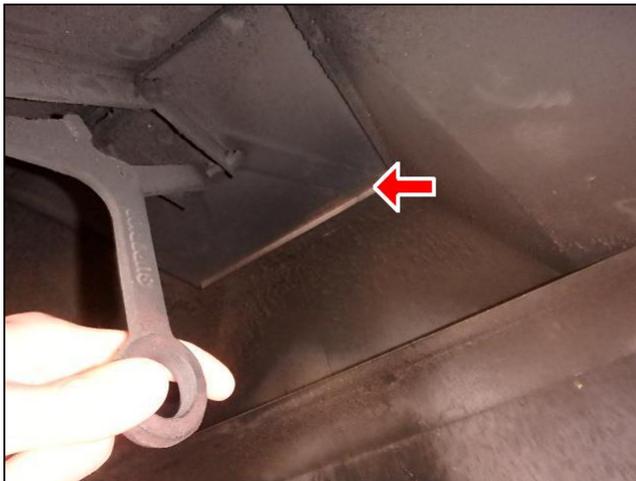
6.5

🔧 (3) C-clamp needed on the damper to prevent it from being closed, since fireplace is using gas logs. This will help prevent carbon monoxide build up in living space.

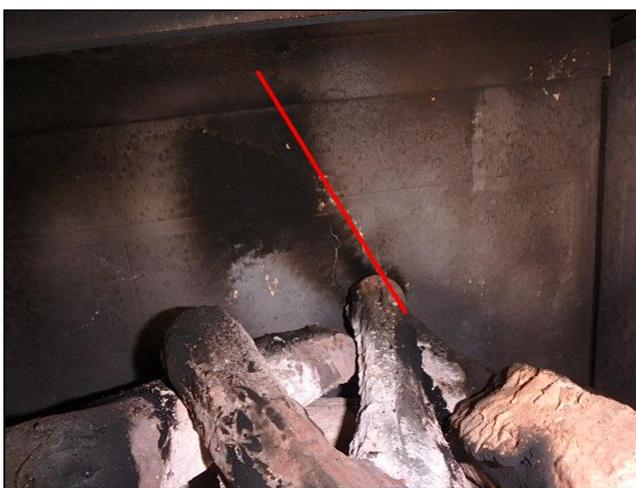
6.5

🔧 (4) Replace the cracked concrete panels in the main level fire place. These are usually held in place by clips or screws and are subject to wear.

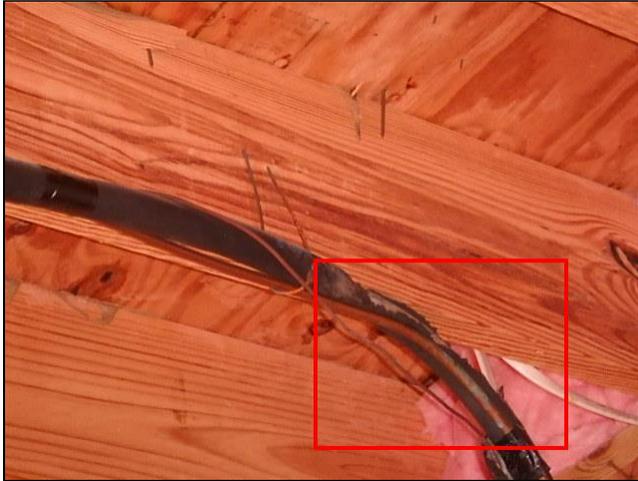
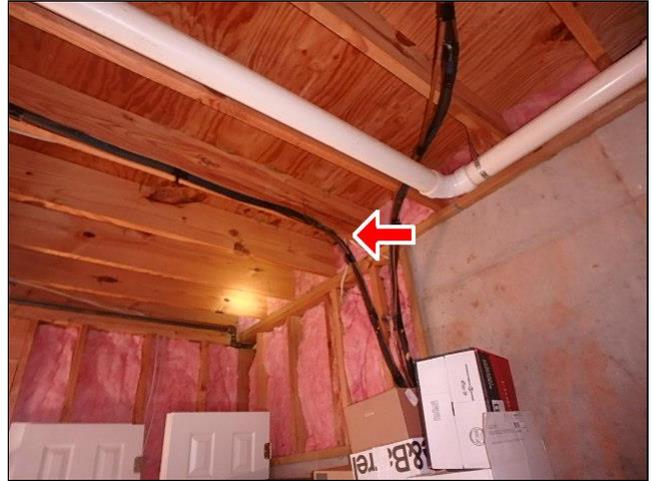
🔧 (2) Gaps found in the insulation wrapping around the refrigerant pipes from the a/c units where these pipes pass through the basement. See photos. Have re-wrapped with more insulation to prevent condensate from dripping on the floor.

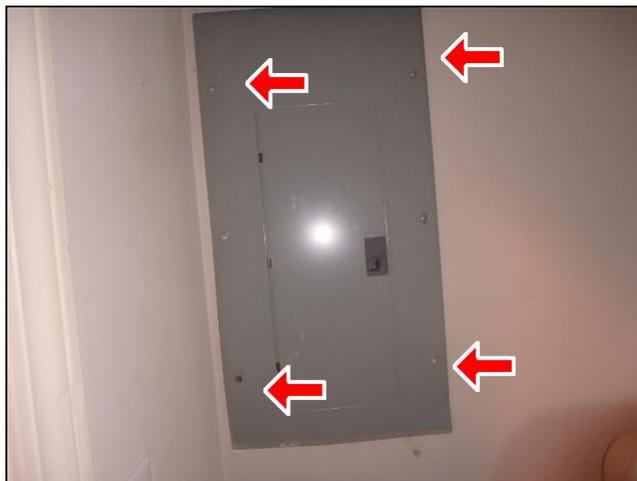
7.2

🔧 (2) Replace missing screws at panel cover.

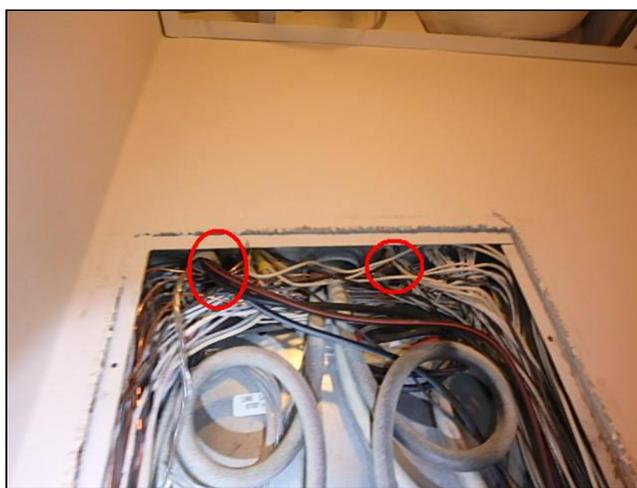
7.2

🔧 (3) See photo of wiring entering metal panel box without the use of a bushing or retainer. Standard wiring practice calls for a bushing or retainer to be installed where the cable enters the box.

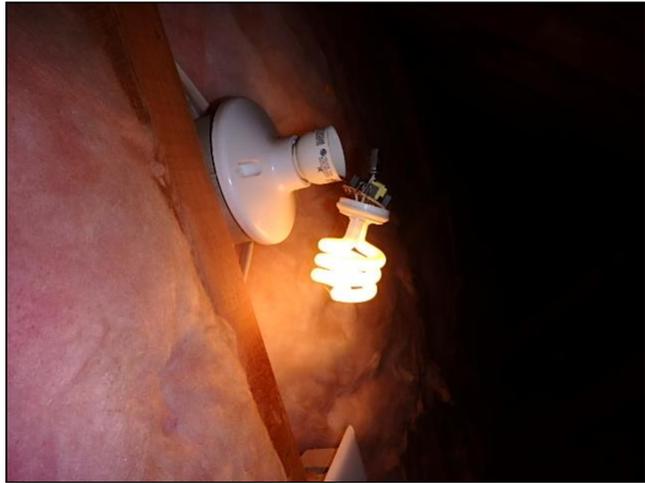
7.4 Garage Attic

🔧 (1) Replace damaged bulb at garage attic.

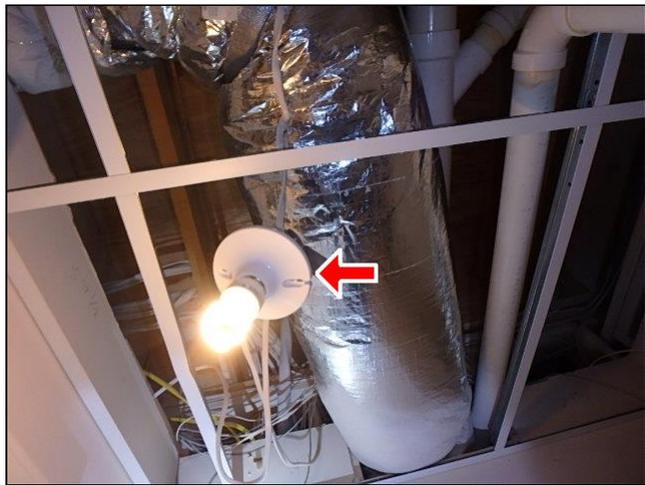
7.4 Basement Closet

🔧 (2) Secure loose light fixture at basement closet by electric panel.

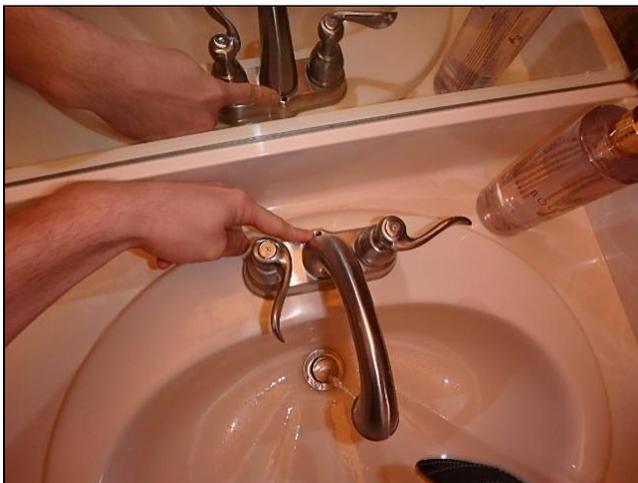
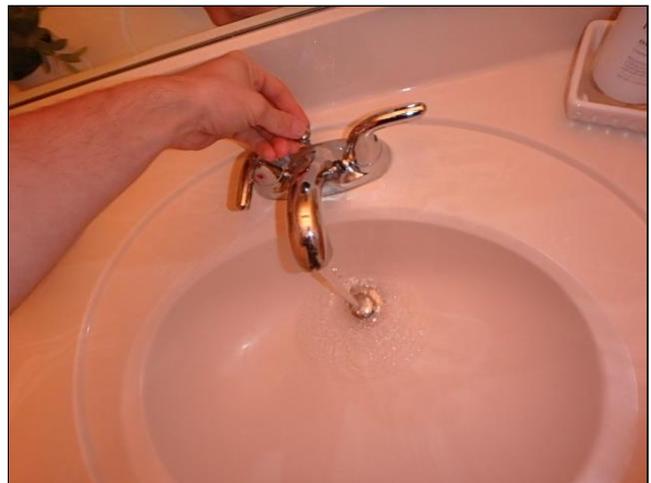
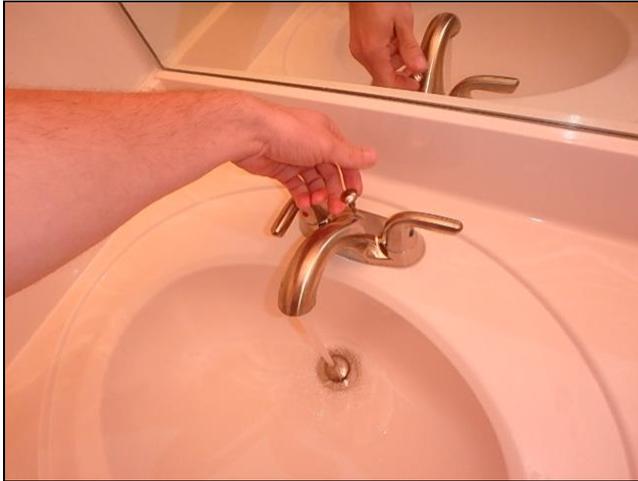
(1) Stopper defective at bathroom sinks in photos. Adjust/replace as needed.

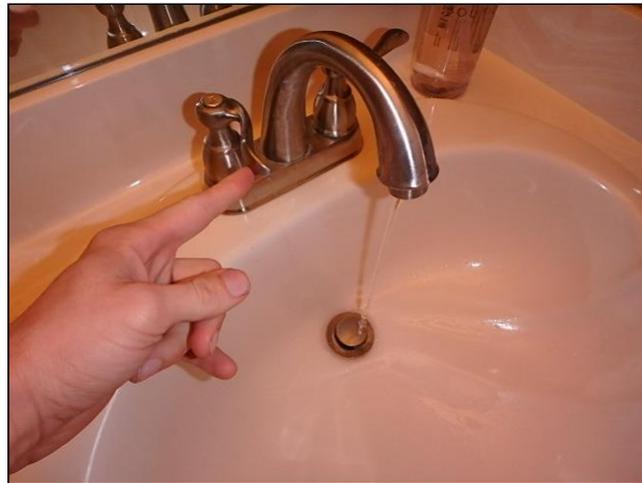
8.2 Main Level Bath

🔧 (2) Low flow noted at main level bathroom sink hot water supply. The shut off valve may need to be opened. Consult with a plumber to repair as needed.

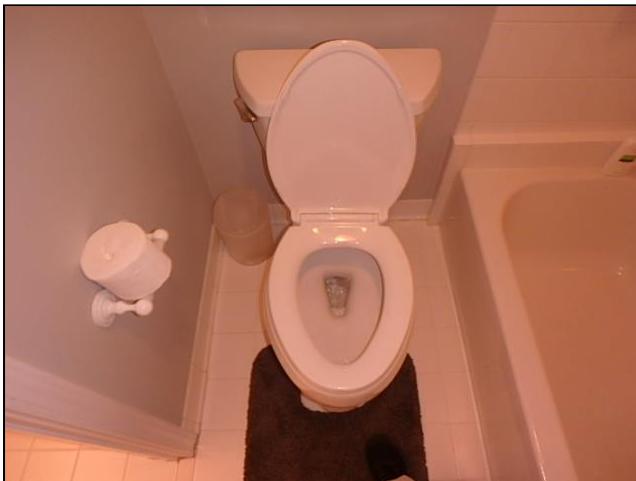
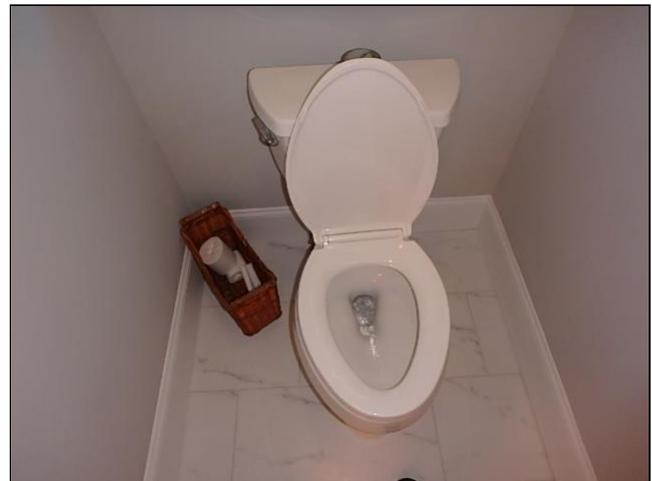
🔧 (3) Secure the loose toilet(s) to the floor(s) in various bath(s). Loose toilets can lead to broken wax seals between toilet and drain pipe that can leak on the floor.

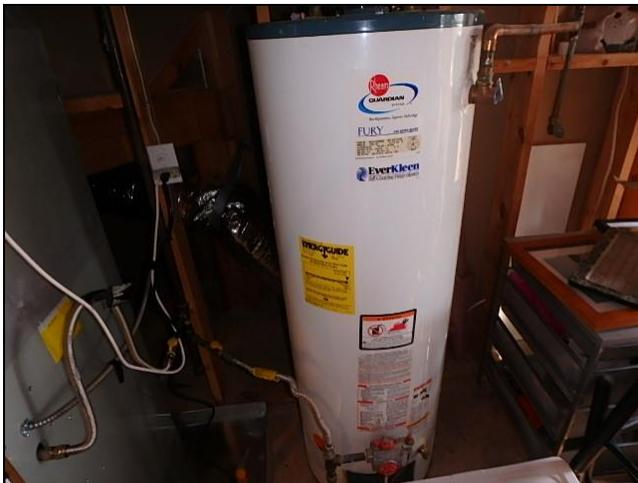
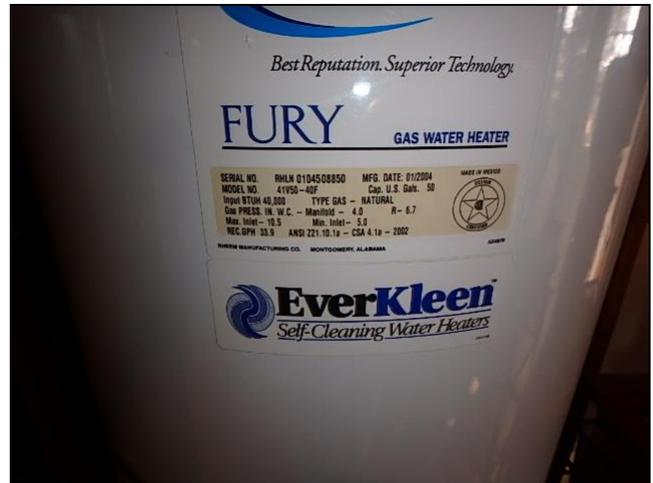
🔧 (1) Water heaters generally last about 10-12 years before needing replacement. Current water heater works and makes hot water but will likely need replacement in the near future due to its age.

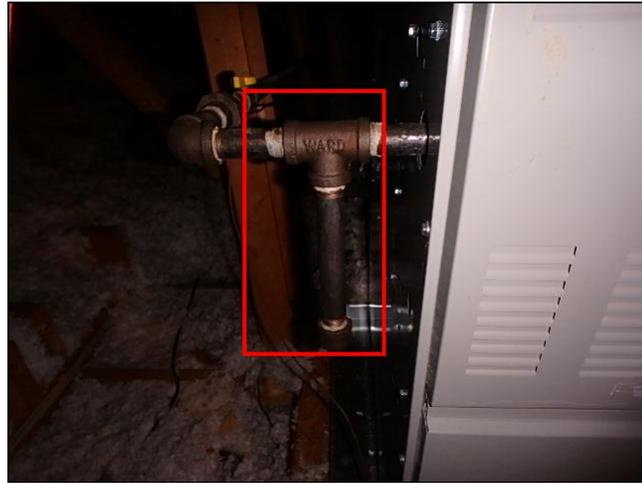
8.5

🔧 Sediment traps (or drip legs/slang term) are not installed in the correct orientation for the attic furnace. This was permitted when the home was built, however, it does not meet current standards and the gas companies requirements. Hvac tech can evaluate. Gas company may not connect gas for new owner if this is discovered. See photo(s).

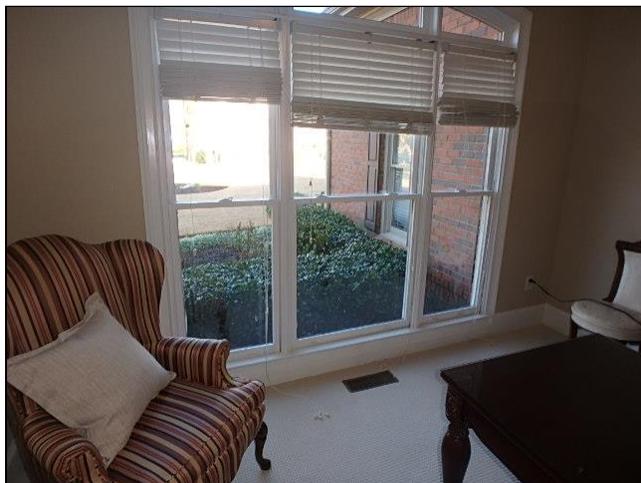
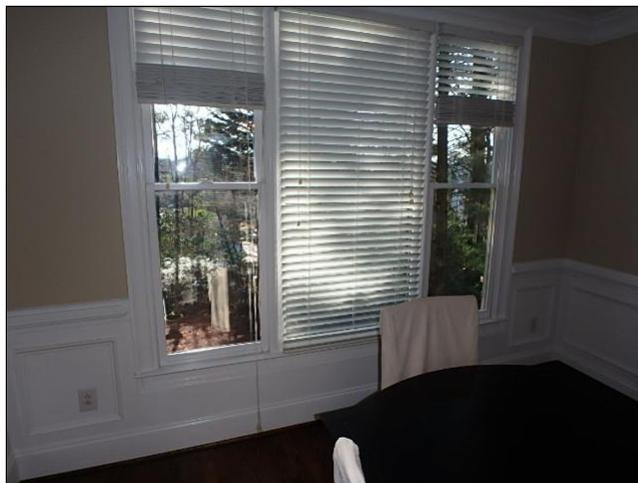
🔧 (1) Most windows were stuck in place and would not open. Make all windows open and close.

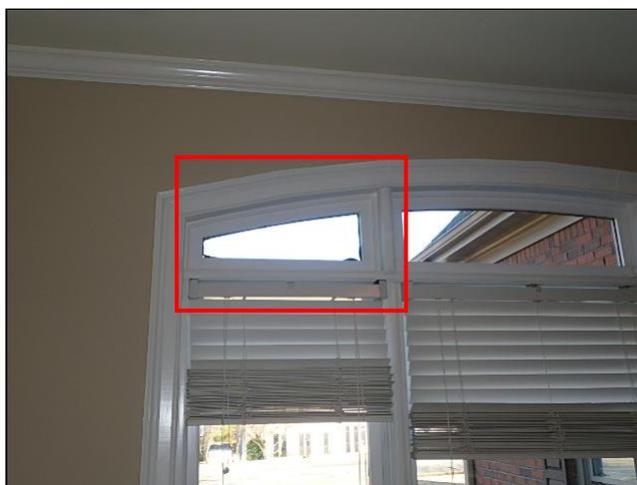
9.5 Office

🔧 (2) Displaced gasket noted at office. Replace pane as needed.

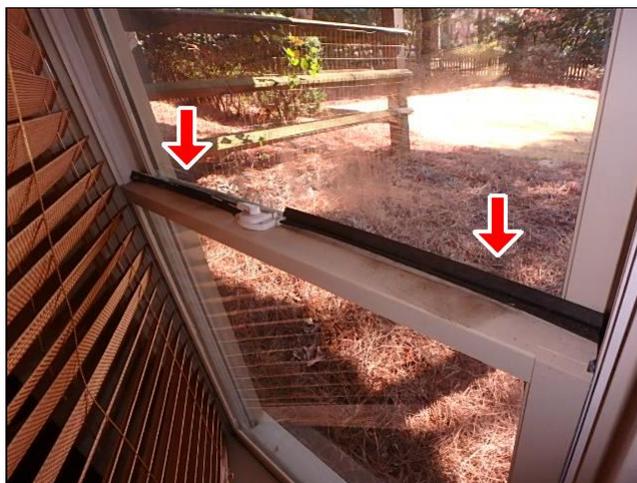
9.5 Rear Left of Basement

🔧 (3) Draft noted at window at rear left of basement. Adjust/seal as needed.

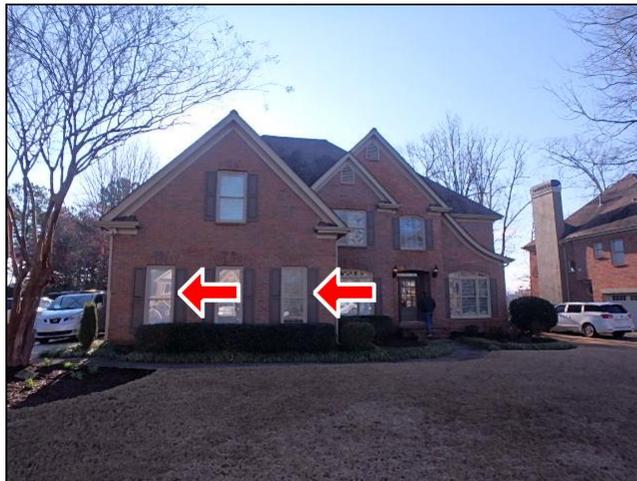
9.5

🔧 (4) Replace all "fogged" windows. The seal between the panes of glass has failed allowing moisture to enter between the panes. It is possible that more may fog in the future. Have window contractor evaluate all windows because it is highly likely that if one window has had a seal failure, that more seal failures in different windows will occur. See photos for examples. It is difficult to identify seal failure in windows when the weather is rainy, over cast, foggy or the glass is wet from recent rains or condensation. Buyer should resolve all concerns prior to closing.

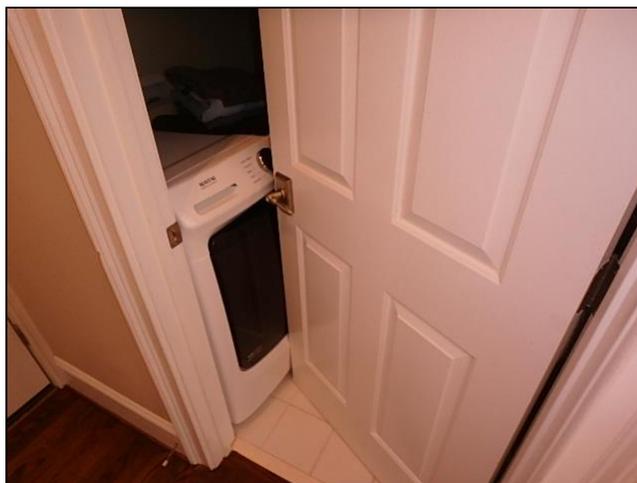
9.7 Laundry Room

🔧 (1) Door does not shut at laundry room due to the size of the dryer. Adjust as needed.

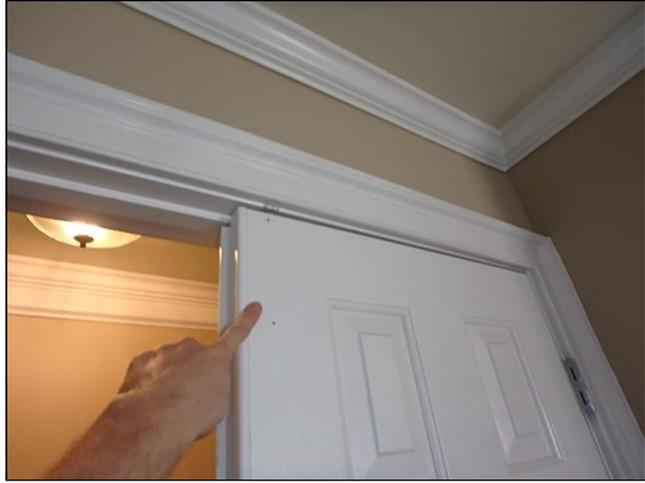
9.7 Master Bedroom

🔧 (2) Missing hardware noted at master bedroom. Replace as needed.

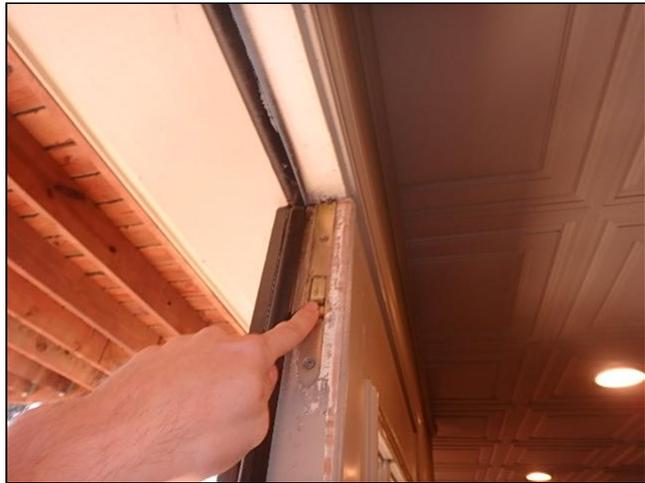
9.7 Basement Entry

🔧 (3) Binding noted at door shown in photo. Adjust as needed.
