Inspection Report

760 Cambridge Crest Ln Alpharetta GA 30005

Champia Real Estate Inspections, LLC

Date: 3/6/2020	Time:	Report ID : 40888
Property:	Customer:	Real Estate Professional:
760 Cambridge Crest Ln	Jie Su	
Alpharetta GA 30005

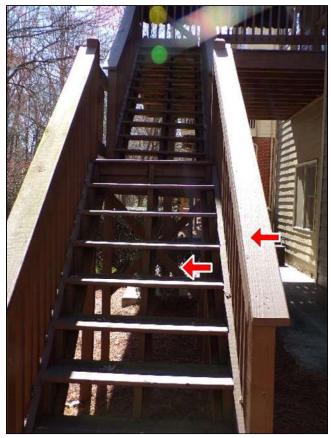
1.0 Rear stairs

1.0 (2) Handrail not graspable at rear deck stairs and open risers where note. This is a fall hazard and child safety hazard. NOTE: Handrails should be graspable. Install as necessary.

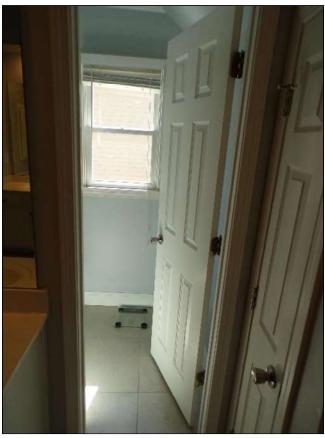
5.4 Master bathroom

5.4 One or more doors within the home binds at the frame (master bathroom). Adjust as necessary by a qualified handyman.

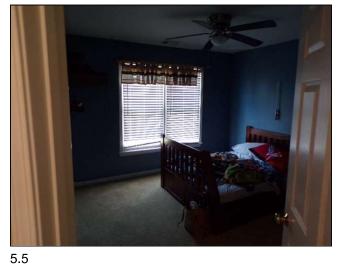
5.5 (2) Almost all the interior windows inside the home appeared to be painted shut (1st and 2nd floor). This is a common issue. However, all rooms should have proper egress in case of a fire. It is suggested to ensure all windows function properly and are not sealed shut. Quick repair is highly recommended for safety before closing. If a window is broken and not just painted recommend review by a licensed window contractor.

5.5 Most windows in the home

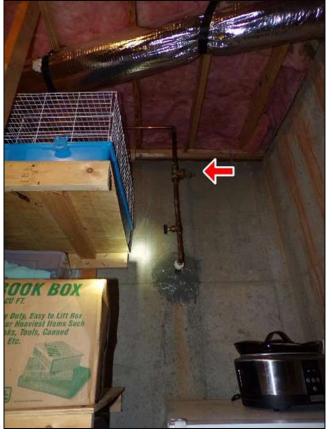
7.2 (2) Excessive water pressure noted. (90 PSI) NOTE: Water pressure should not exceed 80 psi (between 40 and 80 psi). Adjust/replace pressure reduction valve and/or replace as necessary by a licensed plumber to reduce water pressure below 80 psi to protect plumbing system.

7.2 PRV - Pressure reducing valve

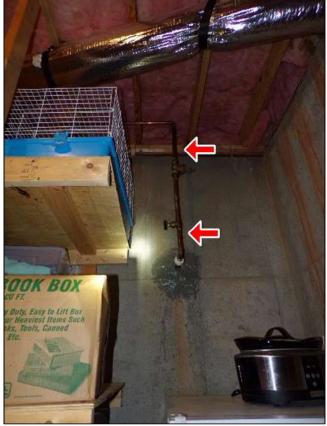
7.2 (3) Missing bonding wire from hot to cold water pipes and at water entrance around the PRV and main water shutoff. All metal components in the house must be bonded to the system so they do not become energized in a lightning strike. The insulated water heater breaks the continuity of the bond. Recommend review by a licensed plumber and/or electrician.

7.2 Missing bonding wire - main shut off

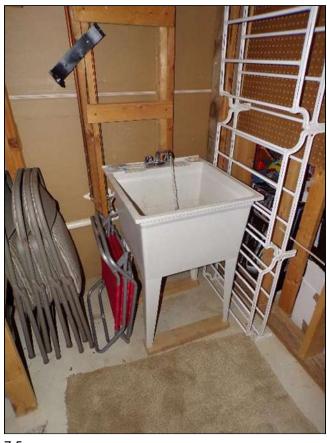
7.5 Loose laundry sink in basement noted. Secure sink as necessary to prevent accidental snapping of the water line. Repair as needed.

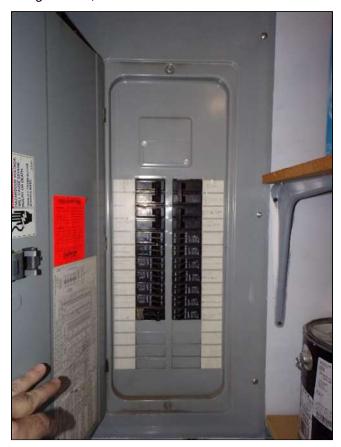
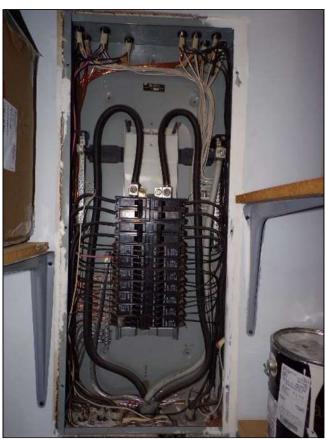
8.1 (2) Neutral wires are doubled or bundled together on neutral buss bar. Current installation practices no longer allows this wiring method, however it was common when the home was built. Recommend review by a licensed electrician.

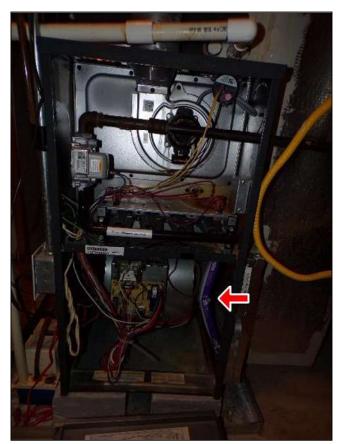
9.0 Interior - damaged filter

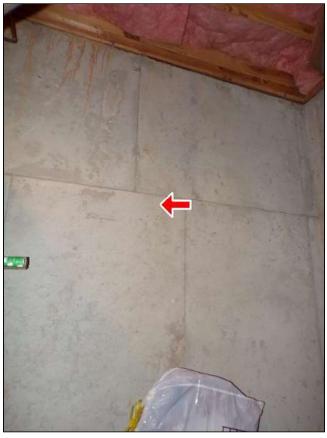
10.1 Basement wall

10.1 Cracking noted at basement wall. These are common and not a cause for structural concern but should be sealed for maintenance and to prevent possible water penetration. If any cracks grows larger than 1/4" in nature, consult a qualified foundation contractor.
