# Atlanta Property Inspections, Inc.

## HOME INSPECTION REPORT

**3950 Chapel Grove Road, Marietta, GA 30062**  
**Inspection prepared for: Jorge Menendez & Angie Menendez**  
**Date of Inspection: 3/9/2020 Time: 9:30 AM**  
**Age of Home: 15 Years Old (2005) Size: 4915 SF**  
**Weather: Sunny, Damp Soil, 40 Degrees**

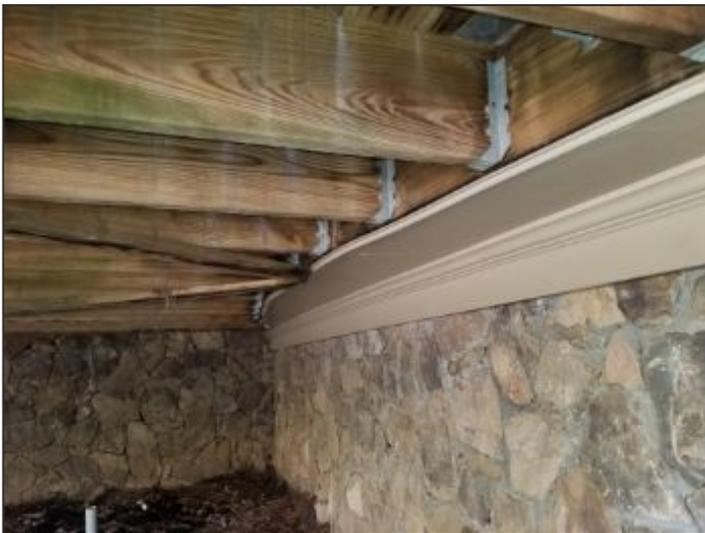
- **The deck ledger board is anchored to the rear bay window which is no longer allowed in newer building codes (see photo); the bay window is not framed or rated for this type of structural attachment. Although there are no signs of any structural stress at this location during this limited visual inspection, it is recommended that vertical support be installed below the deck to bay window connection, to relieve the bay window of any additional future stress.**

Deck bolted to cantilevered surface

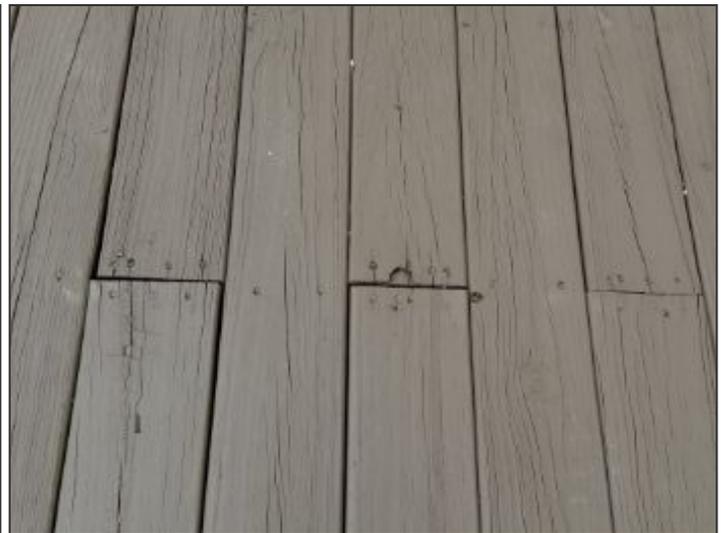
- **Several deck surface boards are worn, split, and slightly damaged (see photo). Replacement of the damaged deck boards should be considered. Further evaluation is recommended by a professional deck contractor to determine the full scope of replacement needs and costs.**

Worn and split deck surface boards

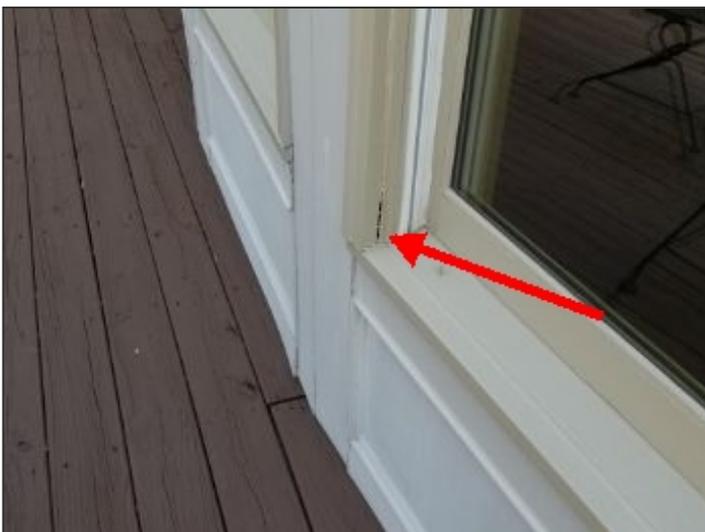
• **Some of the vinyl wood trim, at the rear family room windows and wall, are pulling away and warping (see photos). Repair is recommended to fully secure and seal all loose vinyl trim.**

Curled vinyl trim at rear family room windows

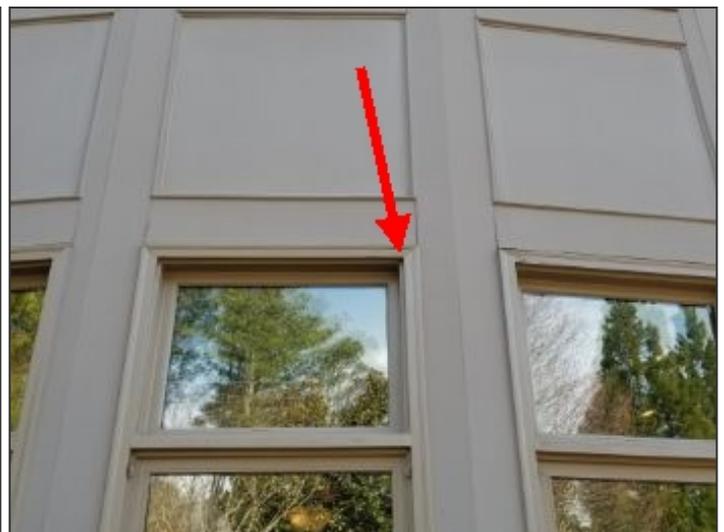
• **Damaged wood trim was noted at the top right corner of the center master bay window (see photo). Replacement of the affected wood trim is recommended.**

Damaged wood trim at center family room bay window

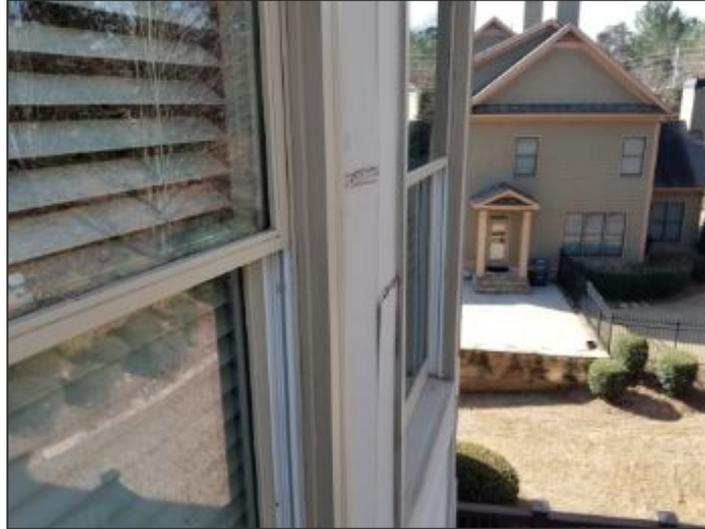
Loose trim at rear family room wall

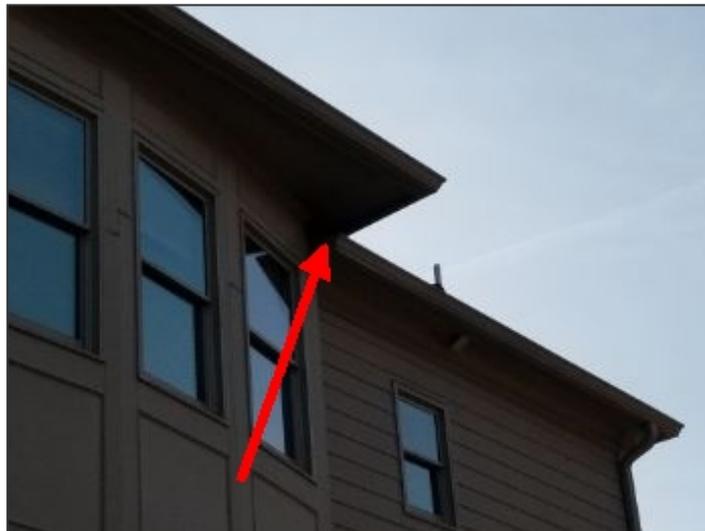
• **A large hole was found at the soffit board located at the rear right upper roof connection above the family room (see photo). The hole appears to have chew markings and is large enough for rodents to enter the attic. Repair is advised by a professional contractor; seal the opening by installing screening or replace the affected soffit board.**

Damaged soffit / large holt at rear roof connection

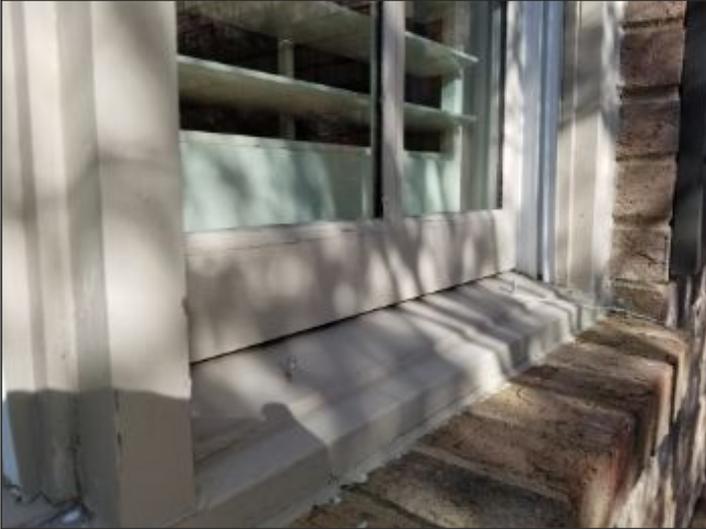
• **Peeling paint and bare wood were noted at several wood locations (see photos). Scraping off loose paint, recaulking, and repainting is recommended soon to fully seal and protect the wood surfaces.**

**Peeling paint at exterior windows**

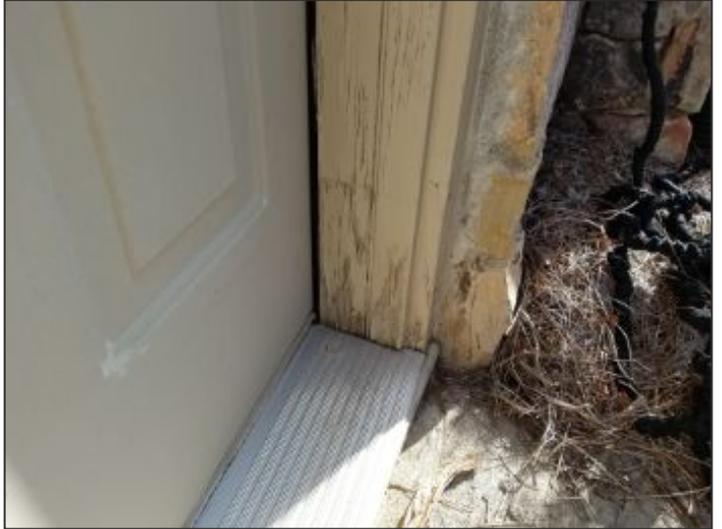
**Peeling paint at exterior wood trim**

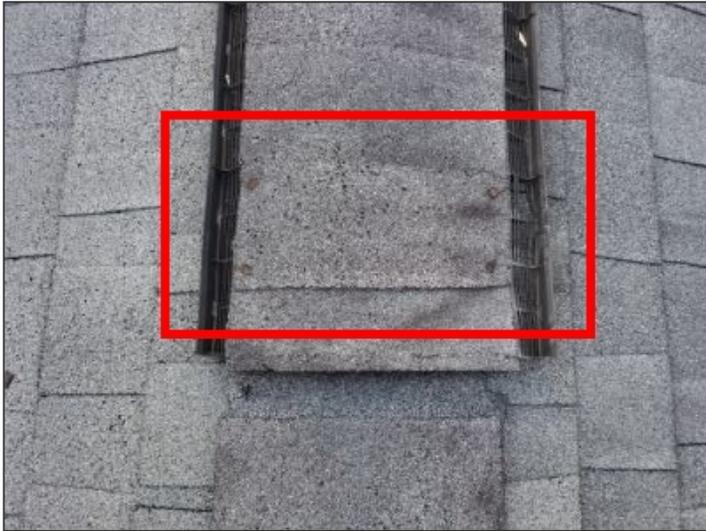
• **Unsealed nail heads were noted on the lower kitchen keeping room roof at the ridge vent and shingle strip next to the master bedroom wall (see photos). Correction is recommended so that the exposed nail heads are properly sealed to prevent possible leaks.**

Unsealed nail heads at rear kitchen keeping room ridge vent

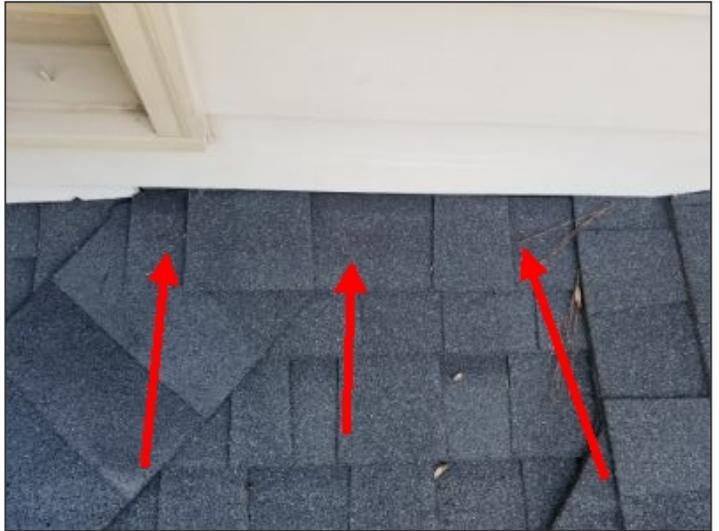
Unsealed nail heads at rear roof

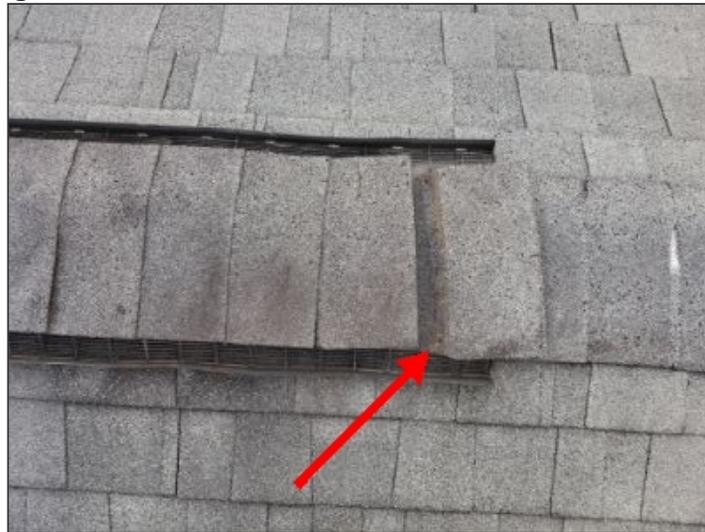
• **A loose ridge cap shingle was found at the kitchen keeping room ridge vent (see photo). Repair is recommended by a professional roofing contractor.**

Loose ridge cap shingle at kitchen keeping room ridge vent

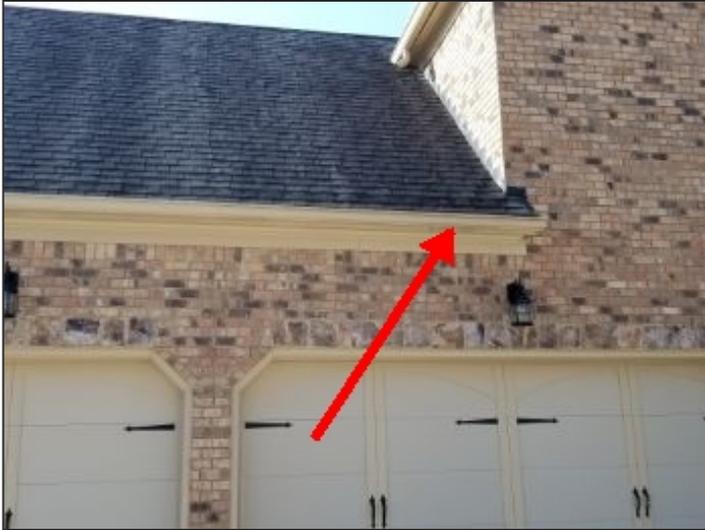
• **A gutter is improperly sloped at the right side garage roof above the driveway and at the rear master bedroom roof connection with the vertical wall (see photo). There are signs of overflow based on water stains on the outer portions of the gutter and intersecting wall. Repair / adjustment is recommended so that the gutter is properly sloped and water flows to the downspout.**

Improper gutter slope at garage roof

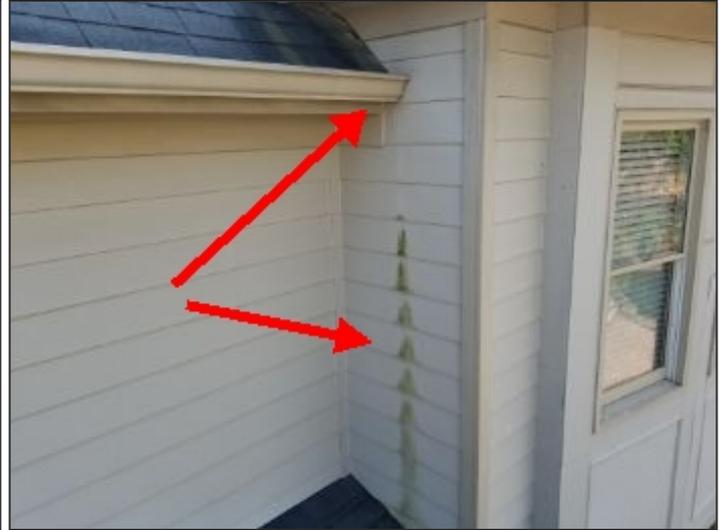
Evidence of a gutter leak and improper slope at rear master bedroom roof

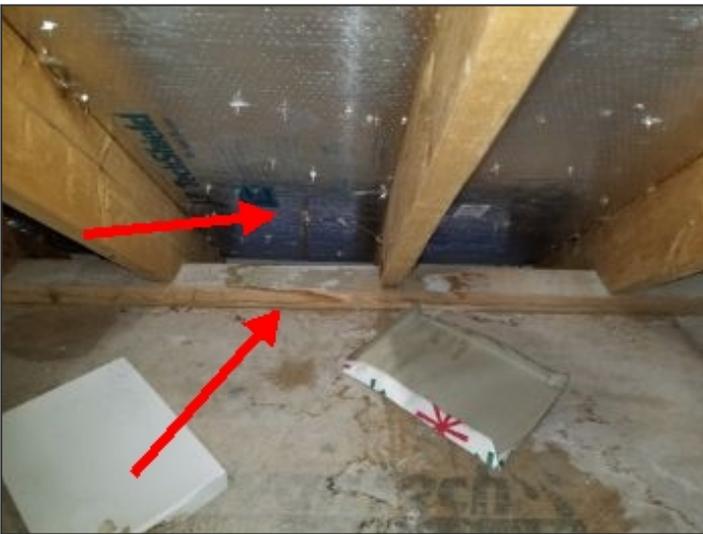
• Evidence of multiple roof leaks were observed in the attic at the small left side master closet attic space, the second floor furnace exhaust vent, and at the front chimney corner (see photos). Water stains were found on the framing and insulation below these locations. This condition is evidence of possible roof leaks but could not be verified during this limited visual inspection. Further evaluation is recommended by a professional roofer to determine the full scope of repair needs and costs.

Evidence of a previous leak at left small master closet attic space

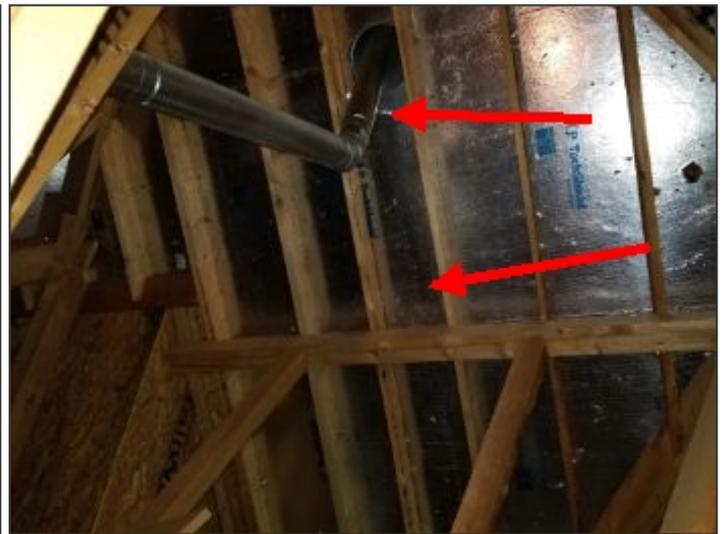
Evidence of a leak at second floor furnace exhaust vent penetration

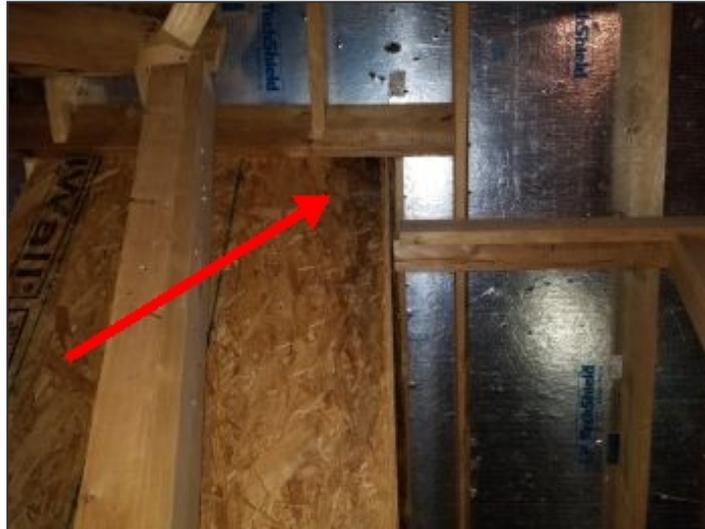
Evidence of a leak at front chimney corner

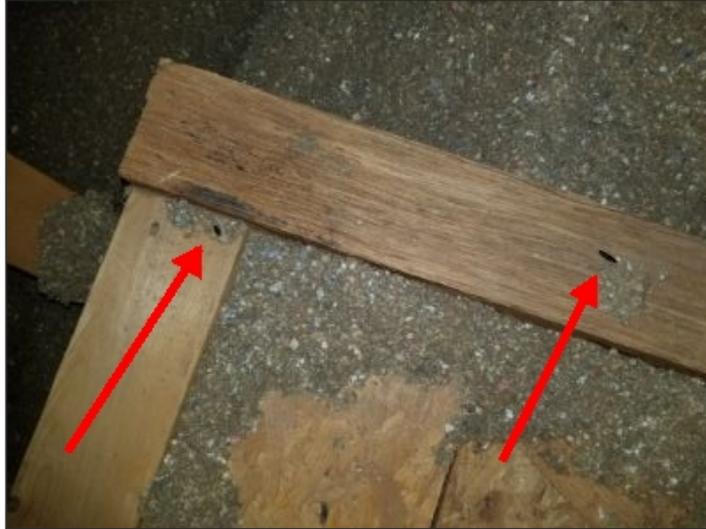
- Rodent droppings were observed in the attic (see photo); this condition is unsanitary. It is recommended that all rodent droppings be removed.

Rodent droppings in attic

- Due to the evidence of rodent activity noted above, it is recommended that further evaluation be conducted by a professional wildlife or pest control contractor, prior to closing, to perform a full rodent and bat infestation inspection, to determine the full extent of rodent exclusion needs and costs. It is understood that this type of specialized inspection may identify other infestation issues not identified or mentioned in this inspection report. All potential rodent entry access points should be sealed to prevent future rodent entry. In many cases, this type of service can develop into a major expense depending upon the amount of work needed.

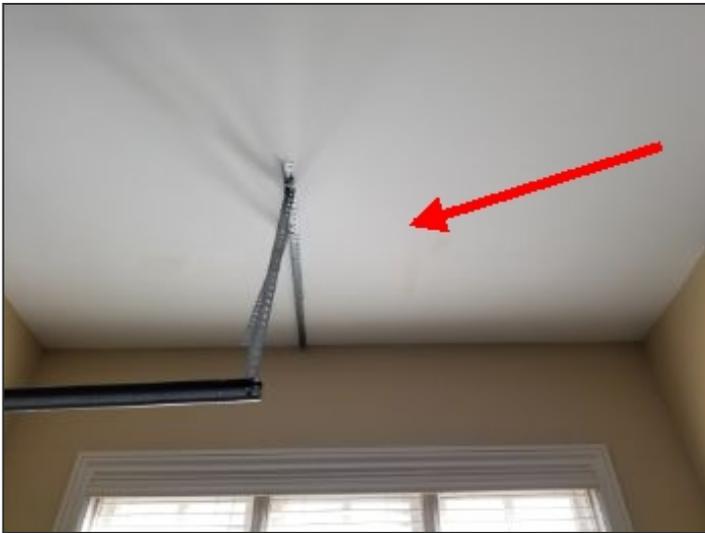
Water stain at garage ceiling

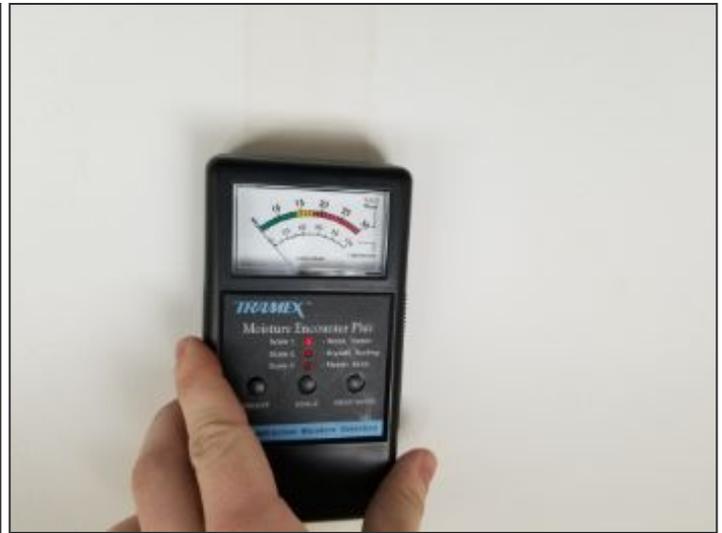
Garage ceiling water stain tested dry

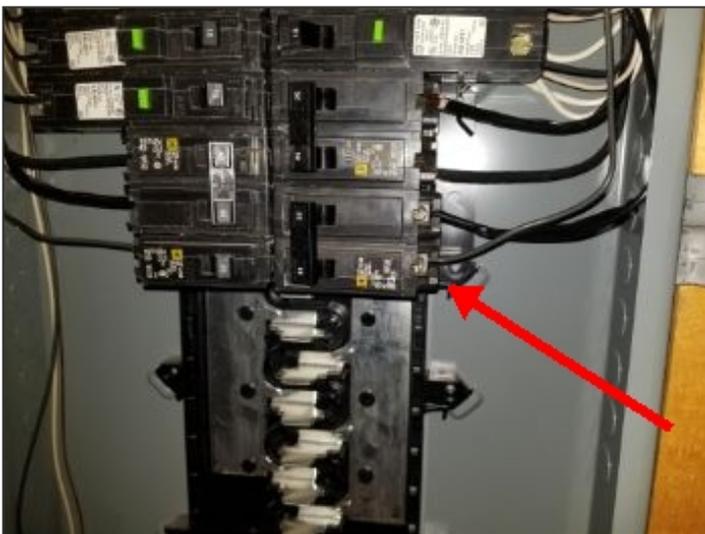
• Improper wiring was noted at the 35 amp circuit breaker located at the bottom right corner of panel A (see photo). The circuit incorrectly has 12 gauge wire which does not meet the safety requirements of the National Electric Code. The minimum wire size for this 35 amp circuit is a 10 gauge wire. Further evaluation and correction is advised by a licensed electrician to meet the safety requirements of the NEC.

Improper wire size at bottom right 35 amp breaker in panel A

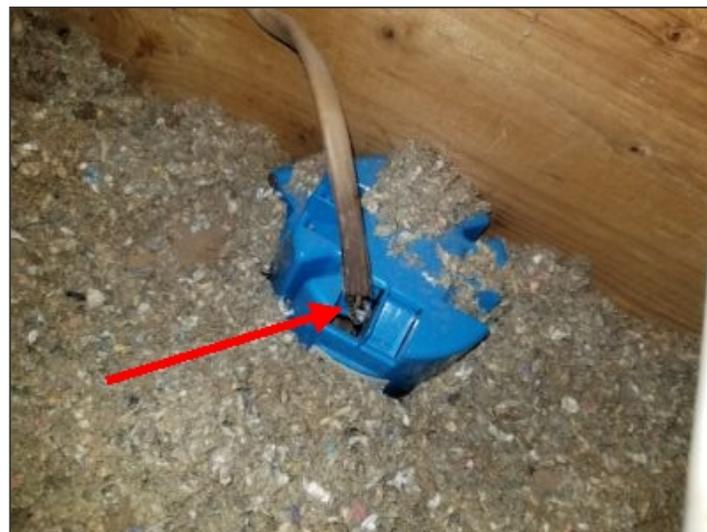
• **A burned electrical wire was found at the light fixture connection, in the attic, above the loft bathroom (see photo). The burned wire is visible at the attic floor and light black markings were noted on the sheetrock ceiling around the light. This condition is a sign of overheating or arcing. Further evaluation by a professional electrician is advised to determine repair needs and costs.**

Burned electrical wire in attic above loft bathroom

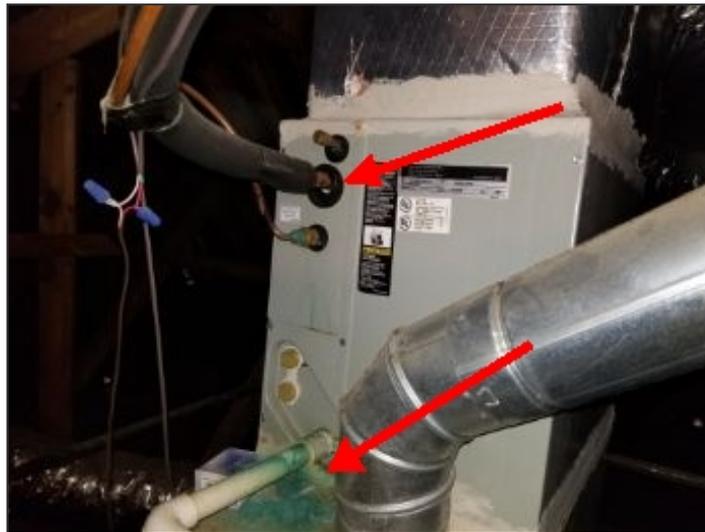
• **MINOR REPAIR:** The coolant line at the entry to the evaporator is not fully insulated as needed which has allowed condensate to drip onto the furnace below (see photo). Correction is recommended so that the coolant line is fully insulated.

Coolant line not fully insulated at evaporator
