**71 East Lake Drive Northeast  
Atlanta GA 30317**

Client(s): Zdradzinski  
Inspection Date: 3/31/2020  
Inspector: Kevin Carey ,

<b>Date:</b> 3/31/2020	<b>Time:</b> 09:00:00 AM	<b>Report ID:</b> 806744
<b>Property:</b> 71 East Lake Drive Northeast, Atlanta, GA 30317		<b>Prepared By:</b> Kevin Carey

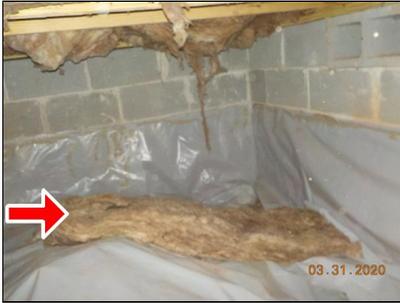
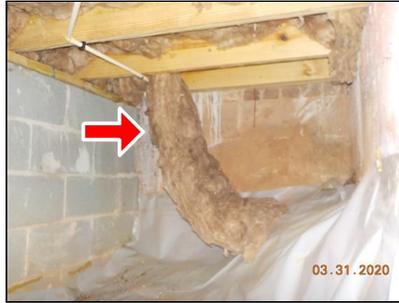
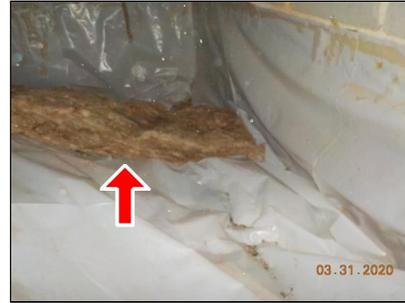
**◆ SERVICE / REPAIR:** Fallen insulation noted in the **crawlspace**. Not only will this reduce the insulating ability it can also allow a path for termites to enter the structure and provide a nesting area for vermin. Re-install/replace all fallen insulation.

Fallen insulation noted in the crawlspace.

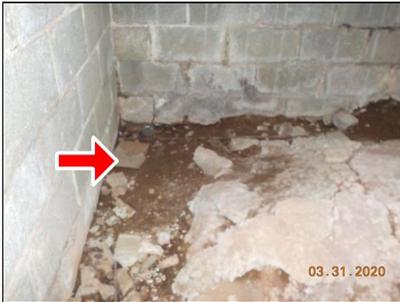
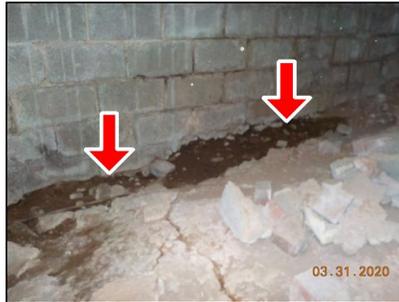
**❌** ♦ **SERVICE / REPAIR:** Signs of moisture intrusion/dampness noted under the front porch area. Verify that the downspouts/runoff drains are working properly. If conditions worsen, recommend further evaluation by a water management specialist. Recommend adding a vapor barrier to prevent moisture from evaporating into the crawlspace area.

Signs of moisture intrusion/ dampness noted

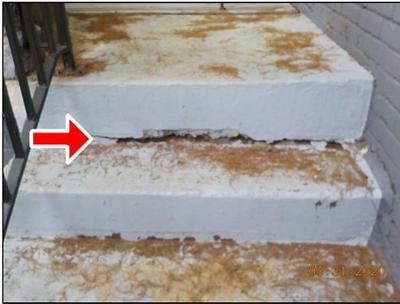
❌ ♦ **SERVICE / REPAIR:** Settlement noted in steps leading to the front porch with opening noted. The top step height is outside the maximum allowed by an inch. This could be a tripping hazard. Advise having system raised back to original position professionally. Pressure grouting or Mud Jack systems are successful in correcting this condition but is costly.

Settlement noted in steps

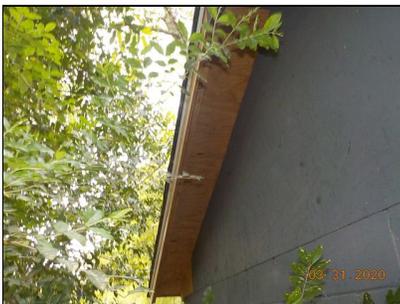
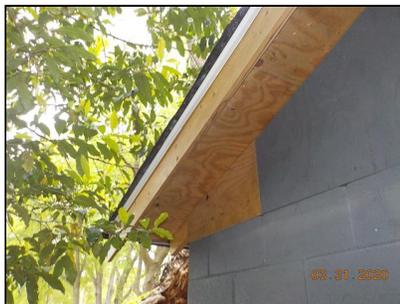
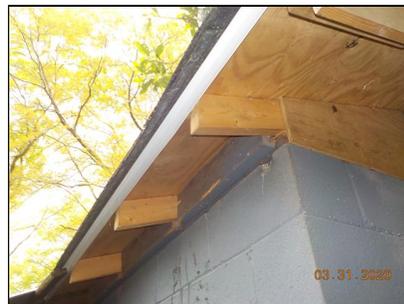
❌ ♦ **SERVECE / REPAIR:** Unpainted soffit and fascia boards noted. Prime, paint and caulk all exposed trim to extend life. Location: **Garage-right side and rear**

Unpainted soffit and fascia boards noted.

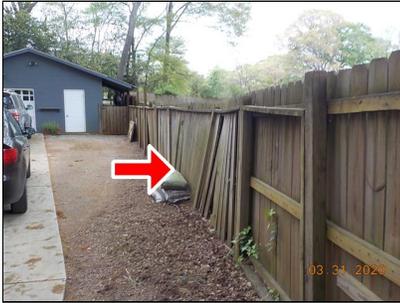
❌ ♦ **SERVICE / REPAIR:** Leaning sections of fencing noted. Have the posts evaluated and repaired/replaced.

Leaning sections of fencing noted.

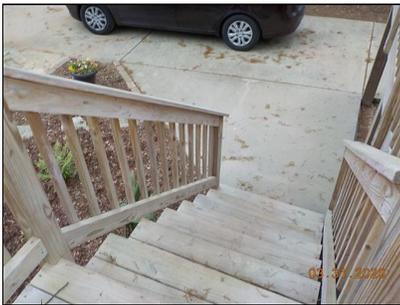
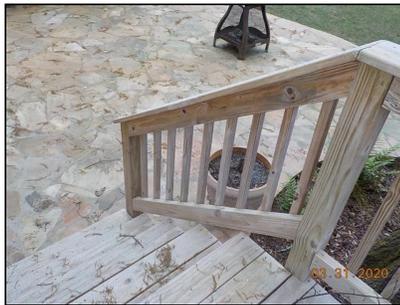
**❌** ♦ **SAFETY / HEALTH:** Handrails should have a gripable rail. Handrails shall have either a circular cross section with a diameter of 1 1/4 to 2 inches, or a non-circular cross section with a perimeter dimension of a least 4 inches but no more than 6 1/4 inches and a largest cross section dimension not exceeding 2 3/4 inches. Have a deck contractor evaluate and add as required.

Handrails should have a gripable rail.

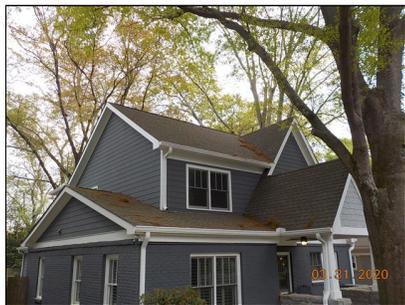
♦ **SERVICE / REPAIR:** Organic debris (leaves, sticks, etc.) is present on the roof covering. Removal of all debris is recommended to prolong the life of the roof.

Organic debris (leaves, sticks, etc.) is present on the roof covering.

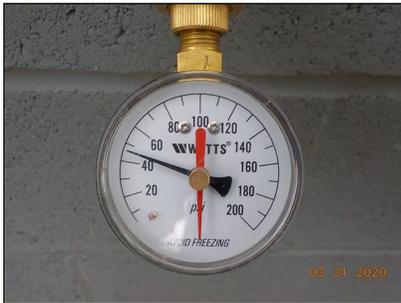
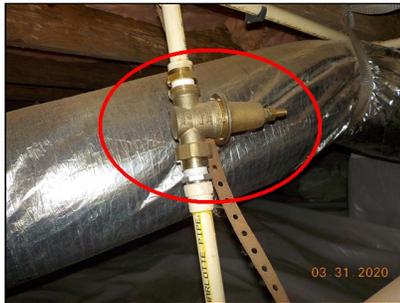
- ⏏ ♦ **GENERAL NOTE:** The water pressure was recorded at 48 PSI. The acceptable range is 40-80 PSI. If higher pressure is desired, have the pressure regulating valve (PRV) adjusted by a qualified plumber.

The water pressure was recorded at 48 PSI. PRV is located in the crawlspace.

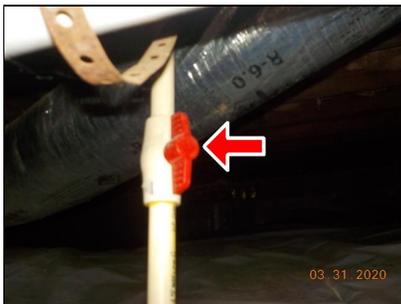
- ⏏ ♦ **GENERAL NOTE:** The main water shut off valve is **located in the crawlspace.**

The main water shut off valve is located in the crawlspace.

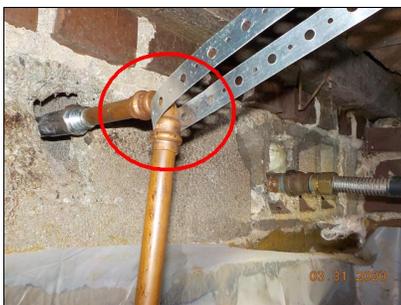
- ⊗ ♦ **SERVICE / REPAIR:** Copper supply pipe found touching steel. When copper or copper alloy tubing and galvanized steel touch it causes a reaction in the copper which will lead to pitting and holes in the copper pipe over time and accelerated corrosion of the steel. Recommend correct to prevent leaks and deterioration of plumbing system. Location: **Crawlspace-at the main water line**

Copper supply pipe found touching steel.

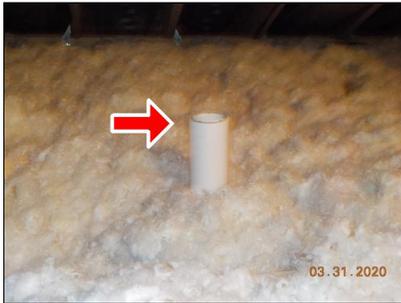
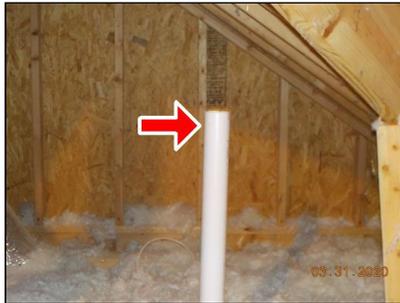
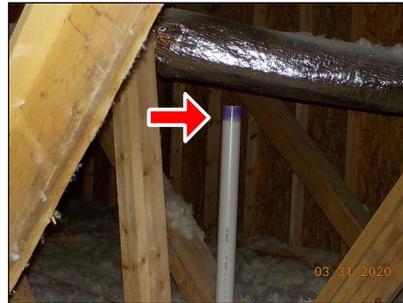
**❌** ♦ **SERVICE / REPAIR:** Plumbing vent piping terminates in the attic and this is not allowed. The piping must terminate on the exterior. One option would be to cap each pipe with a Studor vent. This allows air in but no sewer gases are expelled into the attic space. Recommend further evaluation and code verification by a licensed plumber.

Plumbing vent piping terminates in the attic

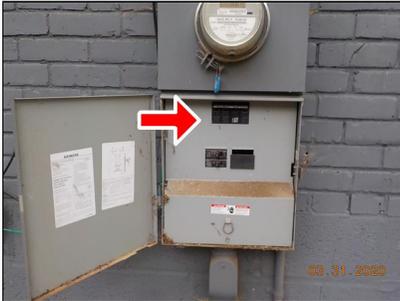
- ☑ ◆ **GENERAL NOTE:** The main electrical disconnect is located at the meter.

The main electrical disconnect is located at the meter.

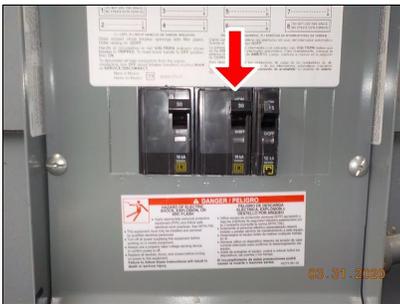
- ✘ ◆ **SAFETY / HEALTH:** The installed breaker is incompatible with the rating listed on the manufacturer label on the A/C condensing unit. Replacement breaker of appropriate size is necessary to provide designed overcurrent protection. Recommend a licensed electrician to evaluate the condition and correct.

**Max. overcurrent device per manufacturer label: 25 amps - Size of overcurrent device found: 30 amps**

A/C breaker is too large

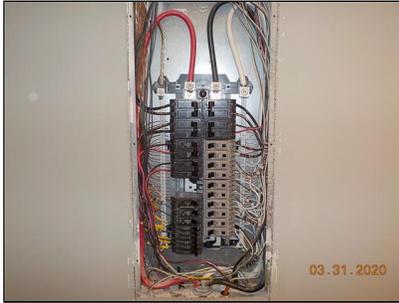
- ☑ ◆ **GENERAL NOTE:** The electrical panel cover was removed and the wiring inspected. No defects were noted.

The electrical panel cover was removed and the wiring inspected.

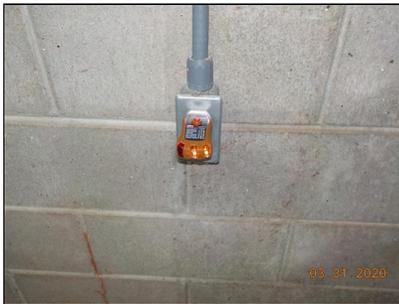
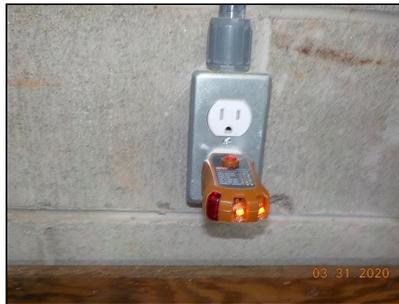
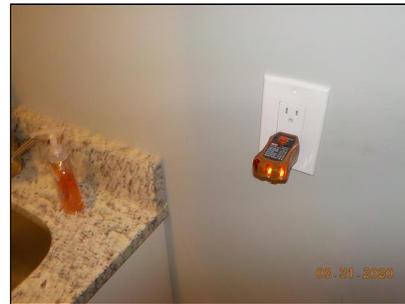
♦ **SAFETY / HEALTH:** GFCI protection is missing. GFCI (ground fault circuit interrupter) protected devices are required to be installed at these location when built/renovated for protection from electrical shock. Have corrected by qualified electrician. Locations: **Garage, laundry room**

GFCI protection is missing.

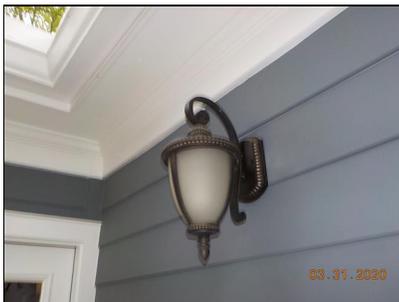
♦ **SERVICE / REPAIR:** Inoperable light noted. Replace bulbs and verify that the fixture is operational. If not, consult an electrician for repairs. Location: **Deck**

Inoperable light noted.

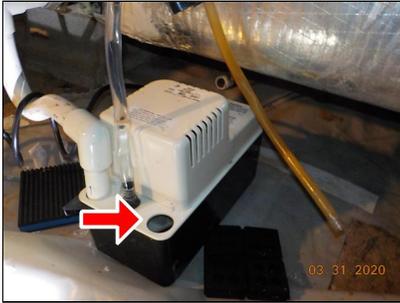
**GENERAL NOTE:** Cleaning the condensate pump reservoir and flushing the line with water is recommended at least twice a year to remove biological growth and reduce the possibility of the drain line becoming clogged.

Cleaning the condensate pump reservoir and flushing the line with water is recommended at least twice a year

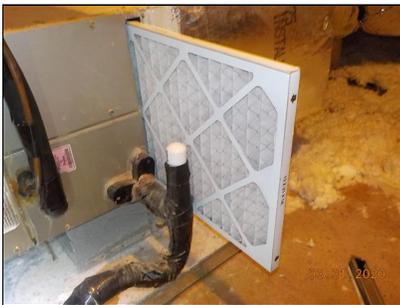
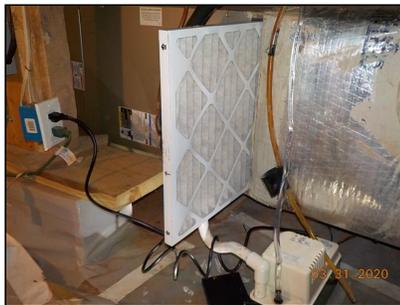
**GENERAL NOTE:** Recommend changing the filter at move-in. Recommend changing filter every two to three months thereafter. Use a good quality, pleated filter that is rated MERV-8 or better. The filter size is: 13 x 21 x 1, 16 x 21 x 1

Recommend changing the filter at move-in.

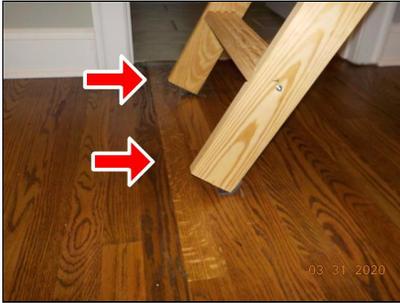
**SERVICE / REPAIR:** The pull down ladder leading to the attic area is not cut to the appropriate length. The base of the ladder needs to be cut so that it sits flatly on the floor.

The base of the ladder needs to be cut so that it sits flatly on the floor.

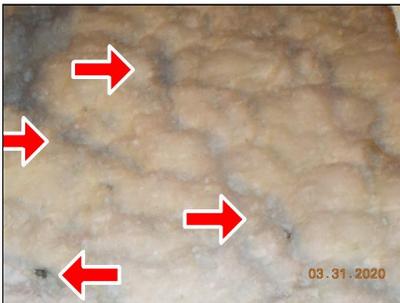
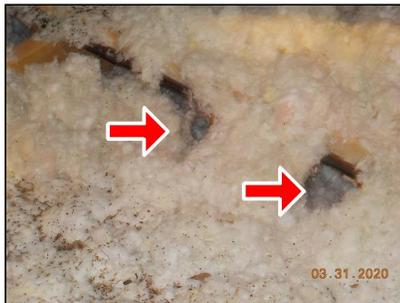
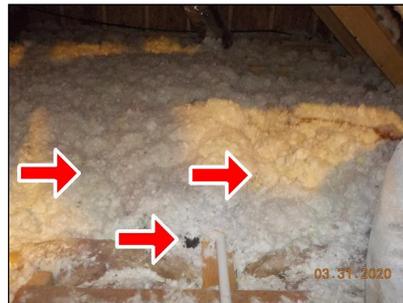
**SERVICE / REPAIR:** Signs of past rodent activity noted. Tunnels and trails through the insulation. Seek disclosure from the seller regarding any efforts taken to eliminate the pests. If none, recommend a complete evaluation and service performed by a qualified pest control contractor.

Tunnels and trails through the insulation.

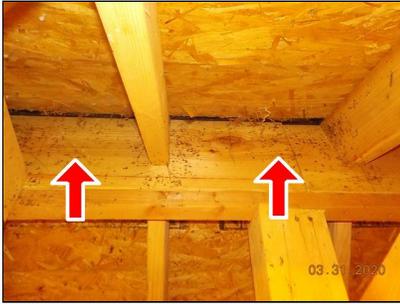
**SERVICE / REPAIR:** Roach droppings noted in the **attic area**. Recommend further evaluation and service performed by a qualified pest control contractor.

Roach droppings noted

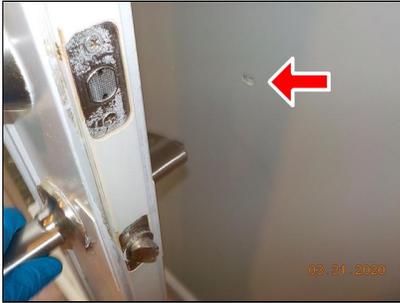
- ♦ **SERVICE / REPAIR:** Hole in the drywall from door knob, where stoppers failed to function as designed. Have drywall repaired and painted to match existing. Consider having door stop replaced to protect assembly. Location: **Right deck door**

Hole in the drywall from door knob

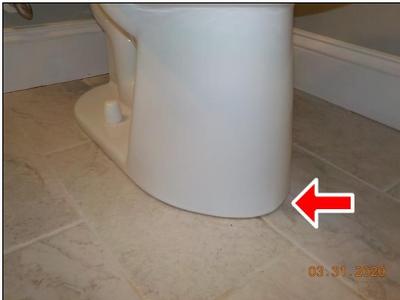
- ✘ **SERVICE / REPAIR:** Toilets should be sealed between the base and floor as required. This helps protect below the unit from contaminates and better holds the unit in place to avoid rotating. The plumbing code also requires caulking fixtures to their mounted surfaces. **Note:** Recommend using clear caulk on darker floor surfaces

Toilets should be sealed between the base and floor

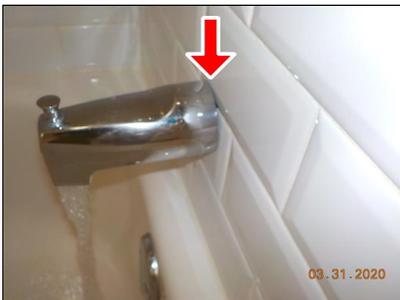
- ✘ **SERVICE / REPAIR:** Fill spout is not tight to the tub wall. Modify and seal to prevent moisture access behind wall assembly. Location: **2nd floor bathroom**

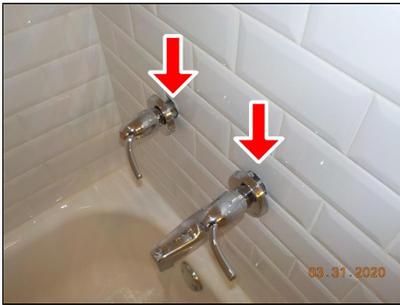
- ❌ ♦ **SERVICE / REPAIR:** Loose fixture noted. Recommend further evaluation and repairs made by a qualified plumber.  
Location: **2nd floor bathroom**

Loose fixture noted.

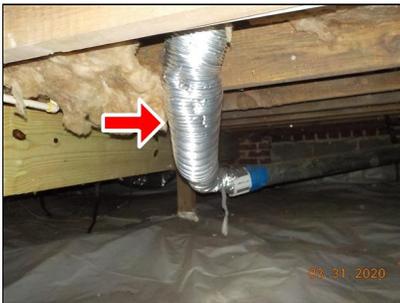
- 🔍 ♦ **GENERAL NOTE:** Recommend that the dryer connecting vent be metal and that it be sealed to the rear of the dryer and the wall vent with metal foil tape to prevent lint from entering the house.
- ❌ ♦ **SAFETY / HEALTH:** The dryer exhaust vent uses flexible metal piping running through the crawlspace. This is only to be used as a connector from the dryer to the wall. Large numbers of house fires have been attributed each year to improper dryer exhaust installations. The system should be run through 4 inch metal piping to exterior for safety and manufacturers specifications on dryer units. The line should be a 25 foot maximum run with mechanical tape attachments [NO screw attachment of sections].

The dryer exhaust vent uses flexible metal piping running through the crawlspace.
