## Property Inspection Report

2475 Rutherford St NW, Atlanta, GA 30318

Date of Inspection: 3/10/2020 Time: 1:00 PM

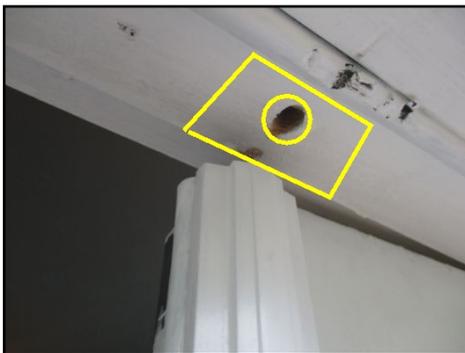
Missing striker plate observed on the french doors on the left side of the house

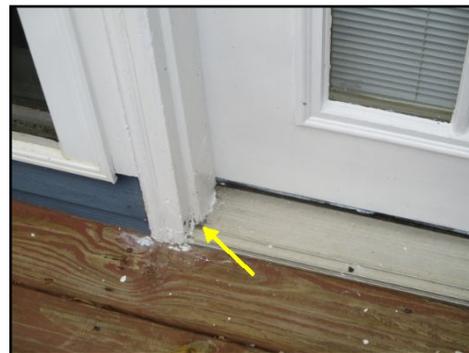
Moisture damage observed on the french doors on the left side of the house

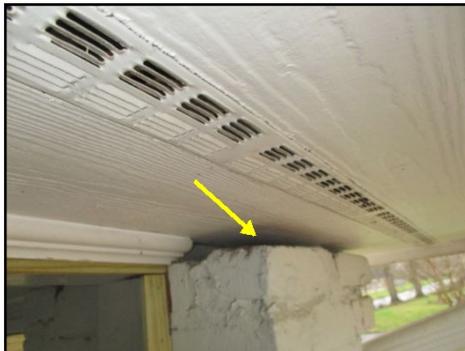
- Open construction gap observed. Recommend further evaluation by a qualified contractor.

Open construction gap observed on the front porch

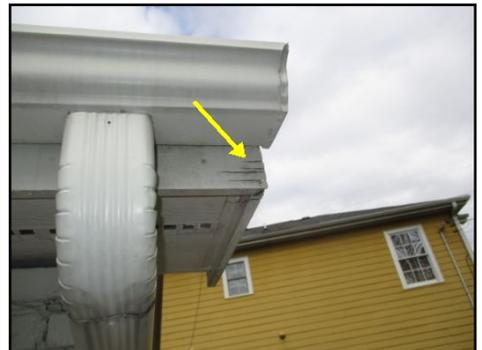
Moisture damage observed on the front of the house

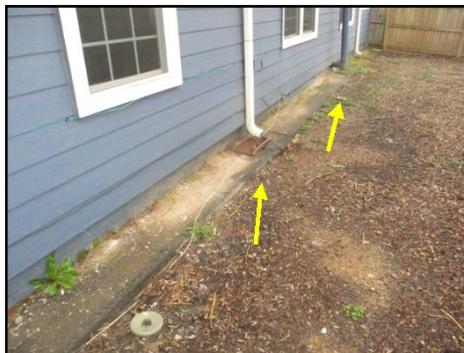
- *Faulty grade observed on the right side of the house. Proper grade should be 6" of fall per 10' away from the house. Recommend further evaluation by a landscape professional.*

Faulty grade observed on the right side of the house

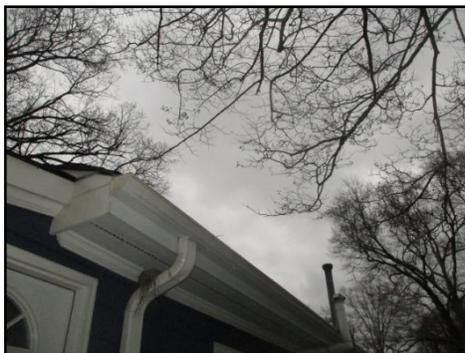
- *Tree limbs within 10 feet of roof should be trimmed away to provide air and sunlight to roof, while minimizing debris & dampness.*

Overhanging tree limbs observed

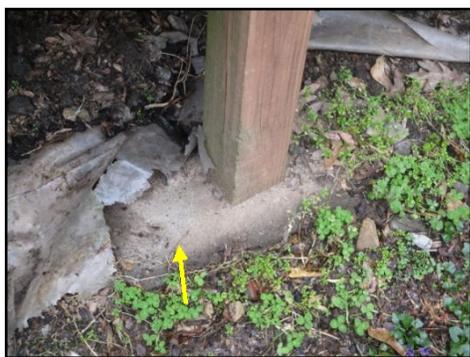
Temporary supports observed below the back deck

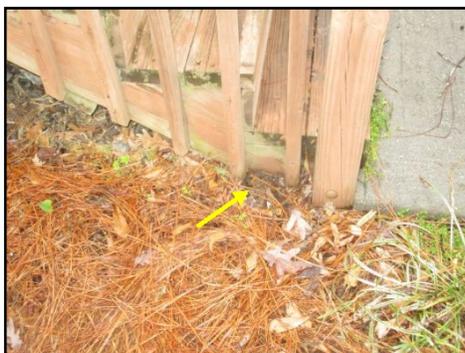
Wood to ground contact observed on the wood steps on the front of the house

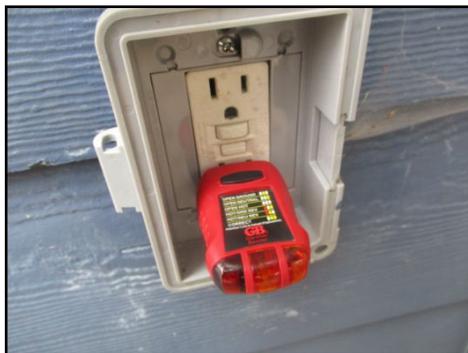
- *The outlet on the front porch did not function properly. Recommend further evaluation by a licensed electrician.*

The outlet on the front deck did not appear to be functional

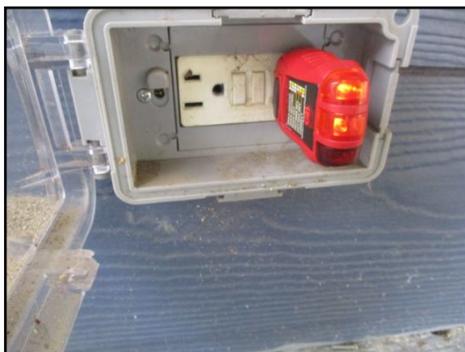
- *The GFCI protected outlets did not function properly during the inspection. Recommend further evaluation by a licensed electrician.*

The outlet on the front patio did not trip when tested

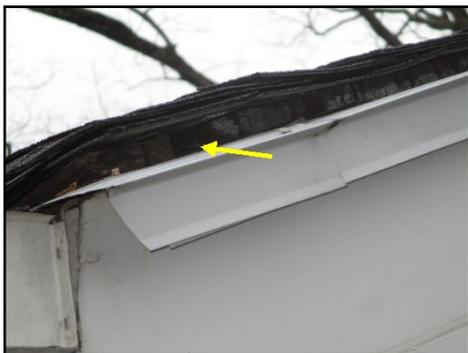
Wood rot observed on the roof decking on the front of the house

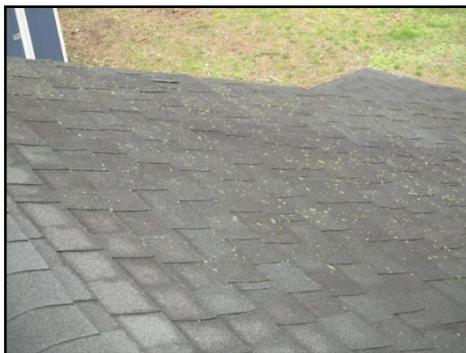
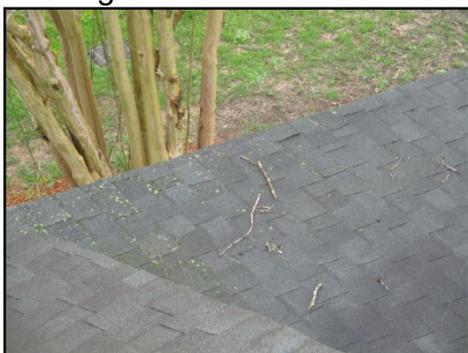
Lichens observed on the roof shingles

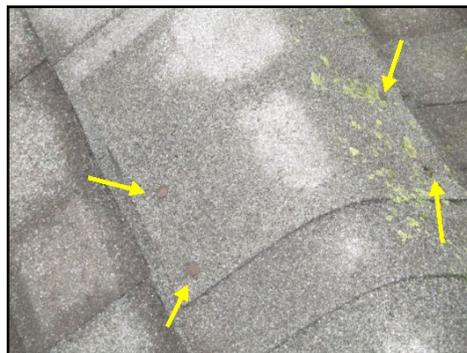
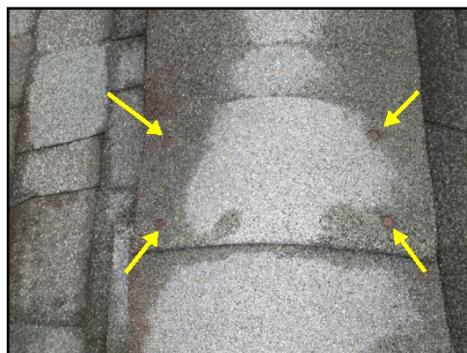
Exposed roof nails observed

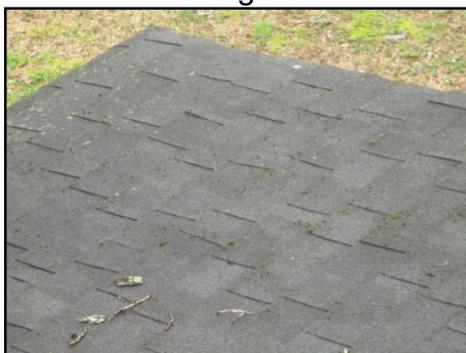
- *Algae growth observed on roof shingles. This can lead to the premature failure of the roofing materials. Consider further evaluation by a trusted roofing company.*
- *Exposed nails on roofing material. Recommend sealing all fastener heads.*

Algae growth observed on the back right corner of the house

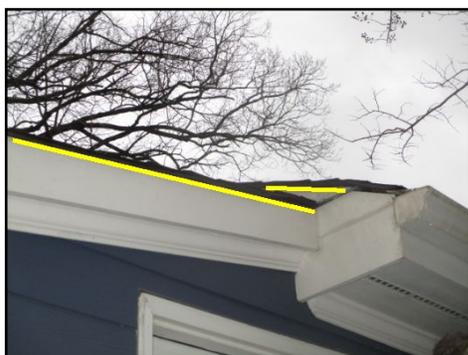
- *Missing drip edge flashing observed around the fascia board on the back of the house. Recommend further evaluation by a qualified roofing contractor.*

Areas of missing drip edge flashing on the back of the house

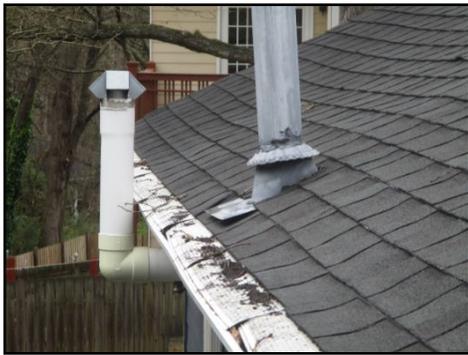
- *Unsecured vent caps observed. Consider further evaluation by a qualified roofing contractor.*

Unsecured vent observed on the roof

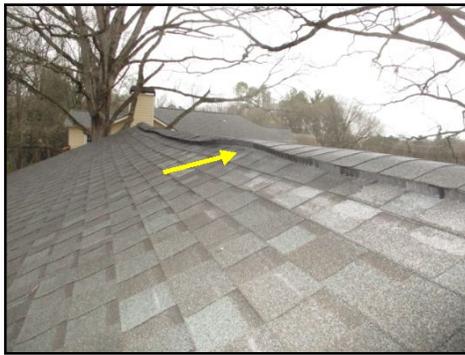
Raised ridge vent observed

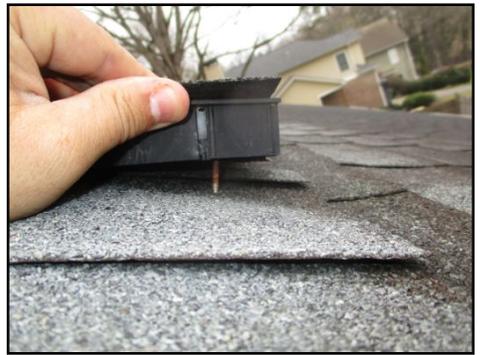
Unsecured ridge vents observed

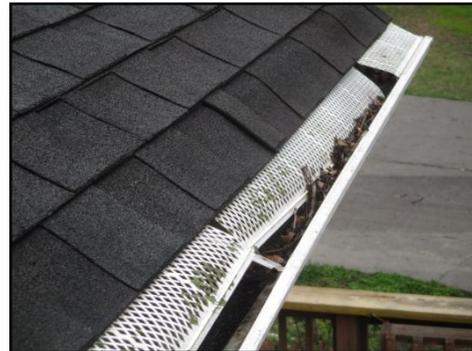
Organic debris observed in the gutters

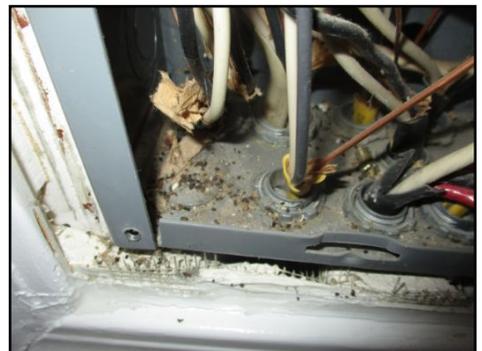
Rodent droppings observed inside of the gas furnace

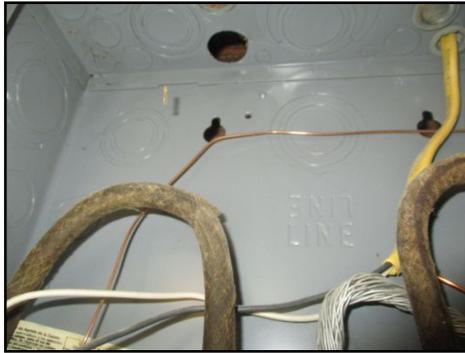
Missing grommet observed in the top of the electrical panel

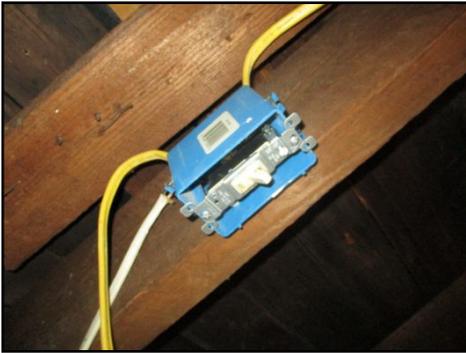
- *Exposed junction boxes. Recommend further evaluation by a licensed electrician.*
- *Wire connections observed outside of a junction box. Recommend further evaluation by a licensed electrician.*

Exposed electrical observed in the attic space

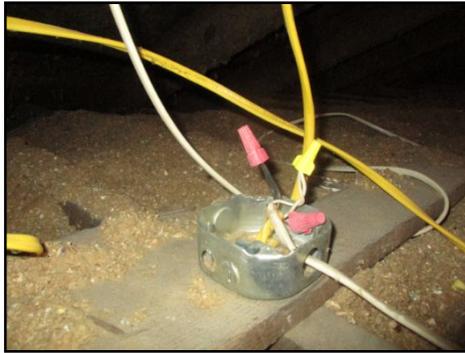
Wire connection observed outside of a junction box

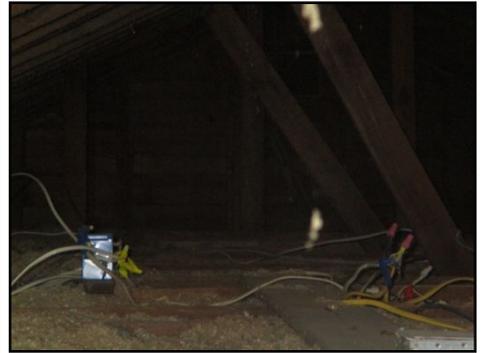
Wire connections made outside of the junction boxes

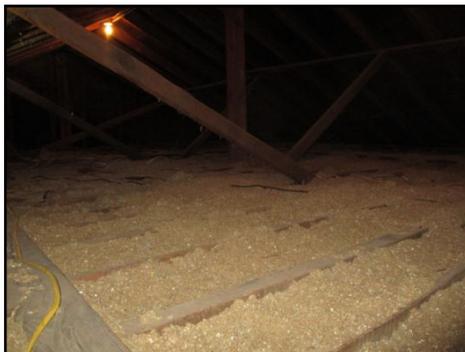
- *Insulation appears inadequate. Insulation depth is less than 4" several areas. Recommend adding insulation to achieve a consistent R-30 Value/ or 13+ inches.*

Thin insulation observed in the attic space

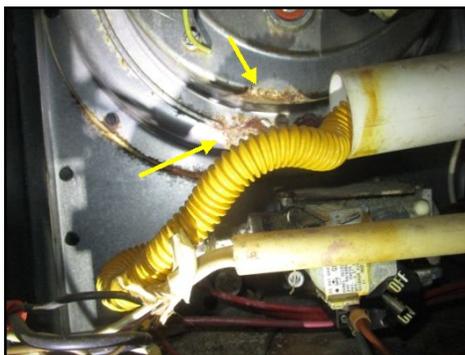
- *Rust observed inside of the gas furnace. Consider further evaluation by a trusted HVAC technician.*

Rust observed inside of the gas furnace

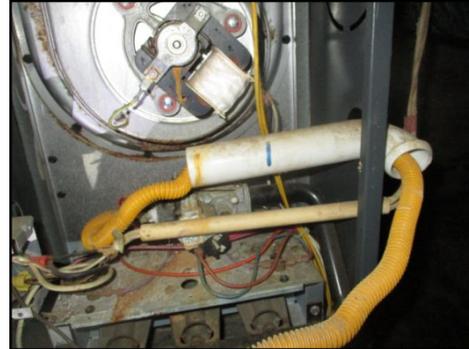
Flexible gas line observed inside of the gas furnace

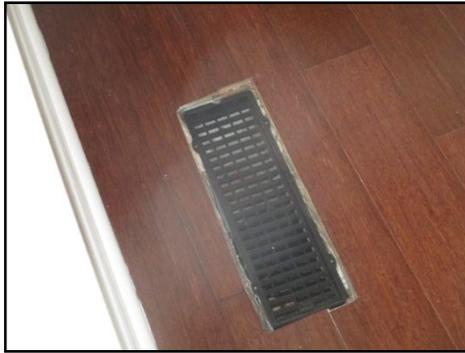
- Improper size of the register in the secondary bedroom. Consider further evaluation by a qualified contractor.

Improper fitting register observed in the middle bedroom on the right side of the house

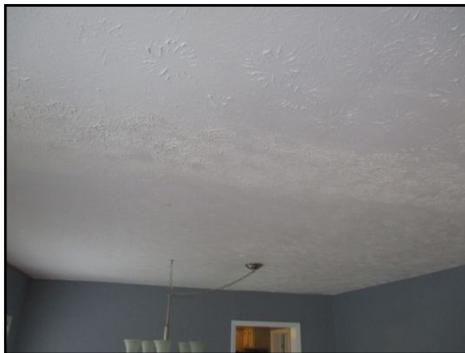
Ceiling repair observed in the living room

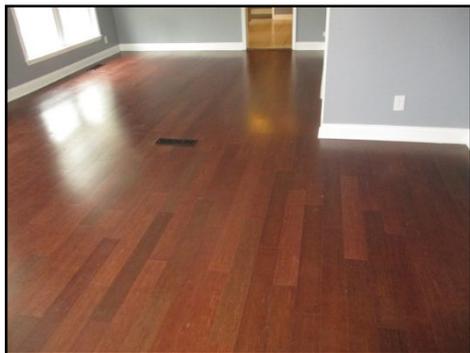
- Unlevel flooring observed throughout the house. Consider further evaluation by a qualified contractor.

Unlevel flooring observed throughout the house

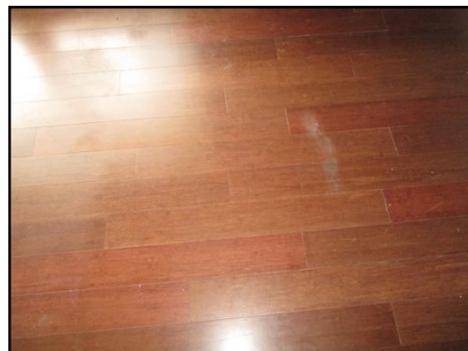
Soft flooring observed in the right middle bedroom Scratches observed on the flooring the bedrooms

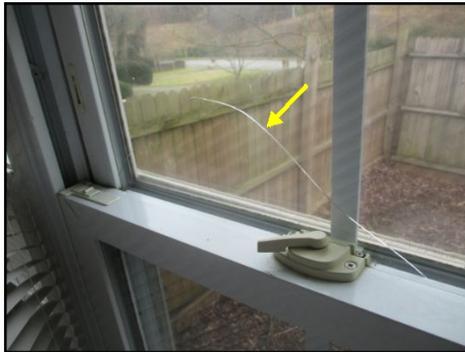
- *Broken window observed in the back right bedroom. Recommend further evaluation by a qualified contractor.*

Broken window observed in the back right rear bedroom

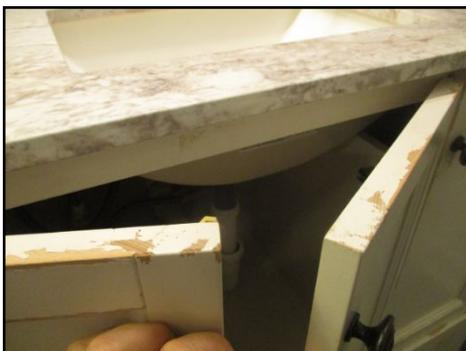
Peeling paint observed in the master bathroom

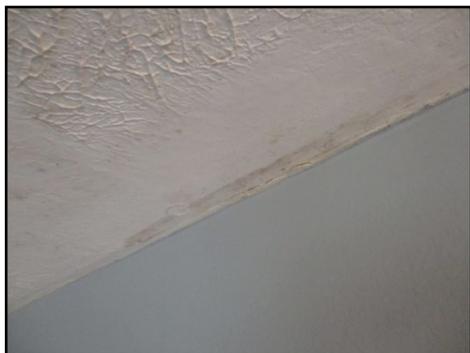
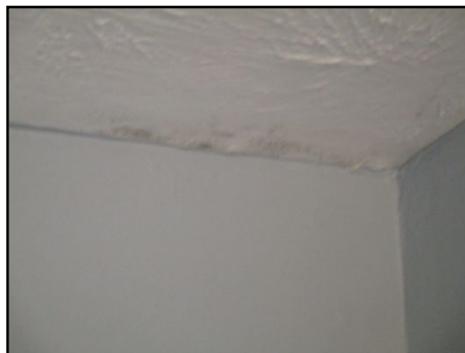
- Possible mold like bio growth observed on the bathroom ceiling in the rear bathroom. Recommend further evaluation by a qualified contractor.

Suspected Microbial growth observed on the ceiling in the rear bathroom

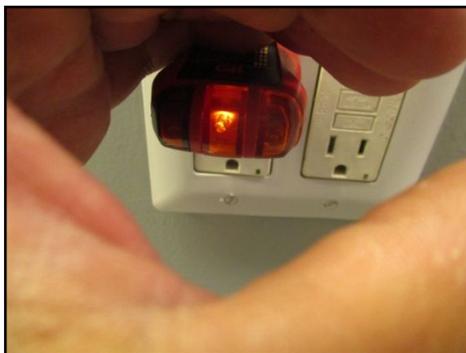
- The outlets in the master bathroom did not appear to be wired properly. Recommend further evaluation by a licensed electrician.

The outlets in the master bathroom did not appear to be wired properly

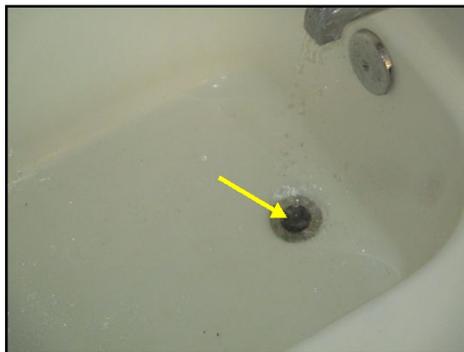
- Missing stopper observed in the bath tub in the rear bathroom.

Missing stopper observed in the rear bathroom tub

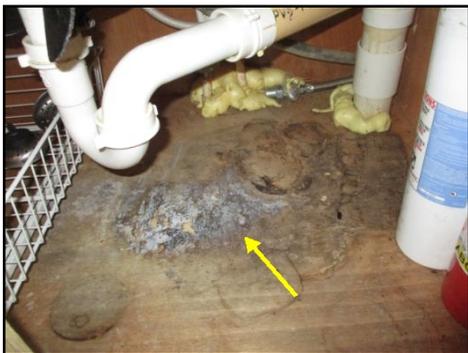
Possible mold like bio growth observed below the kitchen sink

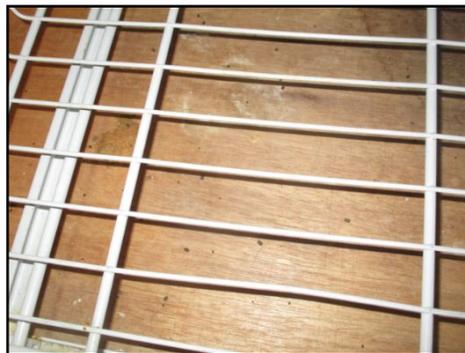
Rodent droppings observed below the kitchen sink

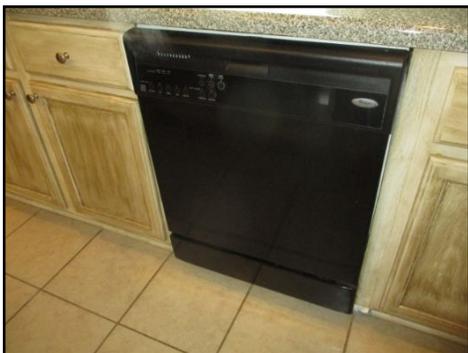
- *Operational, Full cycle run successfully, but appears to drain into the crawlspace. Recommend further evaluation by a licensed plumber or qualified appliance repair technician.*

The Whirlpool dishwasher appeared to be draining into the crawlspace

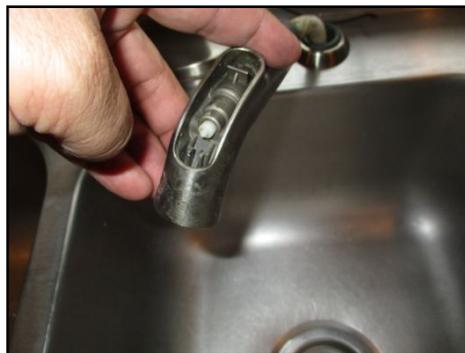
Damaged spray wand was observed at the kitchen sink

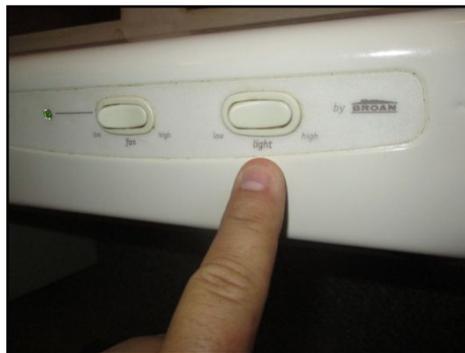
The light below the vent hood was not functional

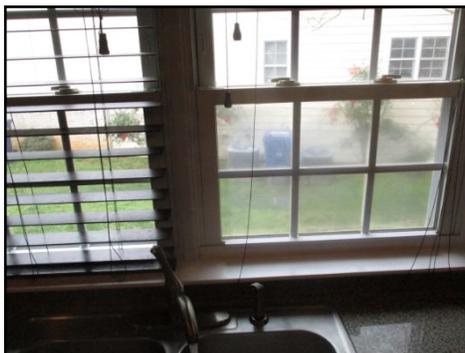
- *Hazy window observed in the kitchen. Recommend further evaluation by a qualified contractor.*

Hazy window observed above the kitchen sink

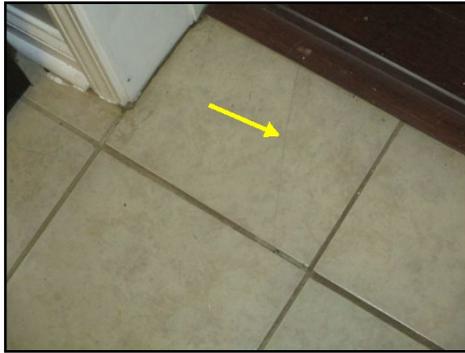
Crack observed on the kitchen floor

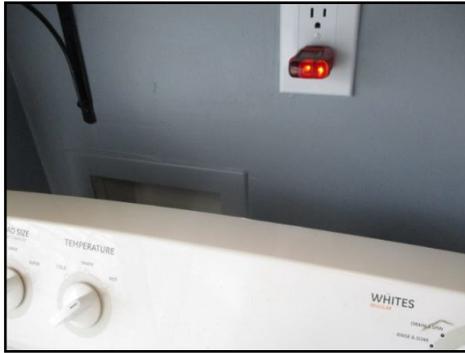
- *The laundry receptacle should be GFCI protected type.*

The laundry room outlet was not GFCI protected

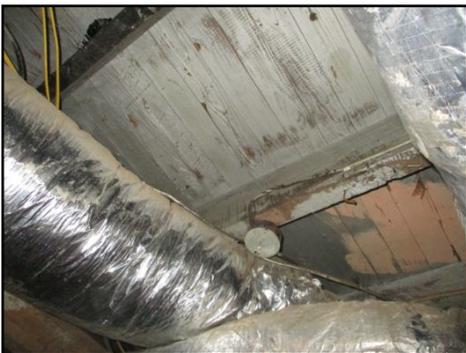
Paint overspray observed on the floor joist in the crawlspace

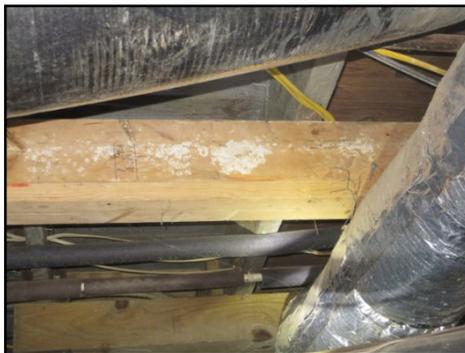
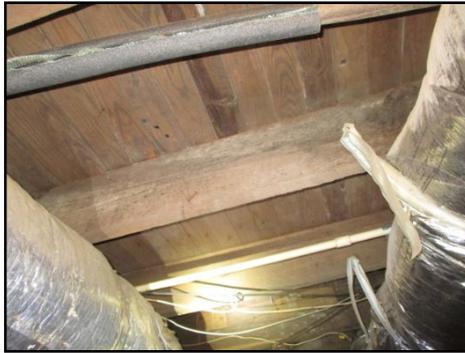
Suspected Microbial growth observed on the structural members in the crawlspace

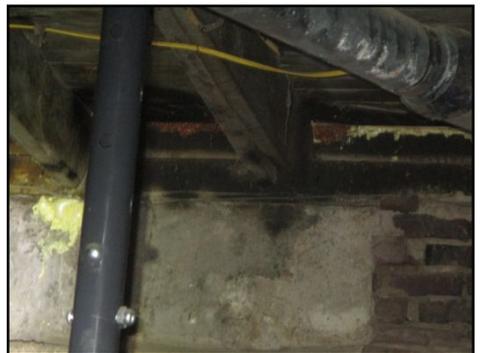
Black residue observed in sections of the crawlspace

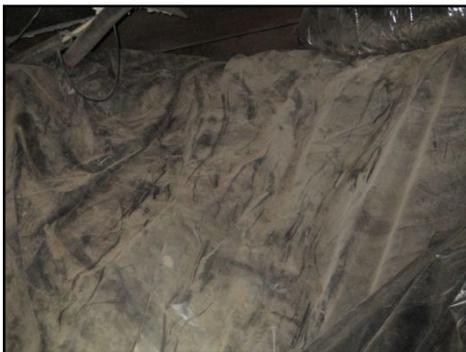
Rodent trails observed on the vapor barrier in the crawlspace

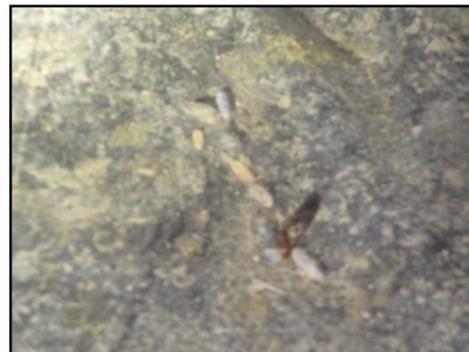
Rodent droppings observed in the crawlspace

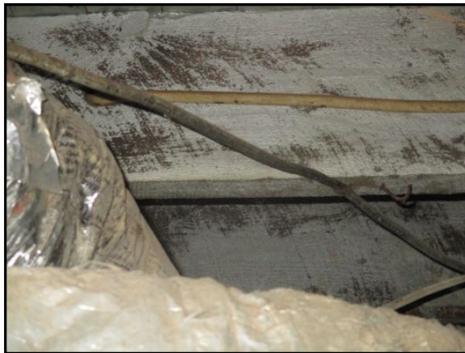
- *Old style wiring observed in the crawlspace. Consider further evaluation by a licensed electrician.*

Old style electrical wires observed in the crawlspace
