CALGARY AIRPORT CASE STUDY

ETHELYNE GLYCOL BIO-REMEDIATION

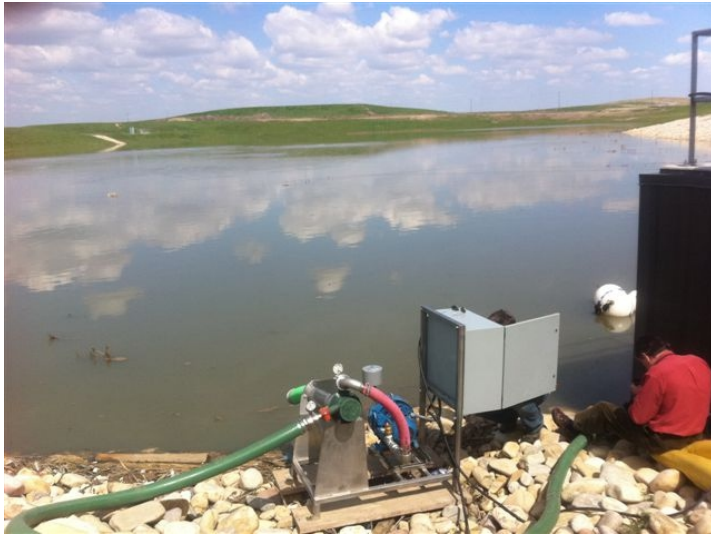
- Hydro Processing installed a 100gpm aerator on the edge of the pond.

Hydro Processing's Aerator being installed at Calgary Airport pond

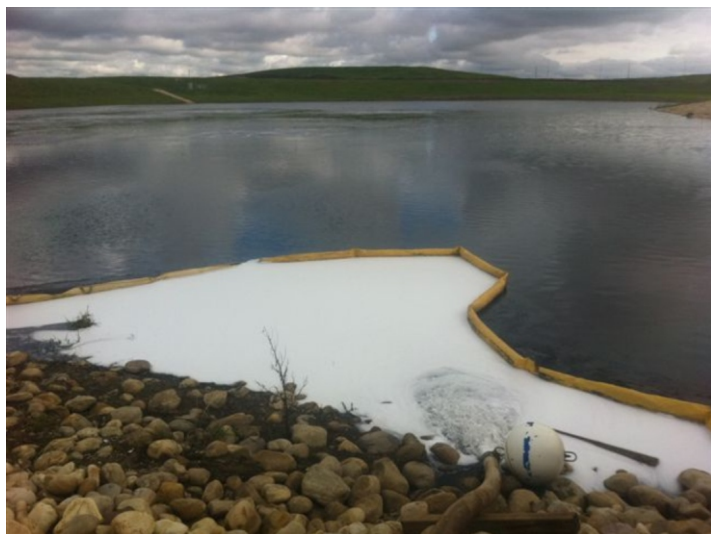
- One 100gpm aerator would not produce enough froth to cover this pond, so a containment boom was put in place to restrict the froth's distribution.

The boom installed to contain produced froth

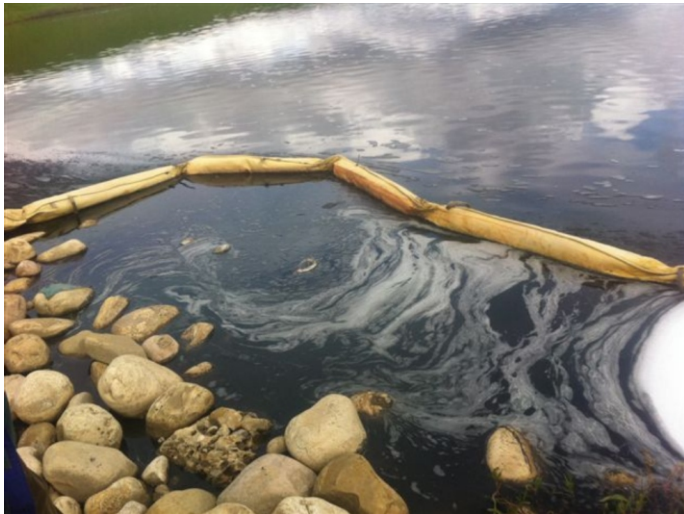
- As a result, the Aerator still possesses flotation/separation qualities.
- These qualities resulted in the building of an oil slick on the pond.
- The Aerator had “floated” the “oil” to the surface. See picture below. Note: inside the boom the surface is not shiny and there is black between and on the rocks.

Oil slick produced by the Aerator

- The dosing pump failed some time during the night resulting in no bacteria addition and no froth being created.
- A version of Hydro Processing's Aerator was initially invented to supply nano and micro size bubbles for the flotation/separation industry.

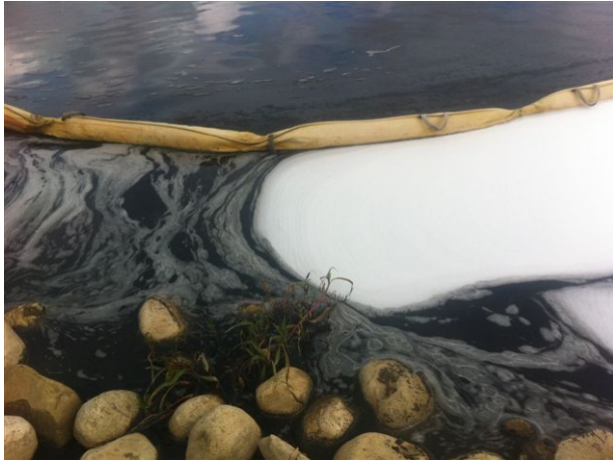
The Froth Cap spreading over the oil slick

- The dosing pump was restarted and the Froth Cap was developed.
- The froth produced by the Aerator is very stable and dense. It can be built up in depth as required. Throughout these pictures it should be noticed that as the Froth Cap built up, the froth actually pushed the boom out into the pond maximizing the round shape of the boom.

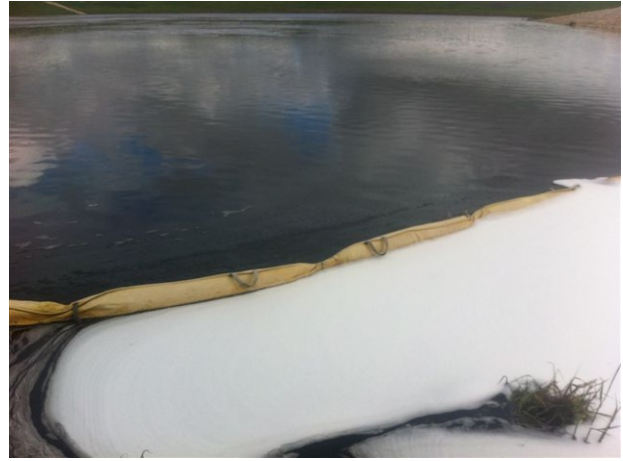
The Froth Cap spreads over the oil slick, over rocks and between grasses.

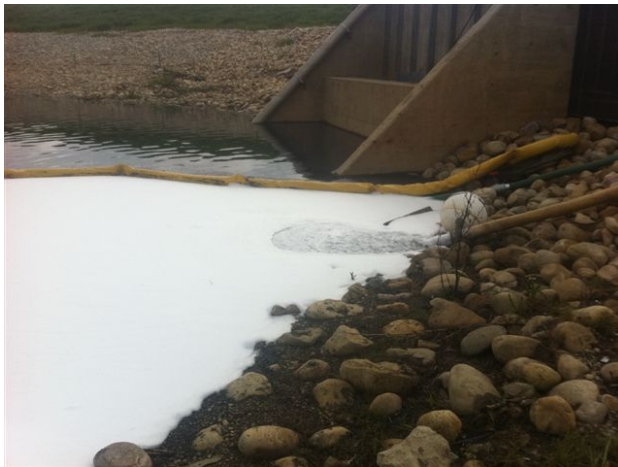
The Froth Cap pushing out the boom and covering the area inside the boom

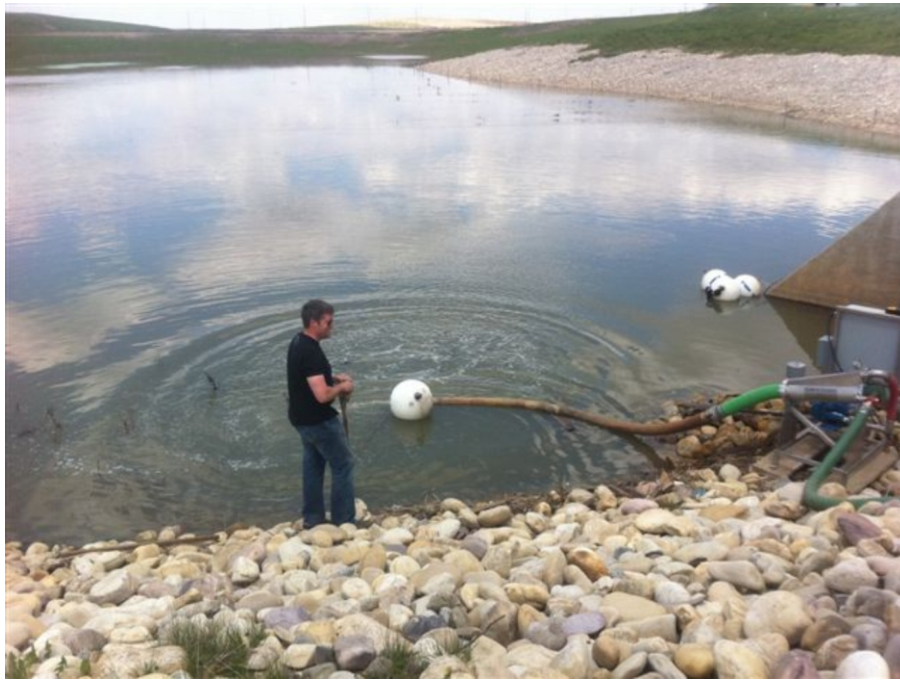
The pond and shore while dismantling the SAR Aerator experiments, no oil present.

- The Froth Cap covered the entire oil slick and was left to run for approximately 4 hours.
- On returning, it was observed that there were bubbles the coloured with primarily reds and blues and visible activity inside some of the larger bubbles.
- When the Froth cap was pushed aside where the oil slick had been, there was no longer an oil slick.
- The boom was removed to see how extensively the froth would travel before dissipating in the pond. (see the video below)
- After observing this miraculous disappearance of the oil slick from the surface of the pond and the rocks surrounding the pond inquiries were made with professors of biology at the University of Calgary.
