COLLECTIONS ASSESSMENT FOR PRESERVATION REPORT

# El Pueblo de Los Angeles Historical Monument

*April 2021*

**HISTORIC RESOURCES GROUP**

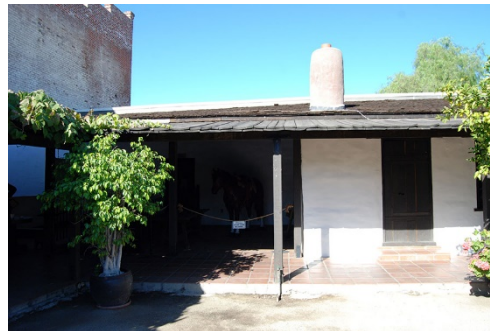
The roof was repaired/replaced about five years ago; there are no current leaks. Wood shingles and plank roofing are in good to fair condition, with normal aging due to full daylight heat and light exposure.

Figure 1: Wood shingle and plank roofing at east wall and corridor.

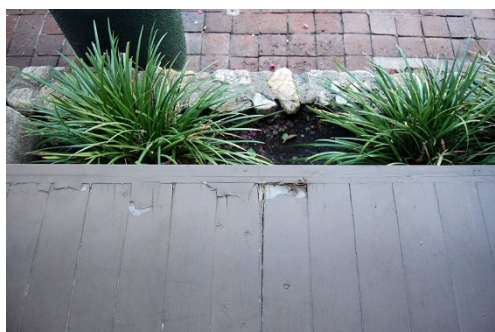
Figure 4: Damage at floor porch boards.

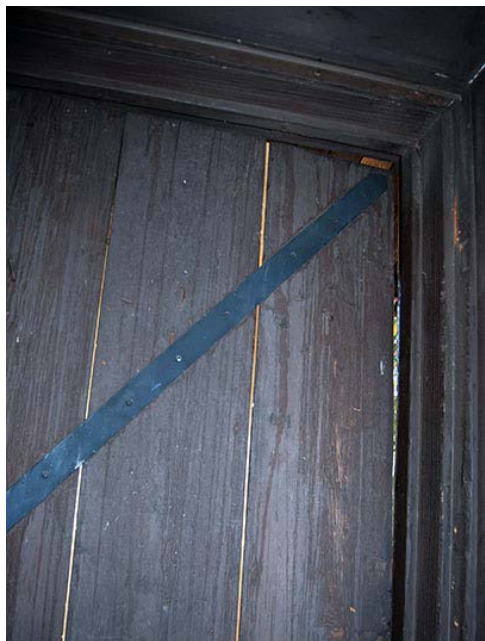
Figure 7: Daylight at exterior opening

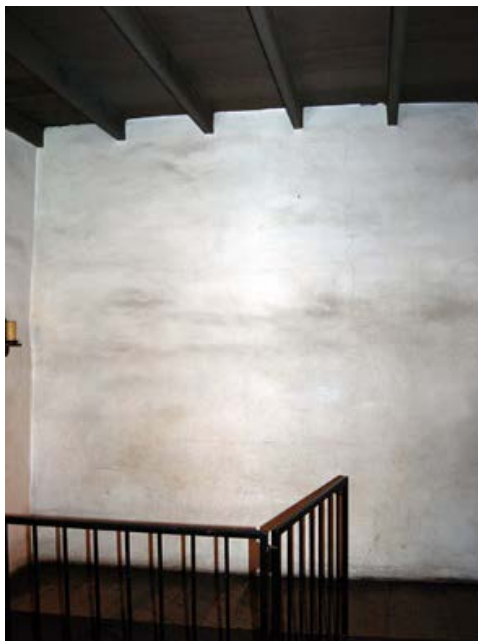
Figure 10: Soil at plaster finishes

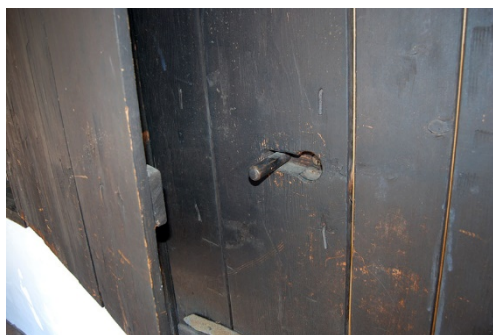
Figure 8: Wear at wood finishes

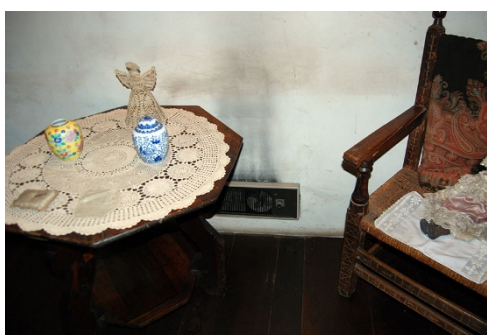
The electrical panels appear to be relatively new and in good condition. It is not known if the distribution, appliances, and wiring devices have been recently inspected for safety and operation. There are electrical wall heaters that are understood to not be in operating condition or are not used. There are power receptacles that are not in good condition.

Figure 11: Wall heater

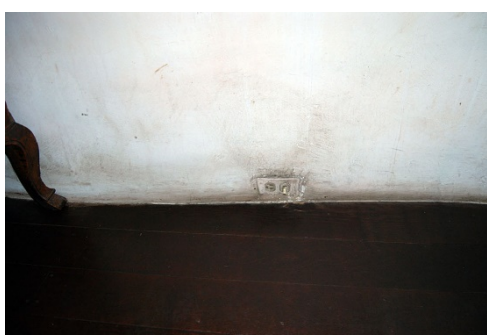
Figure 12: Damaged and unprotected power receptacle.

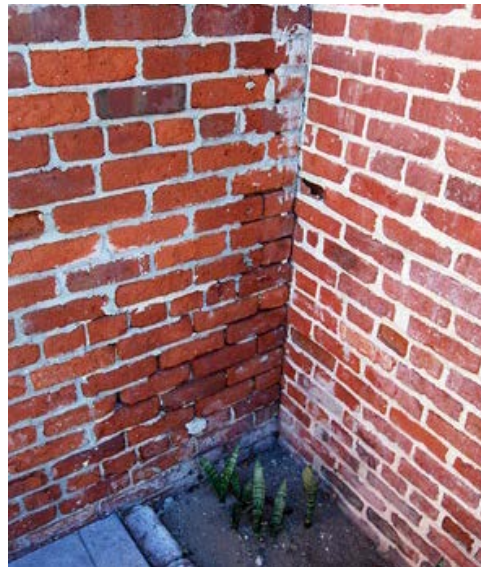
The most notable problem with the firehouse is the deterioration of bricks on both the exterior wythe and the interior wythe at some locations. Exterior spalling, disaggregation (exterior and interior) of the components of a brick bearing wall and substantial loss of mortar is a serious problem. These conditions usually result from a combination of water infiltration that transports salts through the bricks and mortar, and bricks and mortar that are soft. Nineteenth century bricks in Los Angeles may not be uniformly

Figure 16: Eroded brick, mortar loss, poor mortar repointing profiles, with mismatched mortar composition (rear of Hellman/Quon building to left of inside corner).

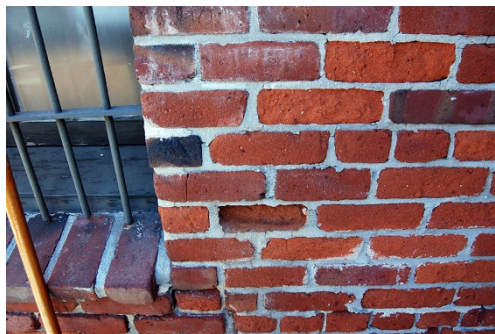
Figure 17: Eroded brick, mortar loss, poor mortar repointing profiles, with mismatched mortar composition (rear of Hellman/Quon building).

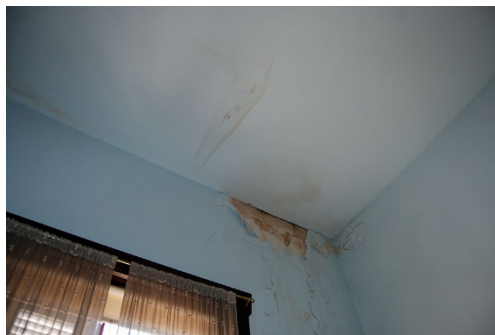
While there is evidence of water damage from roof leaks, there have been recent repairs. Unfortunately, roof repairs are ongoing. The damage to exterior brick walls raises concerns about water infiltration at the roof, roof-to-wall conditions, and the porosity of the walls.

Figure 18: Water damage at ceiling and exterior wall.

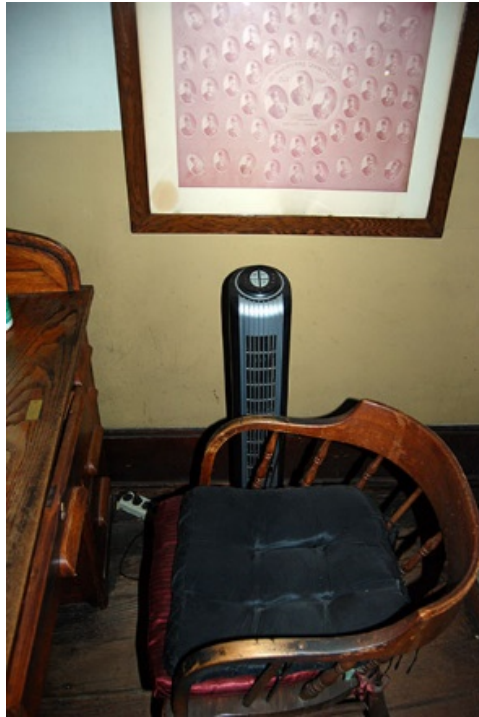
There is no heating, ventilating, and cooling system. Staff and volunteers use portable electrical space heaters for comfort at workstations.

Figure 24: Portable electrical space heater for comfort near workstation.

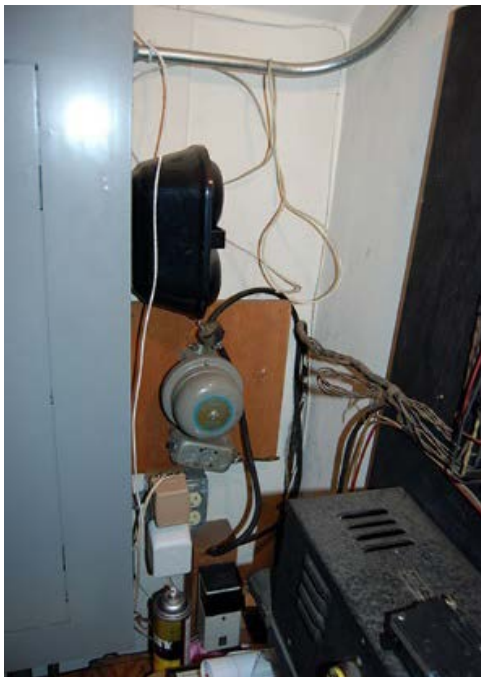
Figure 23: Equipment, clutter, dust, loose wiring, and aerosol can.

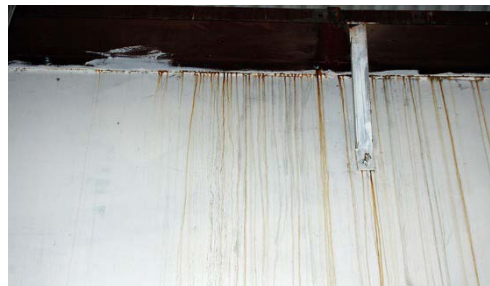
Figure 26: Water stains at interior surface of exterior concrete wall at connection to roof framing

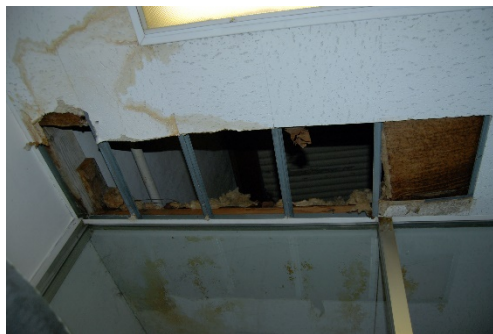
It is reported that the roof has been repaired and there have not been roof leaks recently. There is substantial water damage from old leaks at the west side of the building where office partitions and dropped ceilings are inserted in the larger, taller volume of the building.

Figure 27: Water damage at suspended ceiling

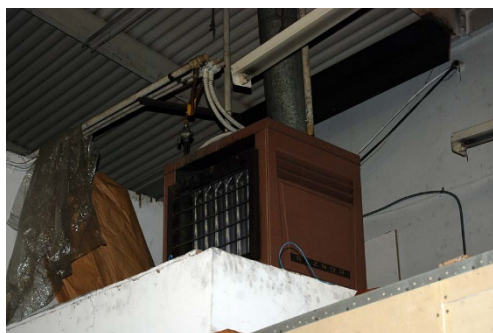
Figure 29: Gas-fired space heater.

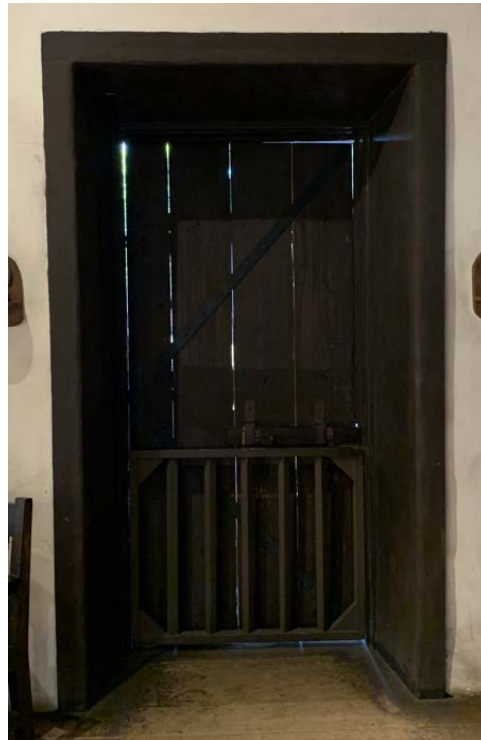
The Avila Adobe holds the majority of the artifacts at this site, aside from those mentioned on display outdoors. The structure is made from traditional adobe and not climate controlled by modern HVAC systems or any other type of environmental controls. Though there is fluctuation in temperature and humidity in the house, there is currently no environmental monitoring system for the building. During normal operations, doors are kept open, which may lead to strong fluctuations in both temperature and humidity whenever it rains or there are heat waves. It also enables easy intrusions by insects and rodents. Large gaps in wood planks at the doors also enable pests to enter the

structure, even when all doors are completely closed. As previously mentioned, there is no pest management in place at the adobe.

Figure 1: Detail of large gaps within and around exterior door in the Family Room.

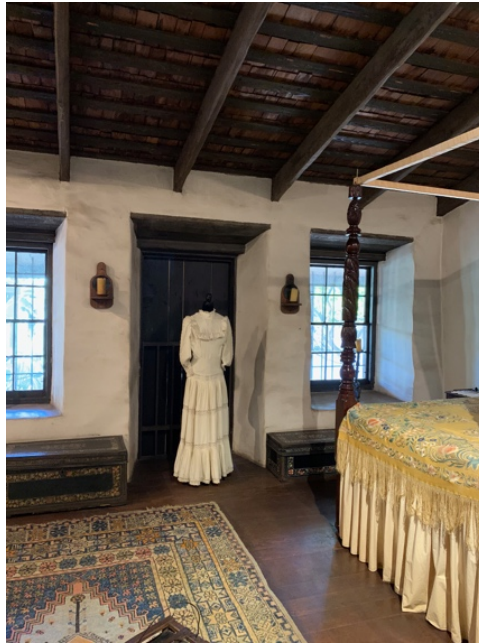
At the time of the assessment (around 2:15 PM) the Parents' Bedroom exhibited very high UV readings compared to all of the other rooms (UV reading of 708 when the next highest was 65 at the Children's Bedroom). This room has two windows, but also has many textiles, some period clothing, paintings, leather, and painted surfaces on display. Colorful surfaces can become damaged over time due to such high UV exposure. Again, additional readings should be taken in the spring and summer as UV will be stronger during these months and objects will be exposed to UV for longer periods of the day.

Figure 2: Overview of Parents' Bedroom with several multi-colored textiles and painted surfaces.

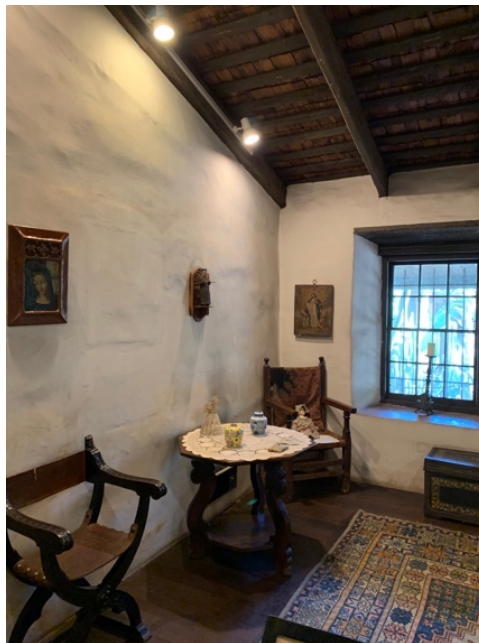
Figure 3: Additional view of Parents' Bedroom with additional leather, textile, and paintings subjected to direct UV light.

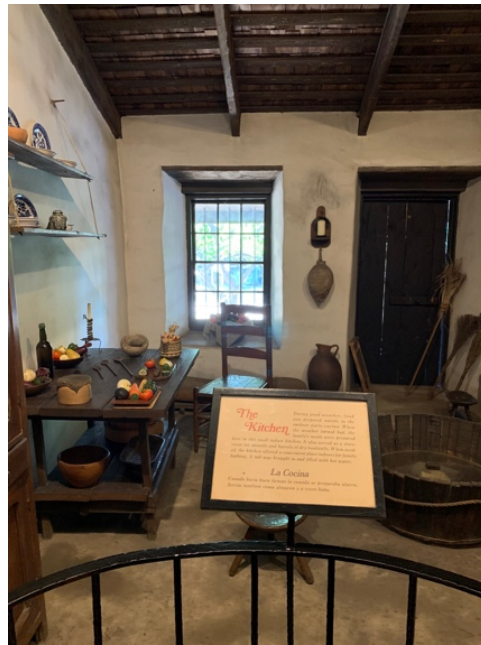
While the UV and visible light (lux) readings were lower in this room compared to the living quarters, the relative humidity was slightly higher at 40% compared to all of the other rooms, which were each between 37-38%. This is the only room with replica dirt floors compared to the rest of the structure, which has wood floors. This may account for the difference in relative humidity. Again, additional readings should be taken during summer months.

Figure 4: The Kitchen with crowded display areas with one window for natural light.

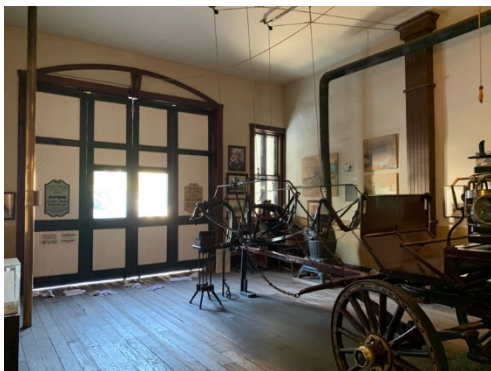
Figure 6: Overview of first floor of Firehouse facing north with strong light coming through barn door windows and side window. Also note gaps in doors and towels on floor.

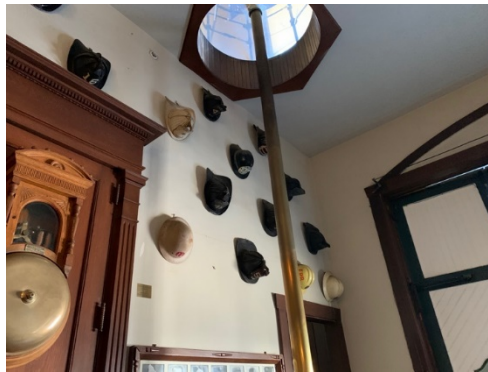
Figure 7: Detail of historic firefighting helmets loosely secured on the wall over a doorway and exposed to direct UV light.

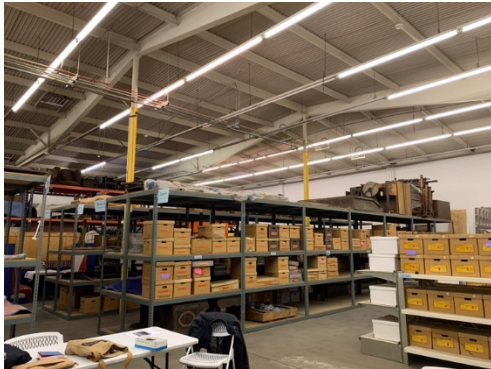
Figure 8: Overview of various types of storage in the open part of the off-site storage facility. Open shelving storage (left-hand and back), archival boxes (center), archeological collection in organized archival boxes (right-hand and front).

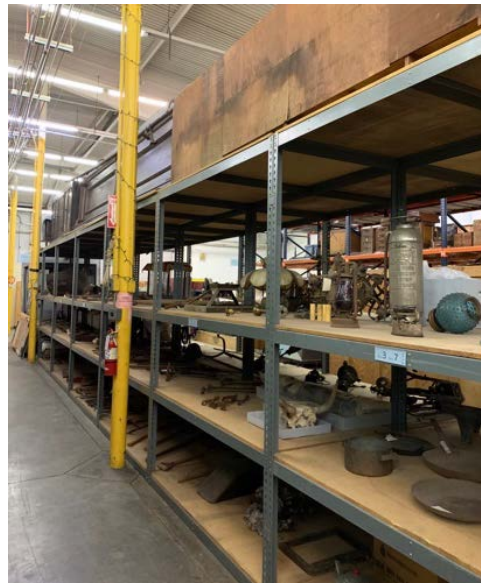
Figure 9: Detail of current open shelving storage with smaller objects on the bottom and large objects on top. Glass items are on higher shelves, but there is no netting or protection to keep objects from coming off of shelves in a seismic event. Shelves are mechanically fastened between units along the length of the rows.

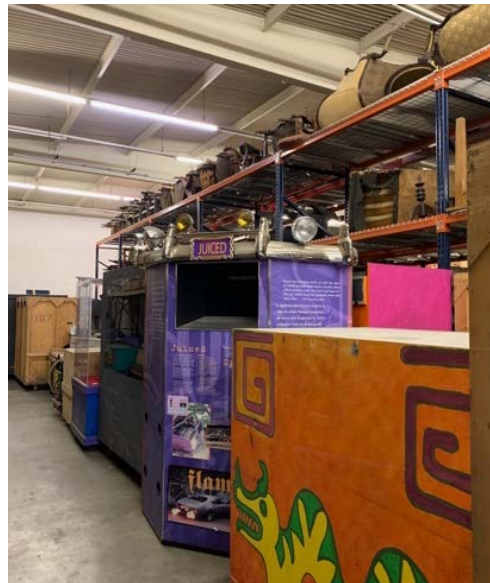
Figure 10: Detail of Cheech Marin "Chicano Now" objects lining storage isles with mission-specific artifacts on open storage shelving in the background. "Chicano Now" materials take up approximately 5,000 sq ft of the 12,000 total sq ft of the facility.
