**Presentation
To**

**Society of
Gas
Operators**

**Open Cut of
Lackawanna
River Using Water
Filled Cofferdams**

**By:
Charlie Brown, P.E.
Senior Project
Manager**

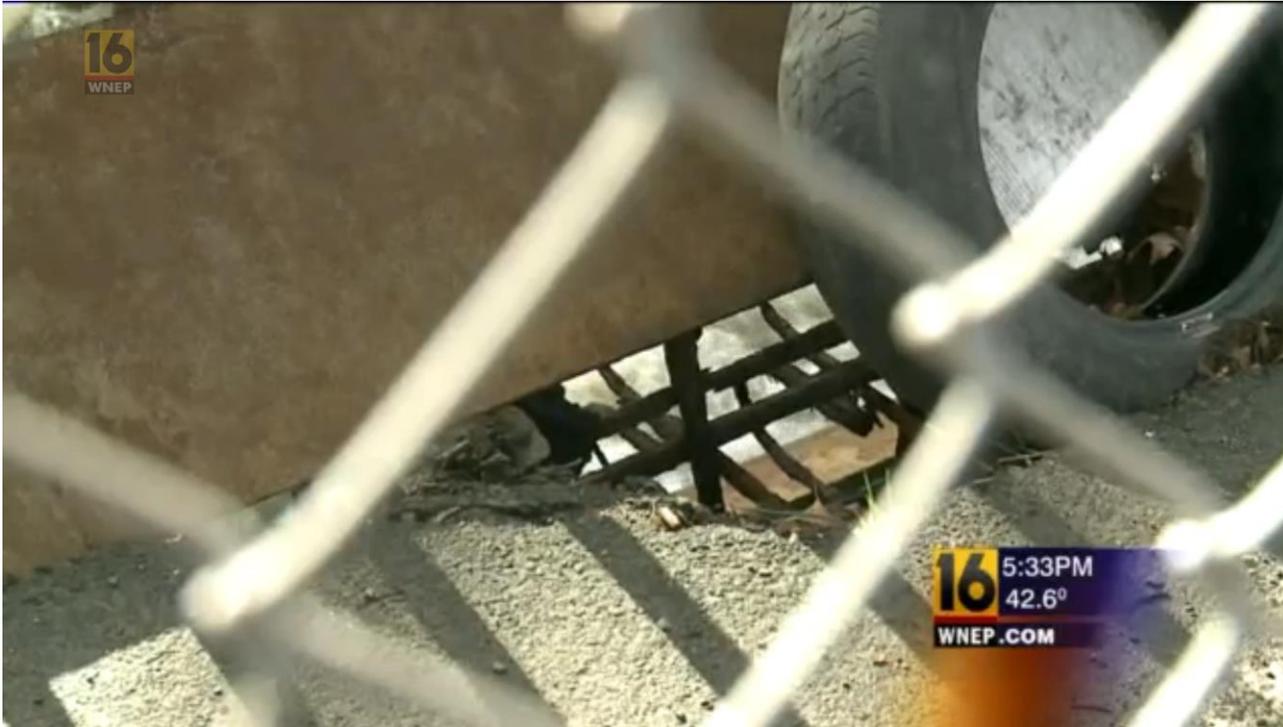
The deck of the bridge had deteriorated to the point that holes in it gave views of the river below.

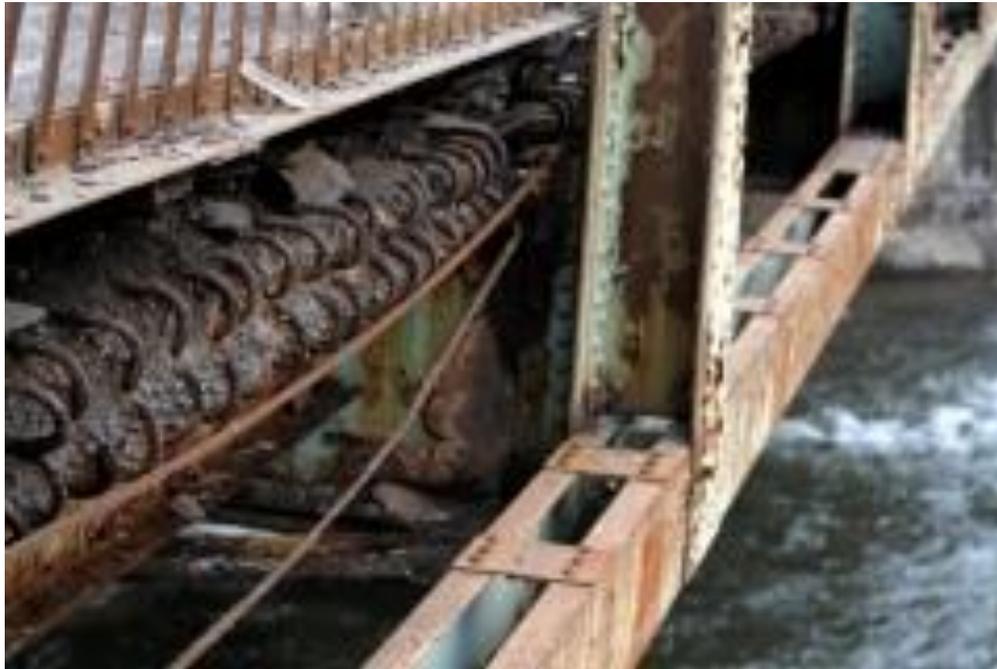
Crumbling deck had
rebar exposed to the
elements and
deteriorating

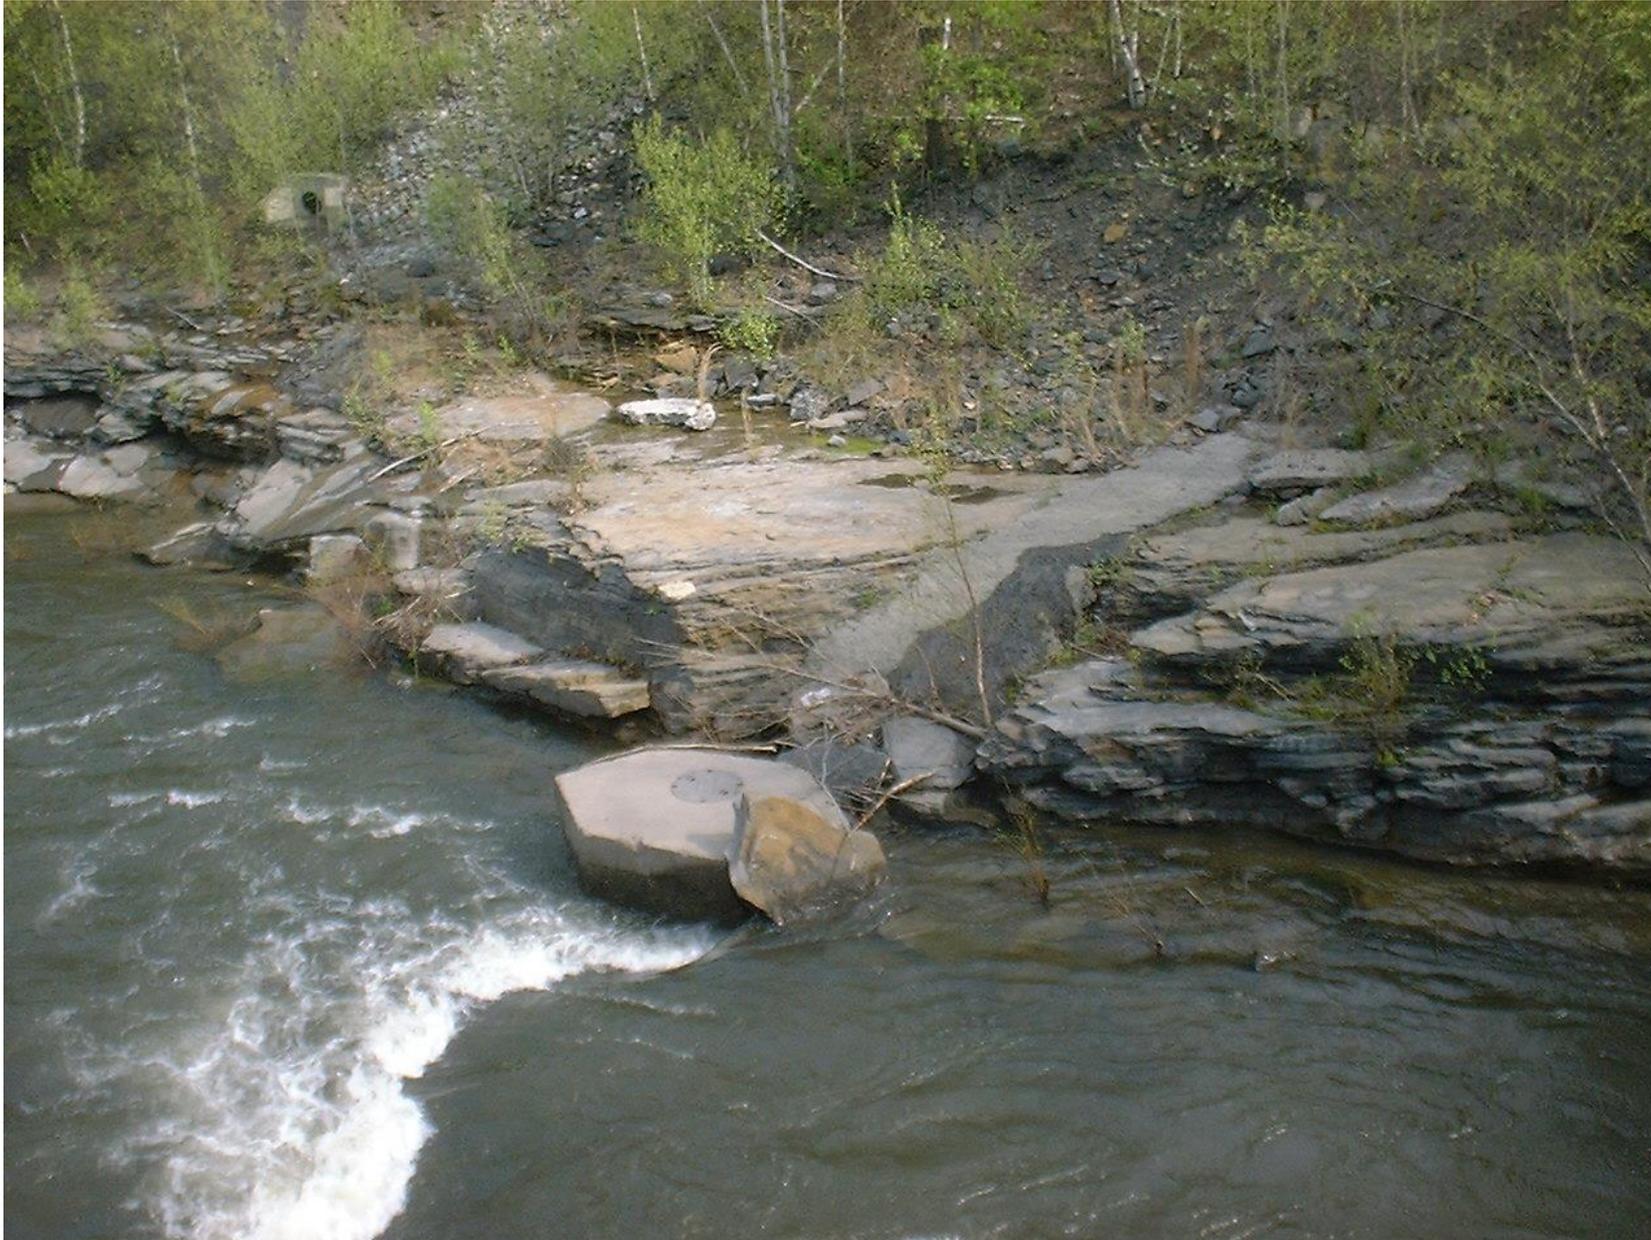
Manhole
for 24"
dia. forced
sanitary
sewer
running
with the
river at a
depth of
12.5 feet
into the
river bed

- The presence of culm piles next to the river bank gave radical elevation changes on the east side of the river which would require longer HDD bores to maintain the angle of attack with further complications due to the presence of a 24 inch diameter forced sanitary sewer main being present in the river near the east river bank at a depth of 12.5 feet below the river bed.

- Needed easement(s) from property owners on both sides of crossings. One was a car wash on the east river bank, which imposed numerous conditions and restrictions on construction activities.
- The 24 inch dia. forced sanitary sewer embedded 12.5 feet into the river bed on the river's east side further complicated any proposed HDD drilling of the proposed replacement main beyond the complications of the unknown locations of coal mine tunnels in the area of the crossing.

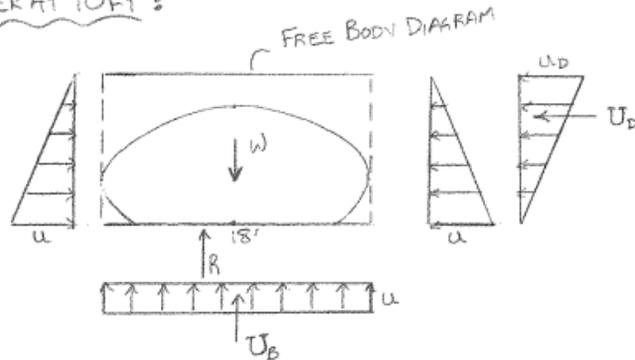
RIVER AT 10 FT :

$$u = 624 \text{ PSF}$$

$$u_D = 161.2 \text{ PSF}$$

$$W = 10(18)62.4 = 11,232 \text{ lb/ft}$$

$$U_B = 624(18) = 11,232 \text{ lb/ft}$$

$$R = W - U_B = 0$$

THE TUBE BECOMES BUOYANT & THE RESISTANCE BETWEEN THE TUBE AND BEDROCK APPROACHES ZERO WHEN WATER OVERTOPS THE TUBE (IGNORING WEIGHT OF TUBE LINER).

THE CURRENT CAN THEN PUSH THE TUBE DOWNSTREAM.

Calculations showed that at 10 feet river depth the water cofferdams would reach neutral buoyancy and be capable of sliding down the river.

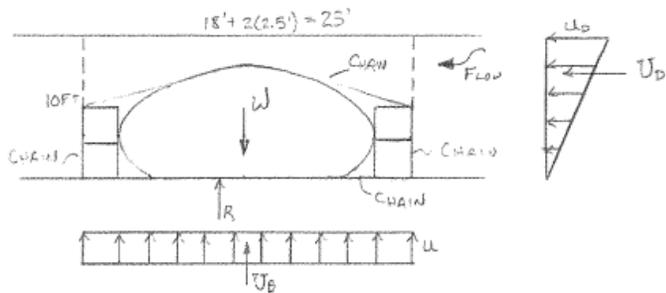
TRY STACKABLE CONCRETE BLOCKS AS BALAST

- USE INTERBLOCK $2.5' \times 2.5' \times 5'$ AT 4320 lb -OR- $\frac{4320}{5} = 864 \frac{\text{lb}}{\text{FT}}$

$$\text{WEIGHT OF BLOCKS} = 864 (W) = 3456 \text{ lb/FT}$$

$$\text{AREA OF BLOCKS} = [2.5(2.5)]4 = 25 \text{ FT}^2$$

$$\text{FREE BODY AREA} = 23(10) = 230 \text{ FT}^2$$

$$\text{AREA OF WATER} = 230 - 25 = 205 \text{ FT}^2$$

$$W = 205(62.4) + 3456 \text{ lb/FT} = 16,248 \text{ lb/FT}$$

$$U_B = 624(23) = 14,352 \text{ lb/FT}$$

$$R = W - U_B = 16,248 - 14,352 = 1,896 \text{ lb/FT}$$

$$FS_s = \frac{R \tan(\delta)}{U_D} = \frac{1896(0.42)}{806.2} = 0.99 \quad (\text{THEORETICALLY UNSTABLE})$$

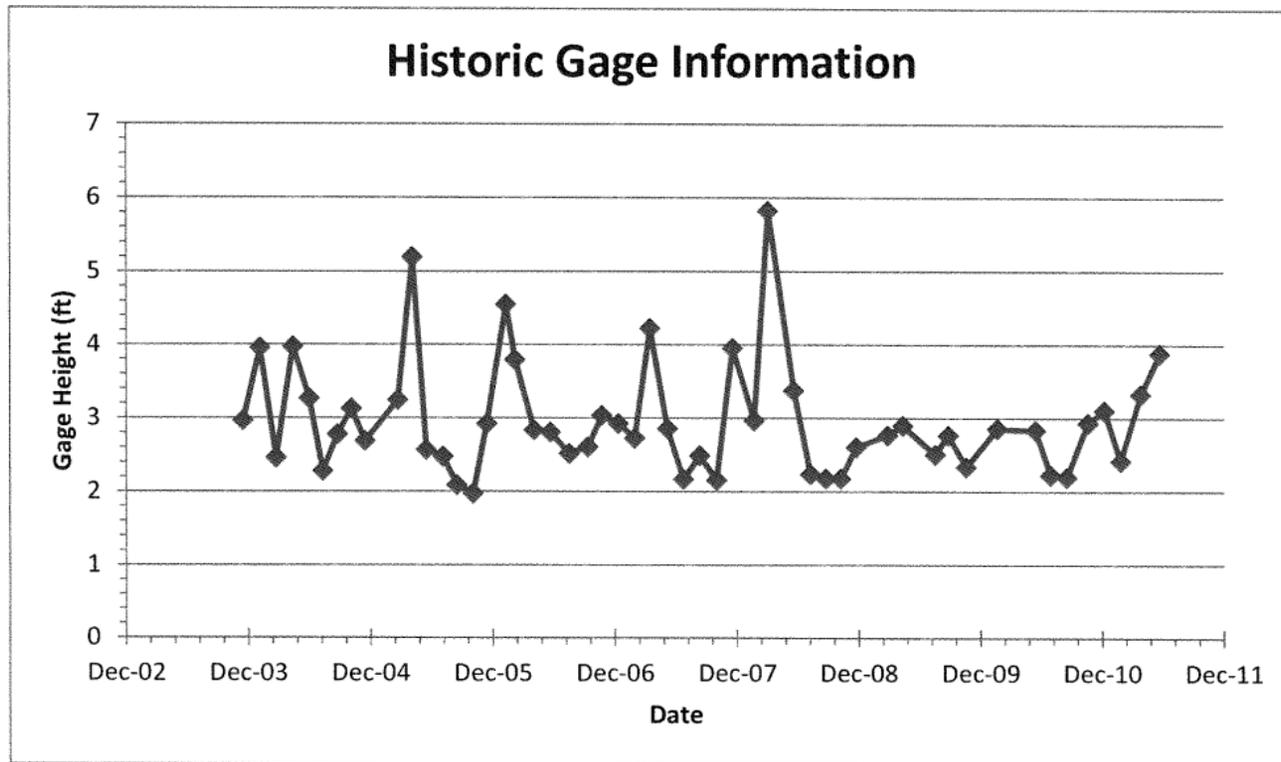
Based on data obtained from a USGS river monitoring station located up stream of the bridge crossing site, a correction factor was established that translated the river gage information on depth at the site of the USGS station and our river crossing location.

Please note that the data shows stable river depths between 2.5 feet and 4 feet for months at a time.

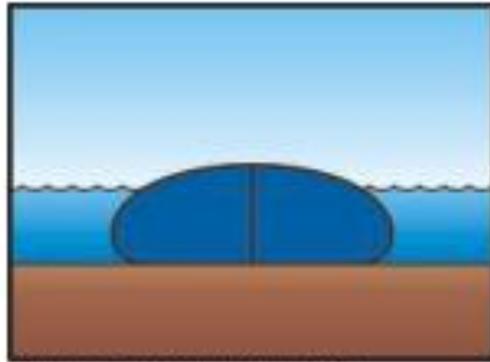
System prior to dewatering worksite

AQUA-BARRIER™ IS A WATER FILLED DAM THAT UTILIZES A PATENTED INTERNAL BAFFLE FOR STABILITY

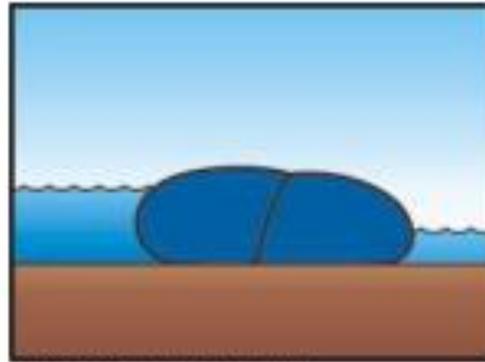
Baffle shifts to stabilize system

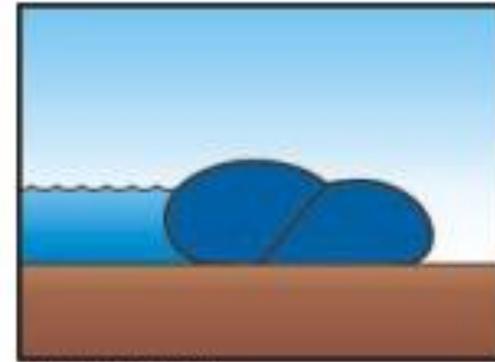
Dewatered worksite;
baffle has stabilized the system

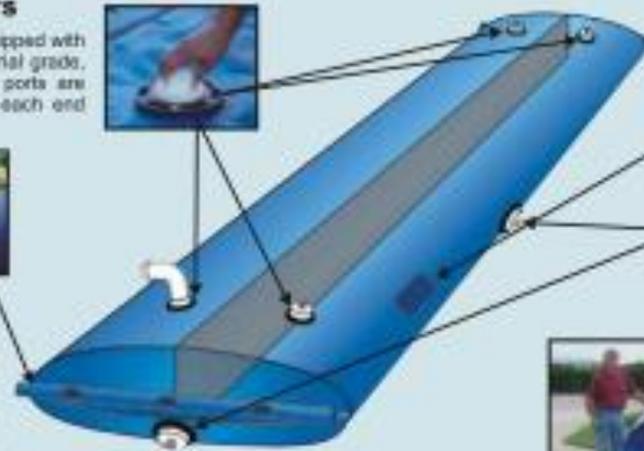
END PIPELOOPS

Pipelops are fabricated on each end of the barrier to facilitate precise placement and rapid removal. Inserting a pipe through the loops allows you to maneuver the barriers with an elevated, heavy equipment arm.

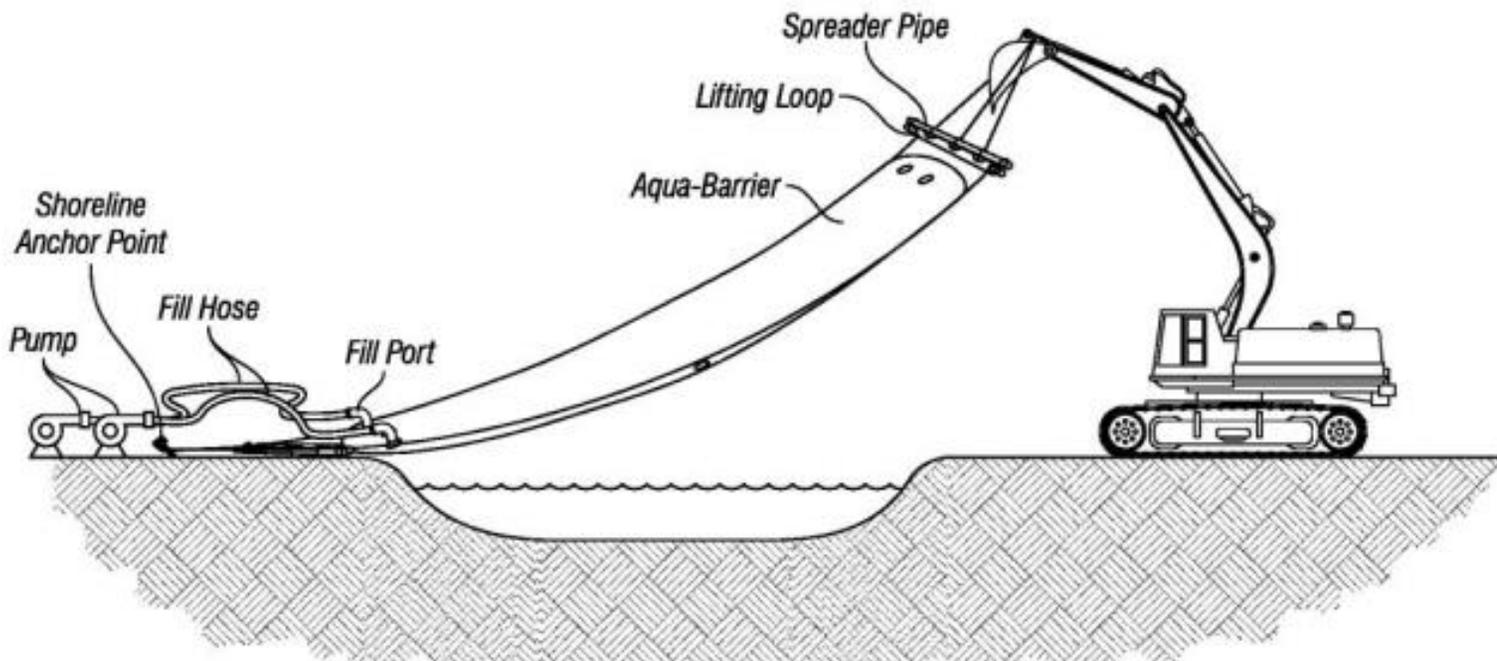
Using one track hoe and shoreline anchor
Phase 1

Aqua-Barrier Deployment Method

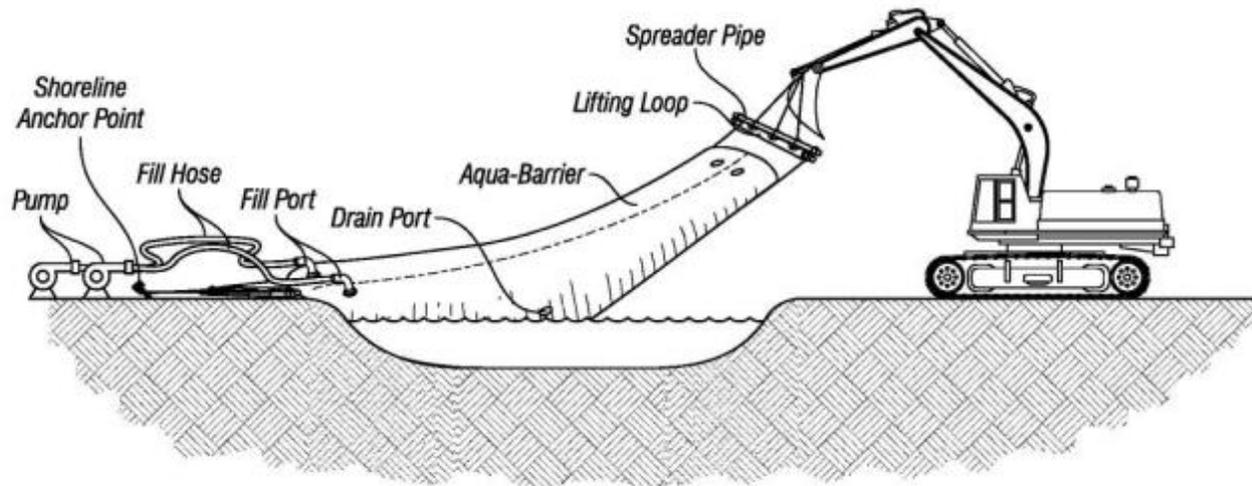
Phase 2

Aqua-Barrier Deployment Method

Using one track hoe and shoreline anchor

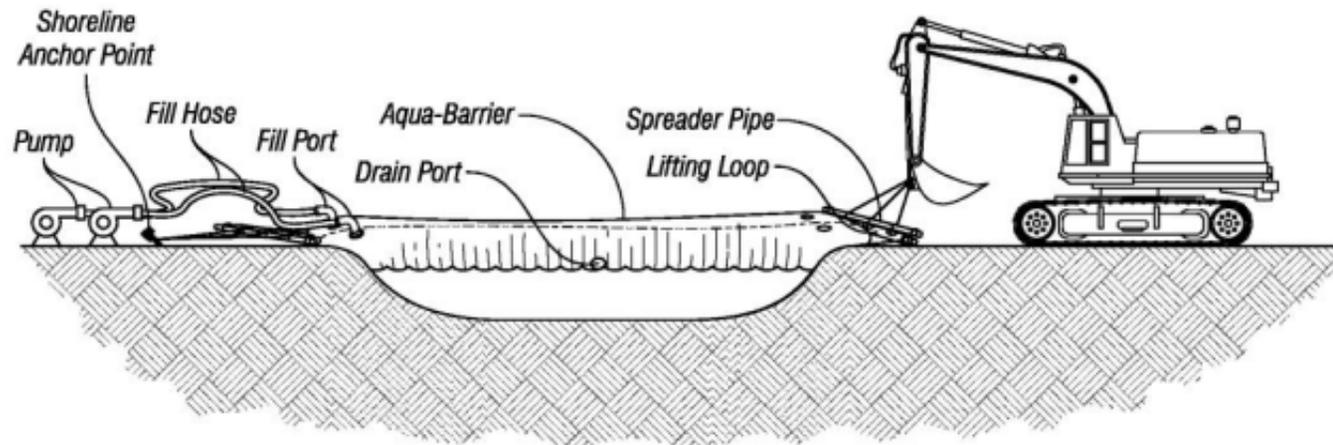
Using one track hoe and shoreline anchor
Phase 3

Aqua-Barrier Deployment Method

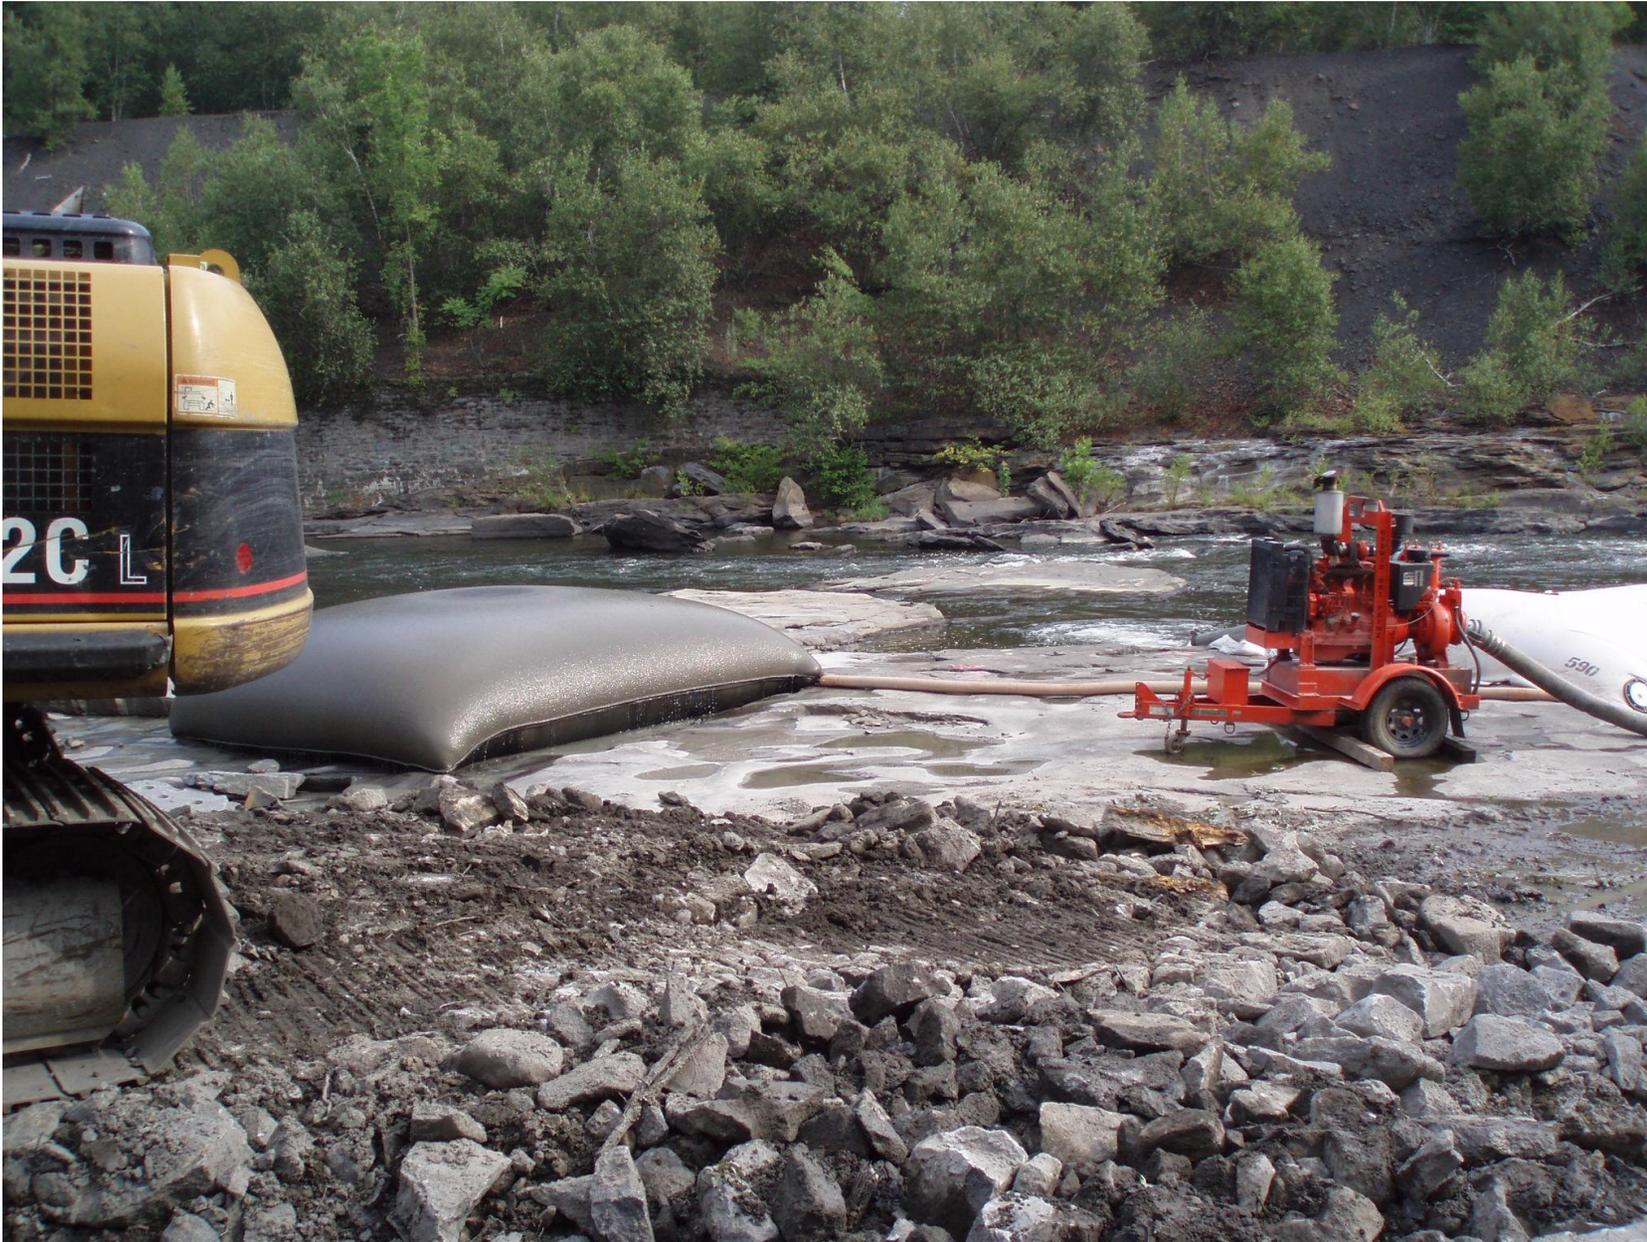
Filling and
placing
water filled
coffer
dams

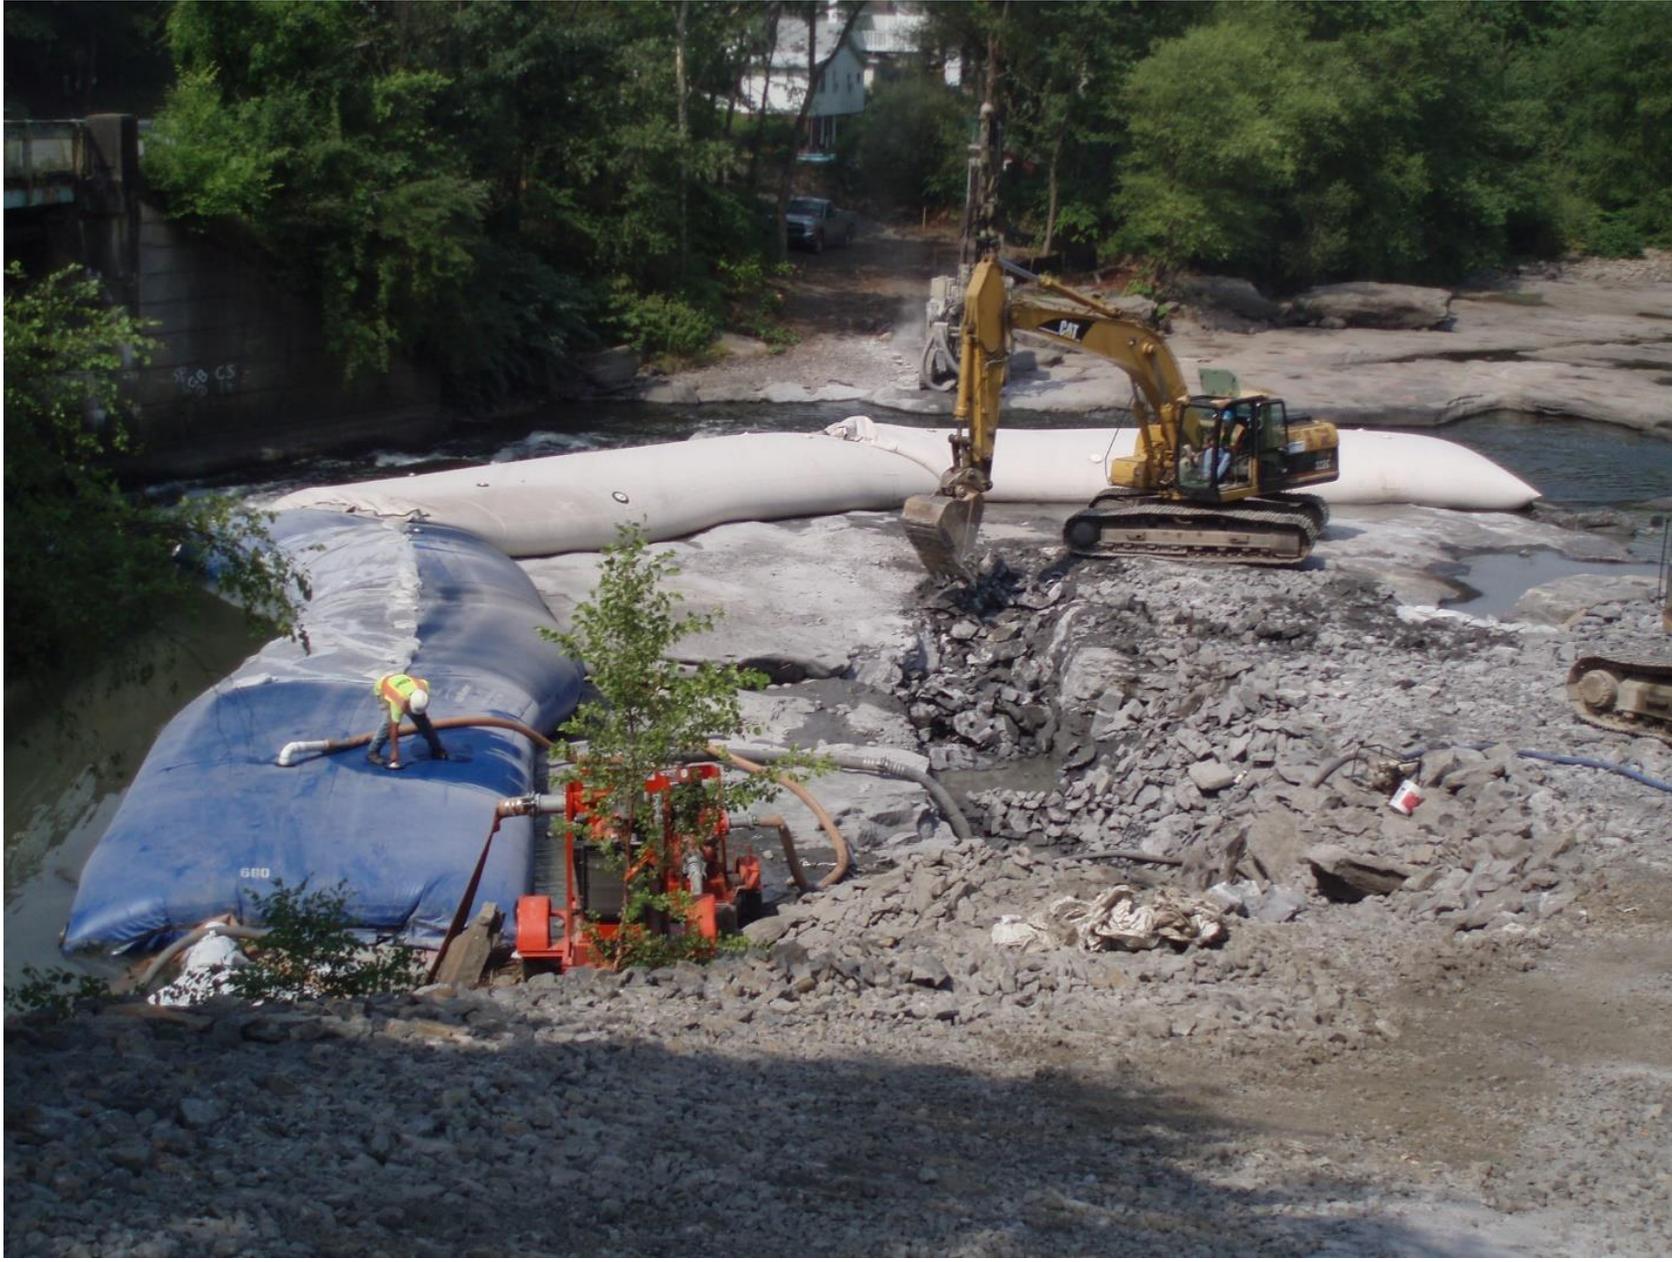
Water filled coffer - dams being filled with water

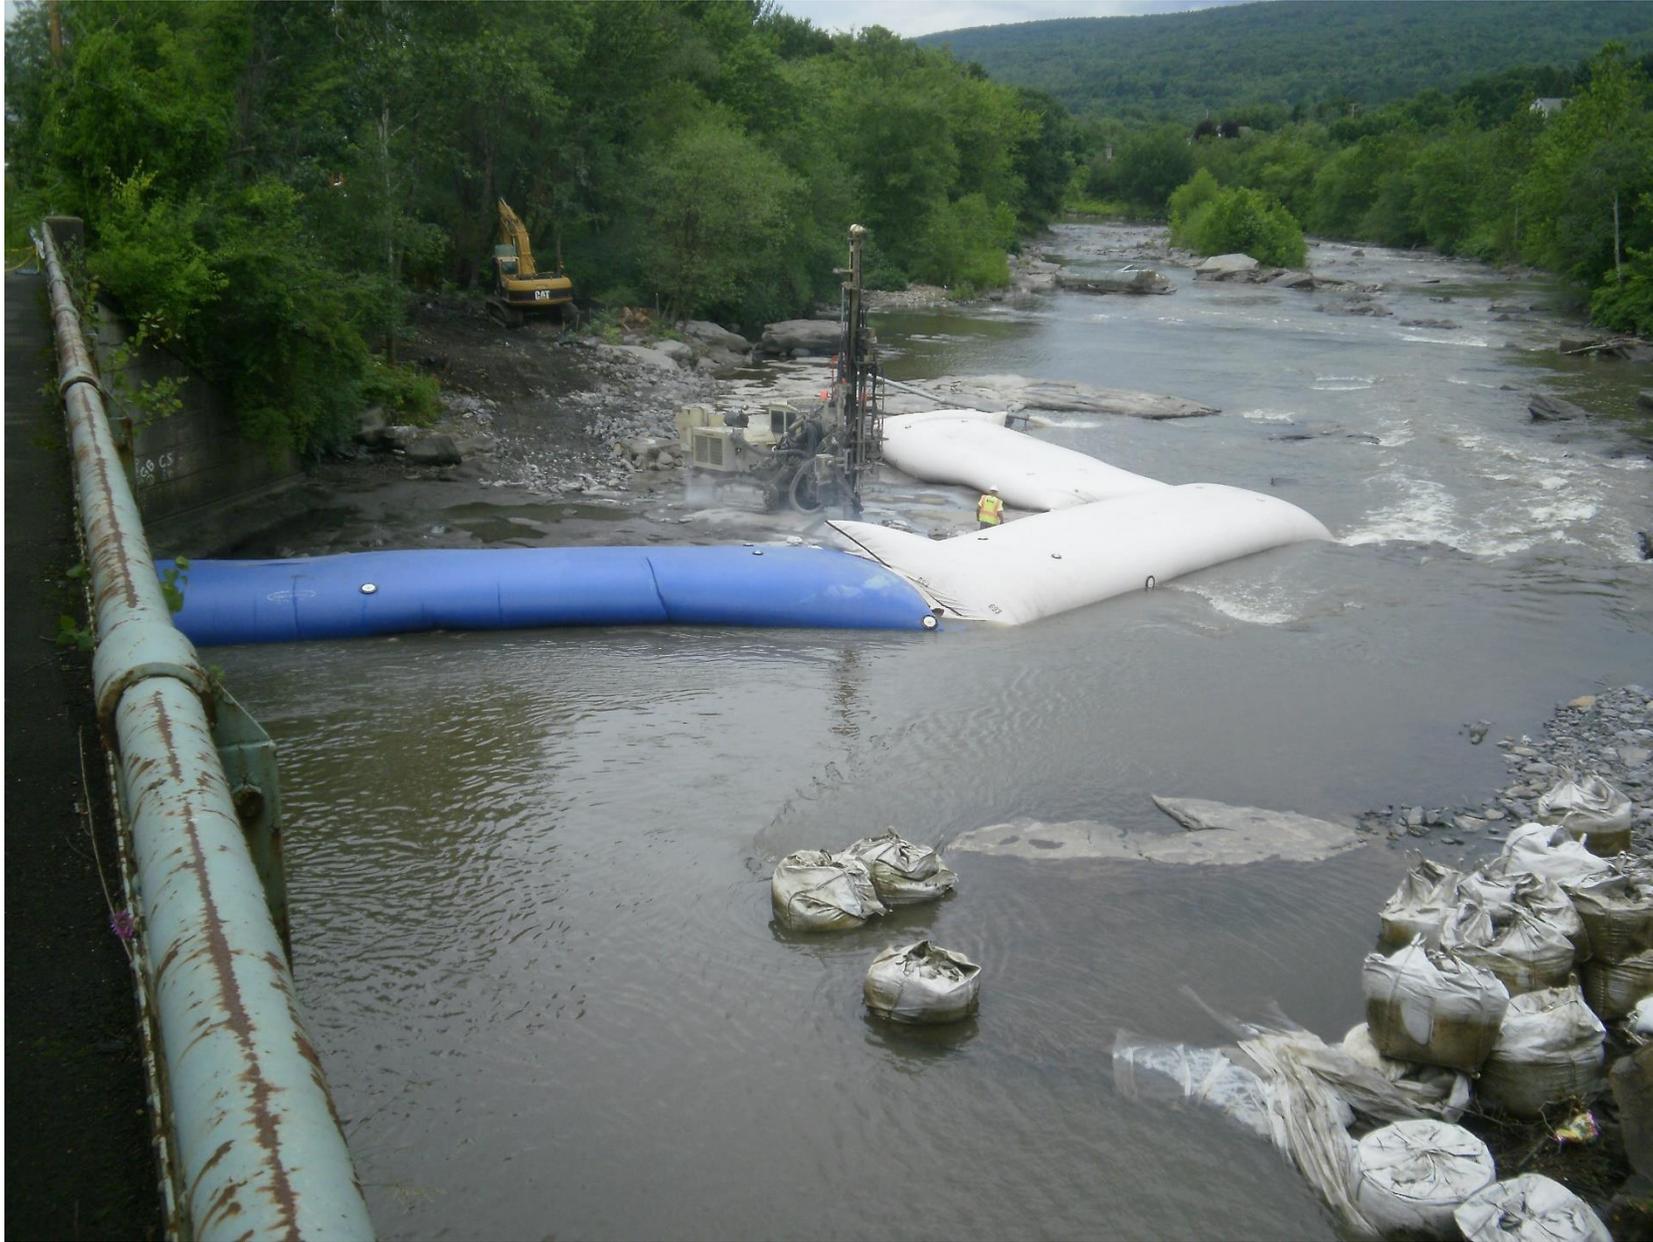
West bank
dams in
place and
drilling
underway

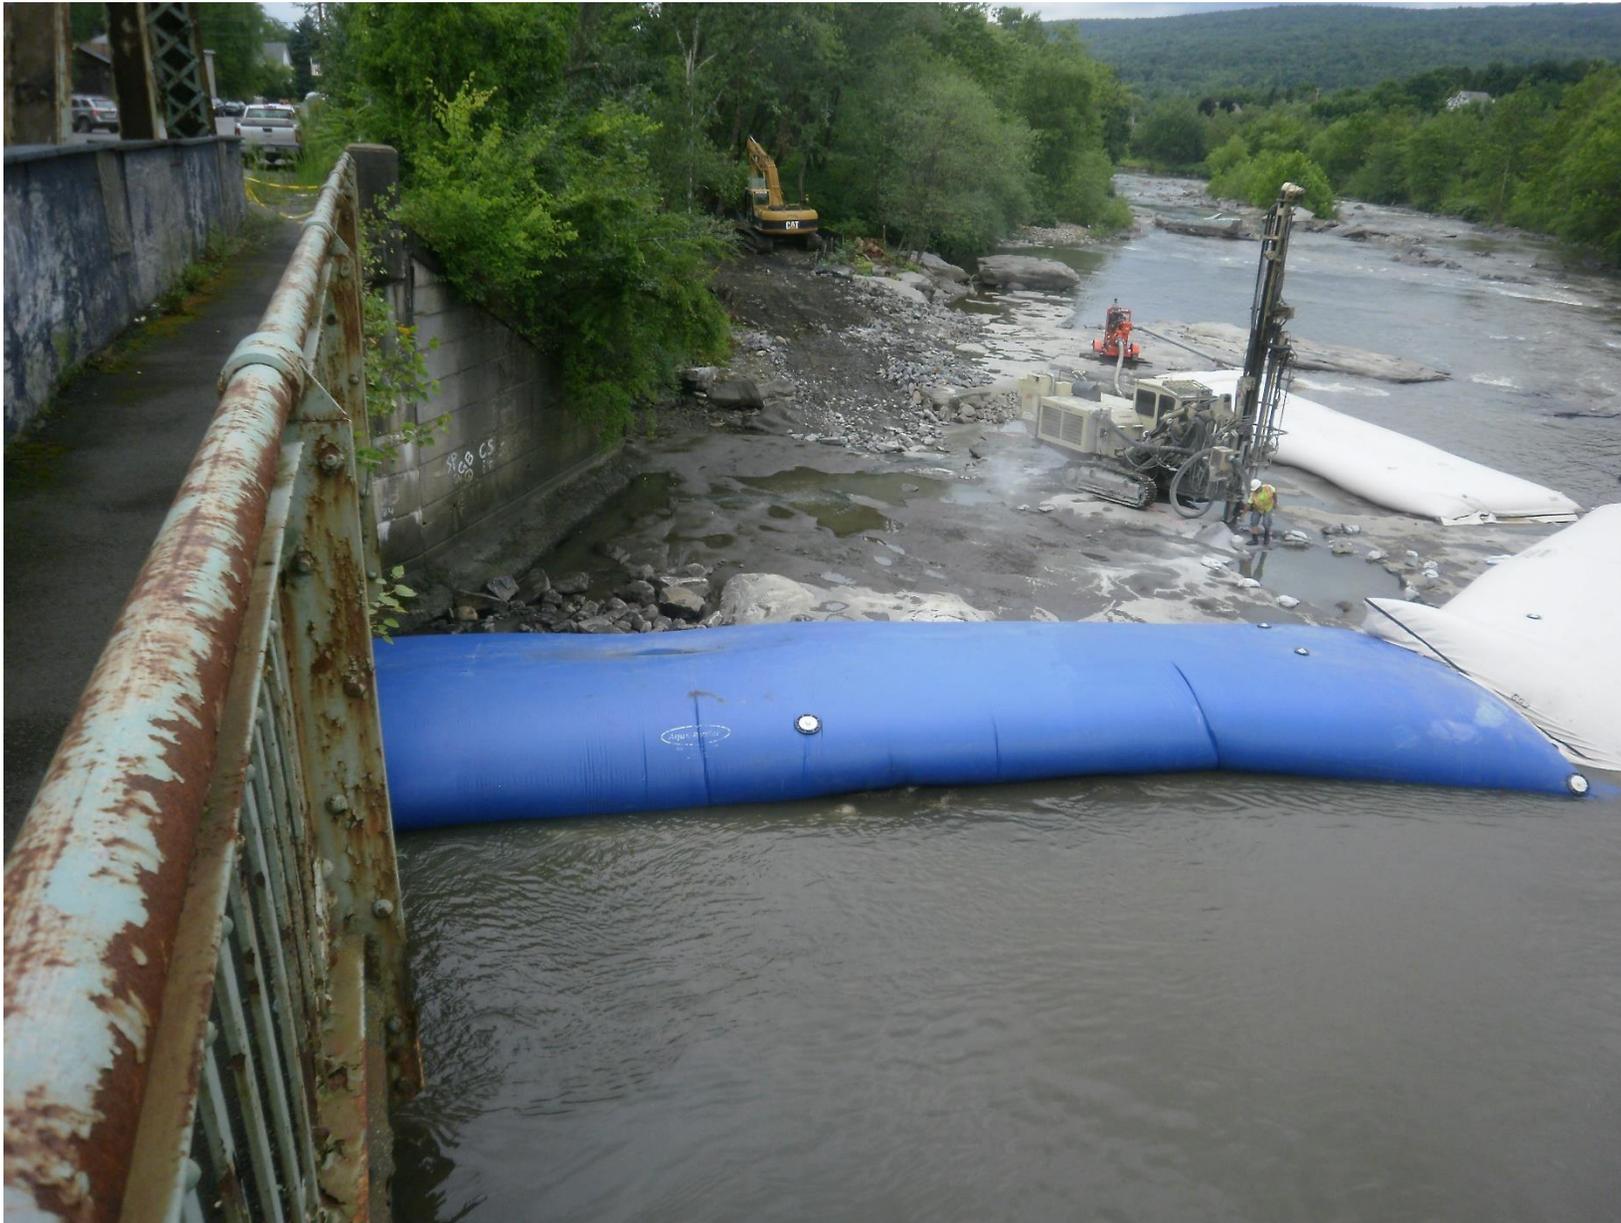
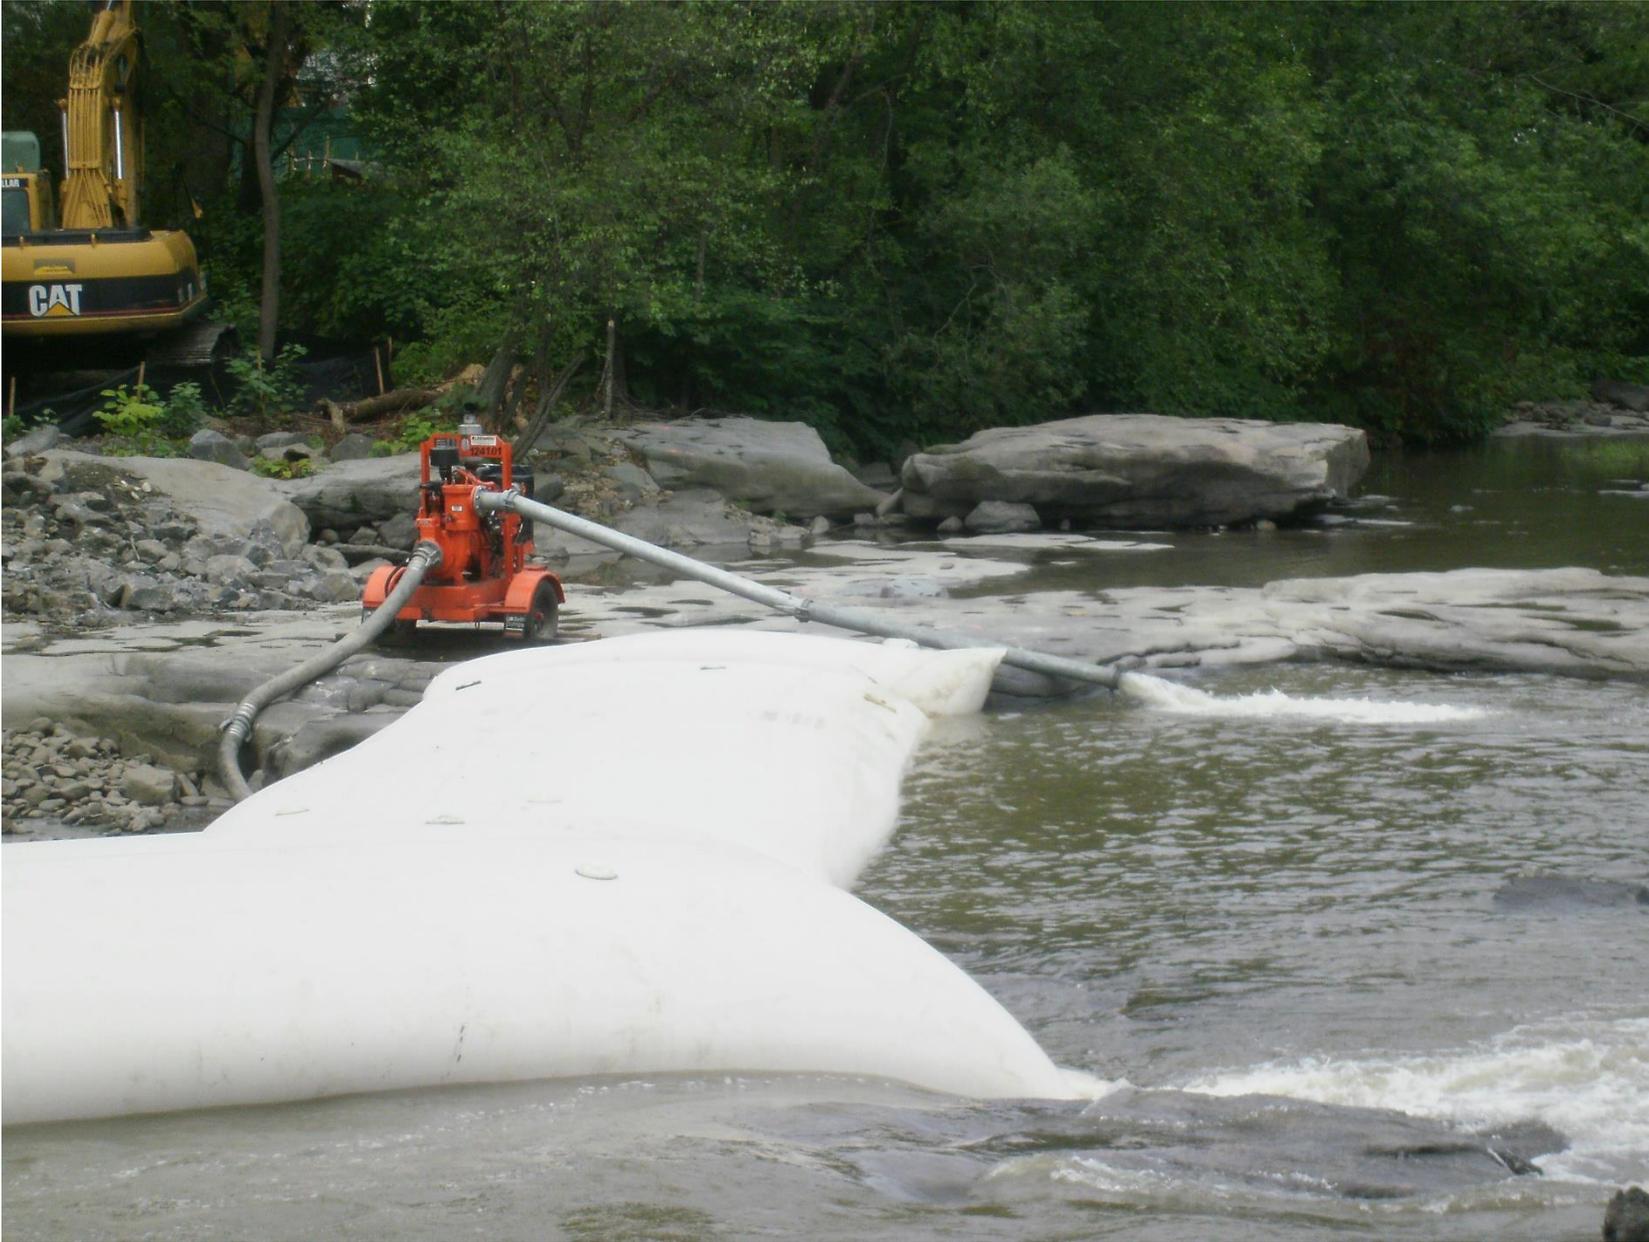
Dewatering
behind
coffer-
dams

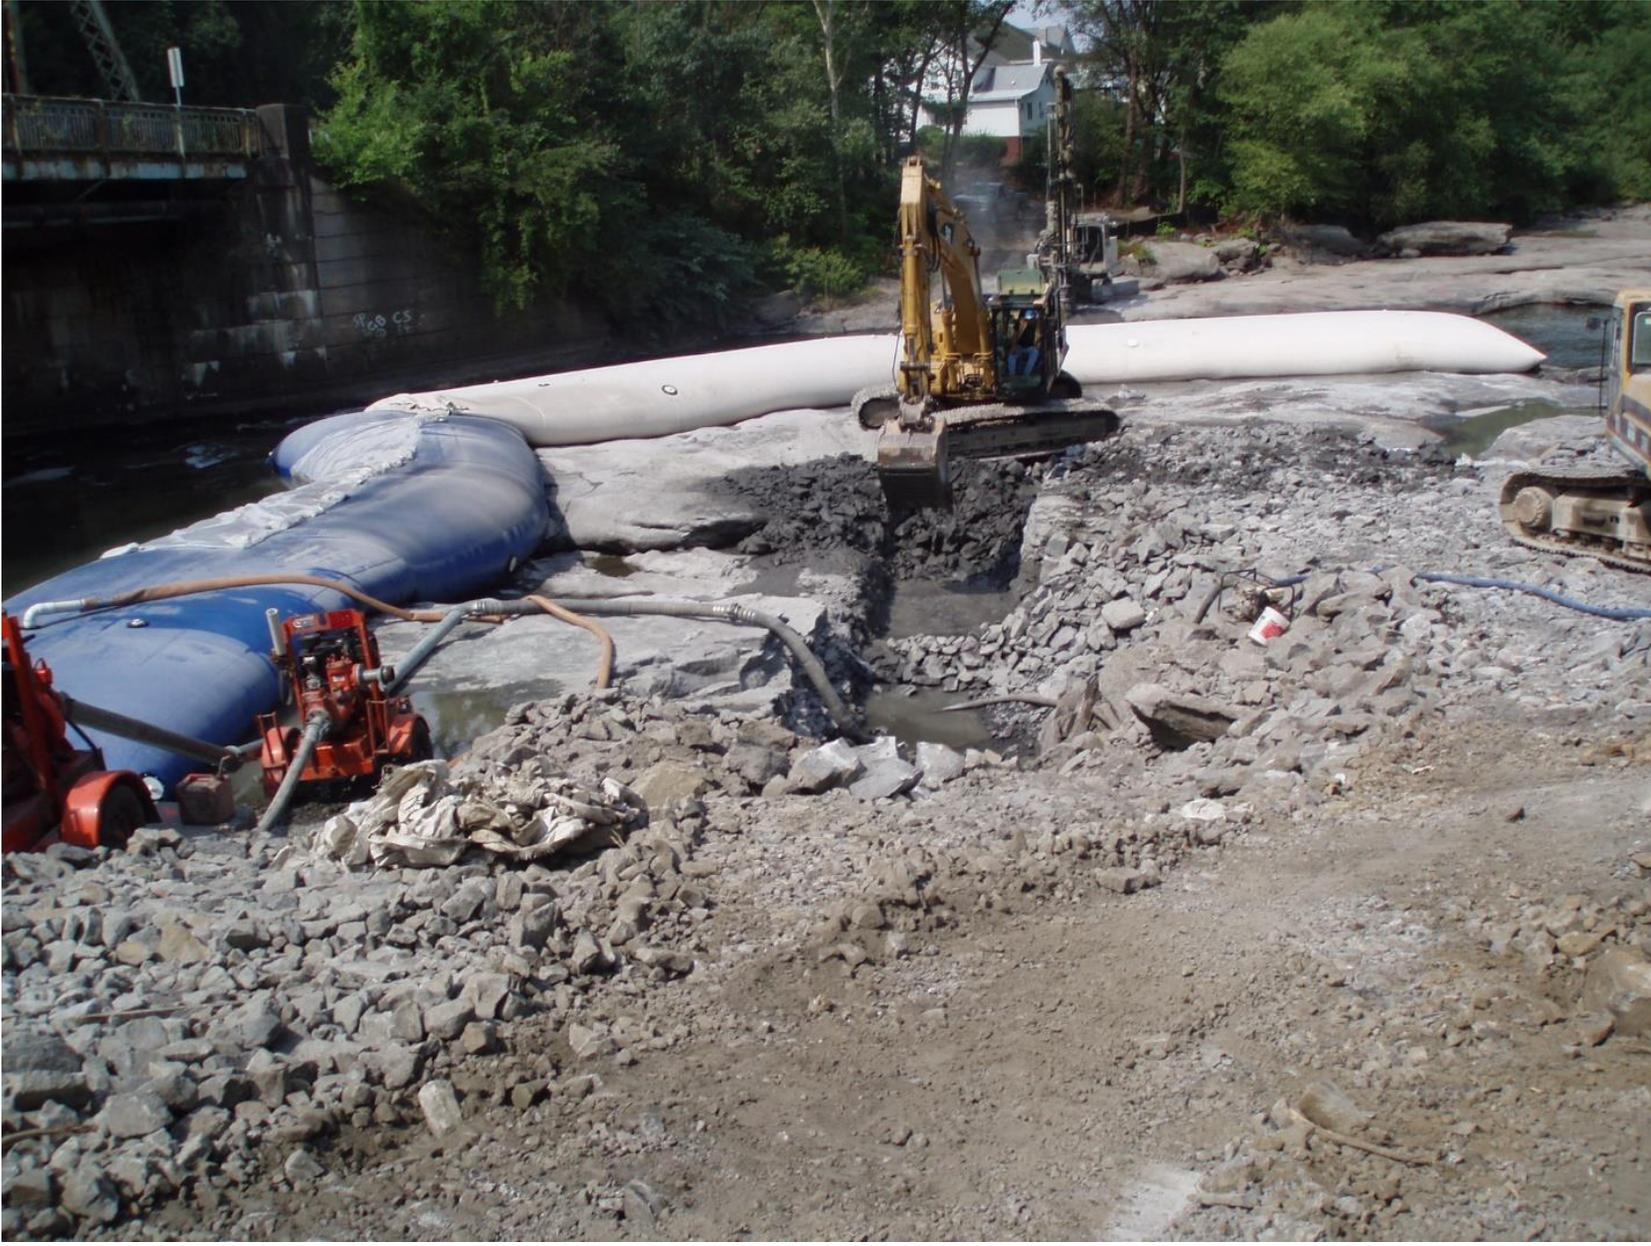
East bank dams in place and excavation of trench underway

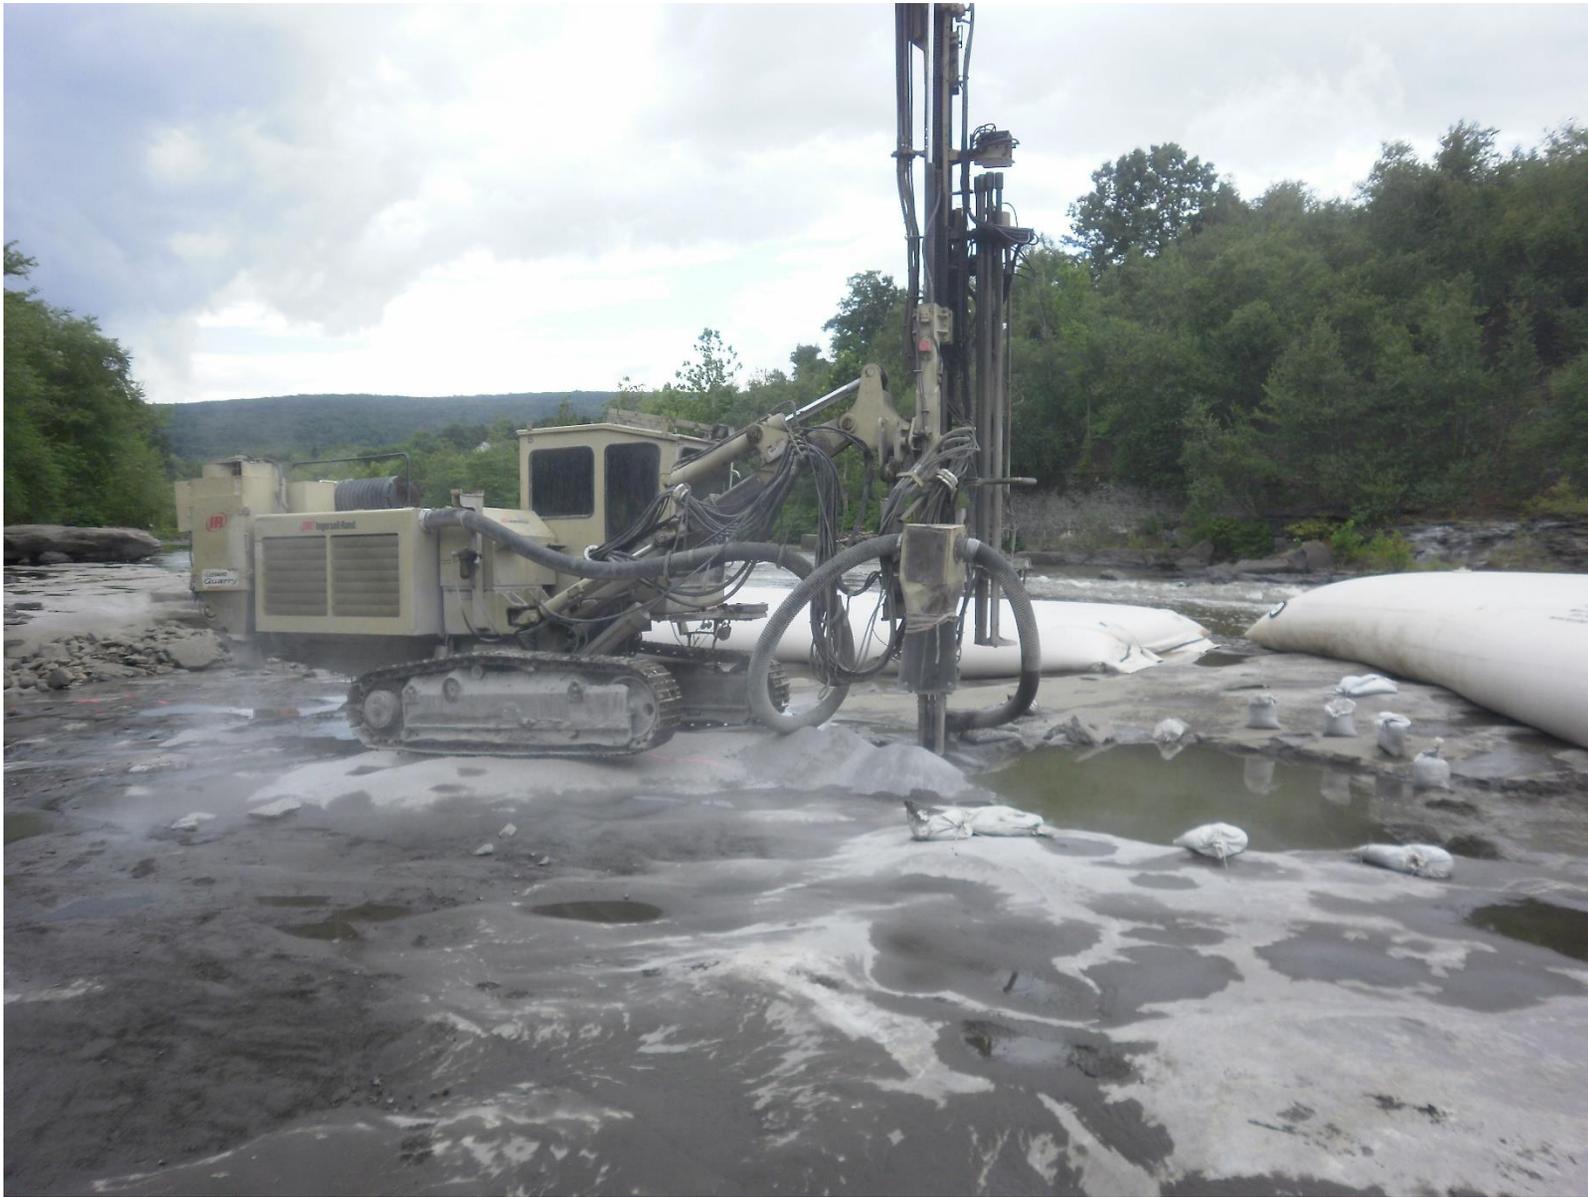
Rock
drilling
machine
drilling
trench for
subsequent
breaking
and
removal
with
excavator
