**Presentation
To**

**Society of
Gas
Operators**

**Open Cut of
Lackawanna
River Using Water
Filled Cofferdams**

**By:
Charlie Brown, P.E.
Senior Project
Manager**

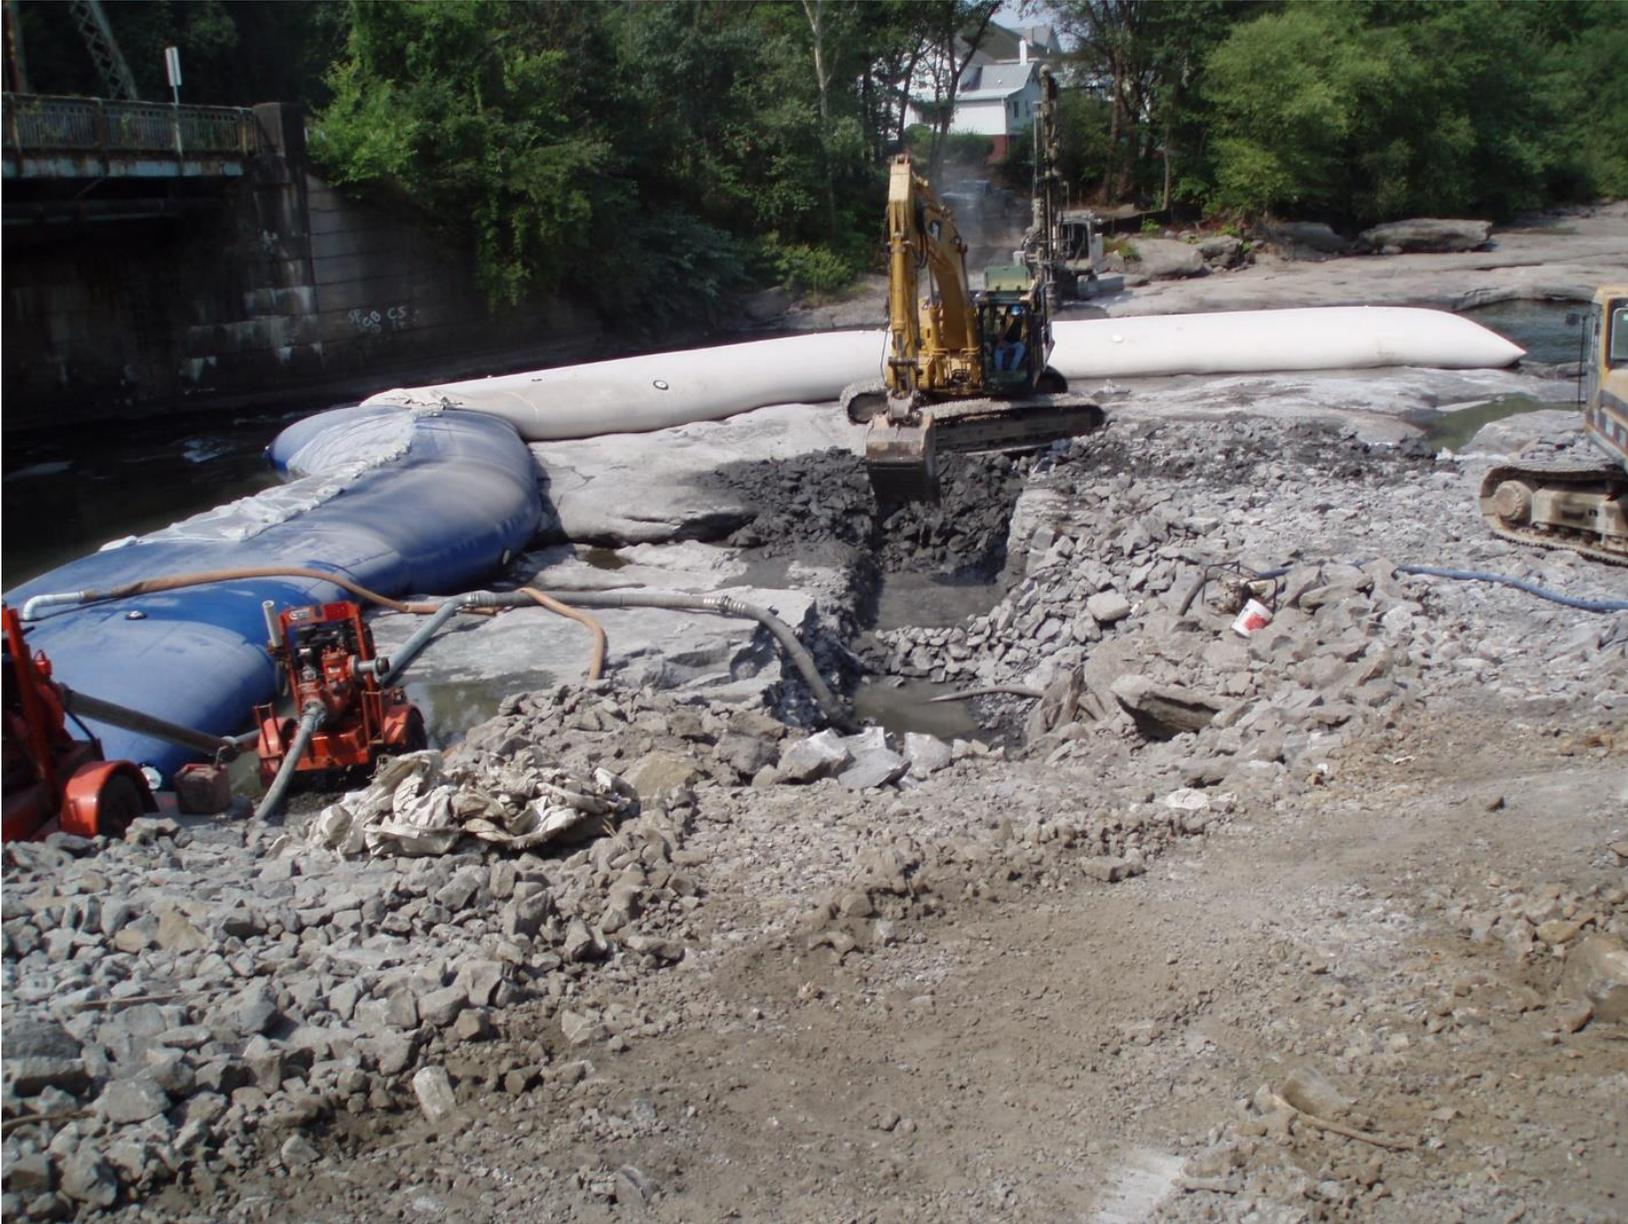
Excavating
drilled
trench in
preparation
for pipe
installment

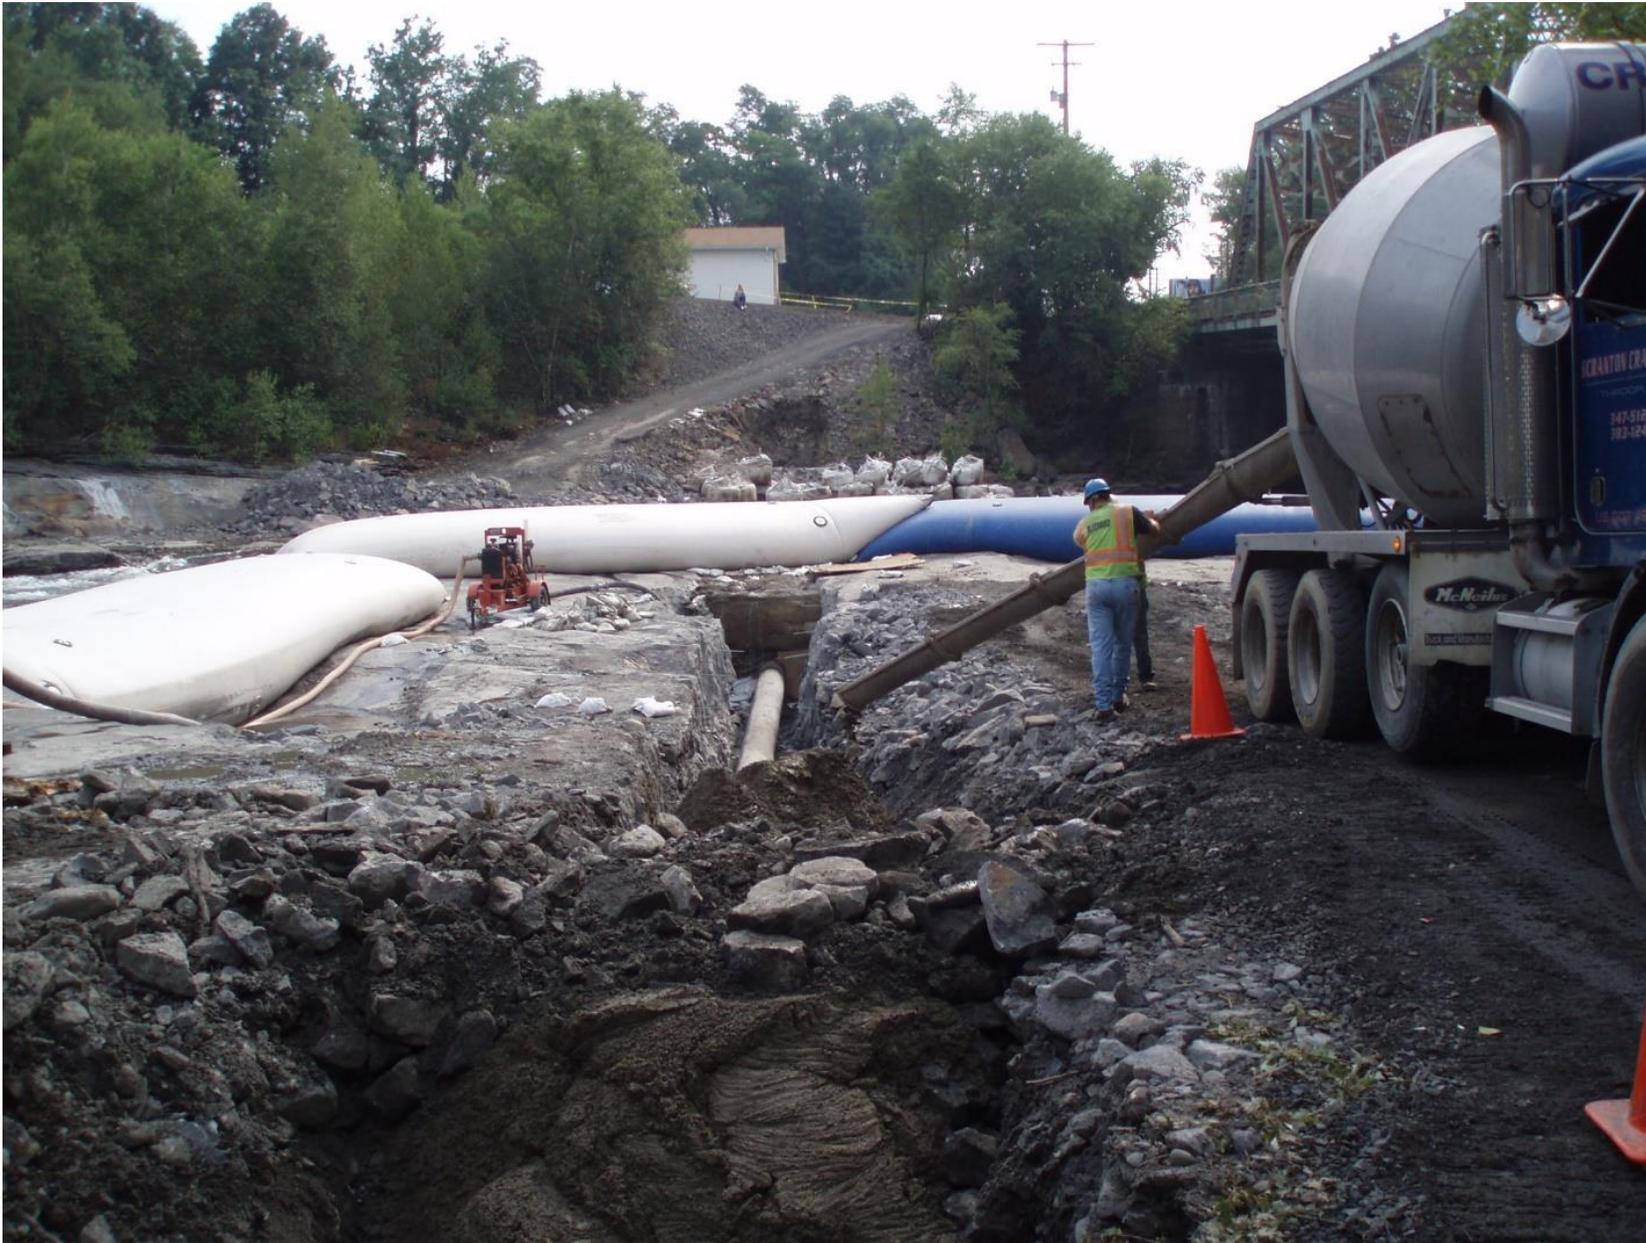
Pipe installed and trench backfilled with flowable fill as specified by GP-5 permit. Original design called for rock backfill from excavating

Only requested change was from rock back fill to flowable fill in the river bed area

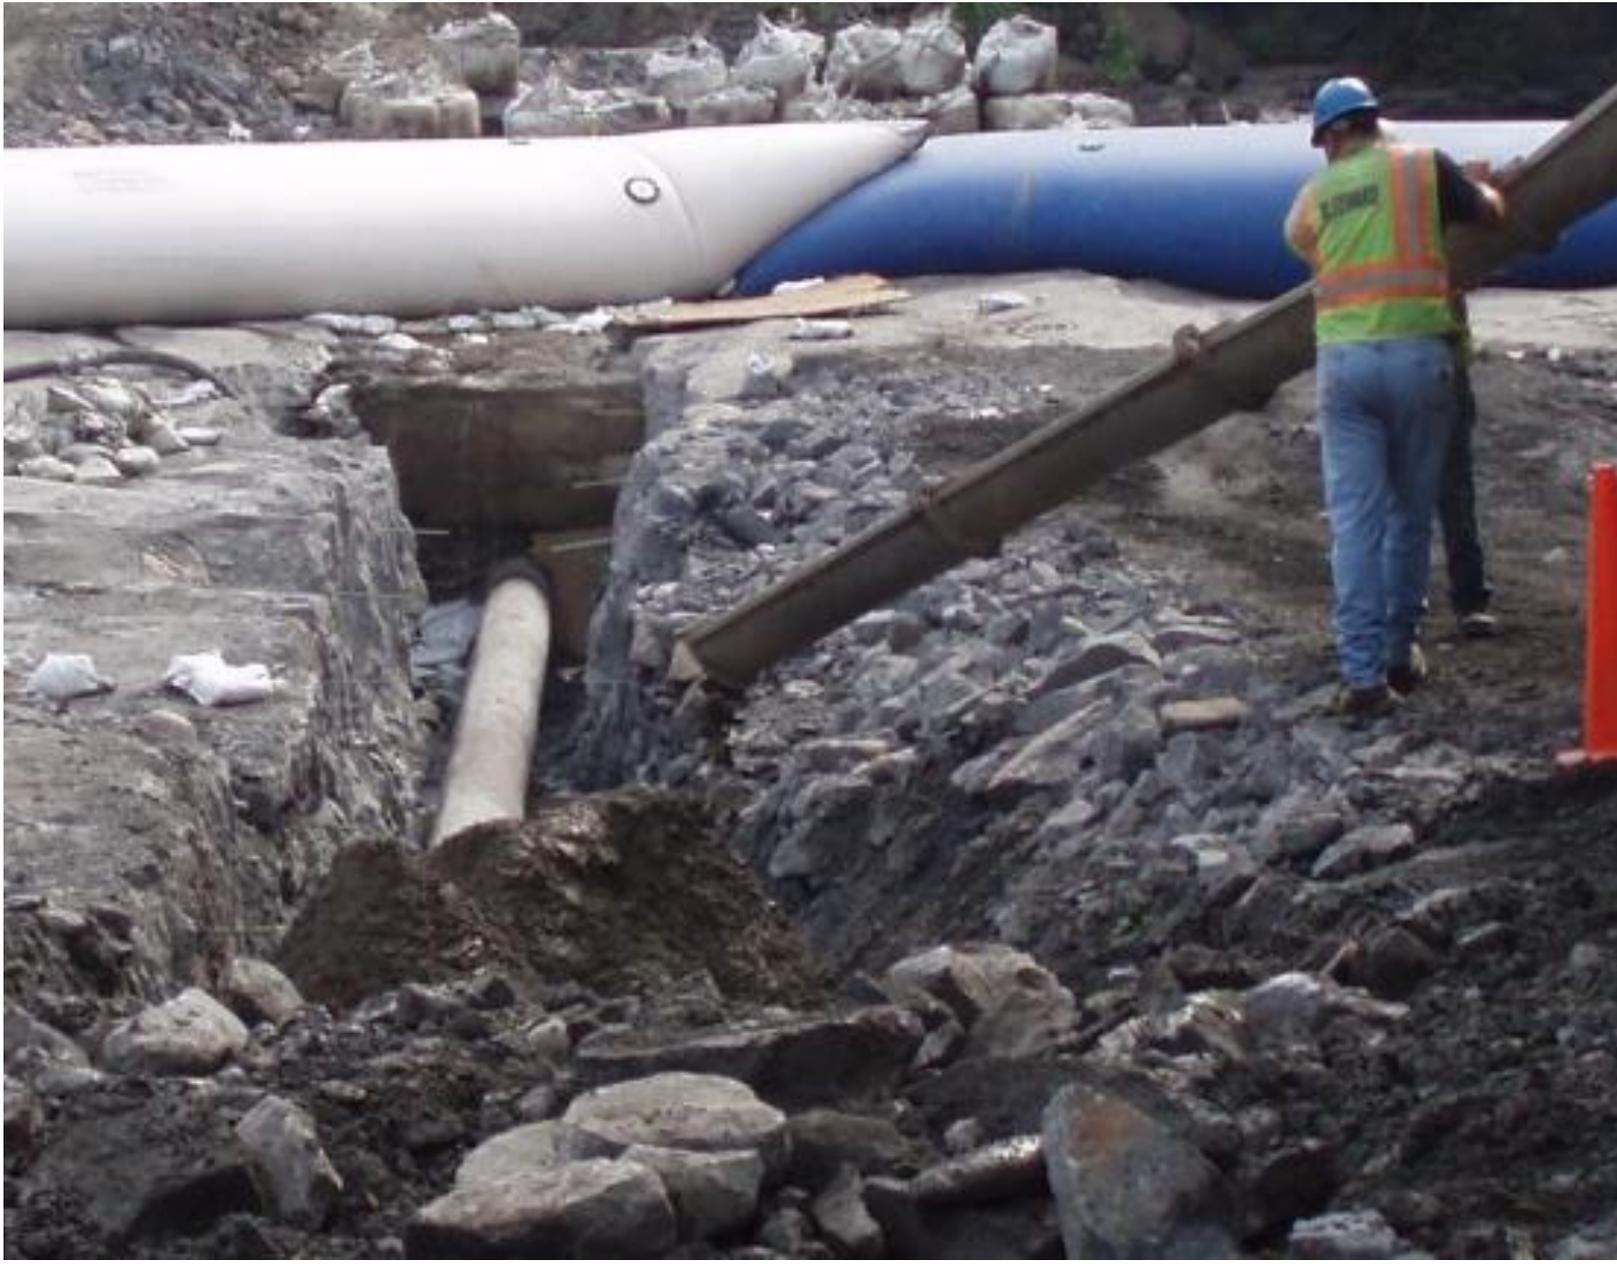
Pipe installed in trench. Note rebar placed into sidewalls of trench as reinforcement and to resist lift out of pourable fill by river current.

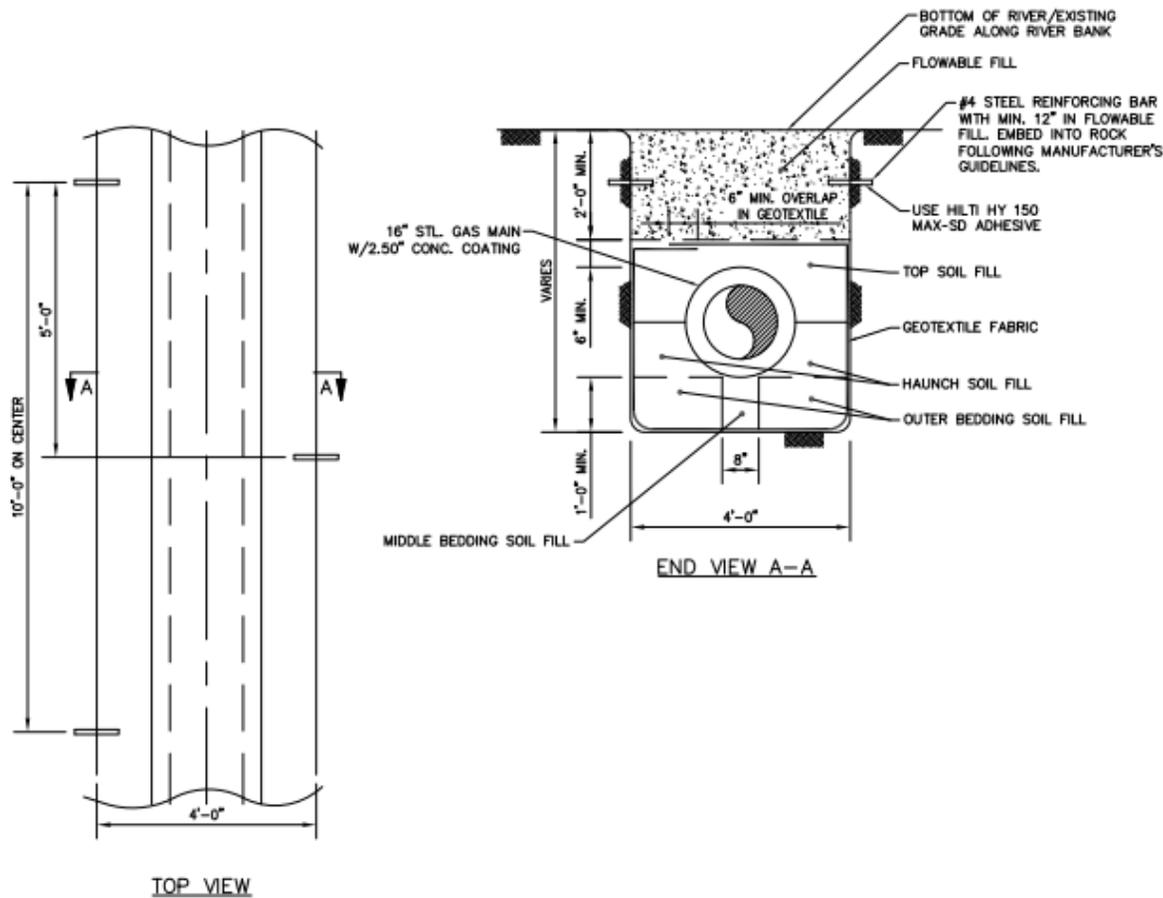
DETAIL "D"
TRENCH EMBEDMENT DETAIL BENEATH RIVERBED
AND UPWARD ALONG RIVER BANK BELOW 100 YR
FLOOD WATER SURFACE ELEVATION
 (FROM SHEET P4)

Design detail of pipe installed in trench. Note rebar placed into sidewalls of trench as reinforcement and to resist lift out of pourable fill by river current.

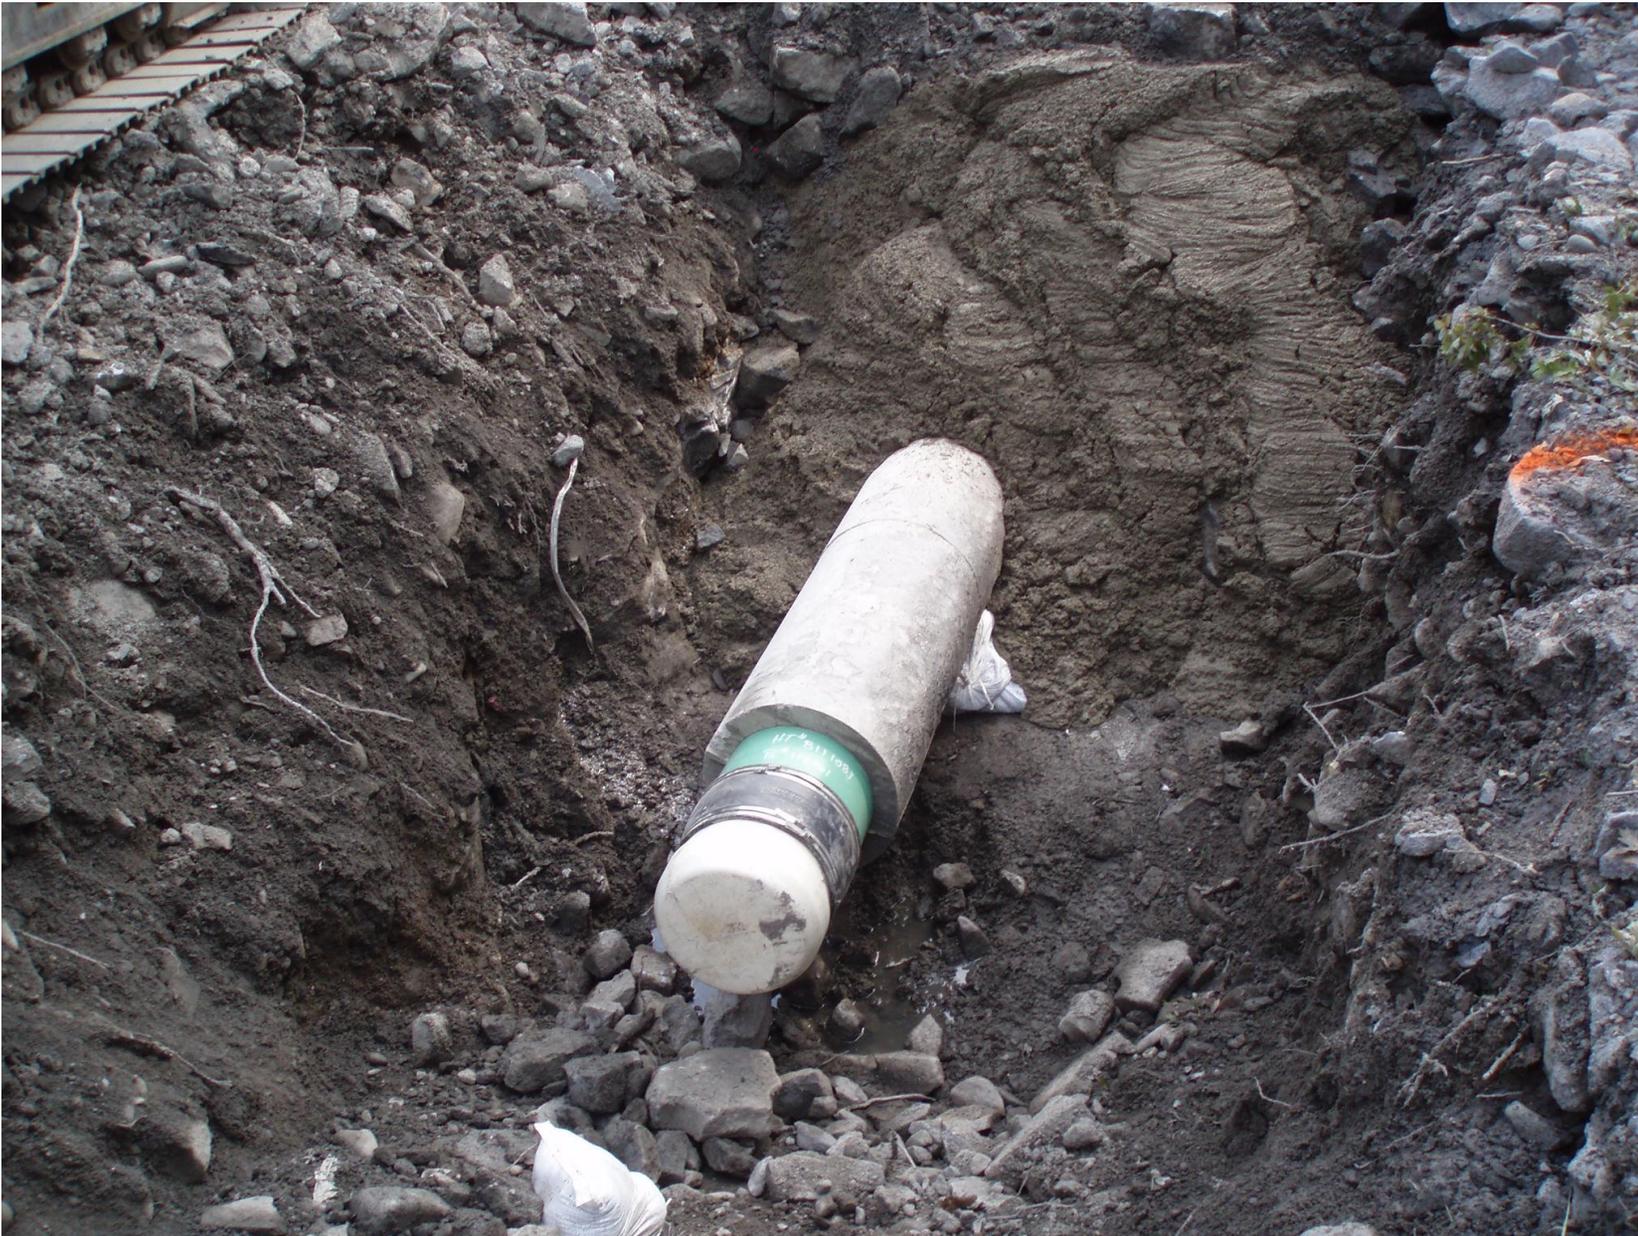
New pipe:

16" dia., x
0.375" WT
API-5L
X-42 with
2.5"
concrete
coating
mill
applied

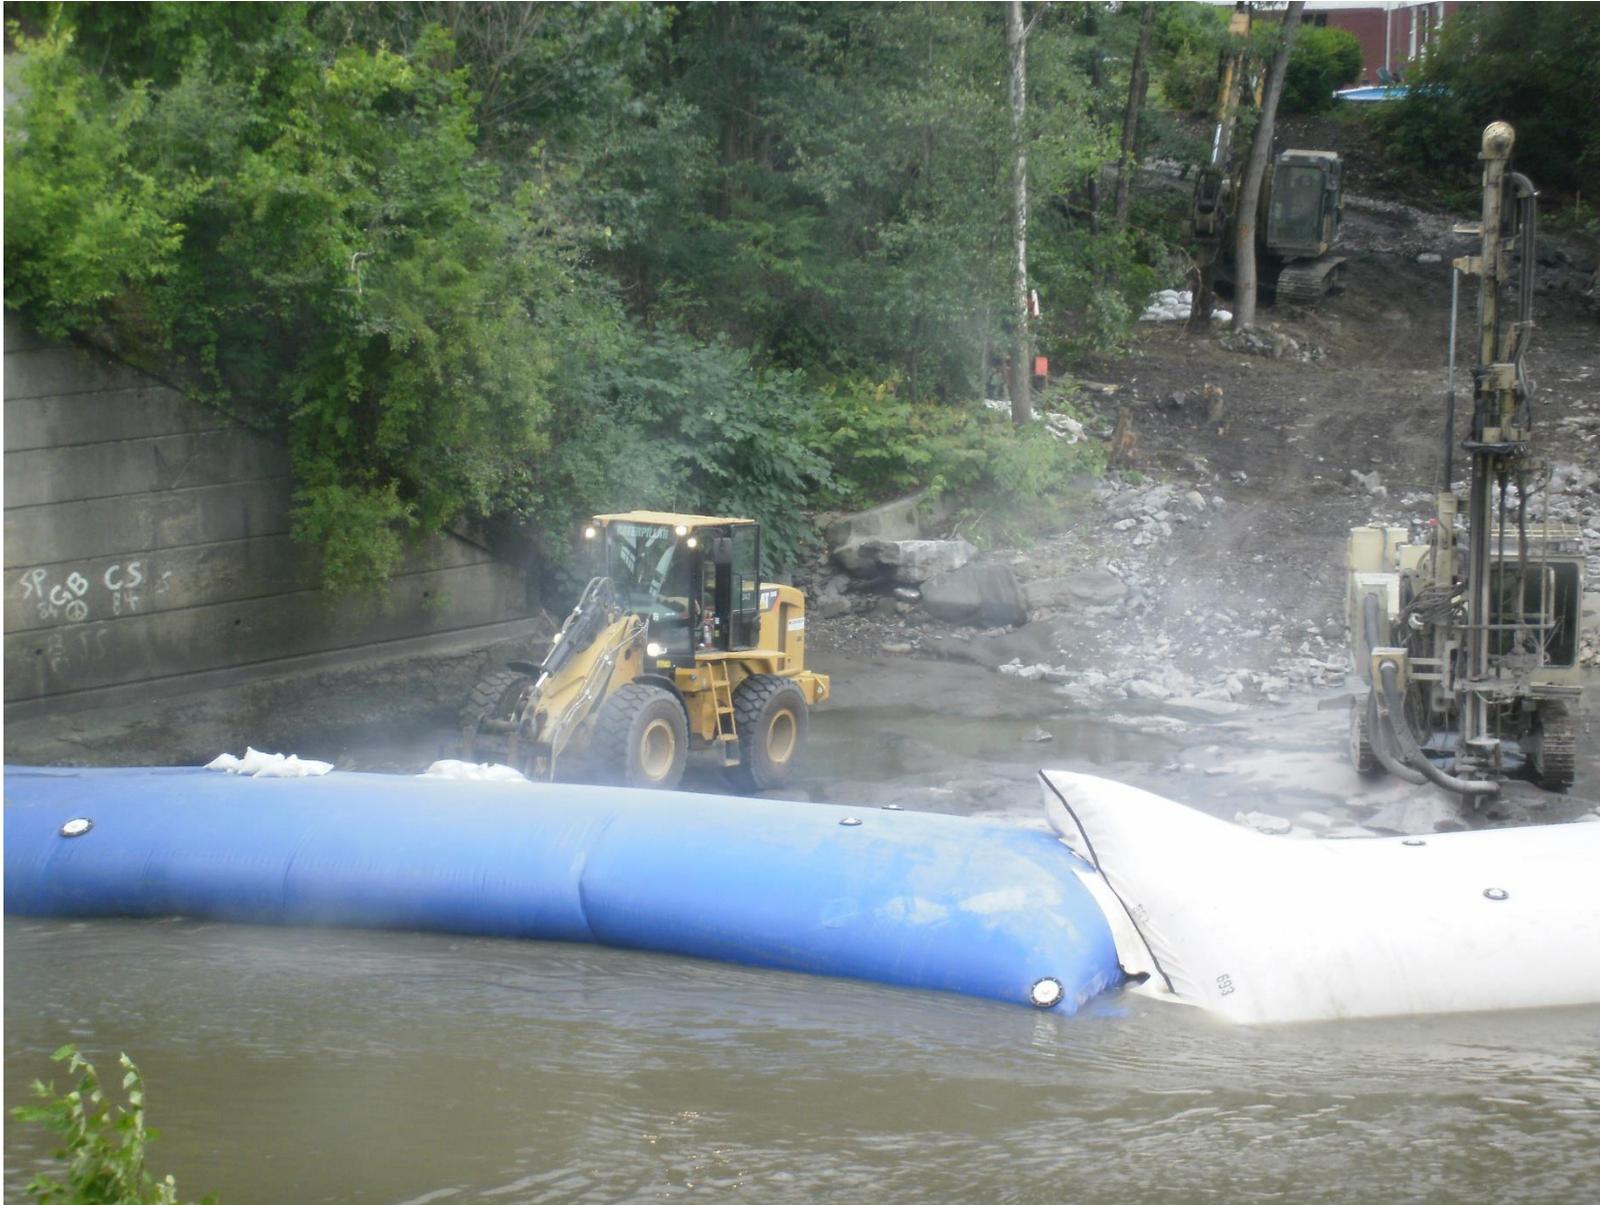
Sandbags were adjusted at base of water filled cofferdams to minimize leakage under cofferdams due to river bed surface irregularities.
