Inspection Report

Property Address:
2720 Greymont Ct
Cumming GA 30041

Serrano's Home Inspections, LLC.

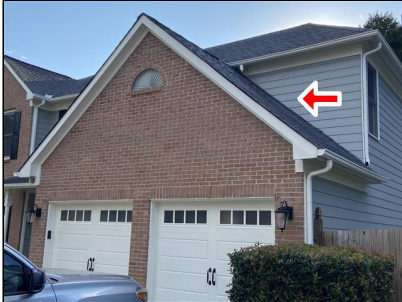
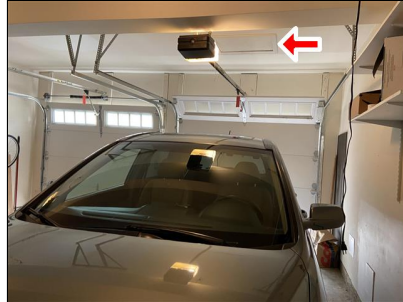
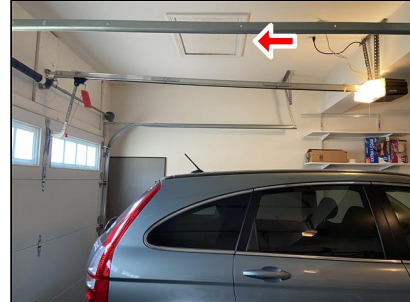
(1) -The access to the attic above the garage was blocked and this attic could not be inspected.

(2) -There is one low/sagging area on the roof at the front right corner of the upper roof. No problems were noted in the attic under this area.

3.5 (2) -There is one low/sagging area on the roof at the front right corner of the upper roof. No problems were noted in the attic under this area.

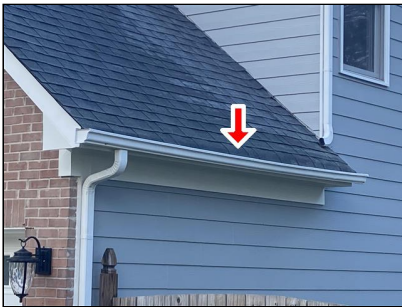
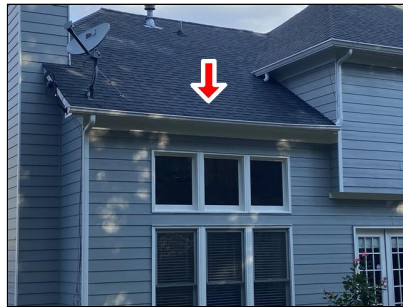
-Gutter on the right side of the garage, the gutter at the right rear of the house are sagging in the middle. Have them adjusted to drain to the downspouts.

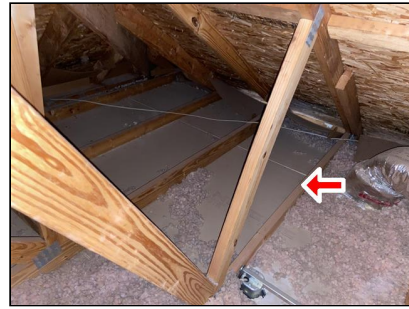
-Insulation is missing on big areas of the attic above the front right bedroom. Have all these areas properly re-insulated.

5.0 -Insulation is missing on big areas of the attic above the front right bedroom. Have all these areas properly re-insulated.

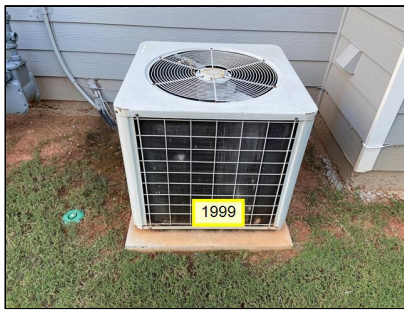
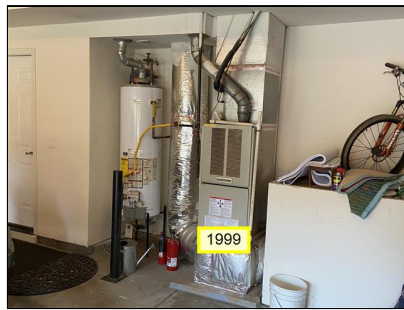
-Heating and cooling units are 21 years old, these units are reaching the end of their average lives and they may need to be replaced in the near future. The heating and cooling units were tested for a short period of time during the inspection and they working; however much of an HVAC system is concealed from view during a normal home inspection and our inspection is basic in scope. Have an HVAC tech service the heating and cooling equipment to clean the blower motor, the heat exchanger, the evaporator coils and the condensing coils, to check the electrical contacts and check the refrigerant,

6.0 -Heating and cooling units are 21 years old, these units are reaching the end of their average lives and they may need to be replaced in the near future. The heating and cooling units were tested for a short period of time during the inspection and they working; however much of an HVAC system is concealed from view during a normal home inspection and our inspection is basic in scope. Have an HVAC tech service the heating and cooling equipment to clean the blower motor, the heat exchanger, the evaporator coils and the condensing coils, to check the electrical contacts and check the refrigerant,

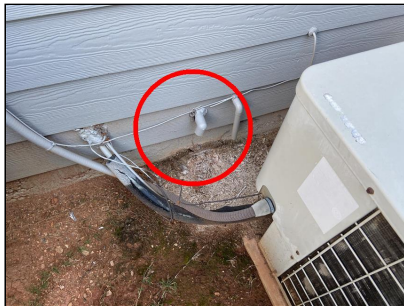
6.2 Item 1(Picture)

-Extend the condensate drain pipe to drain away from the right side of the house behind the a/c unit.

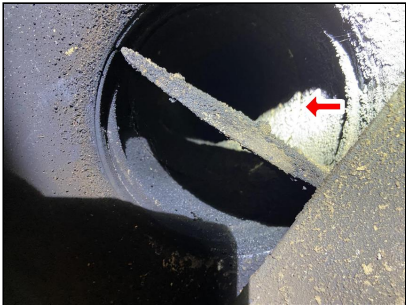
-Flue pipe for the fireplace needs to be cleaned out.

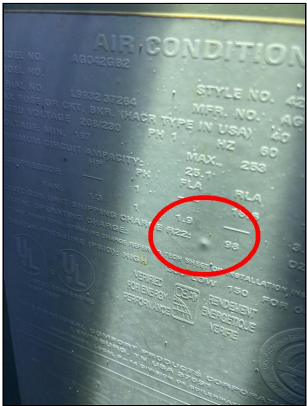
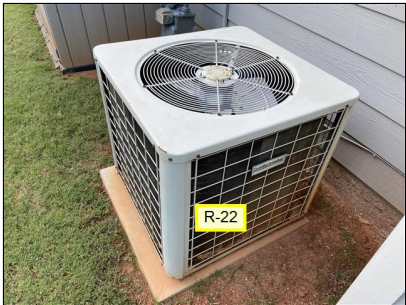
-The typical life expectancy of a/c units is 10-15 years. The a/c unit uses the R-22 type of refrigerant gas (freon), this refrigerant is no longer manufactured in North America and will be expensive and difficult to find in the near future. Have an HVAC contractor evaluate.

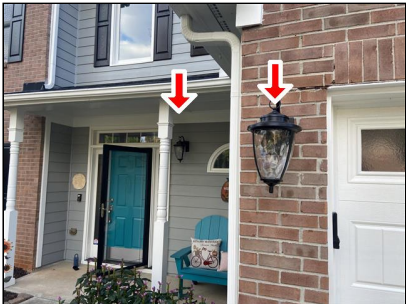
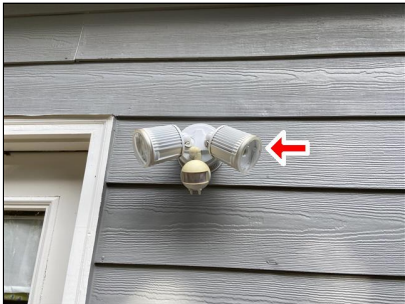
(1) -The front porch light, the exterior light at both sides of the garage doors, the flood light at the rear of the house did not operate when they were tested. It appears that these lights are on sensors. Have the seller ascertain that they are functional or have the repaired or replaced.

7.5 (1) -The front porch light, the exterior light at both sides of the garage doors, the flood light at the rear of the house did not operate when they were tested. It appears that these lights are on sensors. Have the seller ascertain that they are functional or have the repaired or replaced.

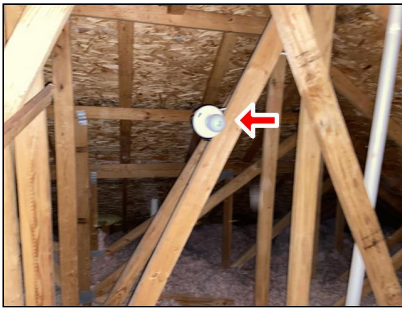
7.5 Item 3(Picture)

(2) -Make the attic light operational. Bulb may be blown.

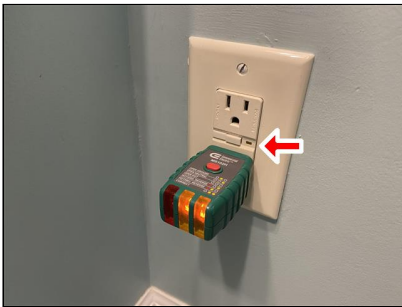
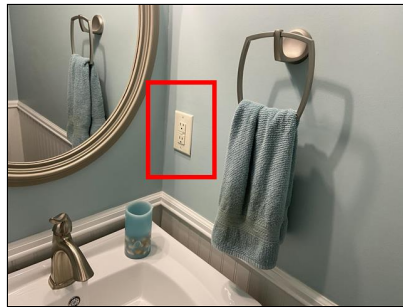
(1) -The GFCI reset outlet at the half bathroom still powered when it was tripped. Have this outlet repaired or replaced.

7.6 (1) -The GFCI reset outlet at the half bathroom still powered when it was tripped. Have this outlet repaired or replaced.

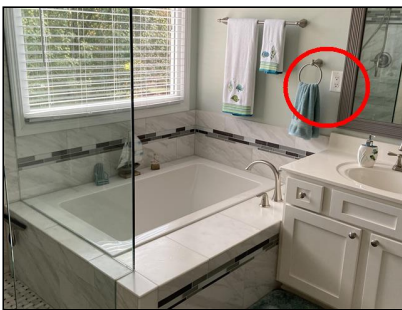
7.6 Item 3(Picture)

(2) -The GFCI outlet on the left side of the left master bathroom sink is too close to the bathroom tub and this outlet can be reached from inside the tub. This is a safety hazard. This was the way that this unit was built; however, it is recommended that this outlet be relocated to correct this condition

7.6 (2) -The GFCI outlet on the left side of the left master bathroom sink is too close to the bathroom tub and this outlet can be reached from inside the tub. This is a safety hazard. This was the way that this unit was built; however, it is recommended that this outlet be relocated to correct this condition

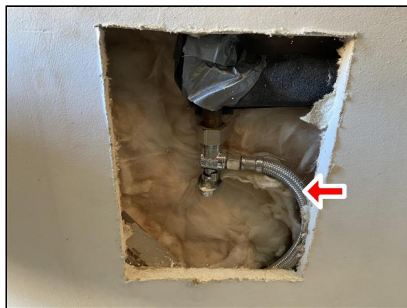
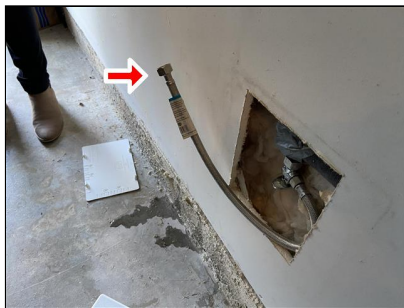
-There is one opened/unused water pipe inside the wall at the left side garage wall. Have this water pipe/hose capped off or have it removed.

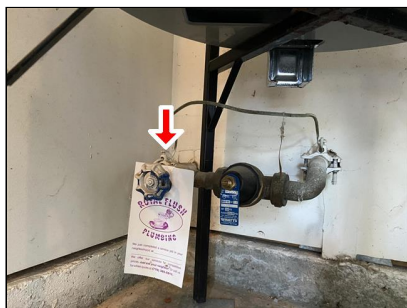
FYI -The main water shut off valve is located under the water heater. The water pressure for the house was tested at the exterior faucet on the front of the house and it was good (60 psi)

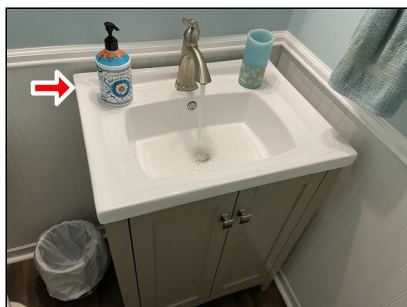
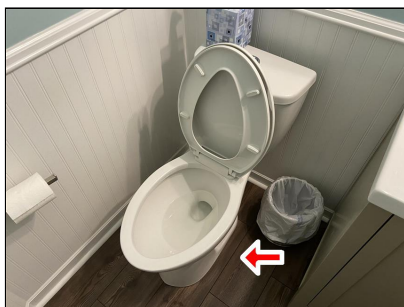
(1) -Half bathroom sink/cabinet is loose to the wall and the half bathroom is loose to the floor. Have them secured.

8.3 (1) -Half bathroom sink/cabinet is loose to the wall and the half bathroom is loose to the floor. Have them secured.

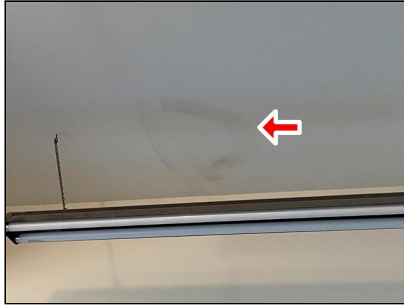
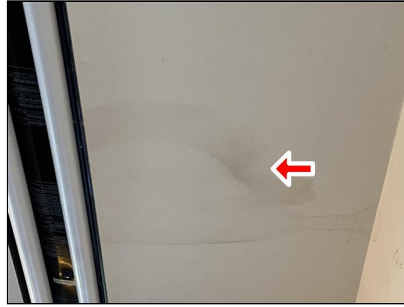
(2) -Water stains were noted on the drywall ceiling at the left rear of the garage. These stains were dry at the time of the inspection; however, seller to provide information about the causes of these stains and to ascertain that any leaks from the bathroom above were properly repaired or have a plumber evaluate to ascertain that there are no active leaks at this area or to make repairs as needed.

8.3 (2) -Water stains were noted on the drywall ceiling at the left rear of the garage. These stains were dry at the time of the inspection; however, seller to provide information about the causes of these stains and to ascertain that any leaks from the bathroom above were properly repaired or have a plumber evaluate to ascertain that there are no active leaks at this area or to make repairs as needed.

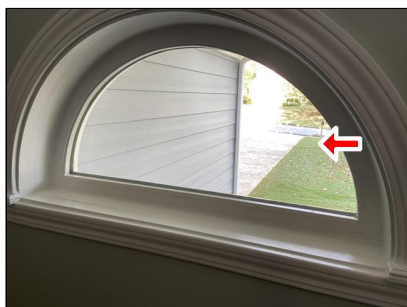
-The arc window at the bottom of the stairs is not tempered glass. This was ok when this house was built; however, it is recommended that this window be replaced with a tempered glass window for safety.

9.6 -The arc window at the bottom of the stairs is not tempered glass. This was ok when this house was built; however, it is recommended that this window be replaced with a tempered glass window for safety.

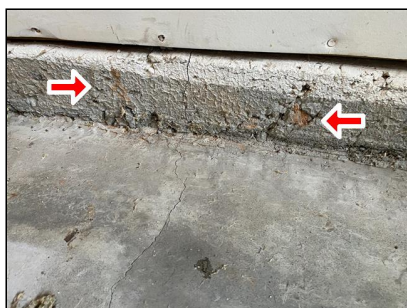
-Old termite trails were noted on the concrete slab at the right side of the garage. The buyer should not depend on this report to discover all termite activity in the house whether concealed or not concealed and a thorough termite inspection will need to be performed.

9.8 -Old termite trails were noted on the concrete slab at the right side of the garage. The buyer should not depend on this report to discover all termite activity in the house whether concealed or not concealed and a thorough termite inspection will need to be performed.
