**BPG Inspection Services**

**1538 Chantilly Drive Northeast Unit 102  
Atlanta GA 30324**

Client(s): Villa  
Inspection Date: 1/4/2020  
Inspector: Kevin Carey ,

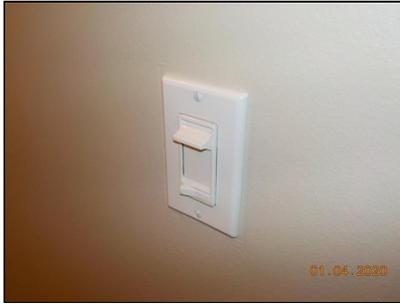
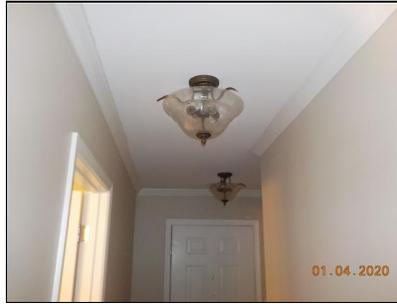
Dimmer switch is not a 3-way device.

- ❌ 4. **SERVICE / REPAIR:** Dimmer switch is not a 3-way device or it is improperly installed. The second switch cannot turn the lights on from its position unless the dimmer is ON. Recommend further evaluation and repairs made by a qualified electrician. Location: **Hallway**

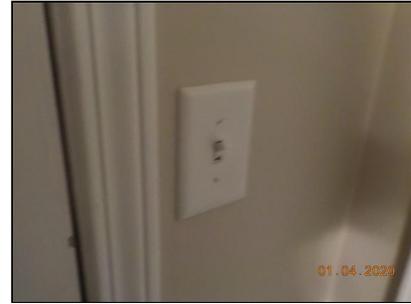
The second switch cannot turn the lights on from its position unless the dimmer is ON.

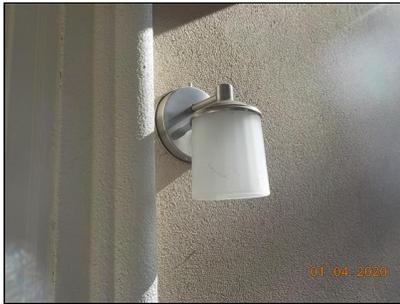
Inoperable light noted.

- ❌ 5. **SERVICE / REPAIR:** Inoperable light noted. Replace bulb and verify that the fixture is operational. If not, consult an electrician for repairs. Location: **Patio**

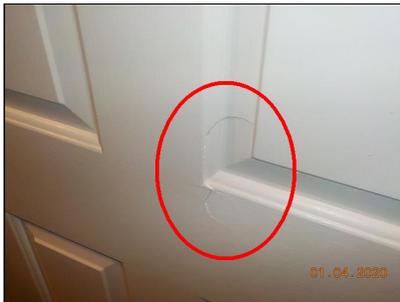
Cosmetic damage to the door noted.

- ❌ 6. **SERVICE / REPAIR:** Cosmetic damage to the door noted. Repair or replace. Location: **Laundry**

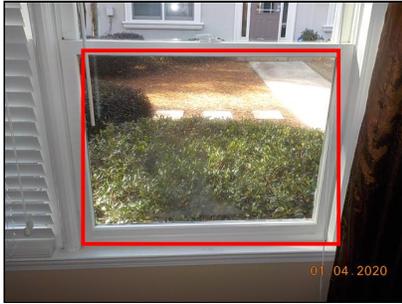
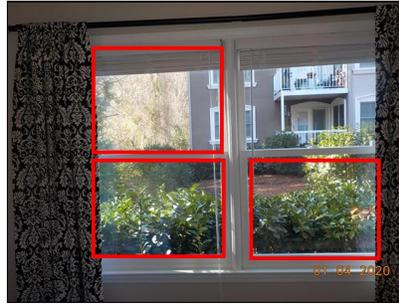
Condensation and / or hazing was noted between insulated window panes.

- ❌ 7. **MAJOR DEFECT:** Condensation and / or hazing was noted between insulated window panes. The thermopane insulated glass has lost its vacuum seal and may eventually completely cloud over. Broken seals also reduce the original insulation value of the window. (Dirty windows should be cleaned to assure that conditions do not exist in other units and were not obvious at time of inspection.) Recommend replacement of all damaged windows listed plus any others throughout house that may be identified by glass service. Locations: **2nd bedroom (1), master bedroom (3)**

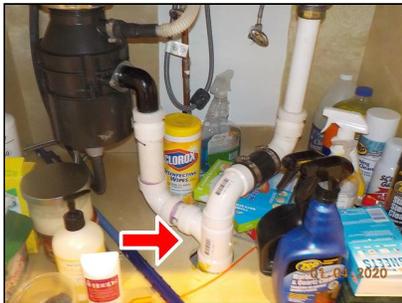
No p-trap found under the kitchen sink.

- ❌ 8. **SERVICE / REPAIR:** No P-trap found under the kitchen sink. A trap is required to prevent sewer gas release into house. Possibly installed below the cabinet floor, in the slab. Recommend a licensed plumber inspect further and repair as necessary.

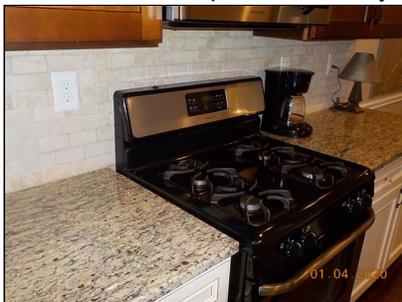
Missing anti-tip device noted.

- ❌ 9. **SAFETY / HEALTH:** A hold down device is necessary for the stove to prevent it from being tipped over when the door is open. Typically this involves a bracket around the stove foot or a chain from the back of the stove to the wall. Install as required for safety.

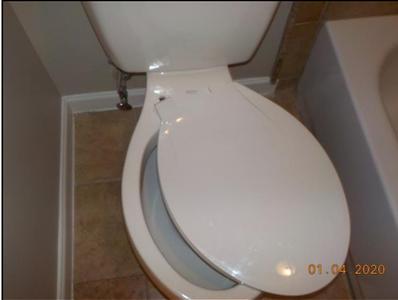
Loose toilet seat noted

- ❌ 10. **SERVICE / REPAIR:** Loose toilet seat noted, missing a bolt. Recommend repair/replace. Location: **Master bathroom**

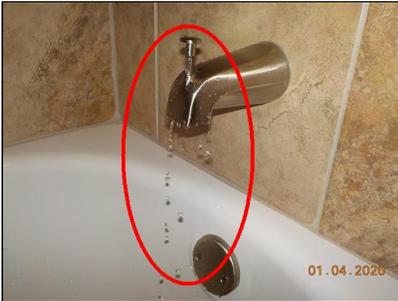
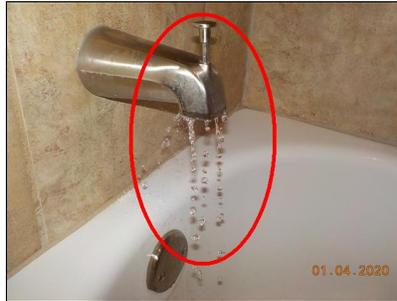
Shower diverter does not seal completely when engaged.

- ❌ 11. **SERVICE / REPAIR:** Shower diverter does not seal completely when engaged. This will result in a weaker flow to the shower head. Recommend correct to prevent water loss and allow normal use of shower. Location: **Both bathrooms**

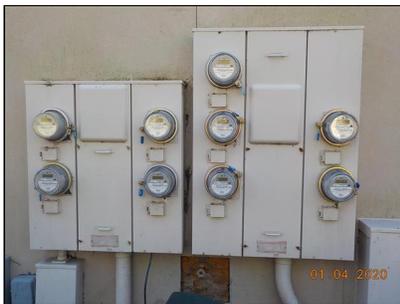
16. **GENERAL NOTE:** The main electrical disconnect is located at the meters. NOTE: The meters are not labeled with the unit numbers.

The main electrical disconnect is located at the meters.

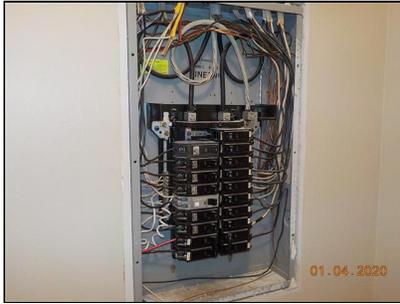
17. **GENERAL NOTE:** The electrical panel cover was removed and the wiring inspected. No defects were noted.

The electrical panel cover was removed and the wiring inspected.

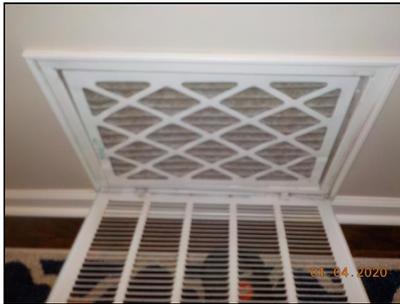
Recommend changing the filter at move-in.

19. **GENERAL NOTE:** Recommend changing the filter at move-in. Recommend changing filter every two to three months thereafter. Use a good quality, pleated filter that is rated MERV-8 or better. The filter size is: 14 x 20 x 1

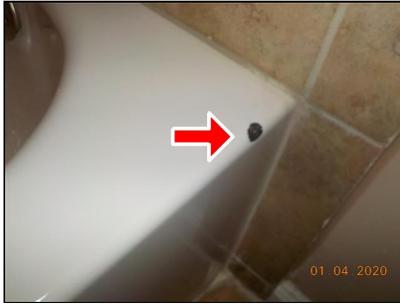
21. **GENERAL NOTE:** Chip noted in the tub finish. Recommended to be repaired by tub restoration company. Location: **2nd bathroom**
