RESIDENTIAL REPORT

3025 Eagle Ridge
Roswell GA 30076

Tommy Norris
FEBRUARY 3, 2020

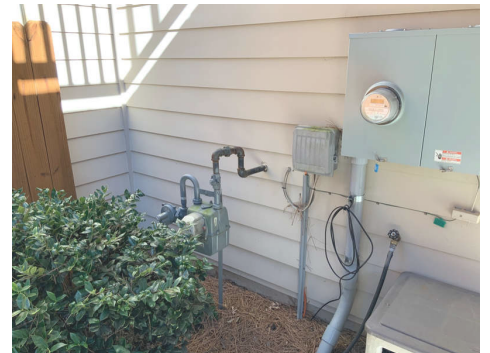
2.1.1 Vegetation/Flora

VEGETATION (AROUND UTILITIES)

Vegetation was overgrown around equipment for one or more utilities such as gas or electric meters. Vegetation should be pruned or removed as necessary to allow unobstructed access.

Contact a qualified professional.

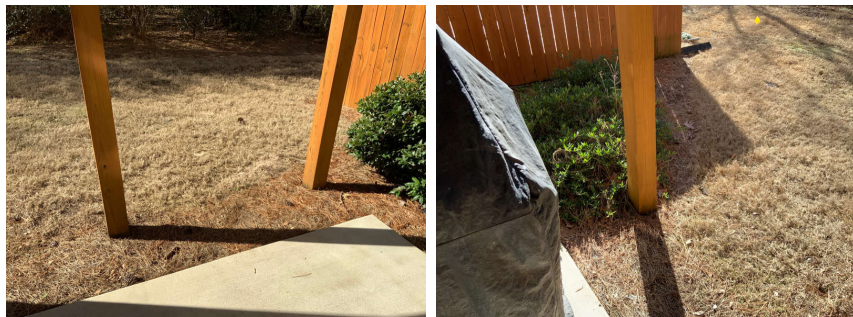
2.4.1 Decks And Porches

SOIL CONTACT WITH DECK OR SUPPORTS

Soil was in contact with wooden decking or their support posts at one or more locations. This is a conducive condition for wood-destroying organisms. Soil should be graded and/or removed from wooden structures.

Contact a qualified professional.

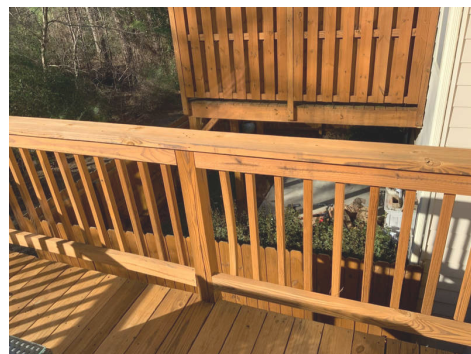
2.5.1 Stairs, Guardrails And Handrails

HANDRAILS AND GUARDRAILS LOOSE, MISSING OR DETERIORATED

One or more sections of handrails/guardrails were loose and or wobbly. Recommended further evaluation and or repair by a qualified professional.

Contact a qualified professional.

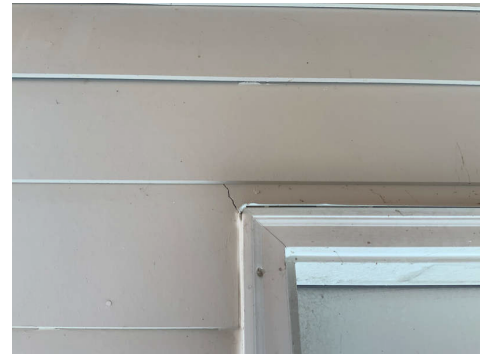
3.1.1 Siding And Trim

DAMAGE - MINOR

Siding and/or trim was damaged, deteriorated, and/or substandard in one or more places. Recommend further evaluation and repair or replacement as necessary.

Contact a qualified siding specialist.

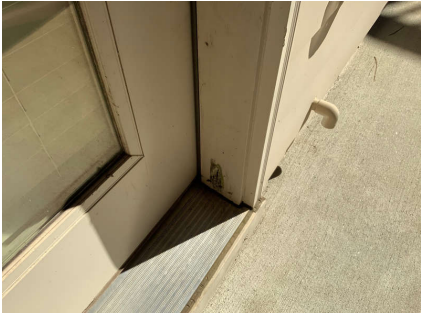
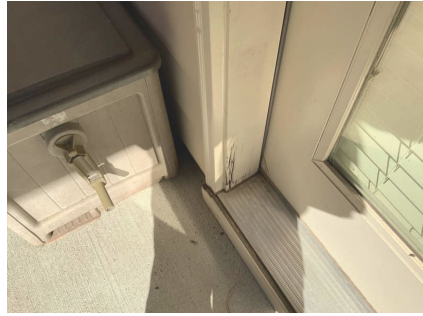
3.2.1 Exterior Doors

DOOR FRAME DAMAGED

One or more exterior door frames were damaged, rotten, and/or had substandard repairs. Recommend repair and/or replacement by a qualified person.

Back Door

Contact a qualified professional.

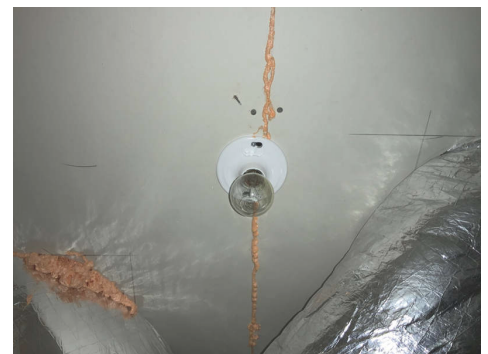
Utility Coset Garage

One or more light fixtures and/or bulbs were inoperable and/or broken. Recommend replacement of bulbs by a qualified person. If this does not correct the issue, recommend repair or replacement of fixtures by a qualified electrician.

Contact a qualified electrical contractor.

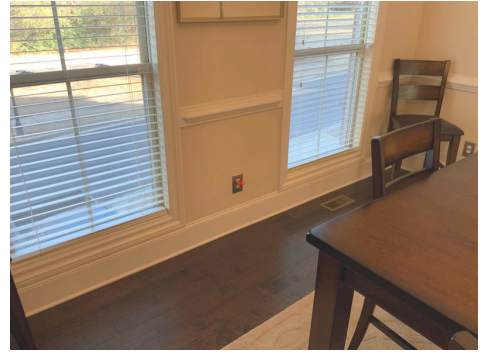
5.6.1 Receptacles And Switches

LOOSE

One or more receptacles and/or switches were loose or not securely installed. This is a safety/fire hazard. Recommend further evaluation and repair by a qualified electrician.

Dining Room

Contact a qualified electrical contractor.

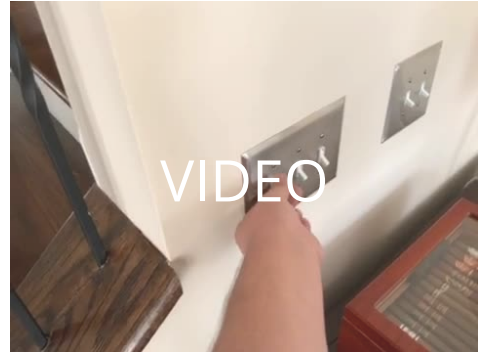
5.6.2 Receptacles And Switches

One or more switches were wired incorrectly and/or malfunctioning causing lights to flicker on and off, or interfering with other electrical components. Recommend licensed electrician evaluate, repair, and/or replaces necessary.

Contact a qualified electrical contractor.

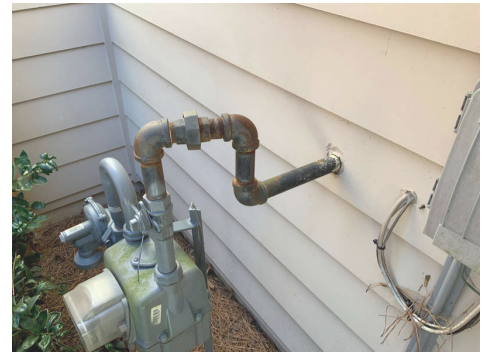
GAS LINES/PIPES (RUST OR CORROSION)

Rust, pitting or significant amounts of corrosion were located on one or more areas of the fuel distribution system such as piping, valves or joints. This may result in a gas leak and is a significant safety hazard. This can be mitigated by cleaning affected areas, removing rust and covering with a protective paint or coating. In more severe cases, replacement may be necessary. Recommend further evaluation, repair and/or replacement by a qualified plumber.

Contact a qualified plumbing contractor.

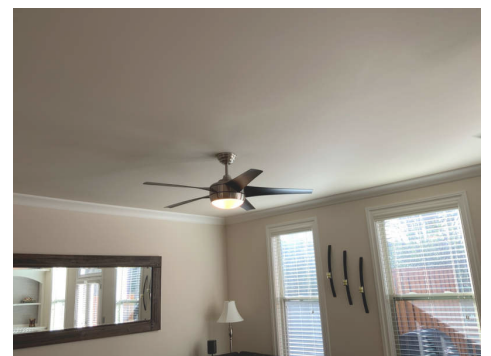
8.3.1 Ceiling and Attic Fans

One or more ceiling fans appeared to be inoperable, or the inspector was unable to find normal controls with which to operate the fan(s). Recommend asking the property owner about their operation, and if necessary, that a qualified electrician evaluate and repair.

Living Room

Contact a qualified professional.

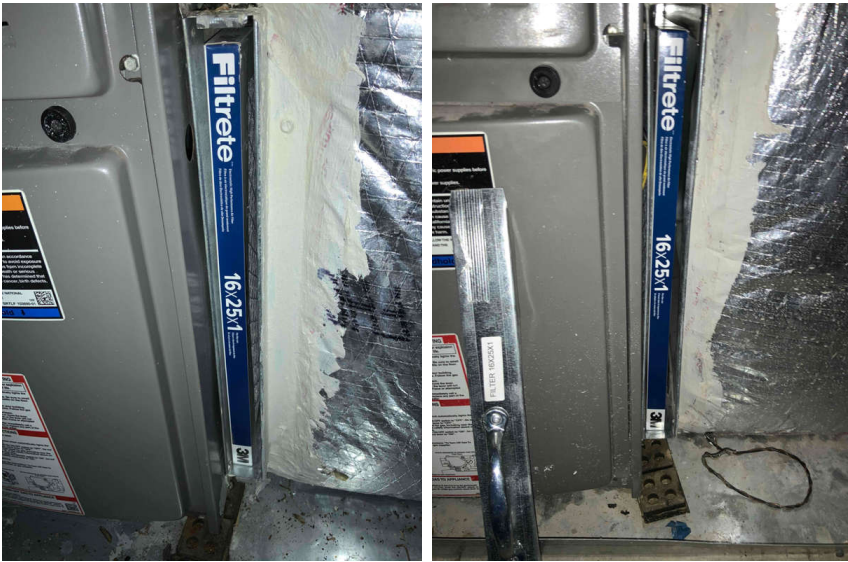
9.1.1 Heating Equipment

FILTER REQUIRES REPLACEMENT

Recommend that home buyers replace the HVAC filters upon taking occupancy. Regardless of the type, recommend checking filters quarterly in the future and replacing them as needed. How frequently they need replacing or cleaning depends on the type and quality of the filter, how the system is configured, and on environmental factors (typically only good for three months).

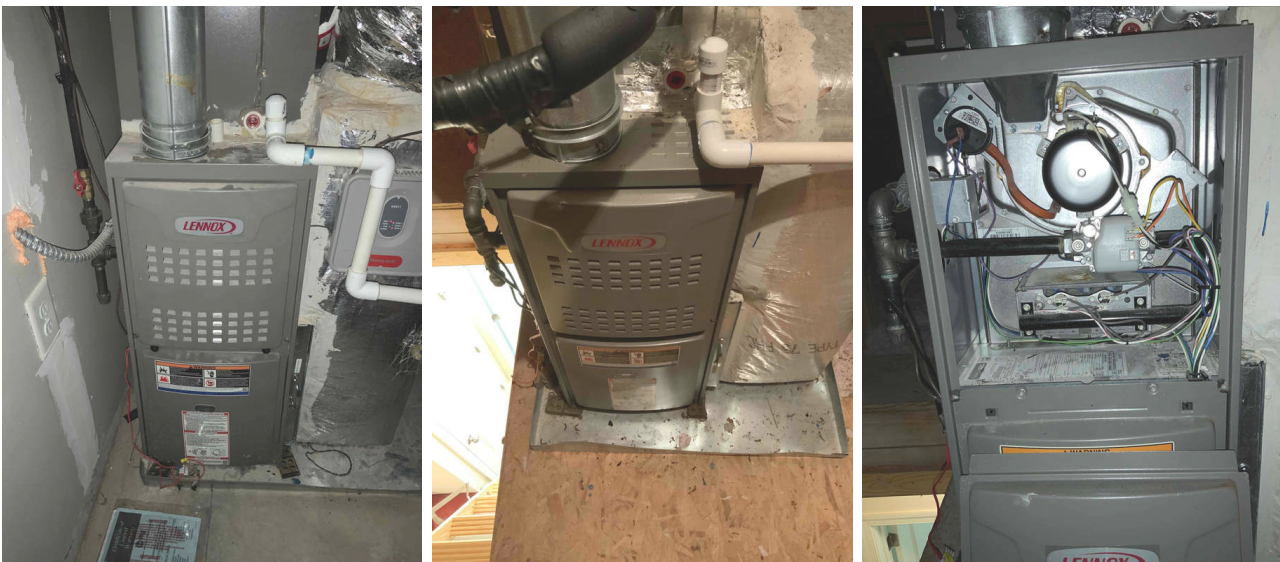
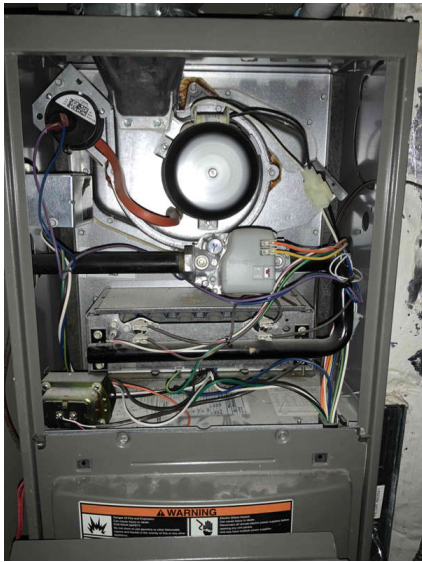
9.1.2 Heating Equipment

NEEDS SERVICING/CLEANING

The furnace didn't appear to have been serviced within the past year. Recommend a qualified HVAC contractor clean, service and certify furnace. Furnace should be cleaned and serviced annually in the future.

Contact a qualified heating and cooling contractor

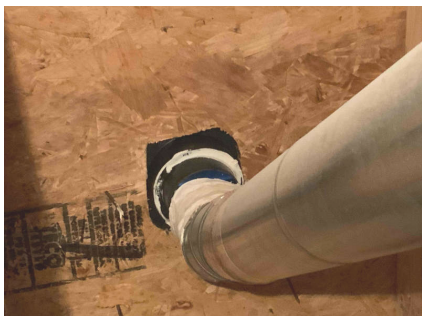
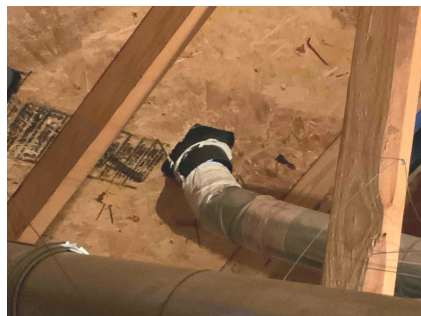
9.3.1 Vents, Flues & Chimneys

VENTS OR FLUES DAMAGED

One or more vents or flues were damaged, deteriorated and/or loose. This could be a safety hazard if it is used for venting CO gas out of the home. Recommend repair or replacement by a qualified contractor.

Attic

Contact a qualified professional.

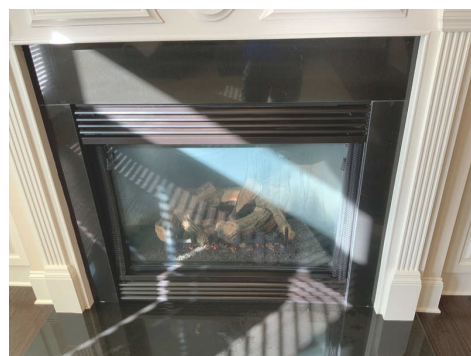
The gas fire place glass cover showed signs of deterioration and was foggy. This happens as the burning of natural gas produces acidic moisture that damages the glass over time. Recommend further evaluation and repair or replacement as necessary.

Contact a qualified fireplace contractor.

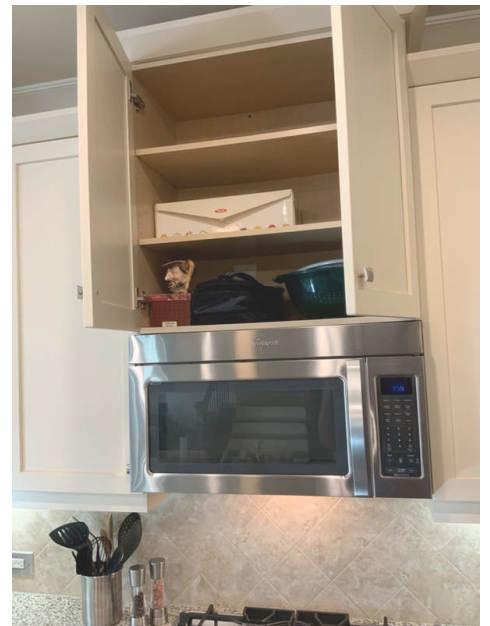
The exhaust hood or down draft was not part of a ducted system and recirculates back into the kitchen. This may fail to provide proper ventilation. Recommend Installing a ventilation duct to the exterior of the home.

Contact a qualified professional.

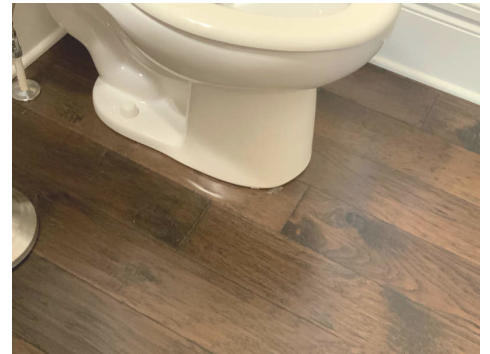
Bathroom 2nd Floor

Caulk at the base of one or more toilets was missing or substandard. Modern standards require caulk to be installed around the entire toilet base where it meets the floor for sanitary reasons. Without it, soiled water can soak into flooring and sub-floor materials if the toilet overflows. Condensation from the toilet can also soak into the flooring. Recommend that a qualified person caulk around toilet bases per standard building practices.

Contact a handyman or DIY project

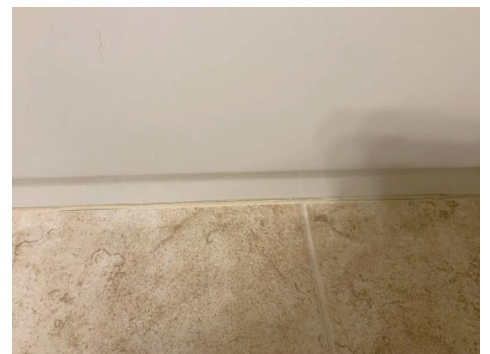
12.3.1 Bathtubs

The caulking at the base of the tub and floor was deteriorated, and/or substandard. Water can penetrate the floor structure causing moisture related damage and/or growth as a result. Recommend repair by a qualified person.

Contact a handyman or DIY project

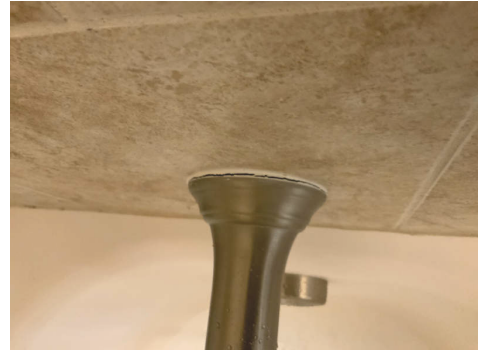
12.3.2 Bathtubs

GAP AT SPOUT

Significant gaps and/or missing caulk was found between one or more tub spouts and the tubs/walls/enclosures. Water may penetrate at these locations causing moisture related damage and/or growth. Recommend further evaluation and repair by a qualified person.

Contact a handyman or DIY project

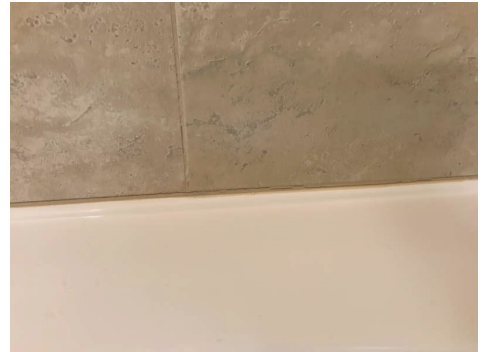
12.3.3 Bathtubs

CAULK SUBSTANDARD

Caulk and/or grout was missing, deteriorated, and/or substandard around the tub at one or more locations. Recommend resealing to prevent moisture intrusion and damage.

Master Bathroom 3rd Floor

Contact a qualified professional.

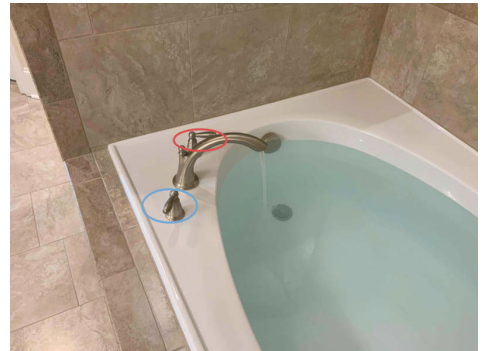
12.3.4 Bathtubs

The bathtub faucet handles were reversed with the cold side being on the left. The left side handle should always be hot to prevent scalding. Recommend repair by a qualified plumber.

Contact a qualified plumbing contractor.

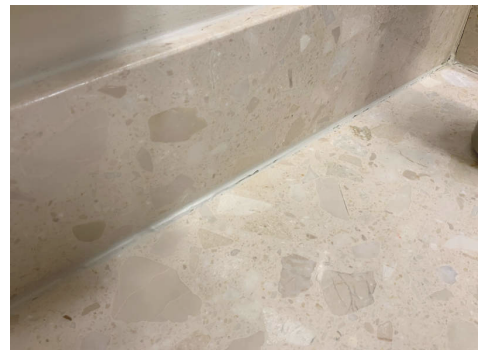
12.7.1 Counter Tops

CAULK DETERIORATED OR SUBSTANDARD

Caulk was deteriorated, and/or substandard at one or more locations such as around sinks or between countertops and backsplashes. Recommend repair by a qualified handyman.

Master Bathroom 3rd Floor

Contact a handyman or DIY project

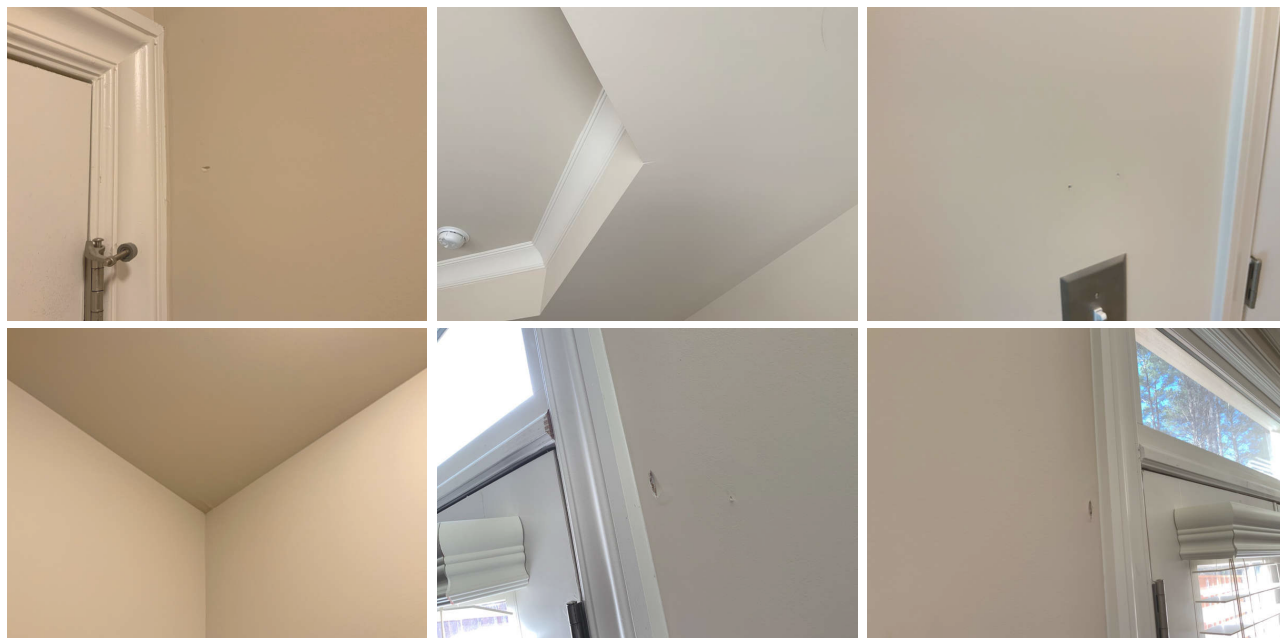
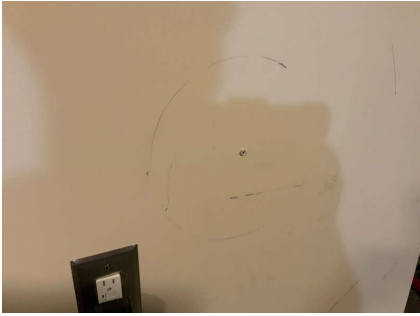
MINOR DAMAGE

Damage, and/or substandard repairs were found in one or more areas of walls, ceilings, and/or trim. Recommend repair by a qualified contractor.

Contact a qualified drywall contractor.

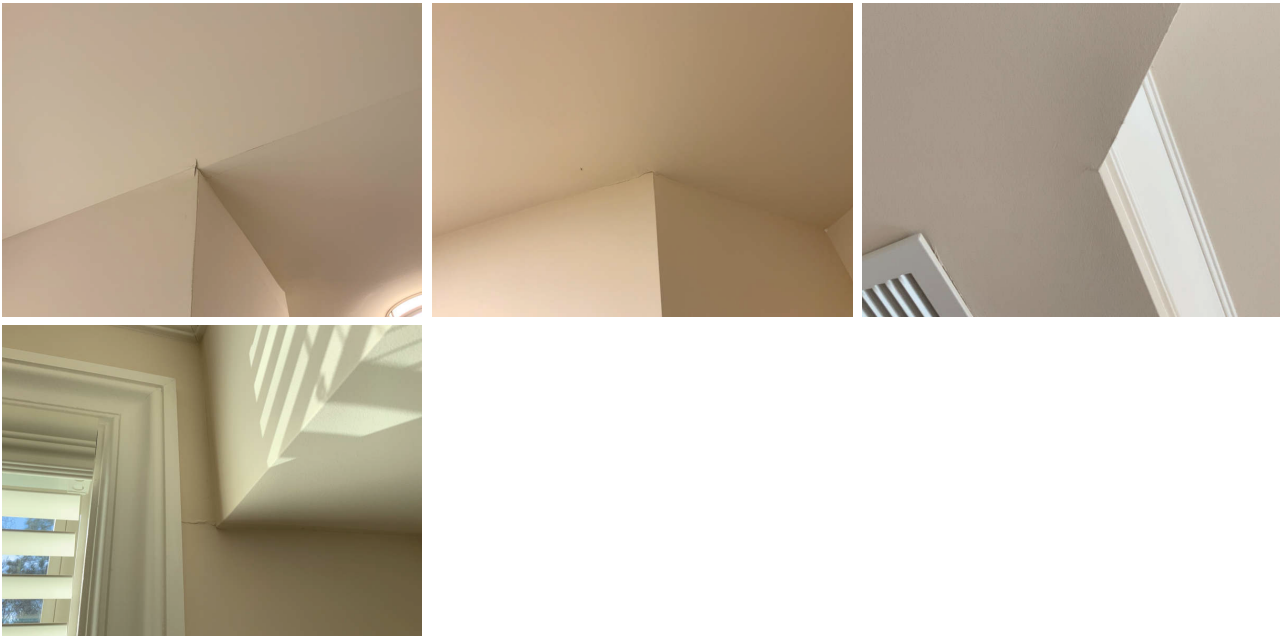
13.1.2 Walls And Ceilings

MINOR CRACKS

Minor cracks and nail pops were found in one or more walls or ceilings. This appeared to be the result of long-term and/ seasonal settling. Some settling is not unusual in a home and these cracks are not considered a structural concern.

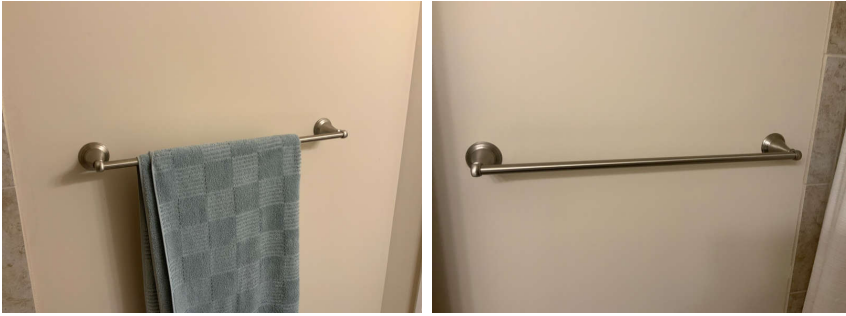
13.1.3 Walls And Ceilings

FIXTURES LOOSE OR MISSING

Fixtures such as toilet paper holders and/or towel racks were loose and/or missing.

Contact a handyman or DIY project

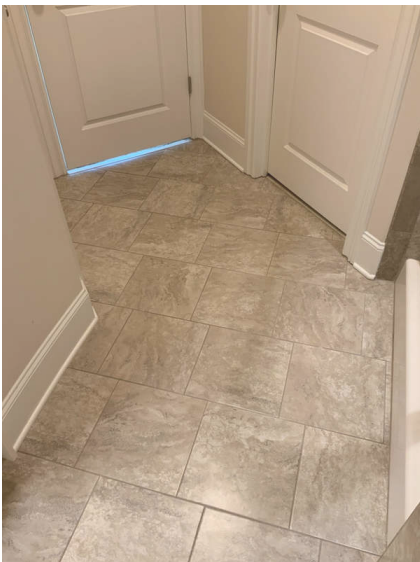
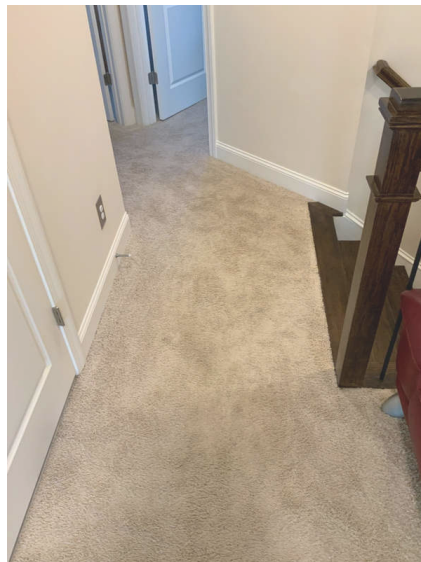
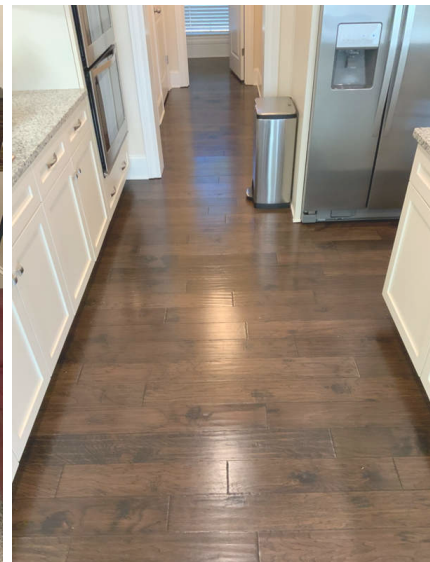
13.2.1 Floors

UNEVEN FLOORS

Floors in one or more areas were not level. This can be caused by settlement or movement of the foundation, posts and/or beams. Significant repairs may be needed to make floors level. Recommend that a qualified contractor and/or engineer evaluate further. Repairs should be performed by a qualified contractor.

Master Bathroom 3rd Floor

3rd Floor Hall

2nd Floor Kitchen/Hall

Contact a qualified flooring contractor

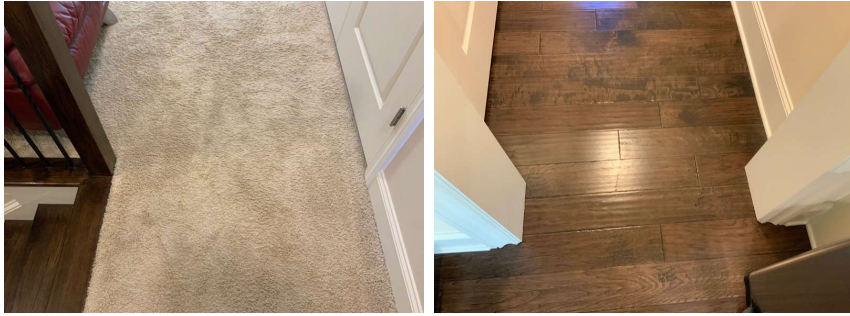
13.2.2 Floors

Squeaking or creaking noises occur when walking on one or more sections of flooring. This can be caused by substandard construction practices and/or aging and settlement of the home. In most cases, this is only an annoyance rather than a structural problem. Floor squeaks may disappear, change locations, and/or occur in new locations as the load is shifted. (For example moving or relocating furniture. Repairs to eliminate the squeaks or creaks may be more or less difficult depending on the floor covering and the access to the underside of the sub-floor. Recommend that a qualified contractor evaluate and repair as necessary.

2nd Floor Kitchen/Hall

Contact a qualified professional.

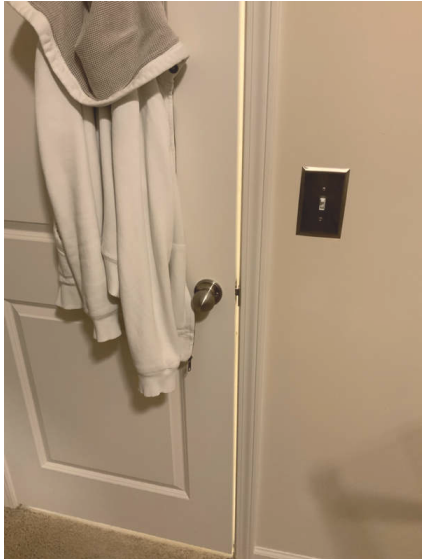
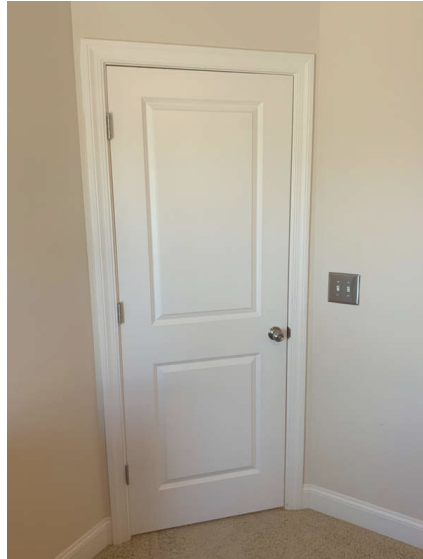
13.4.1 Interior Doors

One or more interior doors were out of square and/or wouldn't latch and/or were difficult to latch. Recommend that a qualified person repair or replace as necessary.

Master Bedroom Closet

Northeast Bedroom 3rd Floor

Contact a qualified professional.

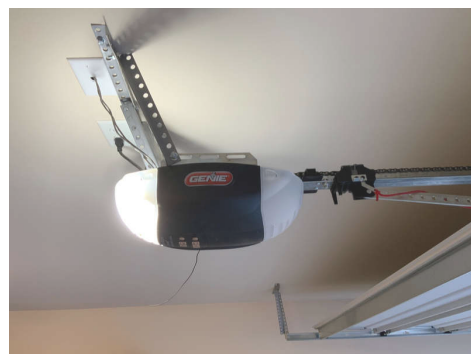
AUTO REVERSE NOT WORKING

The mechanical auto reverse sensor was not responding at time of inspection. This is a safety hazard. Recommend a qualified garage door contractor evaluate and repair/replace.
