## AMENDMENT TO ADDRESS CONCERNS WITH PROPERTY AMENDMENT #1 \_\_\_\_\_

**BPG Inspection Services**

Client(s): Levinson  
Inspection Date: 1/31/2020  
Inspector: Kevin Carey ,

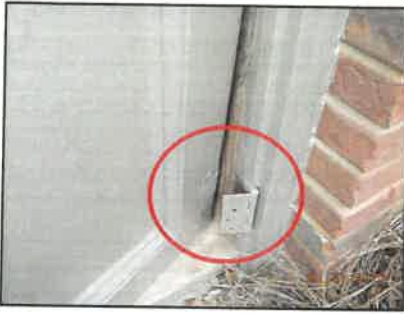
- ☒ 4. **SERVICE/REPAIR:** Loose hinge noted. Have repaired to allow for proper use of the door. Location: **Crawlspace door**

Loose hinge noted.

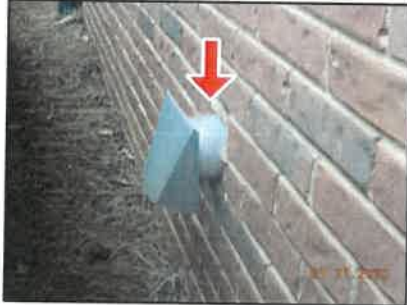
- ❌ 5. **SERVICE / REPAIR:** Vent hood found loose and not sealed to the wall surface. Secure loose hood and seal to siding avoid moisture and insect intrusion to framing cavity. Location: **Left side-abandoned dryer vent and kitchen exhaust vent**

Vent hood found loose and not sealed to the wall surface.

#5 - Building Envelope - Left side abandoned dryer vent. Secure loose vent hood and seal to the siding to avoid moisture and insect intrusion.

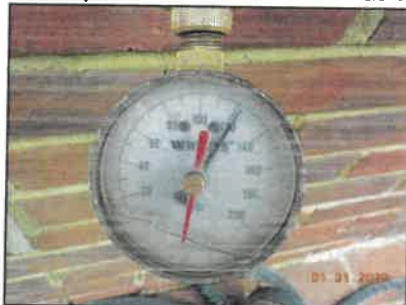
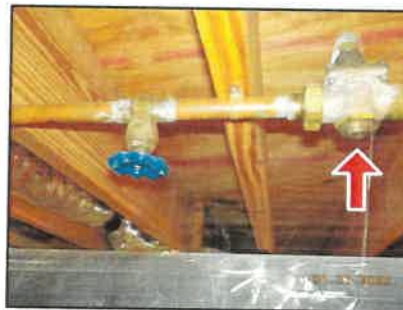
- ❌ 6. **SERVICE / REPAIR:** The water pressure tested at over 80 PSI. This is considered excessive. Adjustment/ replacement of the pressure regulator valve (PRV) is necessary. Correct to have between 40 and 80 PSI. The water pressure was recorded at 120+ PSI

The water pressure was recorded at 120+ PSI

Adjustment/replacement of the pressure regulator valve (PRV) is necessary.

#6 - Service Entrance - The water pressure tested excessive at over 80 PSI (120+PSI) Adjust/Replace the pressure regulator valve to correct between 40-80 PSI

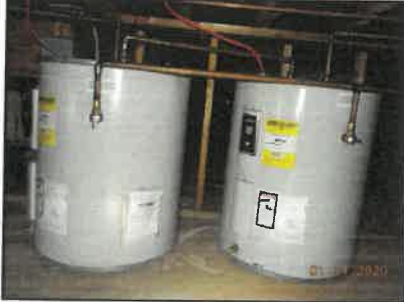
- ❌ 7. **SERVICE / REPAIR:** No expansion device found. To relieve internal plumbing supply pressure during water heating process, a thermal expansion tank or valve is required with the water heater. (mandatory for all closed city water systems). Most all of Georgia implemented in June 1998. The water heater was installed after this requirement was implemented and an expansion device should have been installed. Recommend a licensed plumber inspect further and repair as necessary.

No expansion device found.

#7 - Plumbing - No expansion devise found on water heater as required. Have a licensed plumber repair/install one

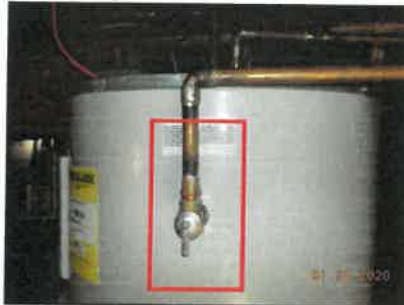
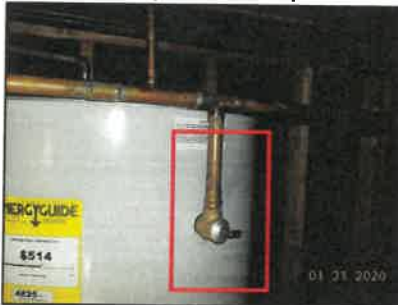
- ❌ 8. **SERVICE / REPAIR:** A bleeder valve is required for temperature and pressure discharge drain lines that are not installed to a gravity drain. This prevents standing water on the safety device which could become rusted stuck, rendering it ineffective. Recommend a licensed plumber inspect further and repair as necessary.

Missing bleeder valve noted.

#8 - Water Heater - A bleeder valve is missing and is required for temp and pressure discharge drain lines. Have a licensed plumber repair/install valve

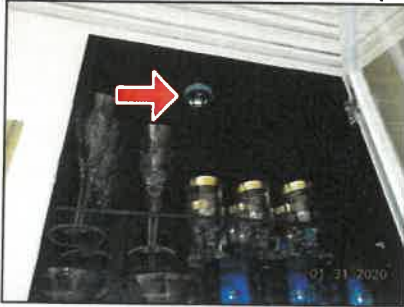
- ❌ 10. **SERVICE / REPAIR:** Inoperable light noted. Replace bulbs and verify that the fixture is operational. If not, consult an electrician for repairs. Location: **Kitchen bar cabinet**

Inoperable light noted.

#10 - Fixtures - Inoperable light noted in kitchen bar cabinet. Replace bulbs and verify the fixture is operational

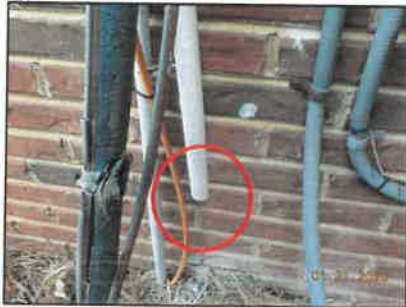
- ❌ 11. **SERVICE / REPAIR:** The condensation drain line terminates next to the building. This will release a considerable amount of water next to the foundation. Recommend the drain line be extended to terminate at least three feet from the foundation and beyond the A/C condensation units. This is also to reduce conducive conditions for termites.

The condensation drain line terminates next to the building.

#11 - Air Conditioner - The condensation drain line terminates next to the building which will release a considerable amount of water next to the foundation. Have the drain line replaced as it needs to extend to terminate at least 3 feet from foundation and beyond A/C condensation units

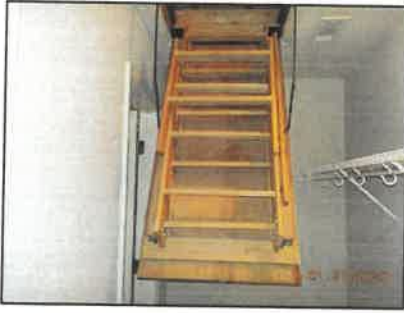
- ❌ 12. **SERVICE / REPAIR:** Attic pull down stair is not substantially weather tight when closed. Have the unit modified (weather stripped / insulated) as necessary to control energy loss. One option is to provide an insulated cover that fits over the stairs when retracted to reduce heat loss in the winter.

Attic pull down stair is not substantially weather tight when closed.

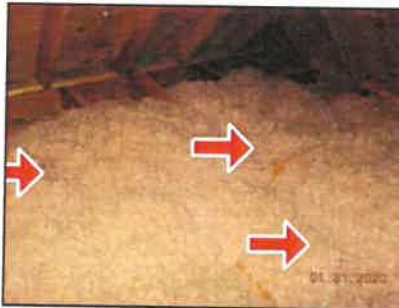
- ☒ 13. **SERVICE / REPAIR:** Signs of past rodent activity noted in the attic. Tunnels and trails through the insulation. Recommend further evaluation and service performed by a qualified pest control contractor, if it hasn't been done recently.

Tunnels and trails through the insulation.

#13 Attic - Signs of past rodent activity was noted in the attic. If a previous wildlife exclusion has been done to correct this please provide documentation. If not, then have the attic evaluated by a professional wildlife exclusion company and treated as necessary to remove and exclude wildlife

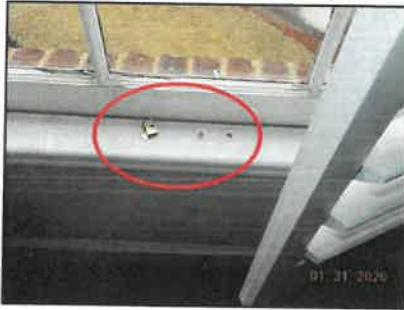
- ❌ 16. **SERVICE / REPAIR:** Broken/missing shutter magnets noted. Have replaced to allow for proper closing of the window shutters. Locations; **Throughout the house.**

Broken/missing shutter magnets noted.

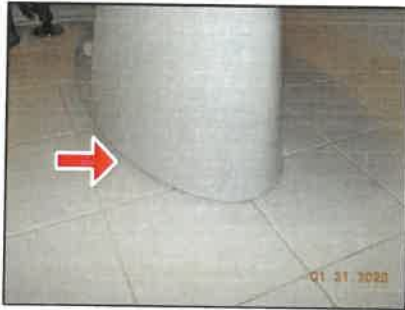
- ❌ 17. **SERVICE / REPAIR:** Toilet should be sealed between the base and floor as required. This helps protect below the unit from contaminants and better holds the unit in place to avoid rotating. The plumbing code also requires caulking fixtures to their mounted surfaces. Location: **All toilets** Note: Recommend using clear caulk on darker floor surfaces

Toilet should be sealed between the base and floor

#17 - All Toilets - Needs to be sealed between the base and floor as required by plumbing code

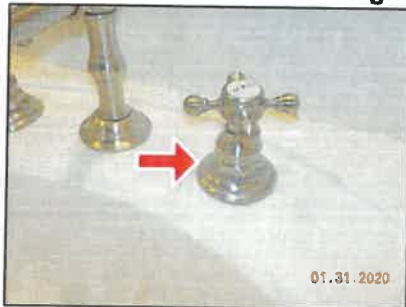
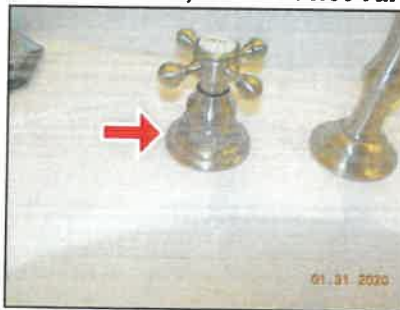
- ❌ 18. **SERVICE / REPAIR:** Loose faucet valves noted. Have secured to the sink to prevent stress on the supply lines. Location: **Master bathroom:right sink-cold valve, left sink-hot valve.**

Loose faucet valves noted.

#18 & #19 - Sinks Master Bath - Loose faucet valves need to be secured to the sink to prevent stress on supply lines. Loose faucet valve handles also need to be repaired. Have repaired by a qualified plumber/handyman

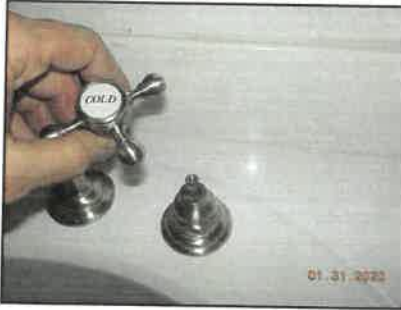
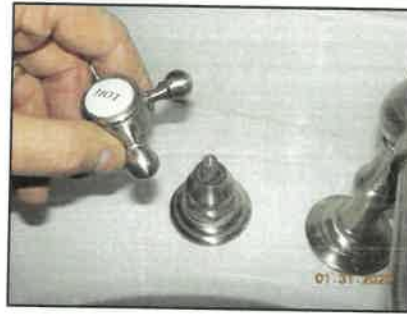
- ❌ 19. **SERVICE / REPAIR:** Loose faucet valve handles noted. Recommend having repaired by a qualified plumber/handy man. Location: **Master bathroom**

Loose faucet valve handles noted.

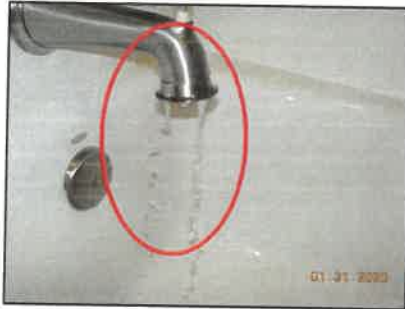
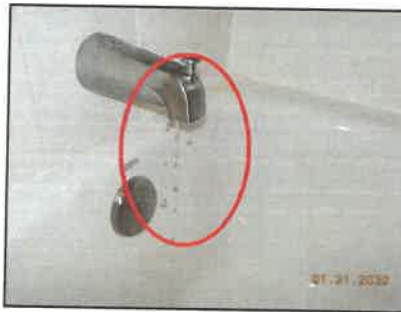
- ❌ 20. **SERVICE / REPAIR:** Shower diverter does not seal completely when engaged. This will result in a weaker flow to the shower head. Recommend correct to prevent water loss and allow normal use of shower. Location: **Both 2nd floor bathrooms**

Shower diverter does not seal completely when engaged.

#20 - Shower - Both 2nd floor Baths - Shower diverter does not seal completely when engaged resulting in weaker flow. Have corrected by a qualified plumber/handyman

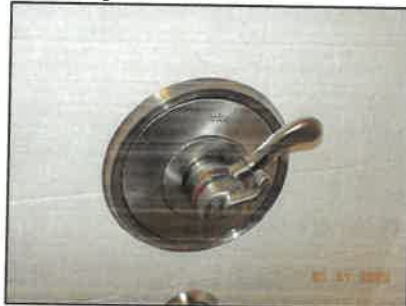
- ❌ 21. **SAFETY / HEALTH:** Reversed hot and cold plumbing noted at the tub/shower valve. This can result in scalding if unfamiliar with this condition. Recommend correct as required for hot to be on the left position. Location; **2nd floor-right bathroom**

Reversed hot and cold plumbing noted at the tub/shower valve.

#21 - 2nd floor right bath -Tub/Shower - reversed hot & cold on tub/shower valve. Correct as required for hot to be on the left position. Have repaired by a qualified plumber/handyman

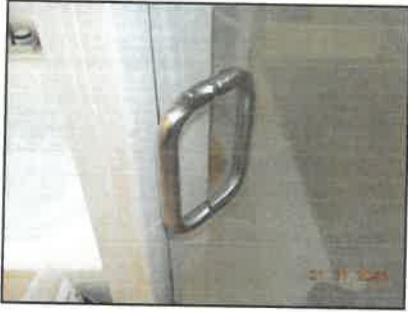
- ❌ 22. **SERVICE / REPAIR:** Loose shower door handle noted. Have repaired by a qualified contractor. Location; Master bathroom

Loose shower door handle noted.

#22 - Master Bath - Loose shower door handle. Have repaired by a qualified plumber/handyman
