Inspection Report

Property Address:
1080 Peachtree St NE
Unit 1806
Atlanta GA 30309

Date: 2/6/2020	Time: 01:00:00 PM	Report ID: 020620LQ185
Property: 1080 Peachtree St NE Unit 1806 Atlanta GA 30309	Customer: Michelle Giannini	Real Estate Professional: ann-marie Sharp keller williams

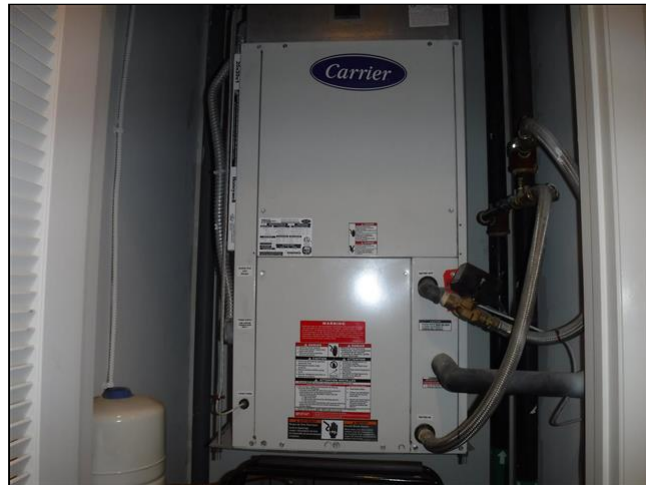
4.0 Item 1(Picture)

(1) View of furnaces.

(2) Have an hvac tech service the heating and cooling equipment to clean the blower motor, the evaporator coils, the condensing coils, the electrical contacts, check refrigerant levels, check size of units compared to size of home and ascertain that the equipment is operating properly and efficiently. Most of internal parts of the hvac system are concealed from view, and our inspection is mostly visual and is intended to check the operation of the system(s). Therefore, an hvac tech should evaluate for any concealed defects or hazards in the system. Furthermore, manufacturers recommend annual maintenance and servicing to keep the system working at peak efficiency.

🔧 (2) Have an hvac tech service the heating and cooling equipment to clean the blower motor, the evaporator coils, the condensing coils, the electrical contacts, check refrigerant levels, check size of units compared to size of home and ascertain that the equipment is operating properly and efficiently. Most of internal parts of the hvac system are concealed from view, and our inspection is mostly visual and is intended to check the operation of the system(s). Therefore, an hvac tech should evaluate for any concealed defects or hazards in the system. Furthermore, manufacturers recommend annual maintenance and servicing to keep the system working at peak efficiency.

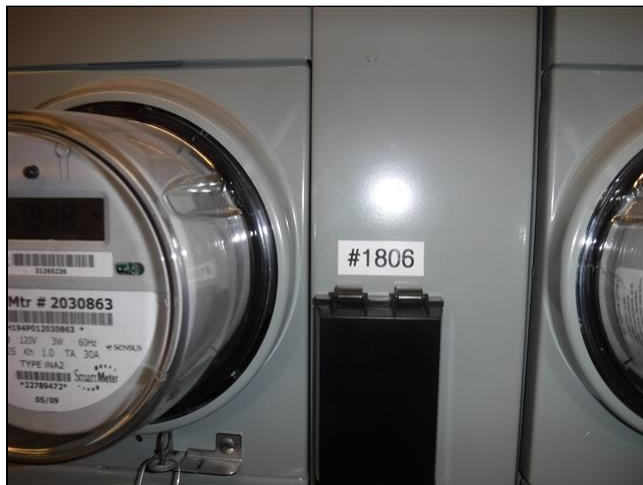
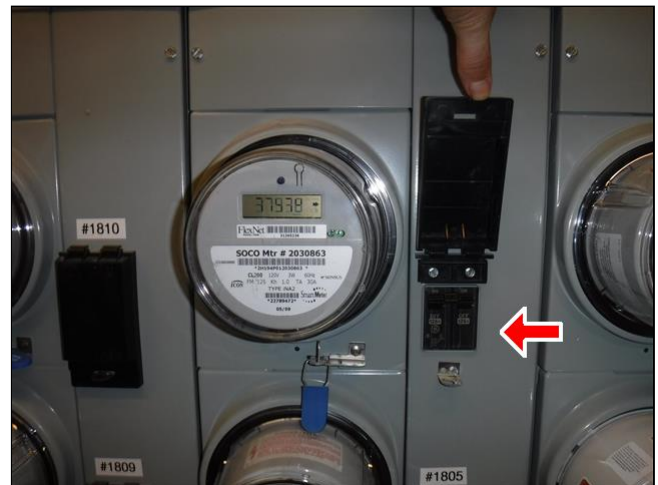
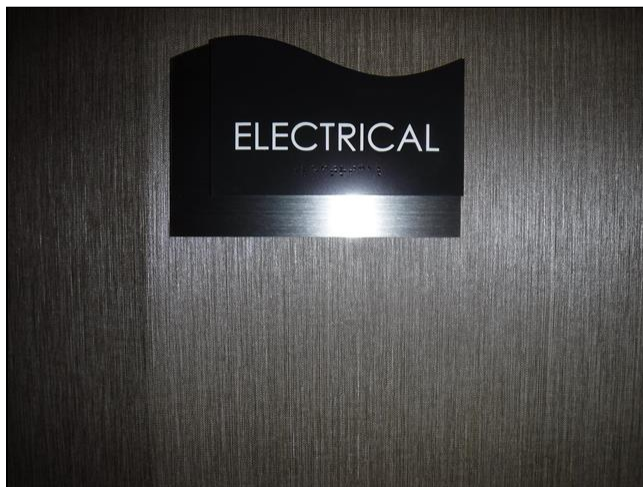
5.0 Item 1(Picture)

Main electrical disconnect location.

Main electrical disconnect is in centralized location for complex, controlled by facility maintenance.

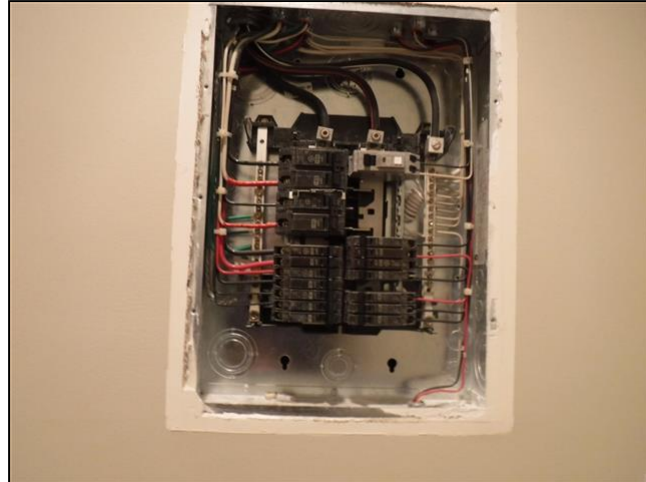
5.2 Item 1(Picture)

View of panel. Panel was inspected for function (not code compliance) and building codes and standards have changed over the years.

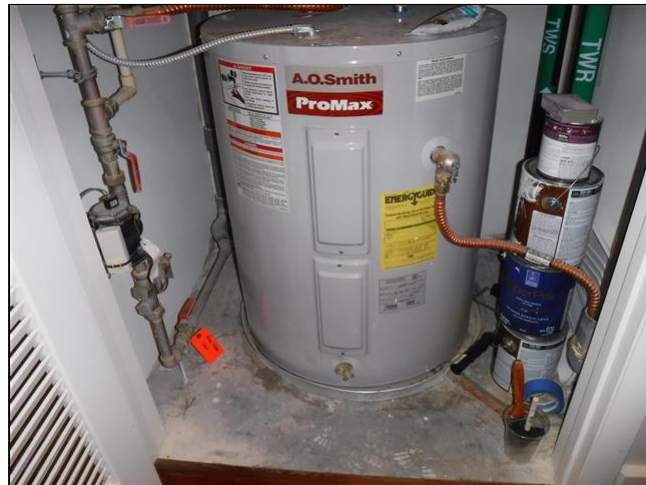
6.3 Item 1(Picture)

View of water heater.

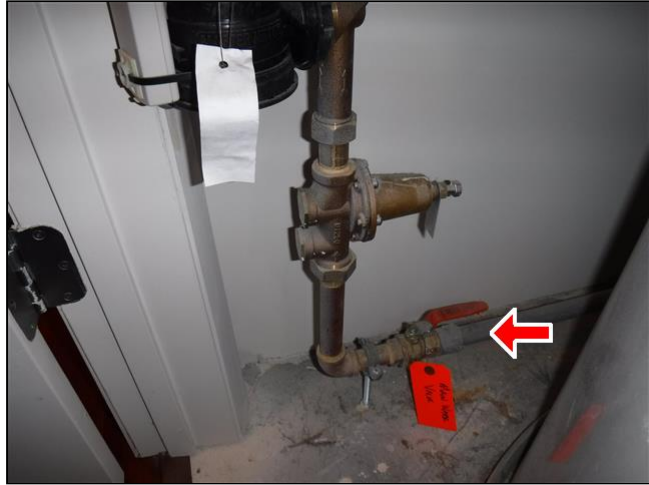
6.4 Item 1(Picture)

The main water shut off is located by the water heater.
