Building Inspection Report

1232 Minhinette Drive Roswell GA 30075

Inspection Date:
11-27-19

Report Number:
M2677

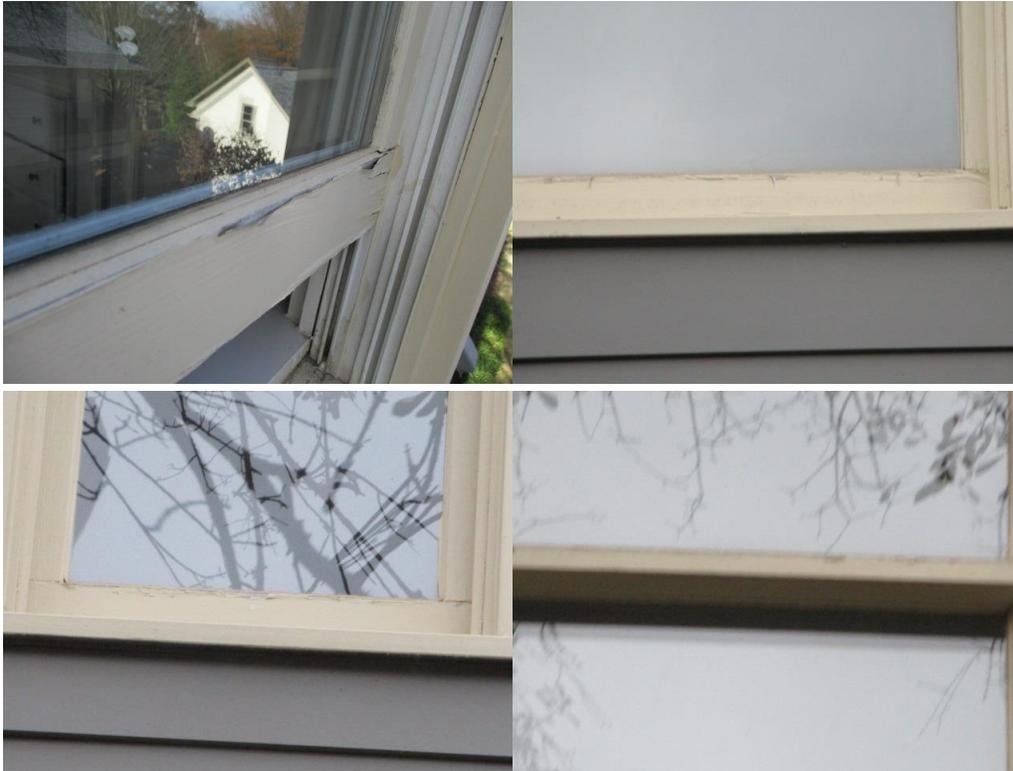
Failing and peeling paint noted on windows around the home particularly in the bottom rails.

- **Repair:** The window frames require painting and caulking as needed around the home. The units show evidence of peeling and failing paint especially at the lower rails.

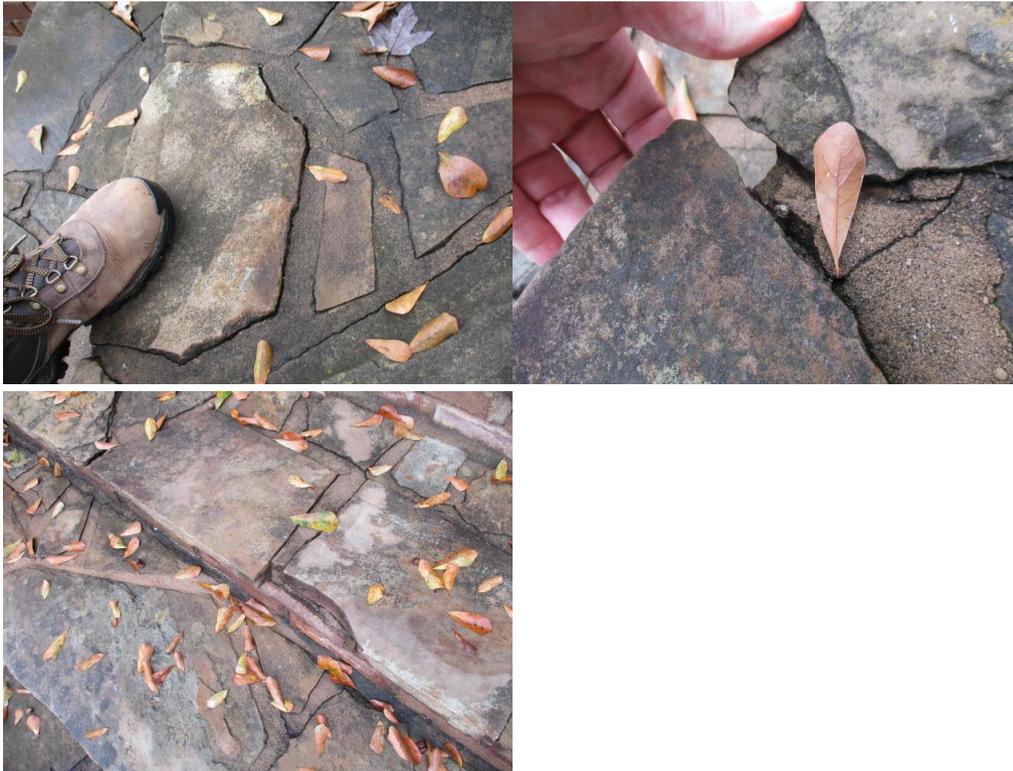
Loose and damaged stone treads noted at the front entry steps.

- **Repair, Safety Issue:** The stone stair treads are loose and damaged in areas at the front entry. This is a safety concern that should be addressed promptly.
- **Repair, Safety Issue:** As there is a danger of falling, a handrail should be provided for the steps at the front entry and at both rear entries.

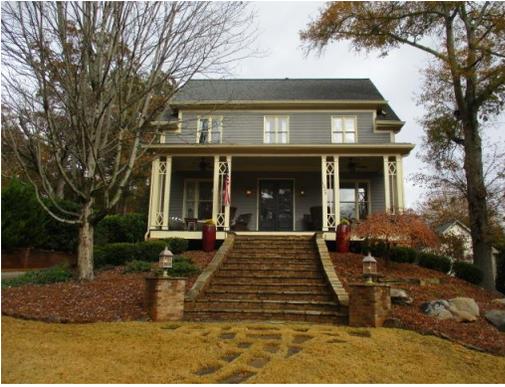
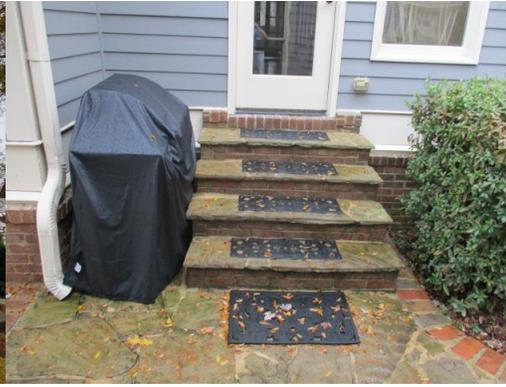
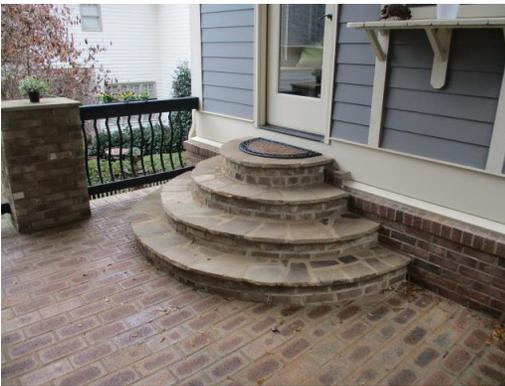
Steps noted to be lacking handrails at the front entry and both rear entry areas.

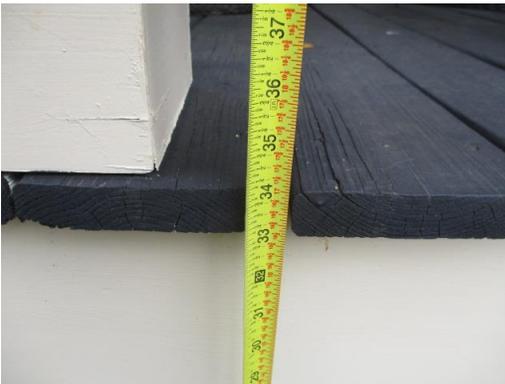
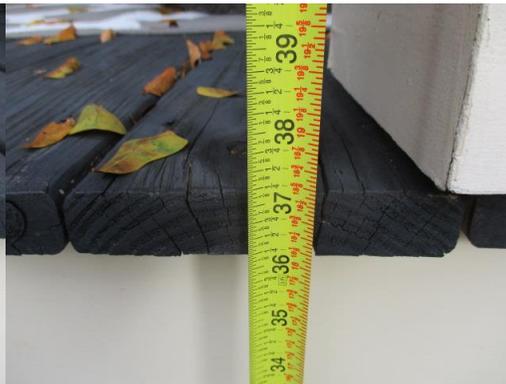
Areas of the front porch were noted to exceed 30 inches from grade with no guard railings present.

- **Repair, Safety Issue:** As there is a danger of falling, a railing should be provided for the front porch given many areas exceed 30 inches from grade.

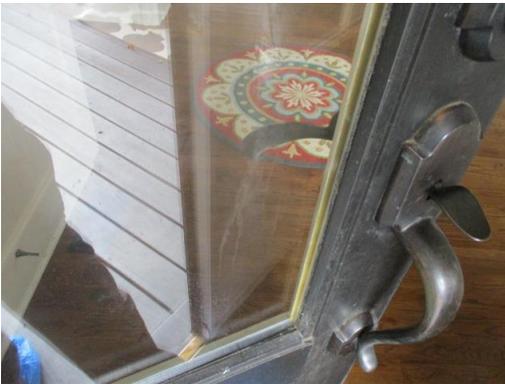
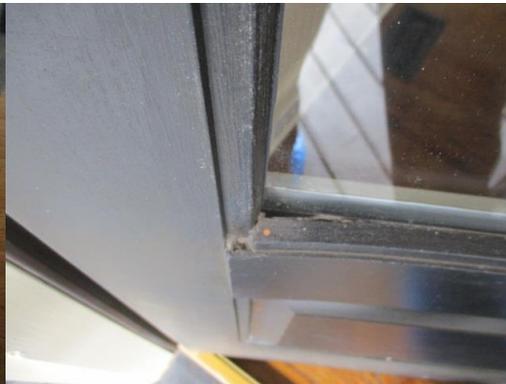
Lost seal noted in the window unit of the front door with some swelling noted in the enclosure.

33. The glass/ window unit of the front door has lost its seal. This has resulted in condensation developing between the panes of glass. This “fogging” of the glass is primarily a cosmetic concern, but may need to be replaced because it has lost its insulating value.

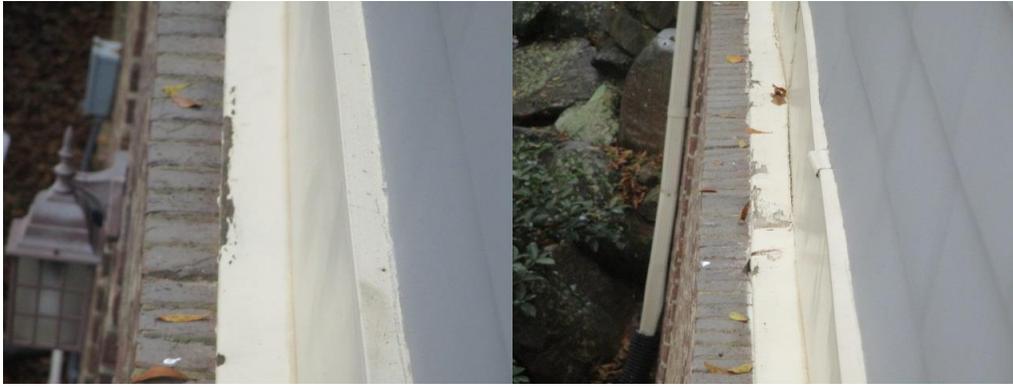
Localized rot and failing paint noted in the wood transition trim at the right side exterior.

- **Repair:** Localized rot and failing paint was noted in the wood transitional trim at the right side exterior between the brick and cement composite siding.
- **Repair:** The exterior brickwork should be tuck pointed or sealed as needed at the right side of the detached garage area near the flashing detail.
- **Repair:** Recommend clearing or cleaning the dryer vent as needed at the right side exterior.
- **Monitor:** Painting and general maintenance would be ideal for the auxiliary/ storage building depending on planned usage.

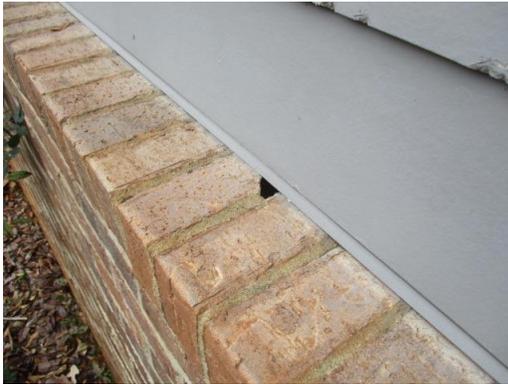
Small opening noted in the brick work at the right side of the detached garage area; tuck pointing or sealing is recommended.

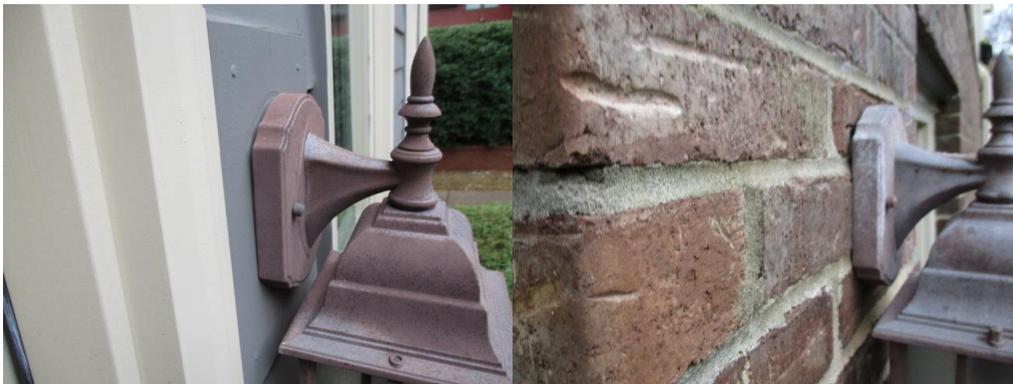
Loose light fixture noted at the rear exterior and right side exterior; recommend securing and sealing.

- **Repair:** The loose light fixtures should be secured and sealed as needed at the rear exterior and right side exterior.

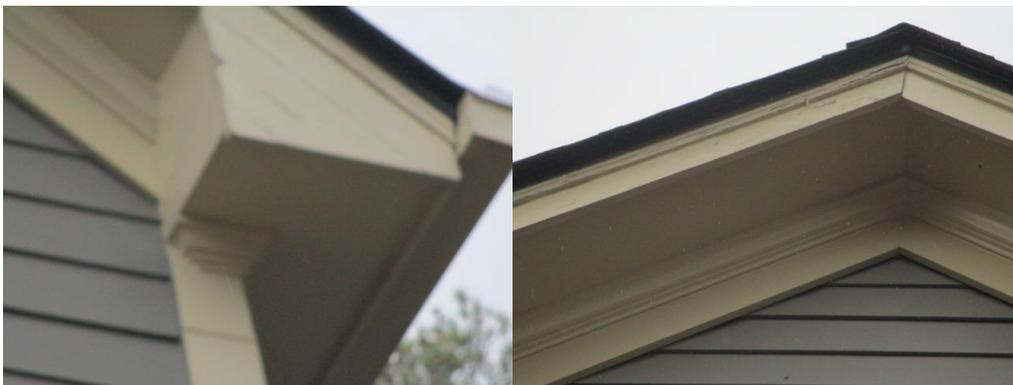
Some touch painting is needed for the eaves at the right side of the detached garage area.

- **Repair:** The soffit and fascia should be painted as needed at the right side of the detached garage area.

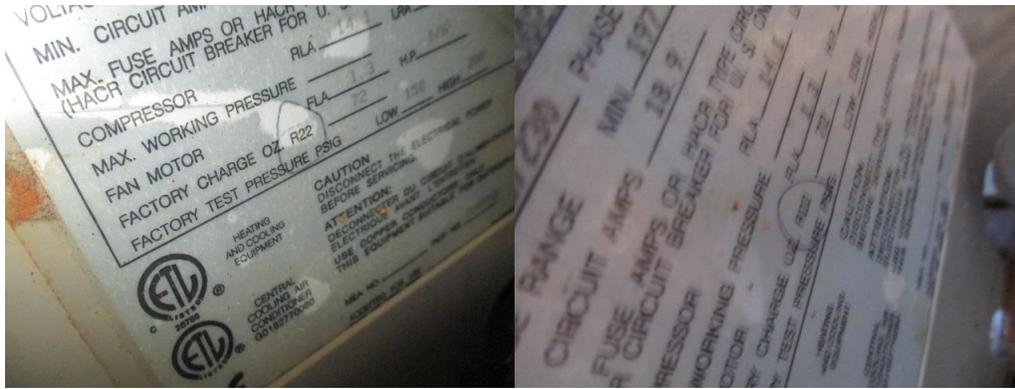
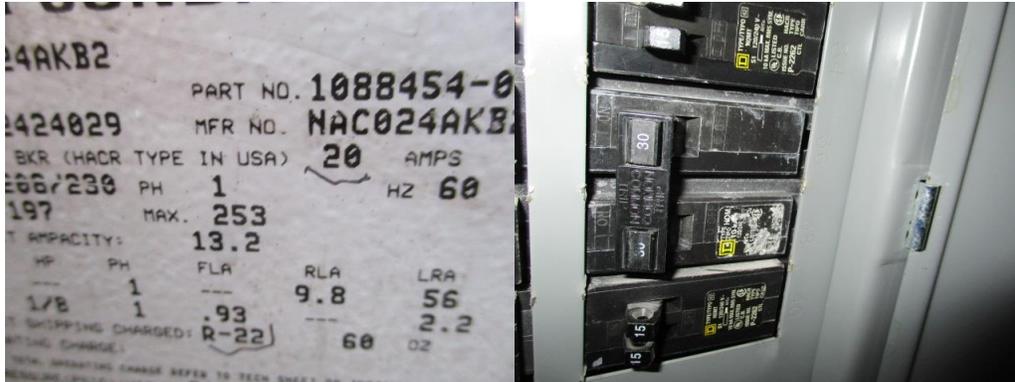
The air conditioning systems were noted to be older with listing for R22. The comfort maker unit was noted to be listed for a maximum over current protection of 20 amps with a 30 amp breaker installed in the main panel.

- **Repair:** Oversized breakers within the main distribution panel should be replaced at slots #36 & 38 serving the comfort maker air condenser. The unit is listed for a maximum over current protection of 20 amps and a 30 amp breaker is installed.

- **Deferred Cost Item:** The air conditioning systems are relatively old with listing for outdated R22 chemical and equipment. They will require a higher level of maintenance, and may be more prone to major component breakdown. Predicting the frequency or time frame for repairs on any mechanical device is virtually impossible. If the compressor fails, or if breakdowns become chronic, replacing the entire system may be more cost-effective than continuing to undertake repairs.

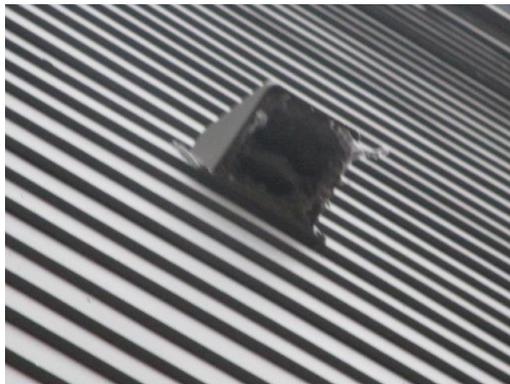
Recommend clearing or cleaning the dryer vent at the right side exterior.

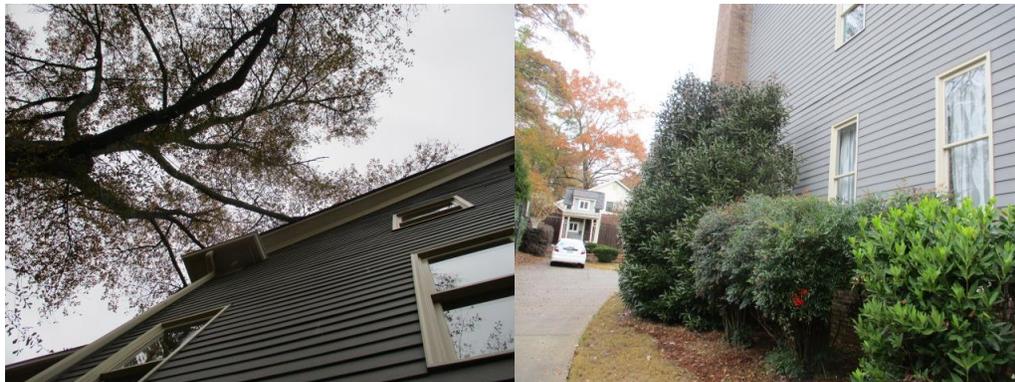
Recommend clearing tree branches and vegetation away from the home.

- **Repair:** Tree branches and vegetation should be trimmed away from the house to avoid damage to the building.

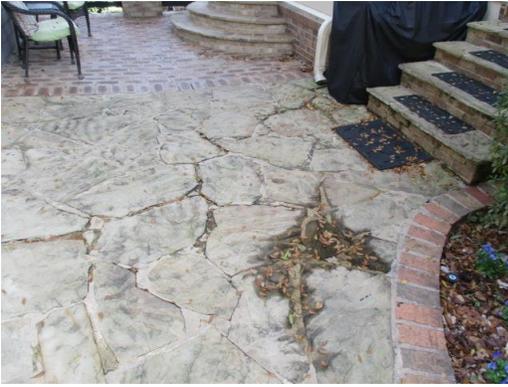
Some water retention and grout loss noted at the rear stonework patio.

- **Monitor:** The walkway/ patio stonework was noted to retain water with some failing mortar noted between the main building and detached garage. Diverting gutter discharge away from the area may help improve the issue.

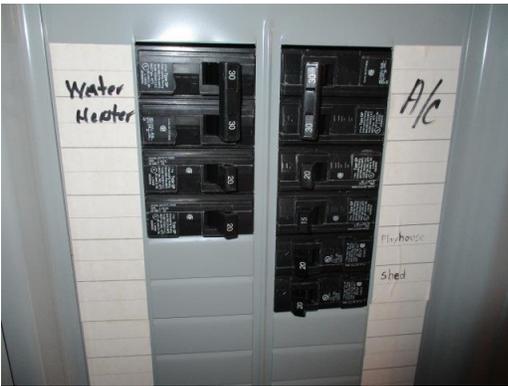
The subpanel serving the detached garage and loft area lacks full labeling and AFCI protected breakers for sleeping areas.

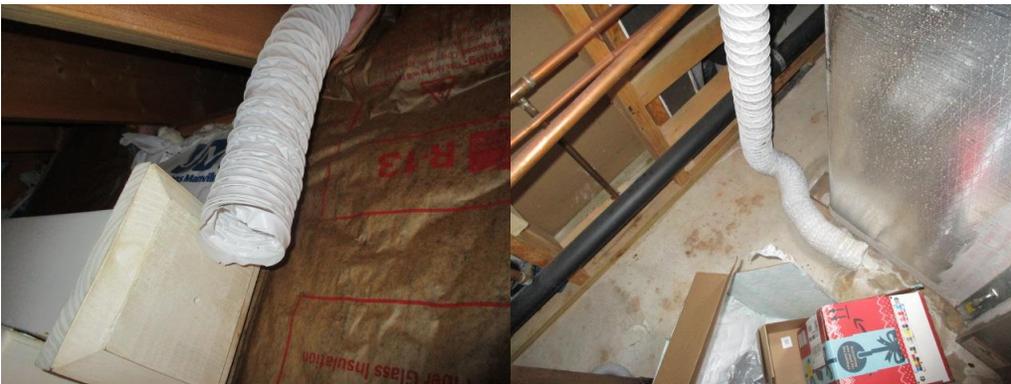
Bathroom exhaust fan vents were noted to lack termination to the building exterior at the detached garage area walk in knee wall attic space and at the basement mechanical area.

- **Repair:** Exhaust vent pipes from the bathroom(s) should be vented to the building exterior at the loft area attic space and basement mechanical area.
- **Monitor:** The insulation batts were noted to be installed backwards at the detached garage area attic space. This can effect performance but is mainly of increased concern in locations exposed to high humidity.
- **Monitor:** There is evidence in the attic space that the older dryer vent has been abandoned and a new vent rerouted. Recommend consulting the current owner on these changes; cleaning the vent would be advisable.

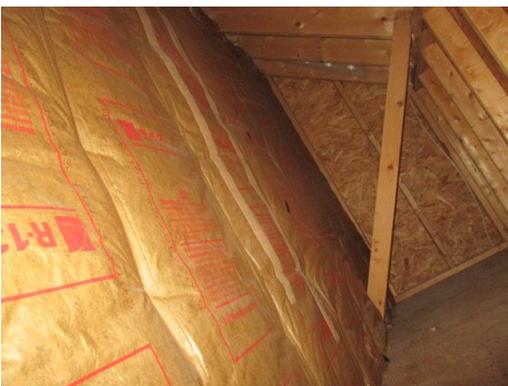
The insulation was noted to be reversed at the detached garage knee wall areas.

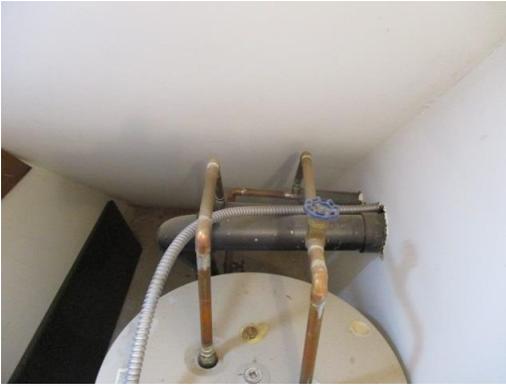
The circuit serving the water heater unit at the detached garage area was noted to lack the required electrical service disconnected.

- **Repair:** Abandoned wiring should be removed or appropriately terminated with a box and cover in the attic space.
- **Safety Issue:** The water heater at the detached garage area should have an electrical service disconnect available within reach of the unit as the panel is not within reach.
- **Safety Issue:** Improper amateur wiring was noted at the basement based comfort maker furnace. The circuit should be hardwired with a service termination switch available.

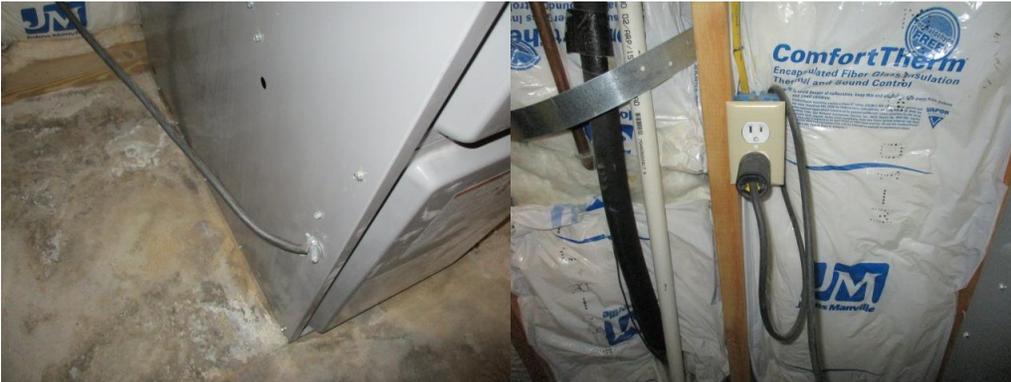
Amateur wiring was noted at the comfort maker furnace in the basement area. The unit lacks hard wiring with an available service switch.

6. [Improper amateur wiring was noted at the basement based comfort maker furnace. The circuit should be hardwired with a service termination switch available.](#)

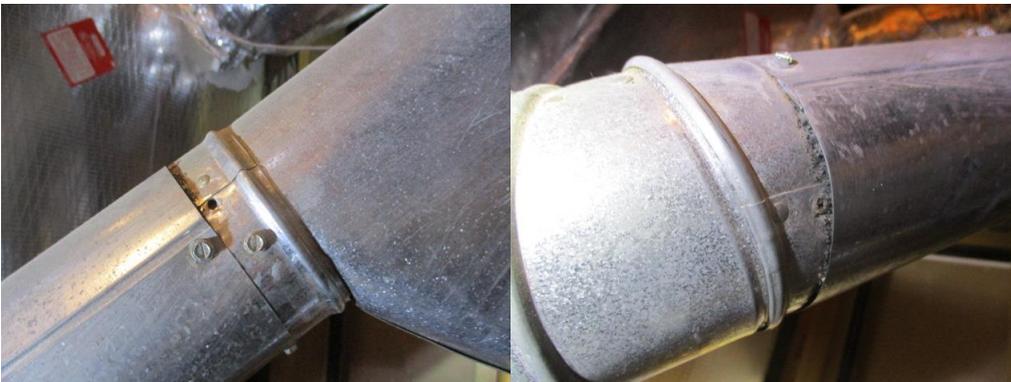
The 1st picture illustrates improper installation of venting with the lower section over the top section which can cause leakage. The 2nd picture shows the beginning of the transition that was likely altered at water heater replacement. The fittings should be properly attached and sealed as needed to prevent leakage of exhaust gases.

- **Repair, Safety Issue:** *Poor exhaust flue connections should be improved immediately in the basement between the furnaces and water heater.* Poor connections risk flue gas and carbon monoxide leakage or other unsafe conditions. All lower sections of venting should be installed inside the upper sections with proper fastening/ sealing as needed.

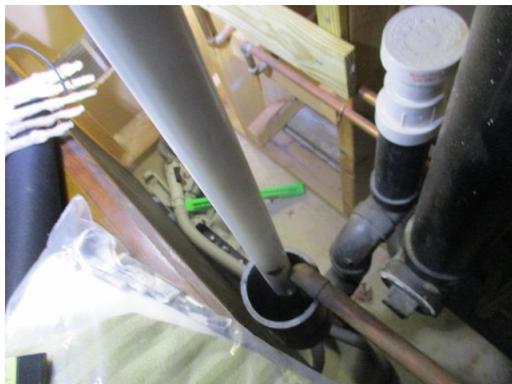
An open trap was noted at the basement mechanical area for discharge lines with no apparent way to consistently prime the trap. A plumber should be consulted to install a trap primer or trap fixture fitting.

- **Repair:** The open waste piping trap at the basement mechanical area should have some form of trap primer or trap fitting. At present only discharge piping is available which can present consistent priming of the trap; recommend consulting a plumber to correct this issue.

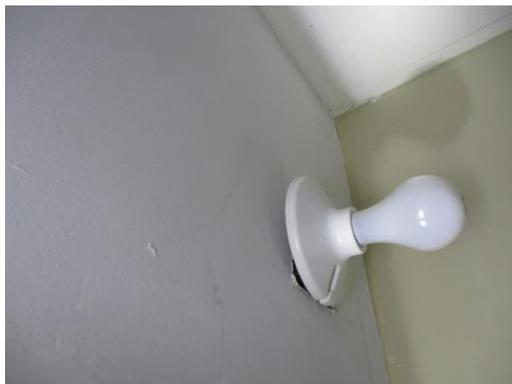
Loose light fixture noted at the front basement bedroom closet.

- **Repair:** The loose light fixture should be repaired or replaced at the basement front bedroom closet.

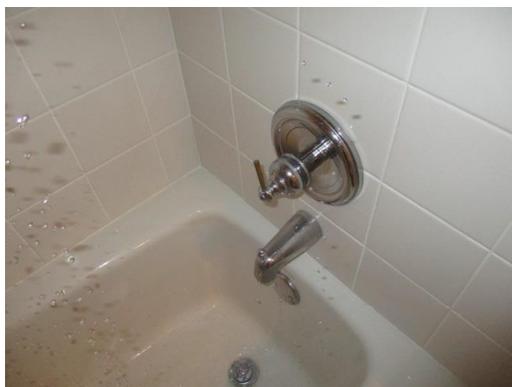
Missing handle noted at the basement bathroom tub enclosure fixture.

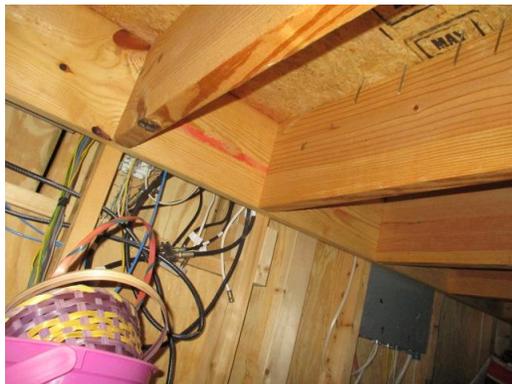
The support joists below the basement stairwell landing were noted to lack end bearing.

- **Repair:** The floor joists have insufficient end bearing below the basement stairwell landing. Additional support is needed to reduce risk of structural movement and damage. This can usually be accomplished with joist hangers.

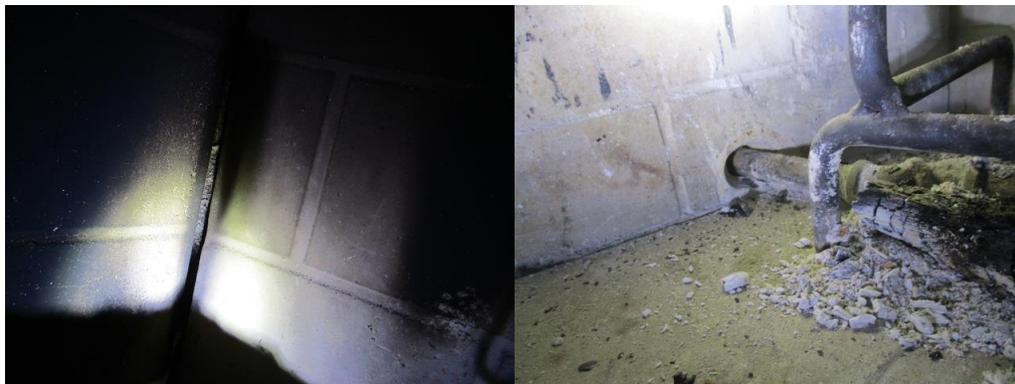
Openings were noted in the refractory panels in the fireplace at the rear corner and at the gas supply entry.

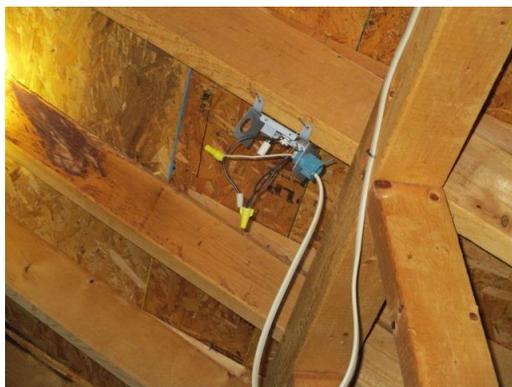
Abandoned circuit noted in the attic space.

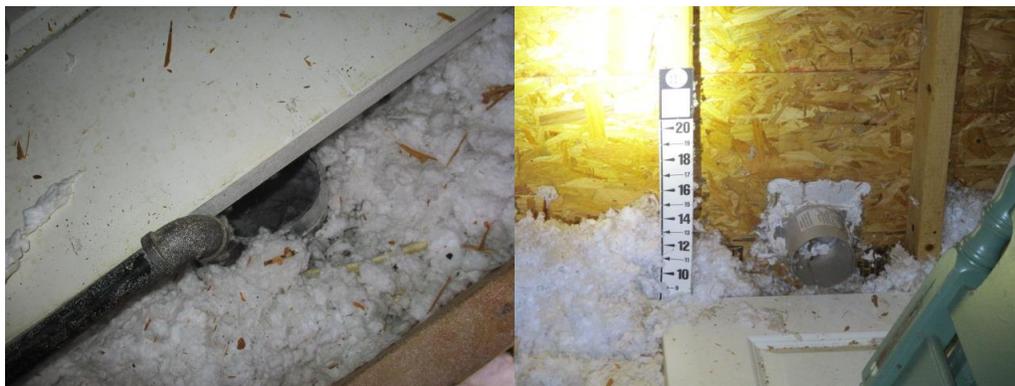
It appears the dryer vent has been redirected with abandoned sections noted in the attic space.

45. There is evidence in the attic space that the older dryer vent has been abandoned and a new vent rerouted. Recommend consulting the current owner on these changes; cleaning the vent would be advisable.
