PEACHTREE Property Inspections
Serving Metro Atlanta and North Georgia

**Prepared for:
Billy & Lori Harbinson
3415 Slater Street
Cumming, GA 30041**

**Inspector: Bobby Beers
January 21, 2020**

PROPERTY INSPECTION REPORT

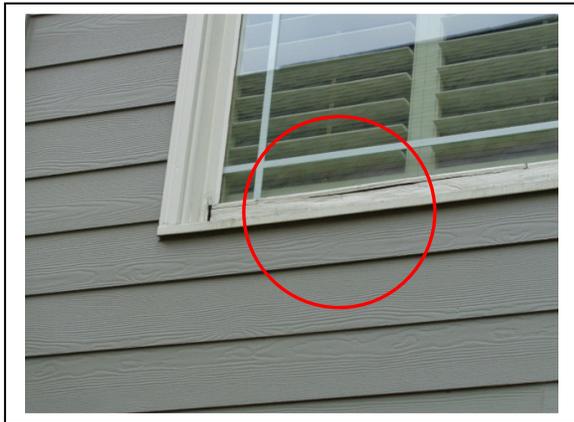
Moisture damage was observed at the exterior surfaces of the master bath window opening at the left side of the home. Needs repair.

Moisture damage to exterior surface of master bath window.

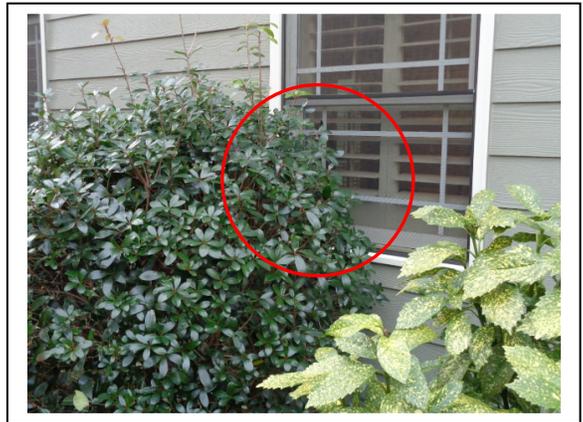
Tree limbs and shrubbery are in close proximity to the exterior structure of the home in some areas. Tree limbs and shrubbery should be kept trimmed away from the exterior of the home to guard against damage, moisture or pest issues.

Shrubbery in close proximity to exterior structure.

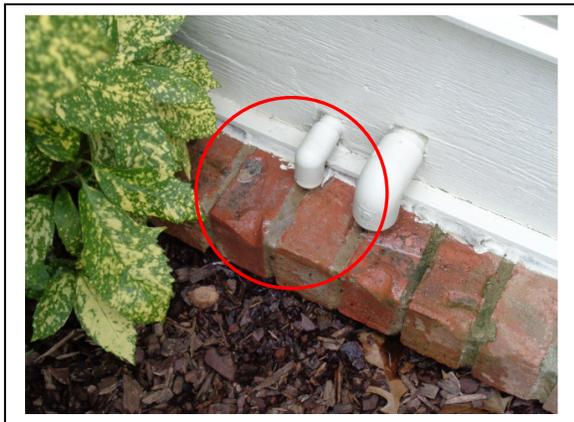
- 20. Water is flowing from the exterior drain for the water heater's pressure relief valve at the base of the exterior wall at the left side of the home. The water pressure was tested and was found to be operating well above the acceptable limit of 80 psi at the time of the inspection (150+ psi when tested). The plumbing system's pressure reducing valve and the water heater's pressure relief valve need evaluation by a licensed plumber.**

Water flowing from pressure relief drain at left side of home.

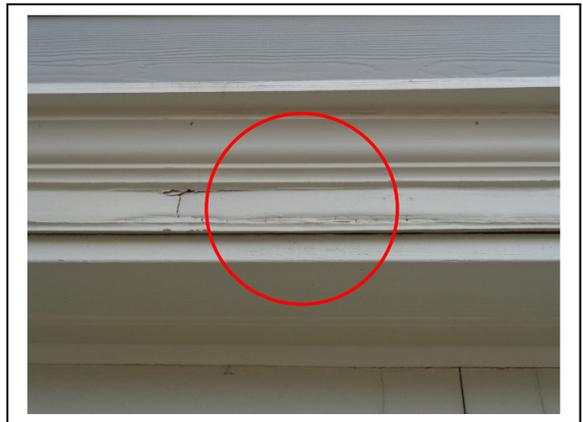
Moisture damage was observed at the exterior wood trim at the top of the left garage door opening at the front of the home. Needs repair.

Moisture damage to exterior trim above garage door opening.

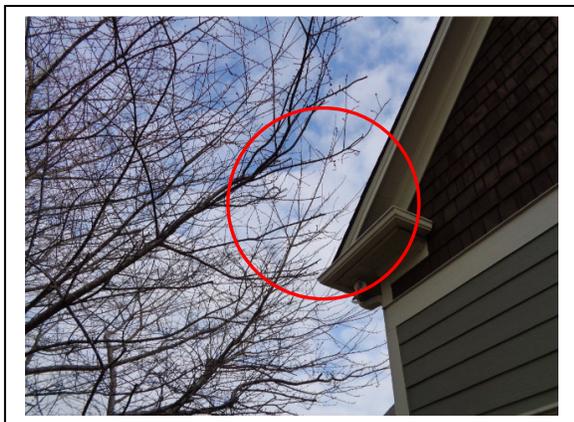
Tree limbs in close proximity to exterior structure.

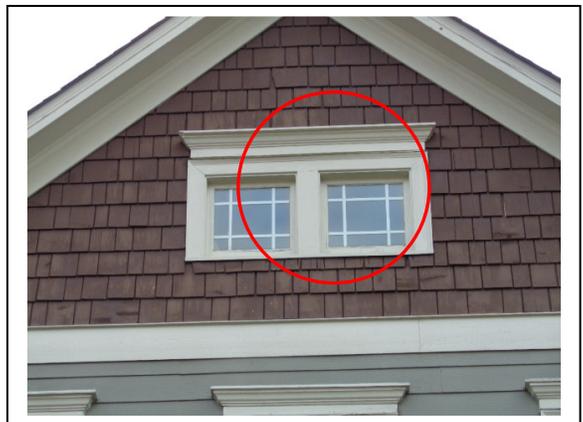
Evidence of possible moisture damage was observed at the exterior surfaces of the windows at the gable end at the front of the home. Staining was also visible at the inside surfaces of the windows visible from the attic. Needs evaluation.

Possible moisture damage to exterior front window surfaces.

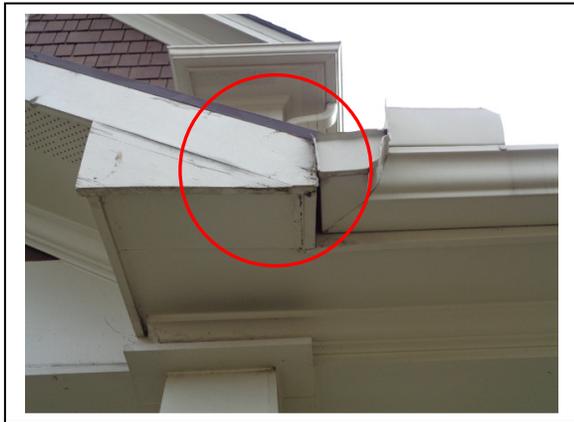
Evidence of possible moisture damage was observed at the exterior wood trim at the roofline above the porch entrance at the front of the home. Needs evaluation.

Possible moisture damage to exterior trim above front porch.

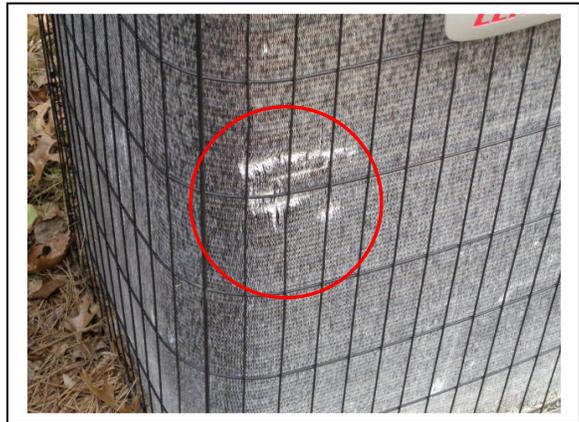
Damaged cooling fins at front exterior A/C unit.

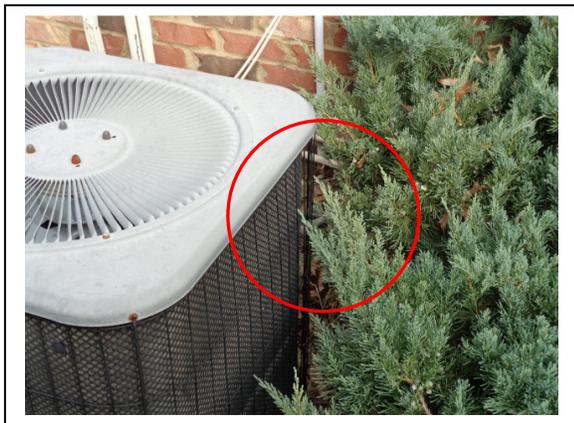
- 21. Shrubbery / vegetation is in close proximity to some of the exterior A/C units at the right side of the home. This can negatively impact performance. A minimum 24 inch horizontal clearance around the perimeter of the units and a minimum 48 inch vertical clearance above the tops of the units should be maintained to ensure adequate air flow.**
- 22. Minor damage was observed a the cooling fins at the front exterior A/C unit at the right side of the home. Any concerns should be addressed with an HVAC contractor.**
- 23. The exterior light fixture at the patio at the rear of the home did not come on when tested. Needs evaluation.**

Shrubby in close contact at rear exterior A/C unit.

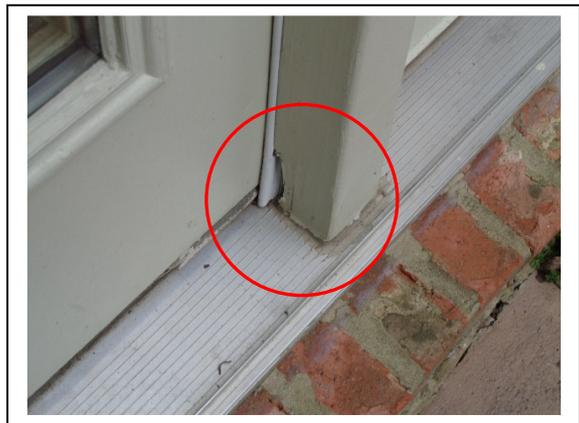
Moisture damage was observed at the exterior wood trim at the base of the entrance door opening at the rear of the home. Needs repair.

Moisture damage to exterior door trim at rear of home.

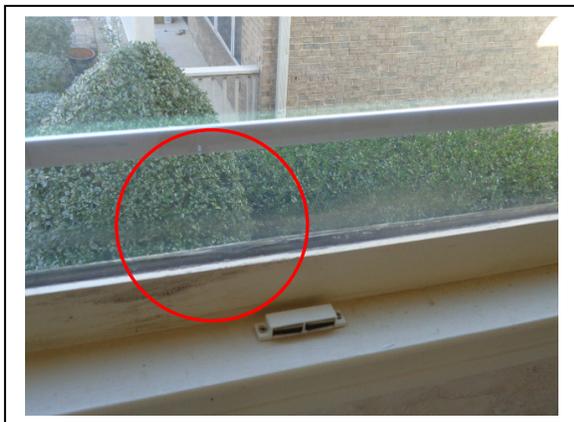
7. The exposed gas piping at the clothes dryer connection in the upstairs laundry room needs to have a cap installed if not in use. Safety issue.
8. The window above the tub in the master bath contains fogged glass, indicating that the seals have failed. Also, there is no identification present verifying that the window contains tempered glass. Tempered glass is required in windows installed less than 60 inches above tub floors. Needs repair. Safety issue.
9. The exterior electrical outlet at the rear patio did not trip when tested, indicating that it is not GFCI protected. Needs repair. Safety issue.
10. The cover to the electrical service panel in the garage was obstructed by the installation of shelving. The cover was not removed, and the connections inside the panel were not evaluated. The shelving needs to be removed so that ready access is provided. Safety issue.

Window above tub in master bath contains fogged glass.

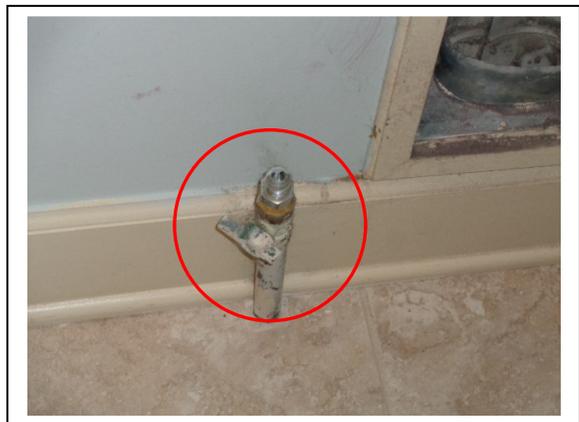
Gas pipe at upstairs laundry room is missing cap.
