Inspection Report

Property Address:
4925 Wilshire Crossing
Cumming GA 30040

Marion Hodges Home Inspection Services

Inspection Date: 2/17/2020
 Report ID:

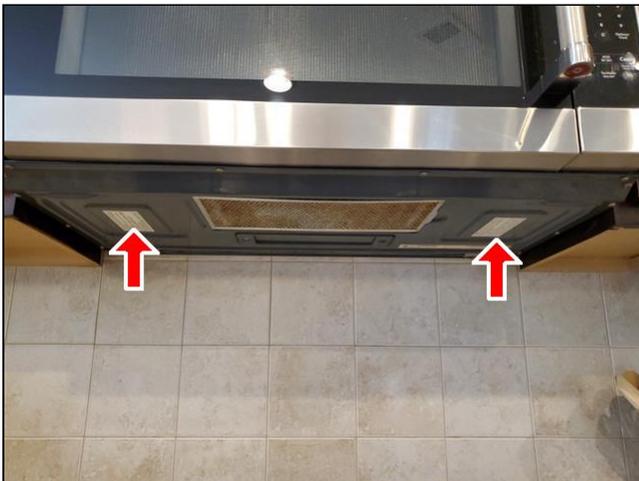
The surface lights on the microwave did not turn on. Replace bulbs and verify operation.

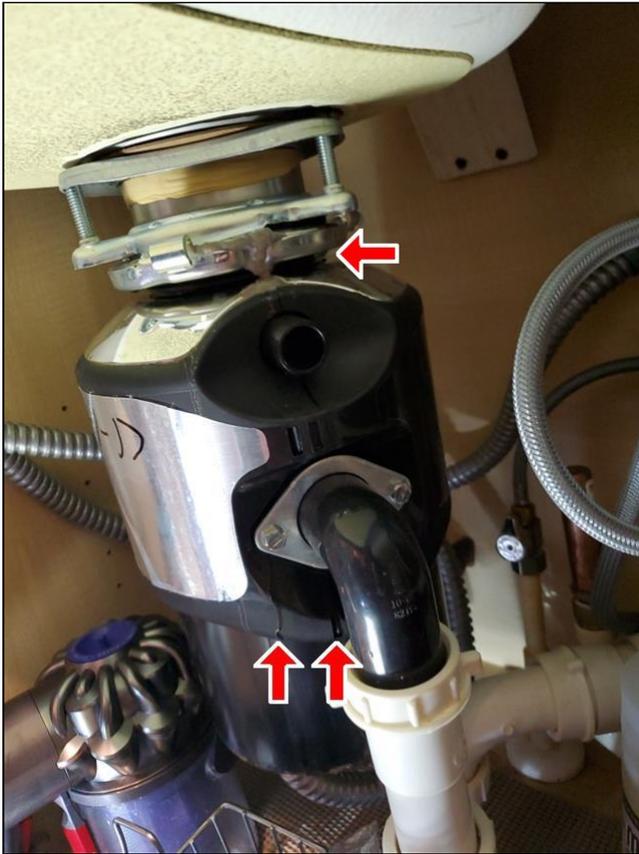
The disposal is leaking at drain connection. A licensed plumbing contractor needs to repair leak or replace disposal as needed.

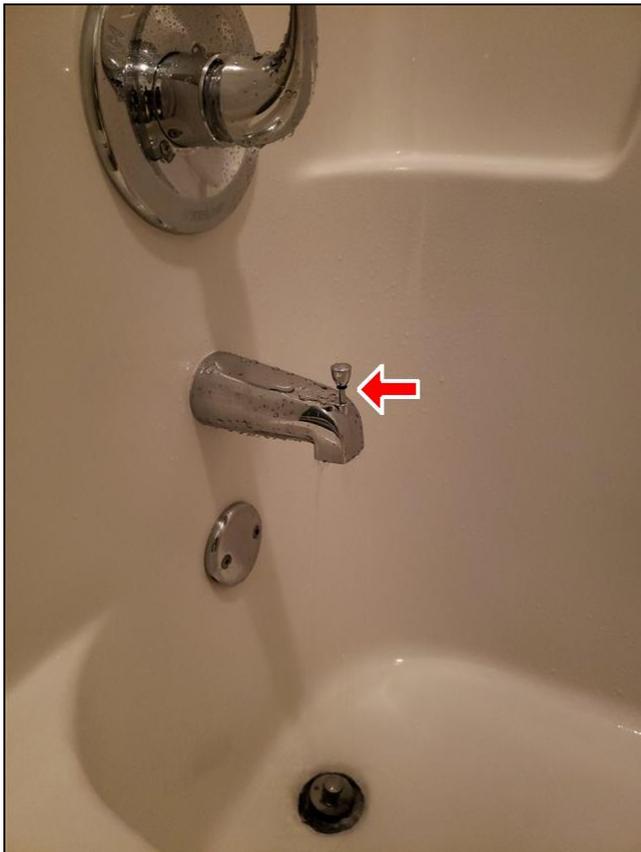
(1) The shower diverter did not divert all water to the showerhead in the hall bath. A licensed plumbing contractor needs to repair.

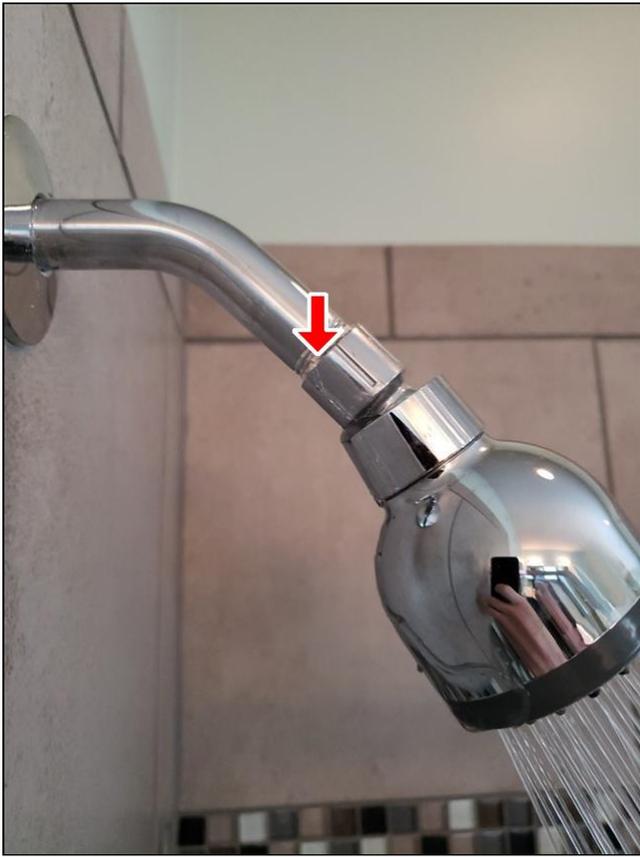
- 🏠 (2) The showerhead in the master bath leaks at connections. Tighten showerhead or replace showerhead.

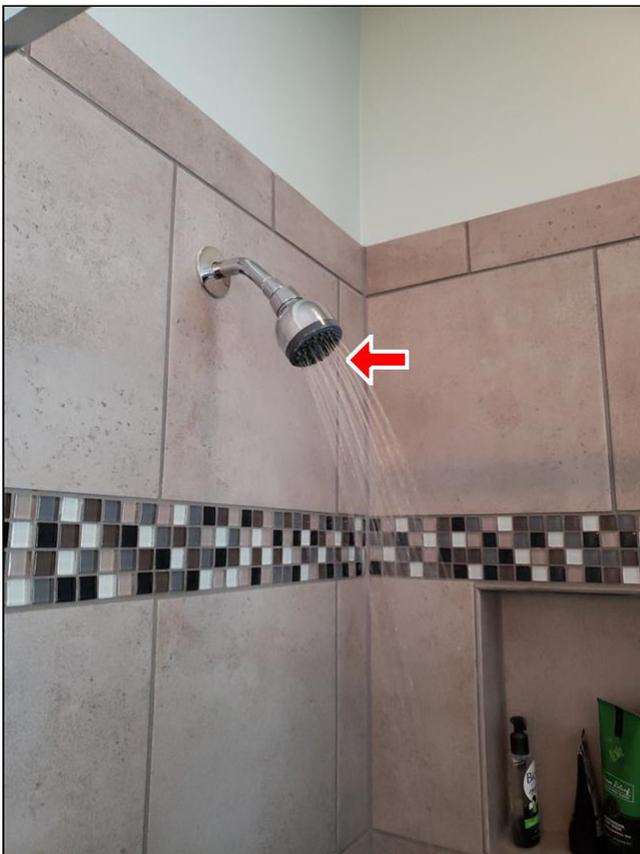
- 🏠 (3) Water pressure drops in the master bath and hall bath when more than one plumbing fixtures is turned on. A licensed plumbing contractor needs to repair.

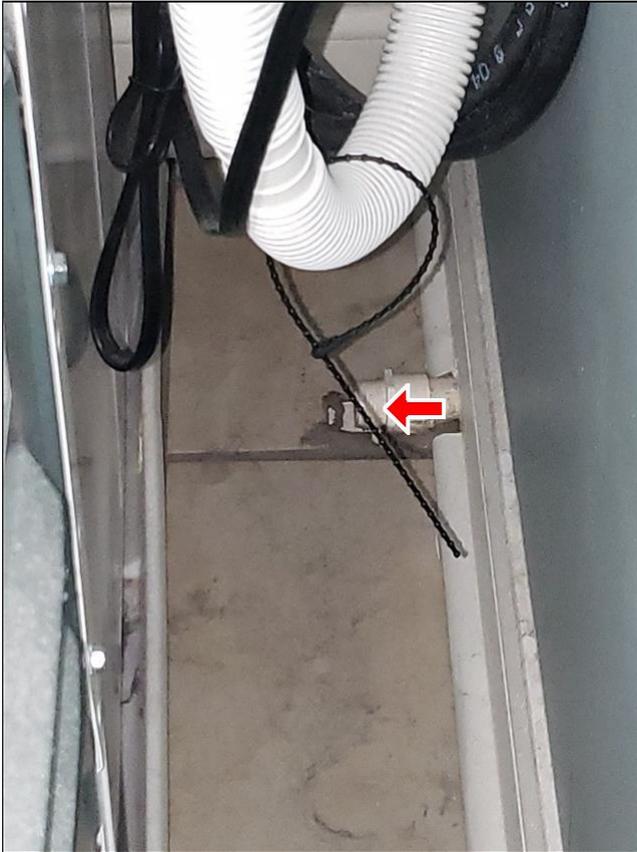
- 🏠 (1) The washing machine overflow drain pipe is disconnected from drain pan. A qualified contractor needs to connect the pipe to pan.

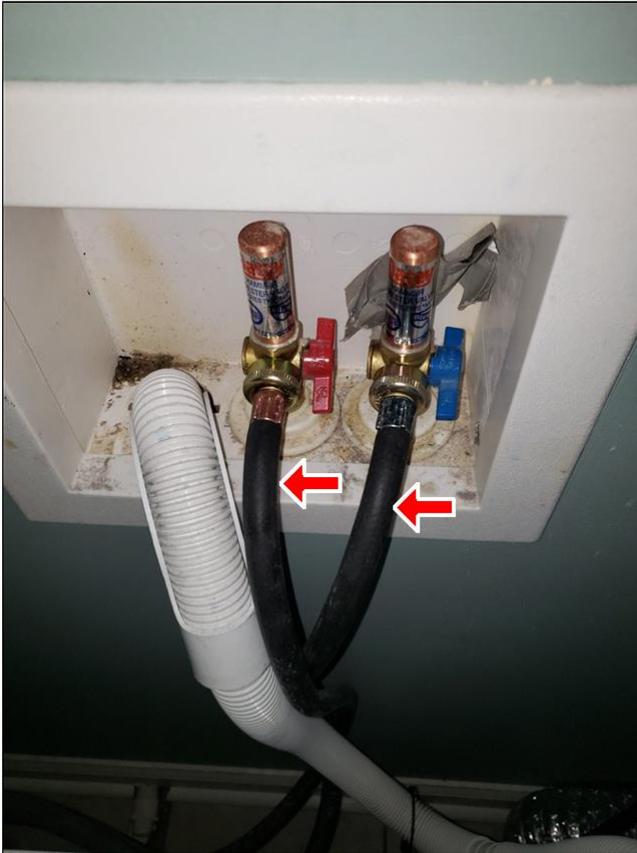
(2) The washer hoses are not stainless steel braided hoses. Recommend using stainless steel braided washer hoses to connect washing machine. Stainless steel braided hoses last about 5 years. The black hoses only last about 3 years.

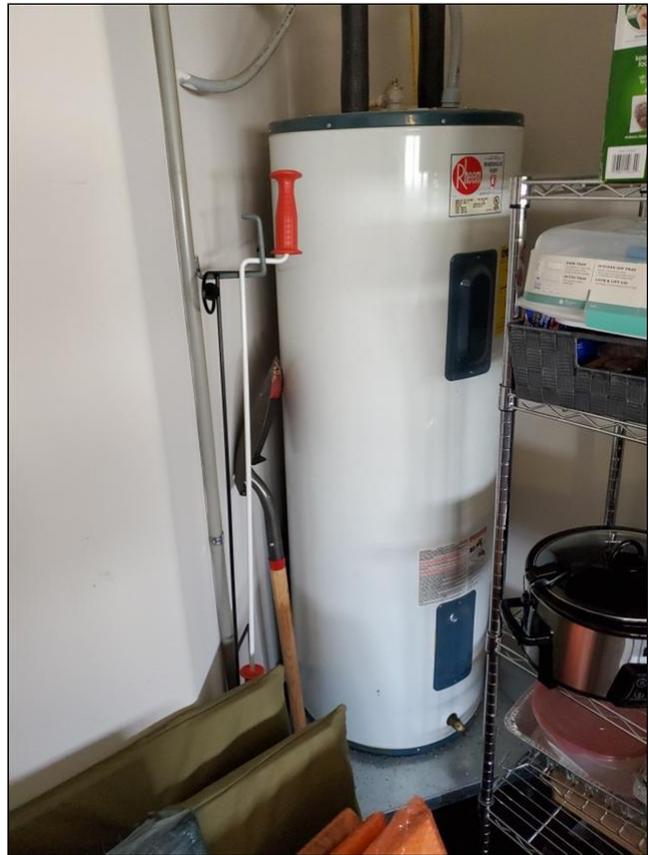
Water Heater

The water heater appeared to be in acceptable condition at the time of the inspection. The inspector makes no warranties or guarantees as to how long the water heater or any components of the water heater will last.

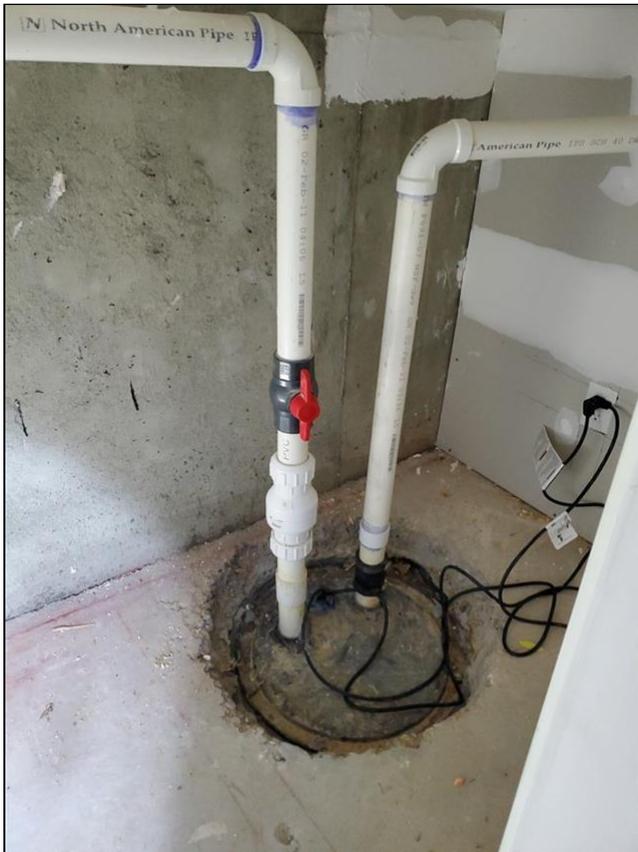
Under the basement steps

The basement plumbing drains into an "ejector" tank where it is then pumped up into the waste line for disposal. Ejector pumps are required when the drain lines are below the main drain line for the house. Do not use plumbing fixtures in this area during power outages as the pump will not operate, which will cause the system to overflow.

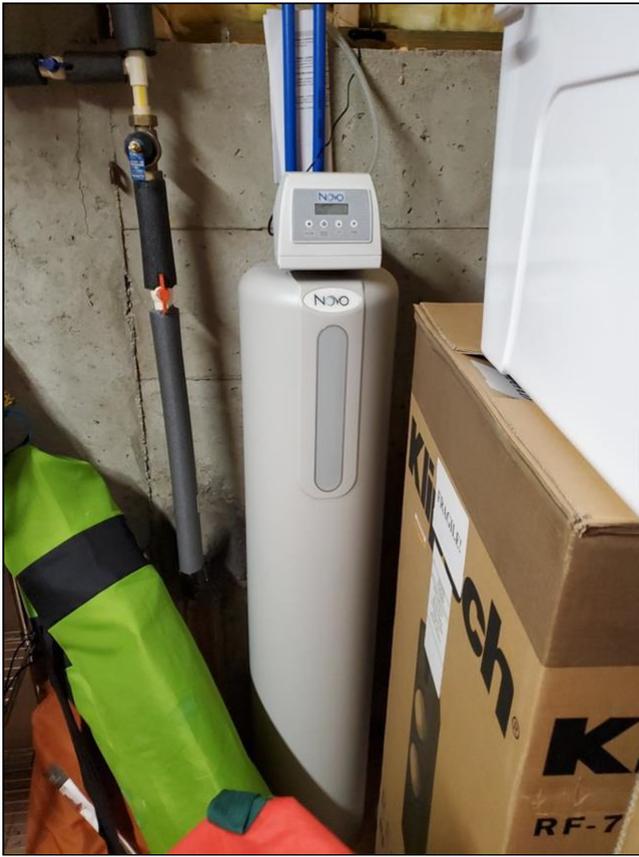
🏠 Seller needs to demonstrate water purification system operation if part of the sale.

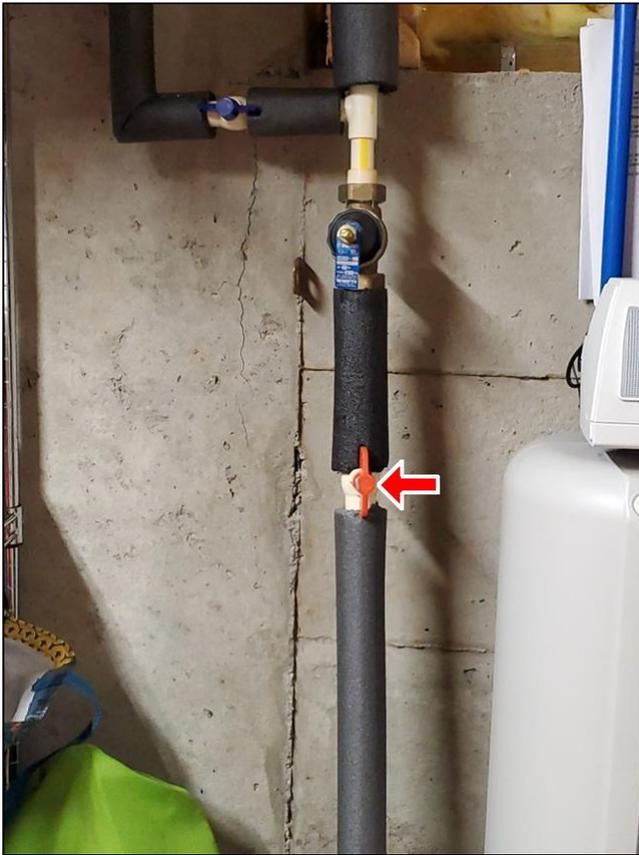
(1) Location of main water cut off (See Photo).

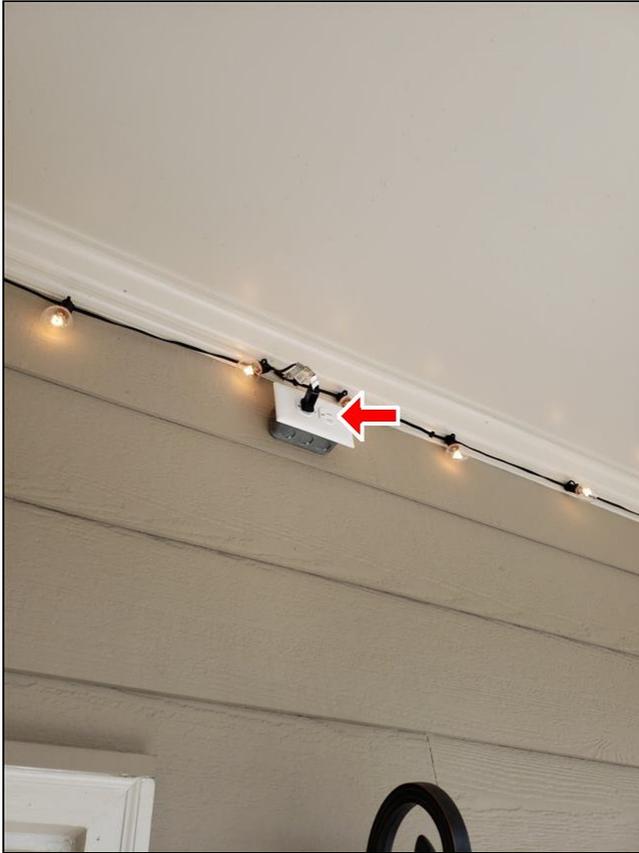
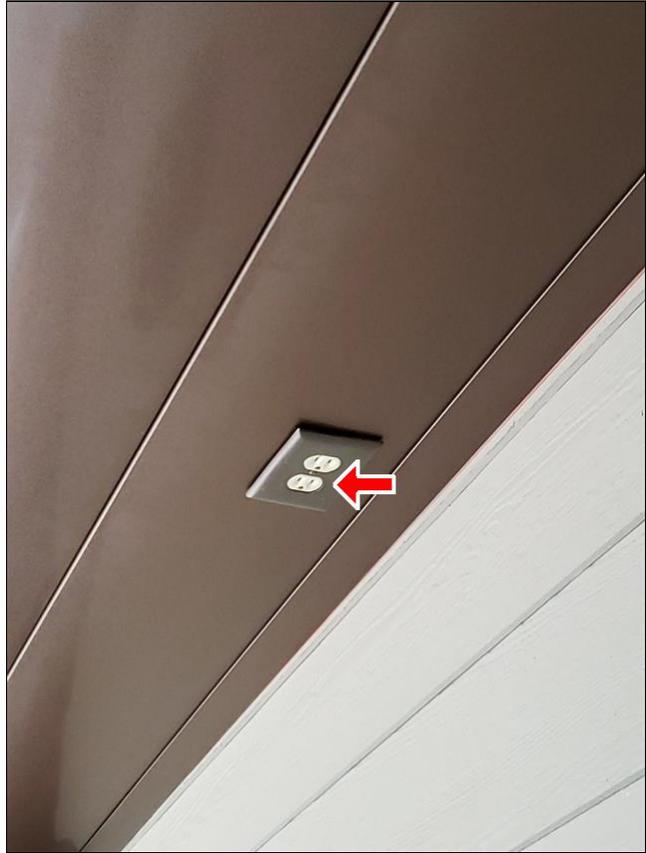
- 🏠 (1) The receptacles on the master bedroom deck, main level deck, and terrace level patio do not have weatherproof covers. A licensed electrician needs to add weatherproof covers.

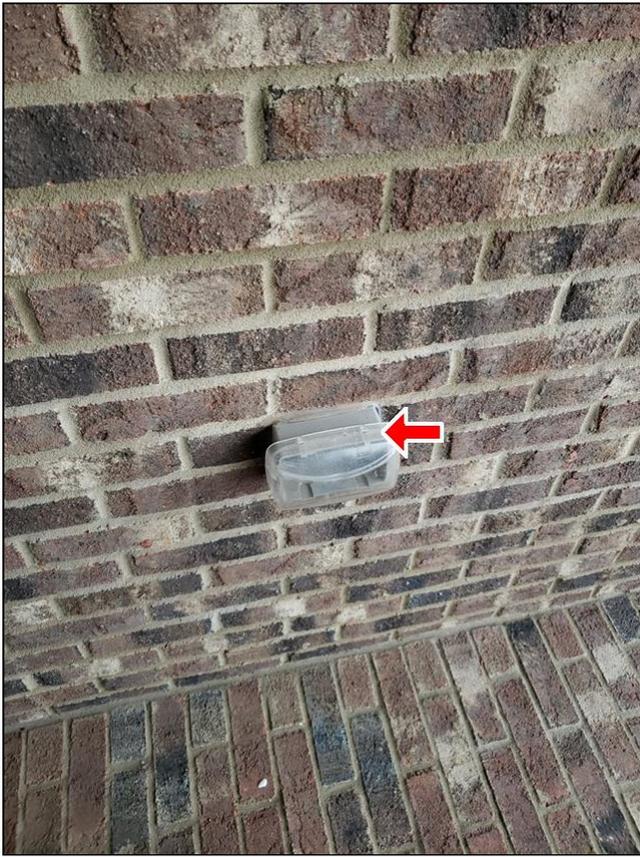
- 🏠 (3) Receptacle box at the front door is not secure to wall. A licensed electrician needs to secure the outlet box.

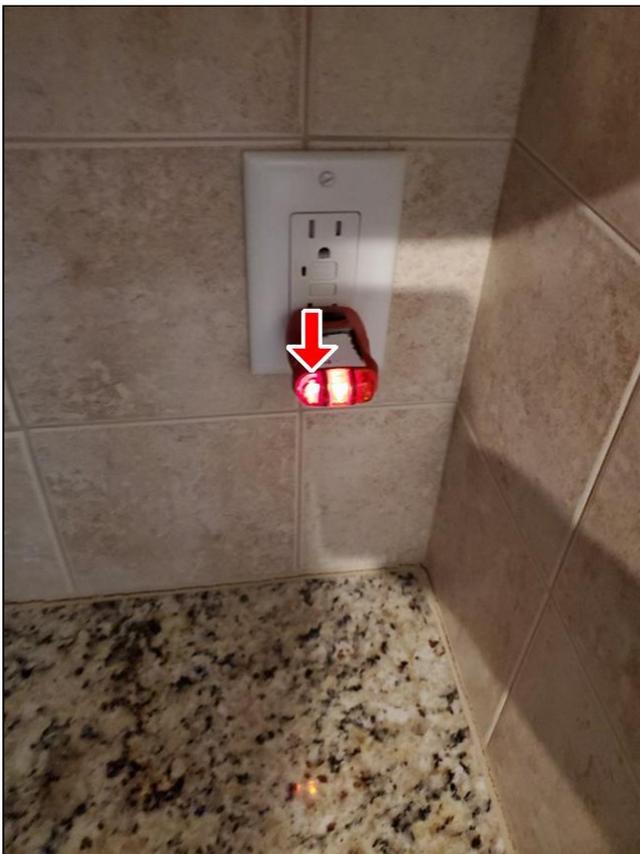
- 🏠 (4) Receptacle(s) in the kitchen to the right of refrigerator wired with hot/neutral reversed. A licensed electrician needs to correct polarity.

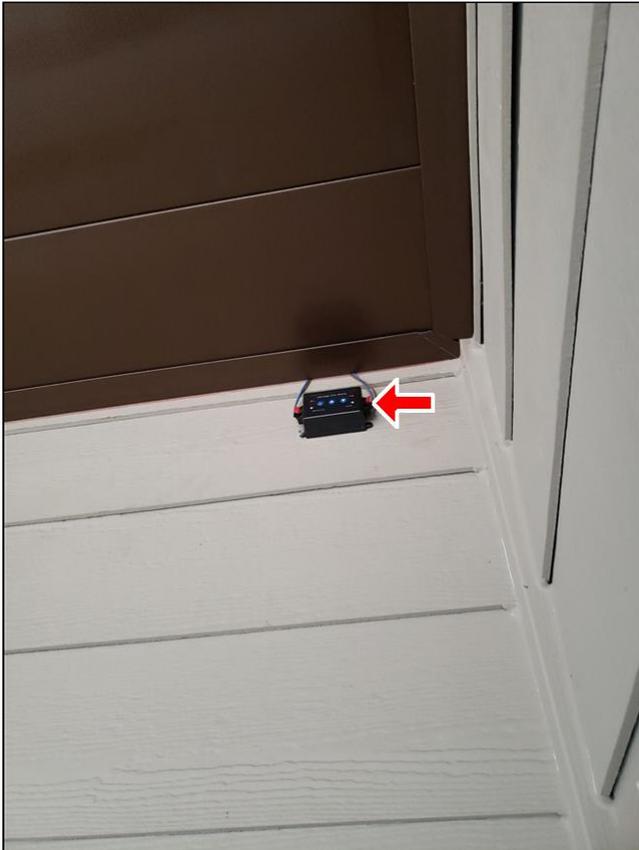
(1) The LED light fixtures on the main level deck ceiling and under the main level deck do not have a dedicated light switch. Seller needs to demonstrate how the lights work or have a licensed electrician add a switch.

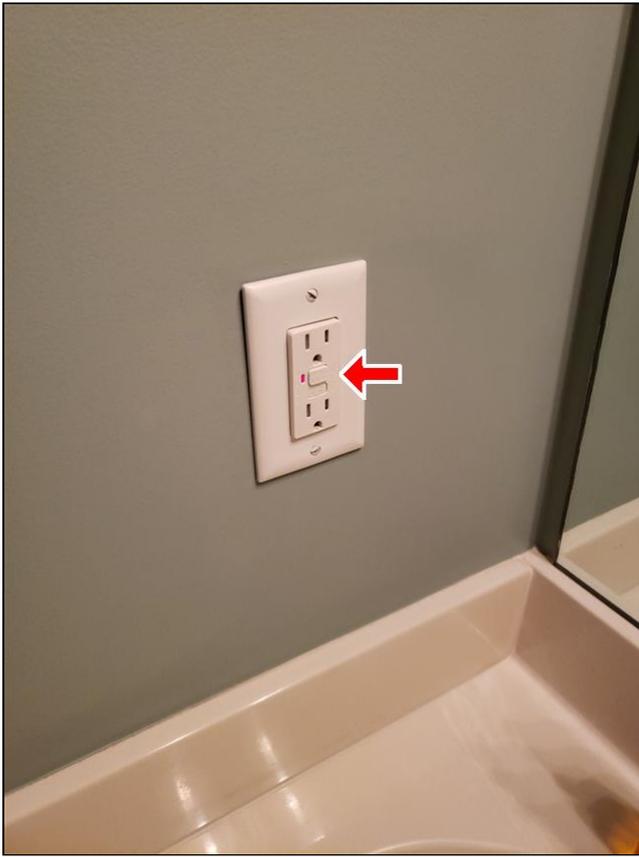
FYI, The GFCI re-set for the bathroom receptacles is in the hall bath.

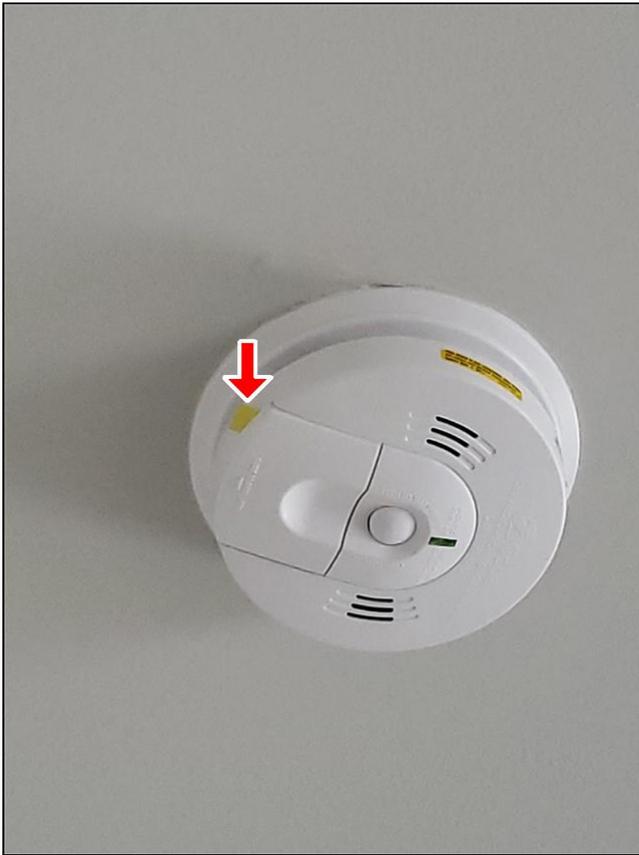
Remove the battery cover on the smoke detector in the back right bedroom and verify operation of the smoke detector.

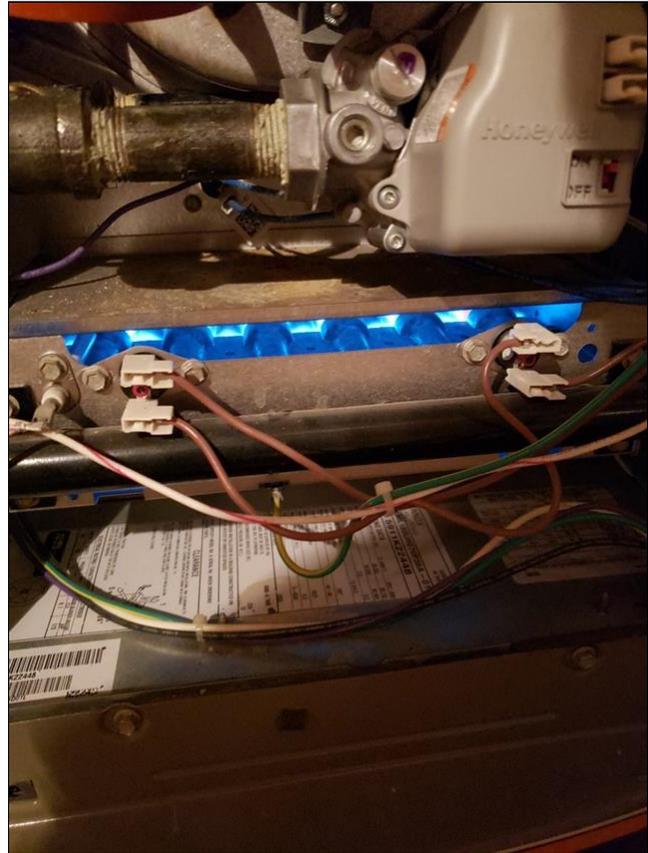
(1) The furnaces were operational at the time of the inspection. If the furnaces have not been serviced by a licensed heating and air conditioning contractor in the past year, a licensed heating and air contractor needs to perform annual

service including but not limited to the following: heat exchanger inspected for cracks & deterioration, burners removed and cleaned if necessary, fan switch checked, pilot assembly cleaned and adjusted, blower assembly cleaned, and electrical connections checked.

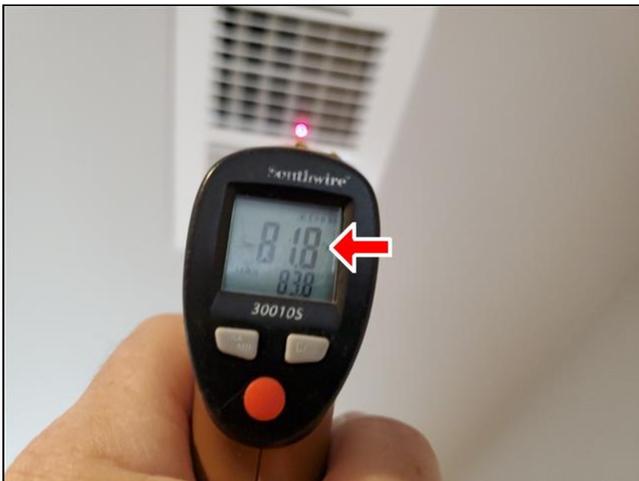
(2) The electric heat pump system was operational at the time of the inspection. If the heat pump system has not been serviced by a licensed heating and air conditioning contractor in the past year, a licensed heating and air contractor needs to service and clean the heat pump system. The inspector makes no warranties or guarantees as to how long the heating equipment and components will last.

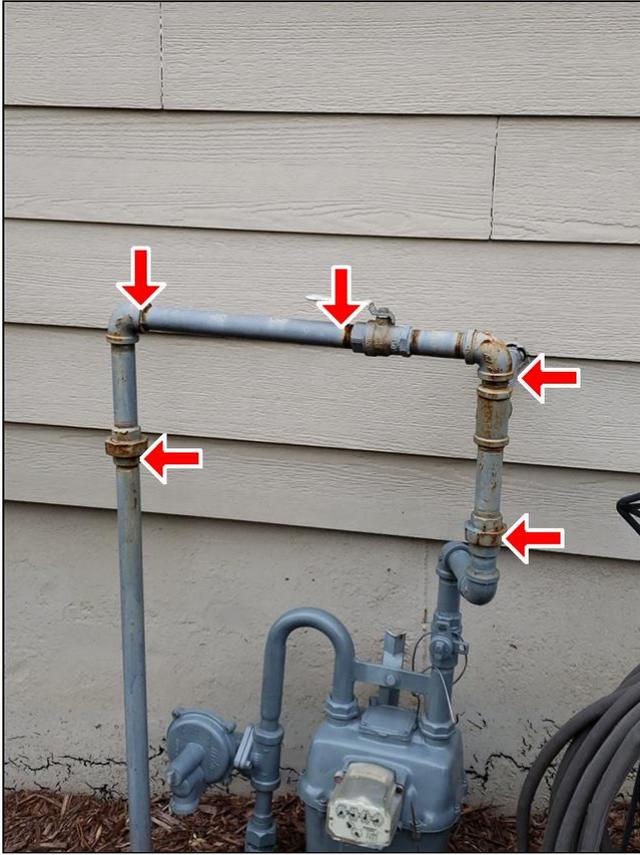
🏠 The gas pipe at the gas meter is not protected from corrosion. Exterior gas piping should be protected from corrosion with corrosion resistant paint. A qualified contractor needs to paint the gas pipe with corrosion resistant paint.

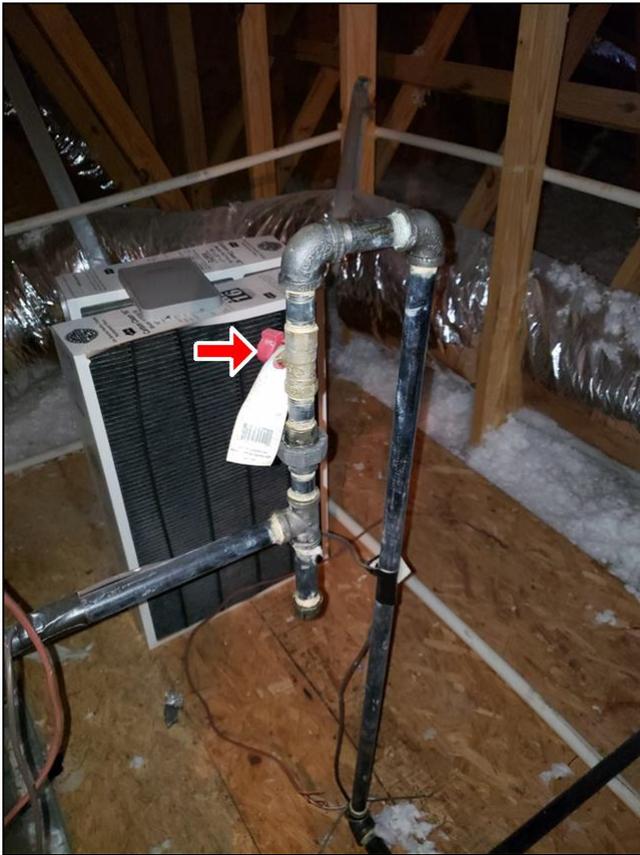
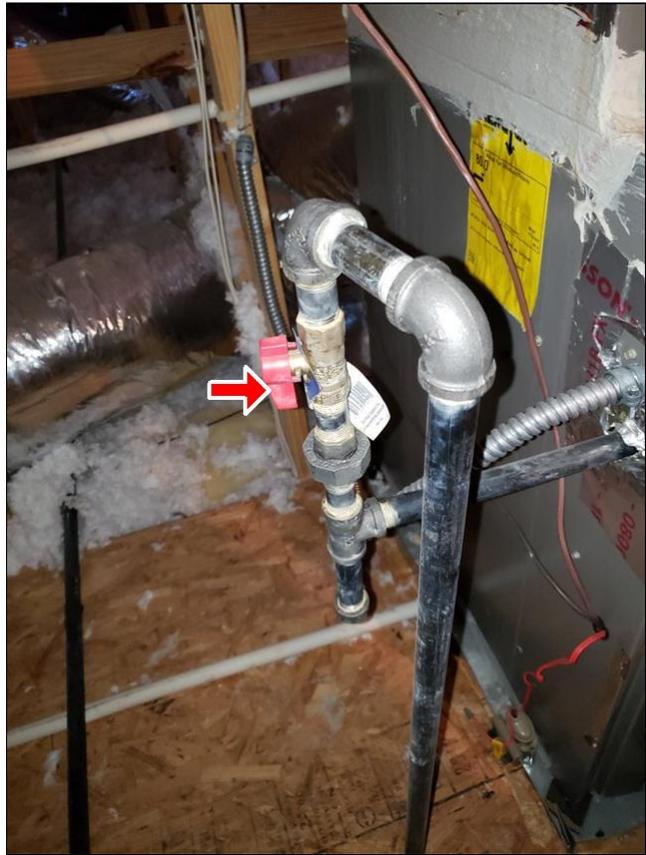
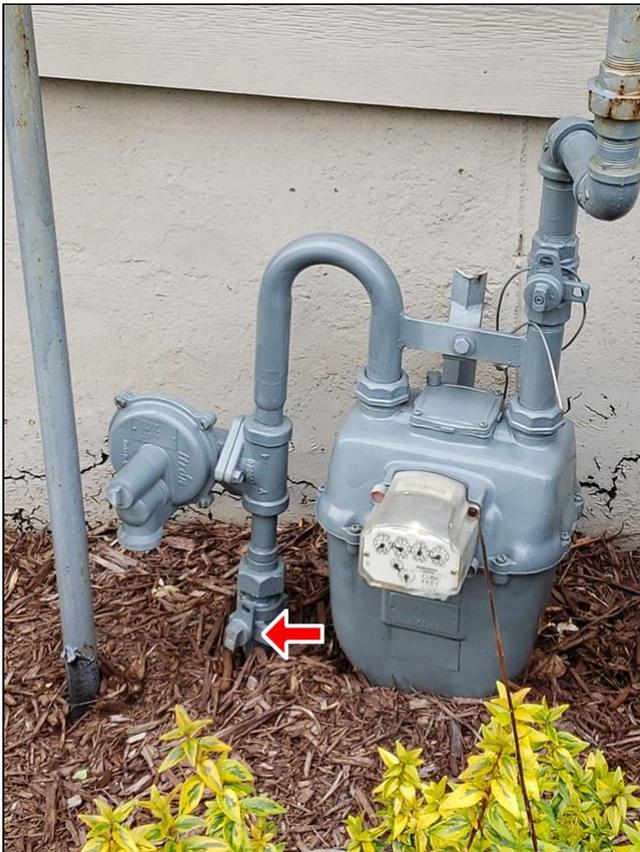
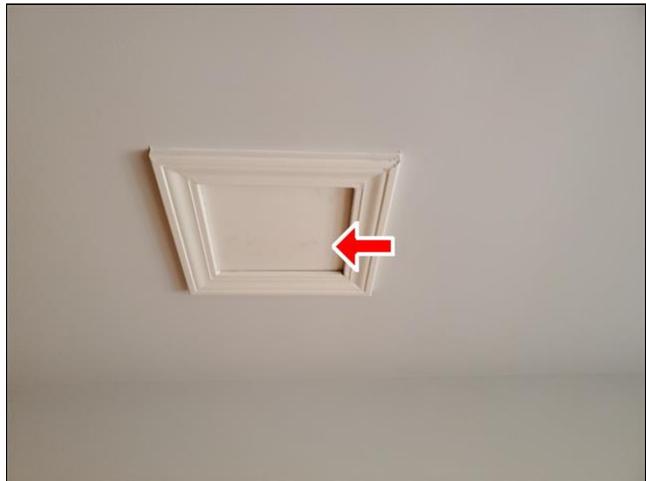
FYI, Location of gas shut off valves. See pictures.

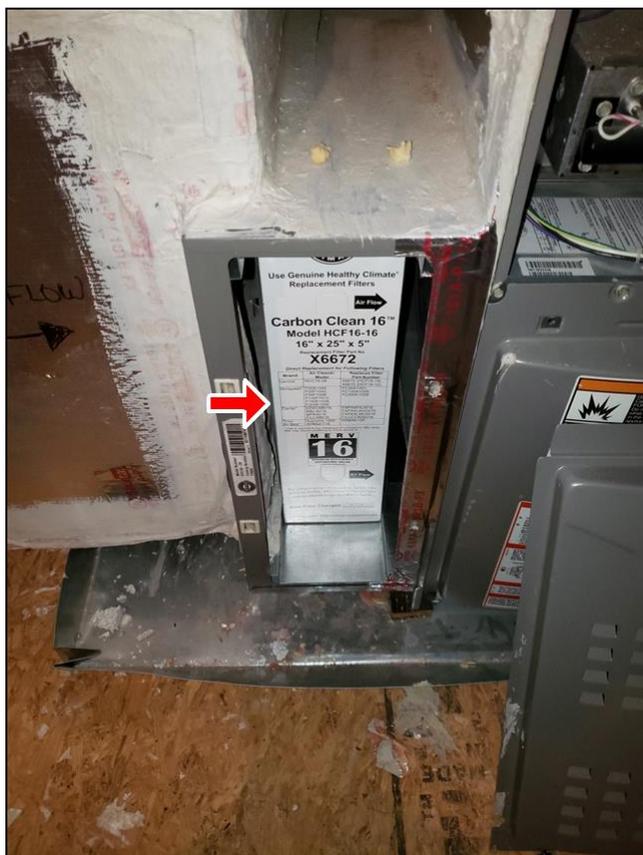
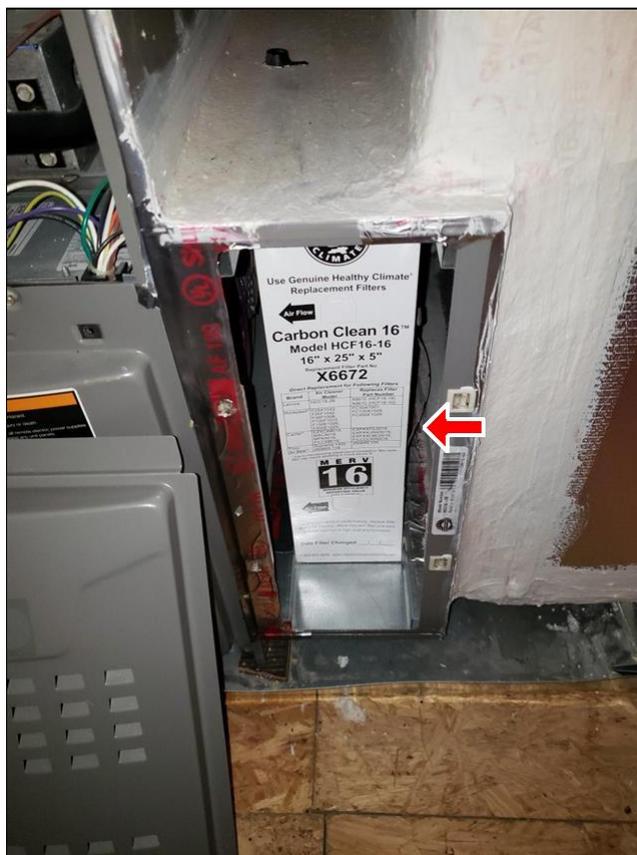
Location of filter(s) for heating and air equipment (see photo). The filter(s) should be changed every 6 months. Recommend that the filters be changed once you take possession of the house.

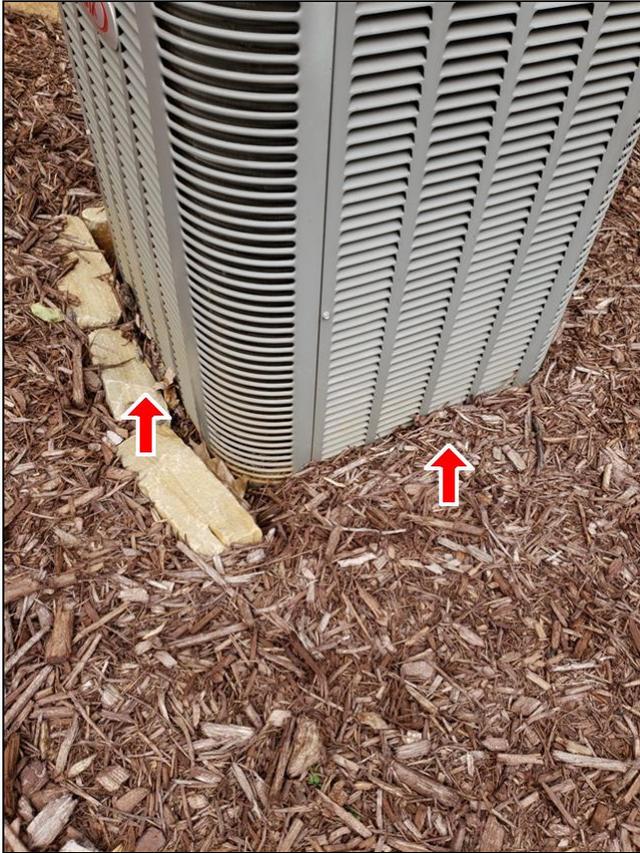
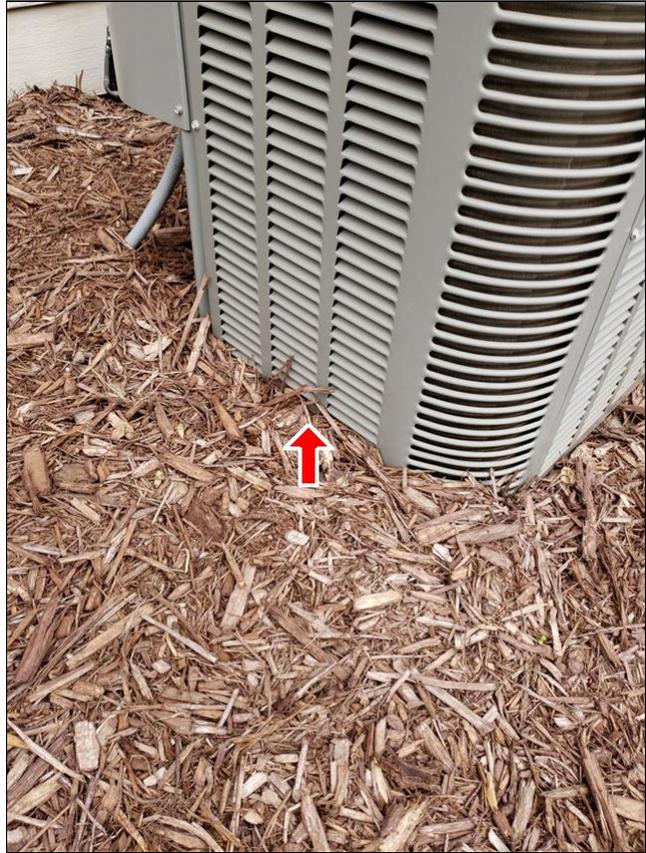
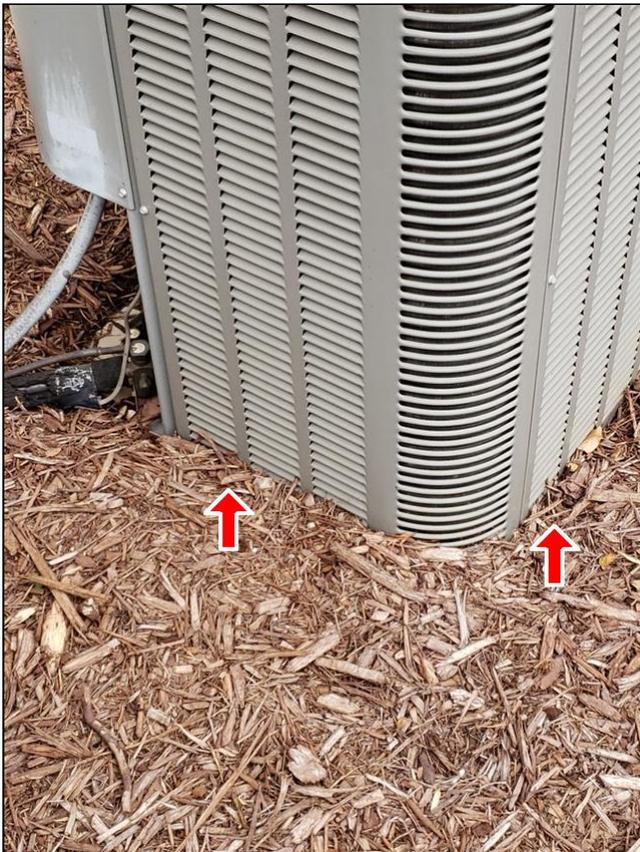
🏠 (2) The condensing unit(s) need all organic material removed from the unit(s) and the coils cleaned. A licensed heating and air contractor needs to repair.

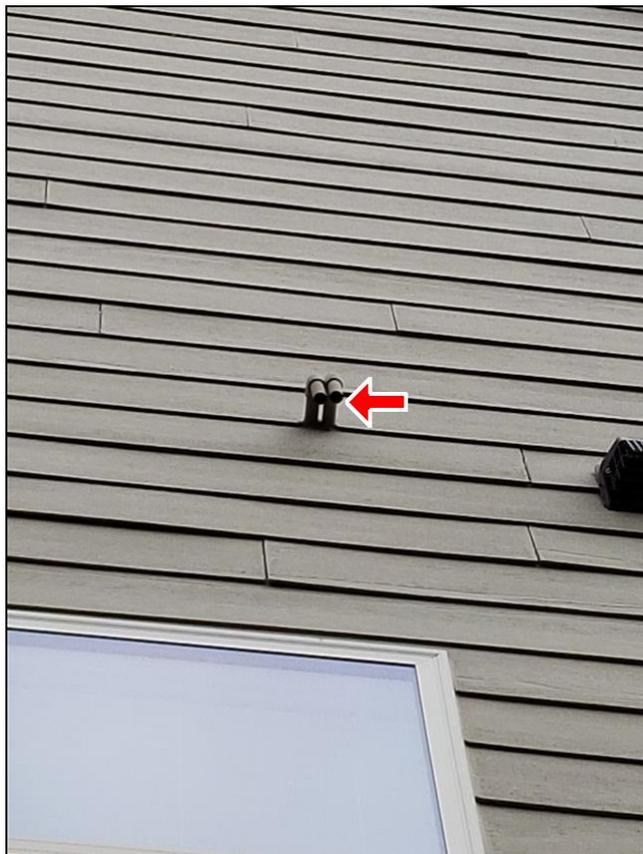
FYI, The picture shown is the location of the auxiliary condensation drain line from the air conditioning system. The drain line is installed in a conspicuous place so that you can be alerted if water is dripping from the pipe. If there is water draining from the pipe, the A/C should be serviced ASAP by a licensed HVAC contractor. The primary drain could be blocked which can cause an overflow.

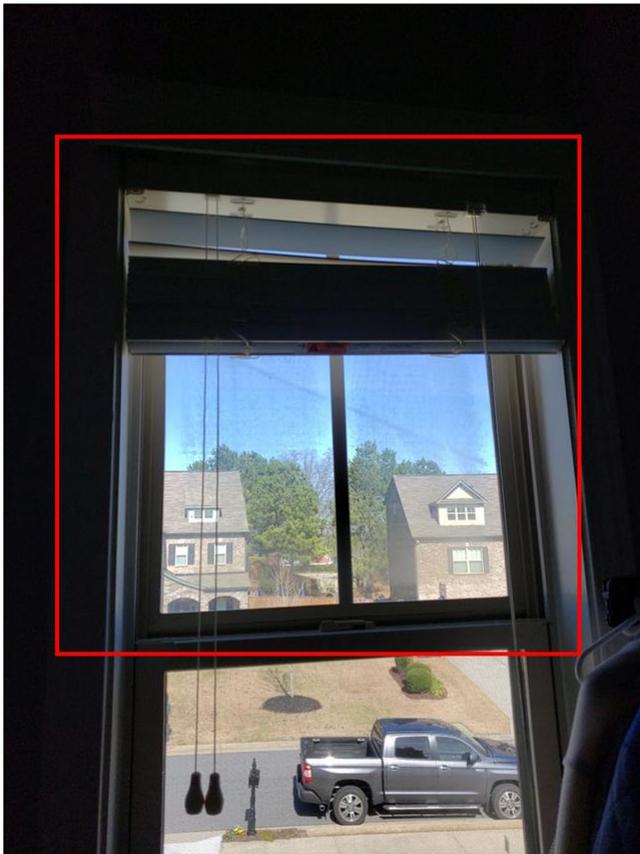
The insulation seal has failed on the window(s) in the front right bedroom closet. A qualified contractor needs to replace failed glass.

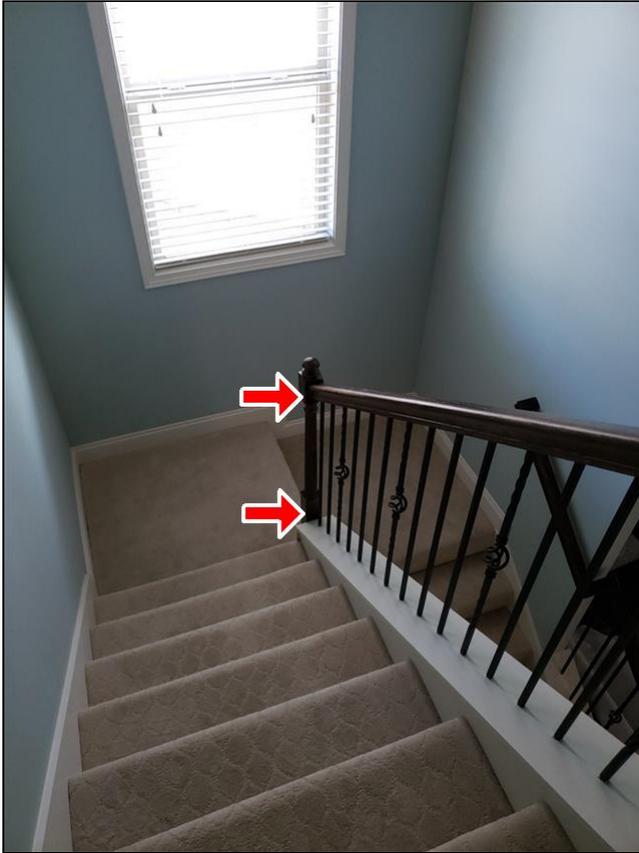
🏠 The handrail and newel post are loose at the bottom of the steps. The newel post and hand rail need to be tightened. A qualified contractor needs to repair.

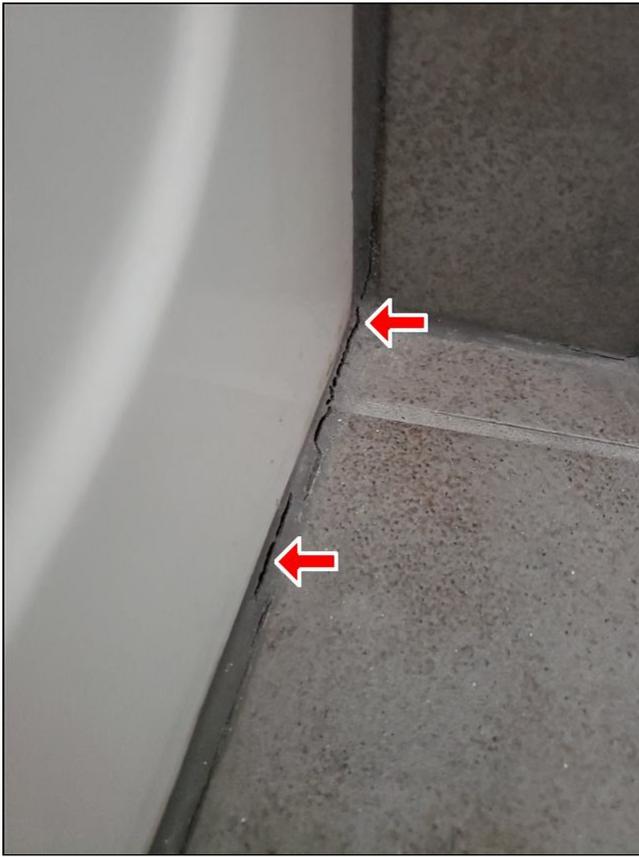
🏠 The floor in the master bath needs to be caulked or grouted. A qualified contractor needs to caulk or grout floor.

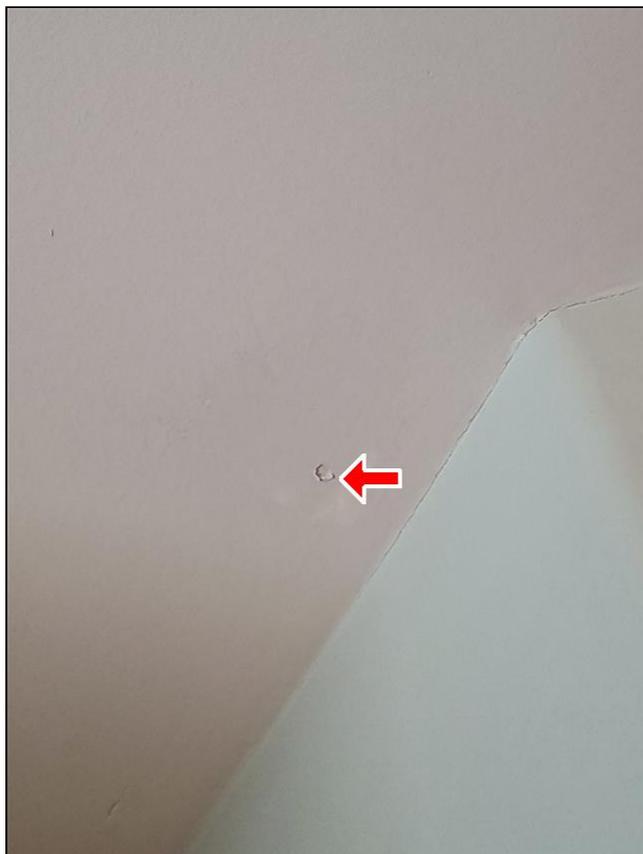
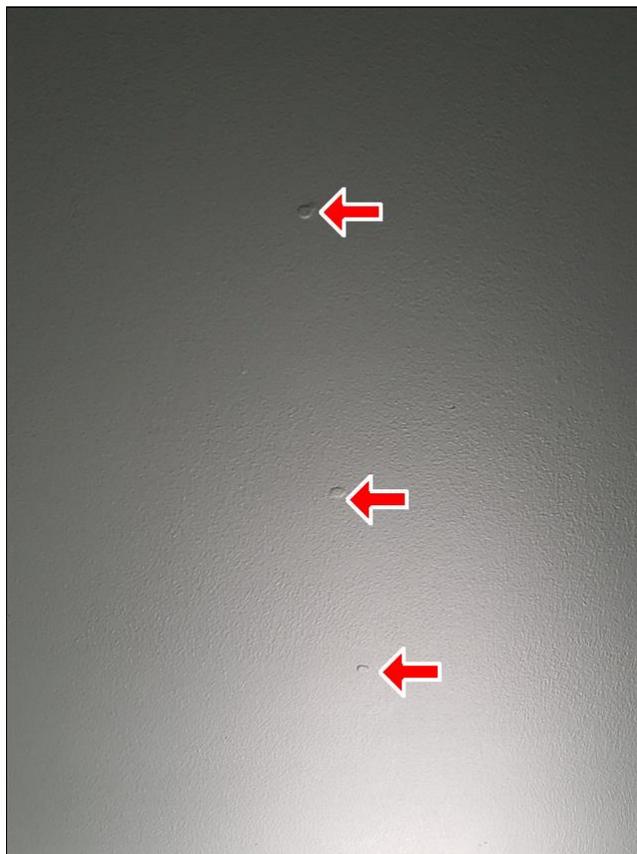
🏠 Nail pops were noted in the master bath and master bedroom. Pictures shown are examples. There could be other nail pops in the house. Repair and paint to match existing as needed.

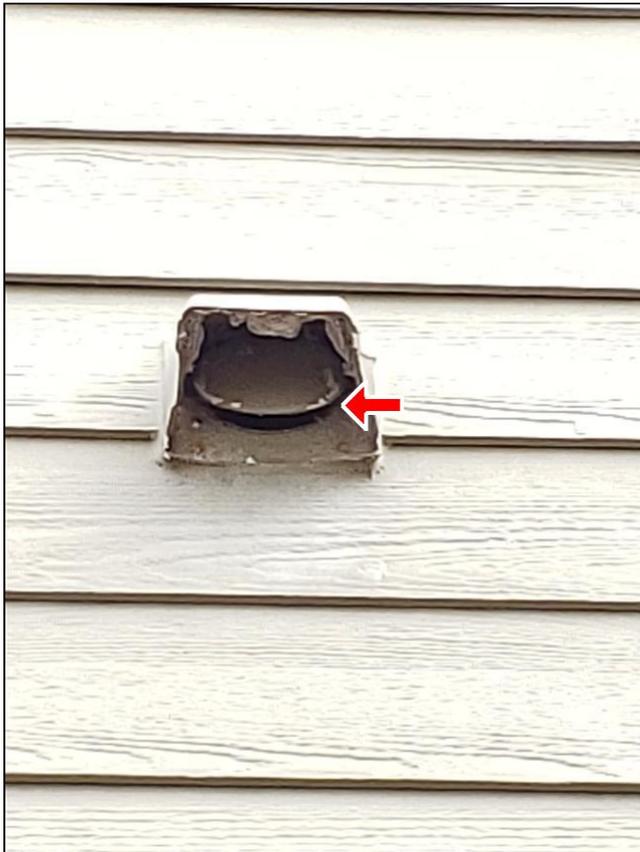
(1) The damper on the dryer vent does not close on the exterior of the house. Outdoor exhausts should have automatic or gravity dampers that close when the ventilation system is not operating. A qualified contractor needs to clean the lint out of the end of duct on the exterior and verify the damper will close.

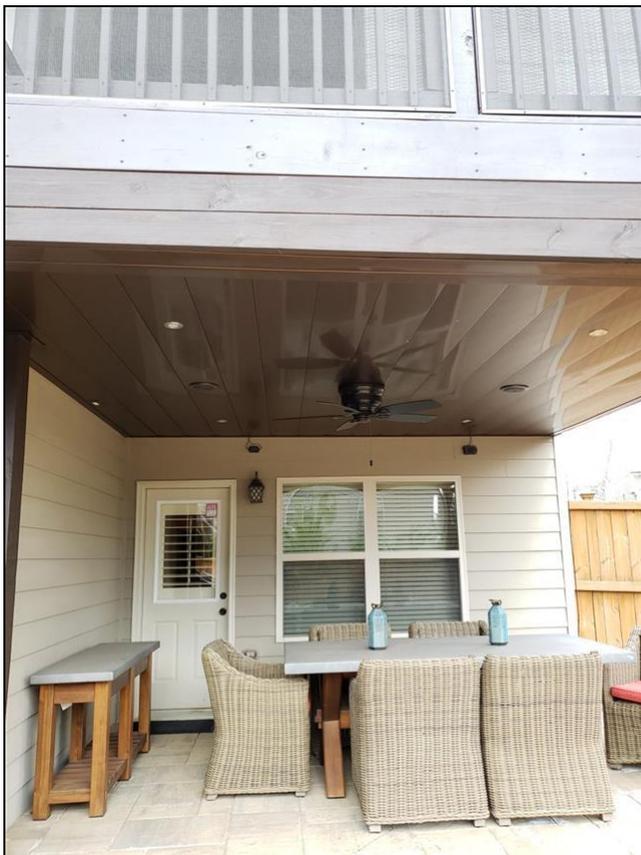
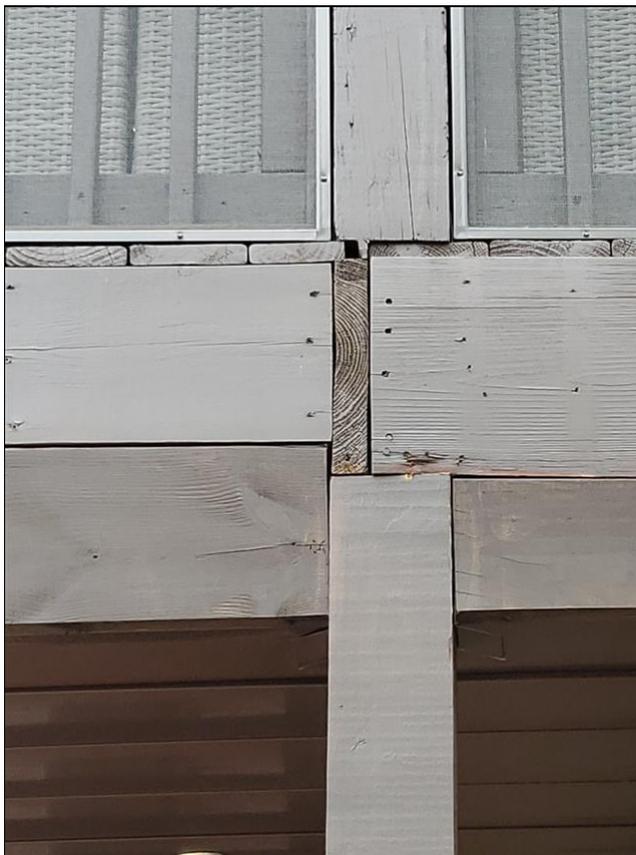
🏠 The deck joist, method used to attach the deck to the house, and deck flashing were not inspected. The bottom side of the deck is covered.
