Inspection Report

Property Address:
4925 Wilshire Crossing
Cumming GA 30040

Marion Hodges Home Inspection Services

Inspection Date: 2/17/2020
 Report ID:

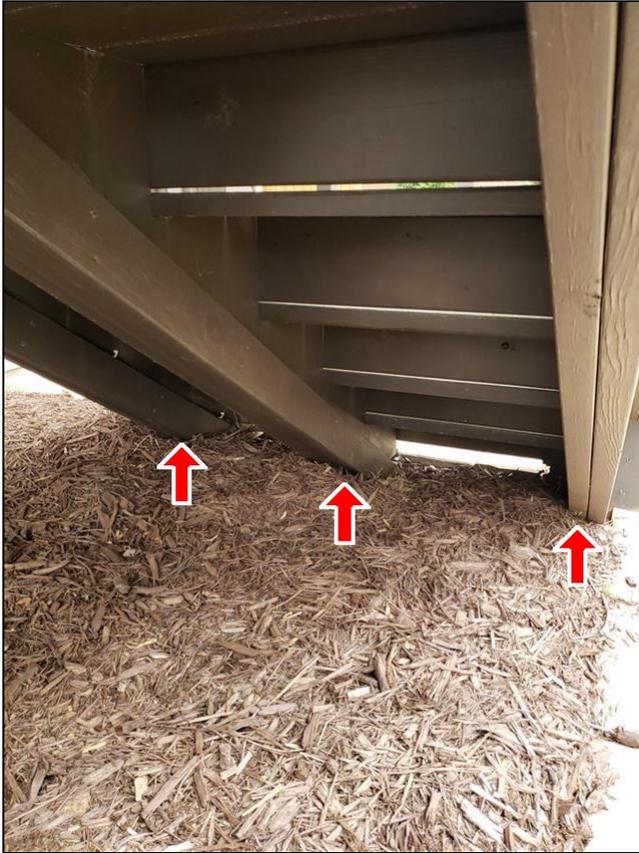
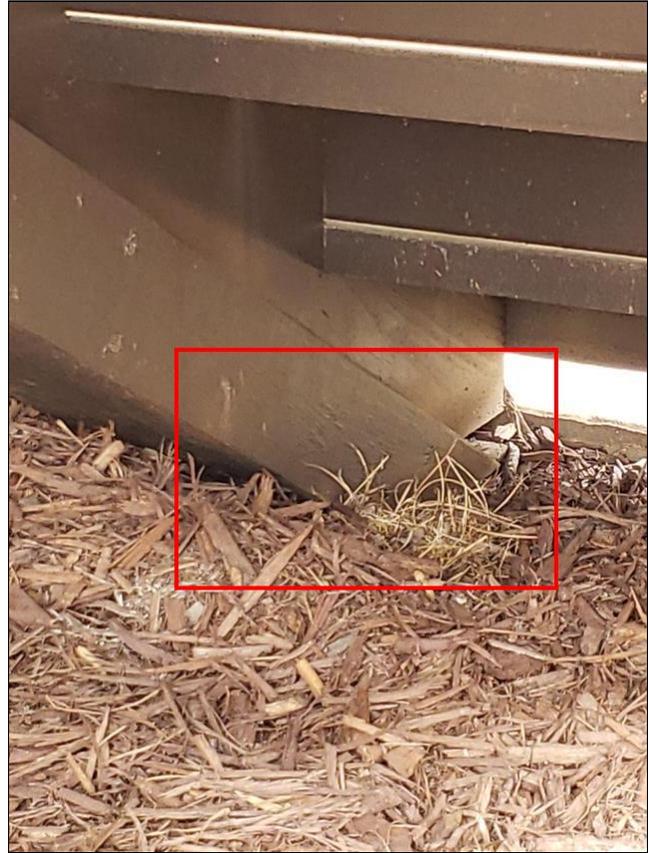
🏠 The steps on the deck are not supported on a concrete pad. This is earth to wood contact. A qualified contractor needs to pour a concrete pad under the steps for permanent support and prevent earth to wood contact.

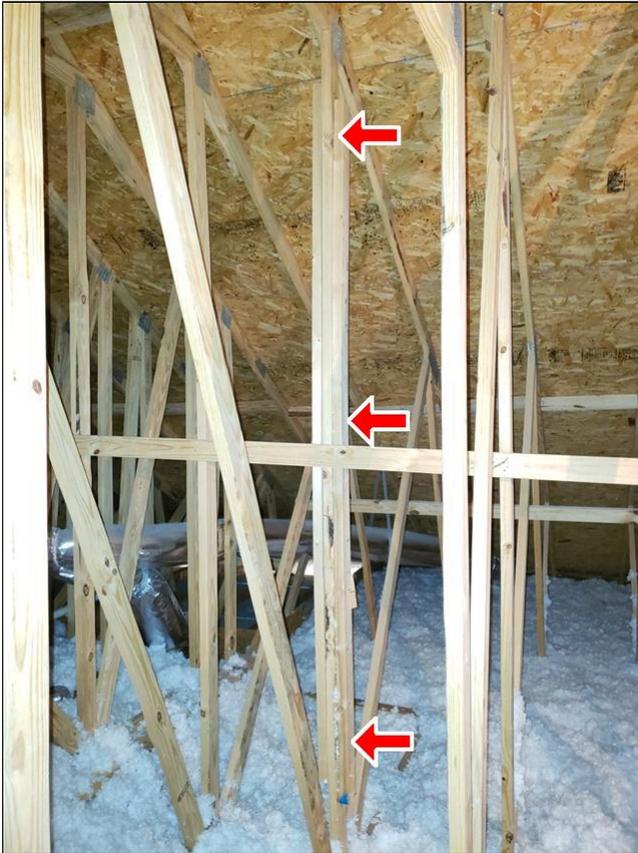
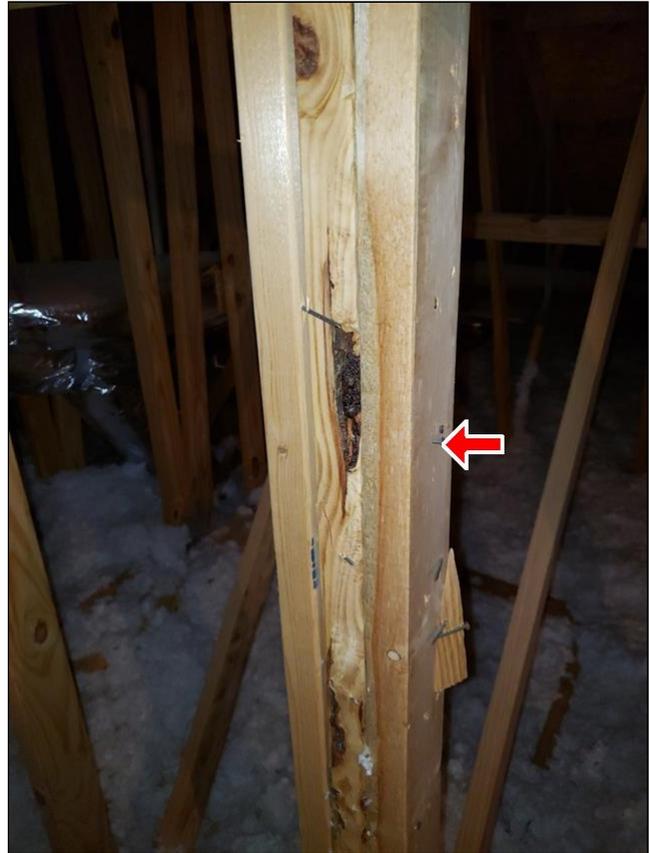
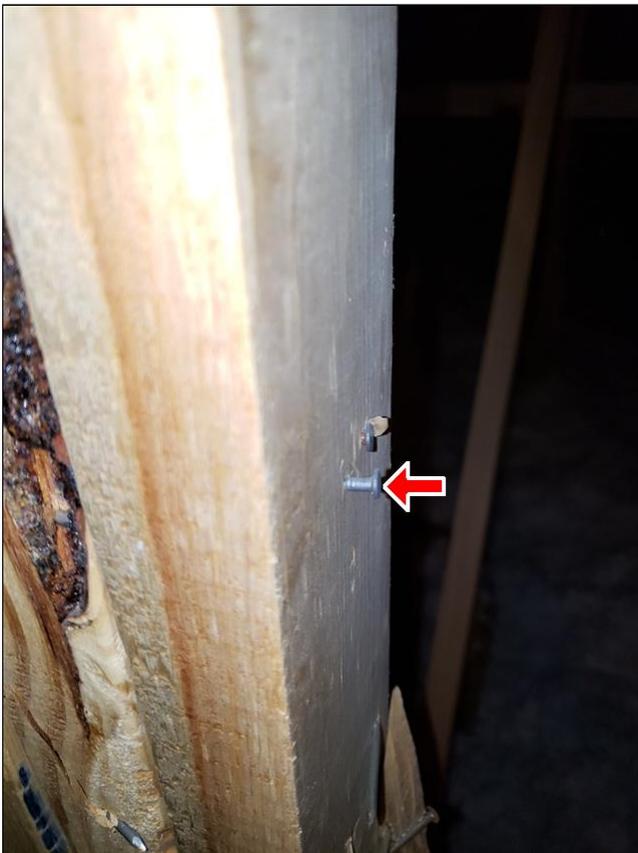
🏠 Roof trusses have been altered and the nails are backing out of the truss. Altered trusses need a designed repair plan from a registered design professional. The repair does not look like an engineered repair. A structural engineer needs to evaluate further and repairs made as needed.

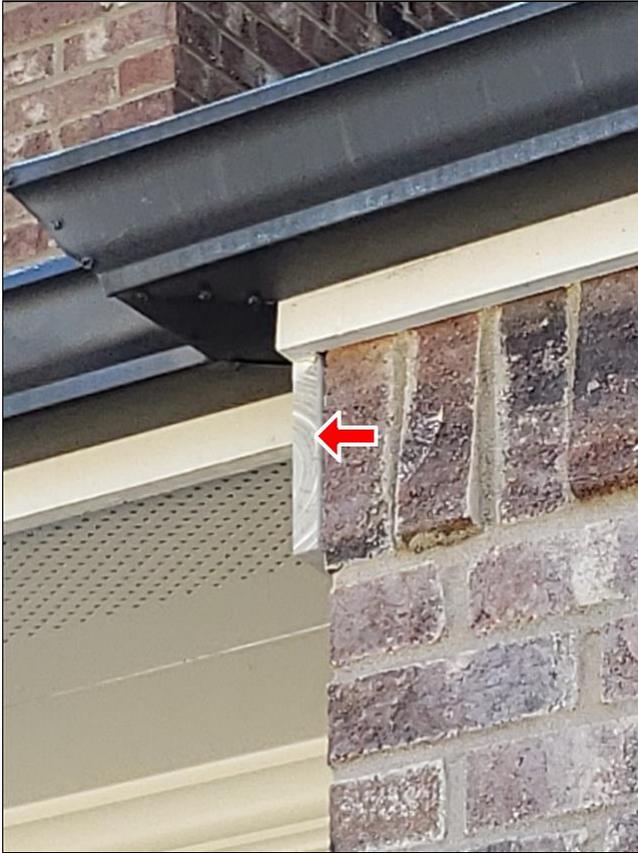
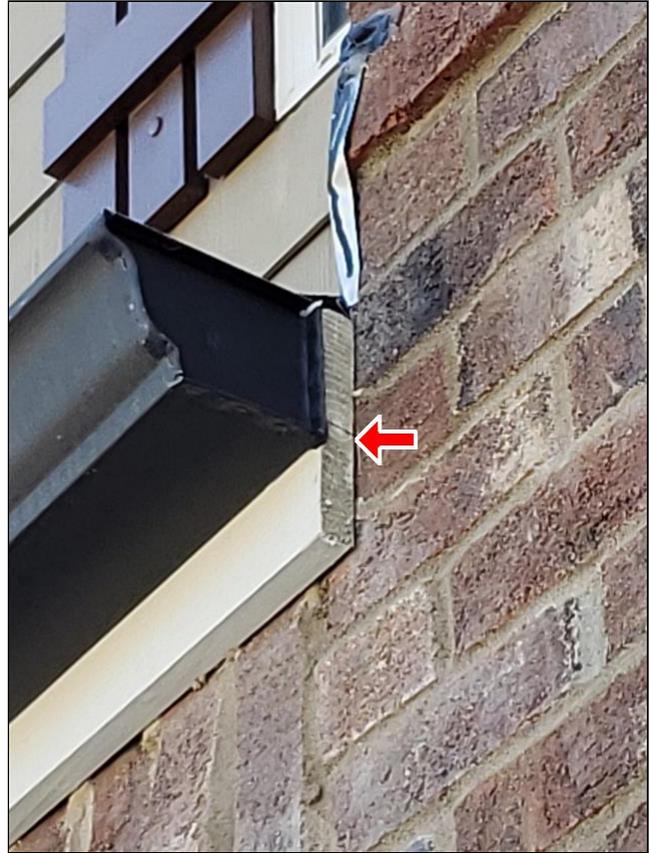
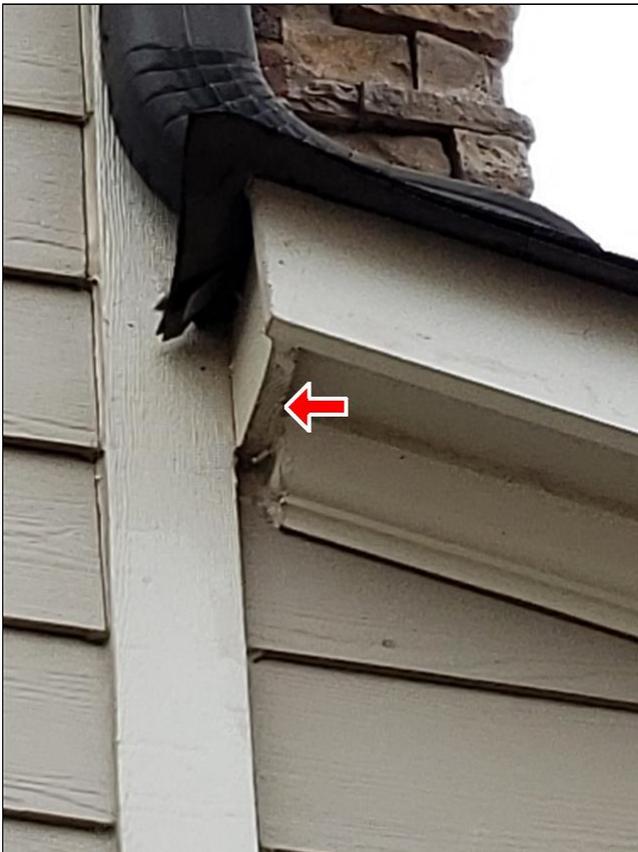
🏠 The ends of the fascia trim needs to be painted on the front of the house. A qualified contractor needs to paint trim to prevent future deterioration.

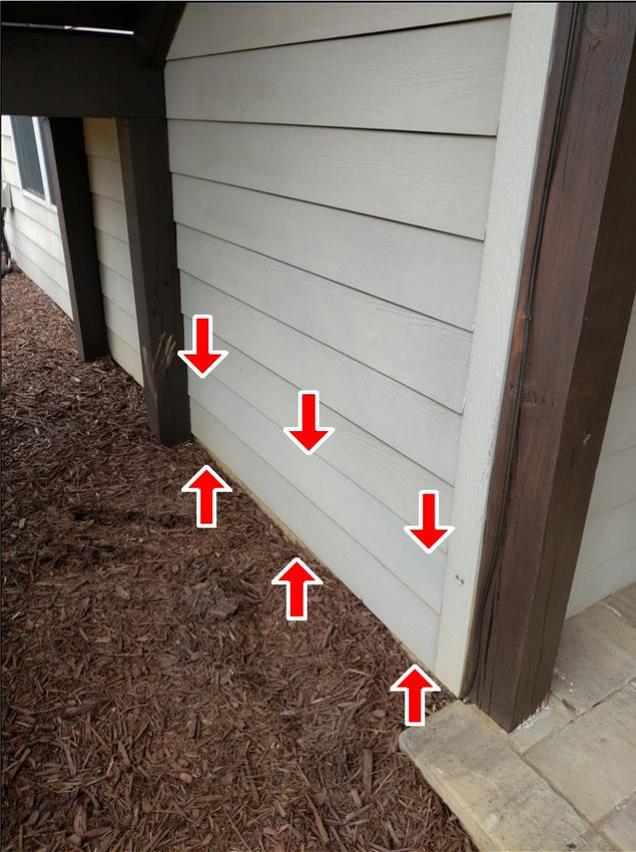
(1) The siding needs to be nailed on the back of the house under the deck steps where the siding is loose. A qualified contractor needs to repair.

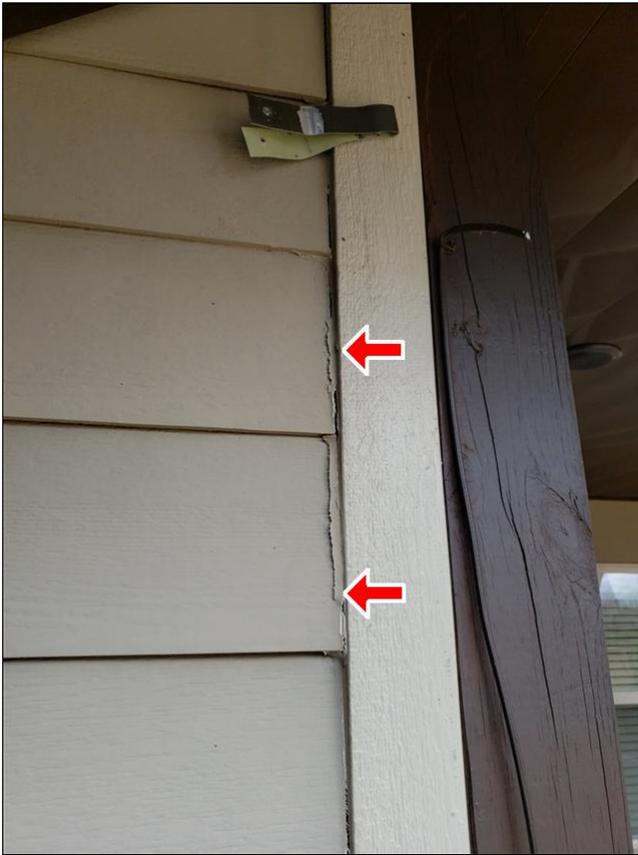
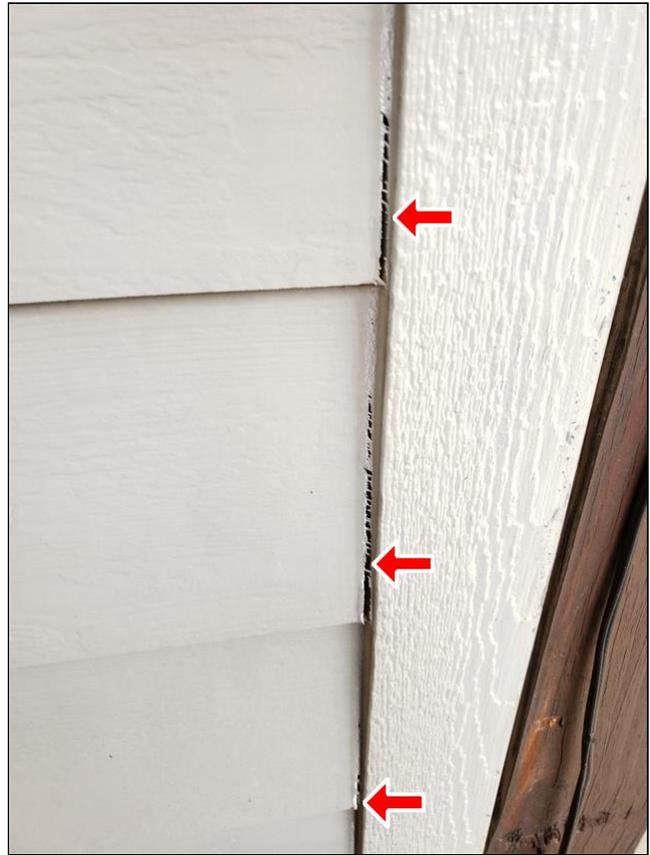
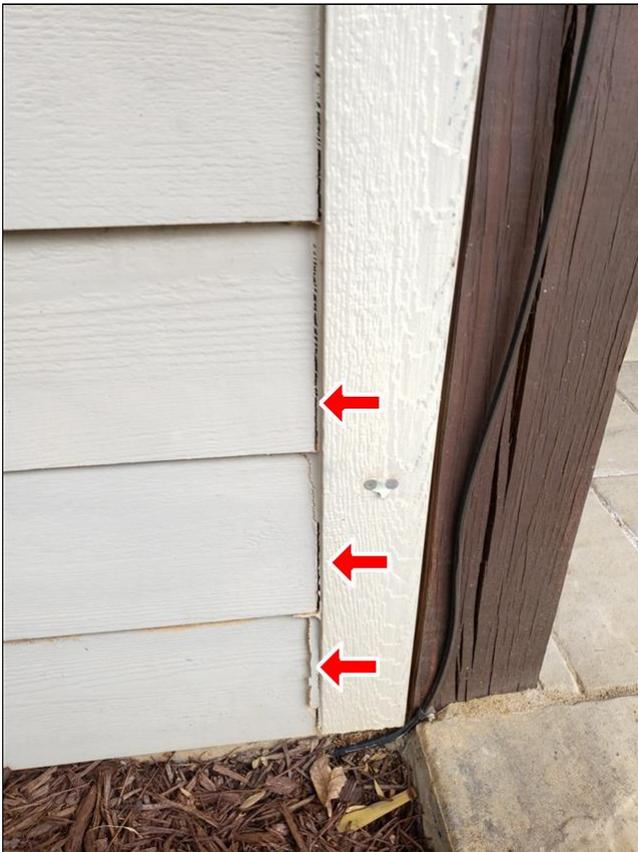
🏠 (2) The siding joints/ends needs to be caulked on the back of the house. See pictures for examples. A qualified contractor needs to caulk siding and paint to match existing as needed.

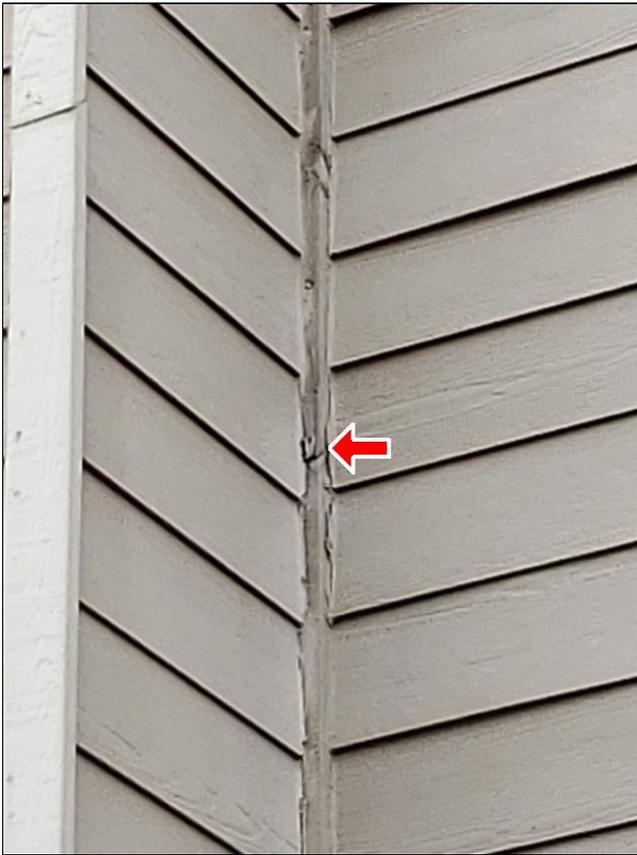
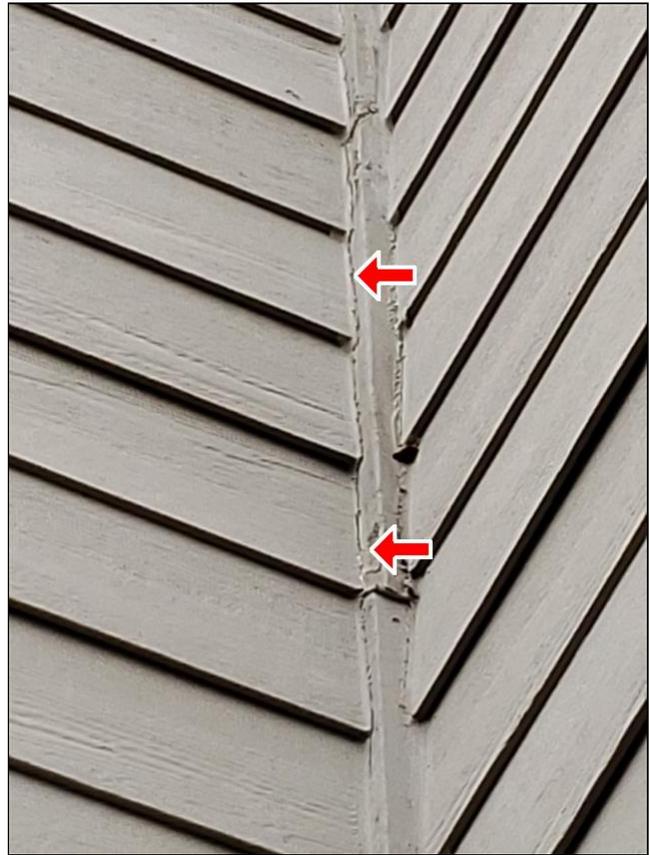
🏠 (3) Corner boards on the chimney need to be caulked and painted. A qualified contractor needs to repair.

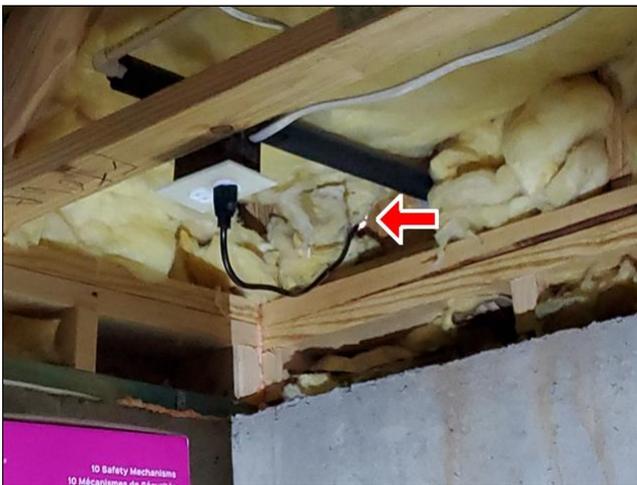
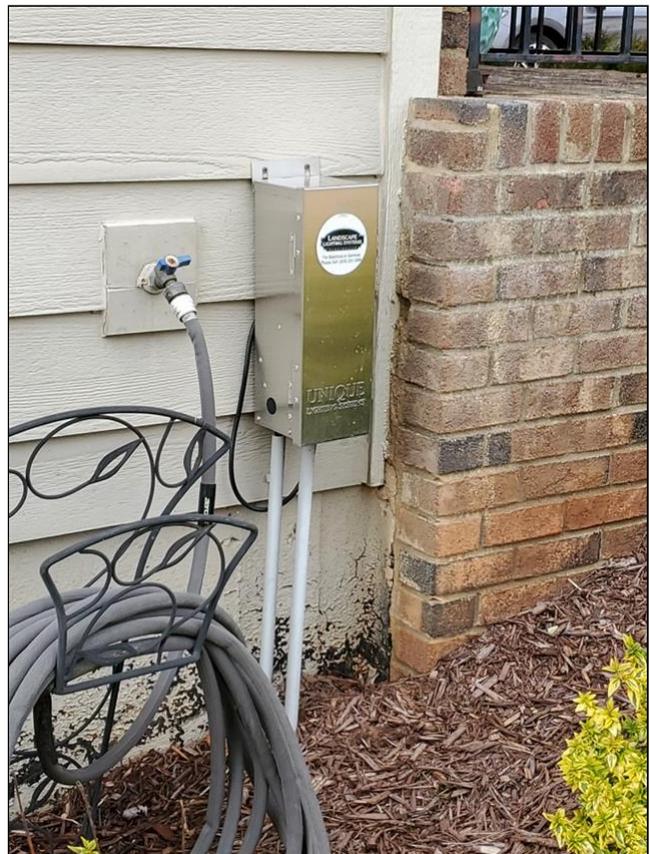
🏠 (4) All utility penetrations through the exterior wall should be caulked or filled with foam. The following utility penetrations should be caulked or filled with foam to limit air infiltration: cord to exterior lighting

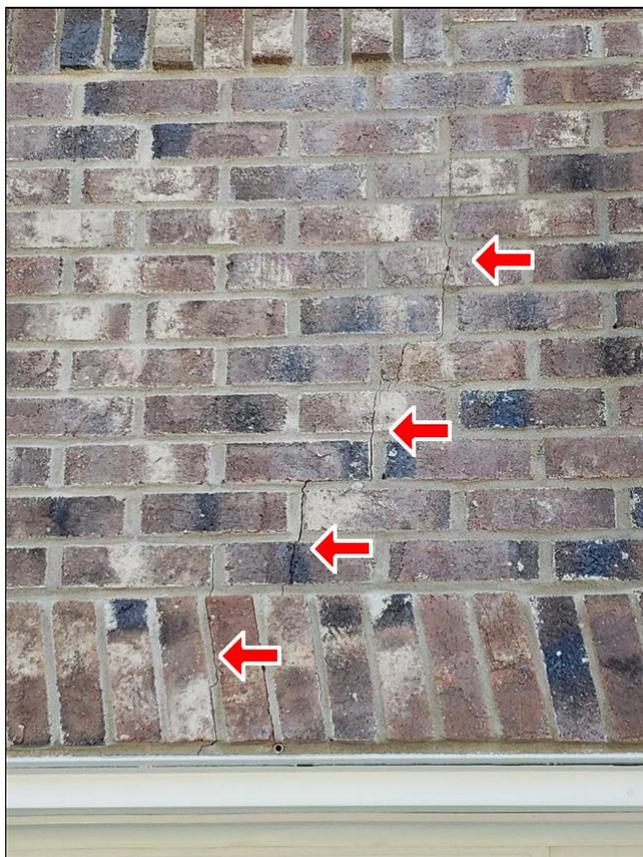
Crack in the brick was observed on the front of the house. A qualified contractor needs to point crack as needed.

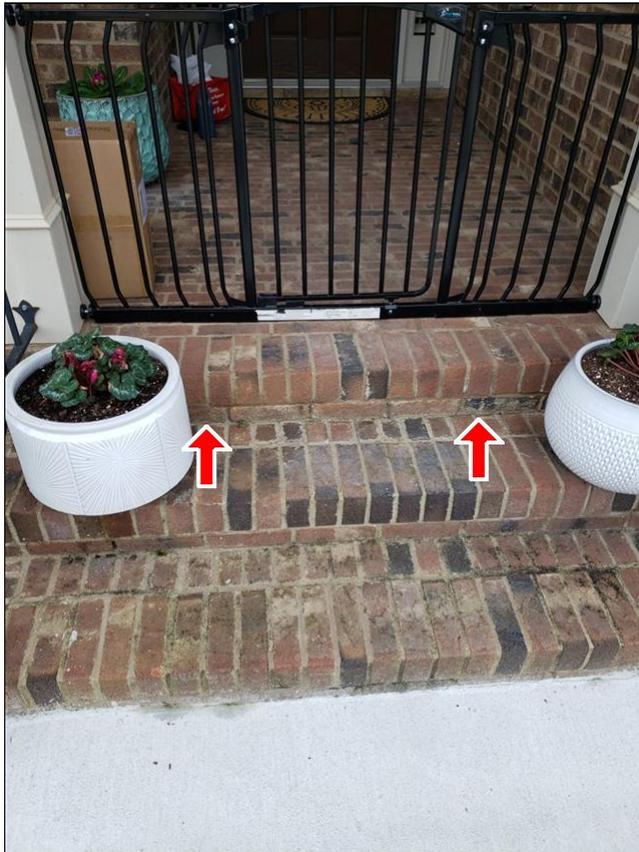
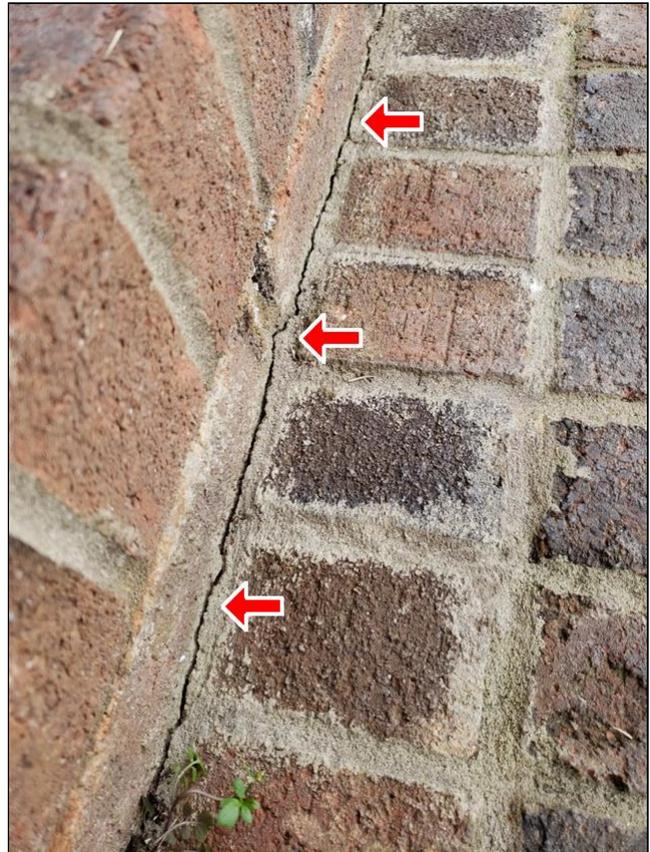
- 🏠 Mortar joints have cracked on the front stoop. A qualified contractor needs to seal cracked mortar joints with mortar to match existing.

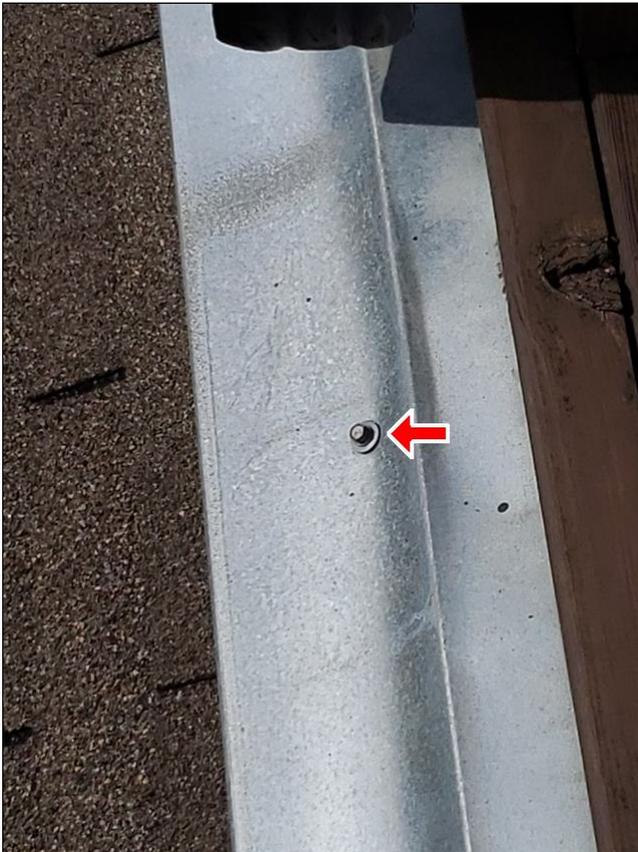
(1) Roofing nails are not sealed on the back porch roof. A qualified roofer needs to seal all nails with a roofing sealant.

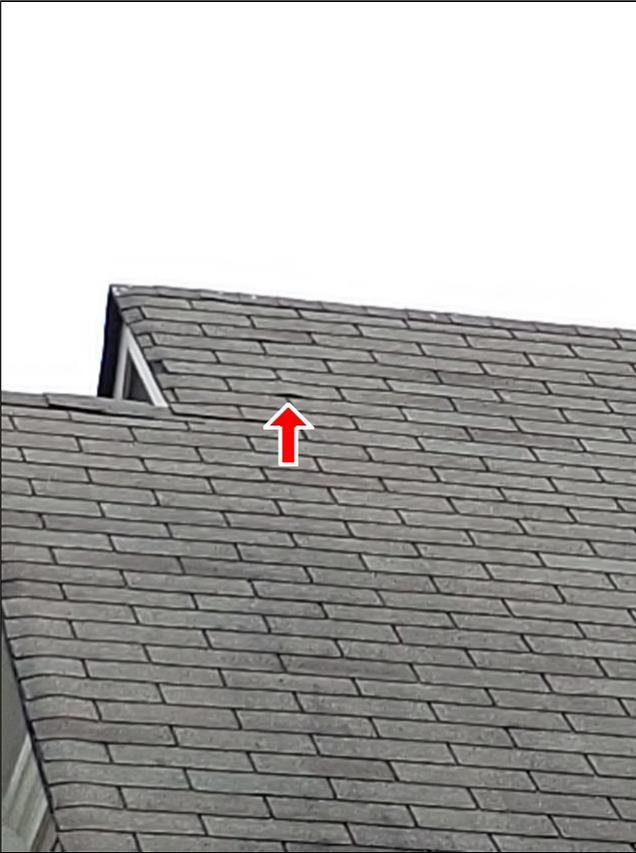
- 🏠 (2) There are uplifted shingles on the right side of the house. A qualified roofer needs to re-nail shingles and seal any holes with a roofing sealant as needed.

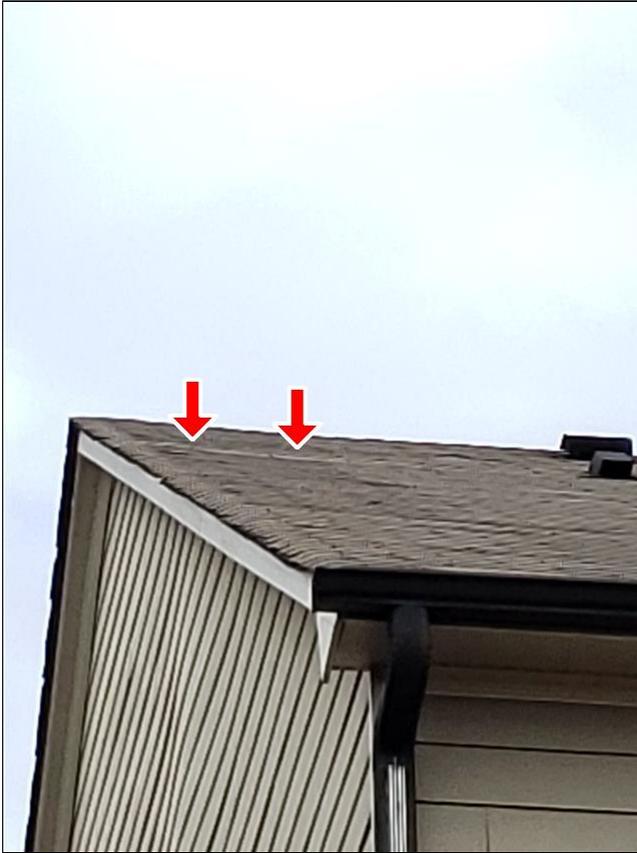
- 🏠 (3) There are uplifted or wind blown shingles on the back of the house. A qualified roofer needs to inspect further and repair.

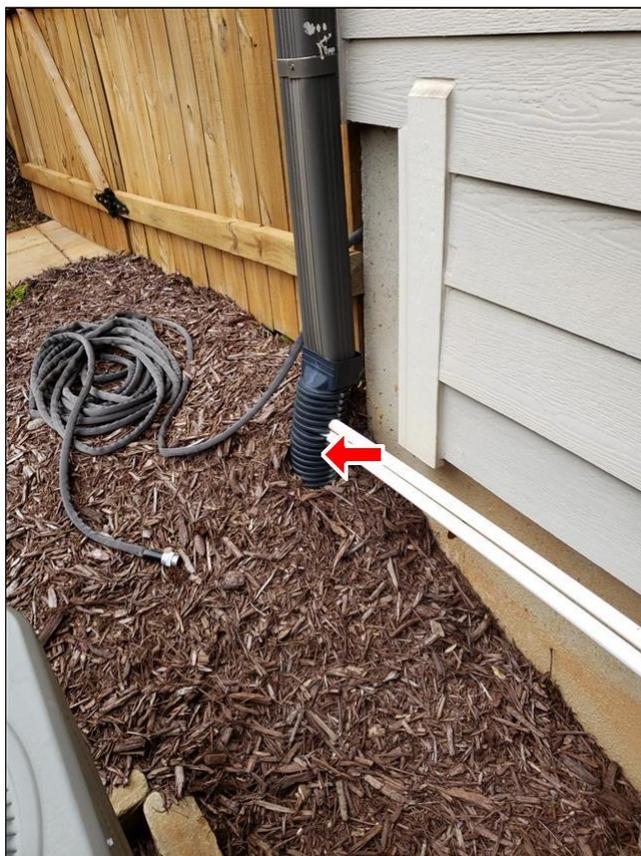
The downspouts are piped away from the house. The buried drain lines were not checked for blockage. The ends of the pipes were not located. Make sure all buried downspout pipes are free flowing and the ends of the pipe located. Blocked drain pipes should be replaced where needed. If pipes are replaced, replace with smooth wall pipe and not ribbed pipe.

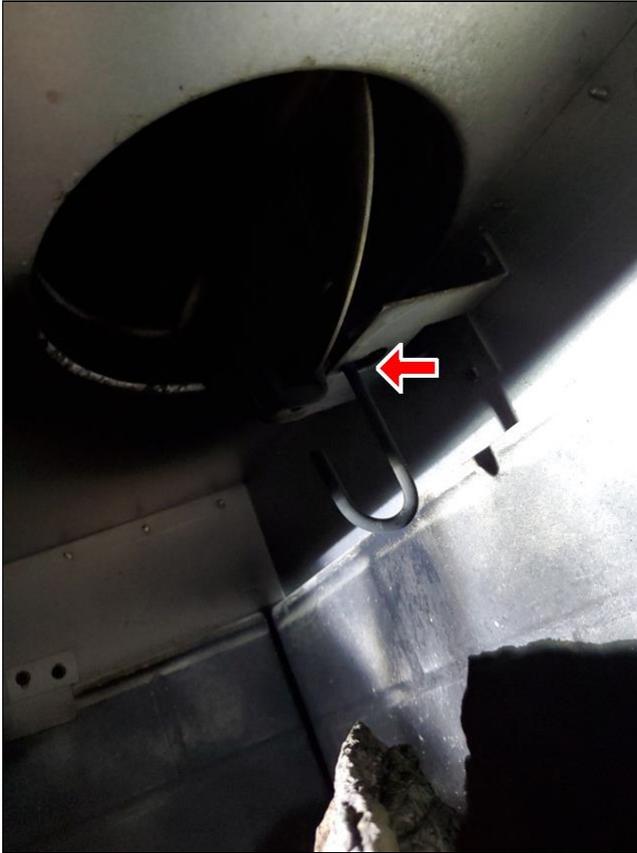
FYI, The fuel source for the fireplace is gas logs The vent on the fireplace should be in the full open position when using gas logs. Failure to do so can cause a build up of carbon monoxide gas in the house.
