BPG Inspection, LLC

**1121 Verdon Drive
Dunwoody GA 30338**

Client(s): Jarrett
Inspection Date: 2/14/2020
Inspector: Kenneth Myers ,

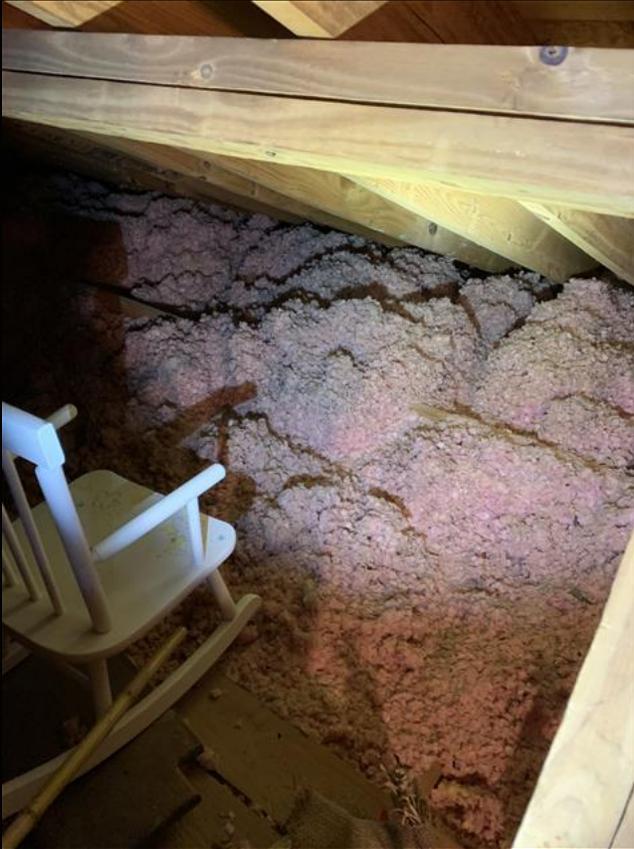
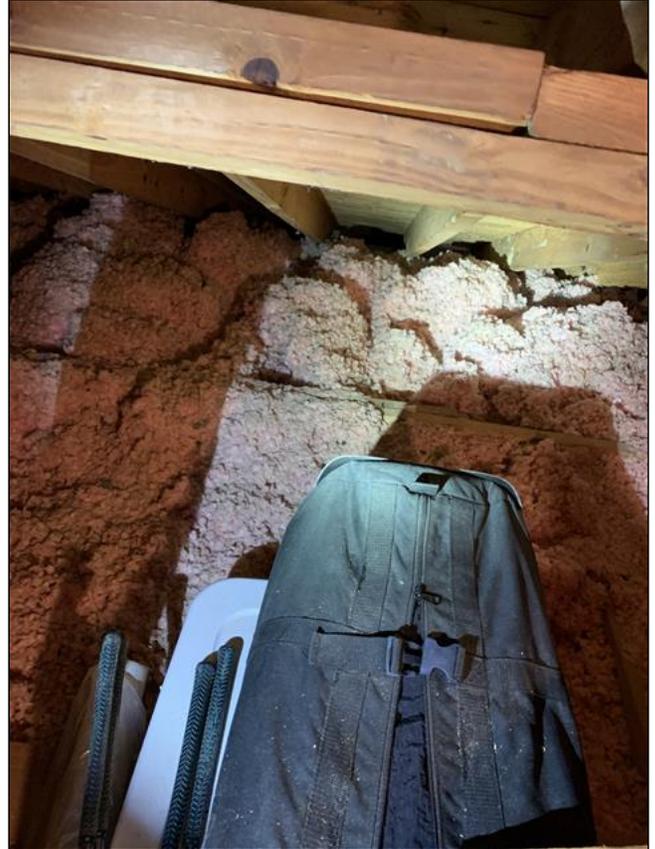
- ❌ 1. **GENERAL NOTE:** Evidence of animal activity seen in attic and or crawlspace (e.g. tunnels, trails on insulation surface). Not present at time of inspection. Have seller disclose if issue has been resolved. Have professional pest control company evaluate and eliminate source of attic access and remove any pests found if seller is not aware of condition.

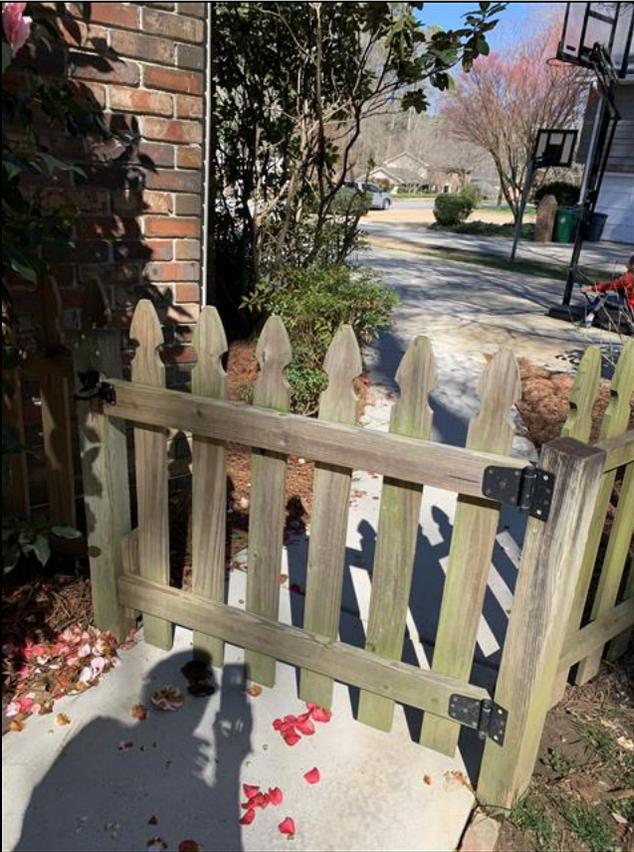
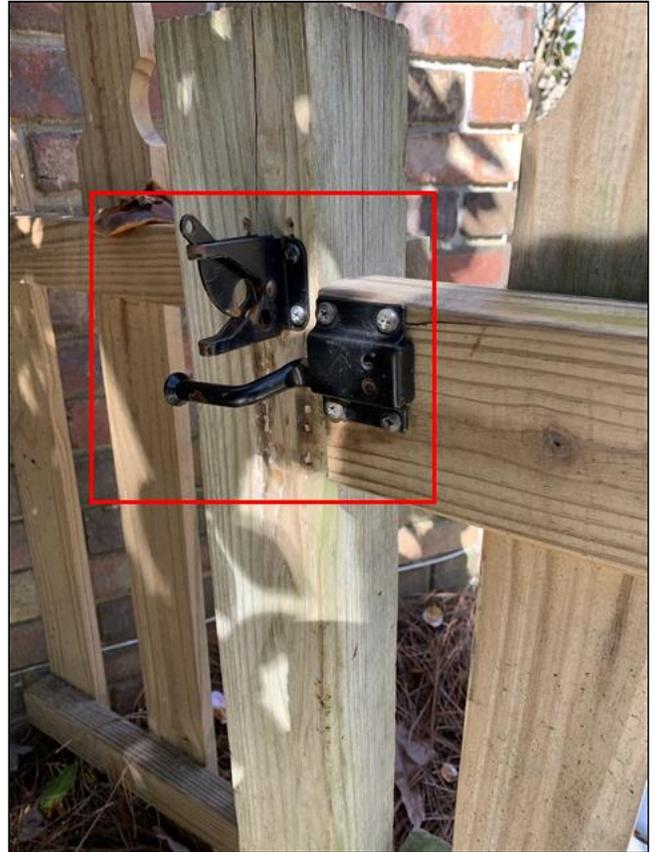
- ❌ 2. **SERVICE / REPAIR:** The fence gate does not latch when operated. Have the gate repaired to operate properly.

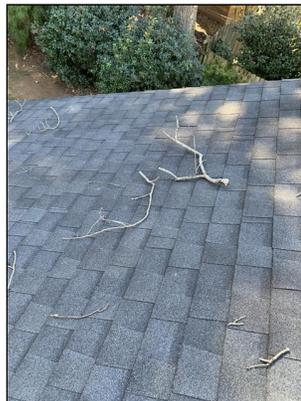
- ❌ 3. **SERVICE / REPAIR:** Organic debris (leaves, sticks, moss, algae, etc) present on the roof covering. Removal of all debris is recommended to prolong the life of the roof.

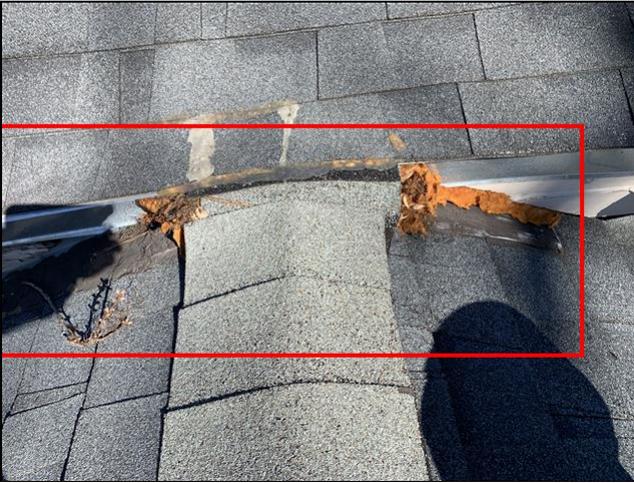
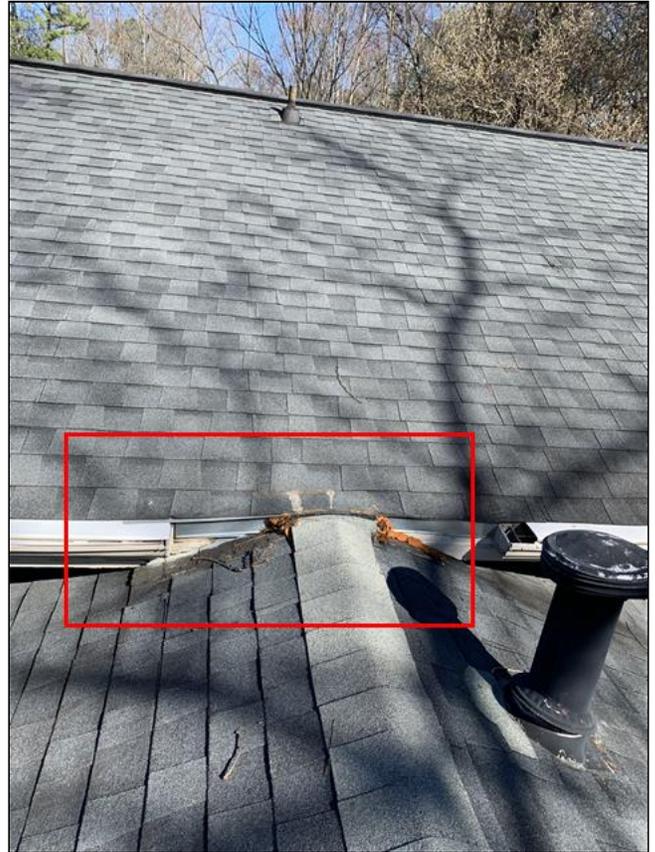
- ❌ 4. **SERVICE / REPAIR:** Improper sealant noted at ridge. Foam is not a exterior approved sealant. Recommend professional roofing contractor repair.

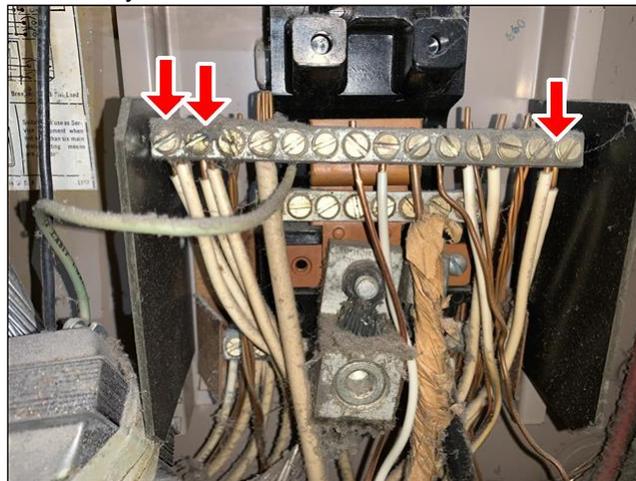
- ❌ 5. **SAFETY / HEALTH:** The neutral (white) wires are doubled, tripled or more under the same lug(s) inside the electrical panel. Although the manufacture of this panel may allow the doubling of ground wires, the doubling of neutral wires is prohibited in most cases due to potential for loose contact. Would recommend having reviewed and corrected by an electrician for safety.

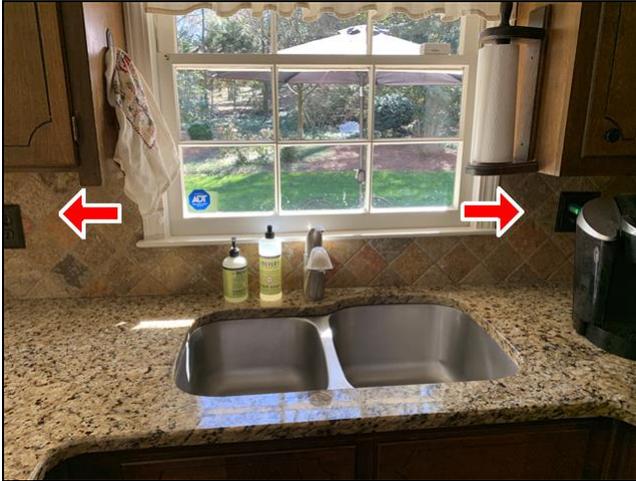
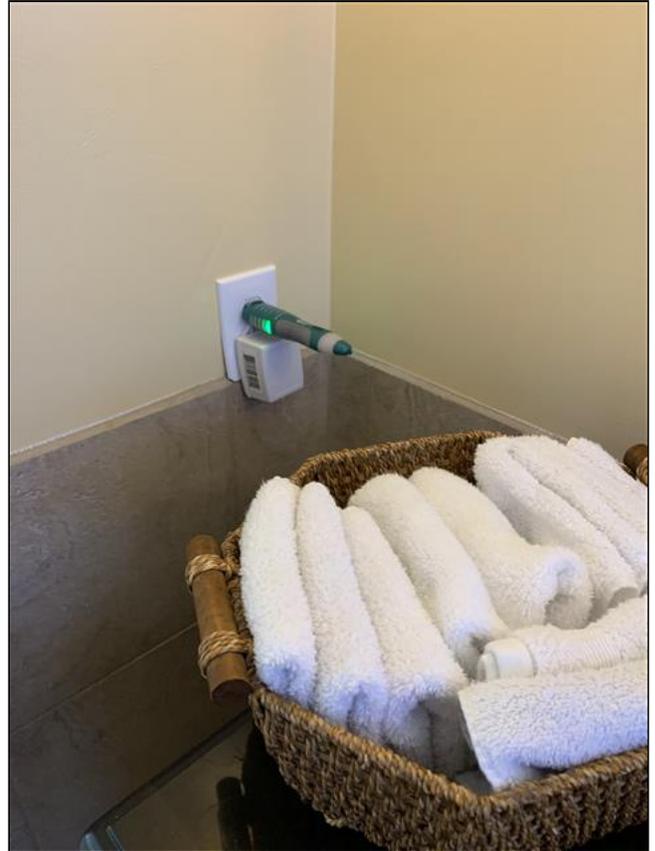
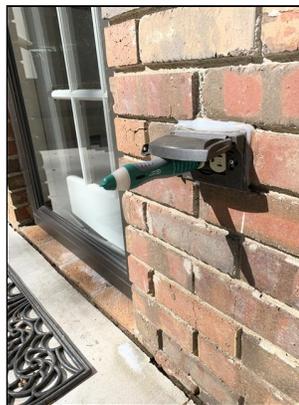
- ❌ 6. **SAFETY / HEALTH:** GFCI protection is missing at kitchen sink, outside receptacles and half bath. GFCI (ground fault circuit interrupter) protected devices required to be installed at this/these location(s) when originally built for protection from electrical shock. Have corrected by qualified electrician.

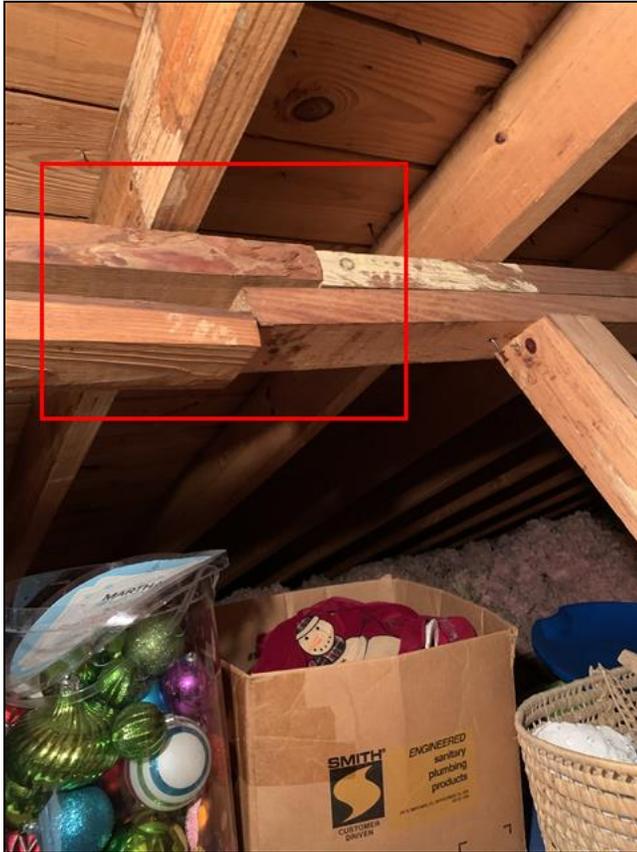
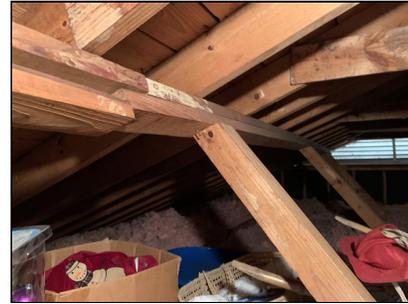
- ❌ 7. **SERVICE / REPAIR:** Purlin has separated at top of stairs in attic. Recommend securing with lag screw or bolt.

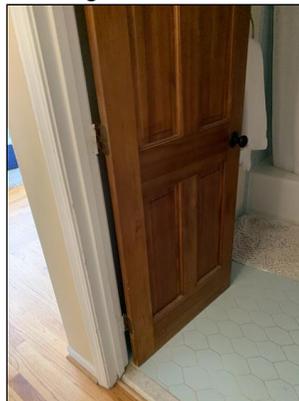
- ☒ 8. **SERVICE / REPAIR:** Door found to rub on the finished floor tile when opened / closed at hall bathroom. This will loosen the hinges and cause damage to the flooring material over time. Recommend correcting.

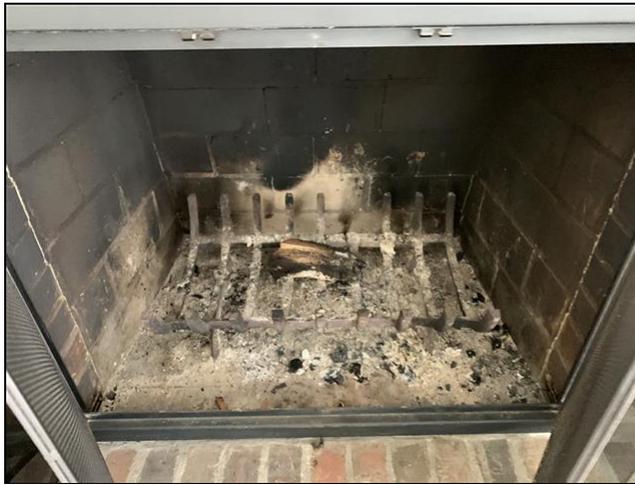
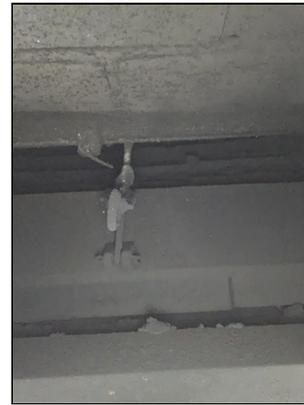
- ☒ 9. **SERVICE / REPAIR:** The NFPA (National Fire Protection Association) recommends a Level II examination of a chimney flue whenever a real estate property changes ownership. This examination includes a complete review of all accessible portions of the fireplace and chimney from the top to the bottom, including both the interior and exterior portions. Video scanning equipment or other means shall be used as necessary to observe these areas.

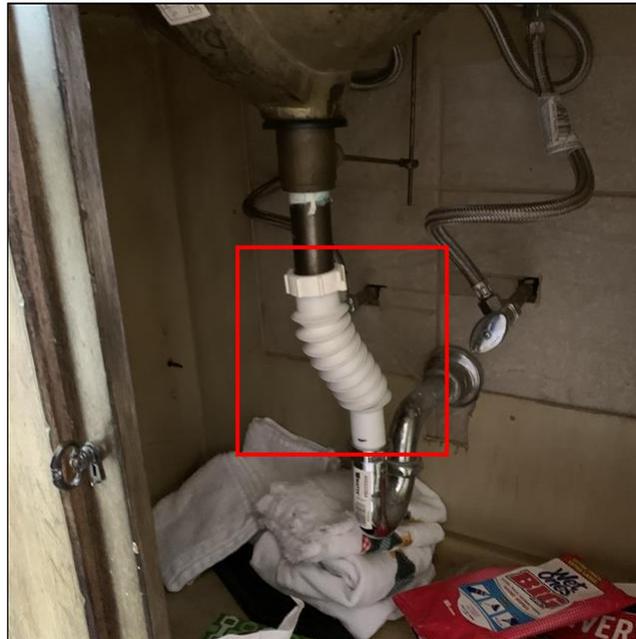
- ❌ 10. **SERVICE / REPAIR:** Trap material used on Half bathroom sink is designed for temporary repair and uneven interior surfaces may lead to clogging. Plumbing drains are required to have smooth interior surfaces. Recommend a licensed plumber repair or replace as necessary.

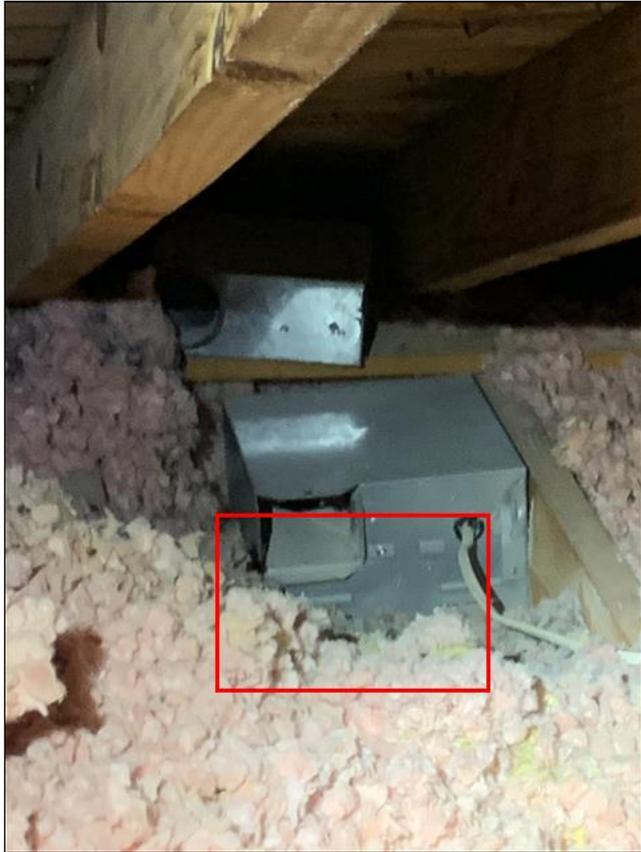
- ❌ 11. **SERVICE / REPAIR:** Bathroom exhaust fans found exhausting horizontally to insulation instead of up. Have piped to upper portion of attic at least. More recent codes require lines to be piped to the outside. Correction recommended.

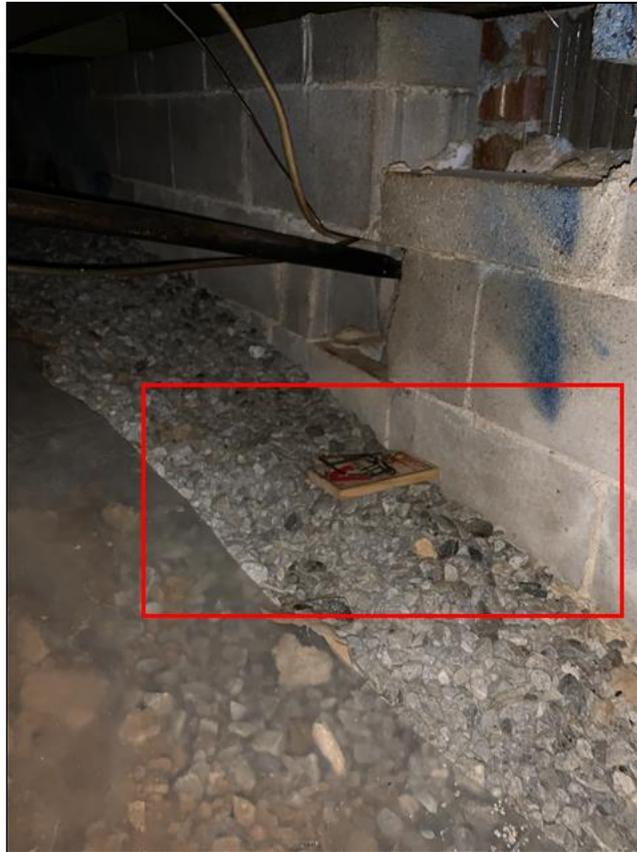
12. **SAFETY / HEALTH:** Evidence of animal activity seen in crawlspace as denoted by traps found. Have professional pest control company evaluate and eliminate source of accesses found and remove any pests which may be hiding.

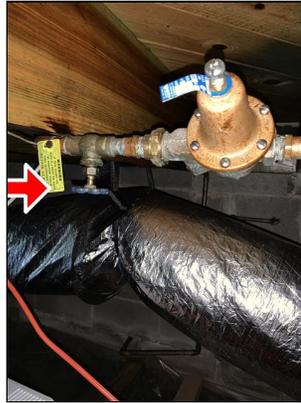
13. **GENERAL NOTE:** Upon arrival, found the water service meter and monitored all dials and indicators for water usage. There was no indication of any leak. This is a solid indicator that prior to entering the home, there are no leaks in the water service or supply line plumbing.
14. **GENERAL NOTE:** The main water shut off is located front wall/ceiling of crawlspace..

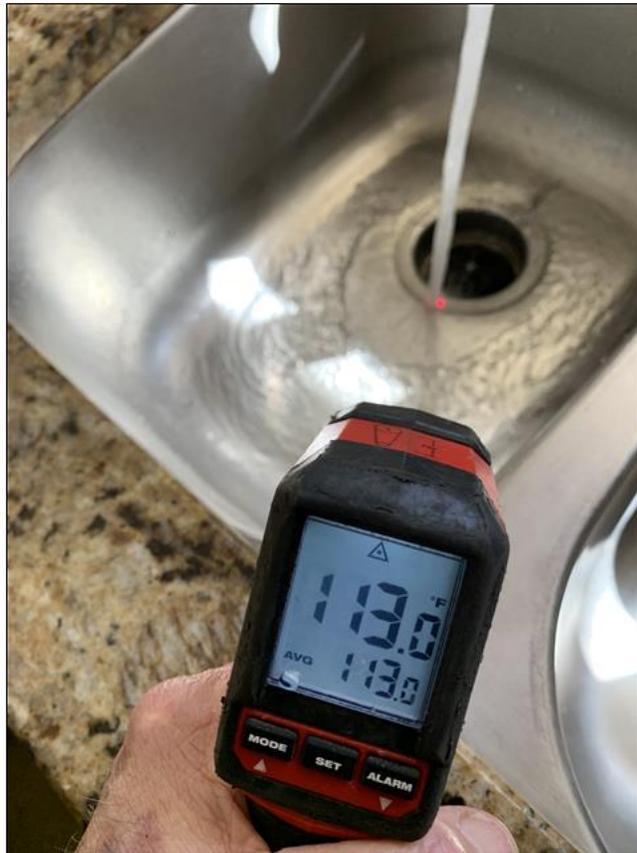
15. **GENERAL NOTE:** Average life expectancy for a water heater is approx. 8 to 12 years in the Atlanta area. Unit manufactured in 1998. Budget for replacement or have warranty program established. Water temperature was measured at 113 degrees.
