**House Smart**

**3809 Castlegate Drive Northwest  
Atlanta GA 30327**

Client(s): Van  
Inspection Date: 3/24/2020  
Inspector: John Lampp ,

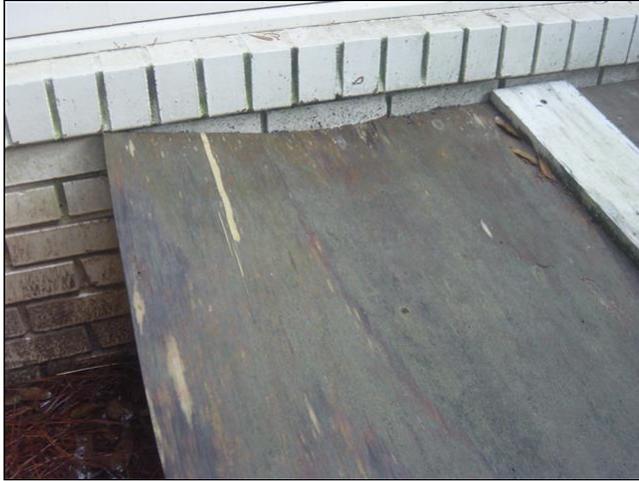
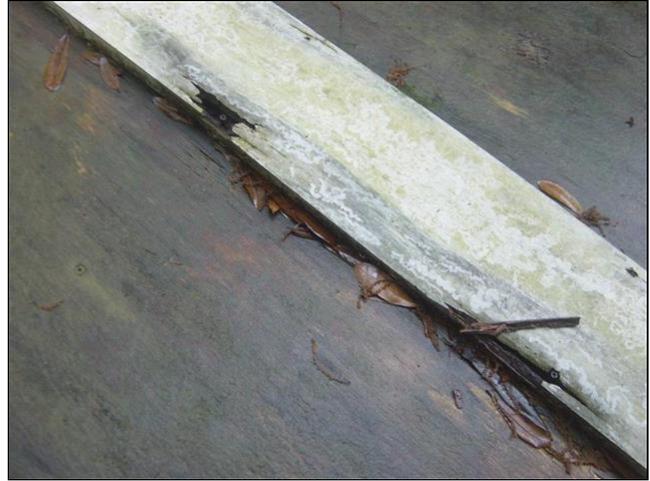
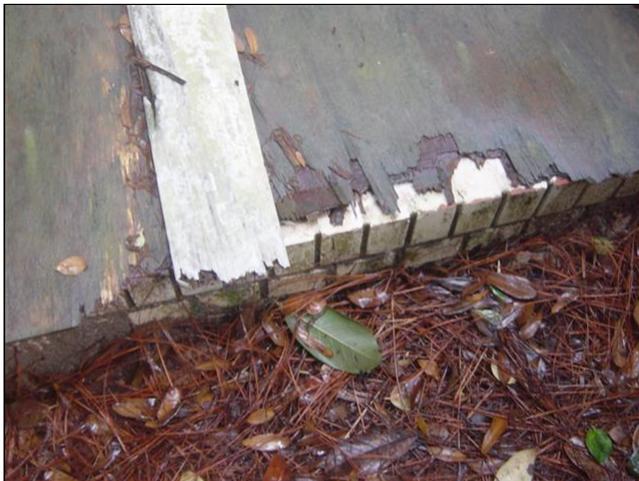
- ☒ 1. **SERVICE / REPAIR:** Cover over access to crawlspace door is warped and rotted. Replace.

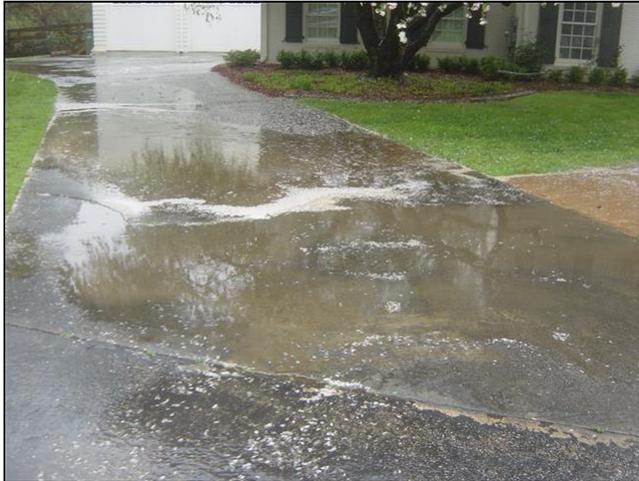
Item 2 - Picture 1

- ☒ 2. **SERVICE / REPAIR:** Driveway is not set up properly to shed water. Water pools on the driveway. Repair as needed.

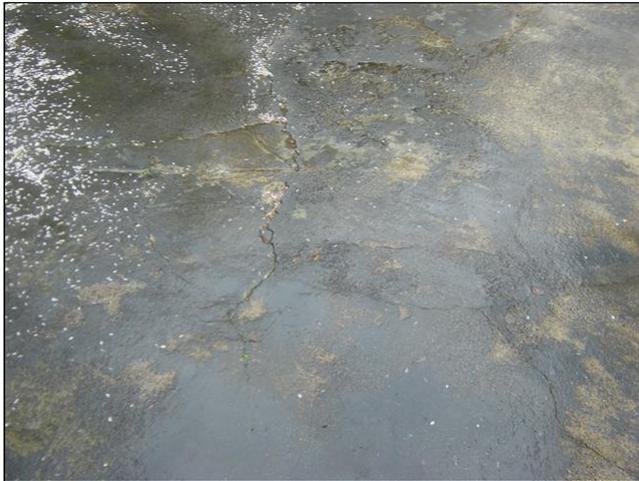
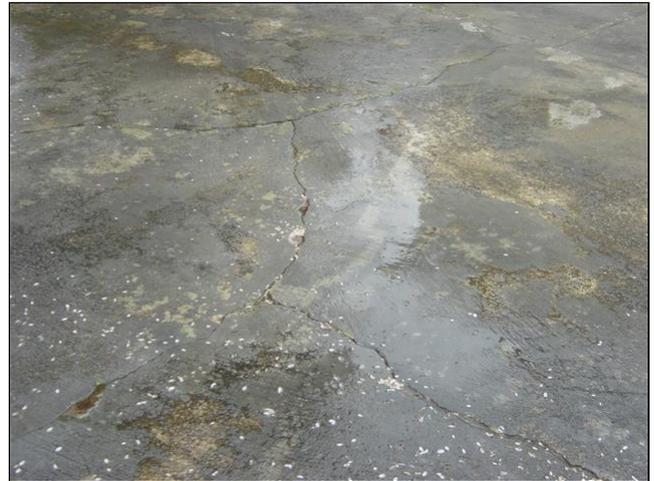
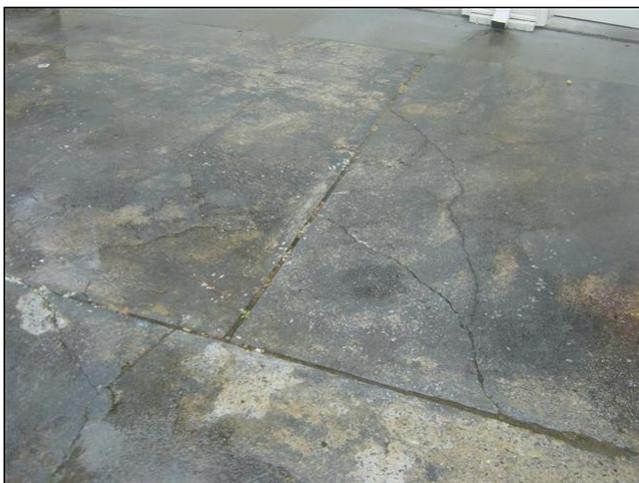
- 3. **SERVICE / REPAIR:** Driveway cracked and breaking up in spots. Repair as needed.

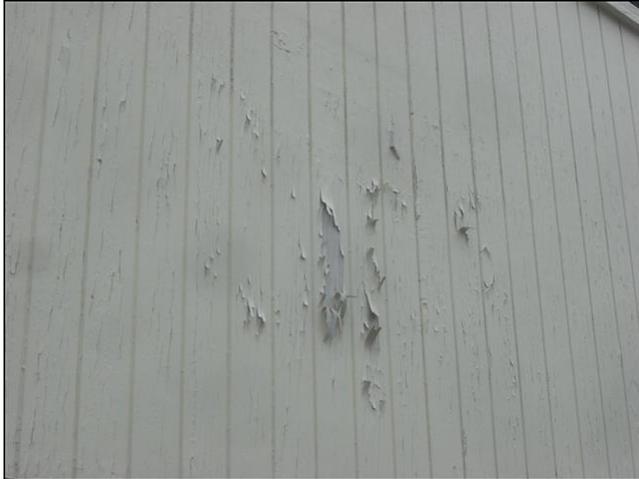
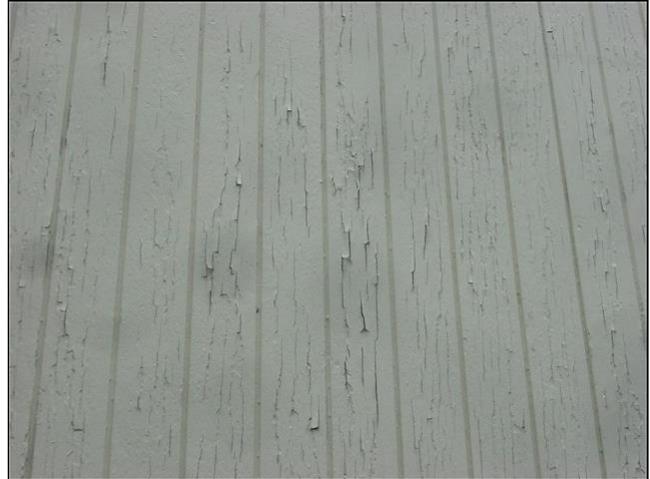
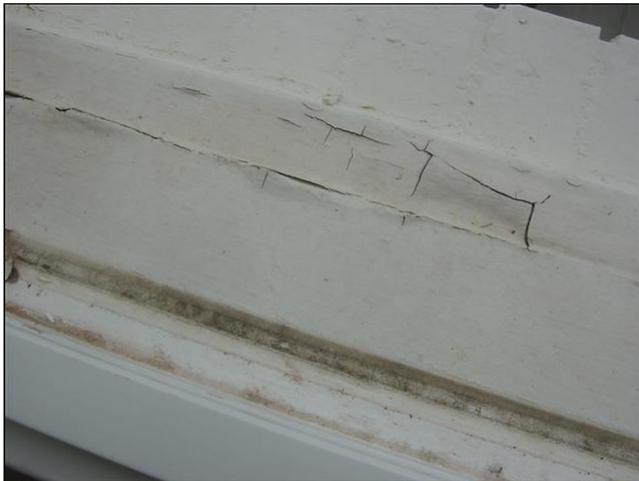
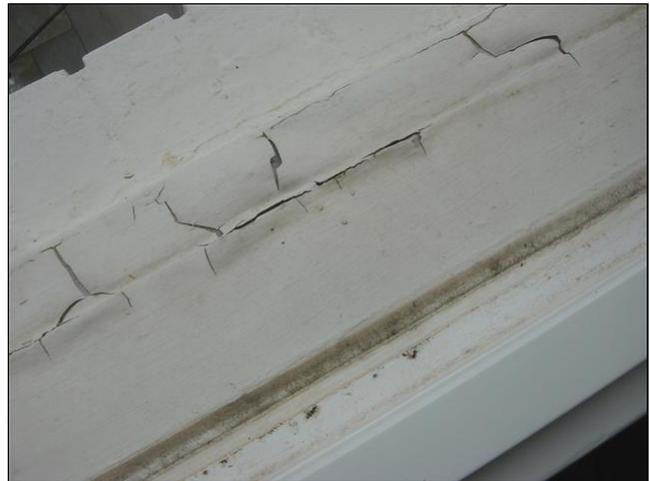
- ❌ 4. **SERVICE / REPAIR:** Paint cracked and peeling in spots. Repair as needed.

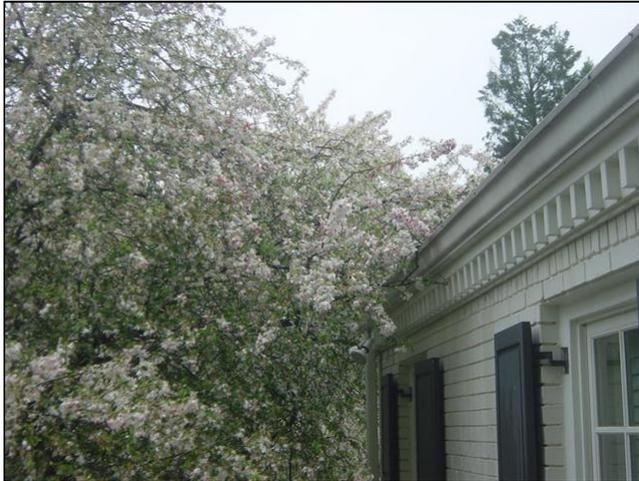
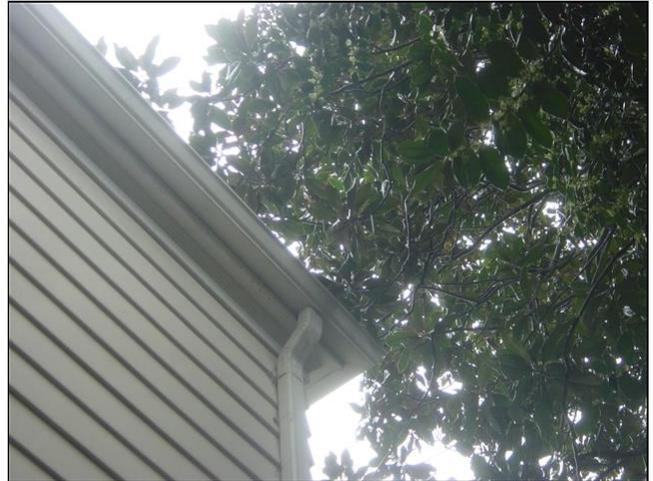
- ❌ 5. **SERVICE / REPAIR:** Tree limbs rubbing roof. Cut back as needed to prevent damage to roof. Repair roof if needed.

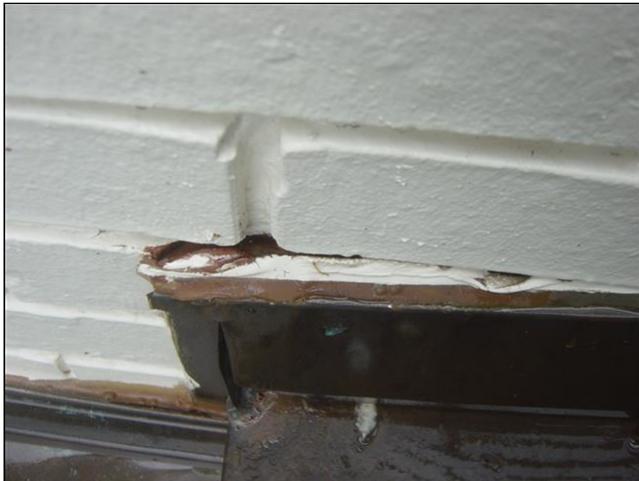
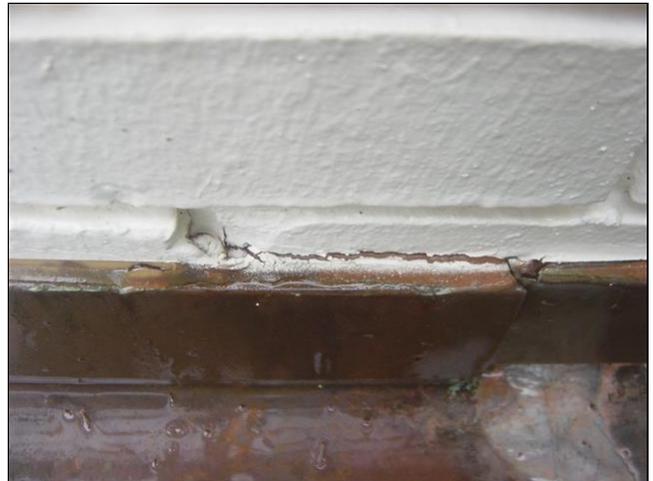
6. **SERVICE / REPAIR:** Cracks in sealant at flashing where metal roof over front entry meets the wall. Reseal periodically as needed to prevent water entry.

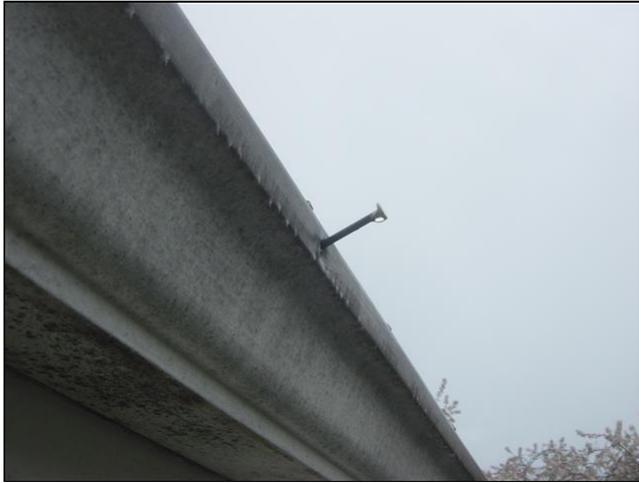
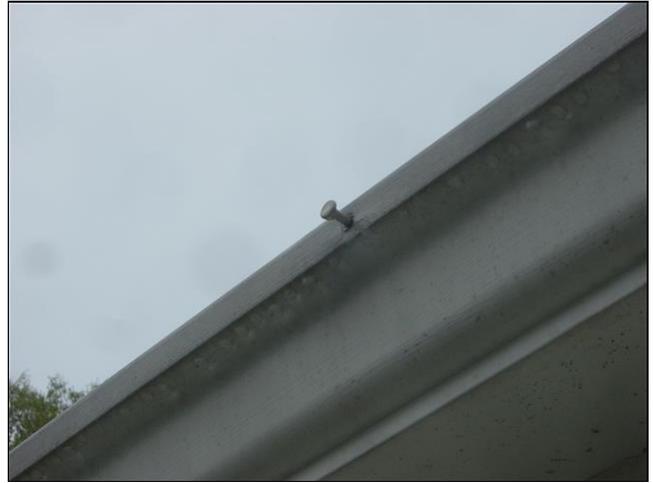
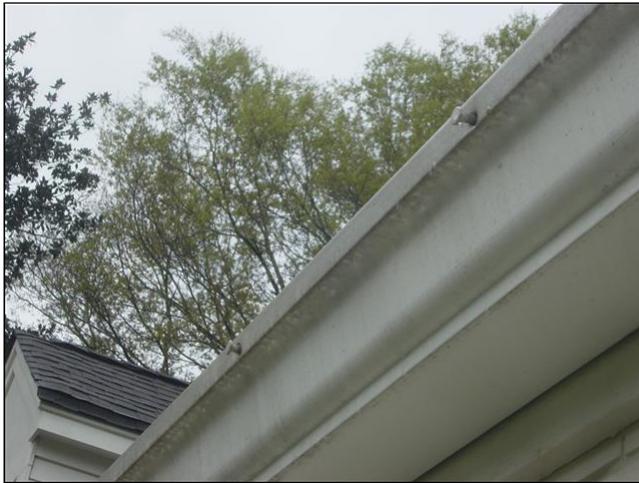
7. **SERVICE / REPAIR:** Some of nails are backing out of gutters. Have gutter specialist evaluate system and make all needed repairs.

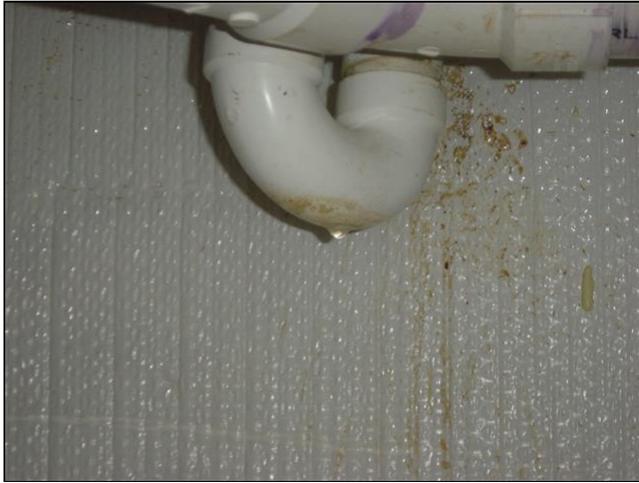
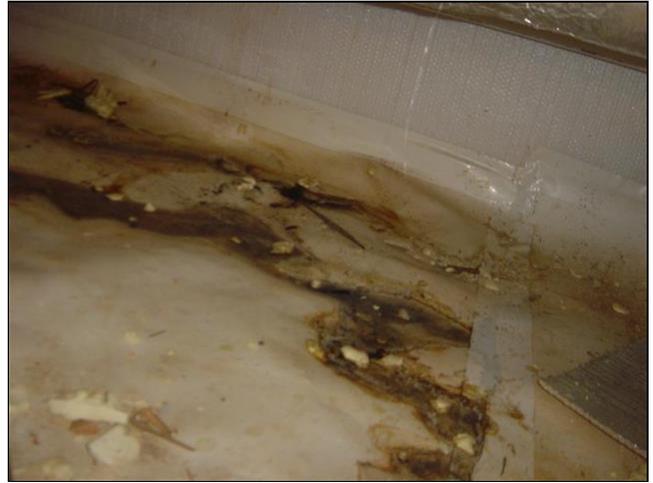
8. **SERVICE / REPAIR:** Leak in drain line at far left end of crawlspace (appears to be the drain for the dishwasher). Water is pooling on the plastic vapor barrier. Recommend a licensed plumber for repair.

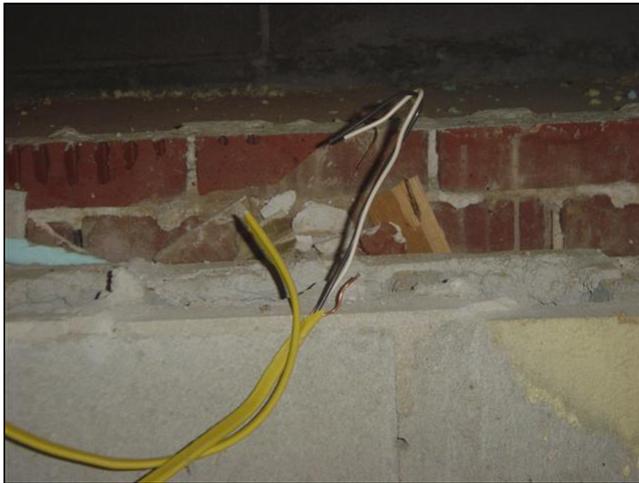
Item 10 - Picture 1

- ❌ 10. **SAFETY / HEALTH:** Improper wiring observed at left rear corner of crawlspace. All electrical splices and terminations should be inside of an approved junction box with cover plate for safety. Advise a licensed electrician to correct as needed for safety.

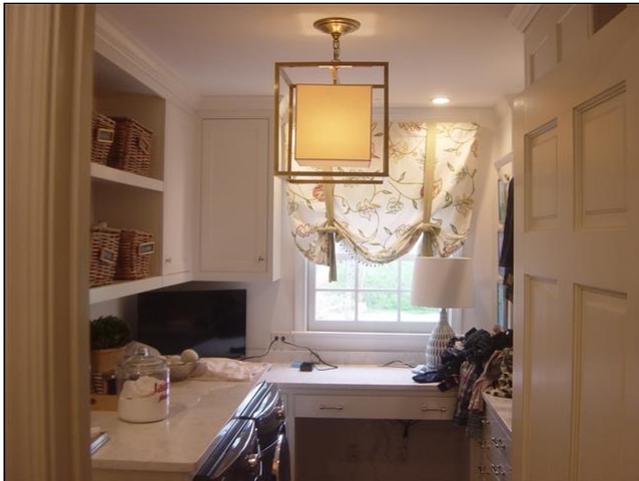
Item 13 - Picture 1

- ❌ 13. **SAFETY / HEALTH:** Several of light fixtures are hanging low enough to hit a taller person in the head or face. Of particular concern would be the metal framed fixture in the laundry. Correct as needed.

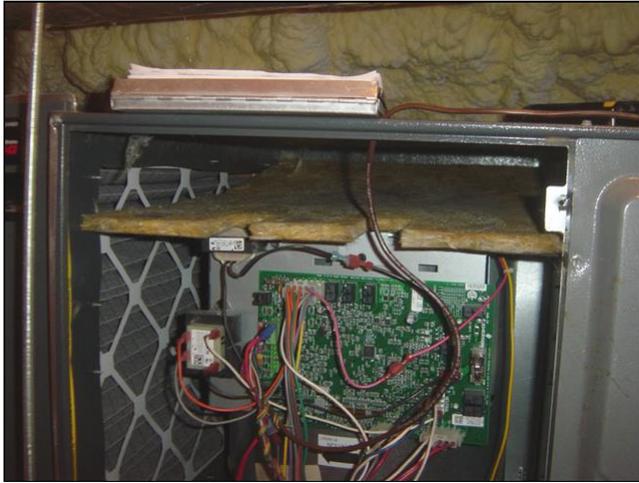
Item 14 - Picture 1

- ❌ 14. **SERVICE / REPAIR:** Insulation panel has come loose inside the furnace in the attic, has fallen down and is blocking one side of the blower. This will reduce the air flow and efficiency of the unit and put extra strain on the blower motor. Have HVAC specialist service HVAC systems and make all needed repairs.

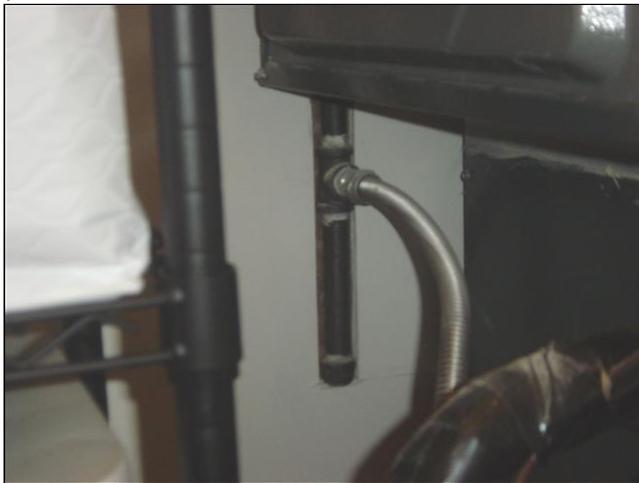
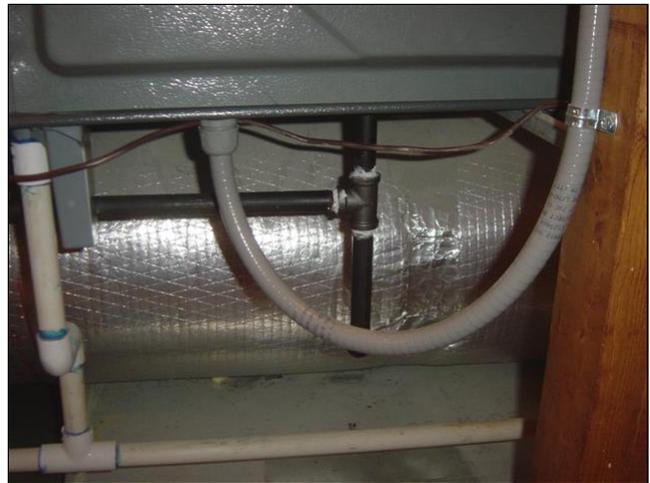
- ❌ 15. **GENERAL NOTE:** Sub-standard configuration of drip legs on gas lines to both furnaces. The configuration is supposed to be designed to catch small amounts of moisture or debris before entering the appliance. The correct configuration has the "trap" going down in direction of gas flow (at the bottom end of a downward directed pipe run). Some gas company technicians will warning tag unit and leave gas valve in off position that is configured with the "trap" going down perpendicular to gas flow. This is less effective in catching debris. Although this regions gas is considered clean, buyer should consider having gas routing corrected to avoid the conflict with gas company personnel.

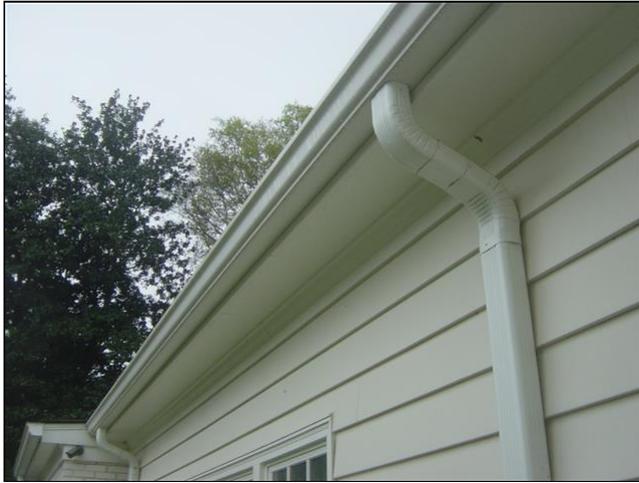
Item 16 - Picture 1

- ❌ 16. **SERVICE / REPAIR:** No soffit venting observed. Soffit vents are at the lower edges of the roof and are crucial for proper air flow through the attic area. Most roof covering manufacturers require at least half of the ventilation to be installed at the lower edges of the roof. Have a professional roofer evaluate and repair as needed.

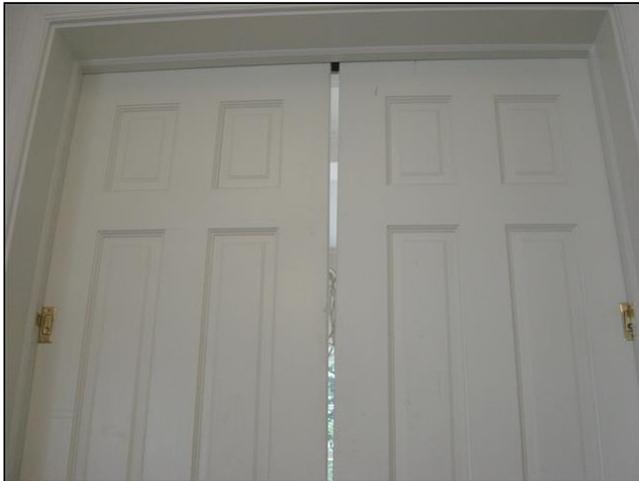
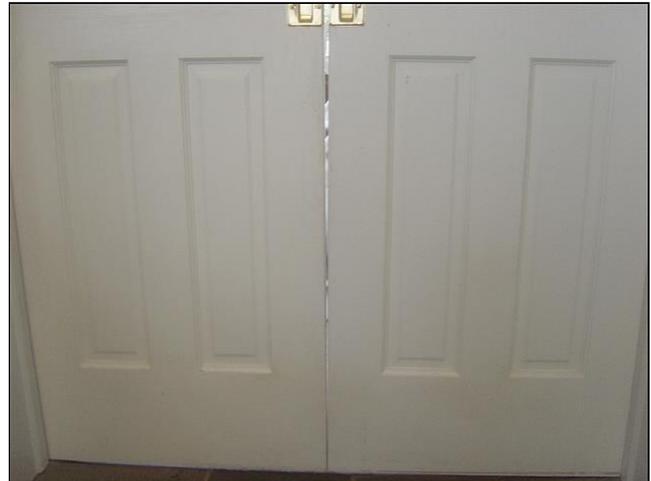
- ❌ 17. **SERVICE / REPAIR:** Door to mechanical room in garage on the right is sagging and will not close properly. Repair as needed to function properly.
- ❌ 18. **SERVICE / REPAIR:** Pocket doors from kitchen to rear hall are not adjusted properly and are gapped open at the top when closed. Adjust as needed.

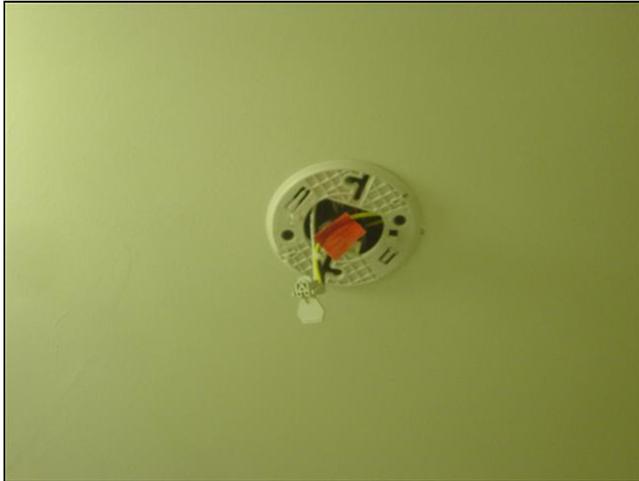
Item 20 - Picture 1

- ❌ 20. **SAFETY / HEALTH:** Smoke detector mounting found but device is missing in mechanical room off of hall bath. Not required in this location but not a bad idea. Consider replacing.

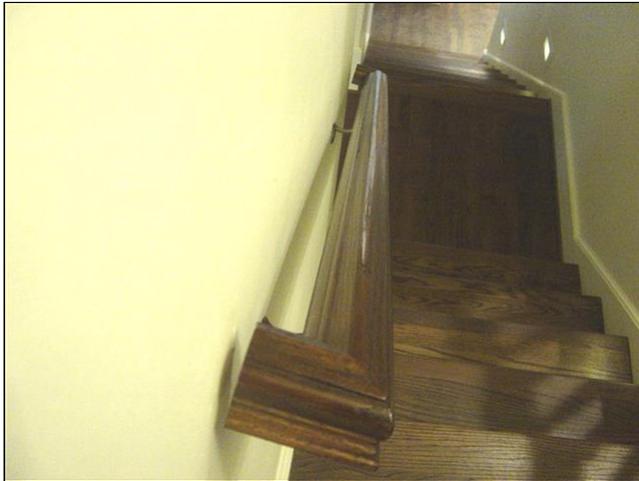
Item 21 - Picture 1

- ❌ 21. **SAFETY / HEALTH:** Handrail at top of main stairway is pulling loose from the wall. Repair as needed.

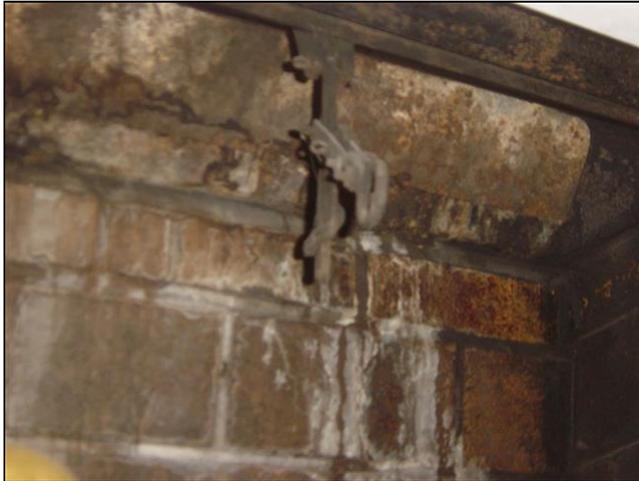
Item 22 - Picture 1

- ❌ 22. **SERVICE / REPAIR:** Fireplace damper is not functional. Have fireplace specialist evaluate fireplace and chimney and clean and repair as needed.

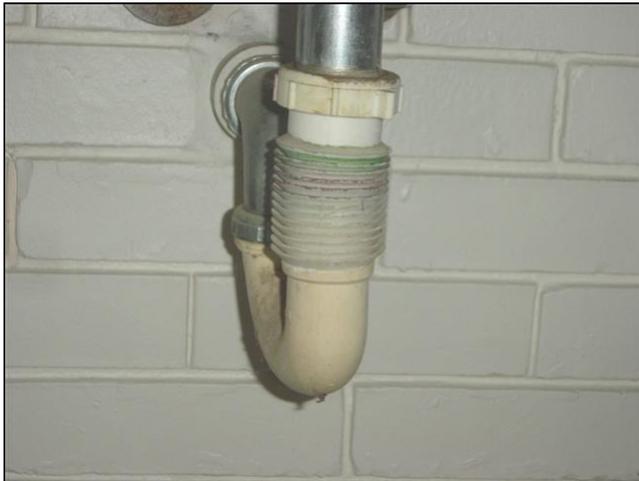
Item 23 - Picture 1

- ❌ 23. **SERVICE / REPAIR:** Trap material used on garage sink is designed for temporary repair and uneven interior surfaces may lead to clogging. Plumbing drains are required to have smooth interior surfaces. Recommend a licensed plumber to correct.

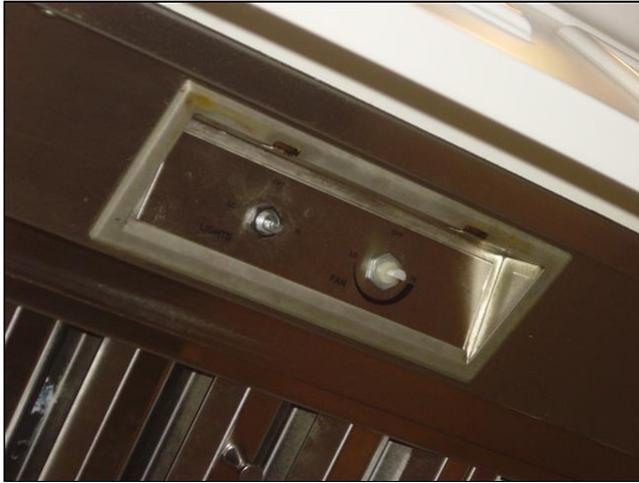
Item 24 - Picture 1

- ❌ 24. **SERVICE / REPAIR:** The knobs are missing from the stove vent hood control panel. Repair as needed.
