Atlanta Property Inspections, Inc.

HOME INSPECTION REPORT

210 Park Ridge Circle, Marietta, GA 30068
Inspection prepared for: Steven White & Maria White
Date of Inspection: 7/14/2020 Time: 1:00 PM
Age of Home: 40 Years Old (1980) Size: 1000 SF
Weather: Sunny, Dry Soil, 90 Degrees

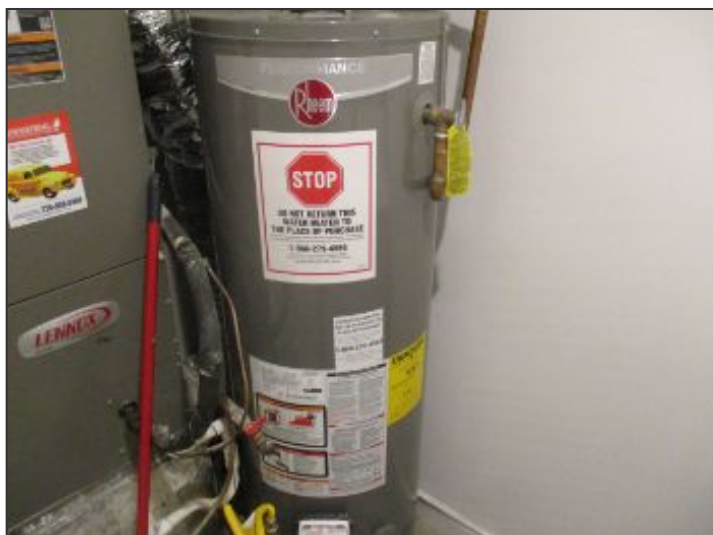
Water heater located in laundry room - 2017

Page 15	WATER HEATER:	<ul style="list-style-type: none"> • The temperature and pressure (T&P) relief drain pipe, which runs upward to the ceiling, does not have the required drain valve to empty the drain pipe after testing the T&P valve. The drain pipe now has standing water inside the pipe that could cause future corrosive action on the interior T&P valve. Correction is recommended by a qualified plumbing contractor so that the drain can be emptied after testing.
---------	---------------	--

- The temperature and pressure (T&P) relief drain pipe, which runs upward to the ceiling, does not have the required drain valve to empty the drain pipe after testing the T&P valve. The drain pipe now has standing water inside the pipe that could cause future corrosive action on the interior T&P valve. Correction is recommended by a qualified plumbing contractor so that the drain can be emptied after testing.

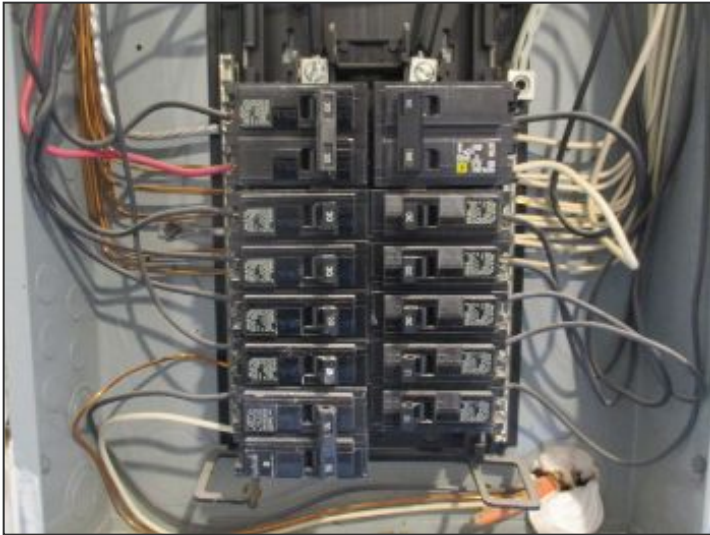
Main electrical panel in laundry room

Page 16	MAIN PANEL:	<ul style="list-style-type: none"> • Two incoming circuits into the panel box are not clamped and secured at the panel entry as required by the National Electric Code (NEC). A minor repair is suggested.
Page 18	RECEPTACLES:	<ul style="list-style-type: none"> • The two front outlets at the living room were found to have an open ground. Correction is recommended by a licensed electrician. • Incorrect Electrical: The master bedroom has a wall switch that is intended to control one or more wall outlets for a lamp; this switch was tested and did not control any of the wall outlets as needed. This condition does not meet the safety requirements of the National Electric Code (NEC). Correction is recommended by a licensed electrician.
Page 18	GFCI / AFCI PROTECTION:	<ul style="list-style-type: none"> • SAFETY CONCERN: GFCI protection is missing at the recently replaced kitchen countertop outlets near the sink which is a required location for GFCI protection. This condition is a potential safety hazard and a violation of the National Electric Code. Correction is advised to meet this safety requirement.

• Two incoming circuits into the panel box are not clamped and secured at the panel entry as required by the National Electric Code (NEC). A minor repair is suggested.

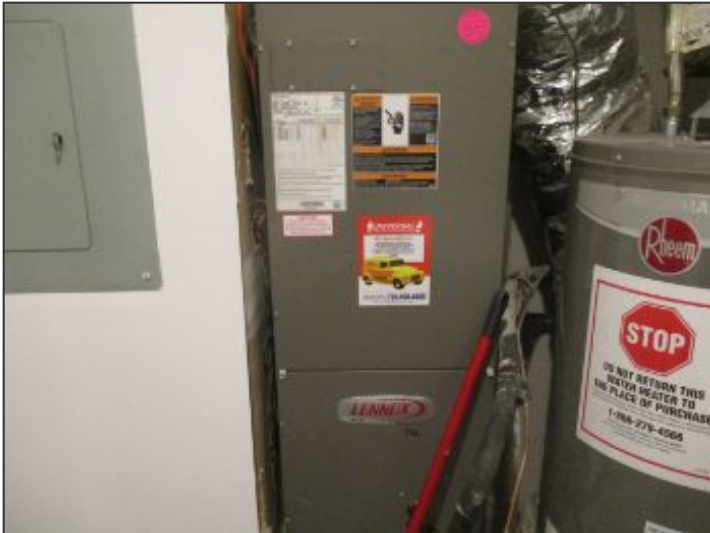
Heating system located in laundry room - 2006

Page 20	HEATING 1:	<ul style="list-style-type: none">• The blower motor is dirty and has excessive dust and debris. It is recommended that the blower motor be cleaned / serviced by a professional HVAC contractor. In addition, it is recommended that the evaporator coils be checked for cleaning needs as well.
AIR CONDITIONING:		
Page 22	AC UNIT 1:	<ul style="list-style-type: none">• The exterior electrical disconnect is missing the required dead front cover, wires are exposed; this condition is a safety concern, correction is advised.• AGING EQUIPMENT - BUDGET FOR REPLACEMENT: Due to the advanced age of this AC unit, client should budget for replacement soon which is expected to be a major expense. Based on the available manufacturing date on the equipment, the AC unit is at or past the normal expected lifespan of 12-15 years. <p>Consider these cost saving strategies when replacing HVAC equipment:</p> <ol style="list-style-type: none">1. MANUFACTURERS REBATES: Check for current rebates from manufacturers on models that may be discontinued or that have higher energy ratings: Carrier Rebates: http://www.carrier.com/homecomfort/en/us/rebates-and-financing/ Lennox Rebates: http://m.lennox.com/promotions/national.asp Trane Rebates: http://www.trane.com/residential/en/buying-a-trane/savings-and-offers.html York Rebates: http://york.com/residential/promotions-savings/default.aspx2. UTILITY COMPANY REBATES: Check for rebates or incentives from your local power company or gas provider - many offer rebates for higher efficiency equipment3. TIME OF INSTALLATION: Wait to have your equipment to be installed in the fall or spring when HVAC contractors are not as busy and ask for an off season discount.4. GET MULTIPLE QUOTES: Always get more than one quote before making your decision - prices can vary widely from one company to another.

• The blower motor is dirty and has excessive dust and debris. It is recommended that the blower motor be cleaned / serviced by a professional HVAC contractor. In addition, it is recommended that the evaporator coils be checked for cleaning needs as well.
