Inspection Report

Property Address:
3080 Pillement Pl
Alpharetta GA 30022

Date: 7/21/2020	Time: 01:00:00 PM	Report ID: 42066
Property: 3080 Pillement PI Alpharetta GA 30022	Customer: Darshan Patel	Real Estate Professional: Mitali Patel Keller Williams (Atlanta) Atlanta Perimeter

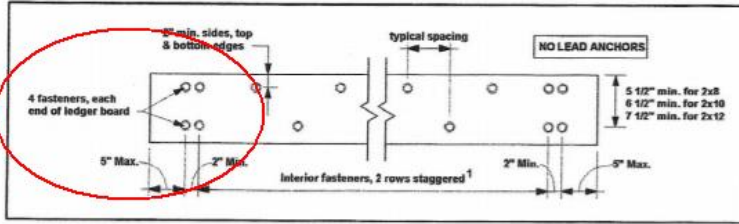
FIGURE 20: LEDGER BOARD FASTENER SPACING AND CLEARANCES

(7) Insufficient ledger board attachment noted at rear deck. NOTE: Ledger boards should be attached with a double row of 1/2" machine bolts (and washers) at ends of board(s). Repair as necessary for increased deck stability.

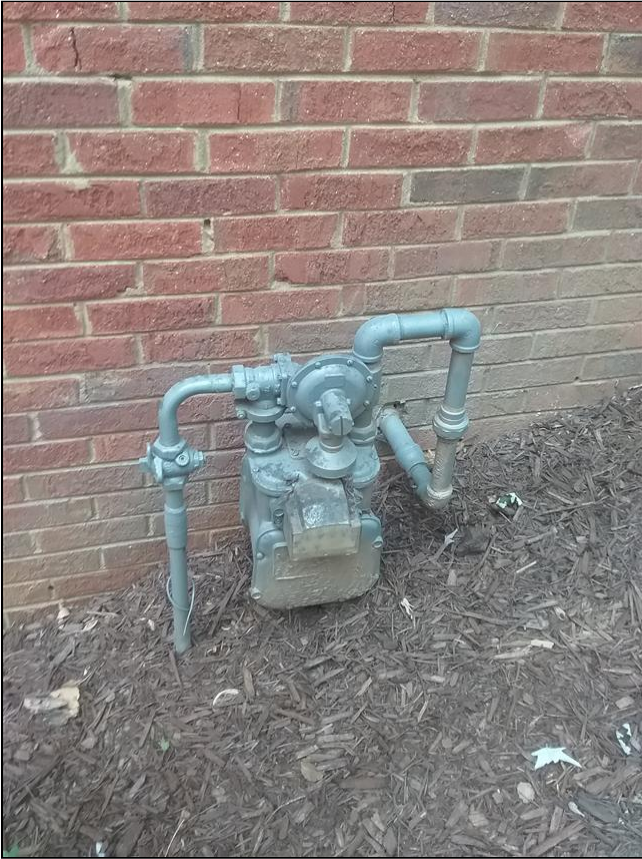
7.2 Fuel service enters left side of house.

7.2 Item 1(Picture) External fuel service entry

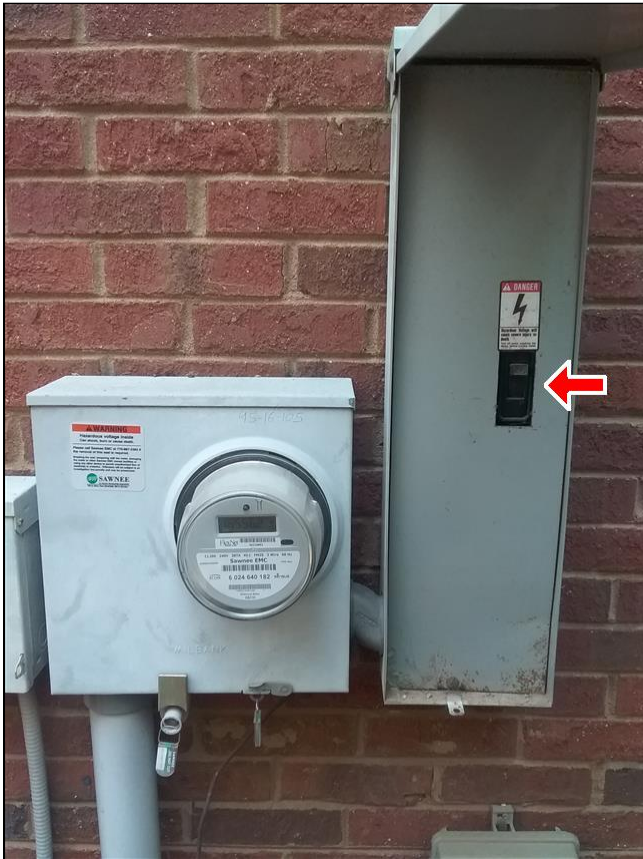
8.0 External electric meter and main disconnect located on left side of house.

8.0 Item 1(Picture) External service and main disconnect

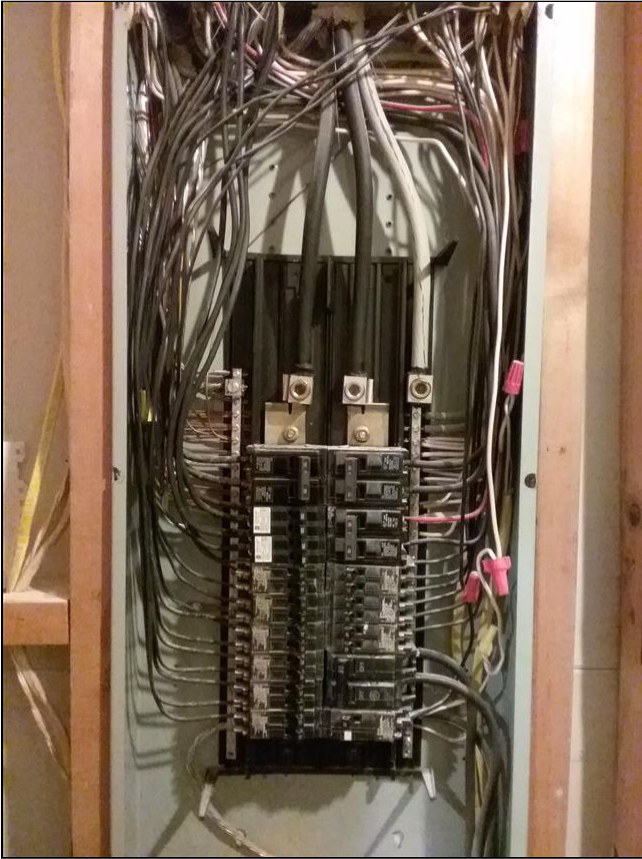
8.1 (1) Main distribution panel is located in closet in basement.

8.1 Item 1(Picture) Open main distribution panel

(3) Multiple neutrals terminate under a single lug in both panels. Each neutral should be installed under a separate lug.

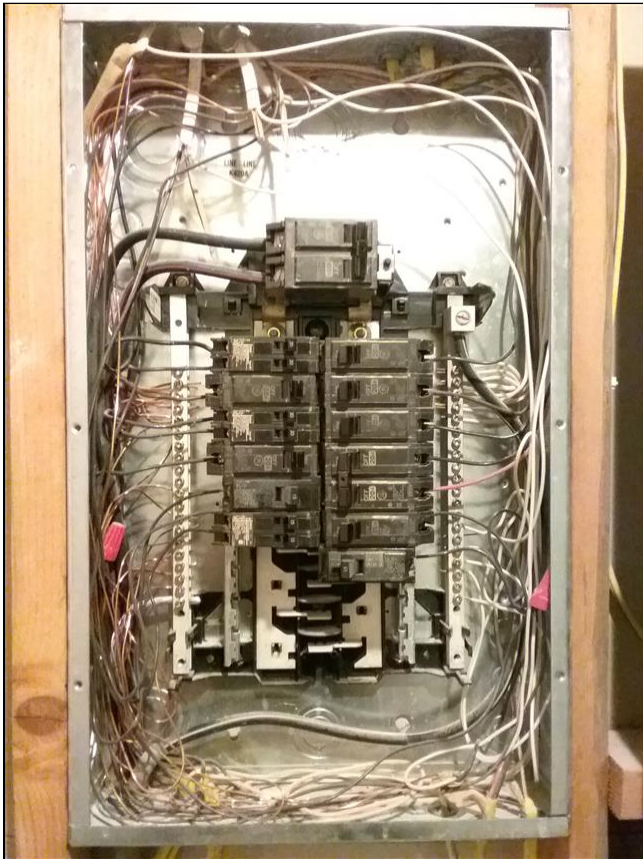
(2) Sub panel is located in closet in basement next to main distribution panel.

8.1 Item 2(Picture) Open sub panel

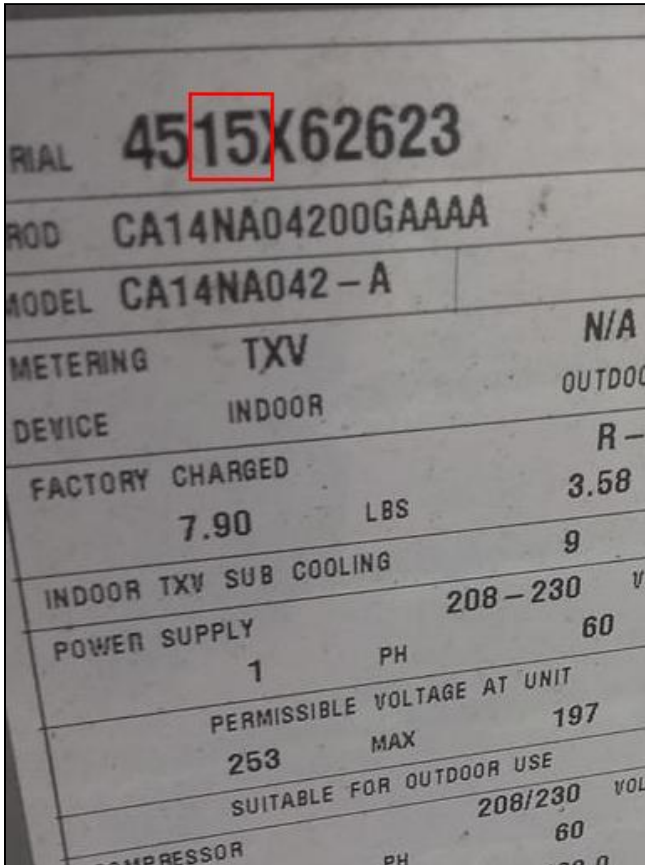
9.4 (1) AC unit for first floor/basement is 5 years old.

9.4 Item 1(Picture) Date of manufacture, 2015
