Atlanta Property Inspections

HOME INSPECTION REPORT

710 Society Street, Alpharetta, GA 30022
Inspection prepared for: Andrea Cueny
Date of Inspection: 7/22/2020 Time: 1:30 PM
Age of Home: 16 Years Old (2004) Size: 5380 SF
Weather: Sunny, Dry Soil, 85 Degrees

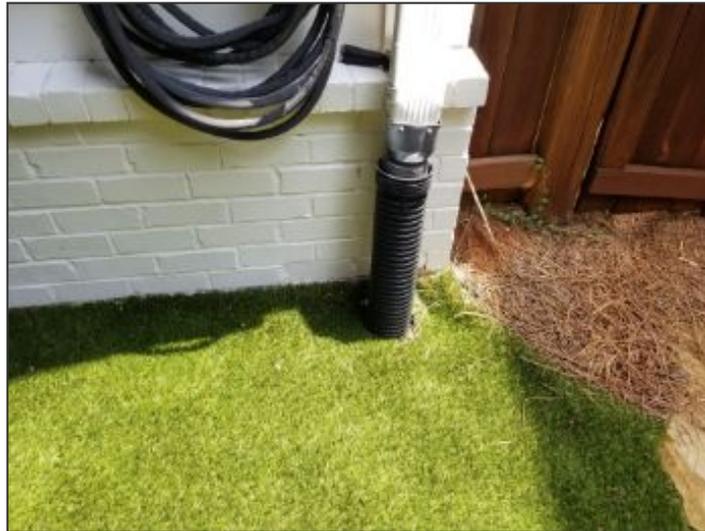
- The overall slope of the yard is moderate;
- The overall condition of the exterior grading and drainage appears to be adequately sloped and maintained. No concerns were observed, continue to maintain good drainage conditions as needed.
- **POSITIVE FEATURE!**
Several downspouts have been extended into underground drain pipes for improved drainage around the perimeter of the foundation (see photo). Continue to monitor these drain pipes and clean as needed.

Underground downspouts present for improved drainage

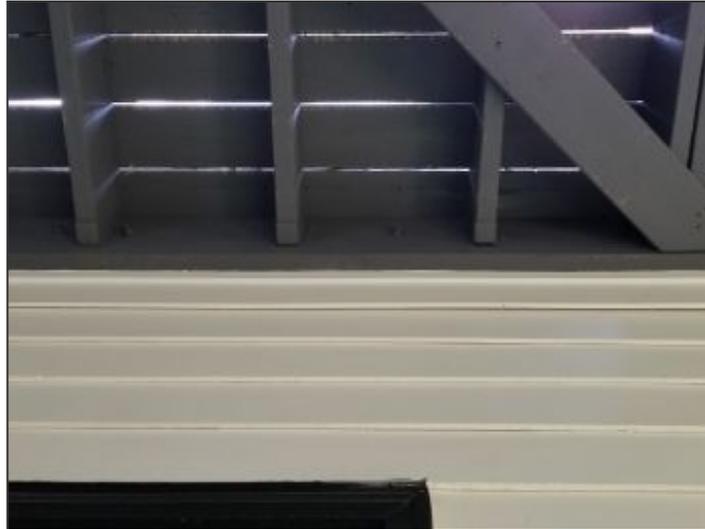
- A wood deck is present at the rear.
- The rear deck appears to be serviceable, no concerns were noted.
- The deck ledger flashings appears serviceable, no concerns were noted.

Good flashing and bolting at rear deck

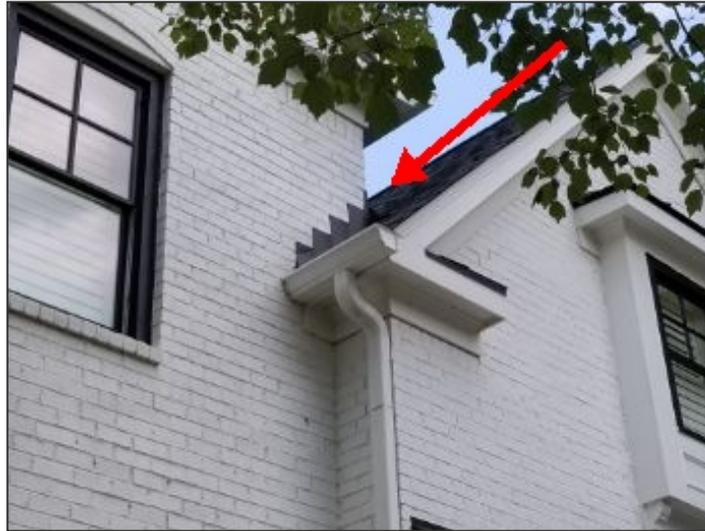
• **Good flashing details were noted at the intersecting walls (see photo).**

Good flashing practices at intersecting walls

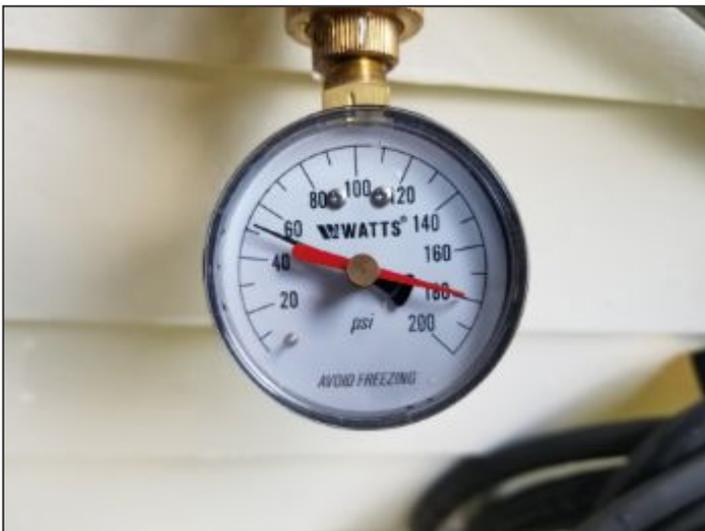
• The supply piping appears to be serviceable, no concerns were noted except as mentioned below. A water pressure reading was taken at the rear hose bib and was found to be normal at 52 PSI (see photo).

Water pressure normal at 52 PSI

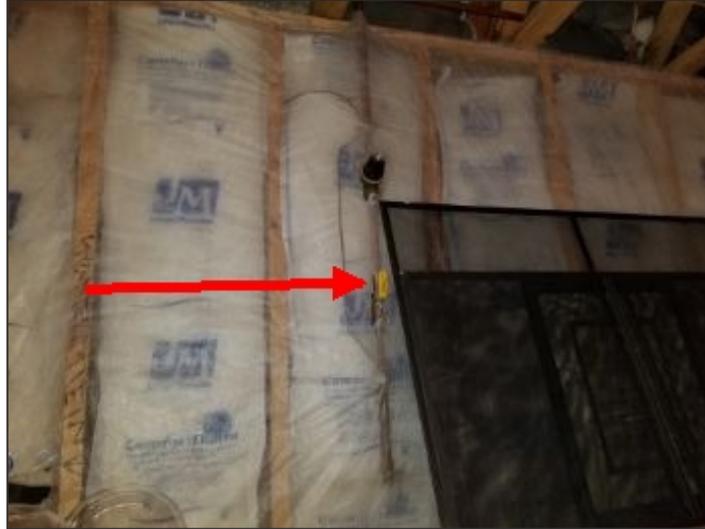
Main water cut-off handle located in basement

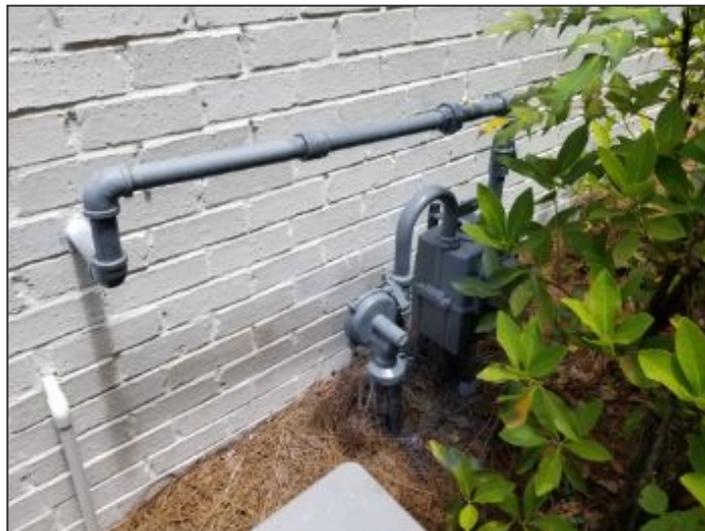
• The gas meter is located at the left side exterior wall and appears serviceable; no concerns were found. (NOTE: The gas lines inside the walls, ceilings and floors are not fully visible for inspection and could not be evaluated).

Gas meter located at left side wall

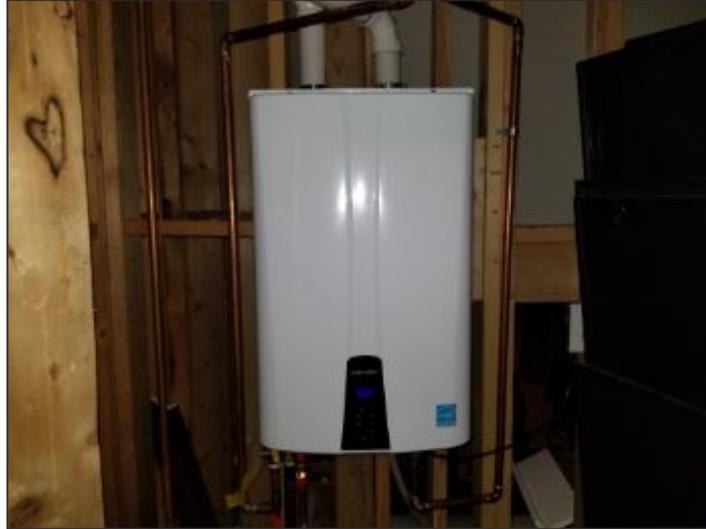
• **The gas water heater appears serviceable, no concerns were noted. The gas piping, exhaust venting and combustion air requirements all look good.**

Tankless water heater located in basement

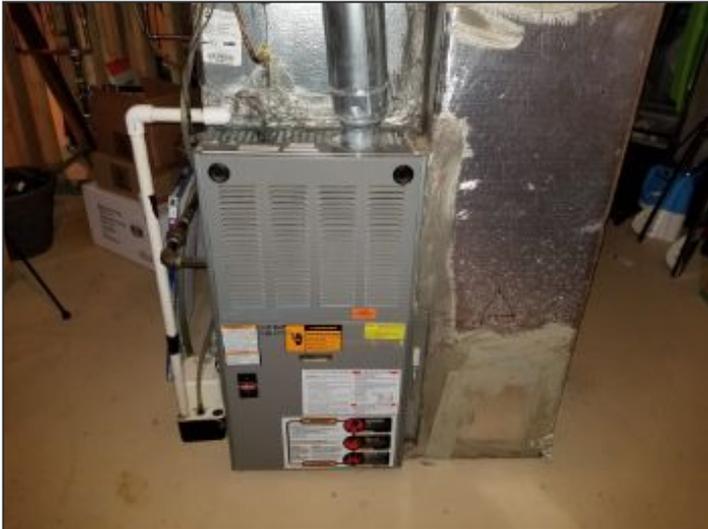
Due to the advanced age of this heating system, client should budget for replacement soon which is expected to be a major expense. Based on the available manufacturing date on the equipment, the heating system is at or past the normal expected lifespan of 15-20 years.

Main floor furnace located in basement

Due to the advanced age of the system, a full heat exchanger inspection is advised by a professional HVAC contractor and to provide written certification that the heat exchanger is in good working condition and is safe to operate. Additional heat exchanger inspections are advised each year for as long as this older furnace is in service.

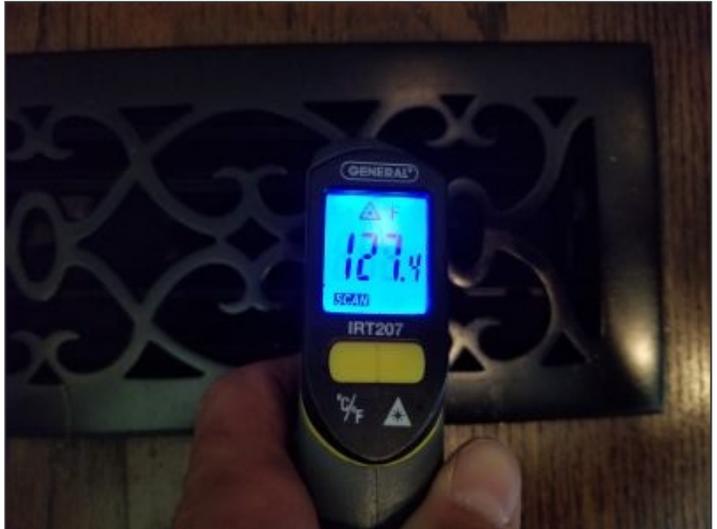
Good temps during testing of main floor furnace

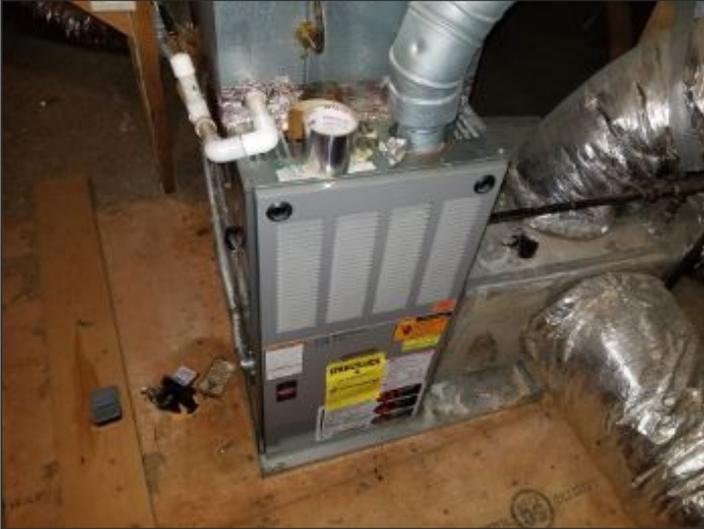
<p>Page 39</p>	<p>HEATING 2:</p>	<p>• BUDGET FOR REPLACEMENT: Due to the advanced age of this heating system, client should budget for replacement of this furnace soon which is expected to be a major expense. Based on industry standards, the furnace appears to be at the end of its normal expected lifespan of 15 - 20 years.</p> <p>HEAT EXCHANGER INSPECTION ADVISED: Due to the advanced age of the system, a full heat exchanger inspection is advised by a professional HVAC contractor and to provide written certification that the heat exchanger is in good working condition and is safe to operate. Additional heat exchanger inspections are advised each year for as long as this older furnace is in service.</p>
----------------	--------------------------	---

Second floor furnace located in attic

Due to the advanced age of the system, a full heat exchanger inspection is advised by a professional HVAC contractor and to provide written certification that the heat exchanger is in good working condition and is safe to operate. Additional heat exchanger inspections are advised each year for as long as this older furnace is in service.

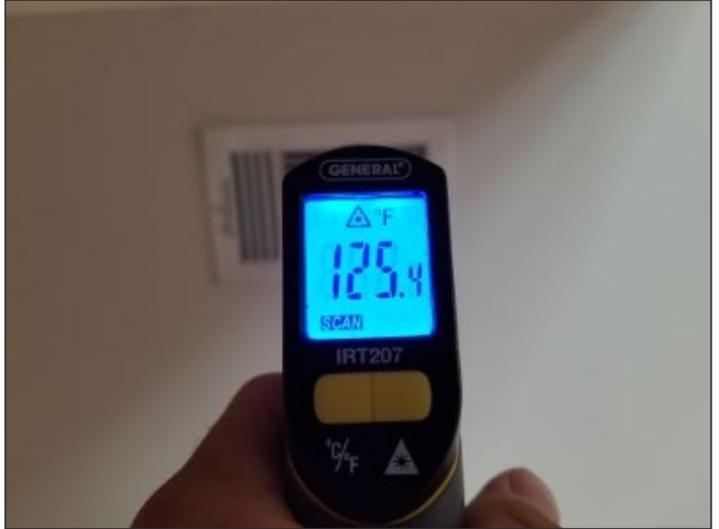
Good temps during testing of second floor furnace

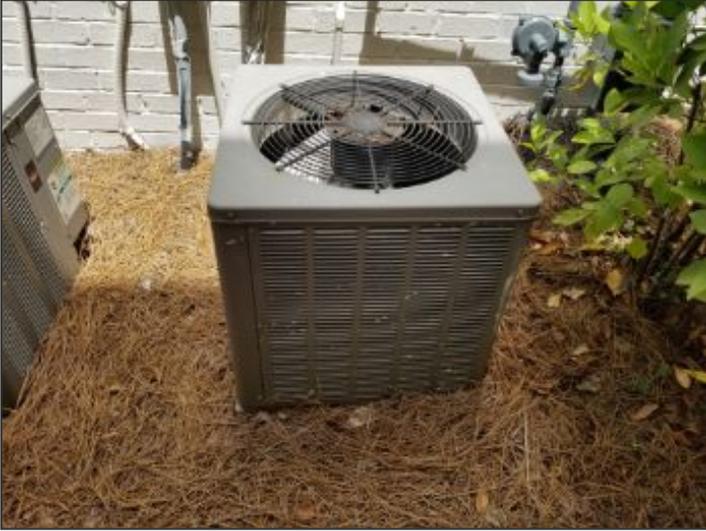
<p>Page 41</p>	<p>AC UNIT 1:</p>	<p>• AGING EQUIPMENT - BUDGET FOR REPLACEMENT: Due to the advanced age of this AC unit, client should budget for replacement soon which is expected to be a major expense. Based on the available manufacturing date on the equipment, the AC unit is at or past the normal expected lifespan of 12-15 years.</p> <p>Consider these cost saving strategies when replacing HVAC equipment:</p> <p>1. MANUFACTURERS REBATES: Check for current rebates from manufacturers on models that may be discontinued or that have higher energy ratings: Carrier Rebates: http://www.carrier.com/homecomfort/en/us/rebates-and-financing/ Lennox Rebates: http://m.lennox.com/promotions/national.asp Trane Rebates: http://www.trane.com/residential/en/buying-a-trane/savings-and-offers.html York Rebates: http://york.com/residential/promotions-savings/default.aspx</p> <p>2. UTILITY COMPANY REBATES: Check for rebates or incentives from your local power company or gas provider - many offer rebates for higher efficiency equipment</p> <p>3. TIME OF INSTALLATION: Wait to have your equipment to be installed in the fall or spring when HVAC contractors are not as busy and ask for an off season discount.</p> <p>4. GET MULTIPLE QUOTES: Always get more than one quote before making your decision - prices can vary widely from one company to another.</p>

Main floor AC unit

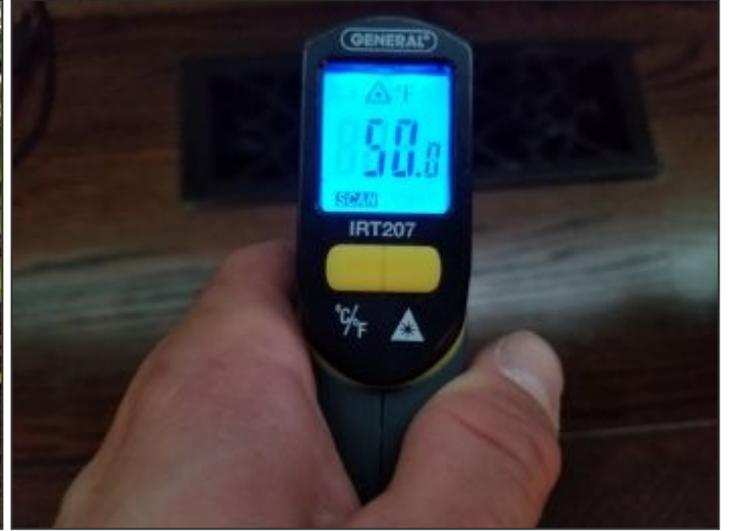
Good temps during testing of main floor AC unit

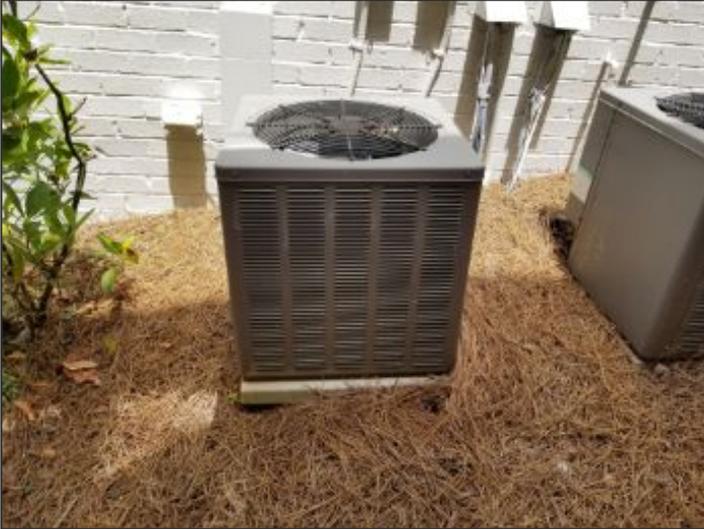
<p>Page 43</p>	<p>AC UNIT 2:</p>	<p>• AGING EQUIPMENT - BUDGET FOR REPLACEMENT: Due to the advanced age of this AC unit, client should budget for replacement soon which is expected to be a major expense. Based on the available manufacturing date on the equipment, the AC unit is at or past the normal expected lifespan of 12-15 years.</p> <p>Consider these cost saving strategies when replacing HVAC equipment:</p> <p>1. MANUFACTURERS REBATES: Check for current rebates from manufacturers on models that may be discontinued or that have higher energy ratings: Carrier Rebates: http://www.carrier.com/homecomfort/en/us/rebates-and-financing/ Lennox Rebates: http://m.lennox.com/promotions/national.asp Trane Rebates: http://www.trane.com/residential/en/buying-a-trane/savings-and-offers.html York Rebates: http://york.com/residential/promotions-savings/default.aspx</p> <p>2. UTILITY COMPANY REBATES: Check for rebates or incentives from your local power company or gas provider - many offer rebates for higher efficiency equipment</p> <p>3. TIME OF INSTALLATION: Wait to have your equipment to be installed in the fall or spring when HVAC contractors are not as busy and ask for an off season discount.</p> <p>4. GET MULTIPLE QUOTES: Always get more than one quote before making your decision - prices can vary widely from one company to another.</p>

Second floor AC unit

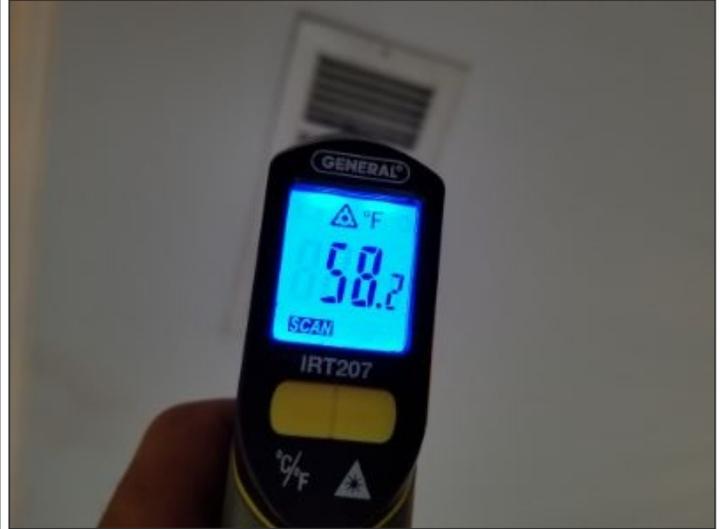
Good temps during testing of second floor AC unit
