Inspection Report

Property Address:
2145 Double Creek Lane
Milton GA 30004

Residential Inspector of America

Property Address 2145 Double Creek Lane Milton GA 30004	Date of Inspection 7/20/2020	Report ID 072020JW727
Customer(s) George and Jennifer Ostyn	Time of Inspection 01:00:00 PM	Real Estate Agent Lisa Williams Century 21 - Results Realty

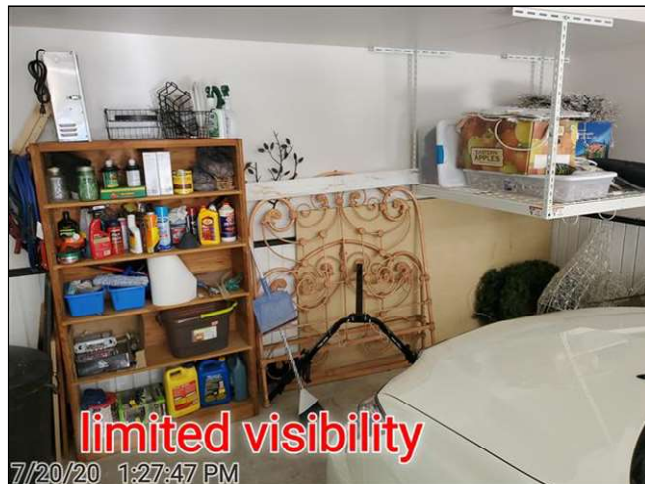
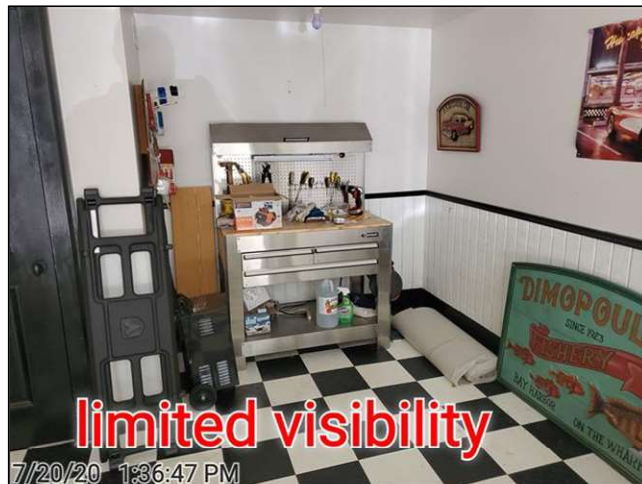
📷 Inspection of garage was limited due to stored items being in the garage at the time of the inspection. See photo(s) for examples. Buyer should resolve all concerns prior to closing.

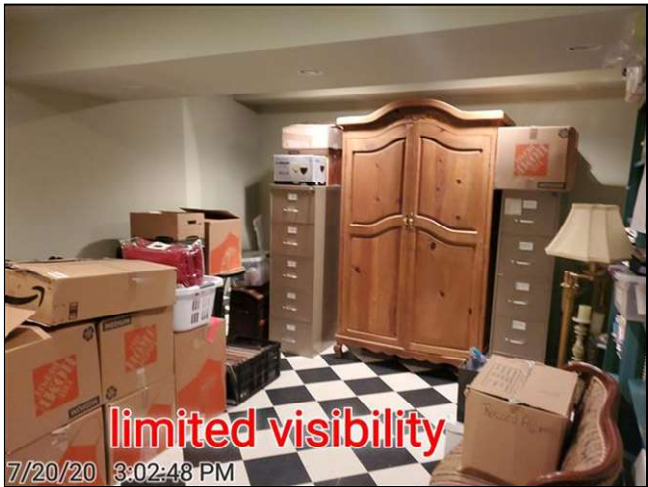
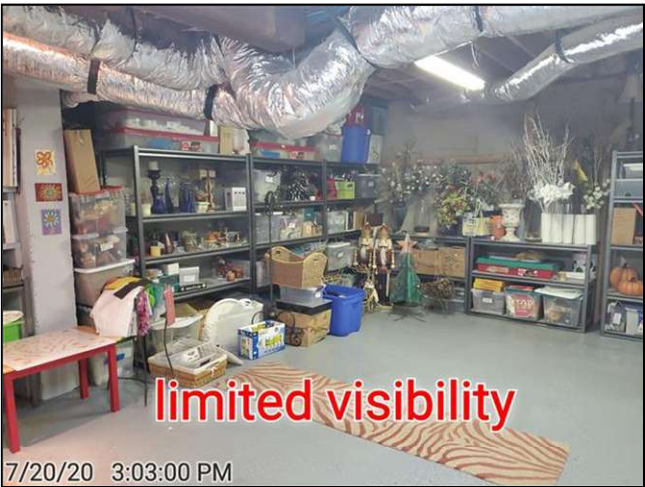
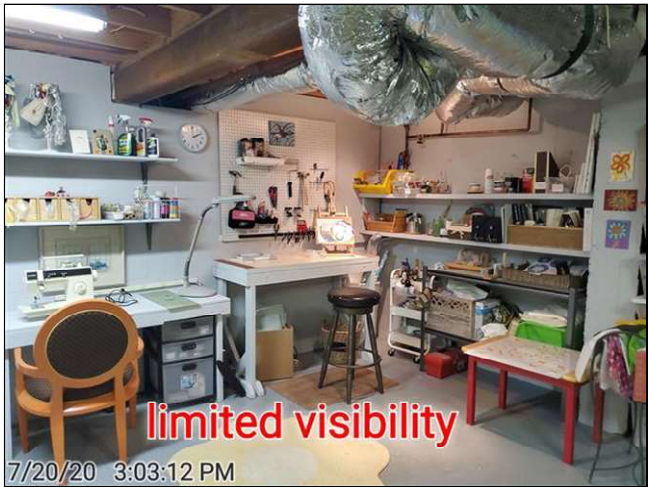
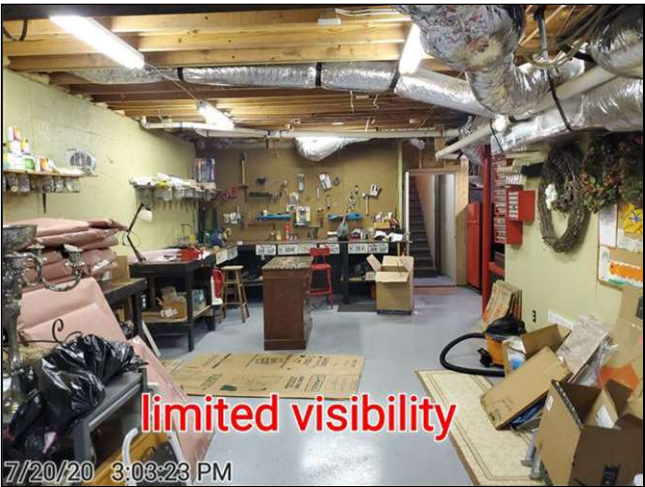
(1) The basement and the foundation wall inspections were very limited due to the basement being finished off and due to a large amount of stored items.
-

(1) The basement and the foundation wall inspections were very limited due to the basement being finished off and due to a large amount of stored items.

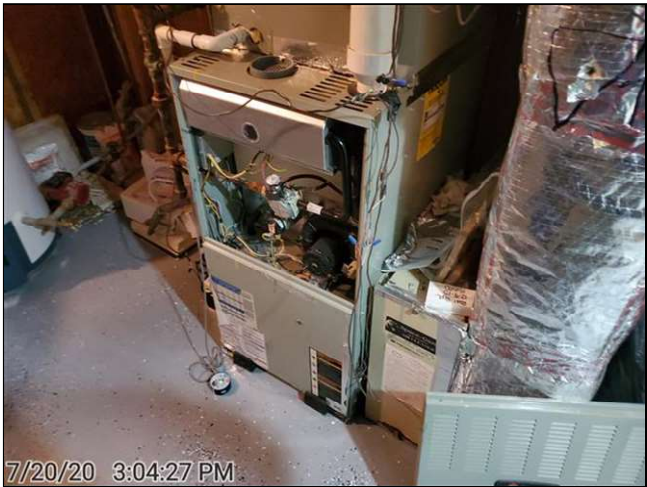
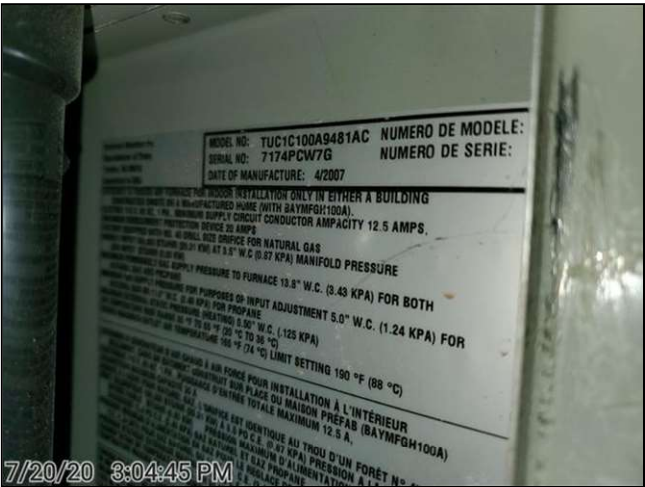
7.0 Item 3(Picture) Basement furnace

🔧 (2) Significant rust noted on the gas line on the furnace in the basement. Recommend a licensed HVAC contractor evaluate and make necessary repairs.

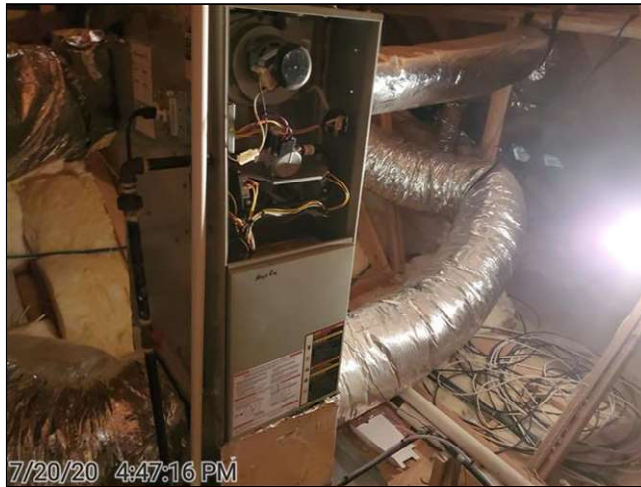
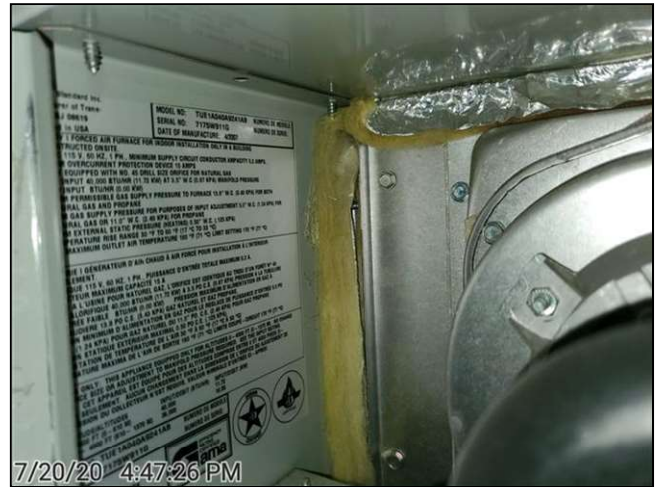
7.0 Item 9(Picture) Second floor main home furnace

🔧 (3) The air handler for the upstairs would not heat properly at time of inspection. Recommend HVAC contractor to inspect for further evaluation.

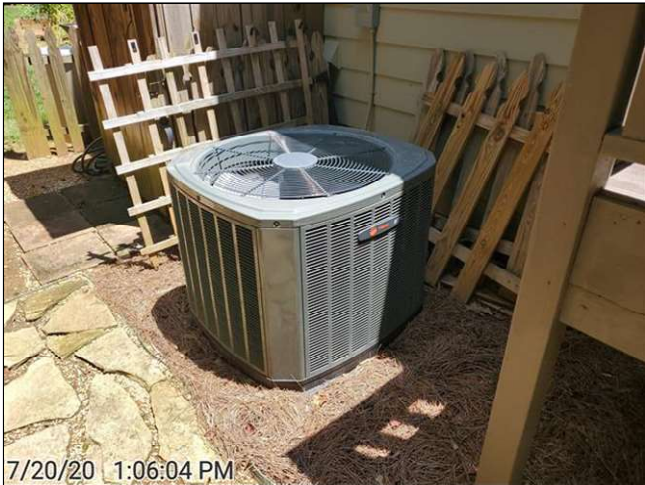
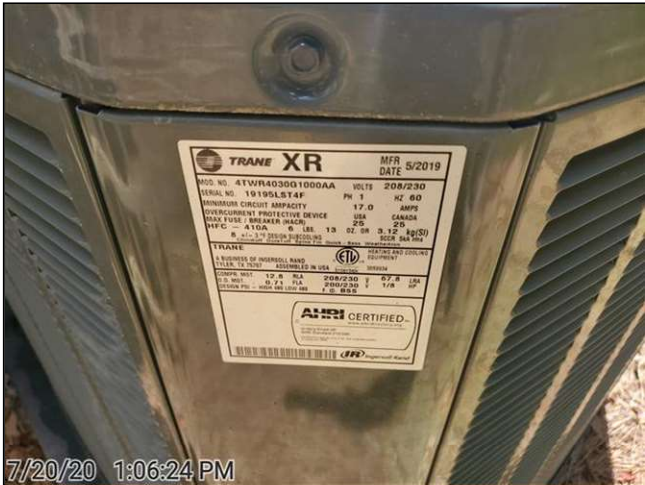
7.7 Item 1(Picture) Guest house unit

⚠️ (2) The condensate drain lines are buried in the soil for the guest house unit behind the garage. Recommend to have these lines cleared of debris and free flowing. See photo(s).

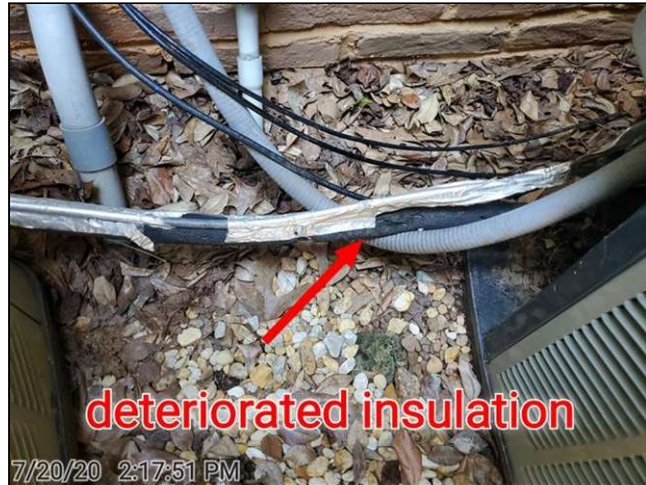
7.7 Item 12(Picture)

🔧 (4) Re-insulate the open portions of the A/C lines between the unit and the siding for the basement unit. This will help maintain energy efficiency.

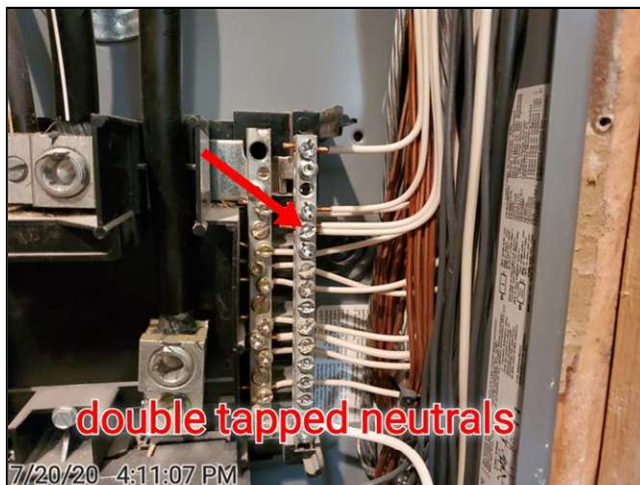
8.2 Item 3(Picture)

🔧 (2) There are multiple neutral wires on the same lug for the bus bar in the main panel in the basement and on the first floor as well as the second floor sub panel. This does not meet current standards but was permitted at the time the home was built. Current standards suggest that neutral wires be placed on individual lugs on the bus bar. Recommend to have electrician inspect and repair as needed. See photo.

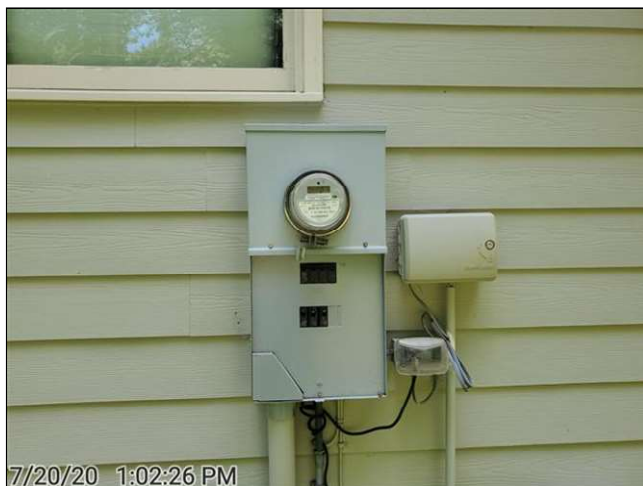
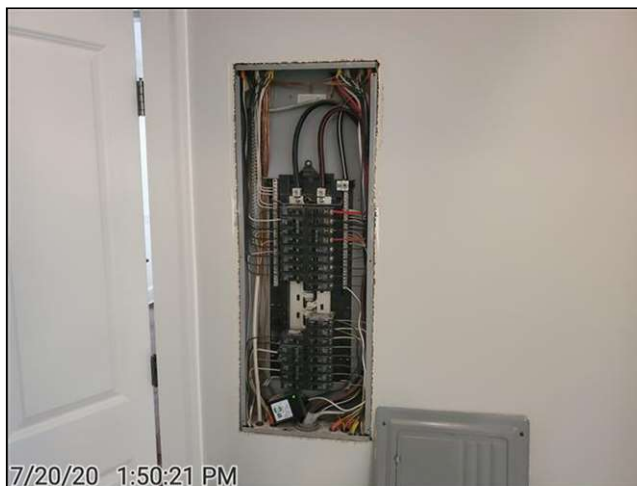
8.3 Item 1(Picture) Gueat house meter and disconnect

(1) The main panel box is located at the bathroom in the garage for the garage system. However, the main disconnect (shut-off) is outside at meter base panel (for your information). Panel was inspected for function (not code compliance) and building codes and standards have changed over the years.

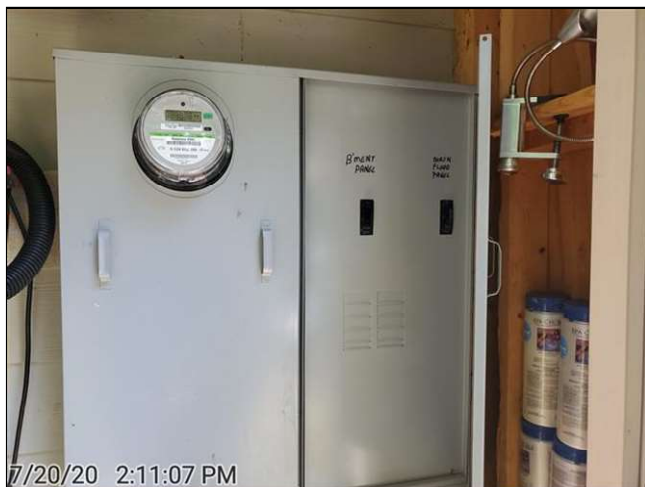
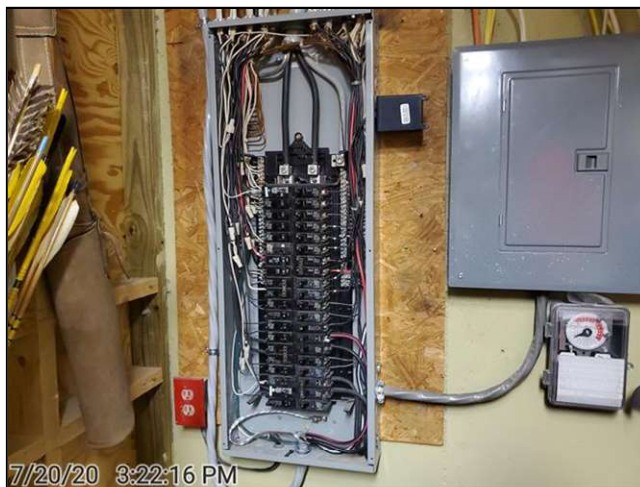
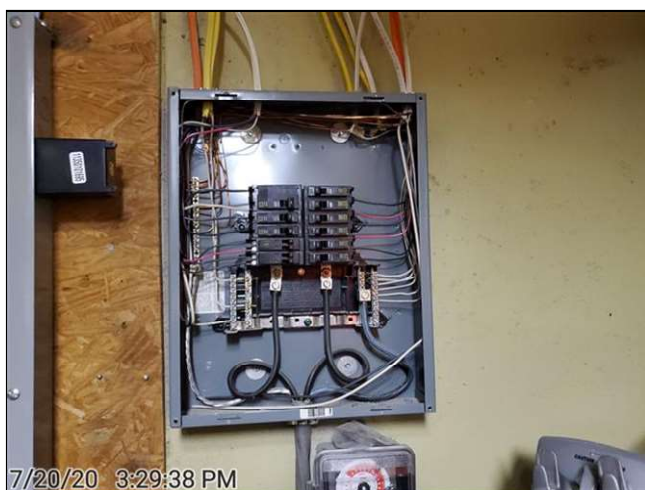
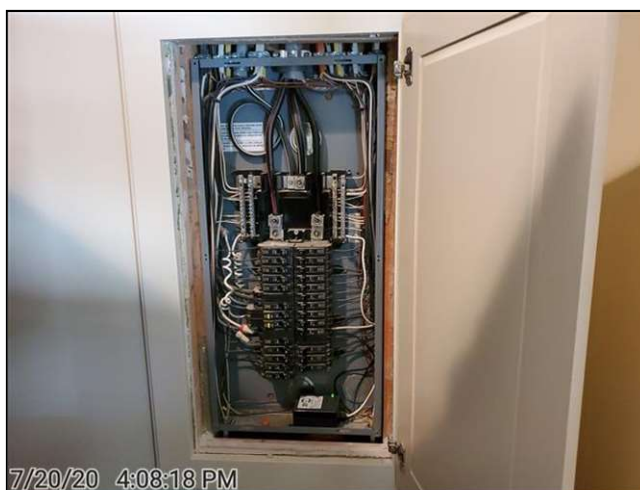
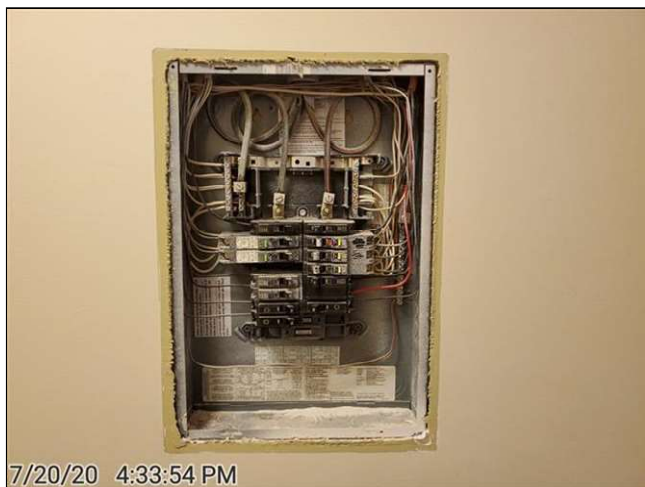
(2) One of the main panel boxes is located in the basement for the main home the other is on the main floor next to the right exterior door leading to the garage. However, the main disconnect (shut-off) is outside at meter base panel (for your information) in the storage room at the back right of the home. Panel was inspected for function (not code compliance) and building codes and standards have changed over the years.

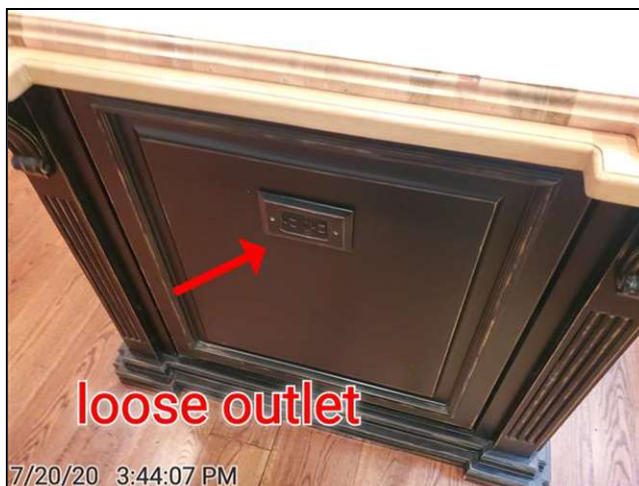
8.5 Item 3(Picture)

- 🔧 (2) Recommend to secure the loose outlet(s) to the wall in the guest house and at the kitchen island in the main home.

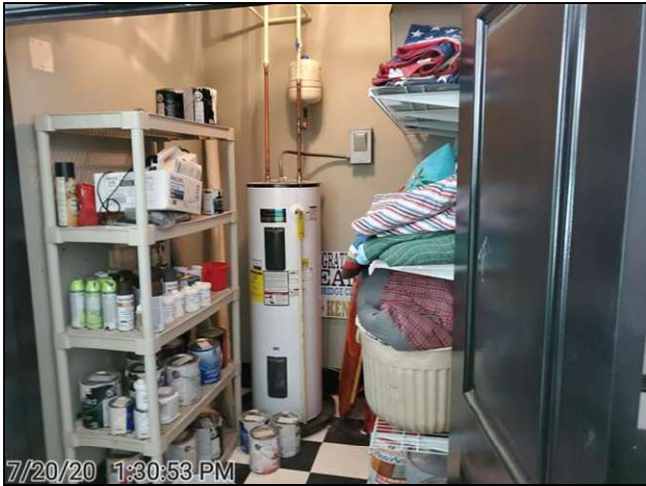
9.3 Item 1(Picture) Guest house water heater

(1) The water heater is located in the garage for the guest house. This is for your information.

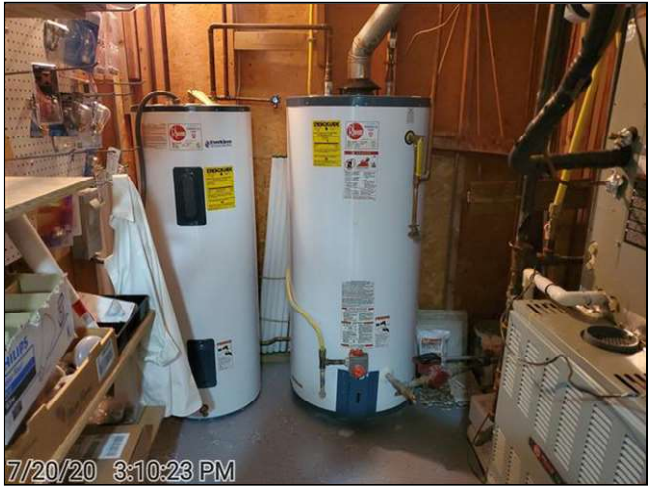
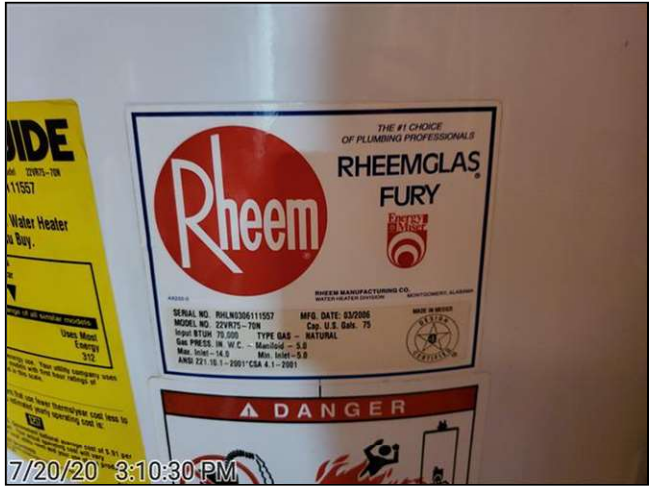
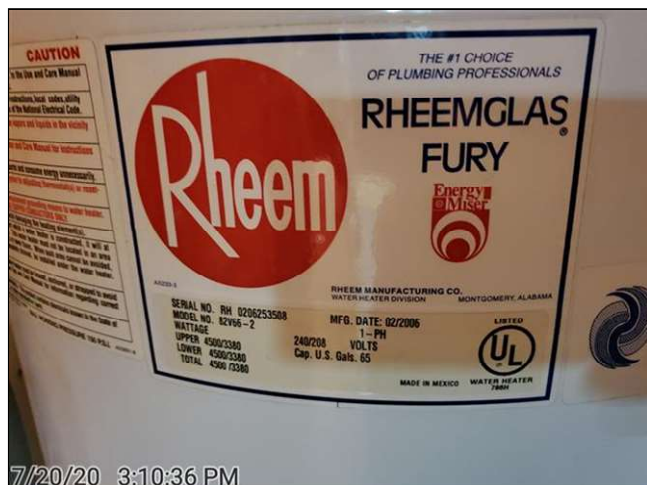
(3) The water heaters for the main house are located in the unfinished basement. This is for your information.

(4) Water heaters generally last about 10-12 years before needing replacement. Current water heater works and makes hot water but will likely need replacement in the near future due to its age.

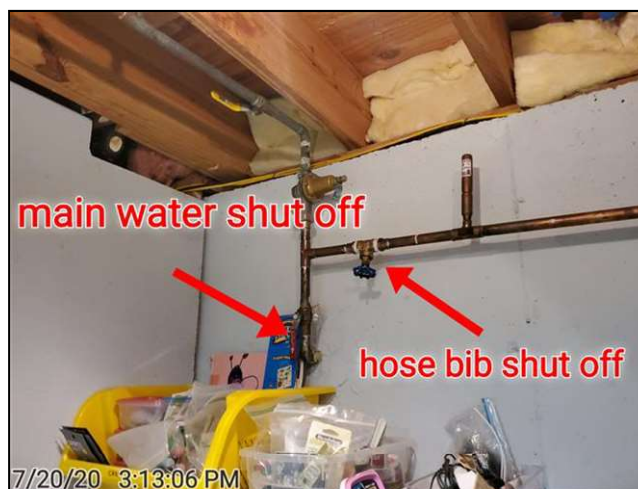
9.4 Item 1(Picture)

The main water shut-off is the red lever located in the basement. This is for your information. See photo.

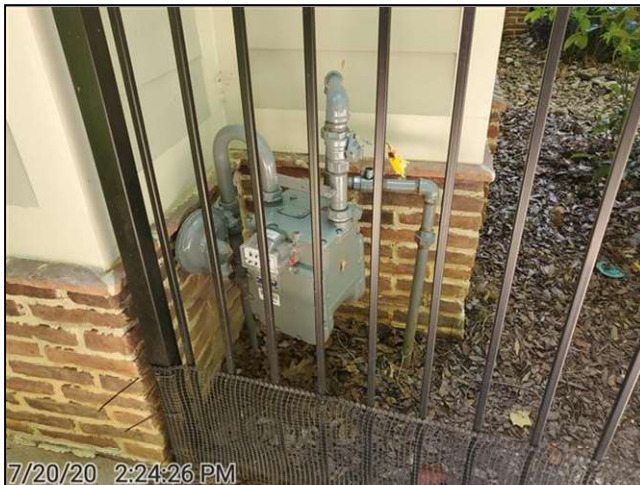
9.6 Item 1(Picture)

The main gas shut off is at the meter located at the front left of the home.
