INSPECTION REPORT
1130 Compton Way
Suwanee GA 30024

INSPECTED BY
Shane Gauthier
Encompass Home
Inspections

7/24/2020

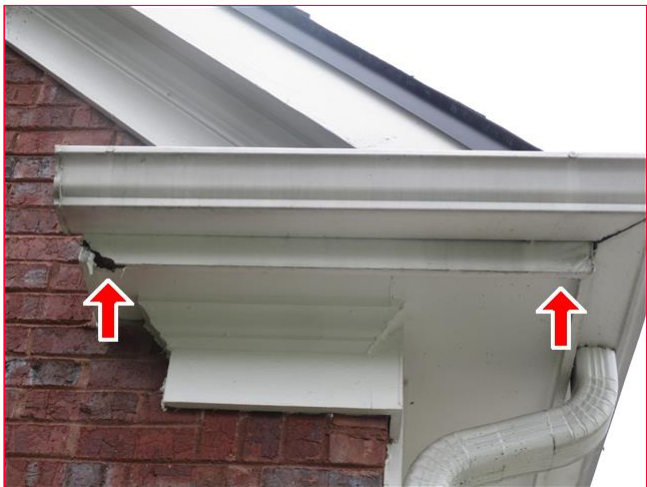
SERVICE / REPAIR: Wood rot and deterioration are present. Evaluate all areas and replace/repair all wood rot to the extent found to prevent further damage to any area. All replacement wood should be primed on all sides, caulked and painted as required. Any damage on the exterior wall or trim that allows openings into the wall cavity or interior can cause significant water damage over time if not repaired.

3.7 Item 2(Picture) right front fascia

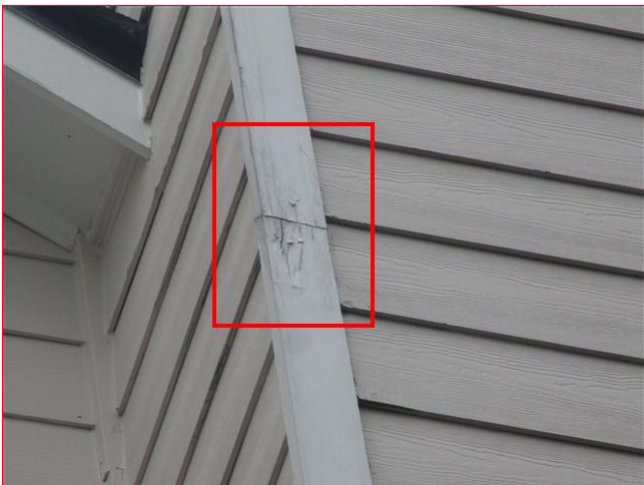
3.7 Item 7(Picture) chimney corner boards

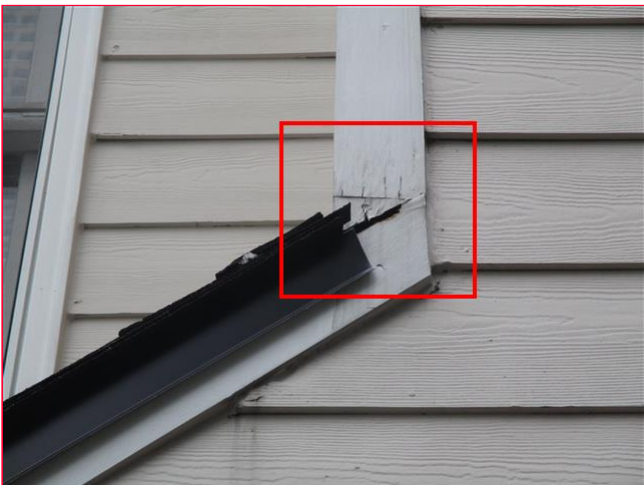
3.7 Item 8(Picture) chimney trim

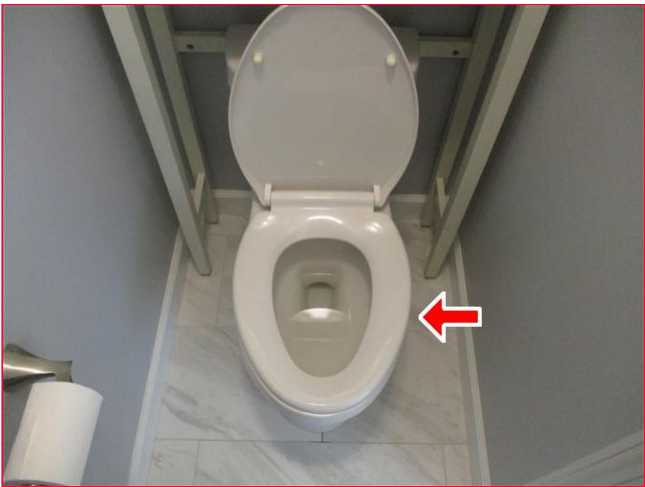
(1) **SERVICE / REPAIR:** The toilet is loose at the base when checked. This is allowing the base to pivot and often results in leaking if not corrected. Recommend that the condition be corrected.

12.1 Item 2(Picture) master bath

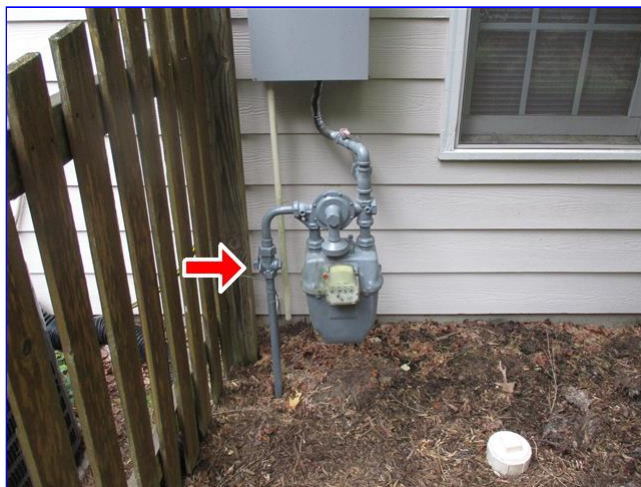
(4) **GENERAL NOTE:** Main gas shut off is located at the left side of the house.

1.0 Item 1(Picture) main gas shut off

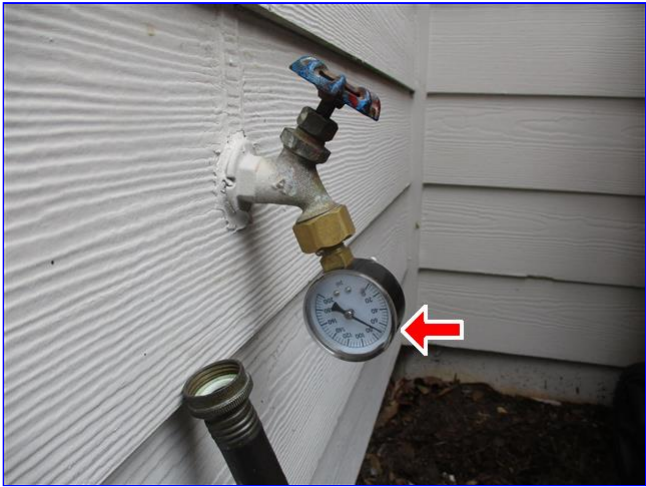
(1) GENERAL NOTE: Water pressure was verified at the time of inspection, pressure was in the safe recommended range of 40 to 80 PSI.

5.0 Item 1(Picture) 70 PSI

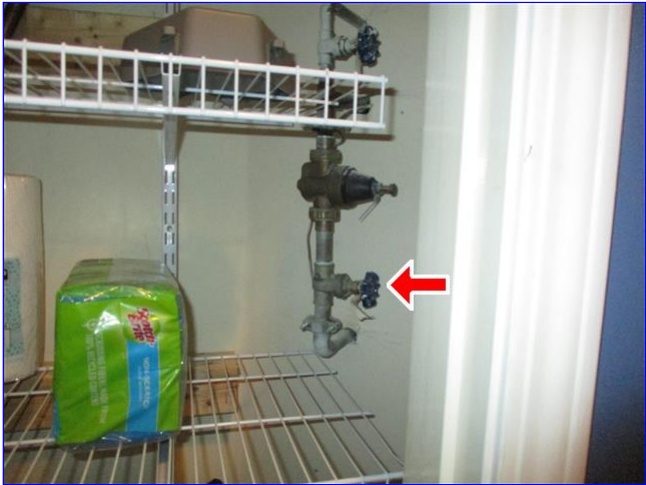
(2) GENERAL NOTE: Main water shut off is located in the closet at the laundry room.

5.0 Item 2(Picture) main water shut off

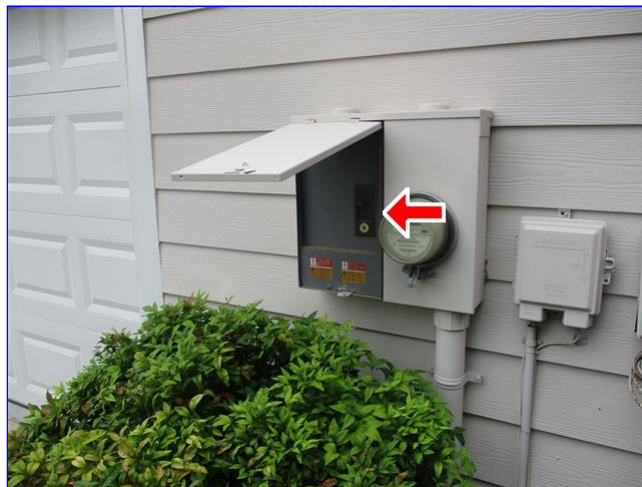
GENERAL NOTE: Main electrical breaker is located at the right side of the house.

6.0 Item 1(Picture) main electrical shut off

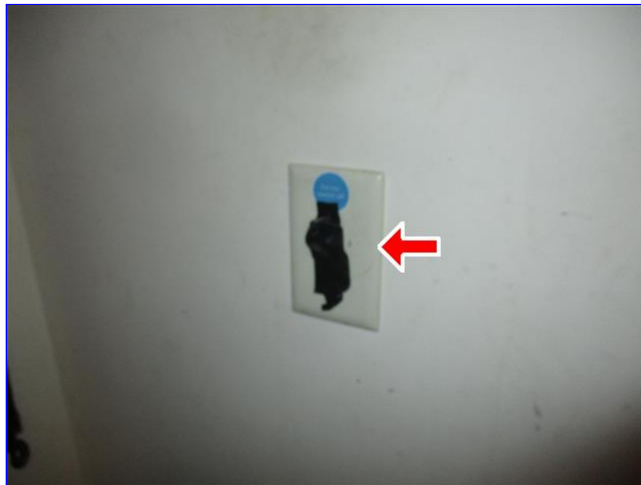
GENERAL NOTE: Switches with tape over them observed. Because we are unable to determine why the switch is in that position it was not operated. Verification by the seller is advised.

6.7 Item 1(Picture) garage

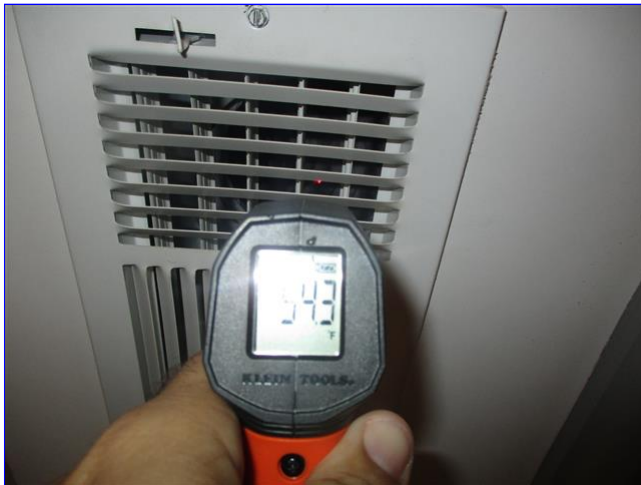
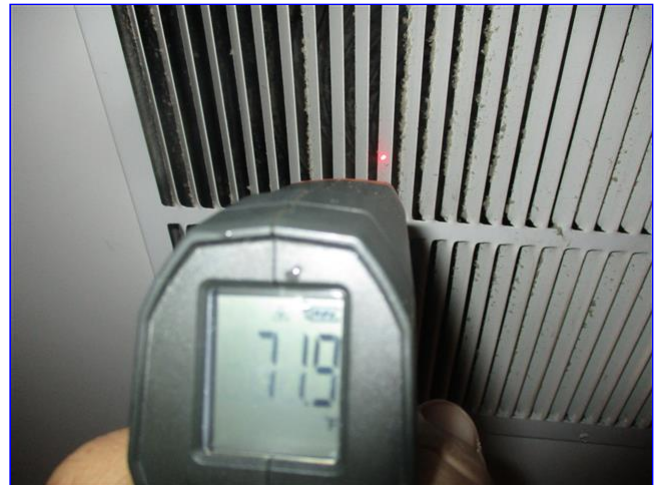
(1) **GENERAL NOTE:** Temperature difference results for Air Conditioning System

Unit upper floor Return temp.= 71 Supply temp. = 54 Differential temp. = 17 degrees, PASS

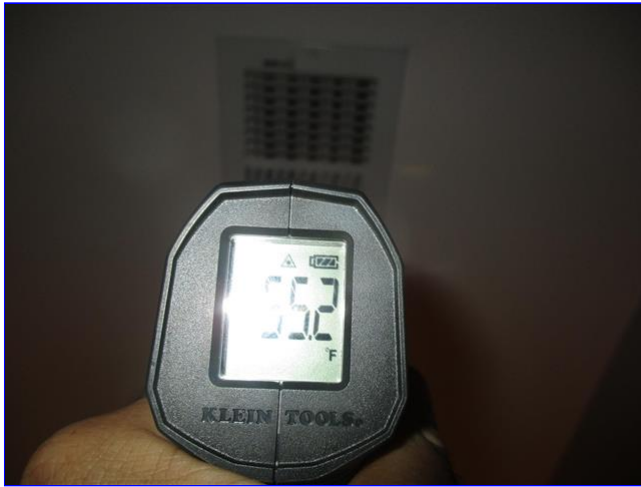
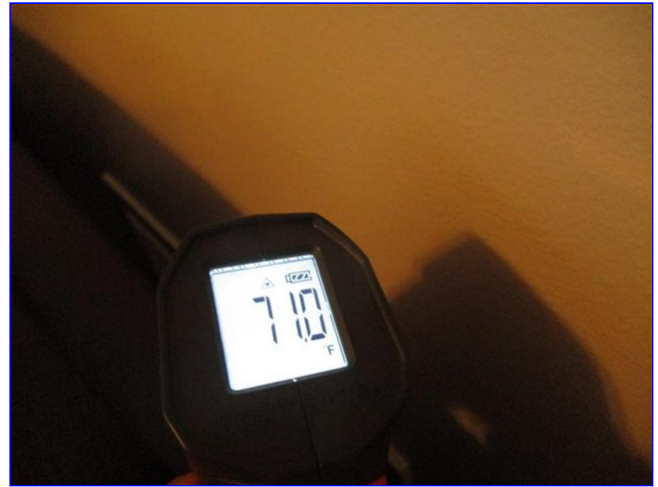
(2) **GENERAL NOTE:** Temperature difference results for Air Conditioning System

Unit main floor Return temp.= 71 Supply temp. = 55 Differential temp. = 16 degrees, PASS

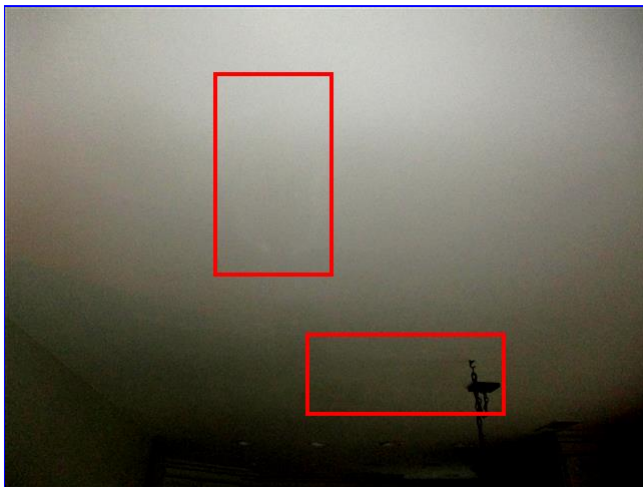
GENERAL NOTE: Touch ups and repairs noted in ceiling(s) during inspection. Seller to disclose cause of problem including extent of repairs made for buyer's future reference. Usually requires full area painting to reduce obvious conditions. Primer needed on stained areas to avoid bleeding back through when painted.

10.0 Item 3(Picture) kitchen and dining area ceiling

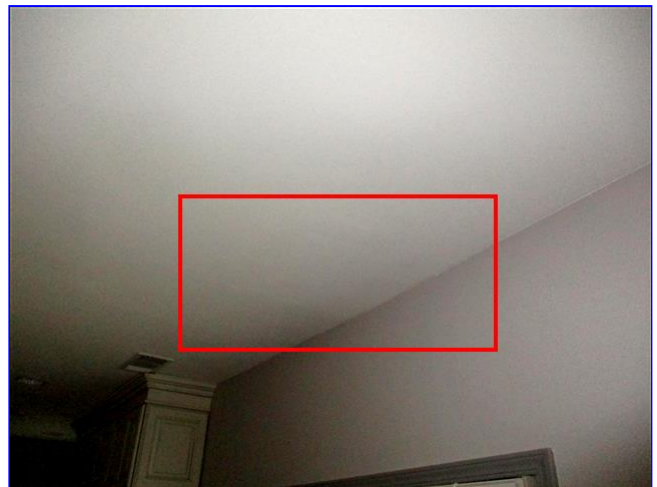
10.0 Item 4(Picture) kitchen ceiling

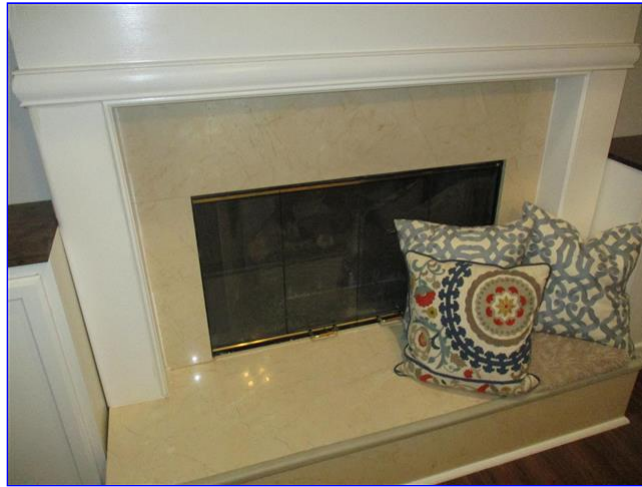
10.7 Item 1(Picture)

(2) **GENERAL NOTE:** The fireplace was not operated because the pilot light is out. Verification of working condition by the seller is recommended.

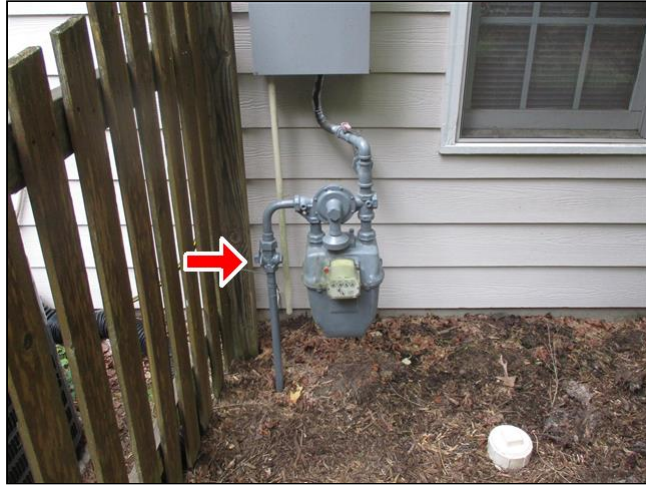
(4) **GENERAL NOTE:** Main gas shut off is located at the left side of the house.

1.0 Item 1(Picture) main gas shut off

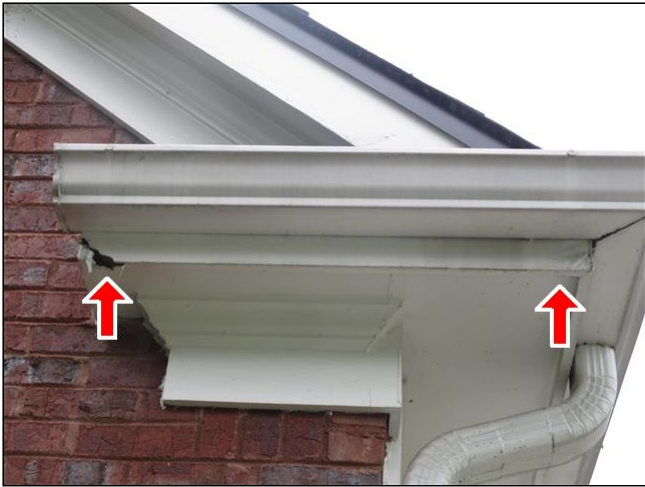
3.7 Item 2(Picture) right front fascia

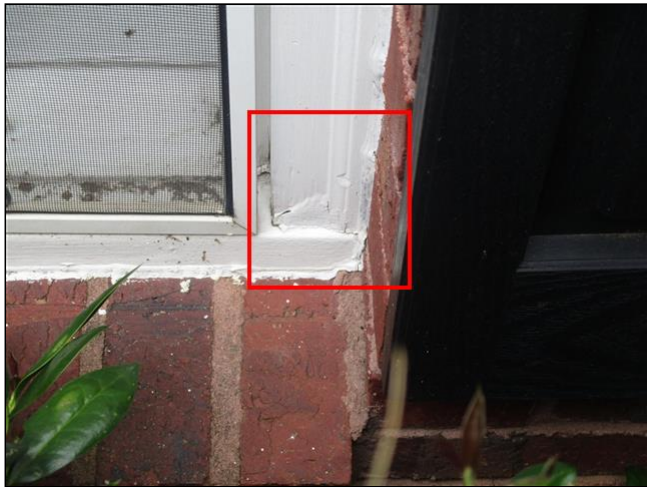
3.7 Item 3(Picture) center front window trim

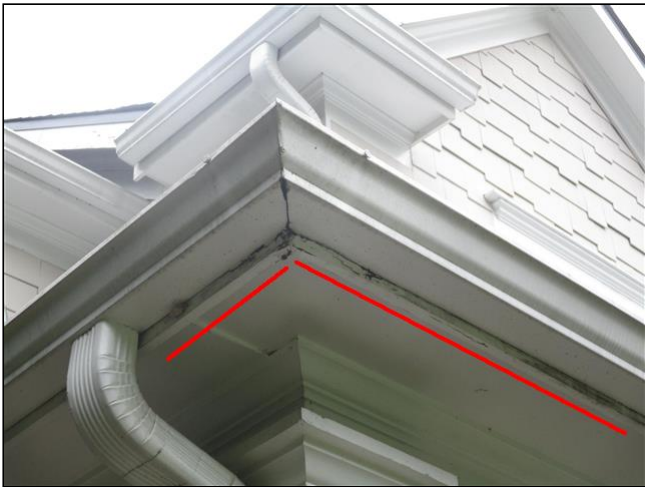
3.7 Item 4(Picture) center front fascia

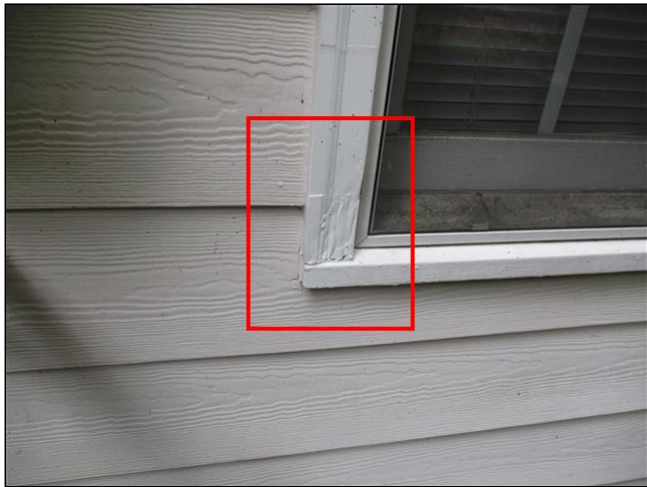
3.7 Item 5(Picture) left side of the house

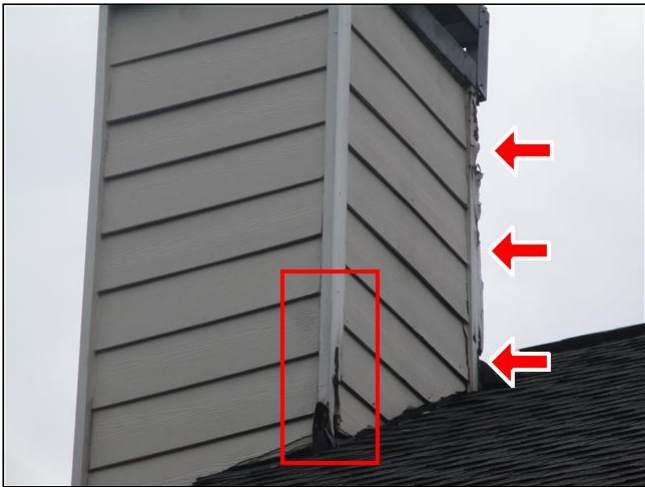
3.7 Item 6(Picture) chimney corner boards

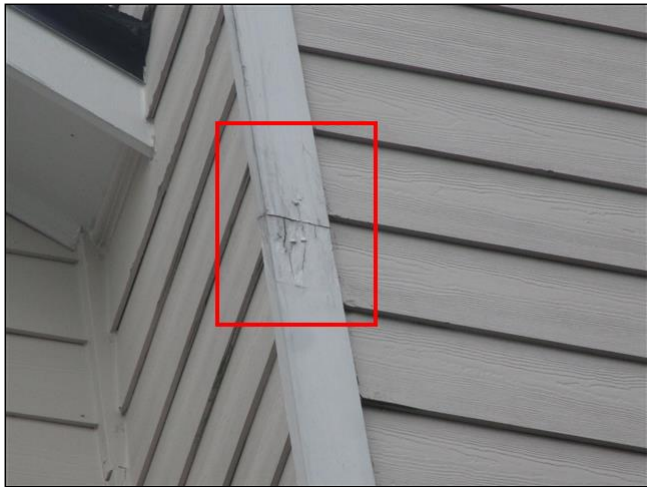
3.7 Item 7(Picture) chimney corner boards

SERVICE / REPAIR: Wood rot and deterioration are present. Evaluate all areas and replace/repair all wood rot to the extent found to prevent further damage to any area. All replacement wood should be primed on all sides, caulked and painted as required. Any damage on the exterior wall or trim that allows openings into the wall cavity or interior can cause significant water damage over time if not repaired.

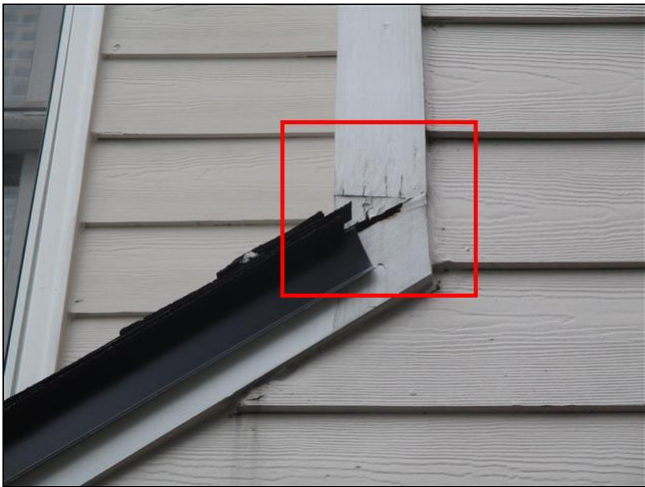
3.7 Item 8(Picture) chimney trim

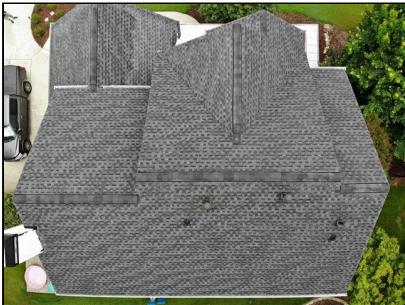
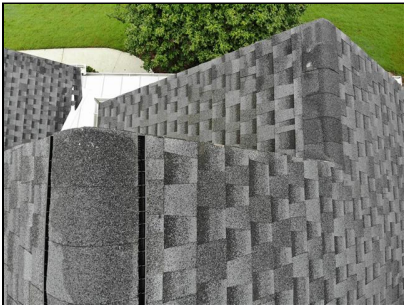
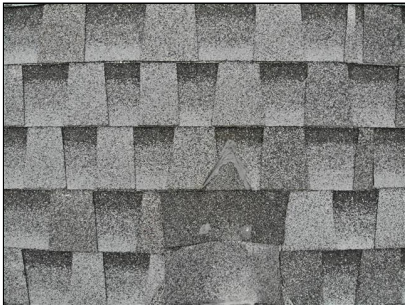
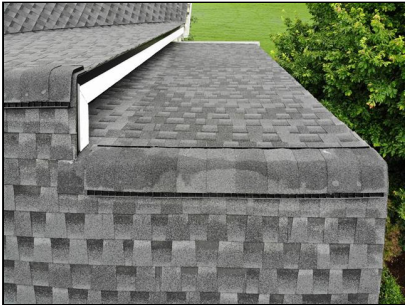
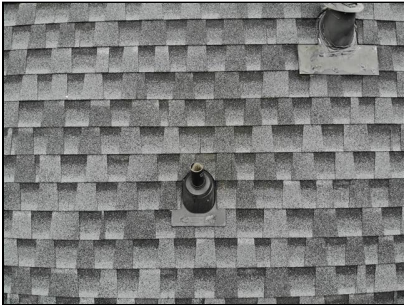
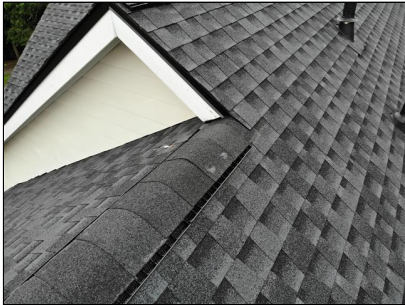
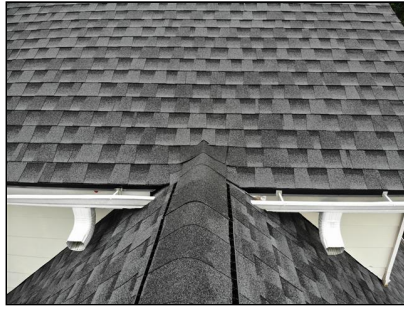
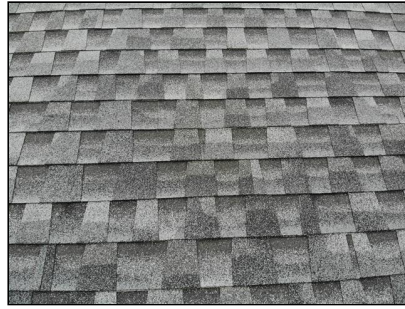
GENERAL NOTE: From our access point the entire roof was not viewable. Our comments indicate the areas that we are able to see from the access point and may not be representative of the entire roof. Drone technology was used to inspect the roof, this method may not identify all defects or installation errors. Seller indicated the roof had just been installed. Obtain the receipts and warranty information from the seller. Roof was in good shape at the time of inspection with no visible defects.

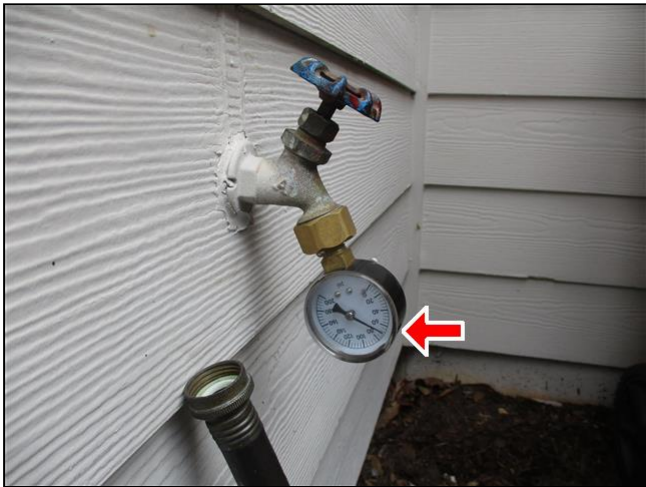
(1) **GENERAL NOTE:** Water pressure was verified at the time of inspection, pressure was in the safe recommended range of 40 to 80 PSI.

5.0 Item 1(Picture) 70 PSI

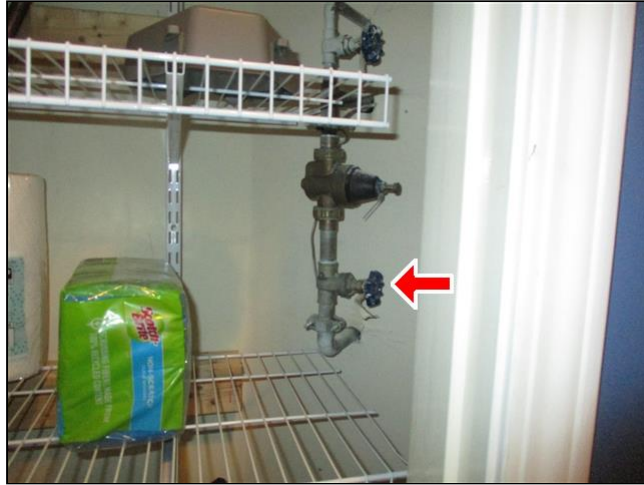
(2) **GENERAL NOTE:** Main water shut off is located in the closet at the laundry room.

5.0 Item 2(Picture) main water shut off

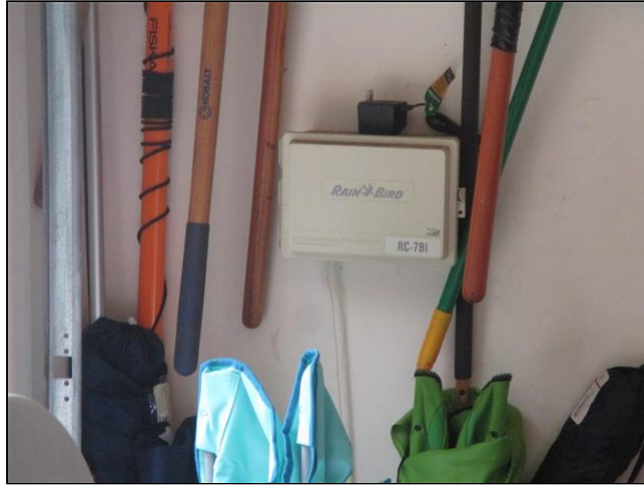
5.9 Item 1(Picture)

GENERAL NOTE: The underground sprinkler system was not tested and is not included in the scope of our inspection. Working condition should be verified by the seller.

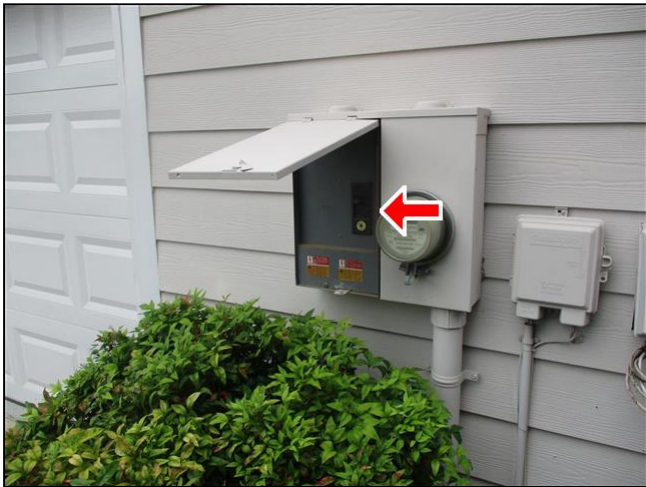
GENERAL NOTE: Main electrical breaker is located at the right side of the house.

6.0 Item 1(Picture) main electrical shut off

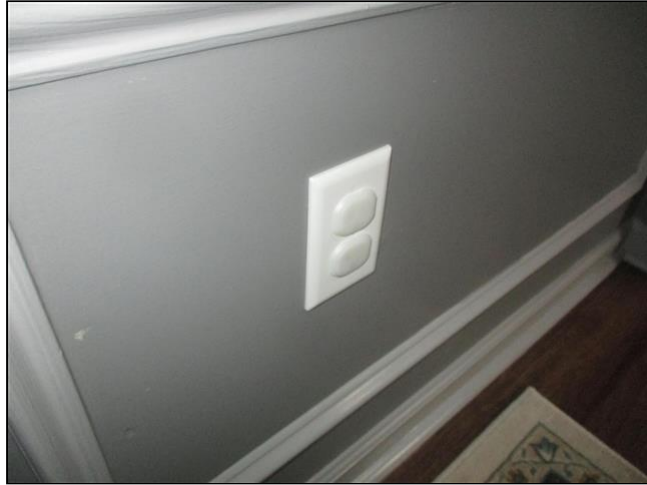
6.6 Item 1(Picture)

GENERAL NOTE: Due to child proof covers installed throughout the house not all outlets were tested for function.

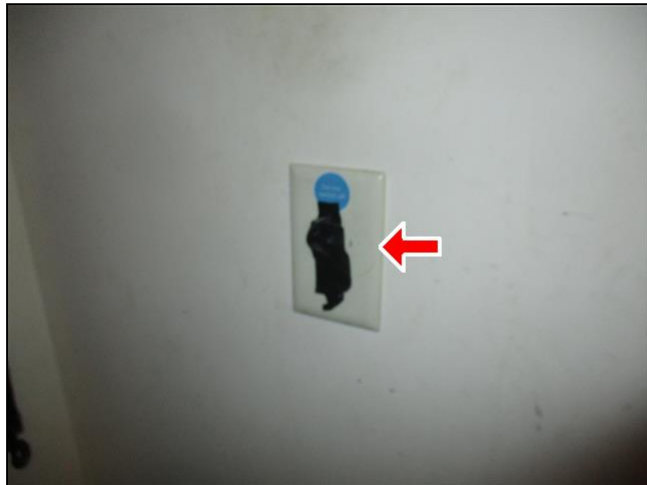
6.7 Item 1(Picture) garage

GENERAL NOTE: Switches with tape over them observed. Because we are unable to determine why the switch is in that position it was not operated. Verification by the seller is advised.

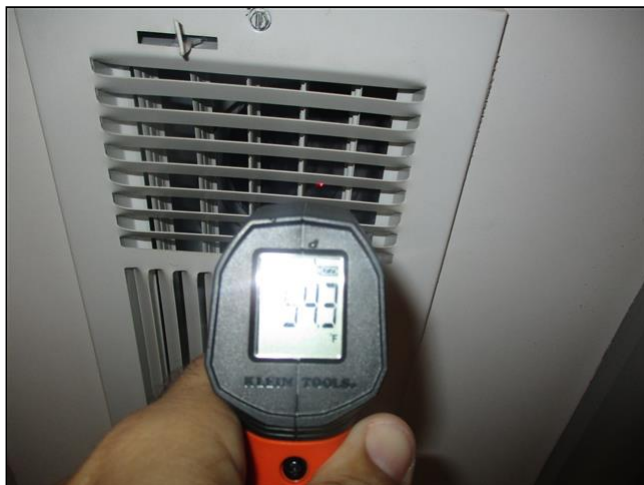
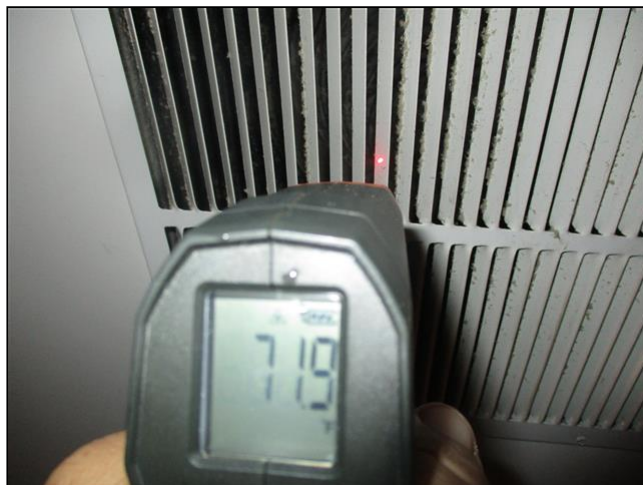
Unit upper floor Return temp.= 71 Supply temp. = 54 Differential temp. = 17 degrees, PASS

The differential temperature target is a minimum difference of 14-15 degrees between supply and return air temperatures. A difference of 14 degrees indicates minimum functioning of the system. No air flow measurements are made as part of this testing. All return and supply vents may not have been accessible today.

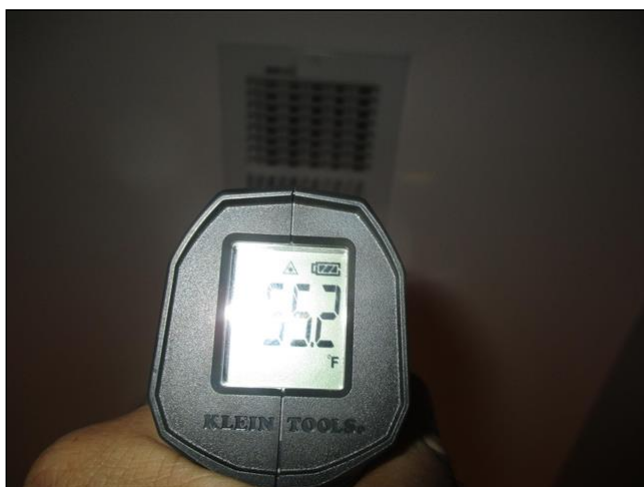
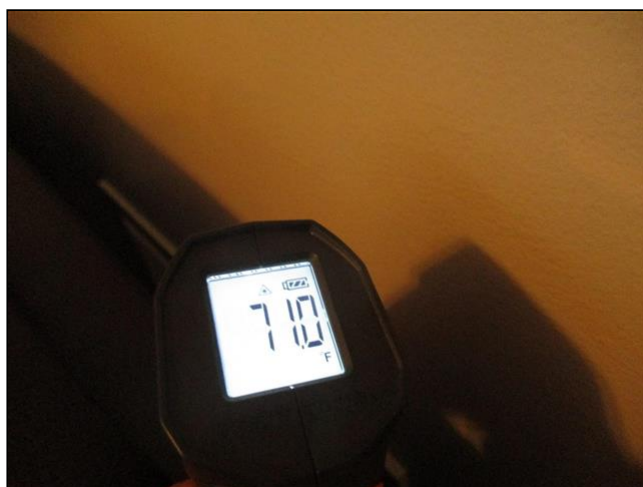
Unit main floor Return temp.= 71 Supply temp. = 55 Differential temp. = 16 degrees, PASS

The differential temperature target is a minimum difference of 14-15 degrees between supply and return air temperatures. A difference of 14 degrees indicates minimum functioning of the system. No air flow measurements are made as part of this testing. All return and supply vents may not have been accessible today.

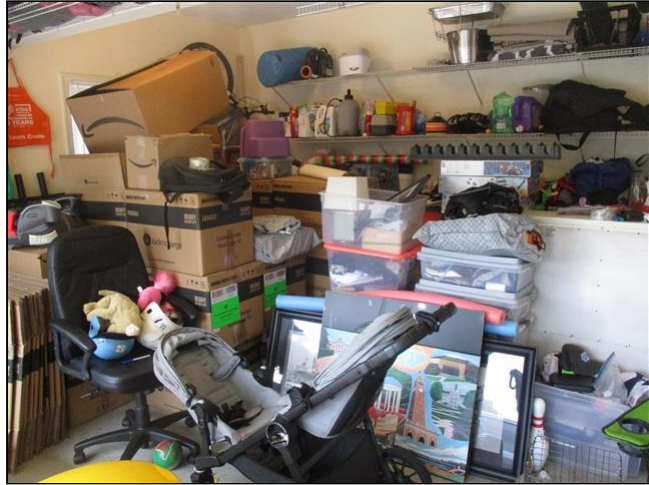
9.4 Item 1(Picture)

GENERAL NOTE: Due to personal objects stored in the garage not all areas were visible. Verification of all conditions by the seller is necessary.

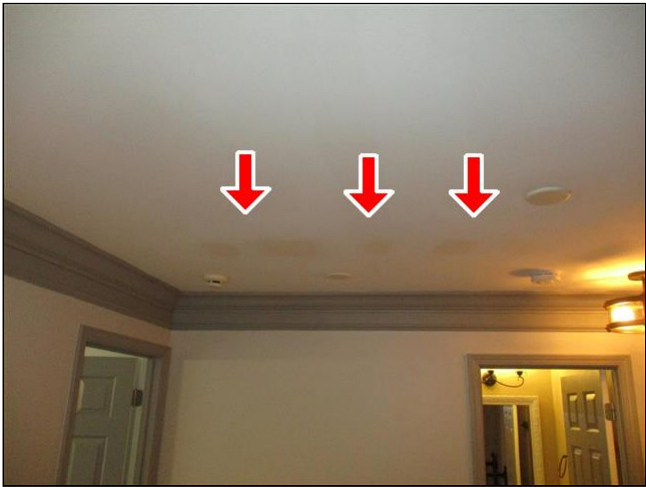
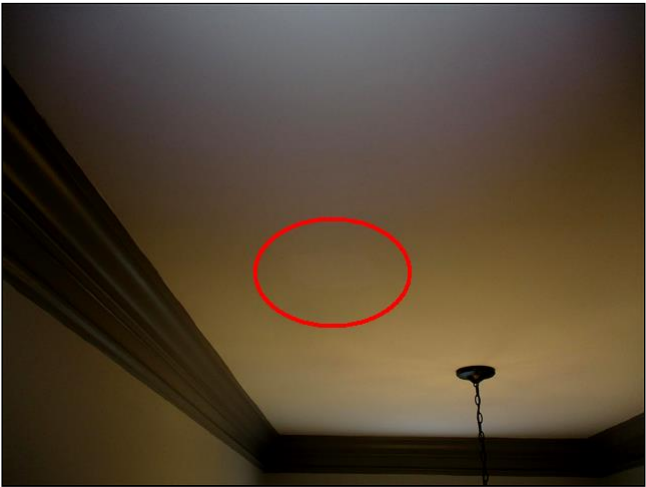
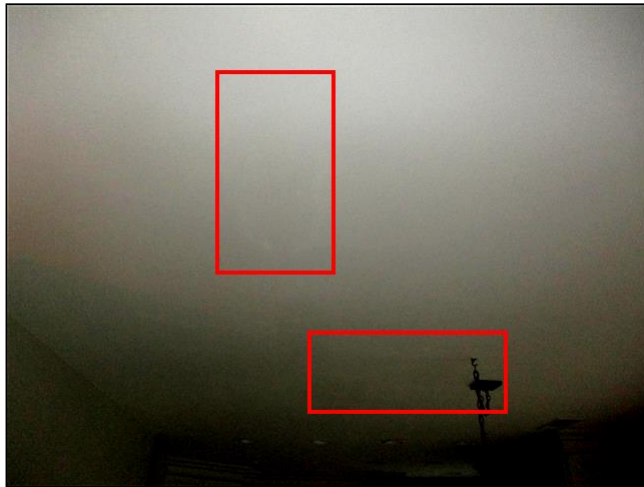
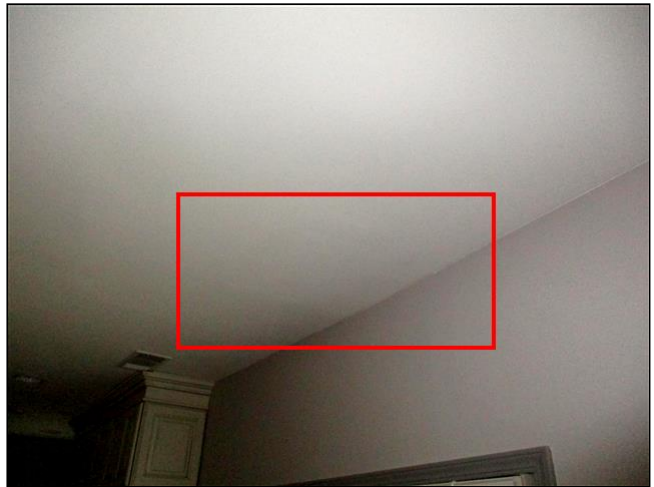
GENERAL NOTE: Touch ups and repairs noted in ceiling(s) during inspection. Seller to disclose cause of problem including extent of repairs made for buyer's future reference. Usually requires full area painting to reduce obvious conditions. Primer needed on stained areas to avoid bleeding back through when painted.

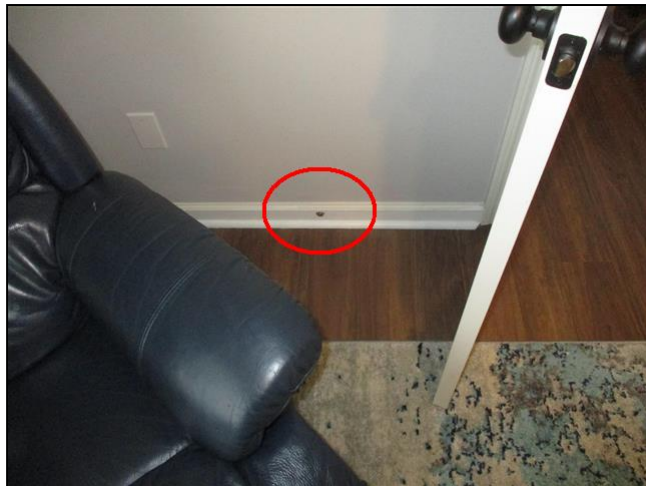
GENERAL NOTE: Door stops are typically installed to provide protection to walls from door knob contact and generally found in wall, floor or hinge mount types. Some found either damaged or missing and consider having installed.

10.2 Item 1(Picture) install door stops at all locations missing them

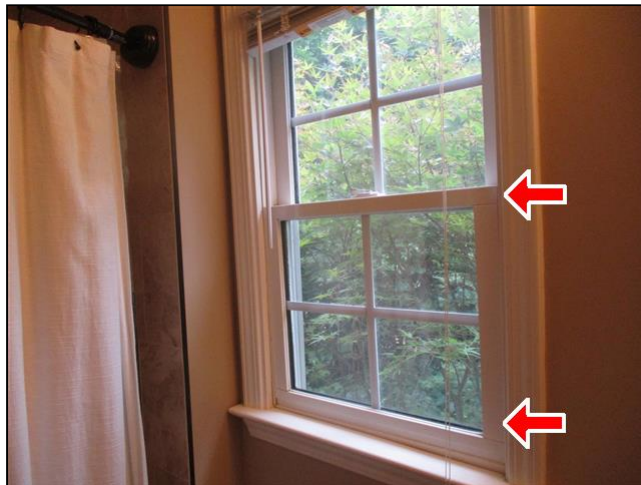
SERVICE / REPAIR: Paint causes many windows to stick and they should be modified to open normally for the average person. At least one window in each sleeping room must be operable as a means of emergency egress.

10.3 Item 1(Picture) repair all windows so they will open for safety and ventilation of the house

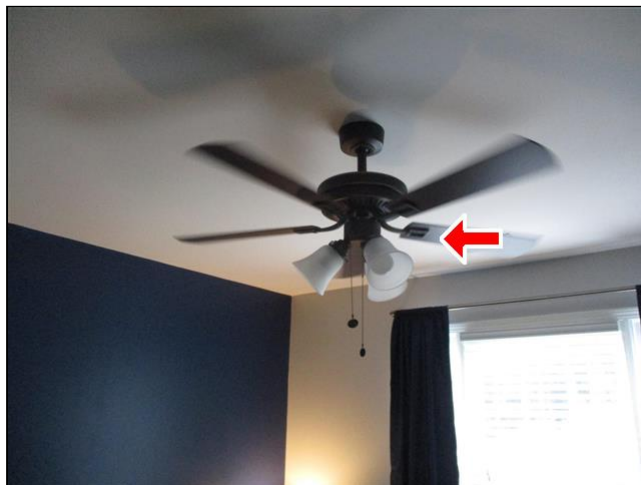
10.6 Item 1(Picture) front bedroom

SERVICE / REPAIR: Ceiling fan somewhat out of balance and produces an unsafe feeling during operation at certain speeds. Correct to function normally.

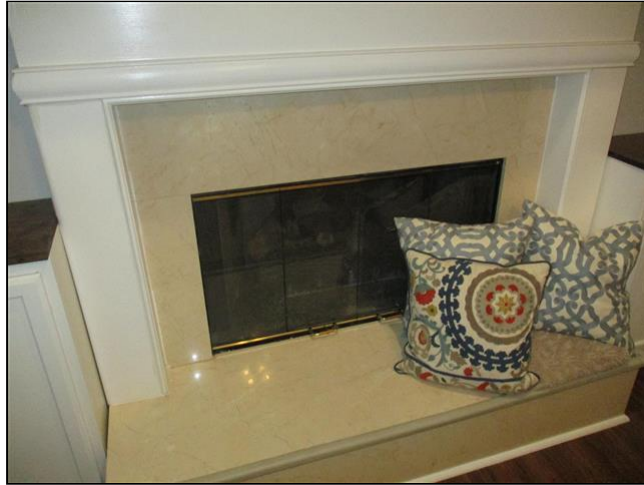
10.7 Item 1(Picture)

(2) **GENERAL NOTE:** The fireplace was not operated because the pilot light is out. Verification of working condition by the seller is recommended.

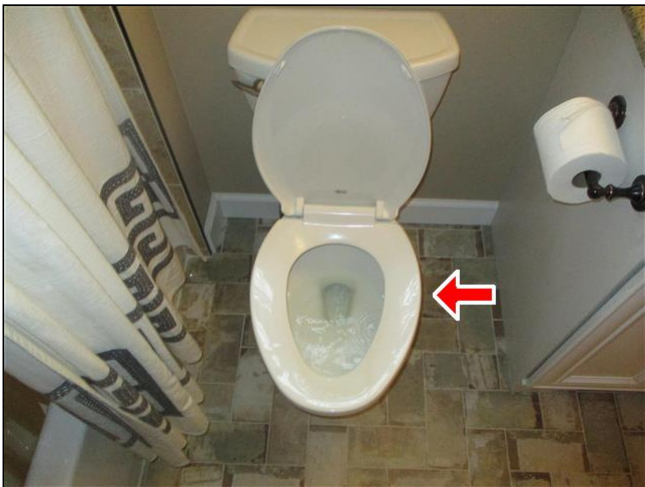
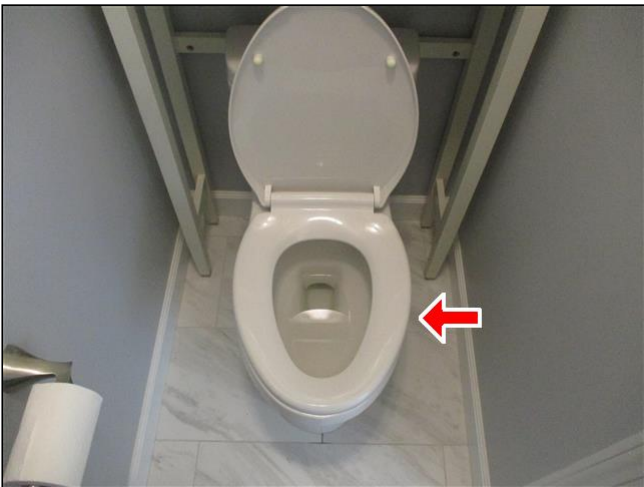
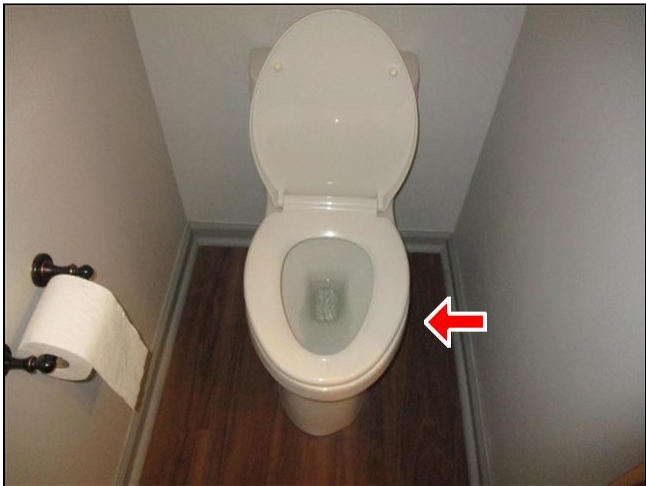
(1) **SERVICE / REPAIR:** The toilet is loose at the base when checked. This is allowing the base to pivot and often results in leaking if not corrected. Recommend that the condition be corrected.

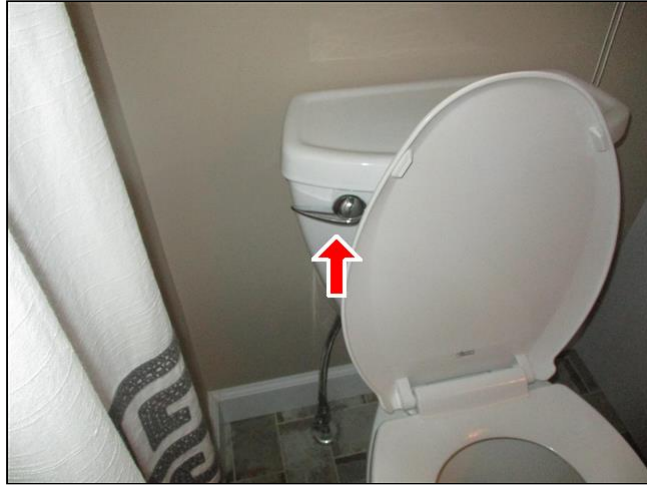
12.1 Item 4(Picture)

(2) **SERVICE / REPAIR:** Flushing the toilet at Upstairs hall bathroom requires holding down the handle to flush completely. Recommend having tank assembly modified to flush with a normal push down and release to obtain normal flush. Recommend that the condition be corrected.

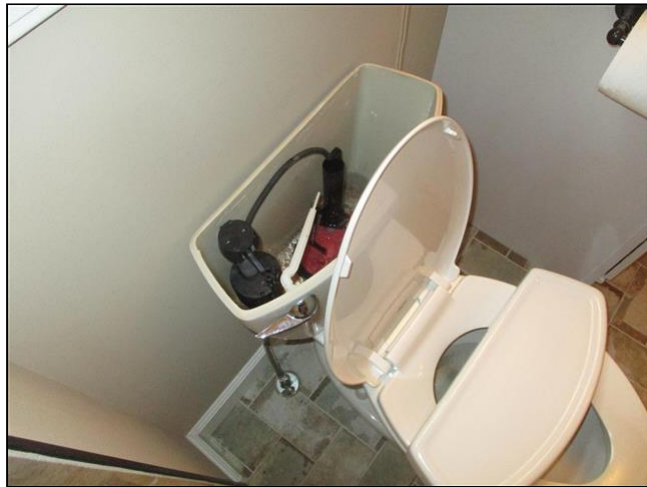
12.1 Item 5(Picture) upstairs hall bath

(3) **SERVICE / REPAIR:** Toilet found to fill slowly after flushing. Have fill device repaired or replaced to function normally..

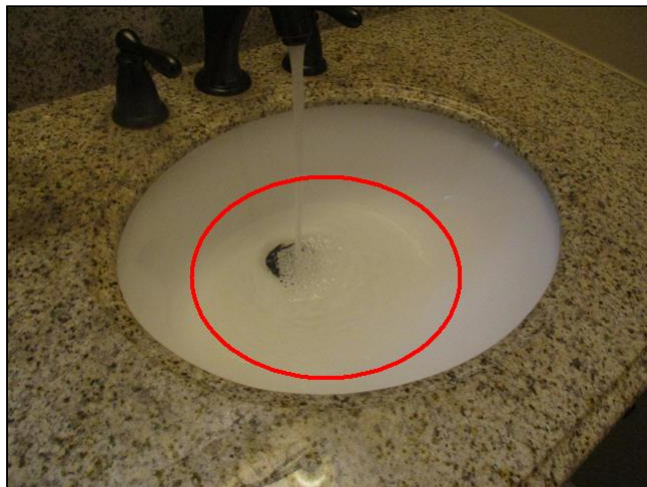
12.2 Item 1(Picture) upstairs hall bath

(1) **SERVICE / REPAIR:** Slow drain observed at Upstairs hall bathroom sink and should be cleaned and/or cleared to function normally. May require disassembly of drain line to clear properly.

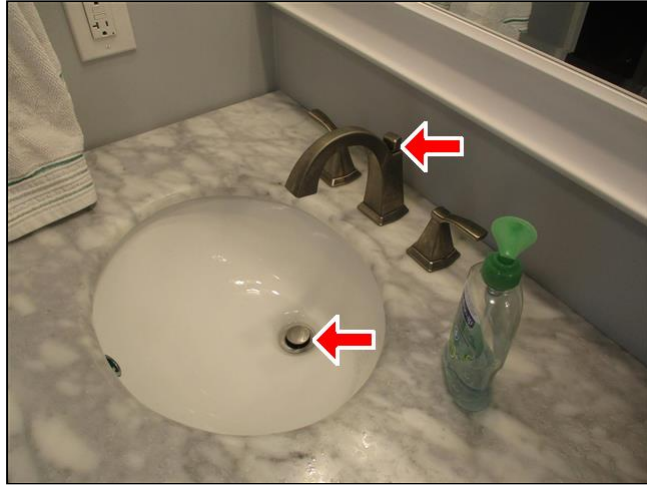
12.2 Item 2(Picture) left side sink

(2) **SERVICE / REPAIR:** Pop up drain assembly not functional should be repaired or replaced at Master bathroom vanity sink(s).

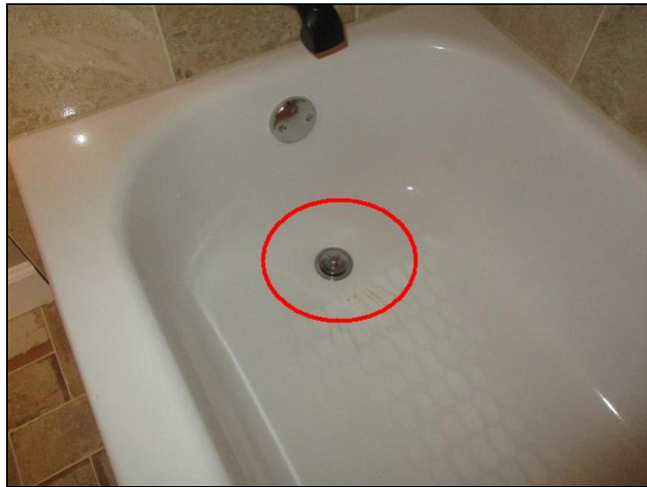
12.3 Item 1(Picture) hall bathroom

(1) **SERVICE / REPAIR:** Tub stopper installed fails to engage to hold water as would be necessary for taking baths at Upstairs hall bathroom. Have device repaired or replaced.
