# Inspection Report

385 Woodbrook Way

Lawrenceville, GA 30043

Saturday, August 01, 2020

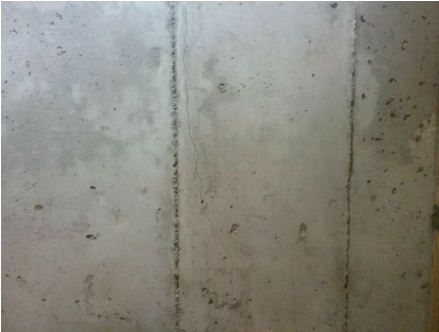
**15:** Small cracks less than 1/8" were observed at front center and left side foundation wall/slab. Small cracks are not unusual in any building and they can occur for a variety of reasons. We cannot legally render an opinion without being a licensed structural engineer. If cracks grow to exceed 1/4" in width across the crack further evaluation would be warranted. Smaller cracks are usually just monitored for future movement before repairs are undertaken. We recommend you inquire with the seller as to any past history of movement, history of evaluation and/or repairs attempted.

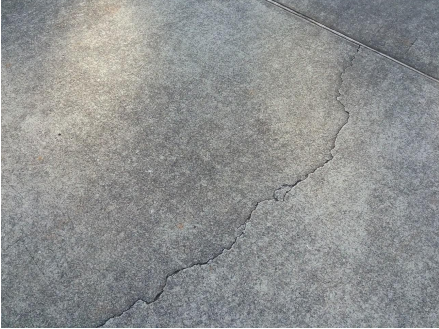
**20:** Cracking observed and appears normal for a driveway of this age and size. No repairs needed, but take pictures to compare in future years. Avoid heavy moving trucks with a full load.

**19:** Recommend filling all cracks and openings to prevent further damage or soil compaction which may lead to settlement.

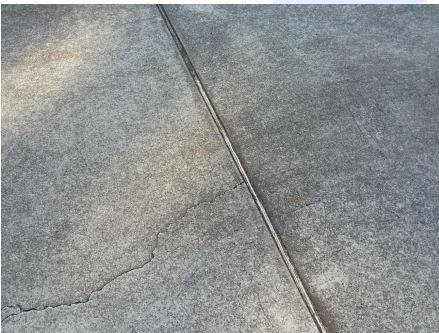
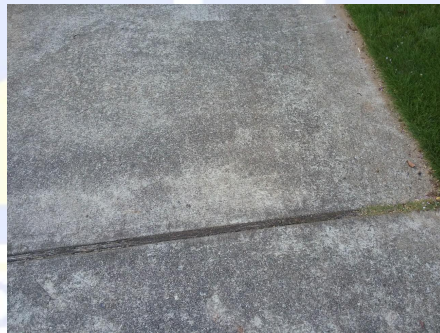
**s-21:** Existing driveway form boards were still observed to be installed and when left in place are conducive for termite activity and moisture damage. We recommend further evaluation and repairs by a licensed contractor.

**21:** Existing driveway form boards were still observed to be installed and when left in place are conducive for termite activity and moisture damage. We recommend further evaluation and repairs by a licensed contractor.

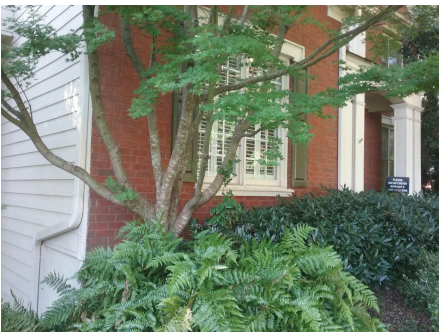
**s-27:** Trees planted close to structure. Removal may be needed if they get too big or there is possible damage to the building from underground tree roots.

**27:** Trees planted close to structure. Removal may be needed if they get too big or there is possible damage to the building from underground tree roots.

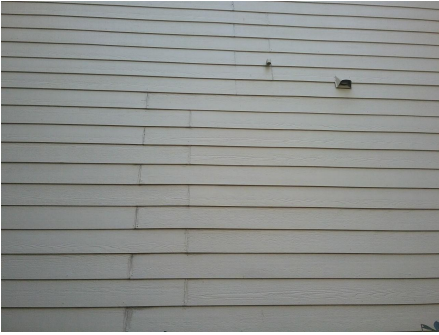
**s-35:** Swelling/moisture damage observed at the following locations: rear right

**35:** Swelling/moisture damage observed at the following locations: rear right

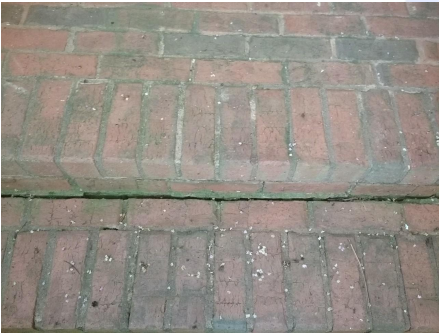
43: Surface raised/settled or rotating.

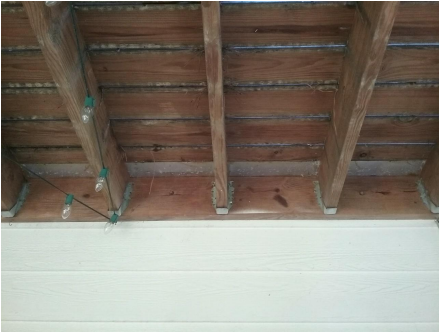
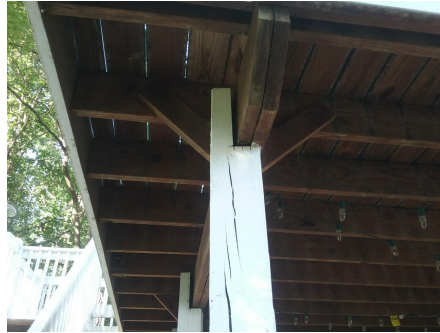
**s-45:** The deck was observed to have several deficiencies including but not limited to improper attachment over siding, lag bolts primarily attaching deck to house, missing lateral bracing on the support posts and excessive weathering/ wear in need of further evaluation and repairs by a licensed deck contractor.

**45:** The deck was observed to have several deficiencies including but not limited to improper attachment over siding, lag bolts primarily attaching deck to house, missing lateral bracing on the support posts and excessive weathering/ wear in need of further evaluation and repairs by a licensed deck contractor.

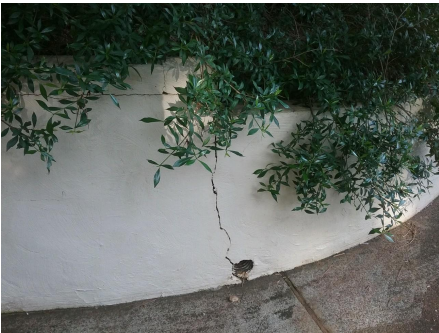
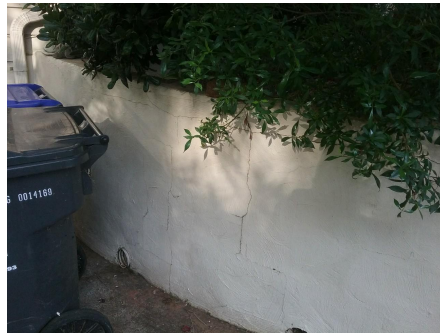
**s-47:** Displacement/Cracks are serious enough to warrant repair or replacement to the wall. At a minimum monitor the movement of the wall by taking photos and budget to make repairs.

**47:** Displacement/Cracks are serious enough to warrant repair or replacement to the wall. At a minimum monitor the movement of the wall by taking photos and budget to make repairs.

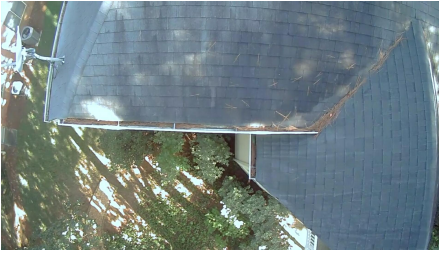
**s-56:** Leaf debris was observed blocking the gutters. Failure to clean the gutters can result in rusted gutters, foundation settlement, erosion of supporting foundation grade and water entering the building. Corrections recommended.

**56:** Leaf debris was observed blocking the gutters. Failure to clean the gutters can result in rusted gutters, foundation settlement, erosion of supporting foundation grade and water entering the building. Corrections recommended.

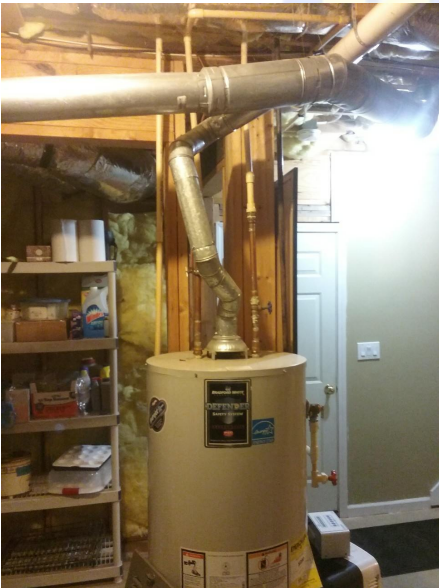
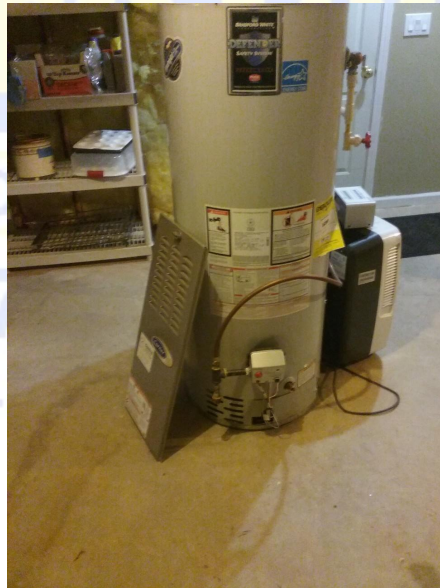
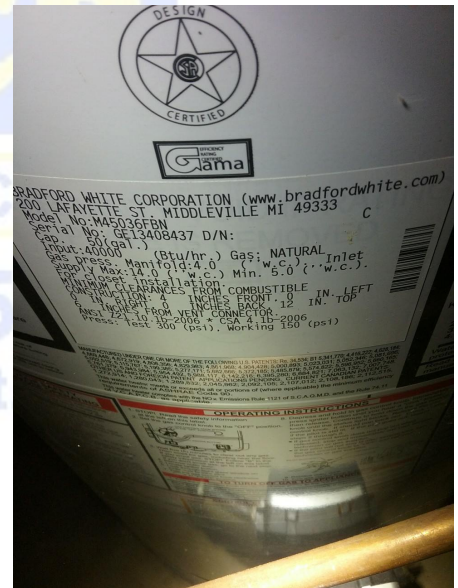
**70:** 50 gallon gas water heater

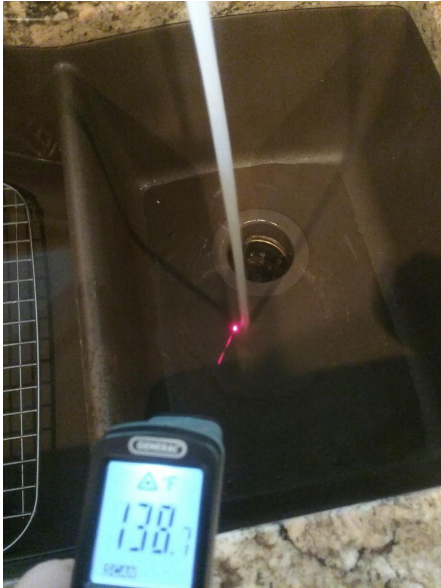
**73:** Operating at the time of the inspection.

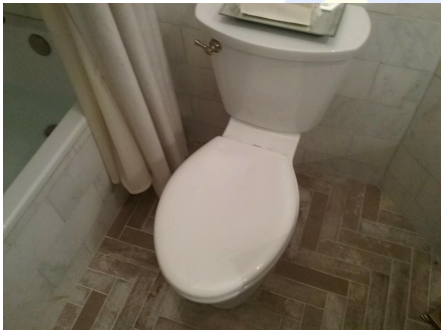
**80:** The commode is loose and needs to have the wax ring replaced at this time to prevent leaks visible and/or hidden. While this is generally not an expensive repair, it can be if the flange is cracked or broken.

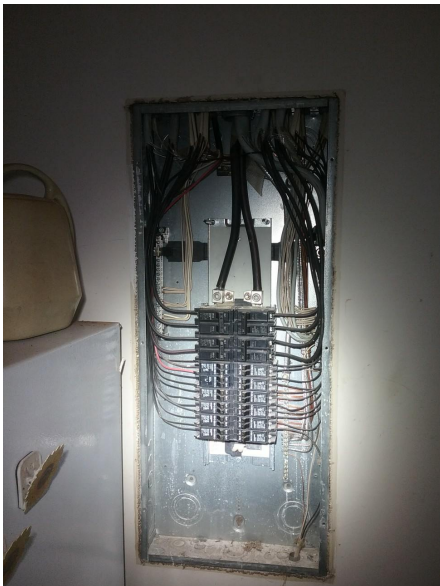
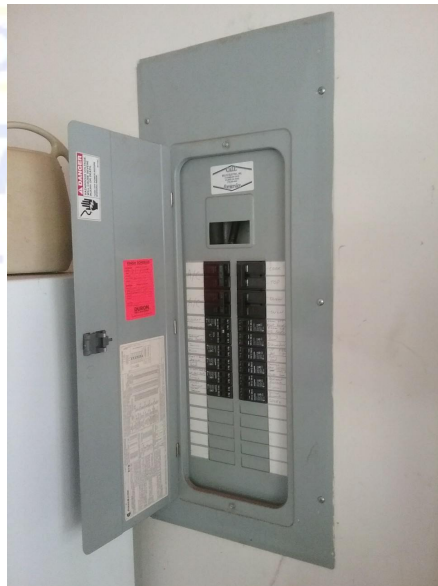
**102:** Garage

**103:** Unsealed opening(s) were observed inside the electrical sub panel. Recommend further evaluation and repairs by a licensed electrician.

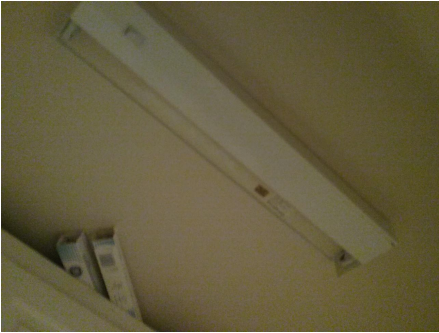
**107:** Lights are not operational in some areas, possibly due to bad/ missing bulbs, recommend having all operating for your final walkthrough to verify proper operation.

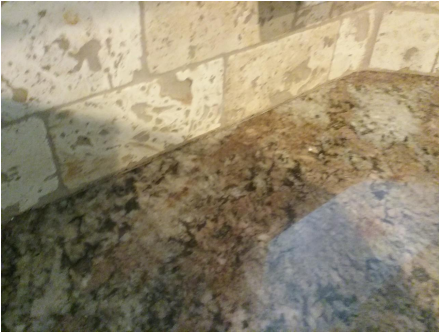
**110:** Grout/caulking is missing in some areas.

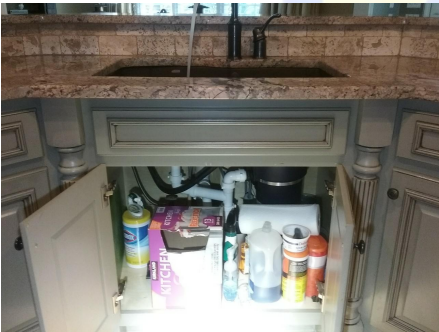
**113:** Aside from any listed defects the sink and faucet were operating properly at the time of the inspection.

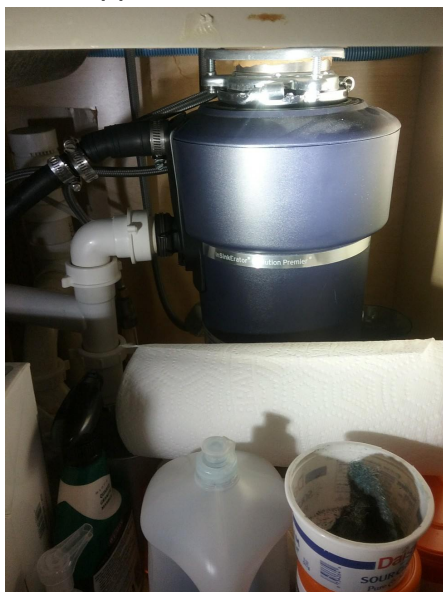
114: Appears serviceable

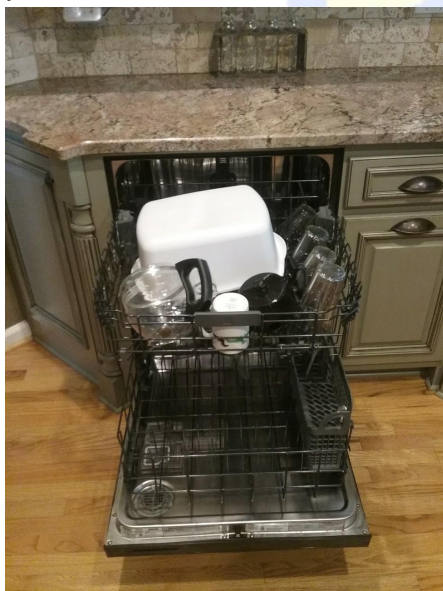
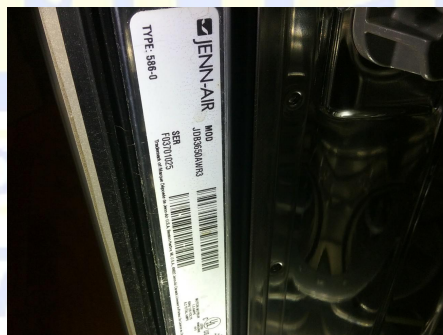
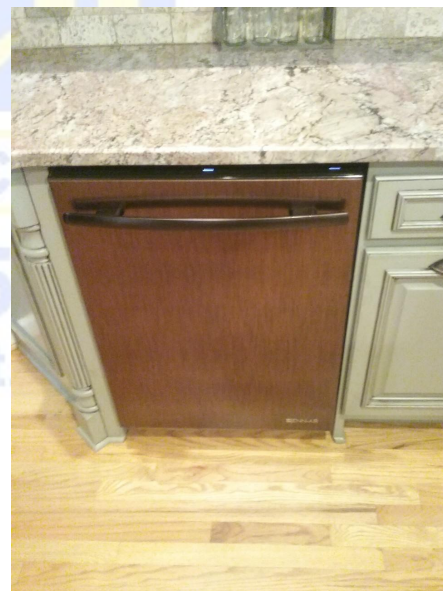
115: Operational as tested, but check again on your final walkthrough as leakage is a common problem.

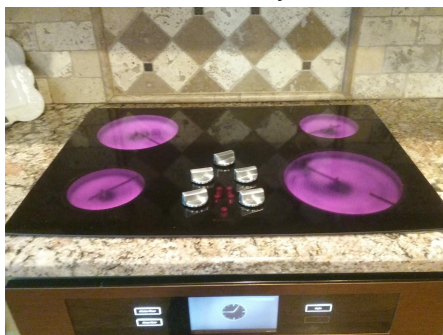
**116:** Aside from any listed defects the stove/ oven appeared to be in serviceable condition.

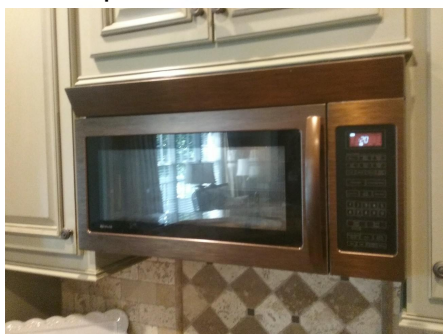
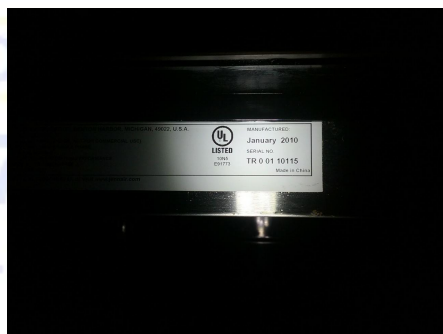
**118:** Operational

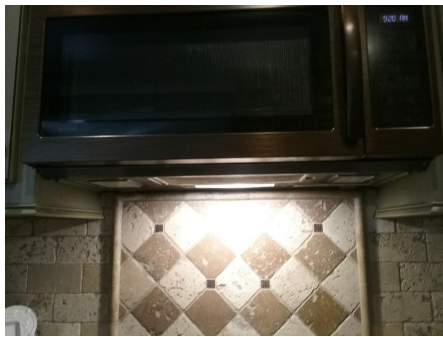
**119:** The stove hood was operating properly at the time of the inspection.

**120:** Installed as part of the microwave.

**121:** The stove hood/ microwave is not vented to the outside. Clean or change the screen from time to time.

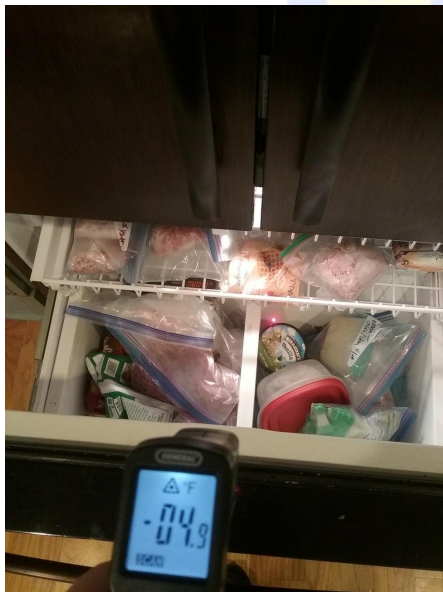
**122:** The unit appears to be operating normally at the time of the inspection. Freezer temperatures were observed below freezing and the refrigerator was cold. Per ASHI standards inspection of the refrigeration, internal components, ice maker, and cooling performance is considered outside the scope.

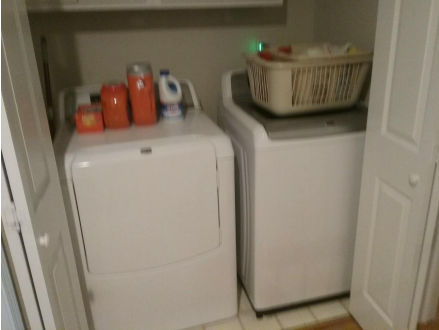
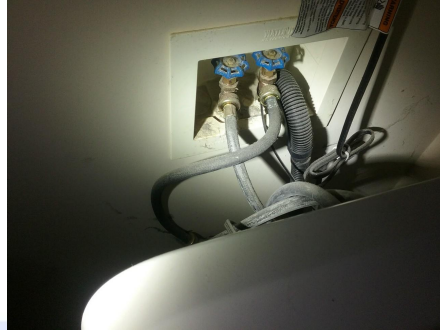
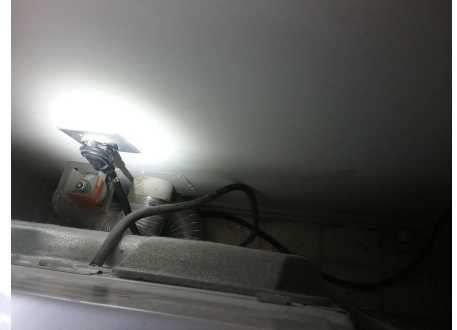
**123:** Laundry wall appears serviceable at time of the inspection. Testing of any clothes washing or drying appliances is considered outside the scope of the inspection. Water cut off valves for washing machines are not tested during the inspection as they are prone to leaking when operated.

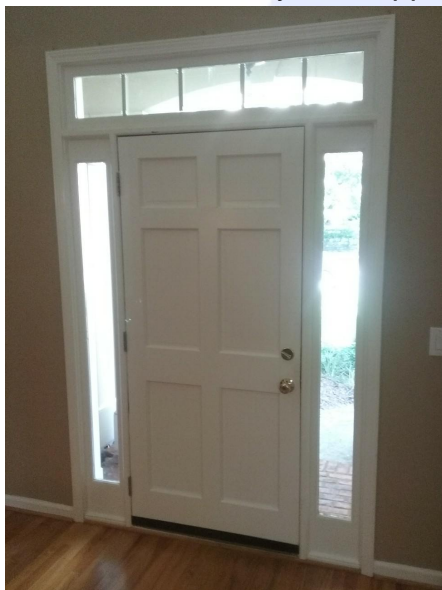
**126:** The main entry door appears to be operational and typical for the age of the home.

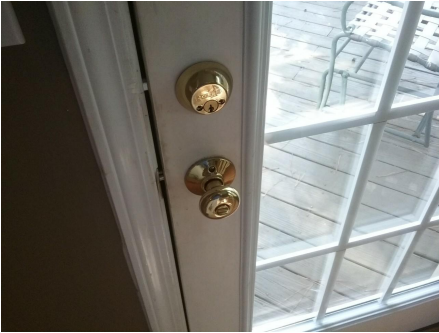
**128:** Double keyed dead bolt locks not allowed at exterior fire egress doors after 2010 were installed at the exterior door(s) and may be replaced with approved thumb flip style dead bolt locks for safety.

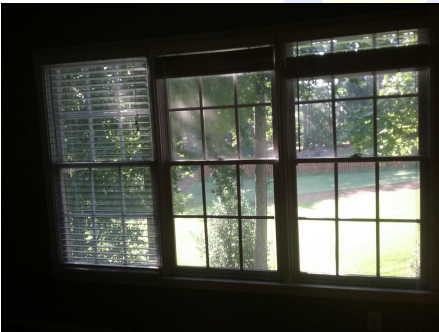
**130:** Wood double hung insulated glass windows

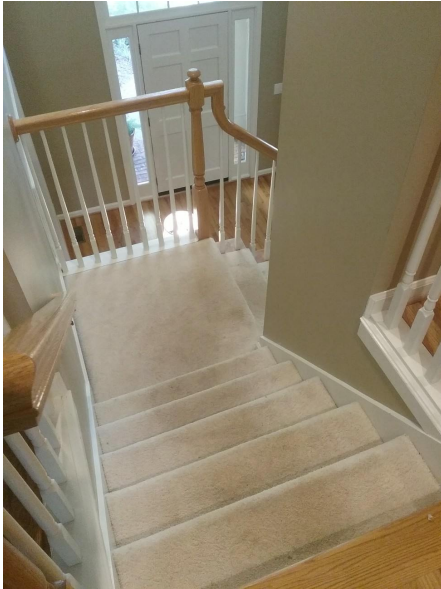
**148:** Wood stairs covered by wall-to-wall carpet

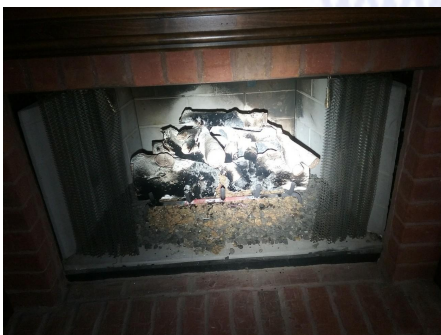
**151:** Prefabricated metal wood burning fireplace

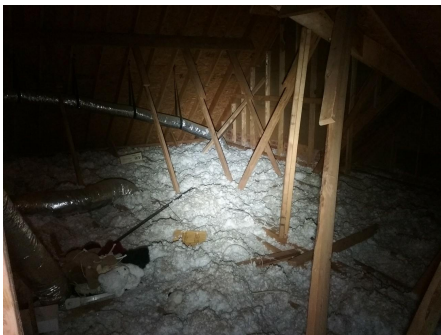
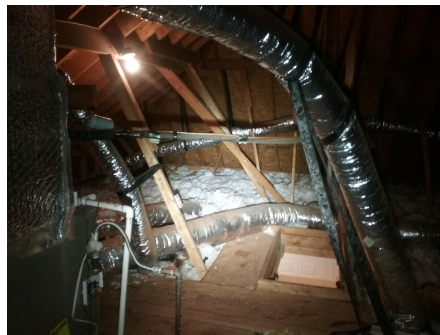
**153:** From attic.
