Property Inspection Report

**Property address: 420 Fawn Glen Dr
Roswell GA 30075-6353**

Inspection date: Thursday, July 16, 2020

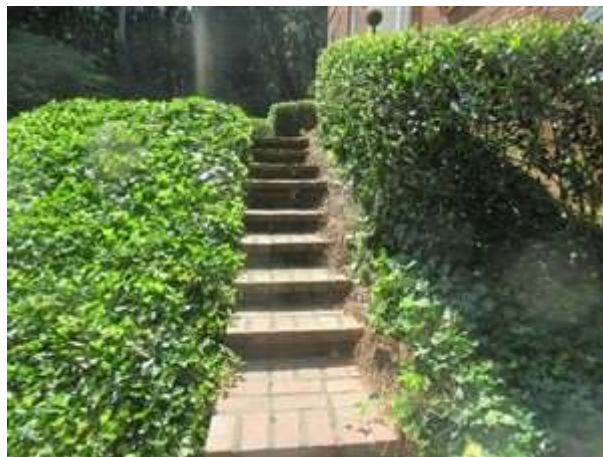
Photo 8-2

One or more flights of stairs with four or more risers have no handrail installed. This is a safety hazard. A qualified contractor should install graspable handrails that your hand can completely encircle at stairs where missing, and as per standard building practices.

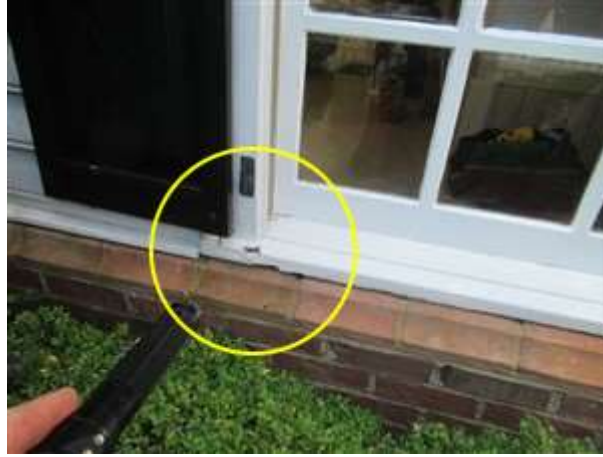
Exterior trim appears to be damaged in one or more areas. Recommend having a qualified contractor evaluate and make any necessary repairs.

**Photo 9-2** Garage window.

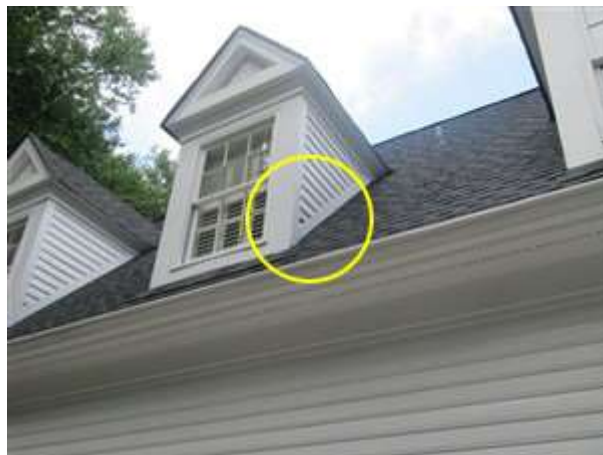
**Photo 11-2**

Siding is damaged and/or deteriorated in one or more areas. A qualified contractor should evaluate and make repairs and/or replace siding as necessary to prevent water and vermin intrusion.

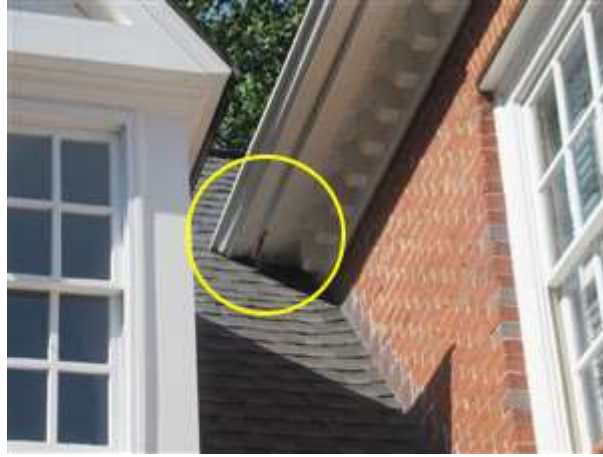
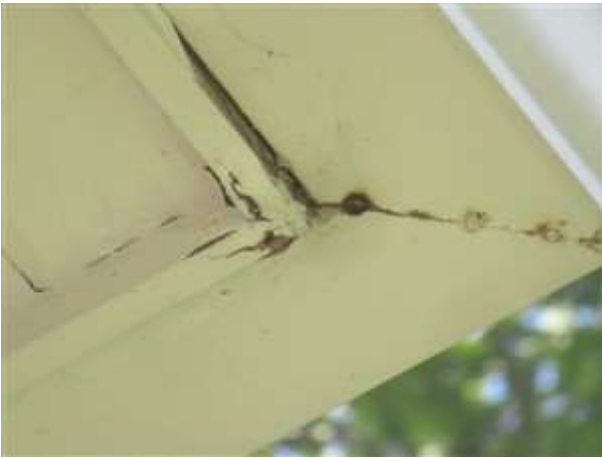
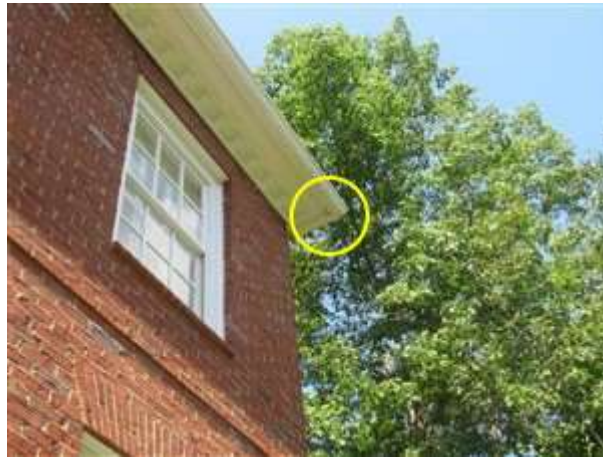
Fascia boards are damaged or deteriorated in one or more areas. A qualified contractor should evaluate and make repairs as necessary.

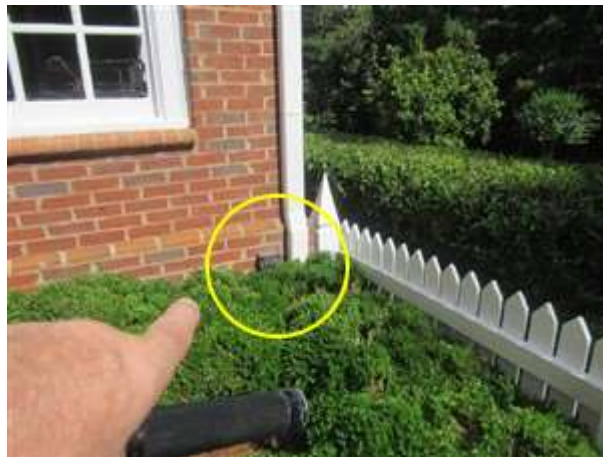
**Photo 13-2**

One or more electric receptacles appear to have no power. Recommend asking the property owner(s) about this. Switches may need to be operated to make some receptacles energized. If necessary, a qualified electrician should evaluate and make repairs as necessary.

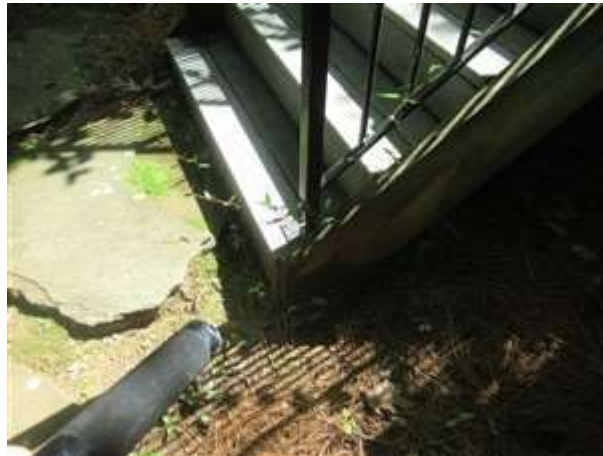
Photo 14-2

Wood beams, joists and/or support posts are too close to the soil in some areas. This is a conducive condition for wood destroying insects and organisms. Standard building practices require the following clearances to soil below:

Efforts should be made, such as grading and/or removing soil, to maintain these clearances. If this is not practical, then installing borate based Impel rods to prevent rot or monitoring this area in the future.

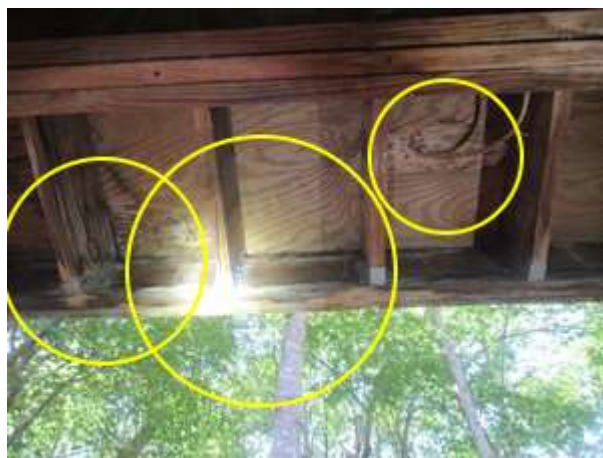
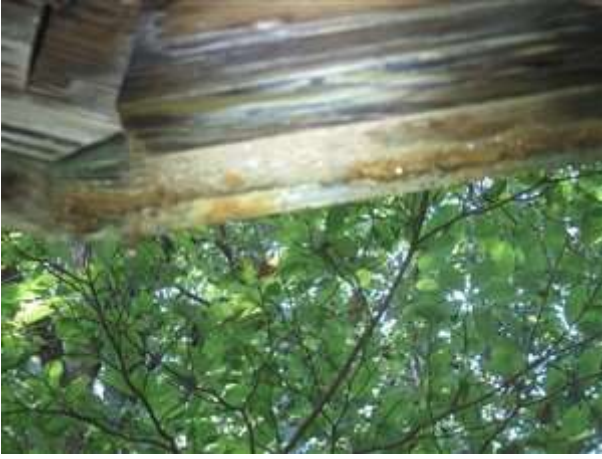
A wood destroying fungus was noticed on the deck frame below the deck. This can be caused by moisture escaping between the stone tiles and the wood. Recommend having a qualified contractor evaluate and make any necessary repairs.

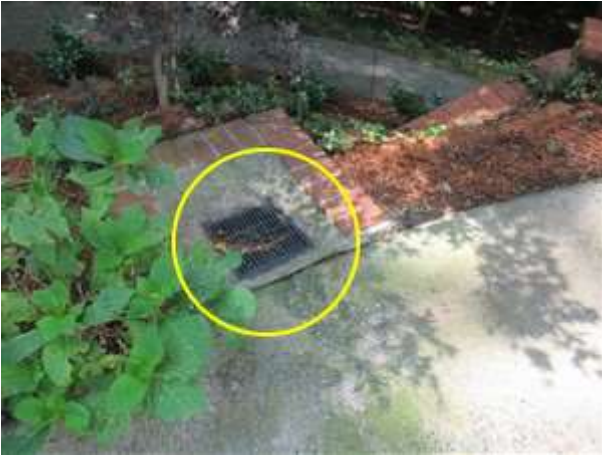
**Photo 17-1**

Under ground drains were noticed in one or more areas around the structure. The grates for all drains should be kept clear of debris to prevent drain clogs.

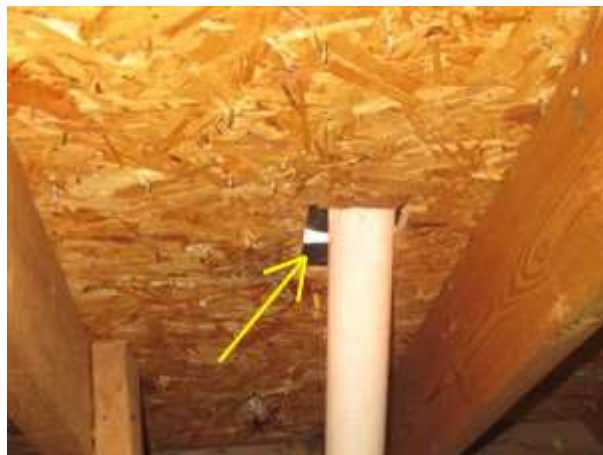
Photo 22-2 View from inside the attic.

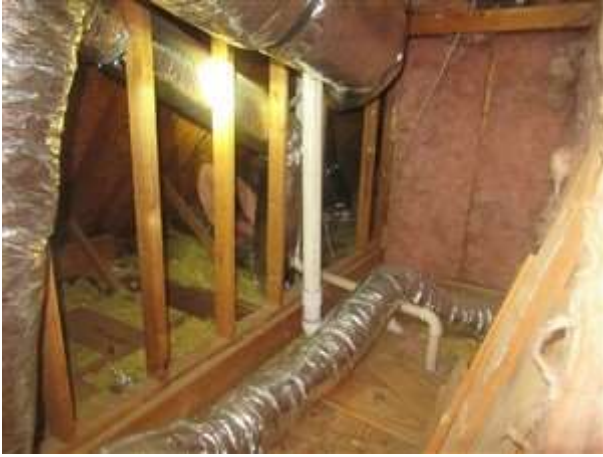
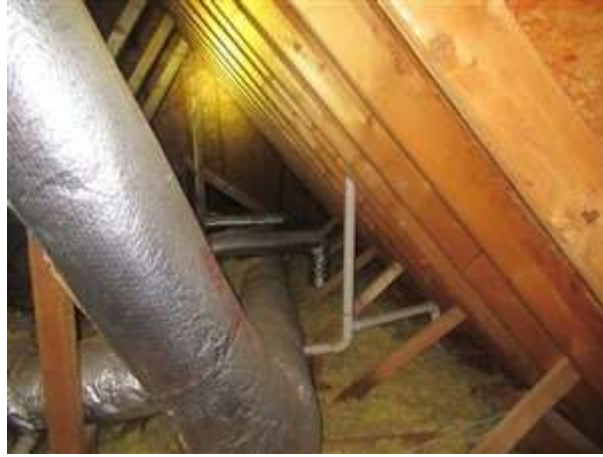
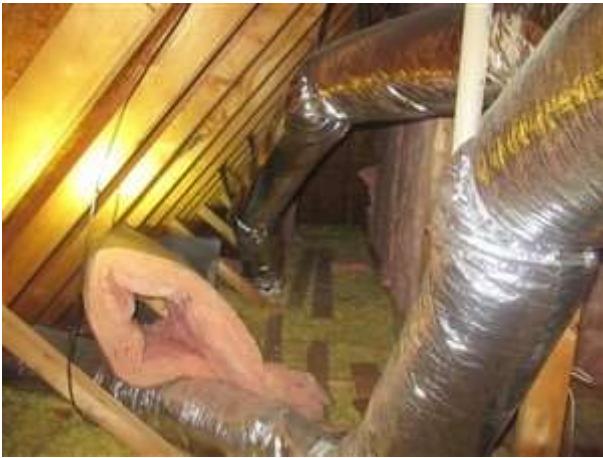
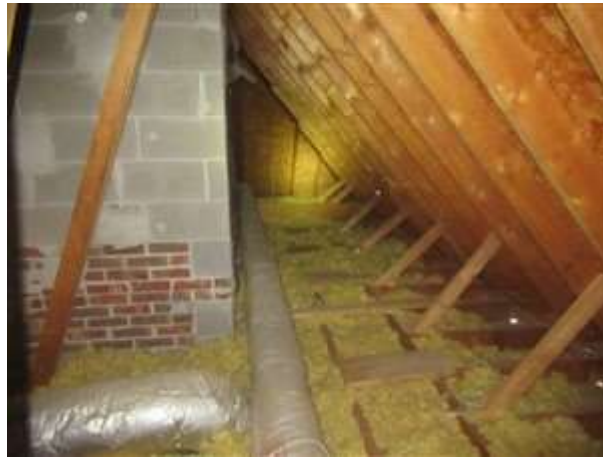
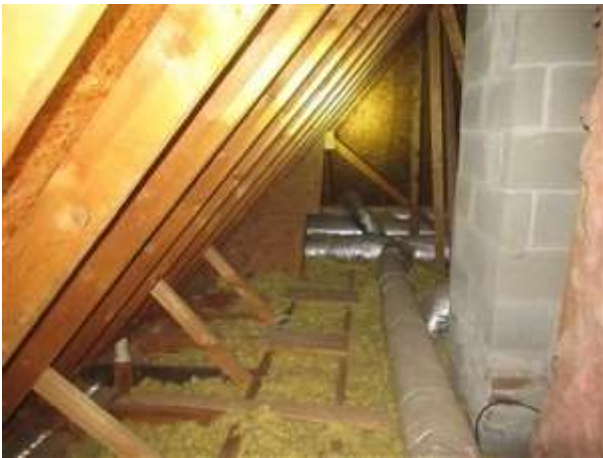
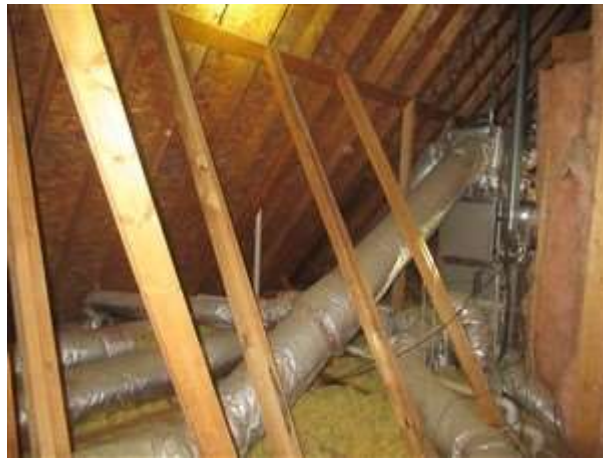
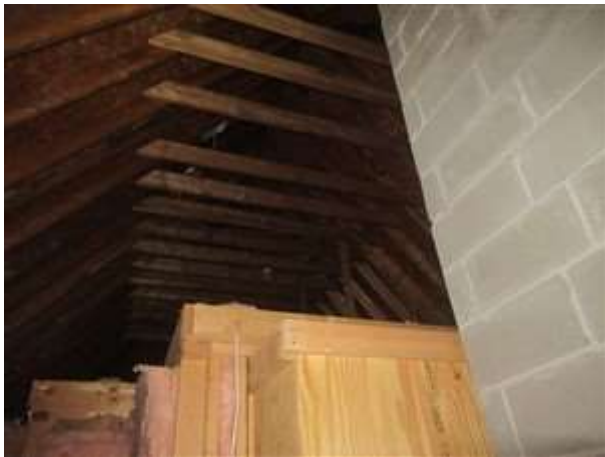
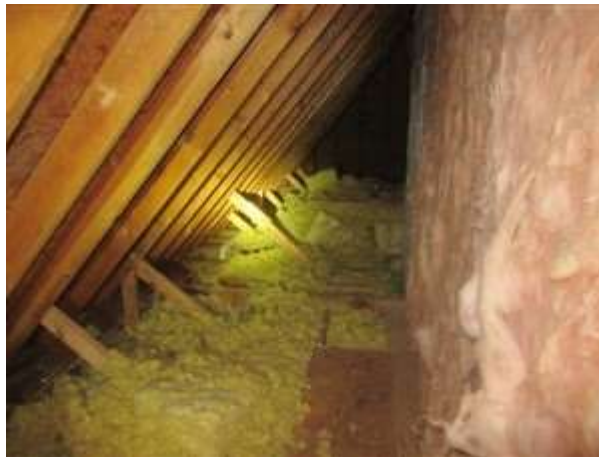
General pictures of the attic area.

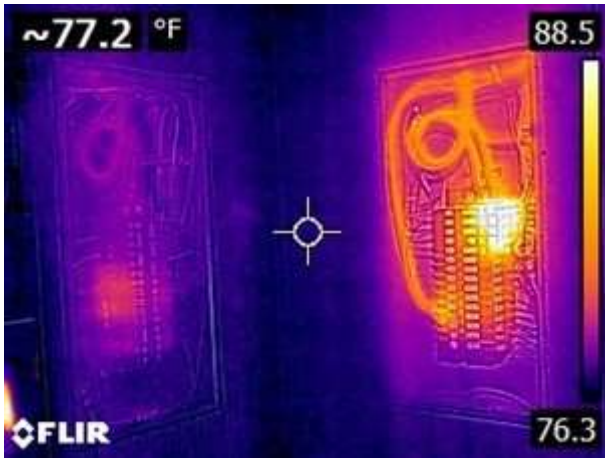
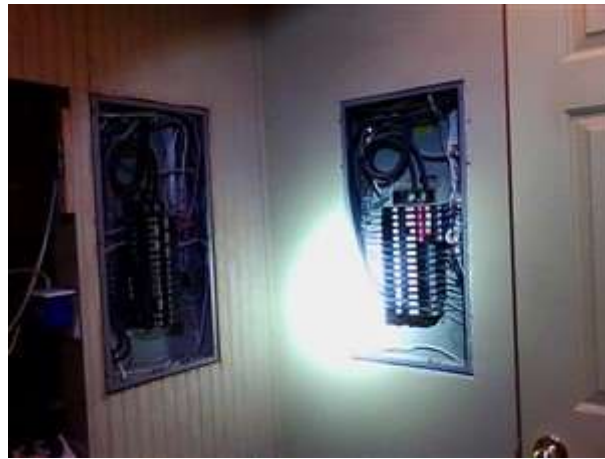
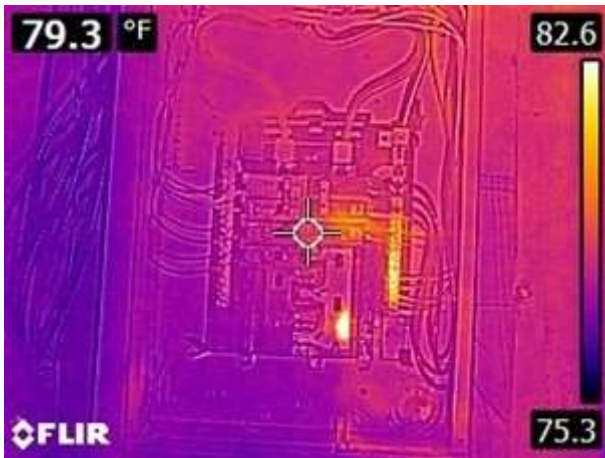
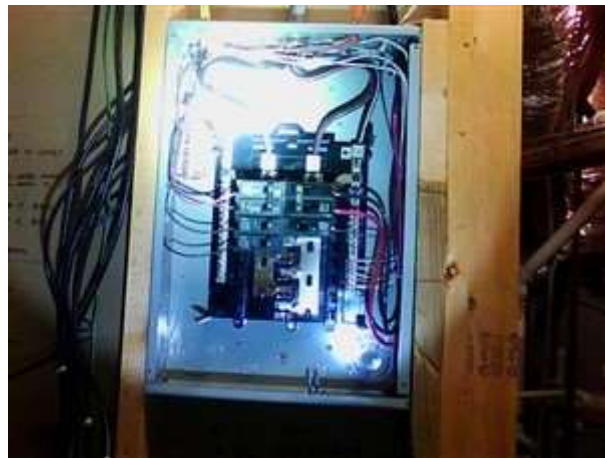
General picture of service panels. The basic infrared scan showed no abnormal anomalies at the time of the inspection.

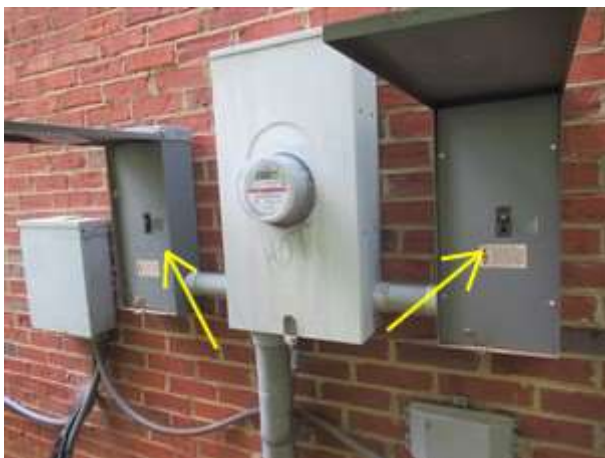
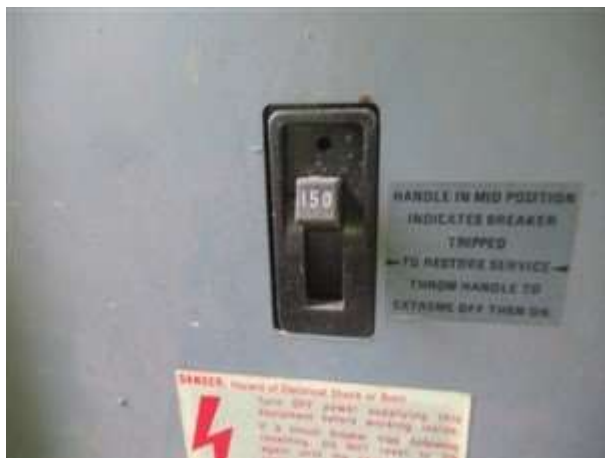
Location of the main service disconnects.

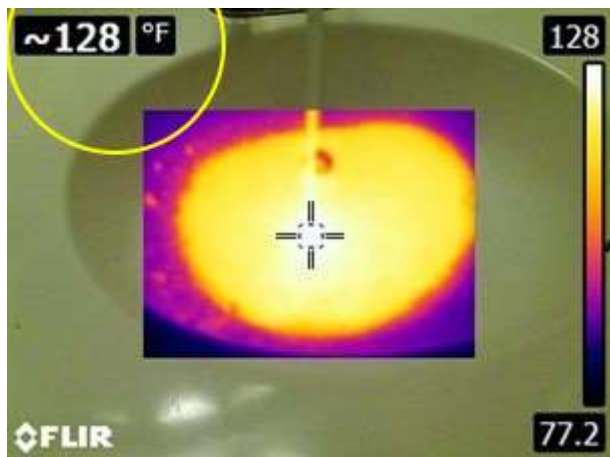
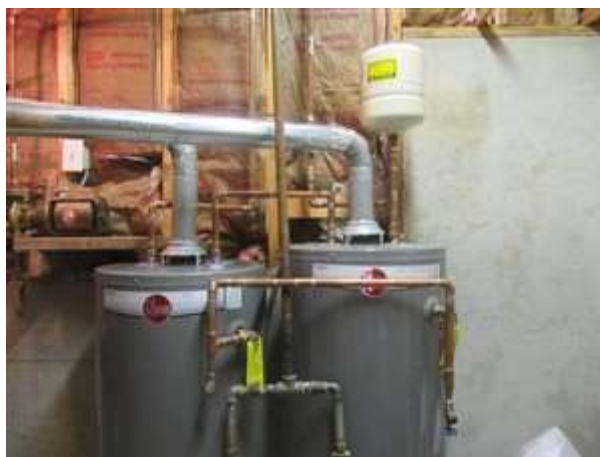
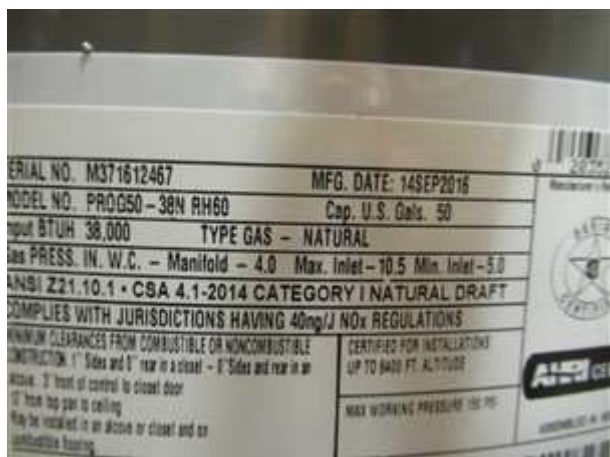
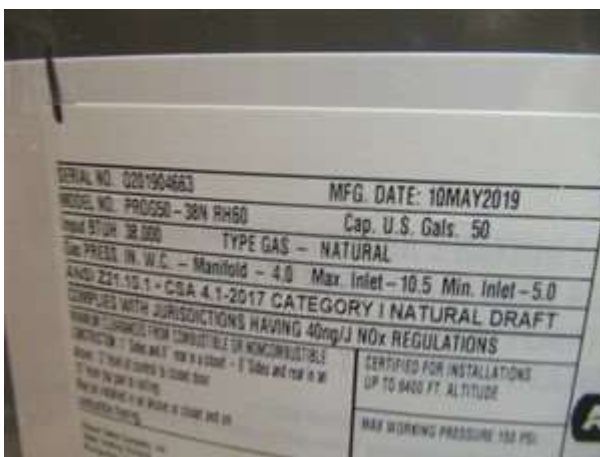
The water heaters were checked and appeared to be functional.

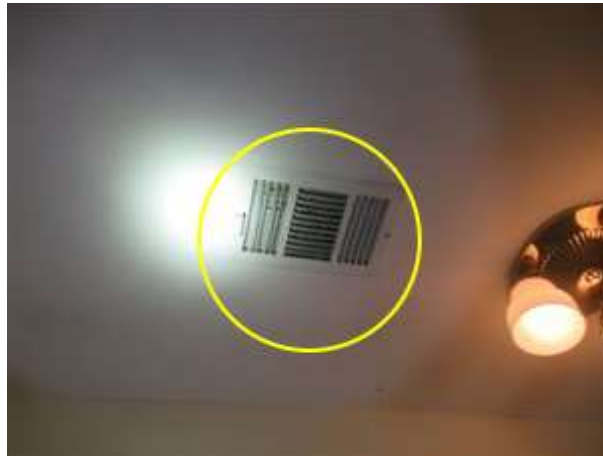
Significant amounts of what appears to be mold is visible in one or more sections of supply and/or return air ducts. If it is mold, it can be a health hazard, especially for those with allergies or respiratory problems. The Environmental Protection Agency (EPA) recommends considering having ducts professionally cleaned when "there is substantial visible mold growth inside hard surface (e.g., sheet metal) ducts or on other components of your heating and cooling system". For more information on duct cleaning in relation to indoor air quality, visit: <http://www.epa.gov/iaq/pubs/airduct.html>

Photo 39-2 Upstairs hallway by the laundry room.

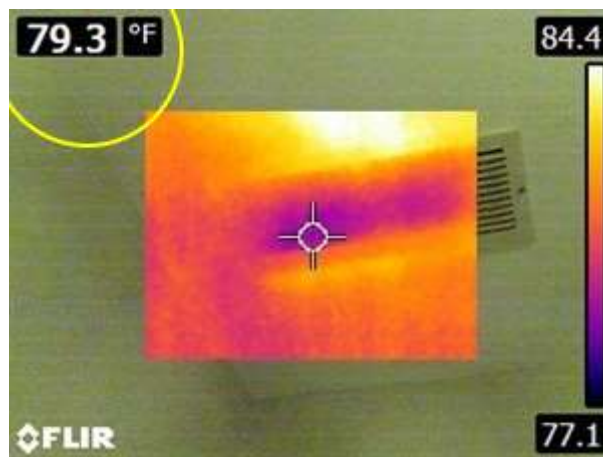
Supply air from the upstairs air conditioning system was not cool enough. It should be 14 to 20 degrees Fahrenheit cooler than at the return duct(s), or current room temperature. This may be caused by refrigerant loss, dirty coils, a failing compressor, an over sized fan, or a deficient return air system. A qualified heating and cooling contractor should evaluate and repair as necessary.

Photo 40-2 Upstairs return air temperature.

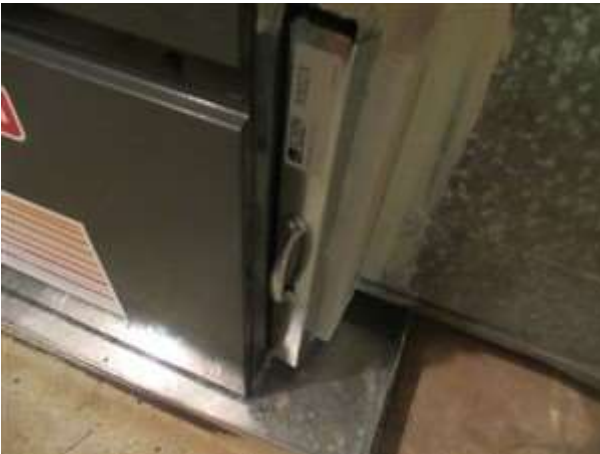
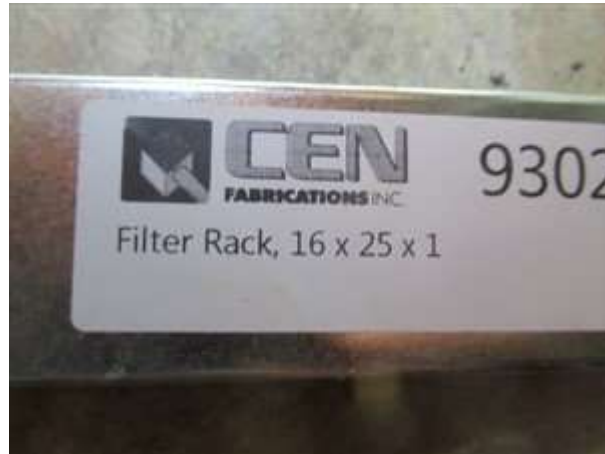
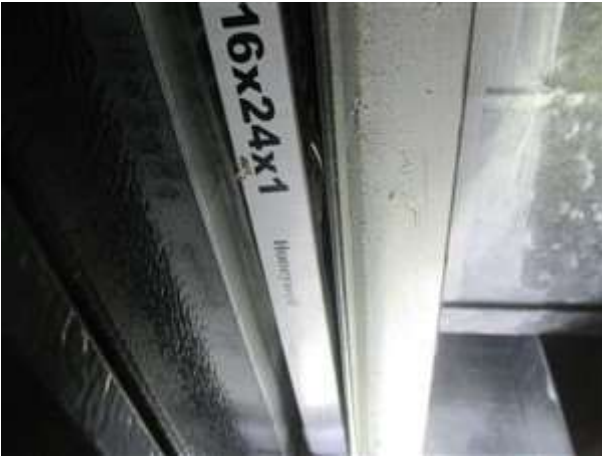
The main floor air handler's filter(s) are the wrong size. As a result, unfiltered air will flow through the system, and the heating/cooling equipment life and the indoor air quality may be reduced. Correctly sized filter(s) should be installed.

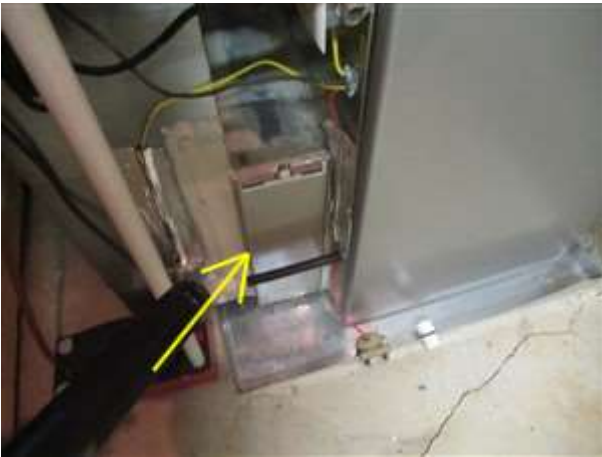
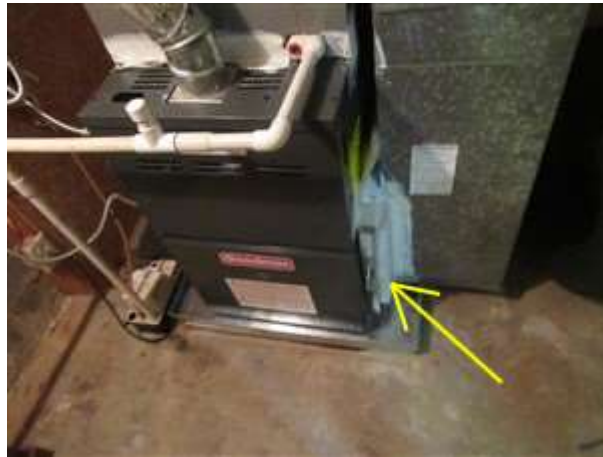
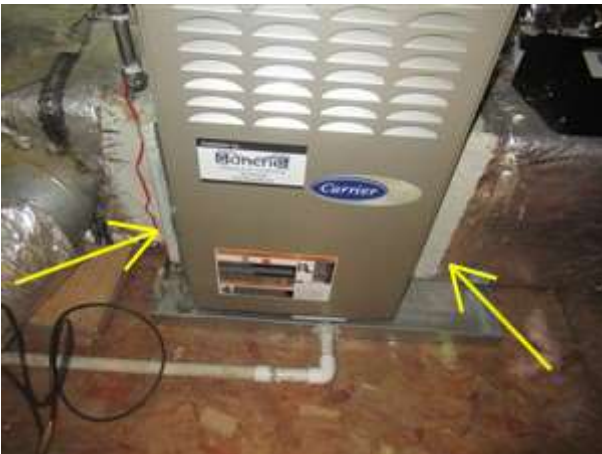
Air handler filter(s) should be checked monthly in the future and replaced or washed as necessary.

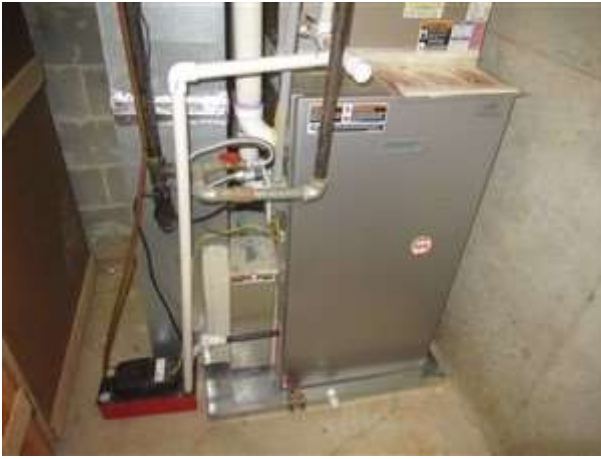
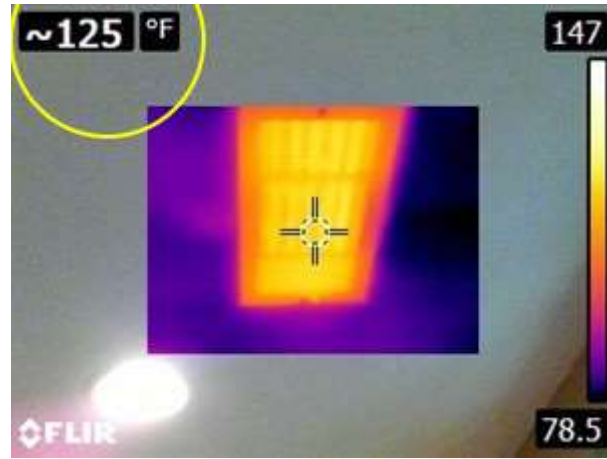
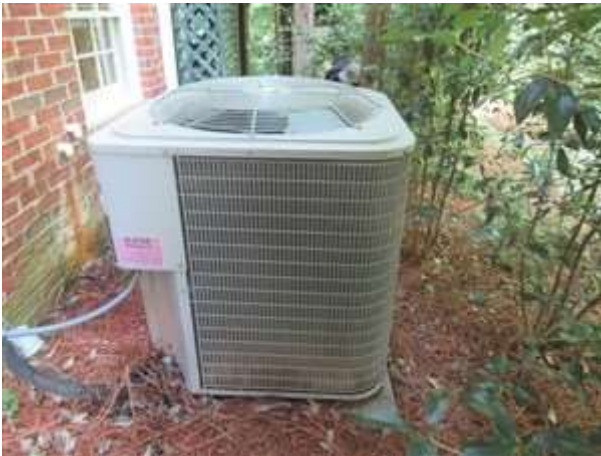
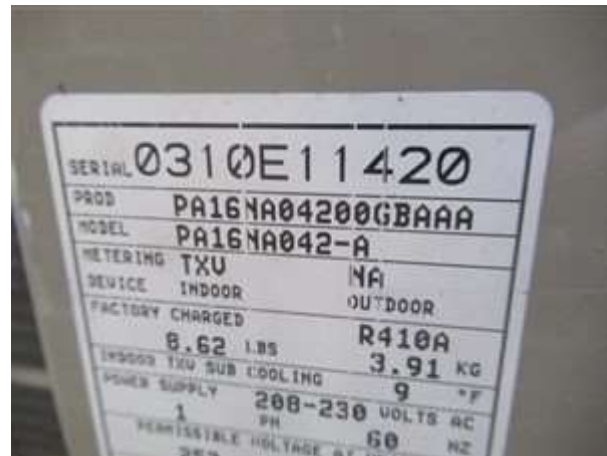
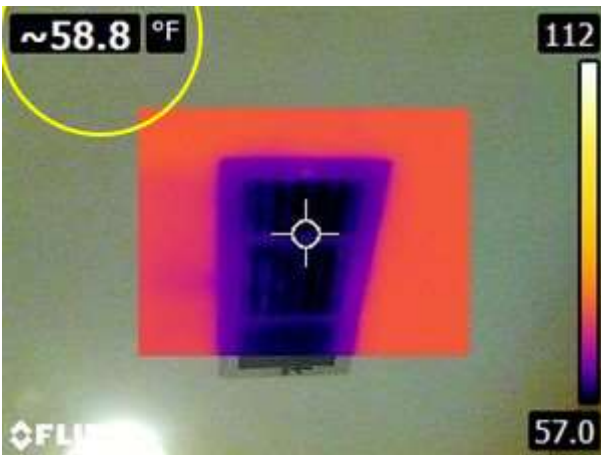
The basement heating and air conditioning system was checked and appears to be functional at the time of the inspection.

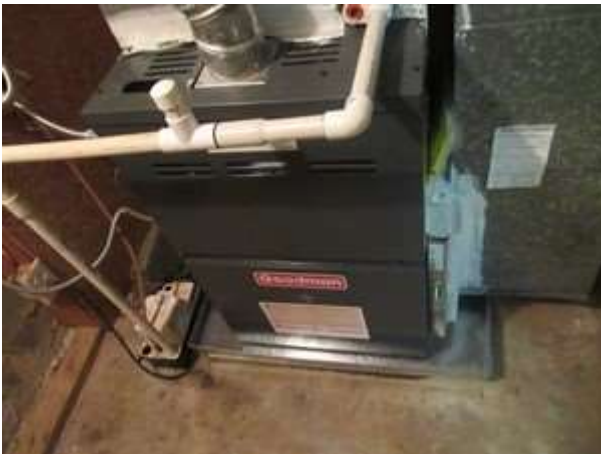
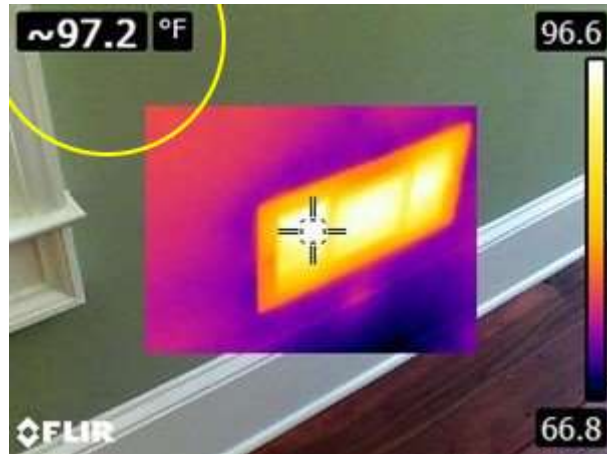
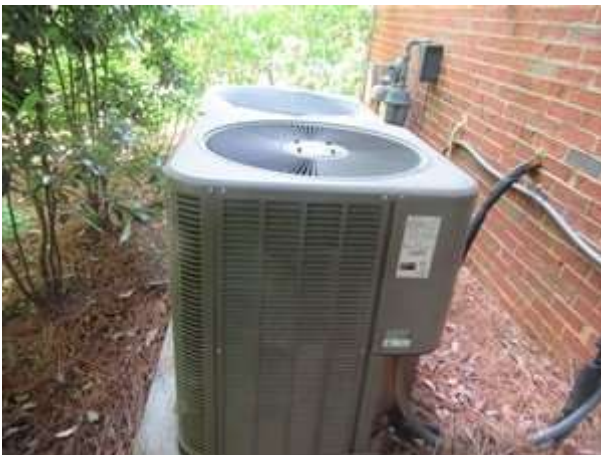
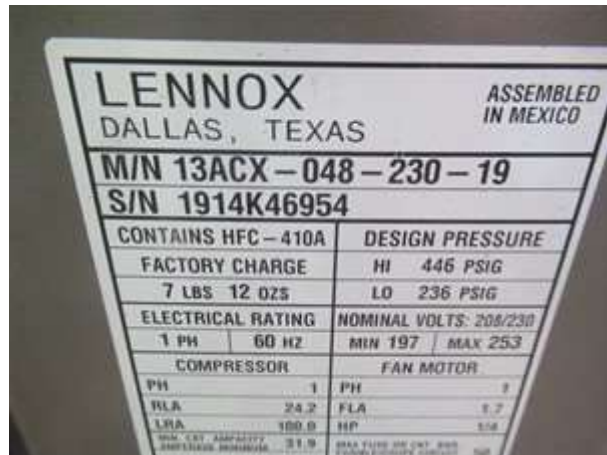
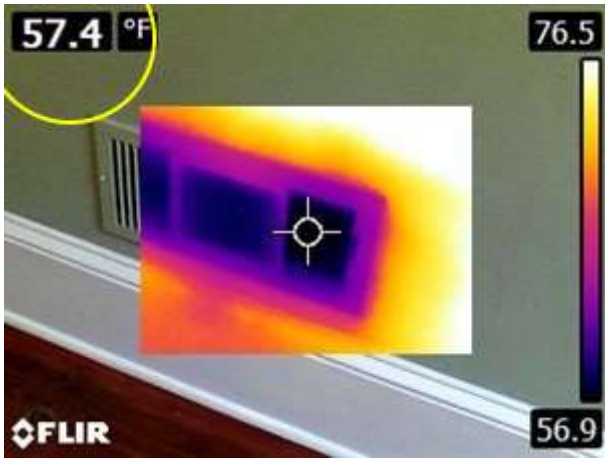
The main floor heating and air conditioning system was checked and appears to be functional at the time of the inspection.

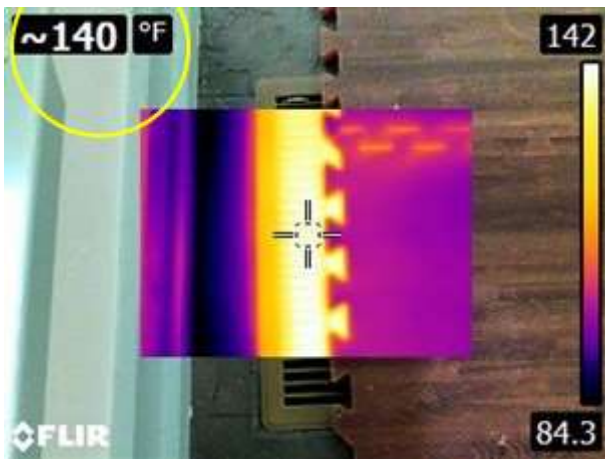
Photo 48-1

The sunroom heating and air conditioning system was checked and appears to be functional at the time of the inspection.

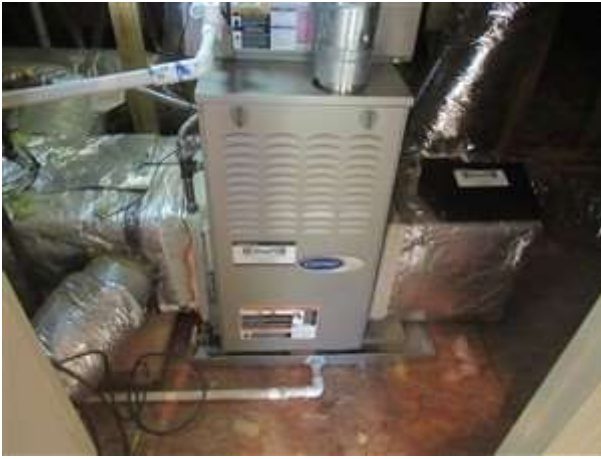
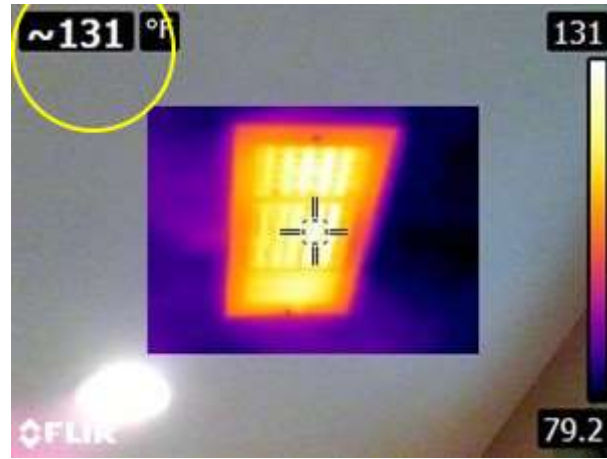
The upstairs heating system was checked and appears to be functional at the time of the inspection.

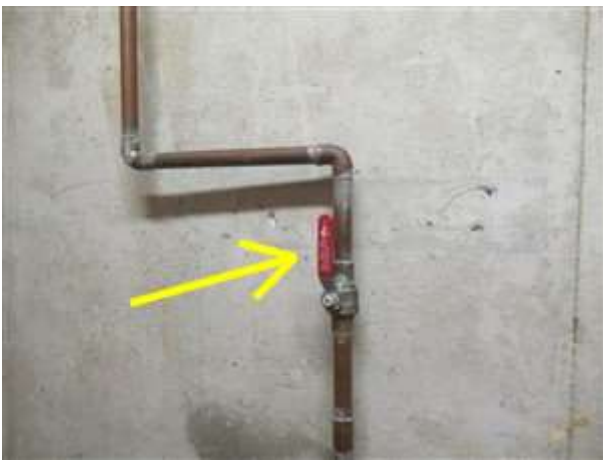
Photo 55-1

55) **i** Location of main water shut off.

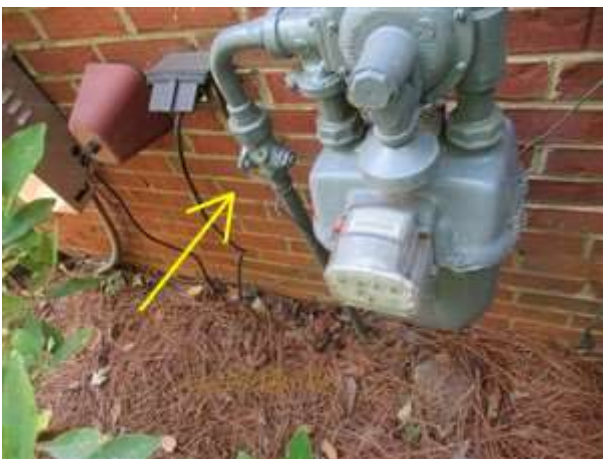
Photo 56-1

56) **i** Location of main gas shut off.

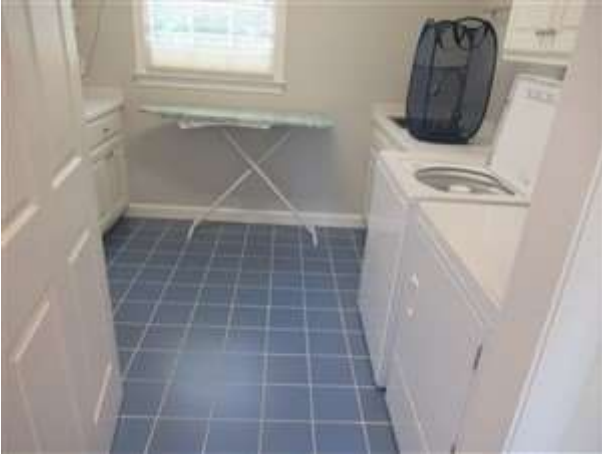
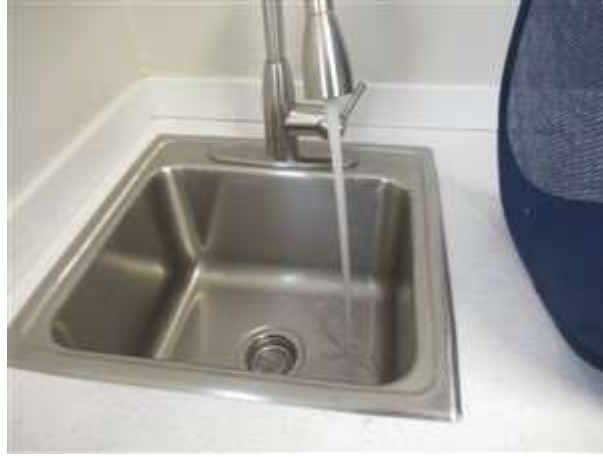
57) **i** General picture of the laundry area.

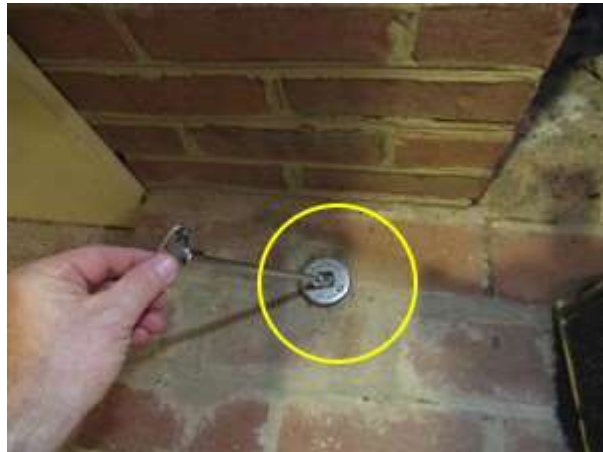
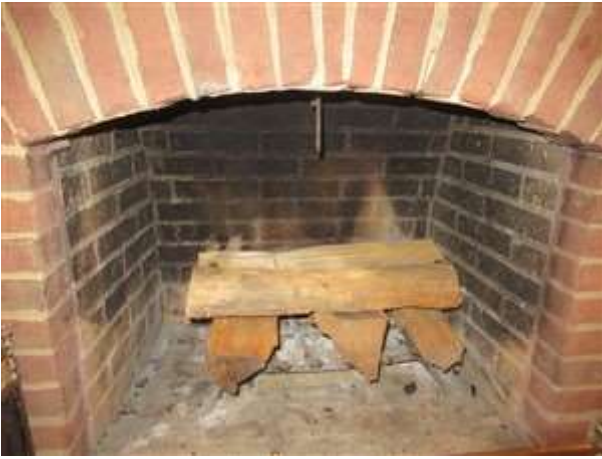
The basement fireplace gas valve was not functional at the time of the inspection. It appears dirt or debris prevents the gas key from turning the valve. Recommend having a qualified contractor evaluate and make any necessary repairs.

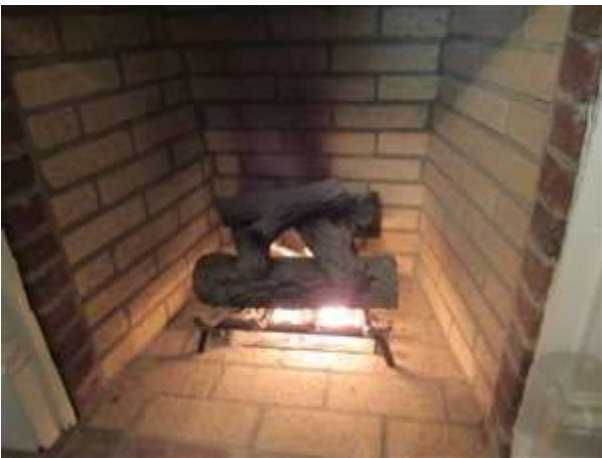
Photo 61-1

The master bathroom gas fireplace appeared functional at the time of the inspection.

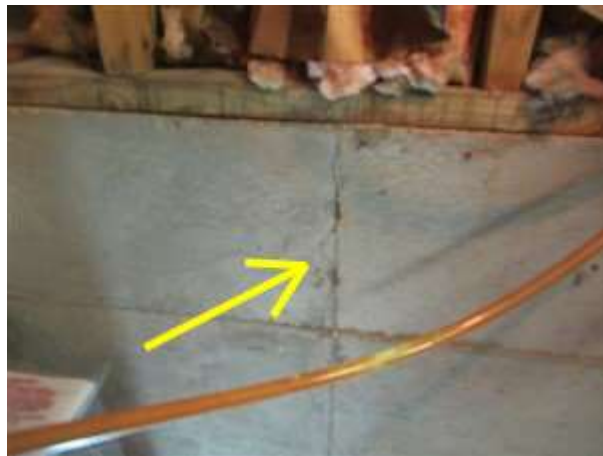
Photo 63-2

Minor cracks were found in the basement concrete foundation wall. These do not appear to be a structural concern at the time of the inspection and no water intrusion was noticed at the time of the inspection. Recommend monitoring these in the future.

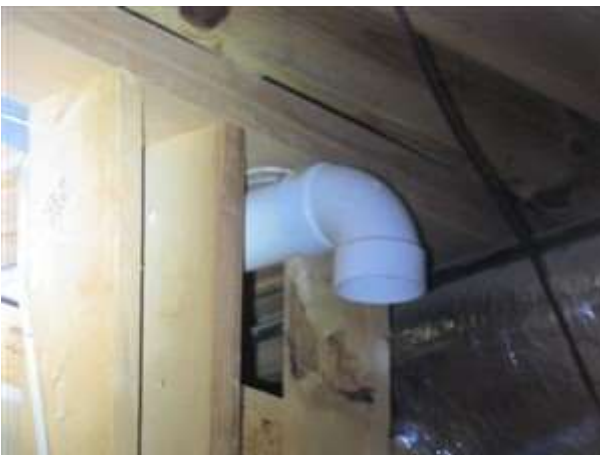
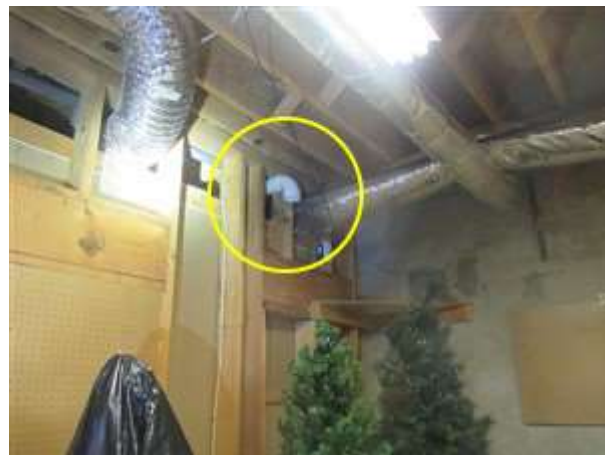
There is a pipe in the basement unfinished area on the left side of the house. The seller did not know what this was used for in the past.

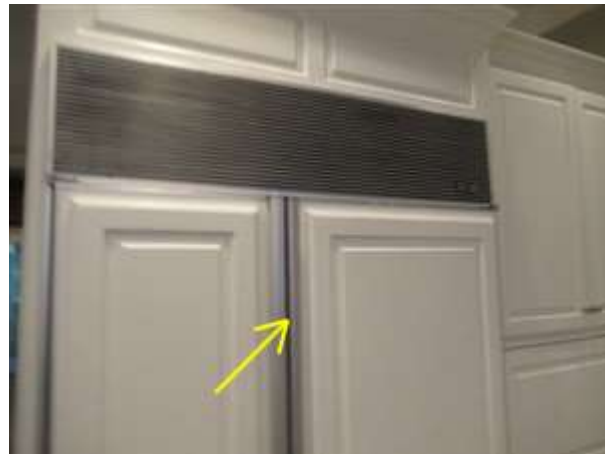
Photo 68-2

The refrigerator door does not appear to close completely. Recommend having a qualified contractor evaluate and make any necessary repairs.

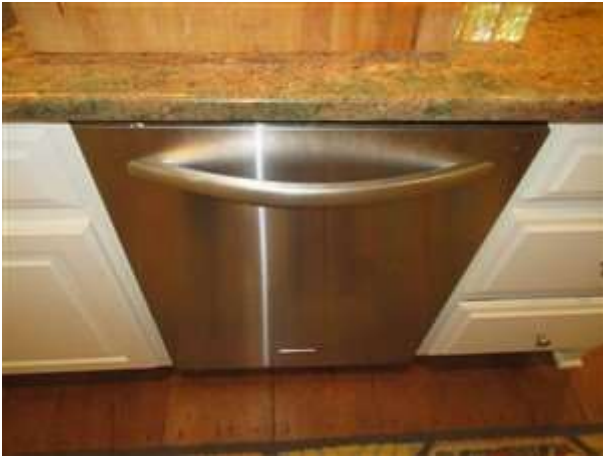
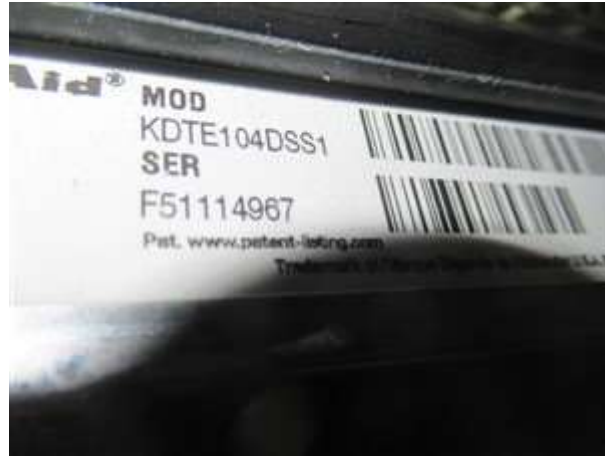
The dishwasher was checked and appears to be functional.

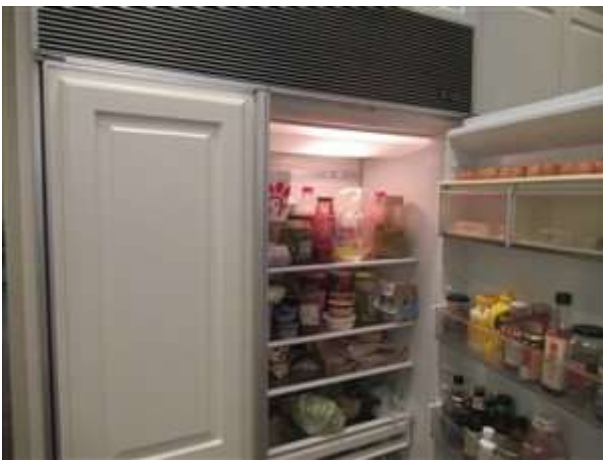
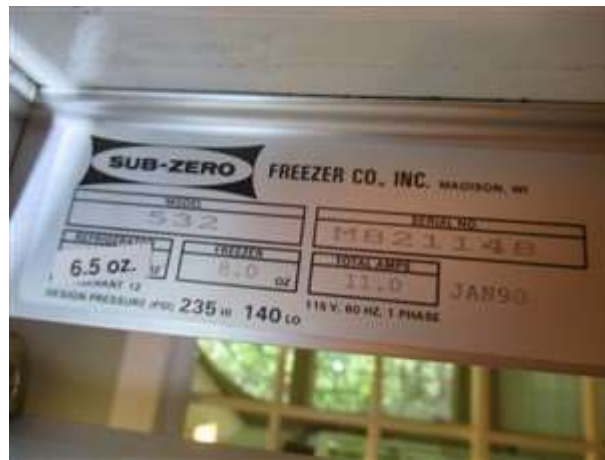
71) **i** The refrigerator was checked and appears to be functional.

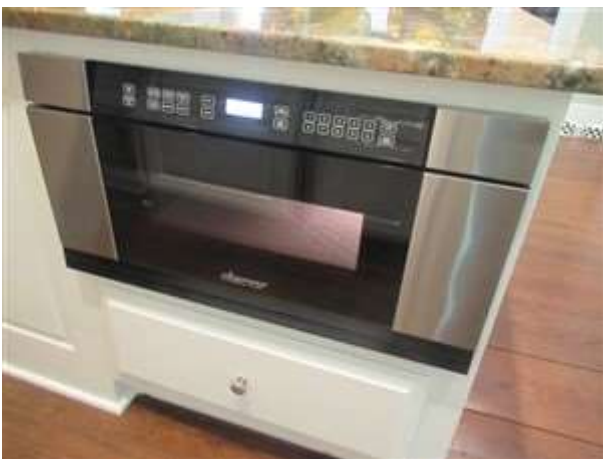
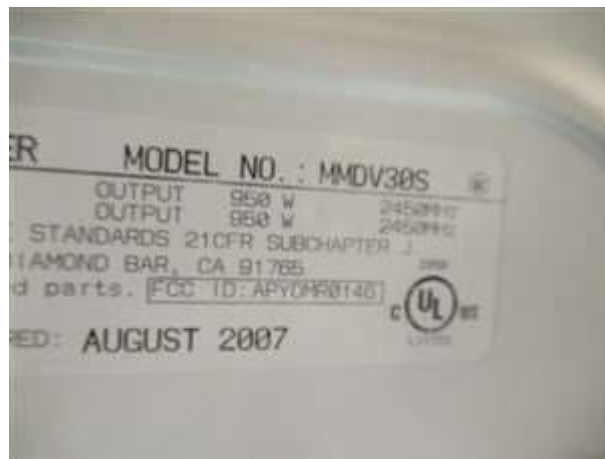
72) **i** The microwave was checked and appears to be functional.

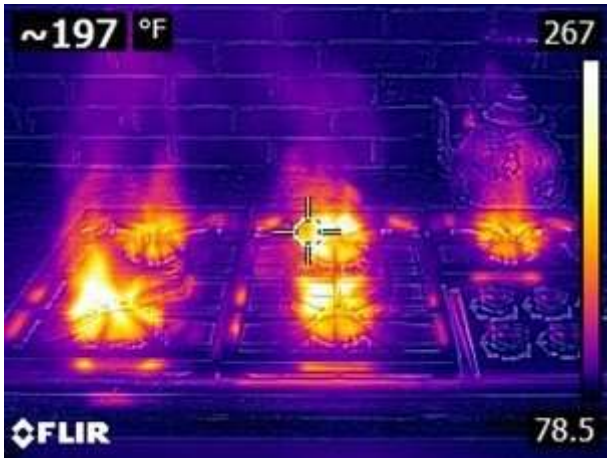
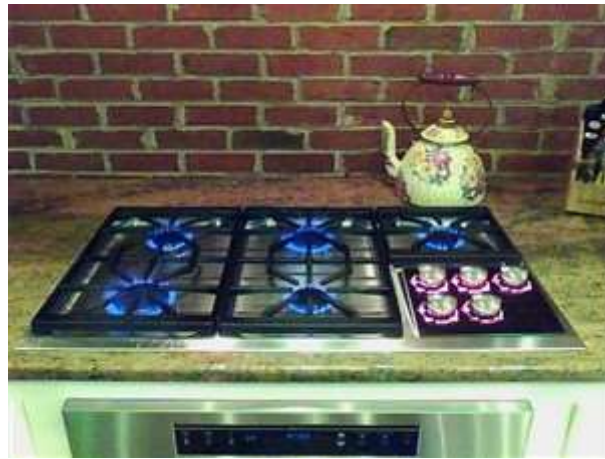
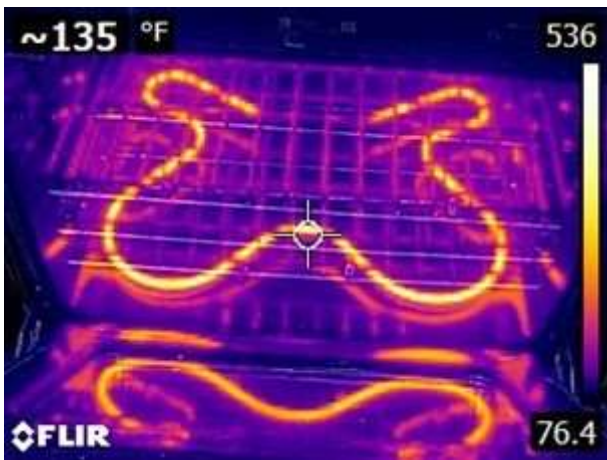
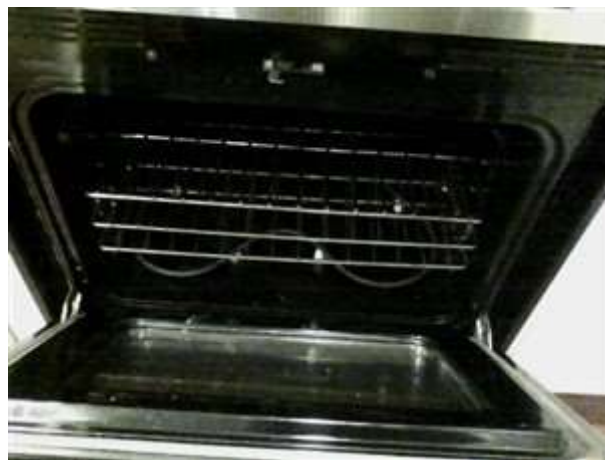
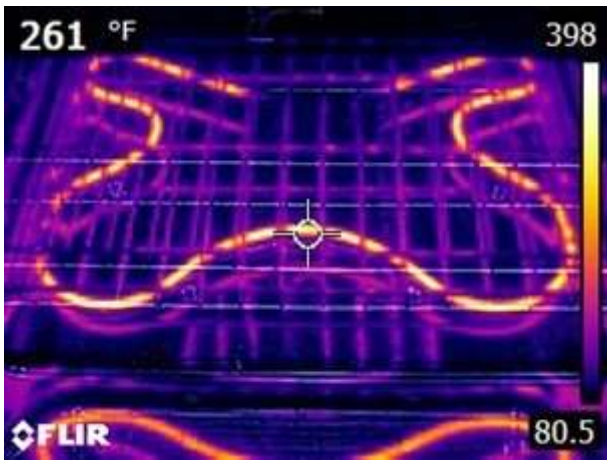
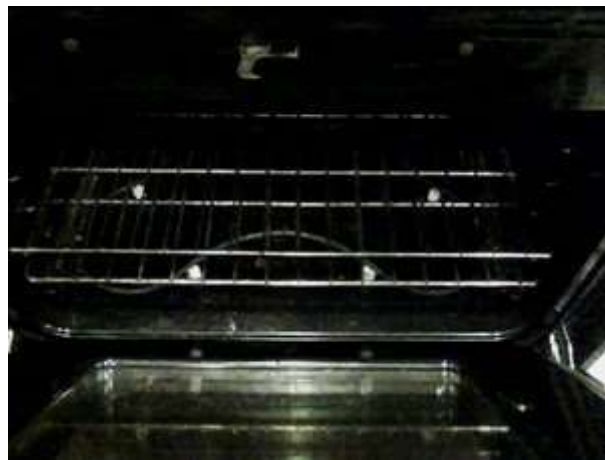
73) **i** The range/ovens were checked and appeared to be functional.

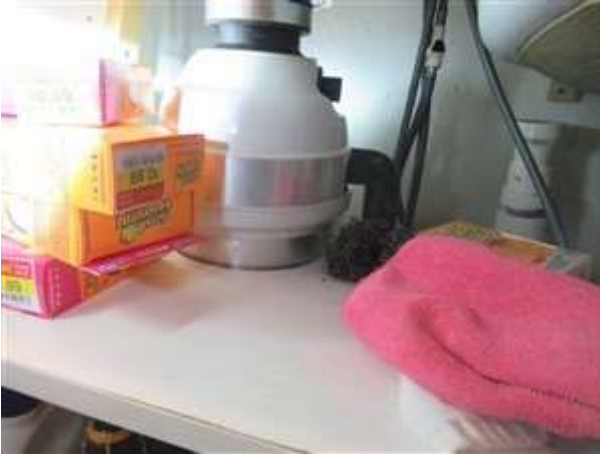
Photo 74-1

Food disposal appeared functional at time of inspection.

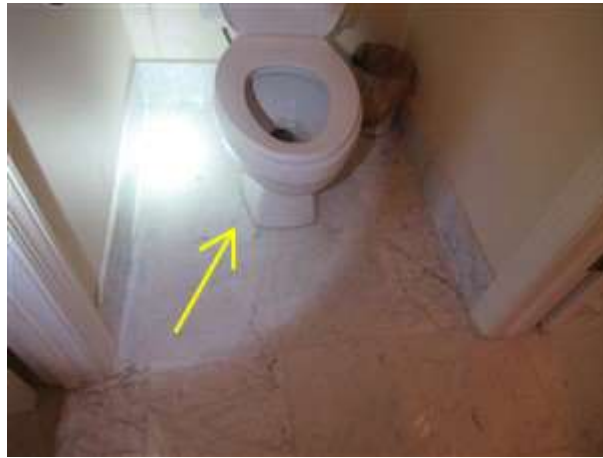
Photo 76-2

The upstairs front bedroom bathroom and one jack and jill bathroom toilets are loose. A qualified contractor should remove the toilet(s) for further evaluation and repairs if necessary. A new wax ring should be installed and toilet(s) should be securely anchored to the floor to prevent movement and leaking.

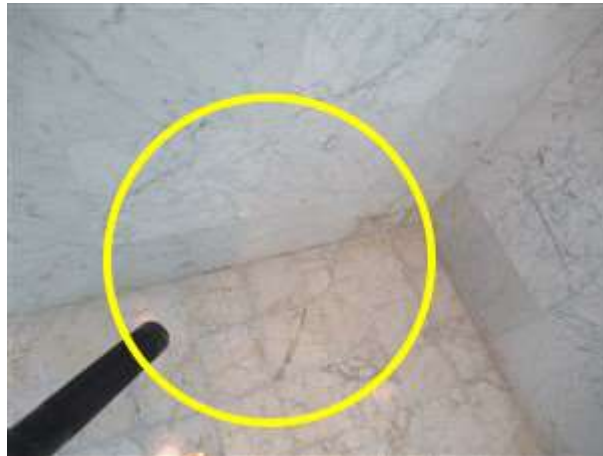
**Photo 79-2**

Caulk is missing or deteriorated along the base of the front bedroom bathroom shower, where flooring meets the shower. It should be replaced where deteriorated and/or applied where missing to prevent water intrusion and damage to the floor structure.
