Property Inspection Report

**Property address: 420 Fawn Glen Dr
Roswell GA 30075-6353**

Inspection date: Thursday, July 16, 2020

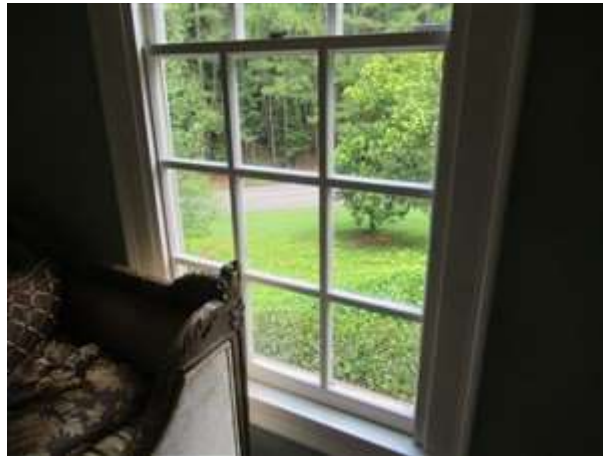
**Photo 86-2**

One or more windows that were built to open, will not open, or open only minimally due to their being painted shut, damaged and/or deteriorated in some way. Repairs should be made as necessary, and by a qualified contractor if necessary so windows open fully, and open and close easily.

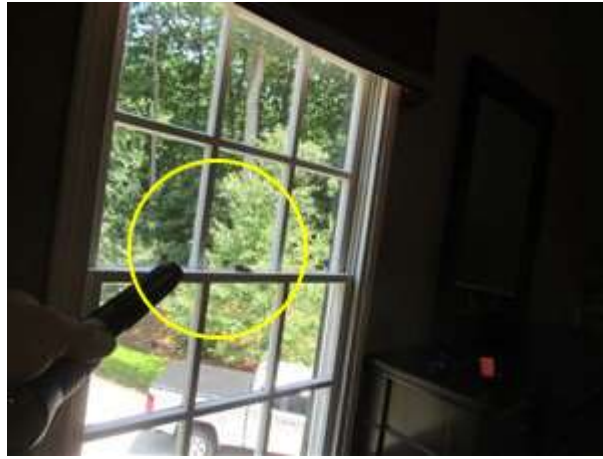
Photo 88-2

Glass in one window in the upstairs front bedroom above the garage, is broken. A qualified contractor should replace glass where necessary.

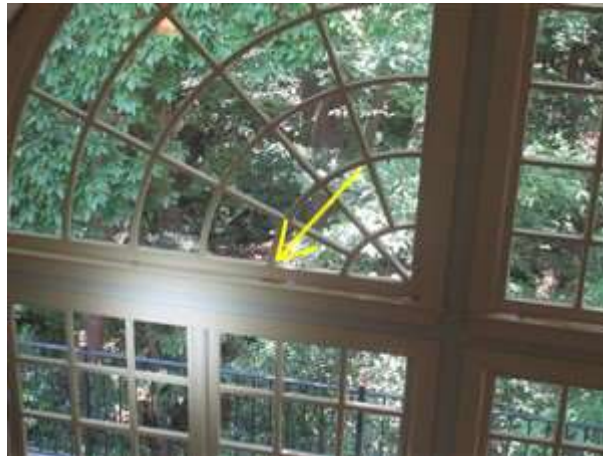
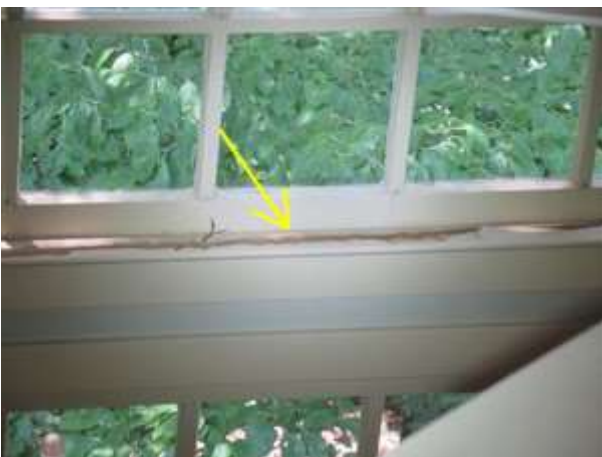
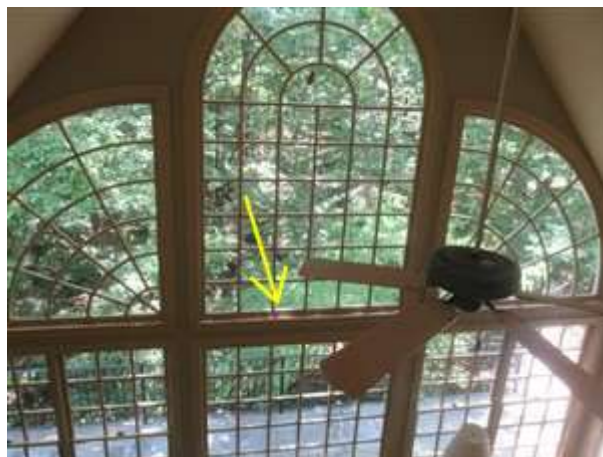
Water stains were noticed on the ledge of the family room back window frame. This is an indication of water intrusion, possibly from the window frame. Recommend having a qualified contractor evaluate and make any necessary repairs.

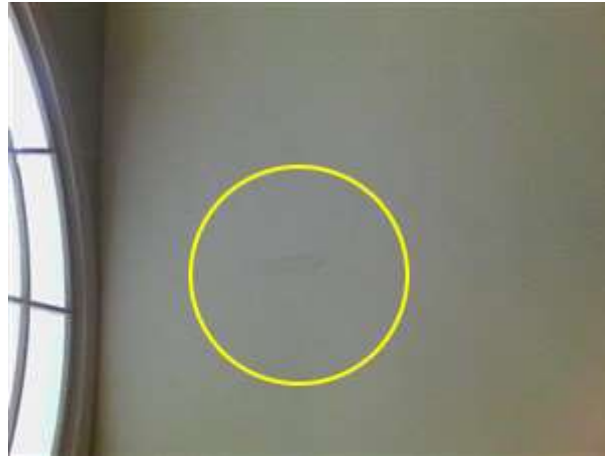
Photo 90-2

Stains were found in one or more ceiling areas. However, no elevated levels of moisture were found. The stain(s) may be due to past roof and/or plumbing leaks. Recommend asking the property owner(s) about this, and monitoring the stained area(s) in the future, especially after heavy or prolonged rain. If elevated moisture is found in the future, a qualified contractor should evaluate and repair as necessary.

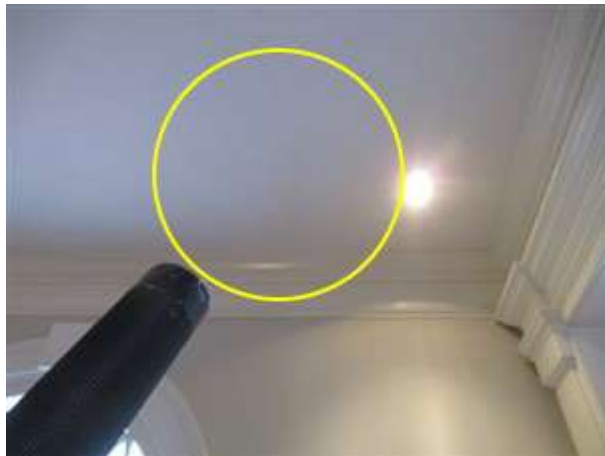
Photo 91-2 Foyer

Minor cracks or nail pops were found in ceilings in one or more areas. They do not appear to be a structural concern, but the client(s) may wish to repair these for aesthetic reasons.

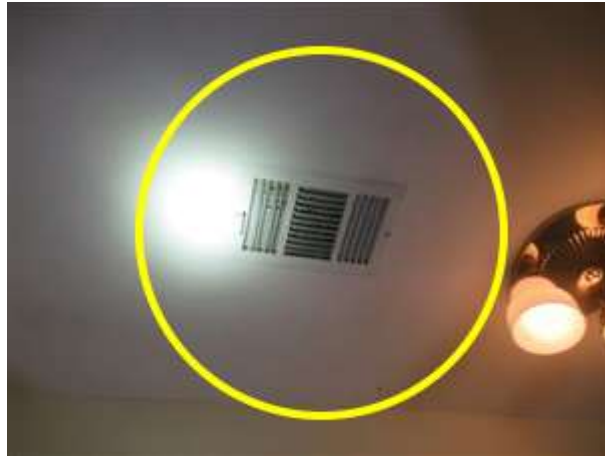
A visible biological growth suspected to be mold was found in several places.

Photo 94-2 Upstairs hallway by the laundry room.

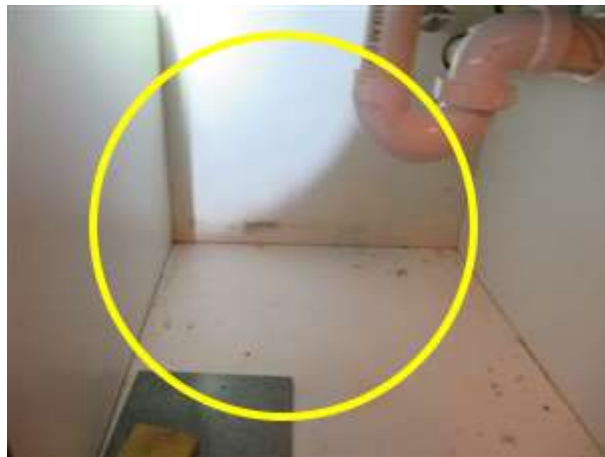
Photo 94-4 Basement bar sink cabinet.

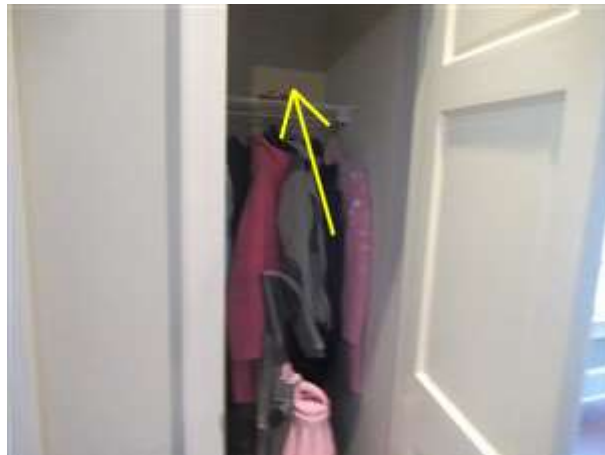
Photo 94-6 Right side foyer closet.
