Property Inspection Report

Property address: **120 Grand Cres**

Inspection date: **Wednesday, August 5, 2020**

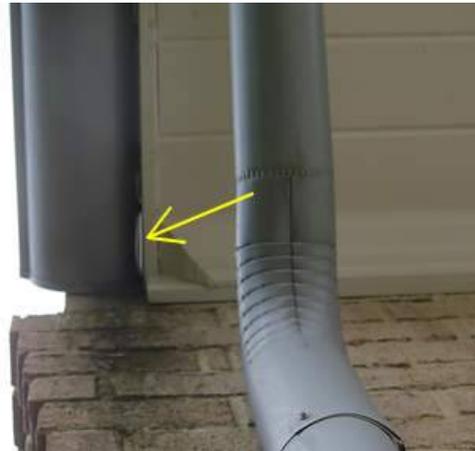
Photo 9-2

Kick-out flashing was missing at one or more locations. Such flashing should be located at the bottom of slopes where roof surfaces intersect with exterior walls above. It directs rainwater away from exterior walls and into gutters so that rainwater is less likely to run down the front surfaces of siding or flow behind siding. Recommend that a qualified contractor install kickout flashings where missing and per standard building practices (min. 4" x 4").

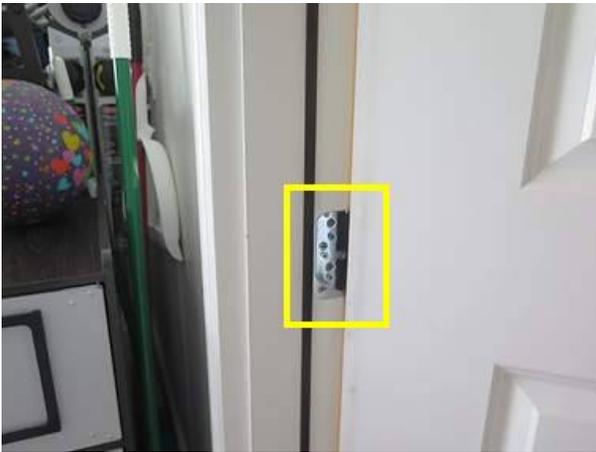
Photo 12-1

12) 🛠️ The garage-house door isn't equipped with an automatic closing device such as spring hinges. This door should close and latch automatically to prevent vehicle fumes from entering living spaces and/or to slow the spread of fire from the garage to living spaces. A qualified contractor should install automatic closing device(s) as necessary, and as per standard building practices, so this door closes and latches automatically.

IRC 09 & 12 - (302.5.1)

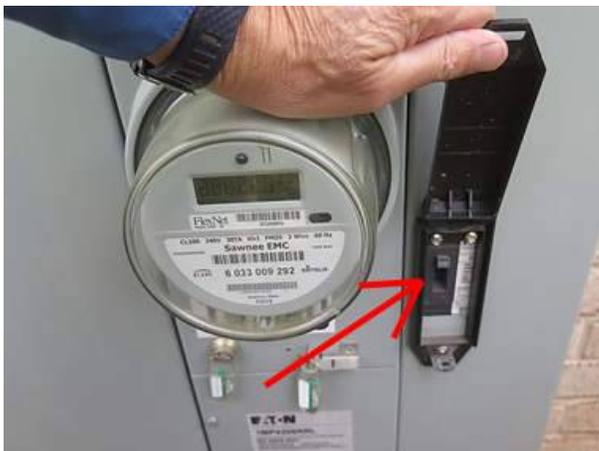
Photo 17-1

17) Photo of the main service switch located adjacent to the meter on the right side of the home.

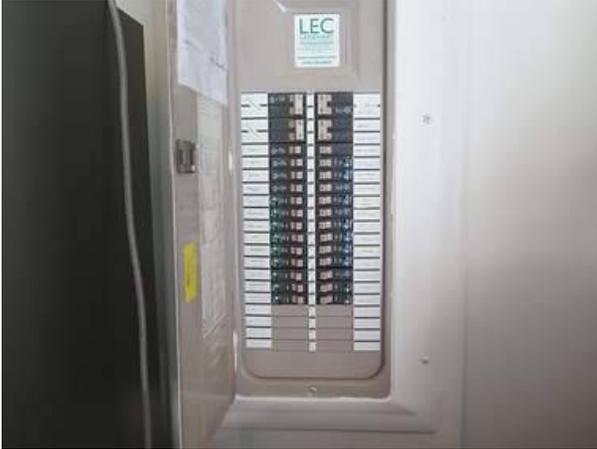
Photo 18-1

18) Photos of the service panel located in the garage.

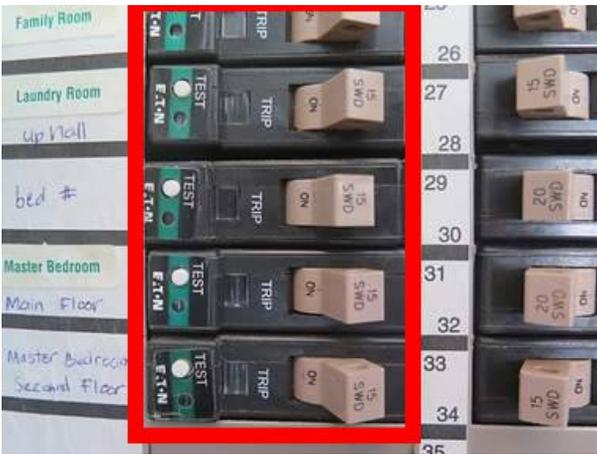
Photo 19-1

19) **i** Arc fault circuit interrupter breakers were installed in one or more electrical panels. These devices reduce the risk of fire by protecting against overheated or arcing receptacles (outlets) or light fixtures. The inspector did not test or trip these devices during the inspection because doing so would disrupt power to clocks, computers and other devices that might be in use. Recommend that upon taking occupancy, and periodically in the future, the homeowner test AFCI breakers per the manufacturer's guidelines.

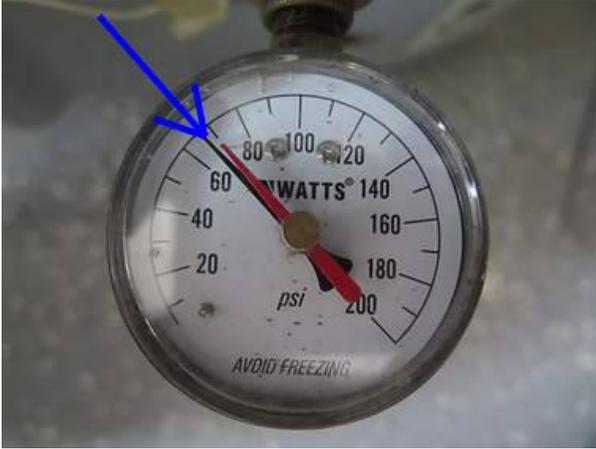
Photo 20-1

20) **i** General picture of the water pressure as tested. 40-80 PSI is considered the normal range for water pressure in a home, and most plumbers recommend 50-60 PSI.

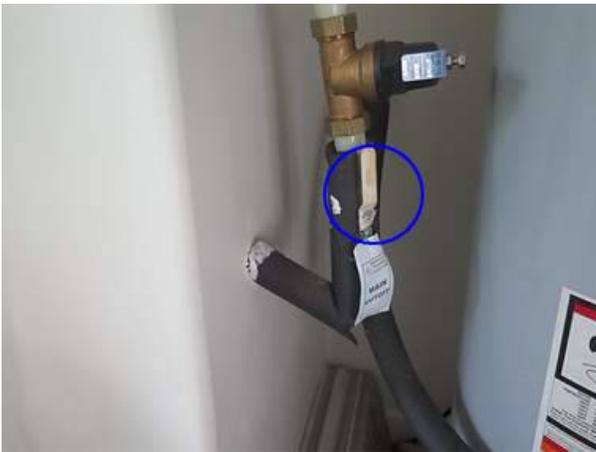
Photo 21-1

21) **i** Photo of the main water shut-off valve located adjacent to the water heater.

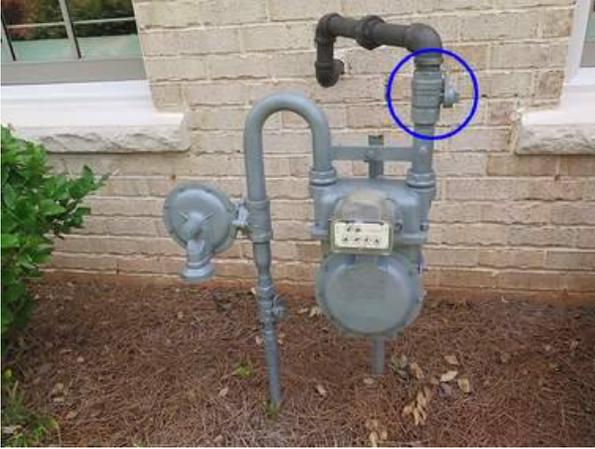
Photo 22-1

22) **i** Photo of the main natural gas shut-off valve adjacent to the meter along the right side of the home.

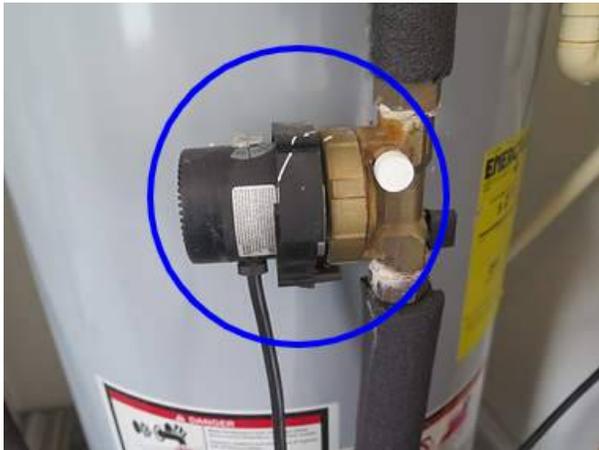
Photo 24-1

24) i A circulating pump was installed for the hot water supply. It is intended to make hot water immediately available when faucets are turned on. Timers

are typically integrated with these pumps, and should be configured so water circulates only at desired times for better energy efficiency. The client should familiarize themselves with the timer's operation and configure it as needed. Note that this is a specialty item and excluded from this inspection. The inspector did not determine if it was serviceable or operable.

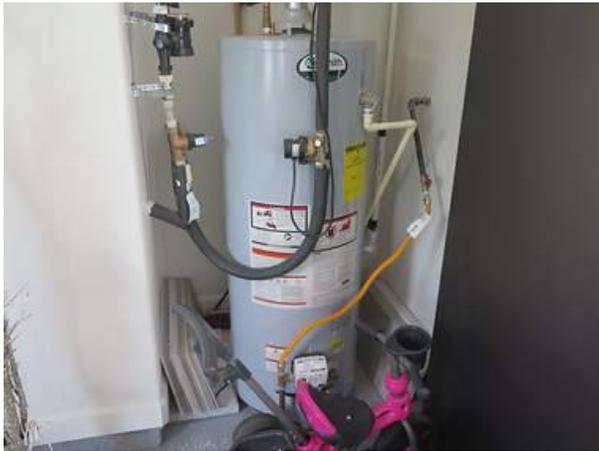
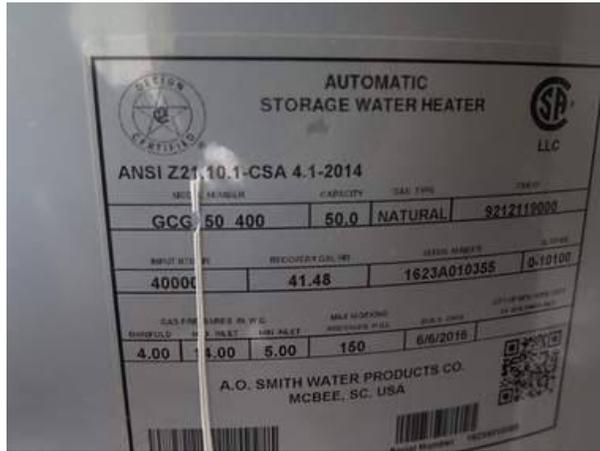
General photos of the water heater located in the garage area.

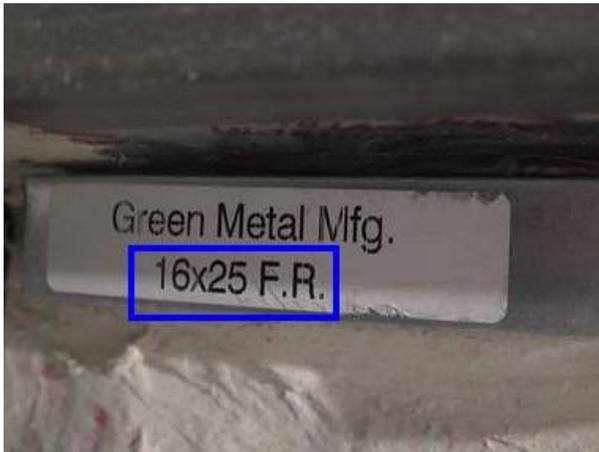
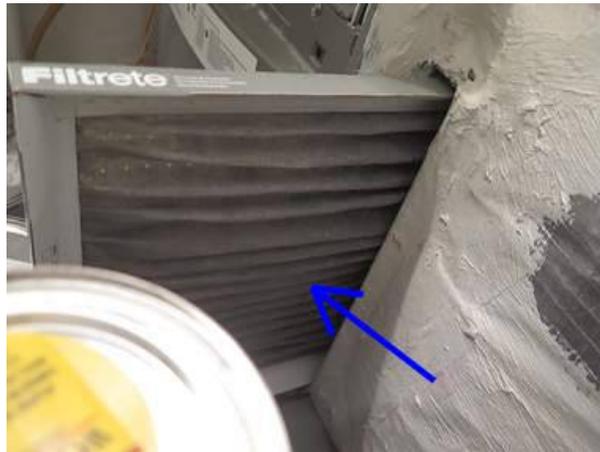
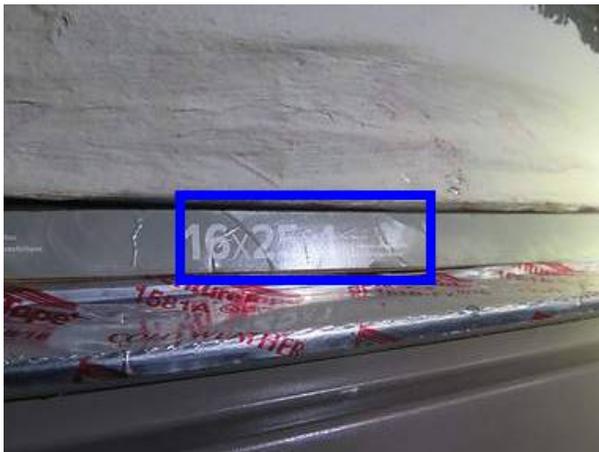
Recommend replacing or washing HVAC filters upon taking occupancy depending on the type of filters installed. Regardless of the type, recommend checking filters monthly in the future and replacing or washing them as necessary. How frequently they need replacing or washing depends on the type and quality of the filter, how the system is configured (e.g. always on vs. "Auto"), and on environmental factors (e.g. pets, smoking, the frequency of house cleaning, number of occupants, the season).

NOTE filter size - 16x25x1

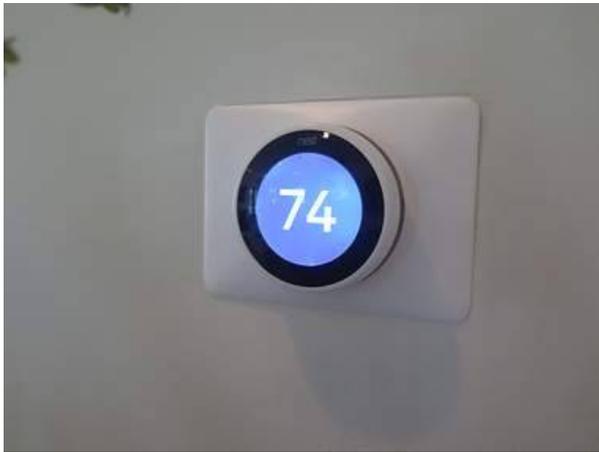
Photo 29-1

This property is equipped with one or more smart or programmable thermostats. Recommend the clients become familiar with the operation and functions of these devices.

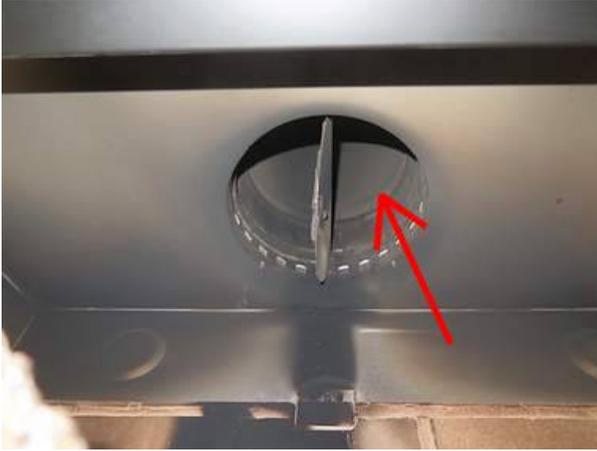
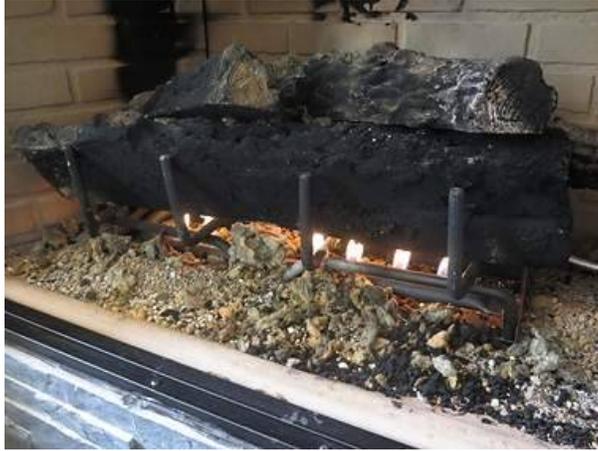
Condition of gas-fired fireplaces or stoves: Required repair, replacement and/or evaluation (see comments below)

Recommend that the client review all available documentation for gas-fired fireplaces and stoves. Depending on how they are operated (for routine heating versus ambiance), such appliances normally need servicing annually or every few years. Consult with the property owner and/or a qualified specialist to determine if service is needed now.

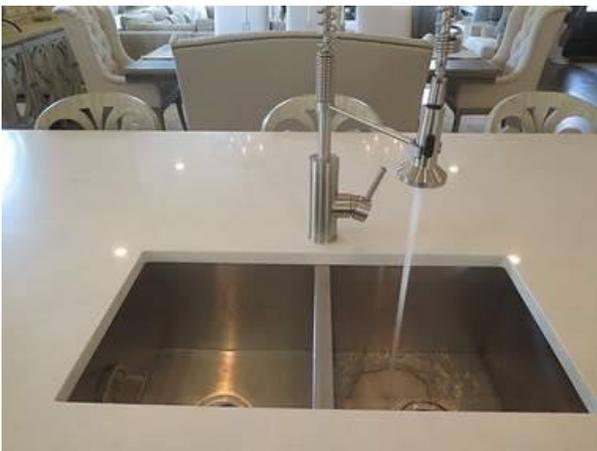
Photo 32-1

32) **i** The sink faucet and sprayer were checked and appeared to be functional.

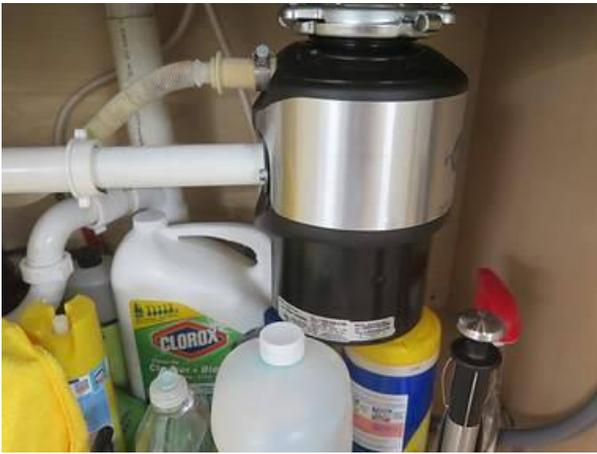
Photo 33-1

33) **i** The under-sink food disposal was checked and appeared to be functional.

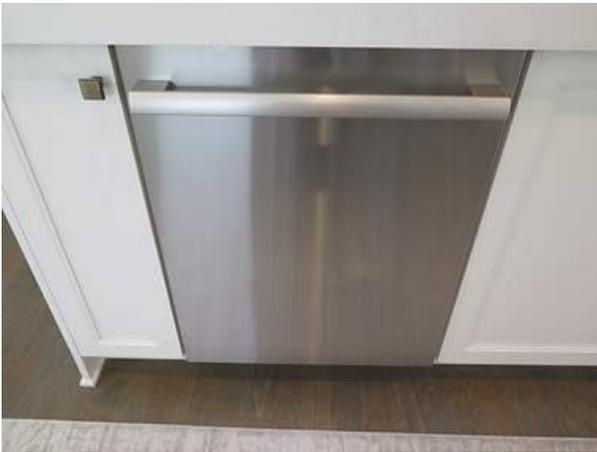
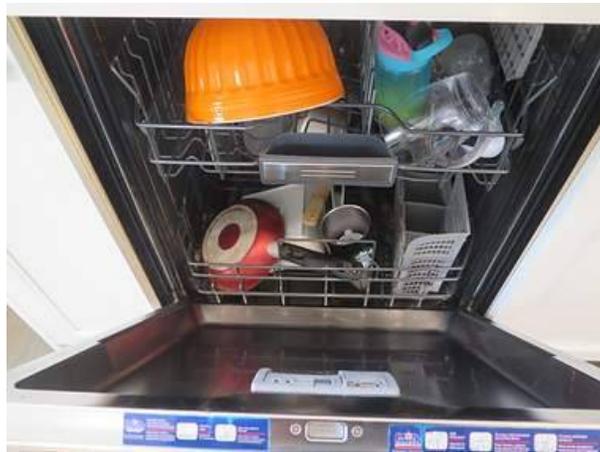
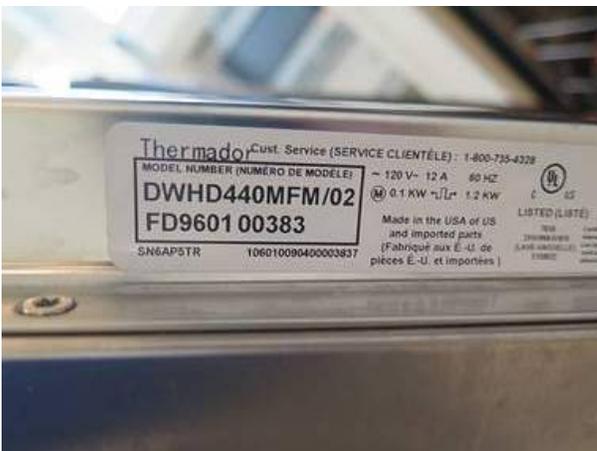
The dishwasher was checked and appeared to be functional.

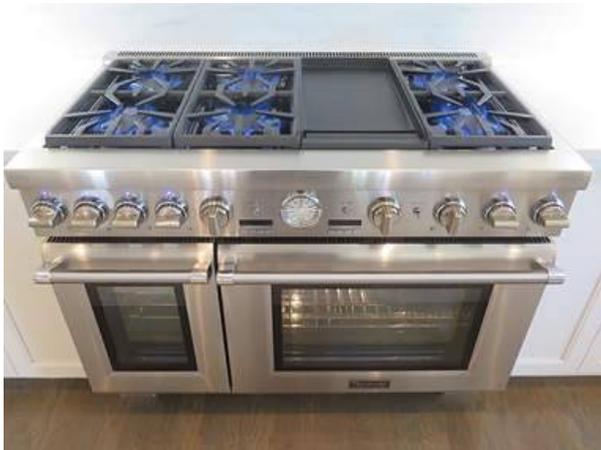
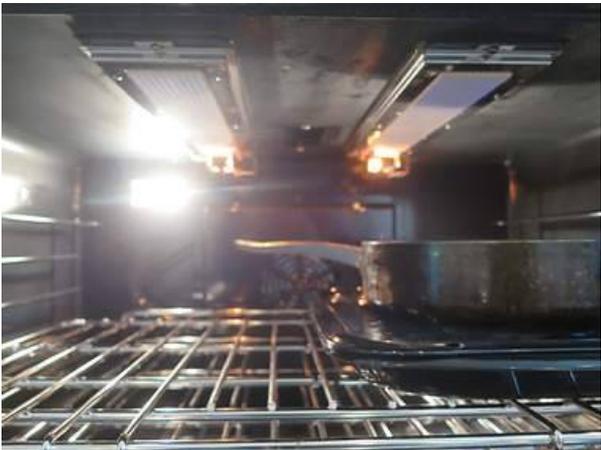
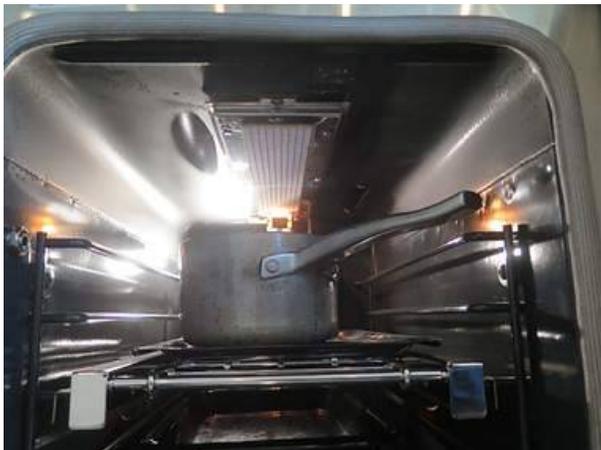
The range/oven was checked and appeared to be functional.

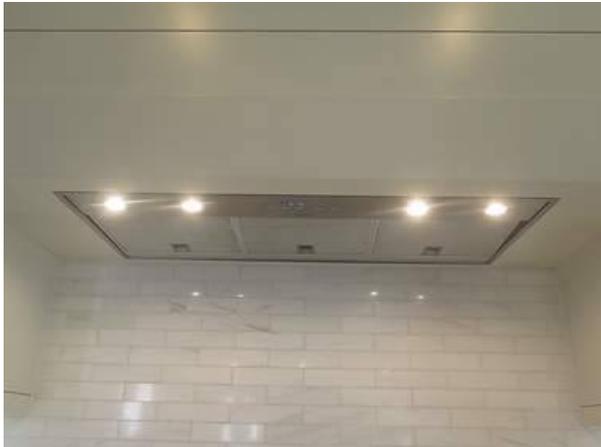
Photo 36-1

36) **i** The exhaust hood/fan was checked and appeared to be functional.

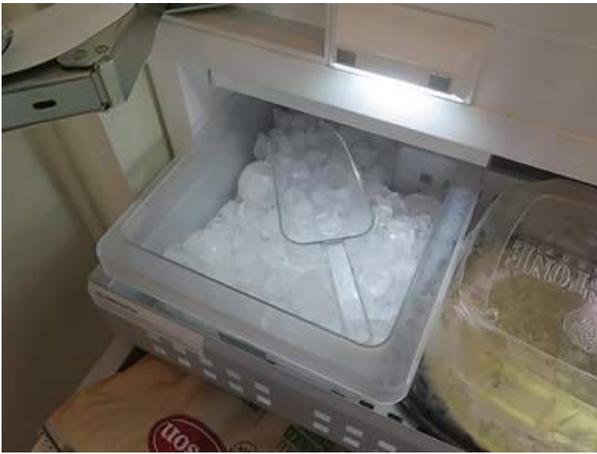
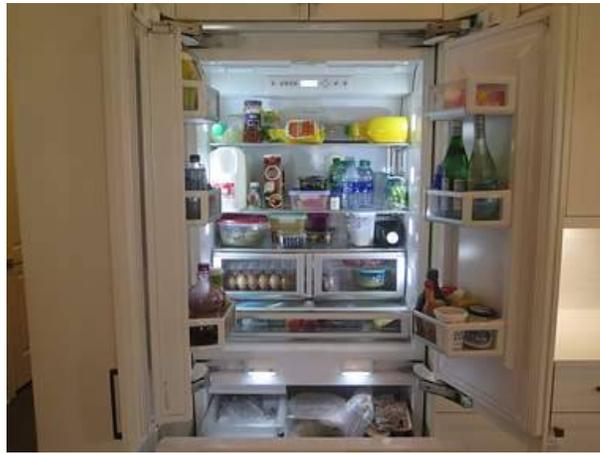
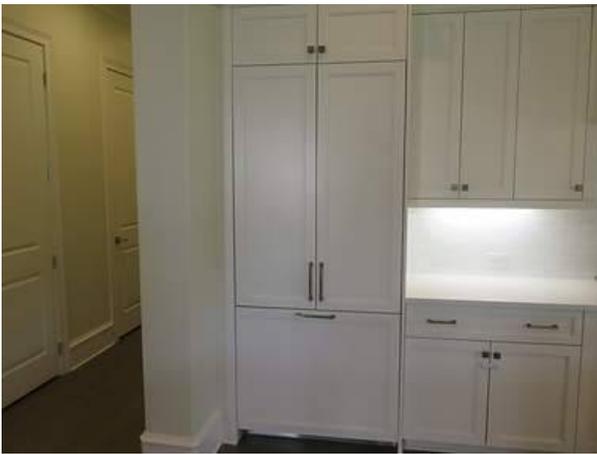
37) **i** The refrigerator was checked and appeared to be functional.

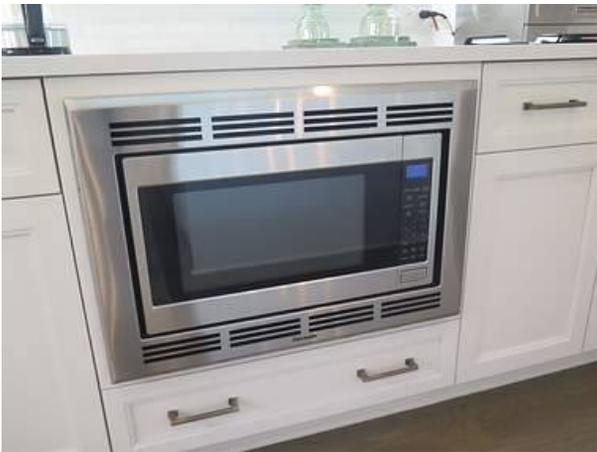
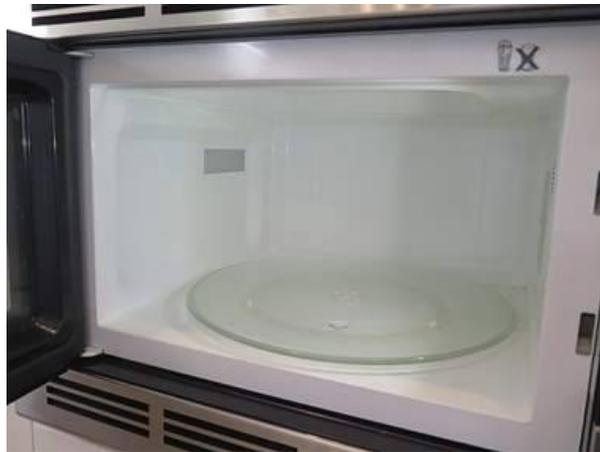
The microwave was checked and appeared to be functional.

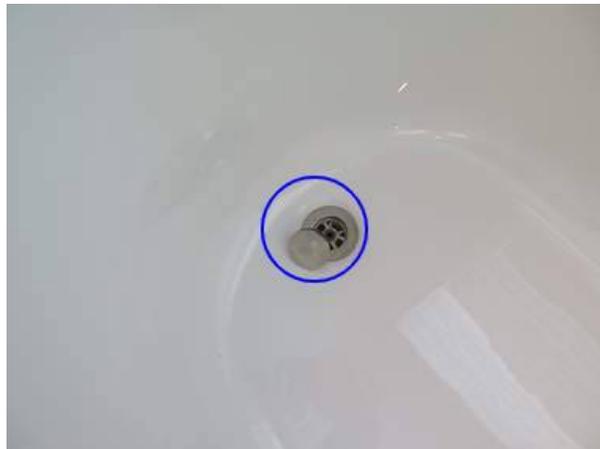
Photo 40-2

40) 🛠️ The bathtub drain stopper mechanism at location(s) #D and E was loose. Recommend that a qualified person repair or replace as necessary.

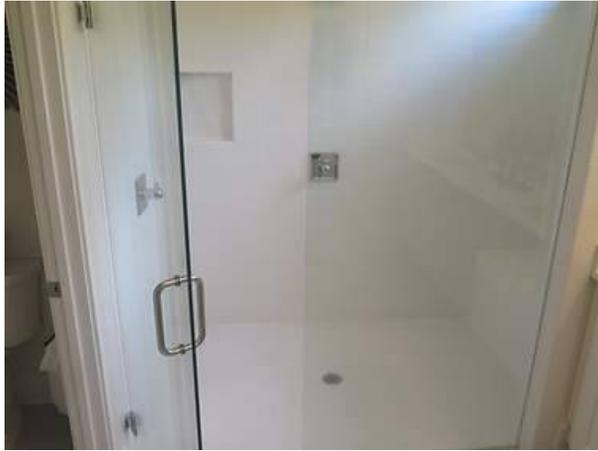
Photo 41-2

The shower door at location(s) #A was dragging on the tile floor below and would not open fully. Recommend that a qualified person repair as necessary.

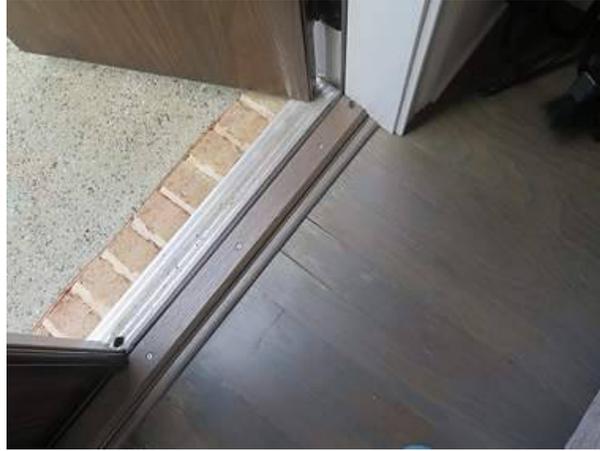
Photo 47-2

Wood flooring in one or more areas was significantly worn, deteriorated or damaged. Recommend that a qualified contractor refinish wood flooring as necessary.

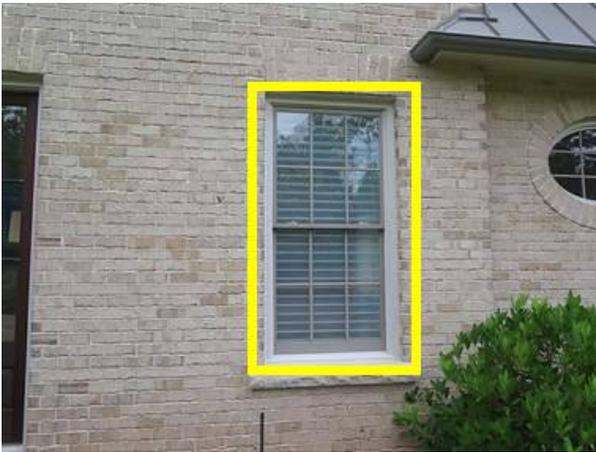
Photo 48-1

48) ⓘ No window screens were installed. Windows may not provide ventilation during months when insects are active.

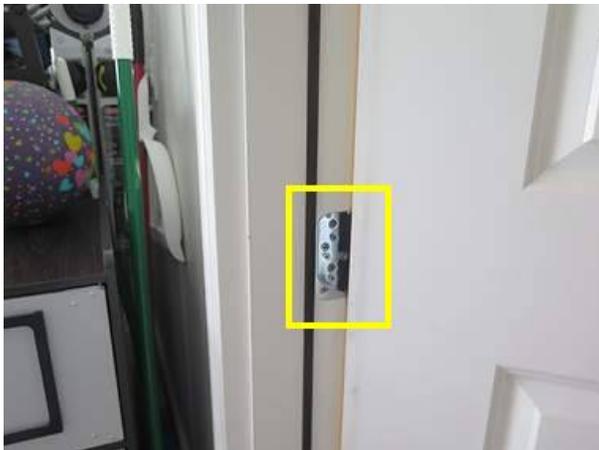
Photo 12-1

The garage-house door isn't equipped with an automatic closing device such as spring hinges. This door should close and latch automatically to prevent vehicle fumes from entering living spaces and/or to slow the spread of fire from the garage to living spaces. A qualified contractor should install automatic closing device(s) as necessary, and as per standard building practices, so this door closes and latches automatically.

IRC 09 & 12 - (302.5.1)

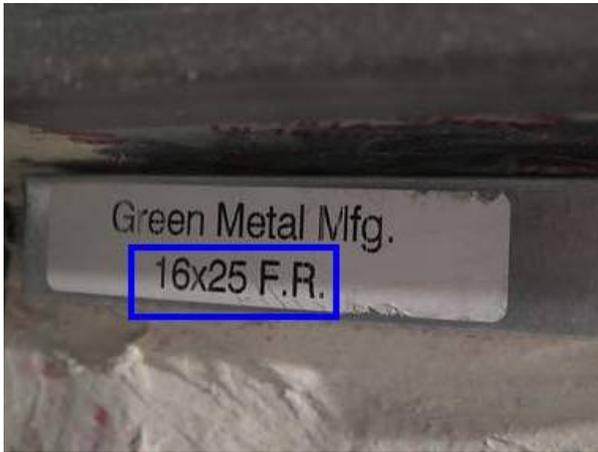
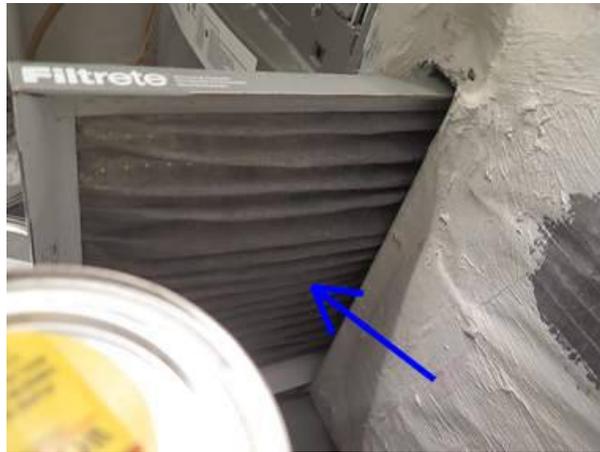
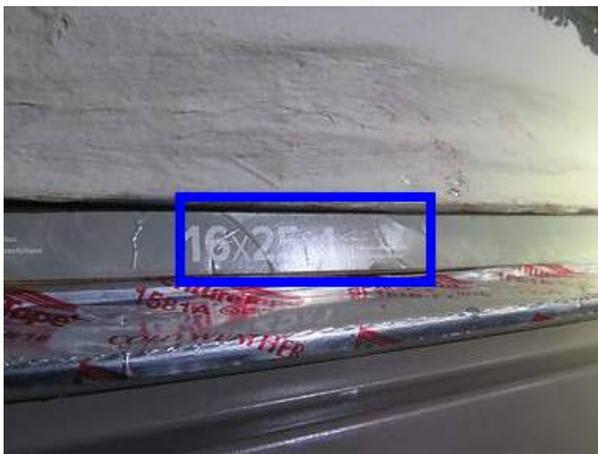
28) 🔧 Recommend replacing or washing HVAC filters upon taking occupancy depending on the type of filters installed. Regardless of the type, recommend checking filters monthly in the future and replacing or washing them as necessary. How frequently they need replacing or washing depends on the type and quality of the filter, how the system is configured (e.g. always on vs. "Auto"), and on environmental factors (e.g. pets, smoking, the frequency of house cleaning, number of occupants, the season).

NOTE filter size - 16x25x1
