Inspection Report

Property Address:
10895 Kimball Crest Dr
Alpharetta GA 30022

Residential Inspector of America
Inspector: Andrew Binosa
3276 Buford Dr, Ste 104-306
Buford, GA 30519
770.476.4963

Date: 8/8/2020	Time: 09:00:00 AM	Report ID: 080720AB227
Property: 10895 Kimball Crest Dr Alpharetta GA 30022	Customer: Santosh Gokhale	Real Estate Professional: Rupali Dalvi

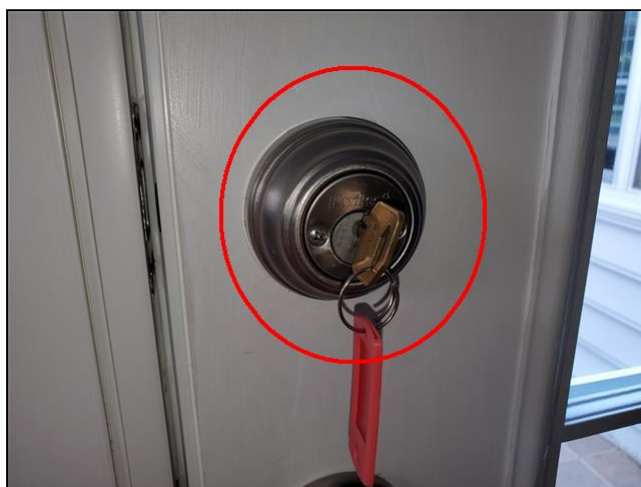
1.2 Item 1(Picture)

🔑 Dead bolt locks on the rear door(s) is the type that uses a key from the interior. These have not been allowed since the mid 1990's because of fire escape reasons. This type of lock can prohibit quick emergency exit from the house.

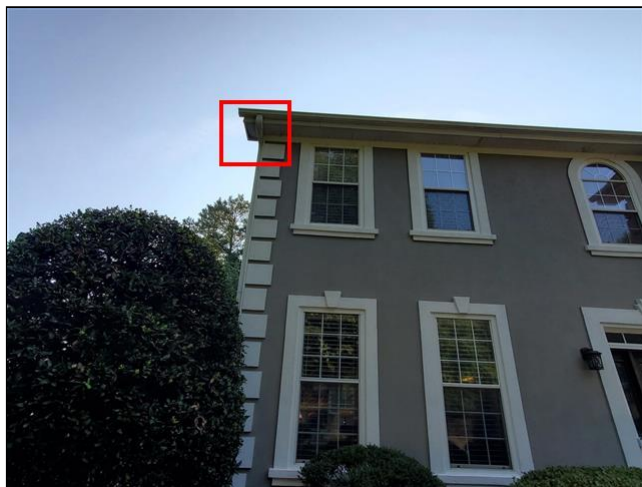
1.6 Item 2(Picture)

Soffit material at eave shown in the photos have been pushed in. Recommend to have seller adjust to avoid pest entry.

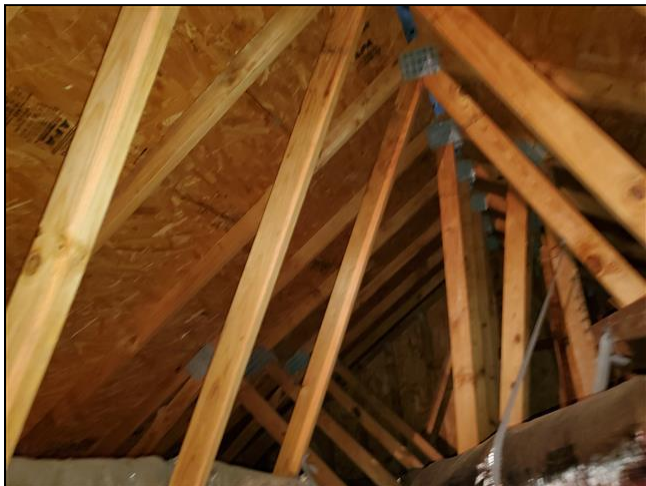
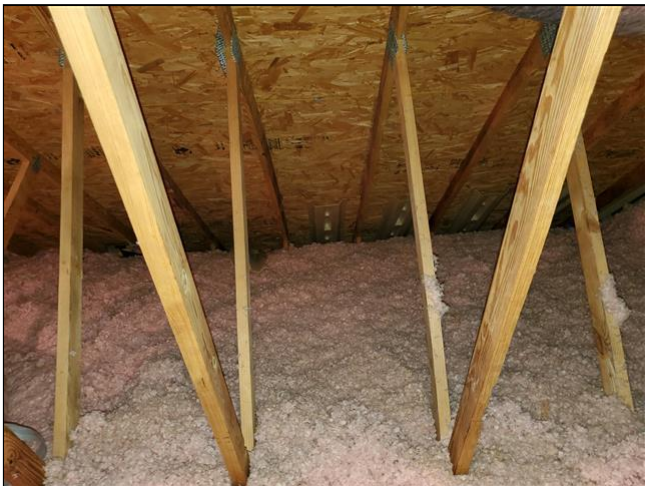
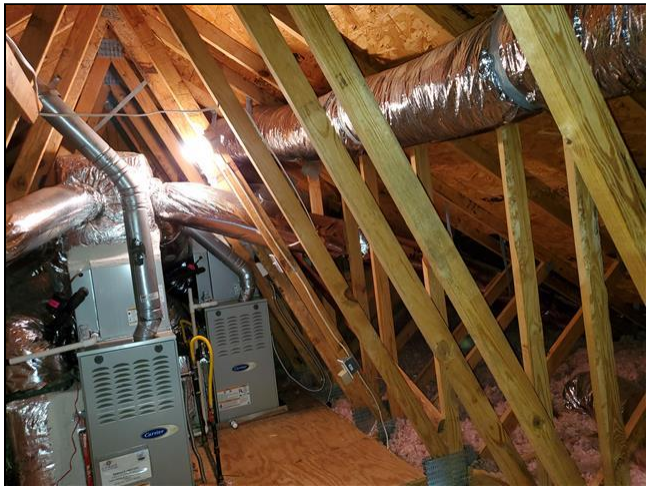
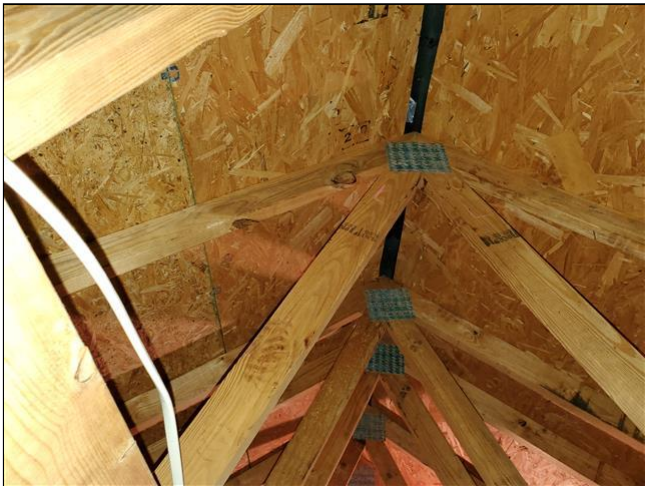
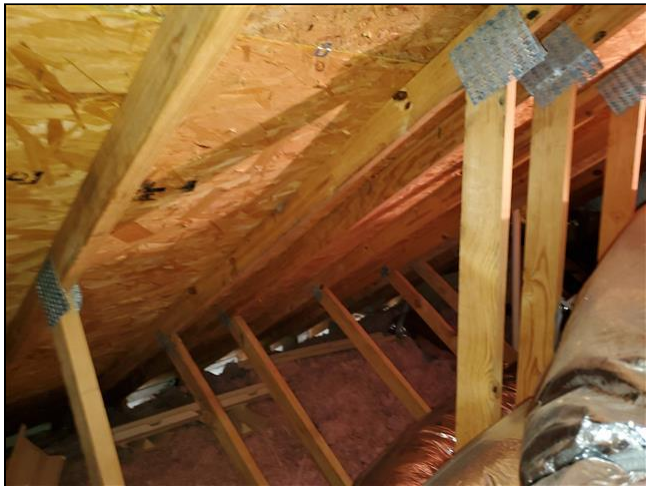
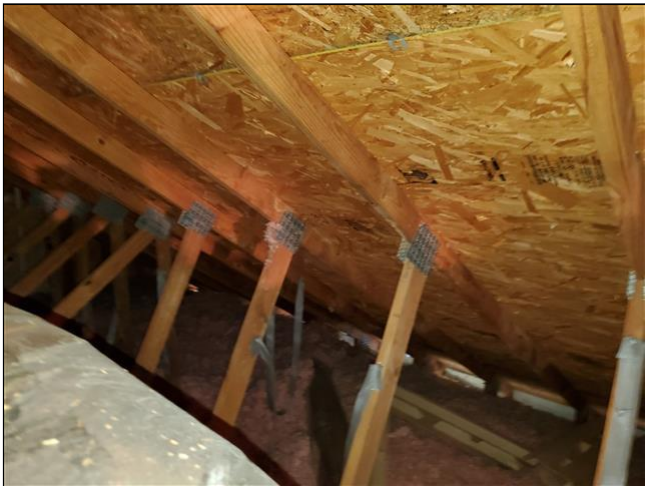
(1) Views of attic framing and insulation. Attic space entered and inspected from the closest locations possible.

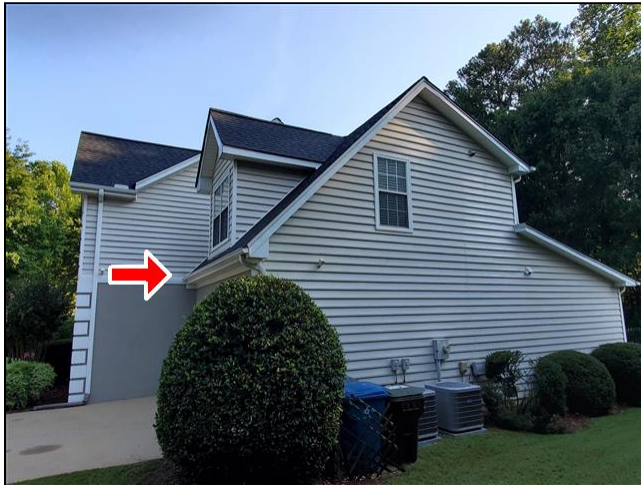
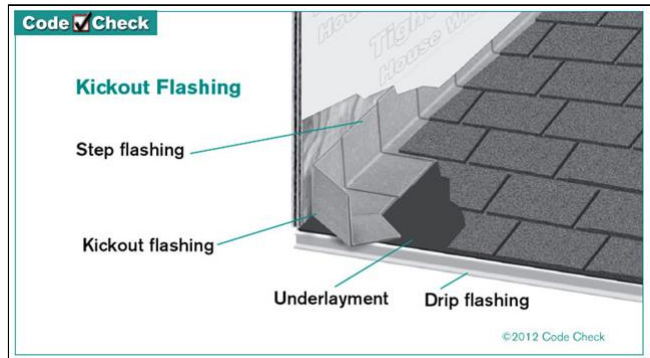
(2) Diverter flashing shall be installed at the roof to wall intersections to prevent water from over-shooting or dripping between the gutter and roof. See photos for example.

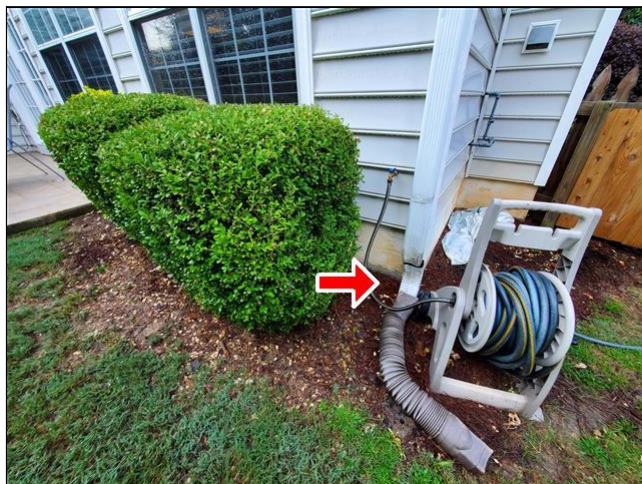
4.3 Item 2(Picture) Rear-left corner

(1) Reconnect the downspout shown in the photos. The bottom elbow and the corrugated extension have been disconnected allowing water to saturate the ground near the foundation.

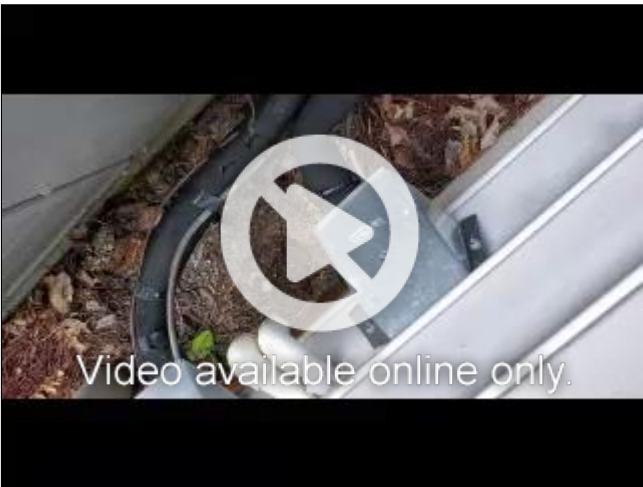
6.6 Item 5(Video)

(2) Water pooling noted at the back of the AC condensers outside caused by the condensation drain pipe. Recommend to extend the drain pipes away from the foundation area to avoid saturating the soil.

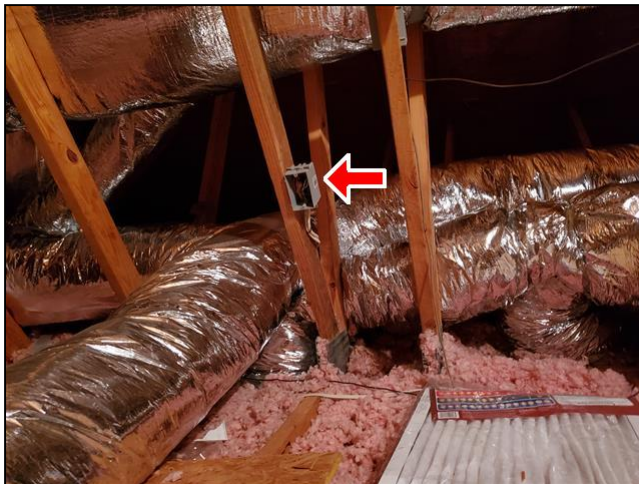
7.3 Item 1(Picture)

🔧 Cover needed on the open junction box in the attic (right part) near the platform area. Covers are used to control sparking.

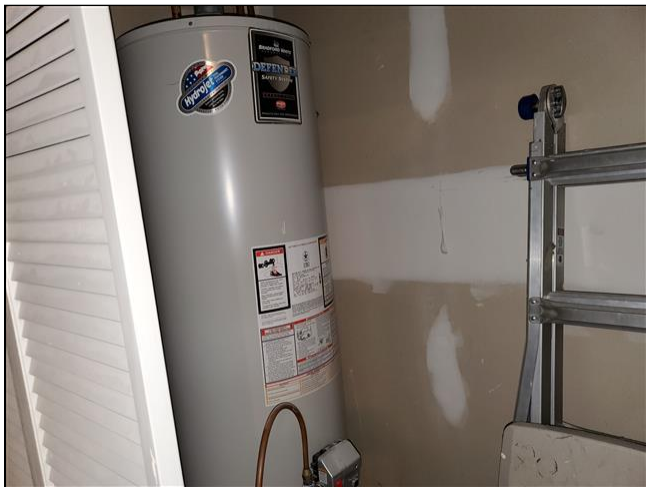
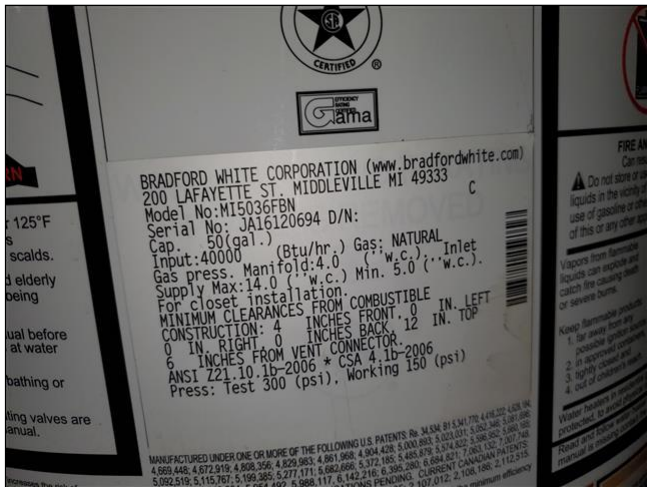
View of water heater.

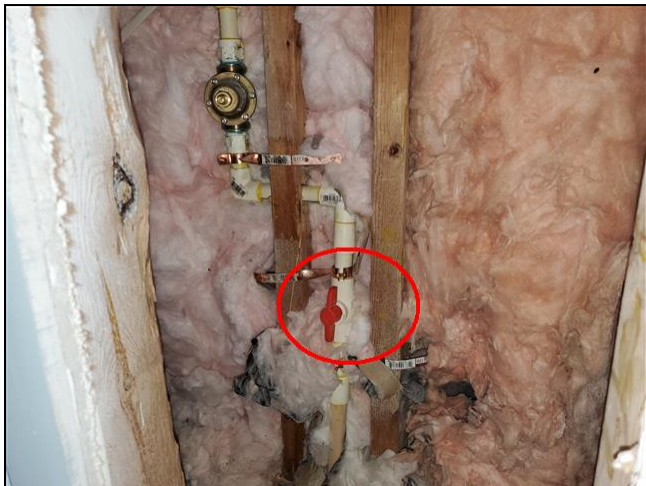
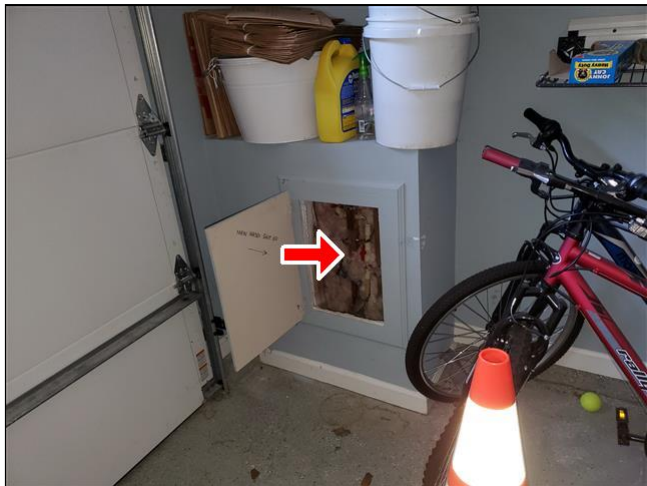
The main water shut off is in the garage.

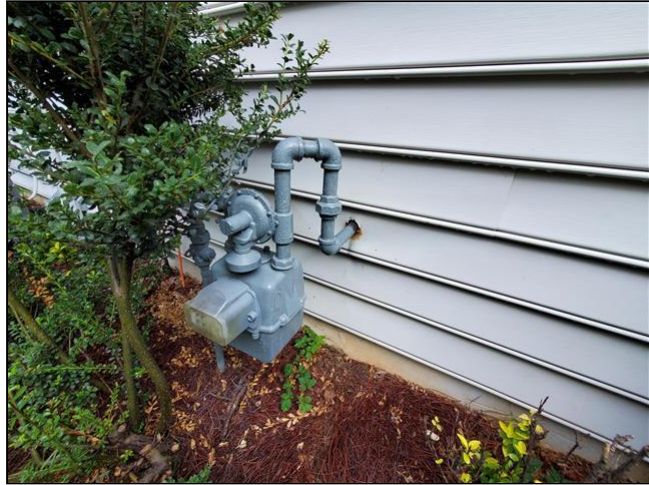
8.6 Item 1(Picture)

Main gas shut off is at the meter.

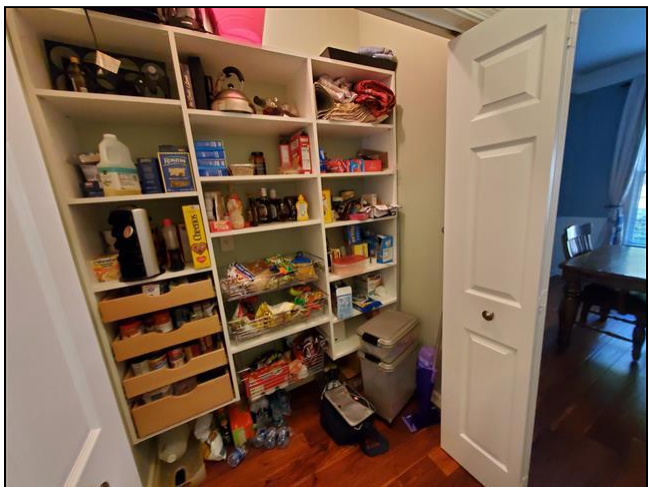
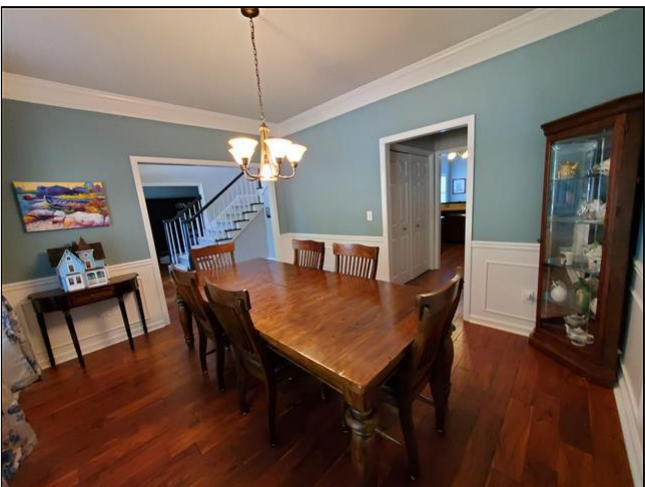
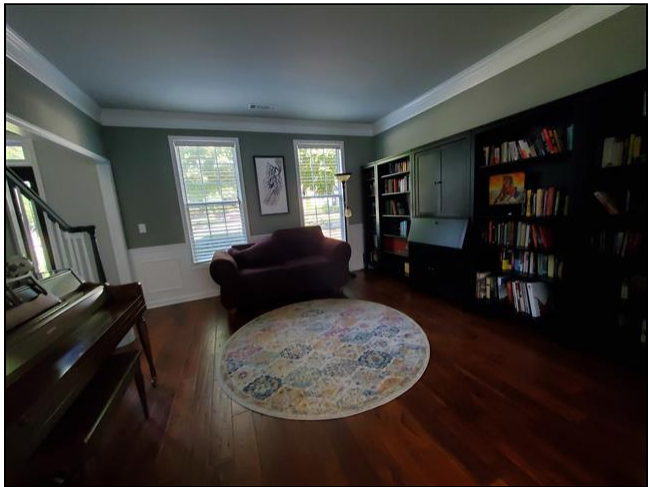
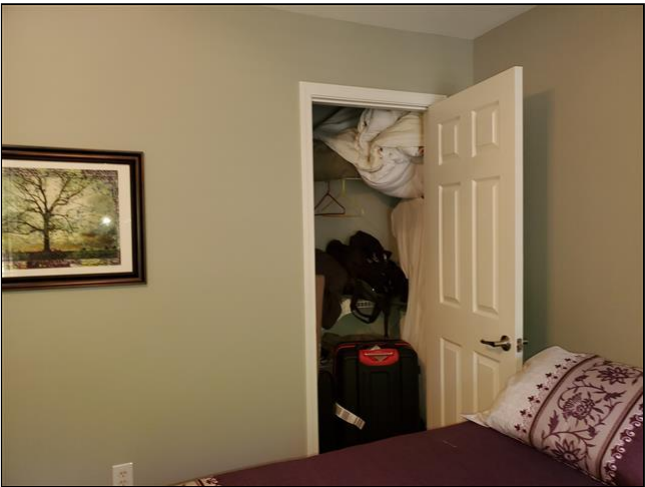
Many stored items were in the house during the inspection, somewhat limiting visual inspection of walls, windows, floors, closets, areas under sinks, etc... It is possible that some defect issues may be concealed in areas not accessible or visible during this inspection.

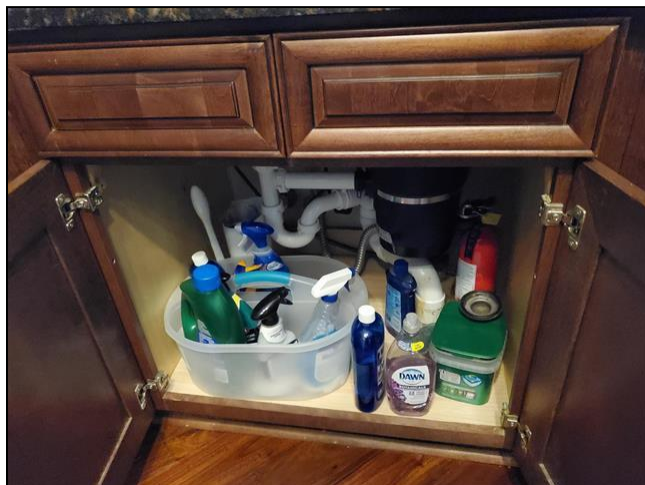
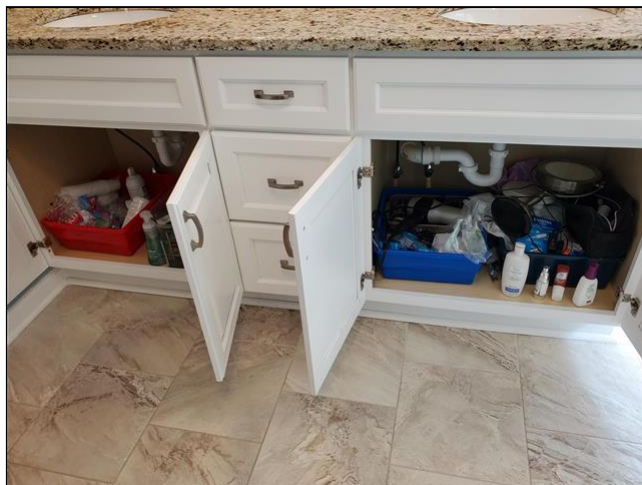
Many stored items in cabinets under sinks, limiting visual of piping.

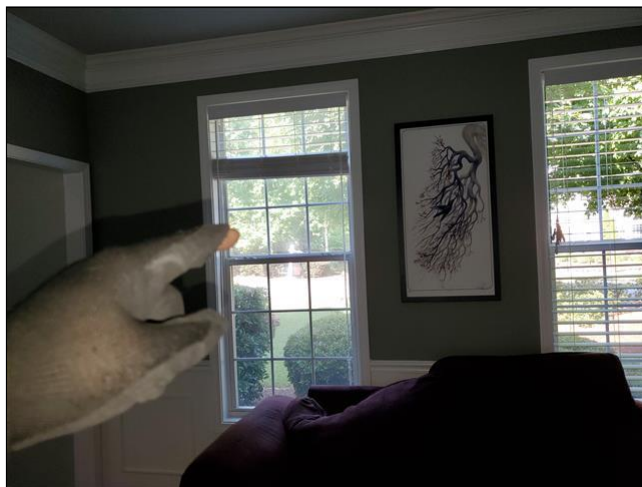
9.5 Item 2(Picture) living room

👉 (1) Replace all "fogged" windows. The seal between the panes of glass has failed allowing moisture to enter between the panes. It is possible that more may fog in the future. Have window contractor evaluate all windows because it is highly likely that if one window has had a seal failure, that more seal failures in different windows will occur. See photos for examples. It is difficult to identify seal failure in windows when the weather is rainy, over cast, foggy or the glass is wet from recent rains or condensation. Buyer should resolve all concerns prior to closing.

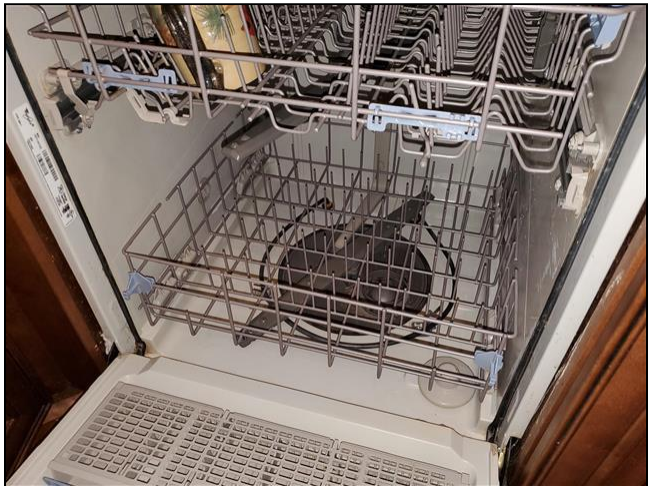
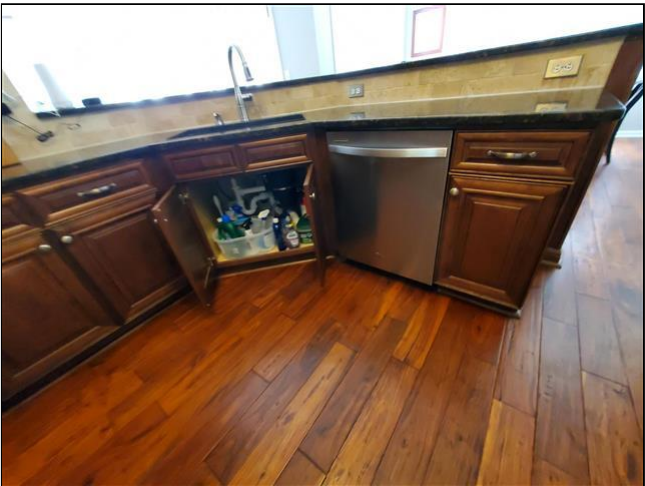
🔧 (1) Worn spring on dishwasher door. Doors falls open. Replacement spring needed.

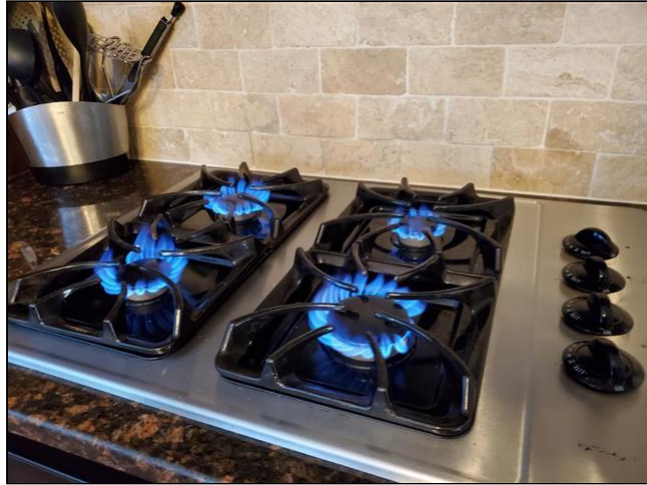
10.1 Item 1(Picture)

Cooktop works and appears to be in good working condition.
