Home and Stucco Inspection

585 Croydon Lane
Alpharetta, GA 30022

HOME AND STUCCO INSPECTION REPORT

Dated 08/07/2020

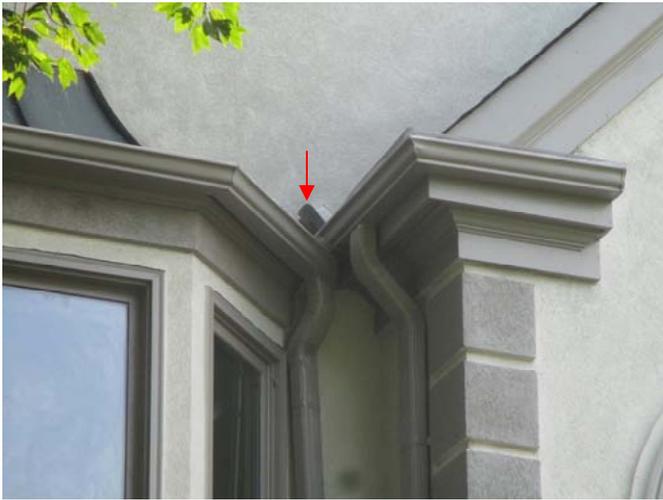
Raintek kick-out flashing has been installed in the stucco system at the primary roof termination located above the right side of the bay window cavity in the left, front bedroom.

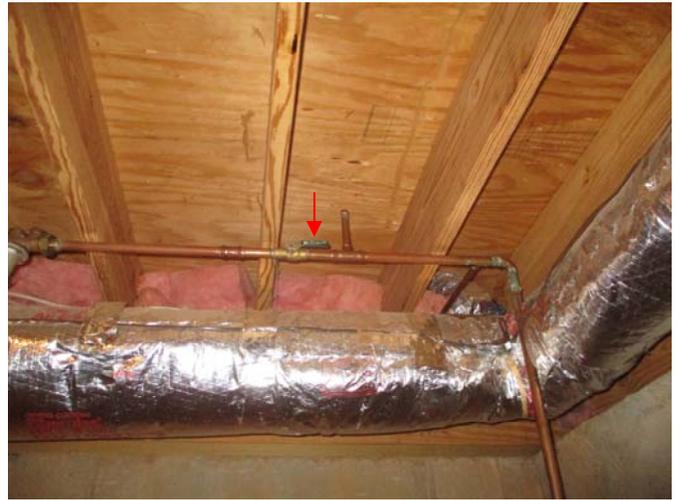
The shut-off valve on the main waterline is located at the right, front corner of the basement ceiling (below the formal dining room).
