Property Inspection Report

Property address: 4065 Hopewell Springs Dr
Milton GA 30004-1705

Inspection date: Friday, August 7, 2020

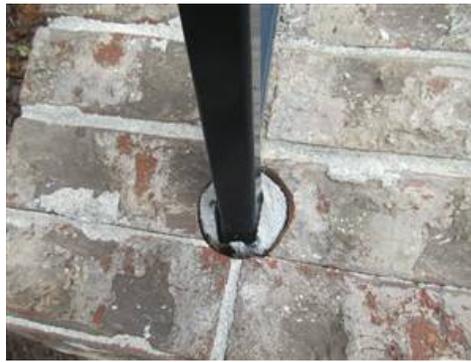
Photo 5-2

Guardrails on the front right side retaining wall, are loose and/or wobbly in one or more areas. This is a safety hazard. A qualified contractor should evaluate and make repairs as necessary, such as installing new fasteners or hardware, installing additional fasteners and/or installing additional railing components as necessary so they are securely attached.

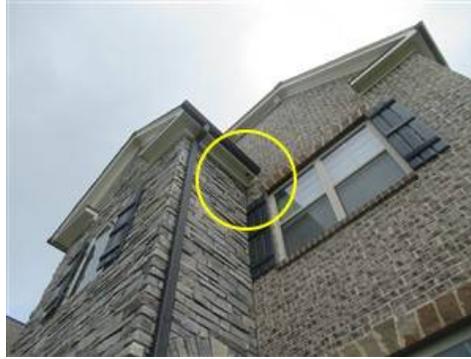
Photo 7-2

One or more hornet, bee and/or wasp nests were found. These can pose a safety hazard. Nest(s) should be removed as necessary.

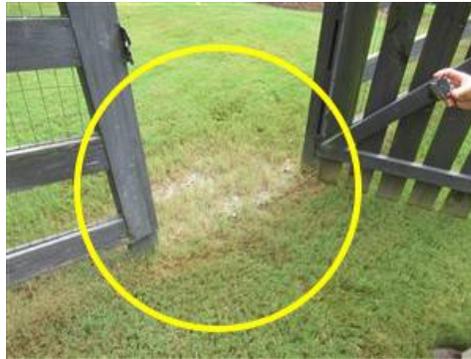
Photo 8-2

One area at the gate on the right side of the structure has significantly soggy soil, standing water or indications of accumulated water at times (sediment, dead grass, etc.). Recommend consulting with a qualified contractor who specializes in drainage, to determine if or what repairs are needed to provide adequate drainage. Possible repairs may involve grading soil, or installing, repairing and/or replacing underground drains.

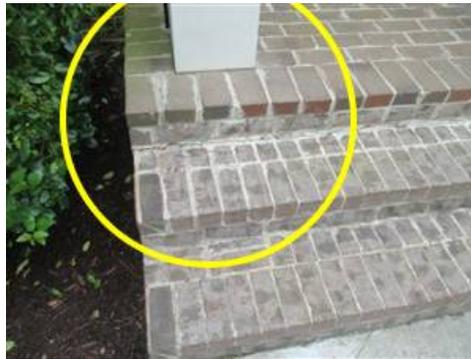
Photo 9-2

Minor cracks were found in one or more sections of brick veneer at the left side stairs. A qualified contractor should evaluate and make repairs as necessary, such as repointing mortar to prevent water intrusion and further deterioration in the future.

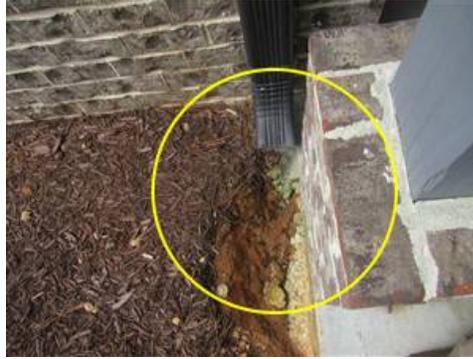
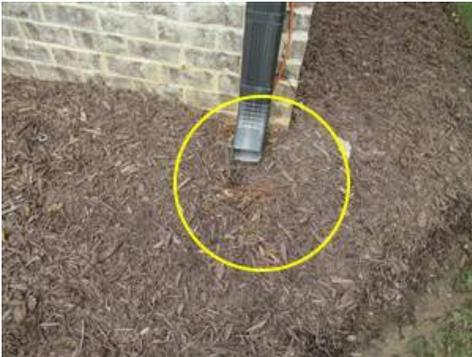
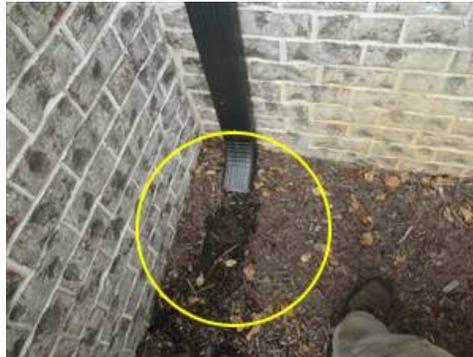
One or more downspouts have no extensions, or have extensions that are ineffective. This can result in water accumulating around the structure's foundation, or in basements and crawl spaces if they exist. Accumulated water is a conducive condition to wood destroying insects and organisms, and may also cause the foundation to settle and possibly fail over time. Repairs should be made as necessary, such as installing or repositioning splash blocks, or installing and/or repairing tie-ins to underground drain lines, so rain water is carried at least several feet away from the structure to soil that slopes down and away from the structure.

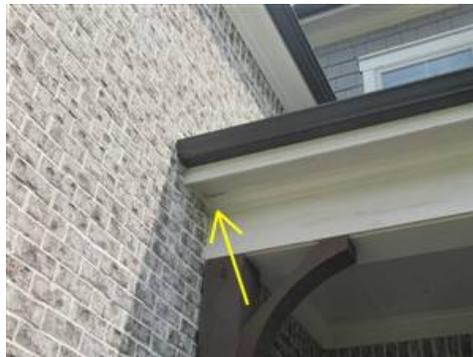
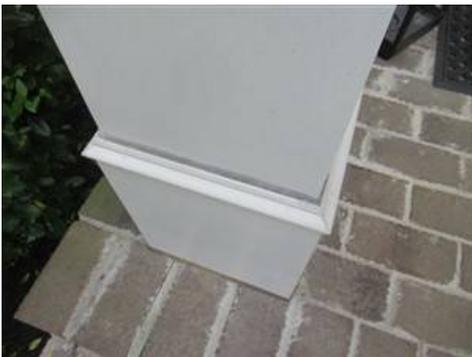
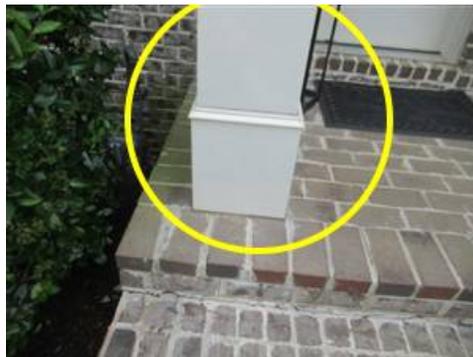
Caulk is missing or deteriorated in some areas and should be replaced and/or applied where necessary. For more information on caulking, visit [The Ins and Outs of Caulking](#).

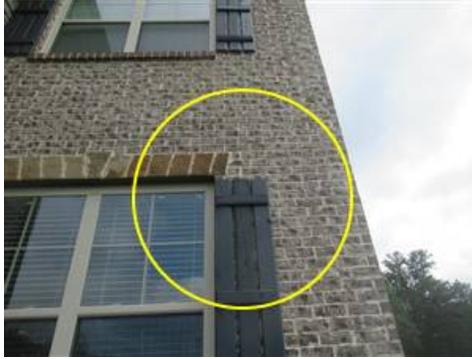
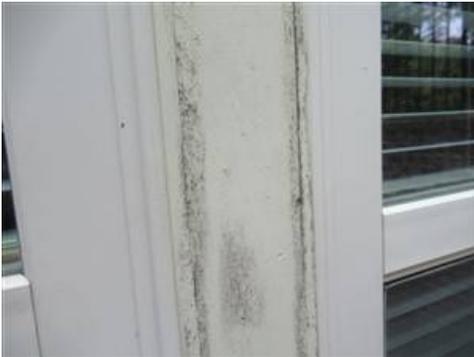
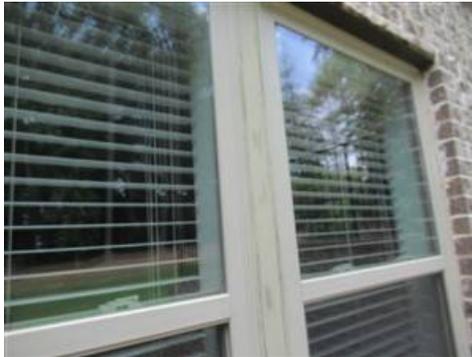
The exterior finish in some areas is failing. A qualified contractor should prep (pressure wash, scrape, sand, prime caulk, etc.) and repaint or restain areas as needed and as per standard building practices.

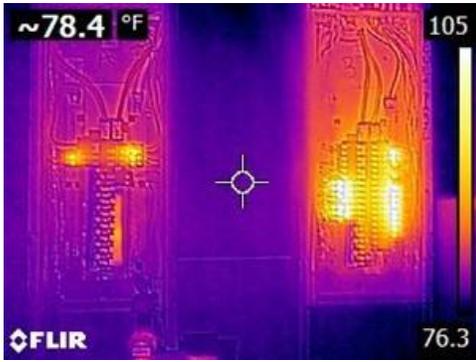
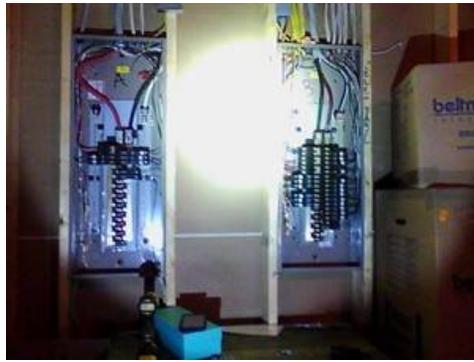
General picture of service panel. The basic infrared scan showed no abnormal anomalies at the time of the inspection.

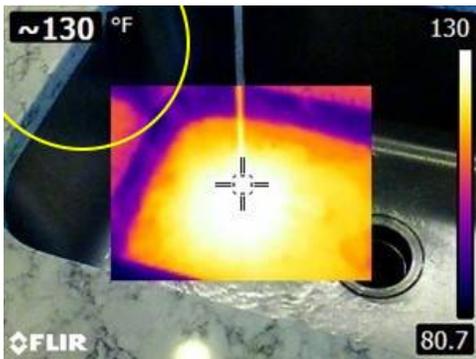
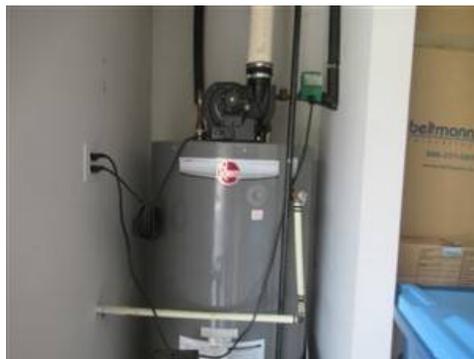
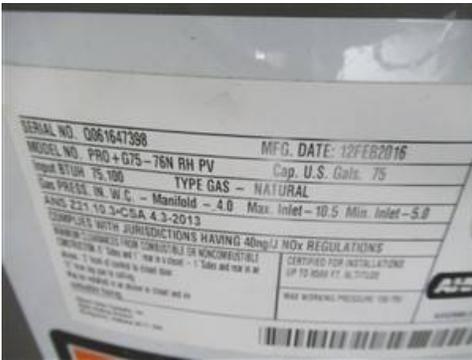
The water heater was checked and appears to be functional.

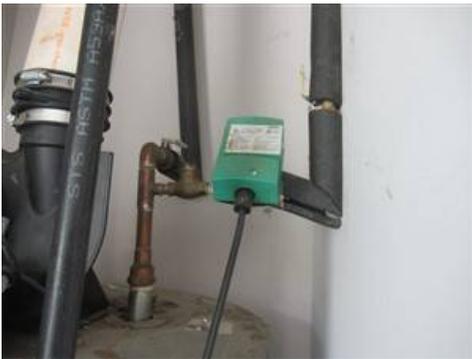
Photo 29-1

- 27) **i** The estimated useful life for most water heaters is 8 to 12 years.
- 28) **i** This house has a thermal expansion relief valve instead of an expansion tank. Homes should have one or the other.
- 29) **i** A circulating pump is installed for the hot water supply. It is intended to make hot water immediately available when faucets are turned on. Timers are typically integrated with these pumps, and should be configured so water circulates only at desired times for better energy efficiency. The client(s) should familiarize themselves with the timer's operation and configure it as needed.

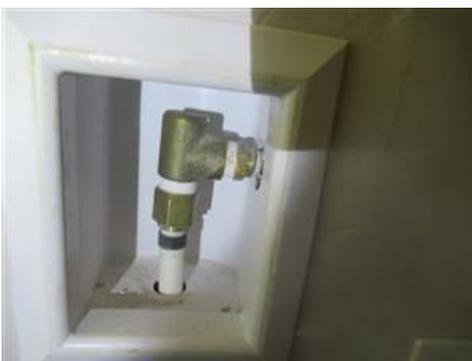
Photo 30-1

- 30) **i** This house has a thermal expansion relief valve instead of an expansion tank. Homes should have one or the other. This is located in the laundry at the back wall.

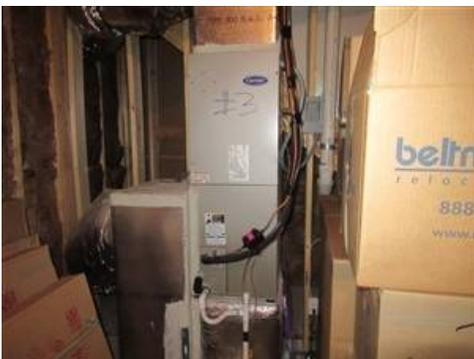
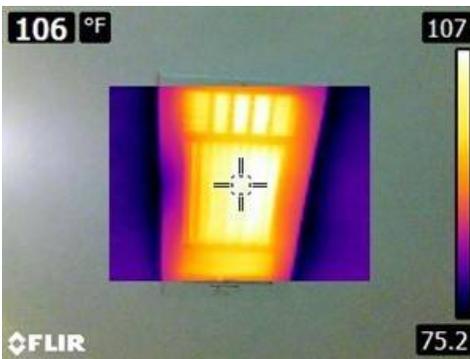
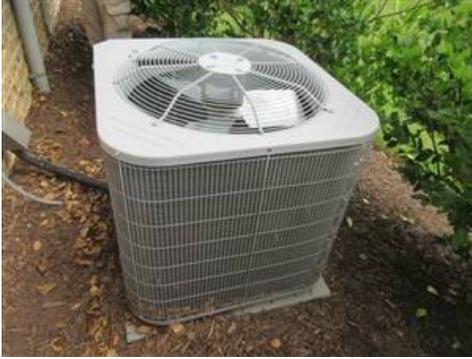
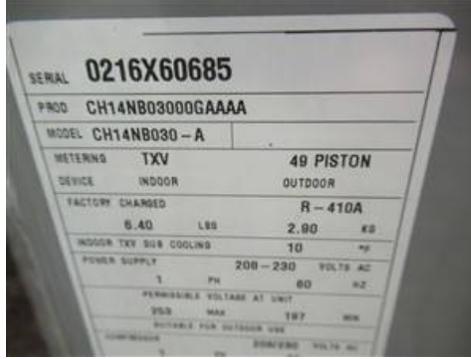
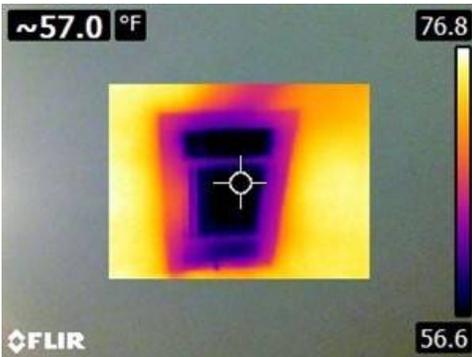
The basement electric heat pump heating and air conditioning system was checked and appears to be functional at the time of the inspection.

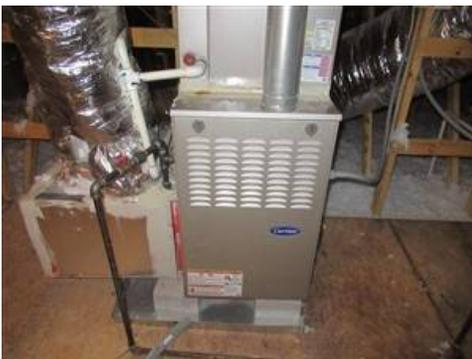
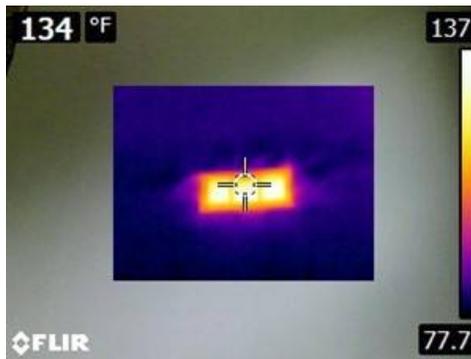
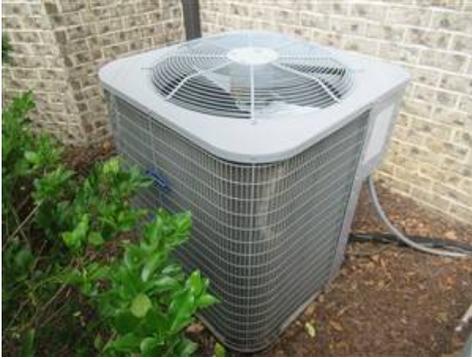
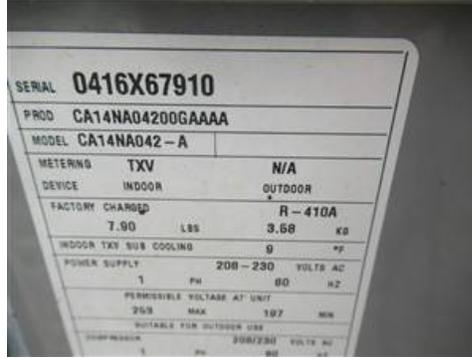
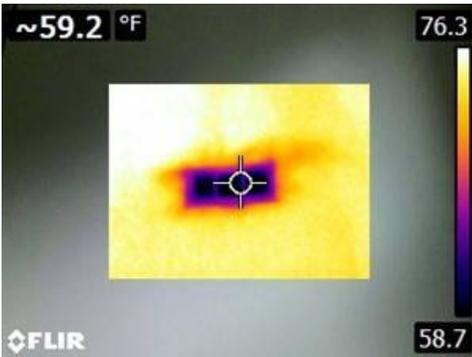
34) The main floor heating and air conditioning system was checked and appears to be functional at the time of the inspection.

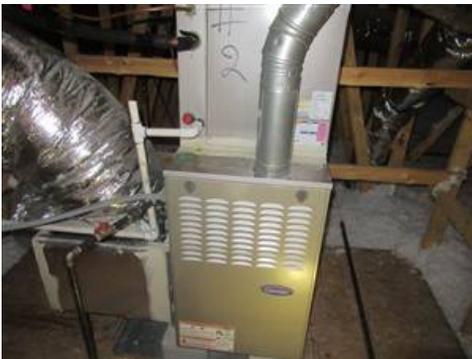
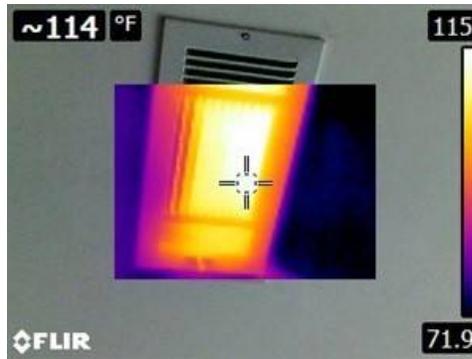
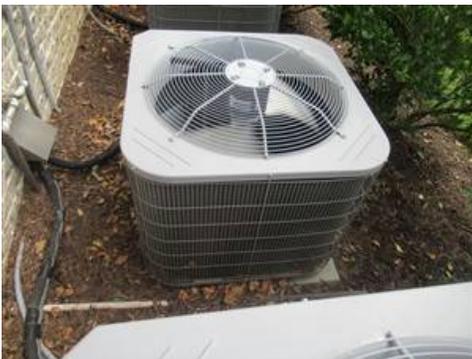
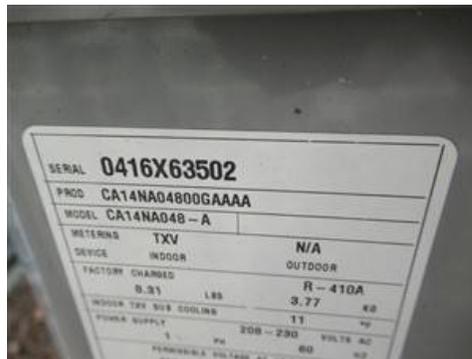
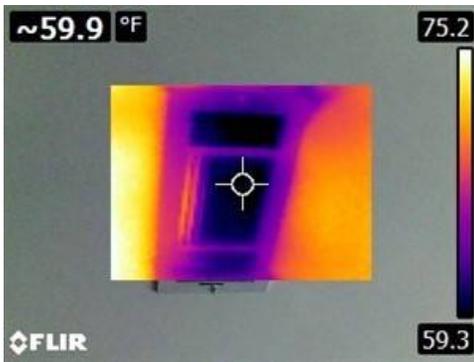
35) 🔍🏠🌡️ The upstairs heating and air conditioning system was checked and appears to be functional at the time of the inspection.

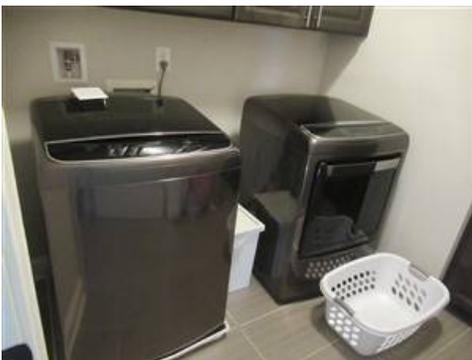
Photo 39-1

- 39) Neither the clothes washer nor dryer were operated or evaluated. They are excluded from this inspection.

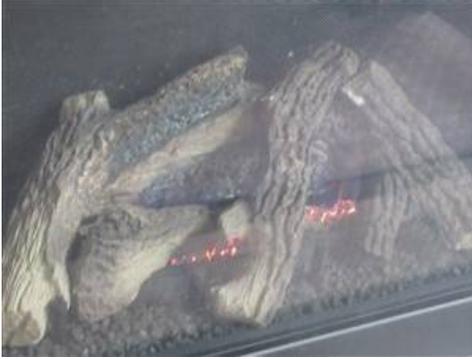
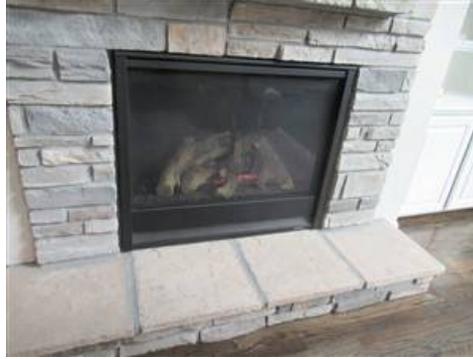
The gas fireplace appeared functional at the time of the inspection.

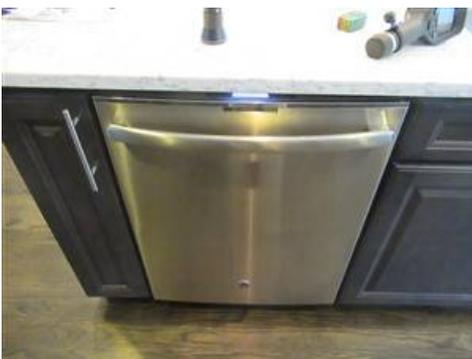
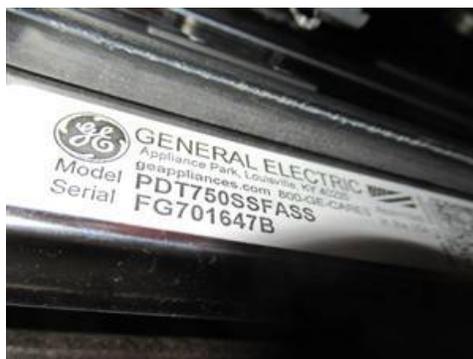
The dishwasher was checked and appears to be functional.

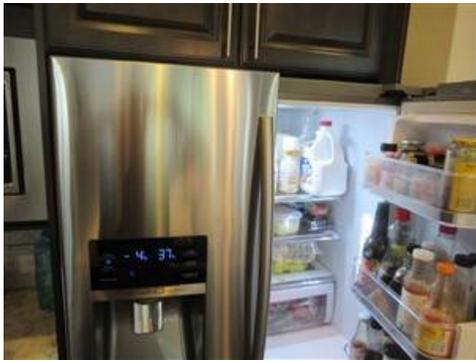
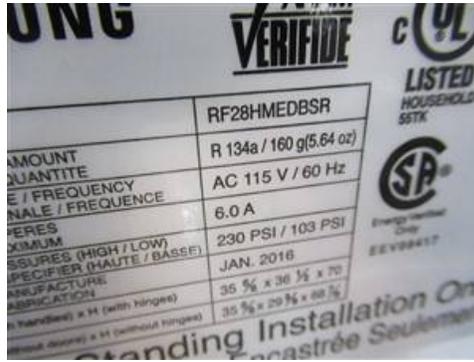
The refrigerator was checked and appears to be functional.

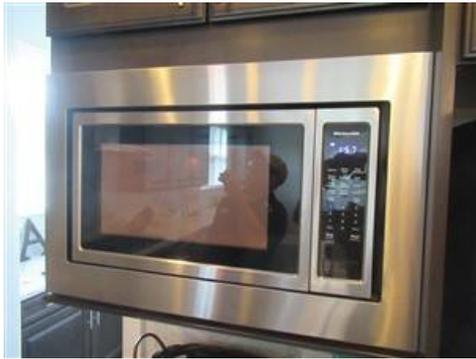
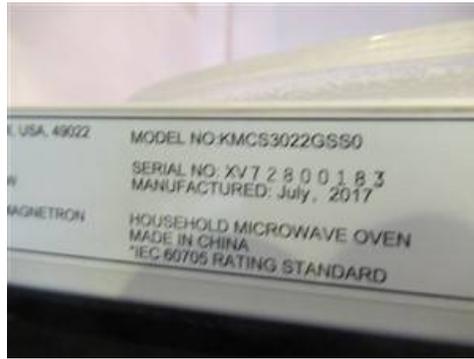
The microwave was checked and appears to be functional.

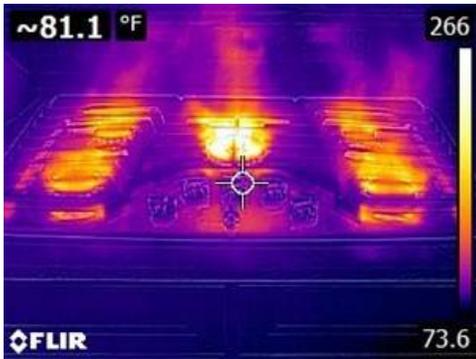
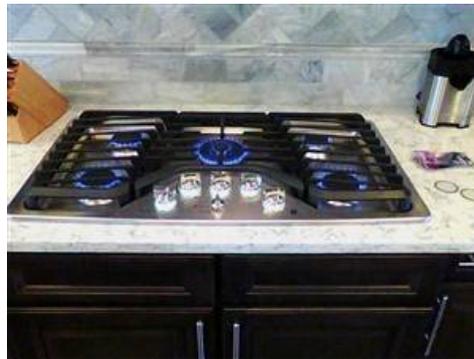
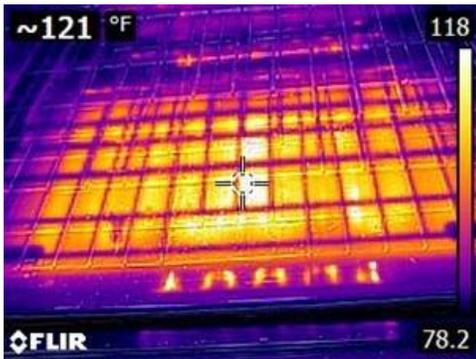
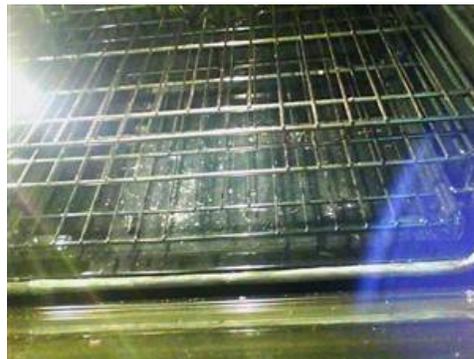
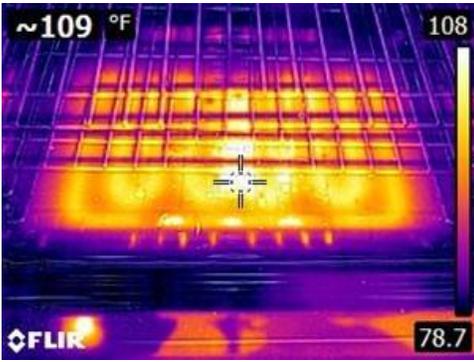
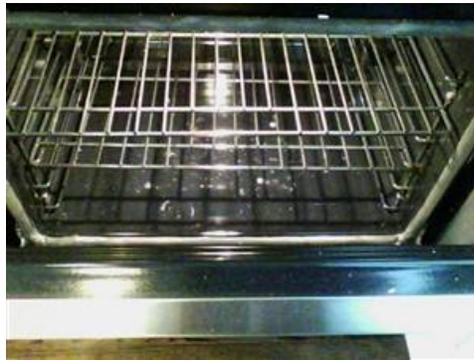
The range/ovens were checked and appeared to be functional.

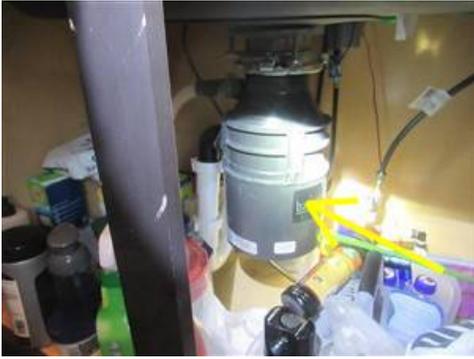
Photo 49-1

49) **i** Food disposal appeared functional at time of inspection.

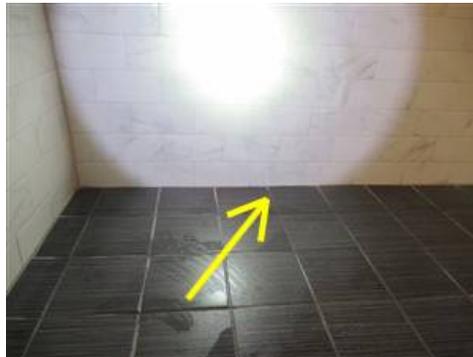
Photo 52-2

Grout or caulk in the master bedroom shower is damaged and/or deteriorated. For example, deteriorated or missing grout, cracked, missing or loose tiles, etc. A qualified contractor should evaluate and repair tile and/or grout as necessary.

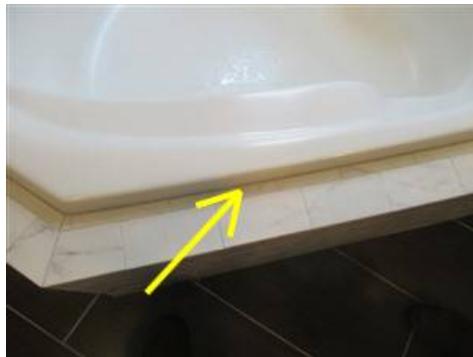
Photo 53-2

Caulk is missing or deteriorated above one or more bathtubs, where the tub surround meets the tub. It should be replaced where deteriorated and/or applied where missing to prevent water intrusion and damage to the wall structure.

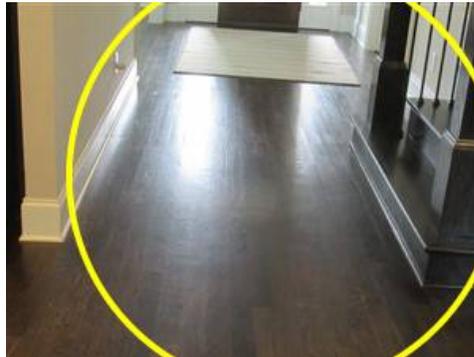
Photo 58-2

Wood flooring and stairs in one or more areas appears to be scratched. Recommend having a qualified contractor evaluate and refinish wood flooring as necessary.

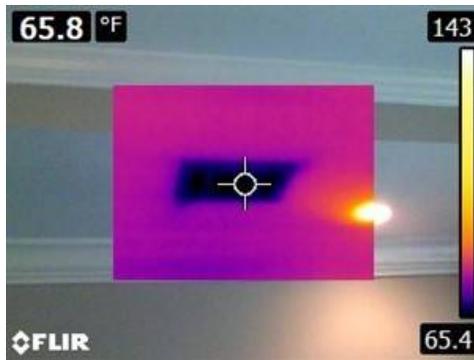
One master bedroom air supply registers has a weak air flow, or no apparent flow, and may result in an inadequate air supply for heating/cooling. Recommend asking the property owner(s) about this. Adjustable damper(s) in ducts may exist and be reducing the flow. If dampers exist, then they should be opened to attempt to improve the air flow. If the property owner(s) are unaware of such dampers, or if adjusting dampers does not improve the air flow, then a qualified heating/cooling contractor should evaluate and repair or make modifications as necessary.

Photo 59-2 This is the right side of the master bedroom bed.

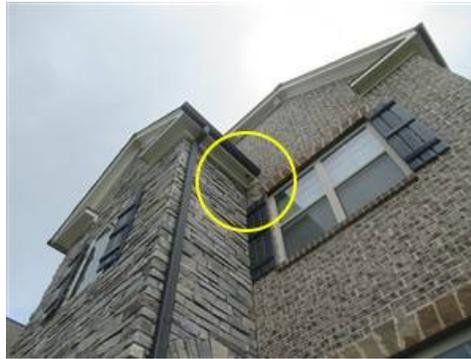
Photo 7-2

One or more hornet, bee and/or wasp nests were found. These can pose a safety hazard. Nest(s) should be removed as necessary.

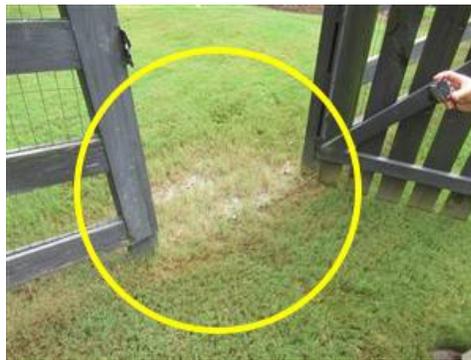
Photo 8-2

One area at the gate on the right side of the structure has significantly soggy soil, standing water or indications of accumulated water at times (sediment, dead grass, etc.). Recommend consulting with a qualified contractor who specializes in drainage, to determine if or what repairs are needed to provide adequate drainage. Possible repairs may involve grading soil, or installing, repairing and/or replacing underground drains.

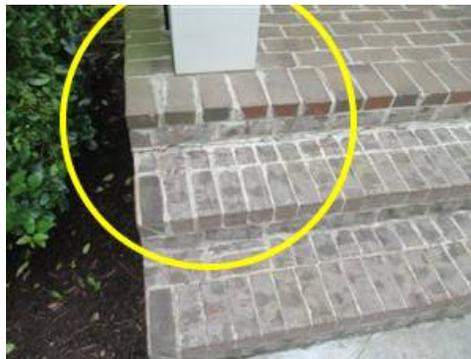
Photo 9-2

Minor cracks were found in one or more sections of brick veneer at the left side stairs. A qualified contractor should evaluate and make repairs as necessary, such as repointing mortar to prevent water intrusion and further deterioration in the future.

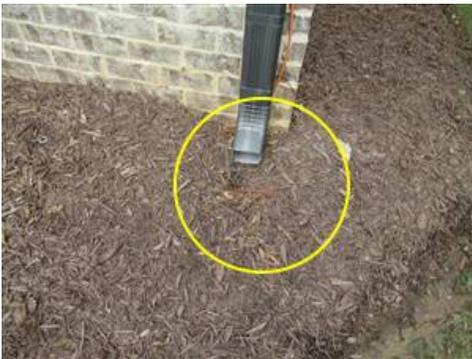
Photo 10-3

One or more downspouts have no extensions, or have extensions that are ineffective. This can result in water accumulating around the structure's foundation, or in basements and crawl spaces if they exist. Accumulated water is a conducive condition to wood destroying insects and organisms, and may also cause the foundation to settle and possibly fail over time. Repairs should be made as necessary, such as installing or repositioning splash blocks, or installing and/or repairing tie-ins to underground drain lines, so rain water is carried at least several feet away from the structure to soil that slopes down and away from the structure.

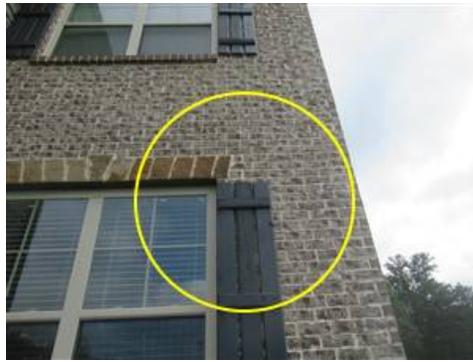
Photo 12-2

The exterior finish in some areas is failing. A qualified contractor should prep (pressure wash, scrape, sand, prime caulk, etc.) and repaint or restain areas as needed and as per standard building practices.

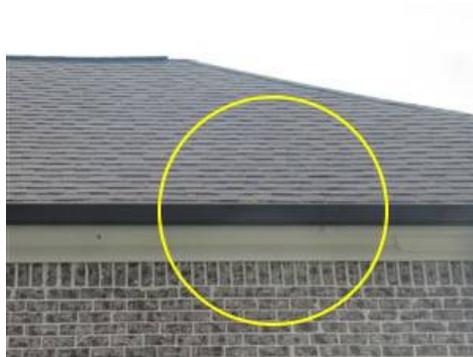
Photo 14-2

14) 🗑️💧 Debris has accumulated in one or more gutters. This is a conducive condition for wood destroying insects since gutters may overflow and cause water to come in contact with the structure's exterior or make water accumulate around the foundation. Gutters should be cleaned now and as necessary in the future.

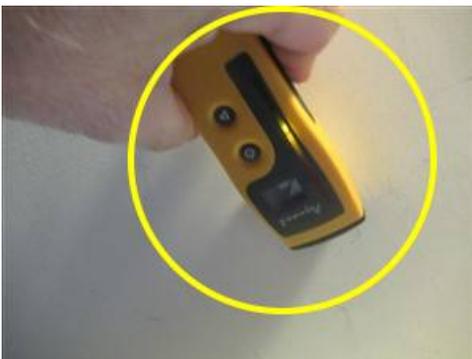
Photo 17-3

Stains and elevated levels of moisture were found in one or more ceiling areas. The stain(s) appear to be due to plumbing leaks. A qualified contractor should evaluate and repair as necessary.

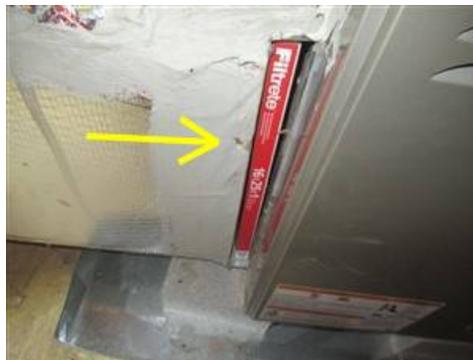
Photo 31-2

31) 🔧🔍🌡️ Air handler filter(s) should be checked monthly in the future and replaced or washed as necessary.

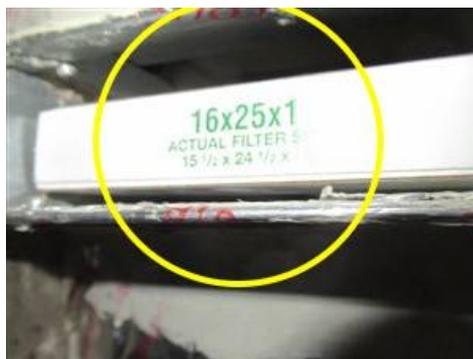
Photo 31-4 Filter size.
