Property Inspection Report

3089 Del Monico Dr , Decatur, GA 30032
Inspection prepared for: Ronald & Lauren Carlson
Real Estate Agent: Angie Leberte - Justin Landis Group

Date of Inspection: 6/3/2020 Time: 9 AM
Age of Home: 1978 | Size: 2,472 SF est.
Weather: 84°, partly cloudy

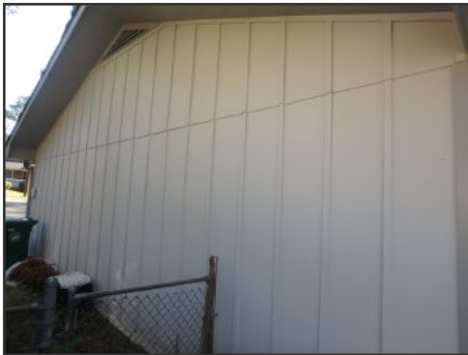
1.2. GRADING--TOO CLOSE TO BOTTOM EDGE OF SIDING: The Inspector observed that the finished grading is too high at side D (right) of the home. The grade should be no higher than 6" below the bottom edge of siding. When the grade is too high, water seepage can cause damage to the wood framing of the home. It can also create a conduit for termites. The Inspector advises the Client to arrange to have a professional landscape contractor further evaluate and address as necessary. Repair any damaged siding that is discovered.

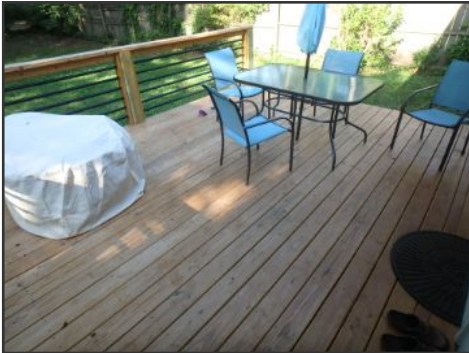
rear deck

4.2. WOOD TO EARTH CONTACT--REAR DECK STEPS: Wood-to-earth contact of the deck was observed; this area may prematurely deteriorate. Except for posts, most types of preservative-treated wood should be kept 6" above ground (note some premium types of treated wood are permitted for contact, but the Inspector cannot determine type without seeing wood labels). The Inspector advises the Client to arrange to have a professional contractor further evaluate and address as necessary.

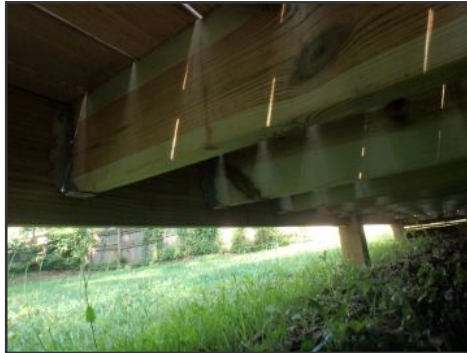
example underside of rear deck

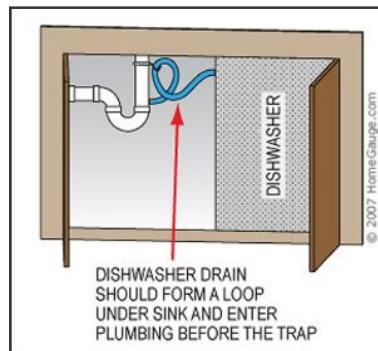
11.2. DRAIN LOOP--DISHWASHER: The Inspector did not observe a drain loop for the dishwasher. Drain loops help prevent dirty dishwater from draining backwards through the discharge tube from the dishwasher. The Inspector advises the Client to arrange to have a professional plumber further evaluate and address as necessary.

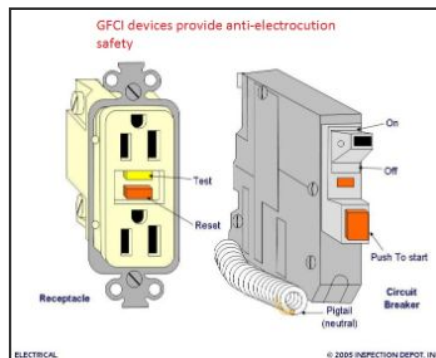
11.3. UNFINISHED BASEMENT RECEPTACLES--GFCI: The unfinished basement area receptacles are not GFCI compliant. GFCI technology is required by the National Electrical Code to protect occupants against electrical shock and injury at "wet locations." GFCI protection may not be present in some older homes, but it is suggested as an upgrade. The Inspector advises the Client to arrange to have a professional, licensed electrician further evaluate and address as necessary for safety.

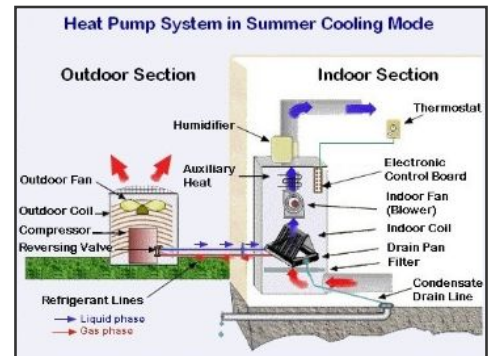
example heating output--"heat pump mode"

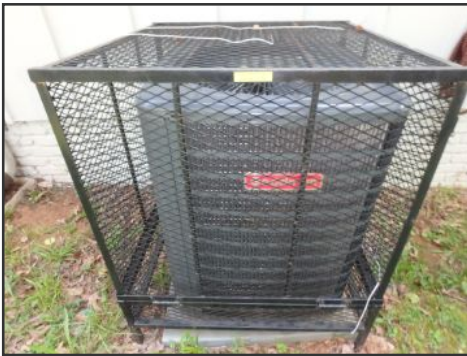
The air condensing unit is relatively new. Typically, units have a 10-15 year lifespan.

Goodman brand unit

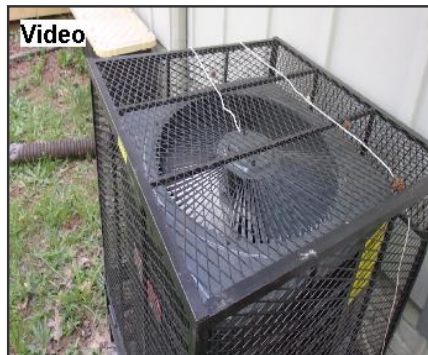
VIDEO--AC operation

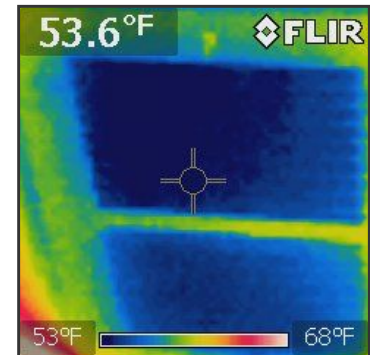
normal temperature drop

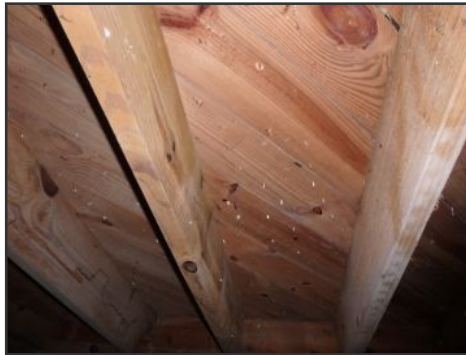
2.1. Appears normal. Minor prior termite damage may exist. It may be hidden (particularly at insulated areas and obstructed areas). No noted floor structures appear to be at risk of failure as noted at time of inspection.

example floor condition
