Home Inspection Report

1539 Brompton Ct
Dunwoody, GA 30338

Hunter Home Inspections LLC.
4651 Woodstock Road, Suite 208
Roswell, GA 30075
678-822-2600

August 12, 2020

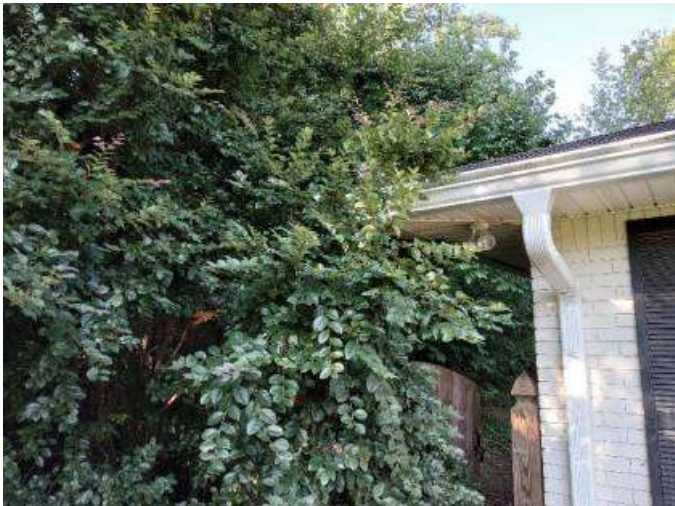
Attention - The shrubs should be trimmed at least 12 inches away from the home. This space is recommended to avoid moisture buildup in the siding.

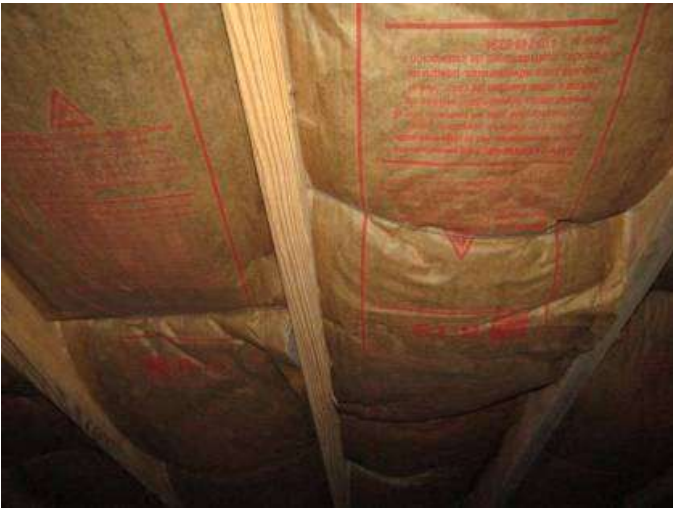
Insulation: **Attention** - The insulation in the crawlspace under the master bedroom is installed incorrectly. The vapor barrier should be next to the flooring (toward the heated side). Also, the manufacturer states that the paper cannot be left exposed because it is a fire hazard.
- The floor above the main crawlspace is not insulated. This was not required when the home was built. Recommend installing insulation to keep the home comfortable and save on energy costs.

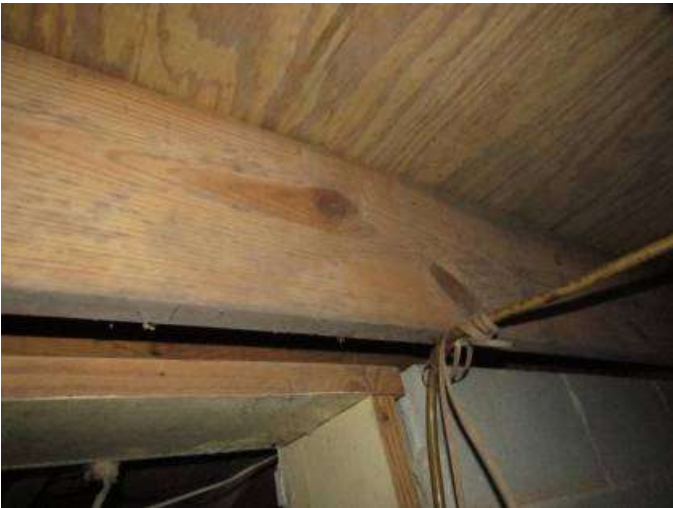
5. - There is a fungus or mold like substance on the floor joists and subfloor in the crawlspace. Not all locations are shown below. This inspection does not include testing for mold.
- Recommend having mold testing or remediation completed by a by a licensed mold remediation company.

Evidence of Fungus: **Action** - There is a fungus or mold like substance on the floor joists and subfloor in the crawlspace. Not all locations are shown below. This inspection does not include testing for mold. Recommend having mold testing or remediation completed by a by a licensed mold remediation company.

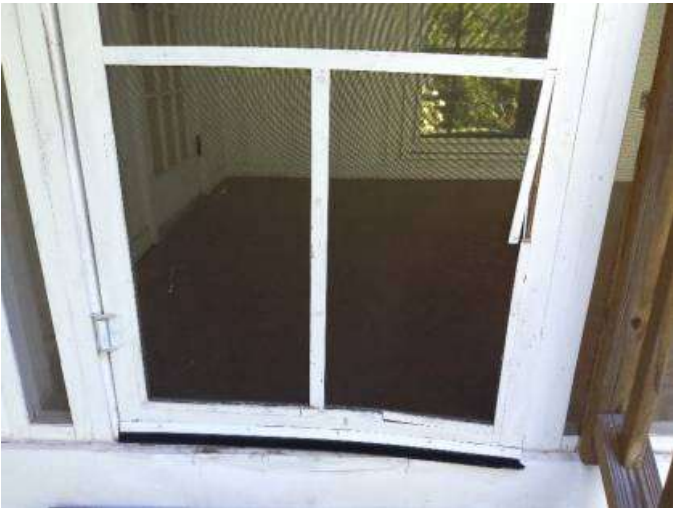
8. - There are loose bricks at the step of the front porch.
 - The sunroom porch is not bolted to the home. This can allow it to pull away from the home.
 - There is not a railing on one side of the screen porch stairway.
 - There is not a graspable railing on the sunroom stairs. A graspable railing is required on at least one side for safety.
 - The screen porch door is deteriorated.
 - One of the screens is torn.
- Recommend having a qualified contractor make necessary repairs.

Condition: **Action** - There are loose bricks at the step of the front porch.
- The sunroom porch is not bolted to the home. This can allow it to pull away from the home.
- There is not a railing on one side of the screen porch stairway.
- There is not a graspable railing on the sunroom stairs. A graspable railing is required on at least one side for safety.
- The screen porch door is deteriorated.
- One of the screens is torn.
Recommend having a qualified contractor make necessary repairs.

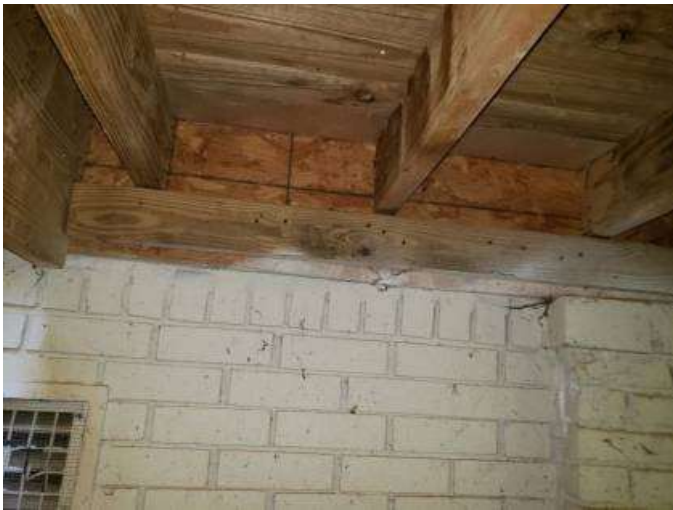
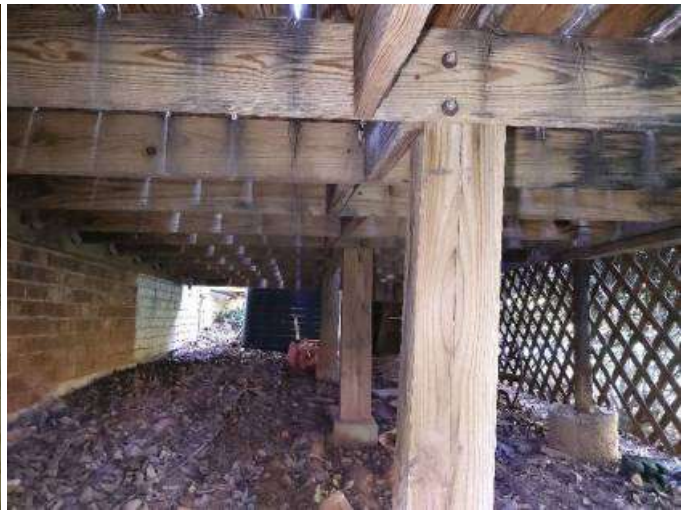
- Action** - The deck is not bolted to the home. This can allow the deck to collapse.
- The floor joists for the deck are too small and are over spanned. 2x6 boards are not allowed to be used for floor joists.
 - The mid span support posts are only supporting three of the floor joists and they do not have proper footings under them.
 - The openings in the deck railings are too wide. Current safety standards allows a maximum of 4" as a safety issue for small children.
 - The railings around the deck are too low. They are 26 1/2 inches high, the minimum height requirement is 36 in.
 - The stairway is too narrow, it is 30 inches wide. 36 inches is the minimum width for all stairways.
- Recommend having a qualified contractor evaluate the deck and repair as needed.

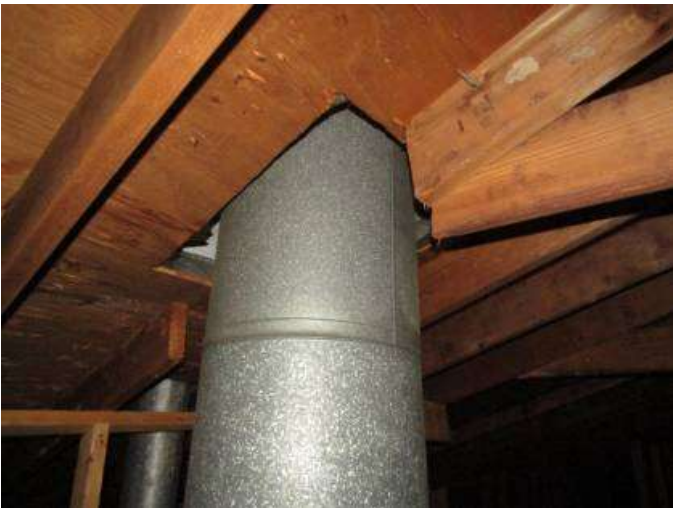
12. - One of the roof rafters above the fireplace was cut to install the flue, and one ceiling joist above the garage was cut to install the access panel.
Recommend a qualified framing contractor repair as needed.

Action - One of the roof rafters above the fireplace was cut to install the flue, and one ceiling joist above the garage was cut to install the access panel. Recommend a qualified framing contractor repair as needed.

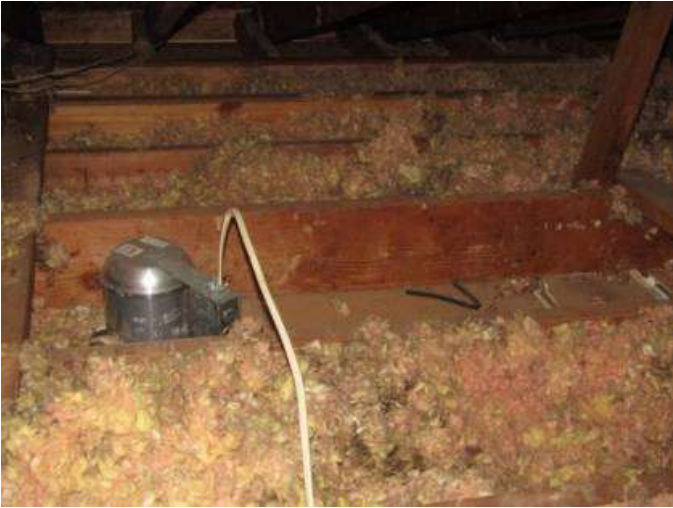
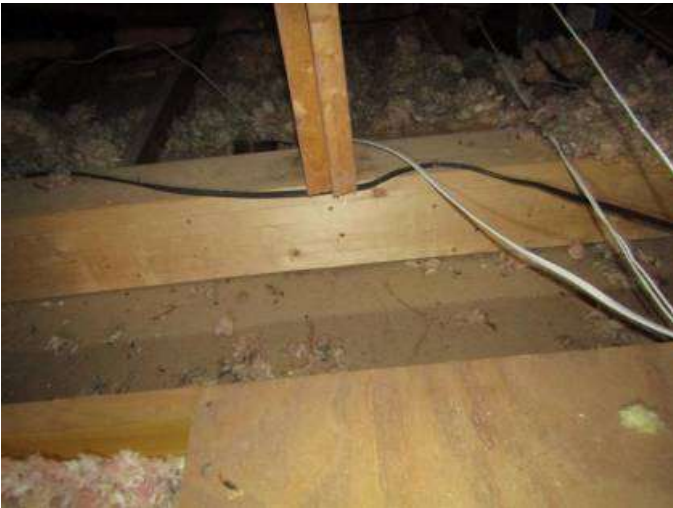
Condition of Insulation: **Action** - There is no insulation above the laundry room, above half of the kitchen, and above a section of the hallway. The insulation in the rest of the attic is low, it is approximately 5 inch thick.

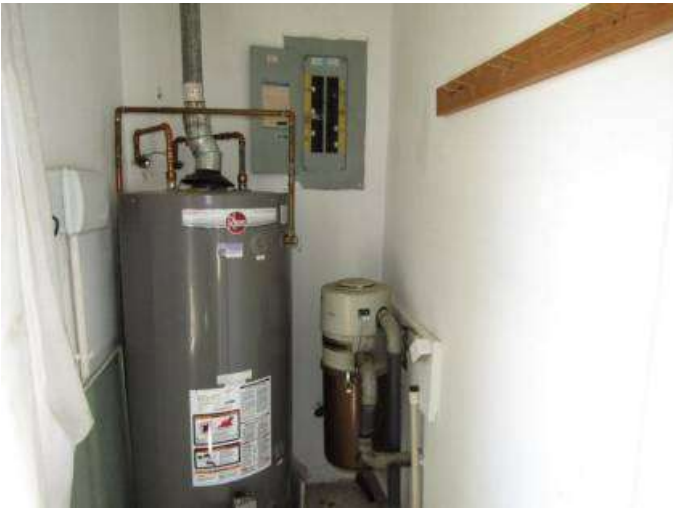
14. - One of the breakers in the electrical panel is double tapped. This is when two wires are connected to one breaker. These need to be separated so that each circuit will have its own breaker.
- There is more than one wire installed in the terminals on the neutral bar in the panel box.
- The electrical panel is not installed in a manner to allow for safe access for operation, repair, or inspection as required by industry standards. The clear space in front of a panel box is required to be a minimum of 30" wide, 36" deep and 80" high.
Repair by an electrician is recommended.

Electric Service:	The electrical service to the home is 150 amps, 120/240 volts.
Service Condition:	The overhead electrical service lines to the home are in satisfactory condition.
System Ground:	The grounding conductor for the electrical system is connected to the water piping and is satisfactory.
Service Cable to Panel:	Stranded aluminum wire. The visible portion of the cable is in satisfactory condition.
Distribution Panel:	Circuit breaker type, 150 amp. It is located in the store room off the garage. Split Buss type distribution panel. This is an older style electrical breaker panel. Instead of one main breaker, there is a series of main breakers in the panel. The top six breakers must be turned off to shut off all power in the panel box.
Panel Condition:	Action - One of the breakers in the electrical panel is double tapped. This is when two wires are connected to one breaker. These need to be separated so that each circuit will have its own breaker. - There is more than one wire installed in the terminals on the neutral bar in the panel box. - The electrical panel is not installed in a manner to allow for safe access for operation, repair, or inspection as required by industry standards. The clear space in front of a panel box is required to be a minimum of 30" wide, 36" deep and 80" high. Repair by an electrician is recommended.

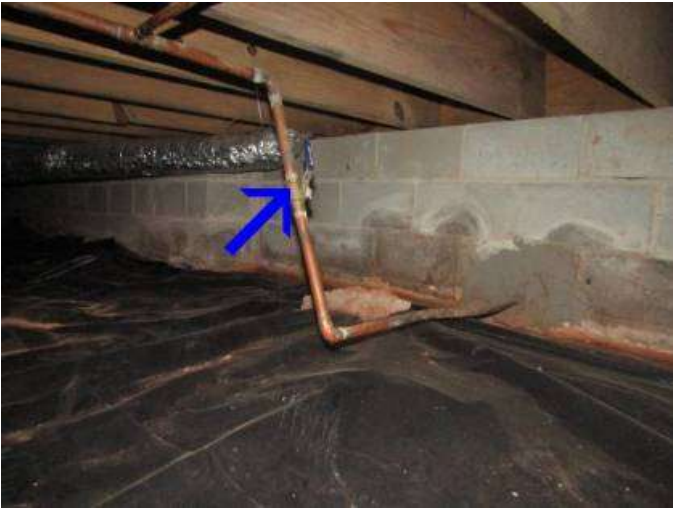
Main Water Shut off: The main water shut off valve is located in the middle front of the crawlspace and at the meter by the street.

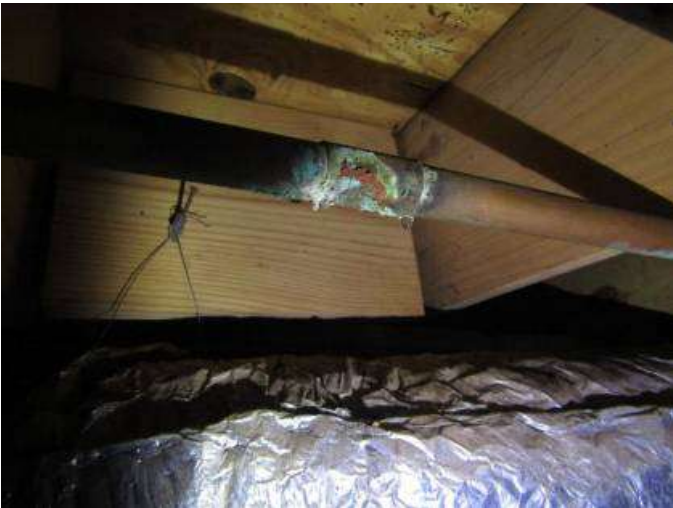
19. - There is a leak on the water pipe in the crawlspace under the kitchen.
- The saddle valve in the crawlspace under the kitchen is rusted.
Repair by a plumber is recommended.

Action - There is a leak on the water pipe in the crawlspace under the kitchen.
 - The saddle valve in the crawlspace under the kitchen is rusted.
 Repair by a plumber is recommended.

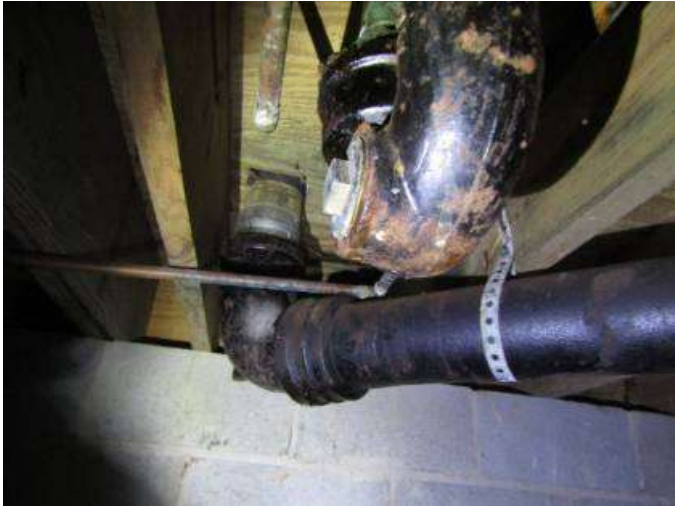
20. - There are leaks in the drain piping in the crawlspace.
Recommend having the waste piping evaluated and repaired as needed by a licensed plumber.

Action - There are leaks in the drain piping in the crawlspace.
Recommend having the waste piping evaluated and repaired as needed by a licensed plumber.

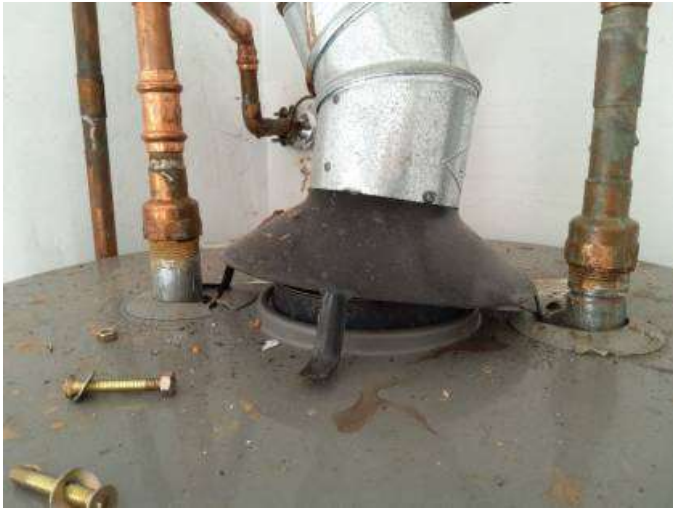
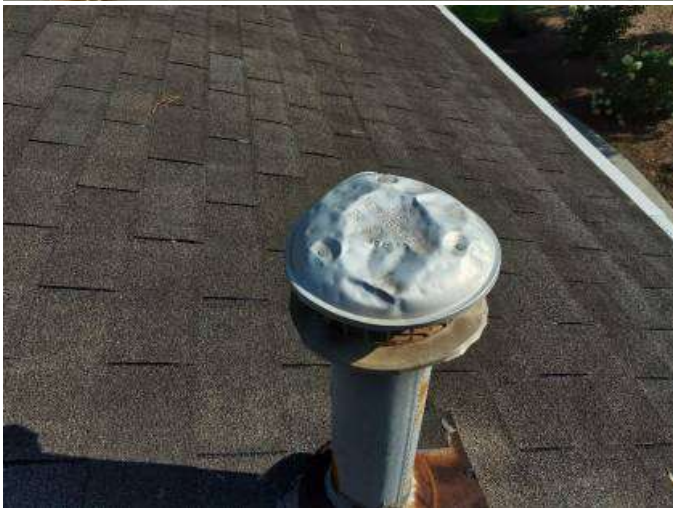
21. - The water heater flue collar is not properly installed and centered over the exhaust pipe on the tank.
- The flue pipe for the water heater was reduced from 4 inches down to 3 inches. This is too small for a 75 gallon water heater. This can allow carbon monoxide to spill into the home. Recommend having a licensed plumber make all necessary repairs.

Flue Pipe: **Action** - The water heater flue collar is not properly installed and centered over the exhaust pipe on the tank.
- The flue pipe for the water heater was reduced from 4 inches down to 3 inches. This is too small for a 75 gallon water heater.
This can allow carbon monoxide to spill into the home. Recommend having a licensed plumber make all necessary repairs.

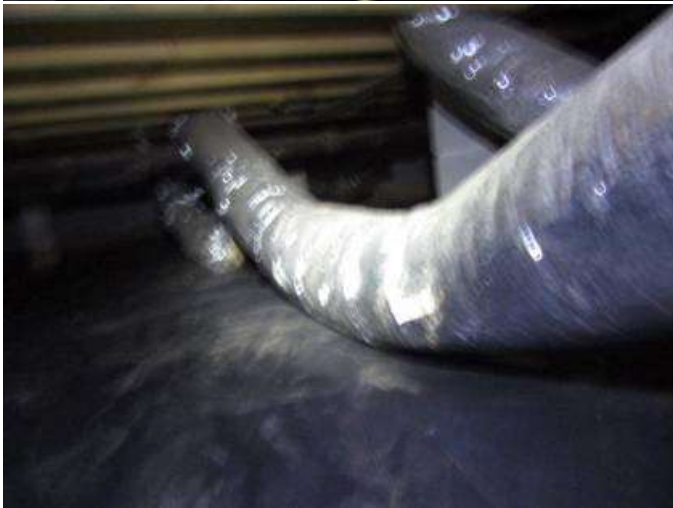
27. - One of the ducts in the crawlspace is disconnected, one of the ducts is crushed and several are laying on the ground.
- There are gaps and air leaks at the plenum.
- Some of the ducts in the crawlspace are not insulated.
- Current building standards do not allow HVAC return vents in garages because of concern of carbon monoxide entering the home.
- The ducts are dirty, professional cleaning of the ducts is recommended.
Recommend having a HVAC contractor evaluate the ducts and repair as needed.

Action - One of the ducts in the crawlspace is disconnected, one of the ducts is crushed and several are laying on the ground.
- There are gaps and air leaks at the plenum.
- Some of the ducts in the crawlspace are not insulated.
- Current building standards do not allow HVAC return vents in garages because of concern of carbon monoxide entering the home.
- The ducts are dirty, professional cleaning of the ducts is recommended.
Recommend having a HVAC contractor evaluate the ducts and repair as needed.

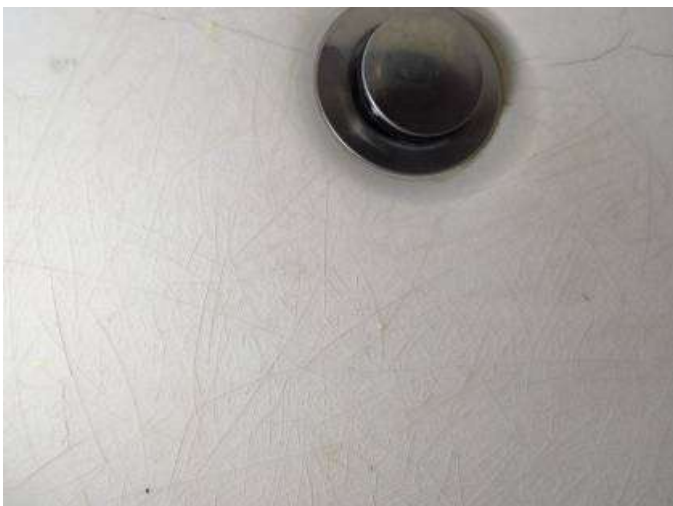
Sinks: **Action** - The pedestal sink in the hall bathroom is loose. This can cause leaks in the piping. Repair by a plumber is recommended.
- The middle rear bathroom sink has minor cracks in the finish, it is not currently leaking. Eventually it will need to be replaced.

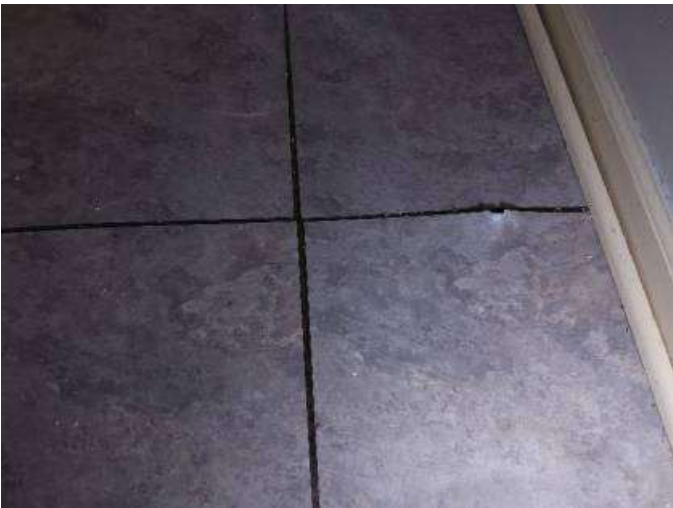
Flooring: **Attention** - Some of the flooring in the laundry room is loose.

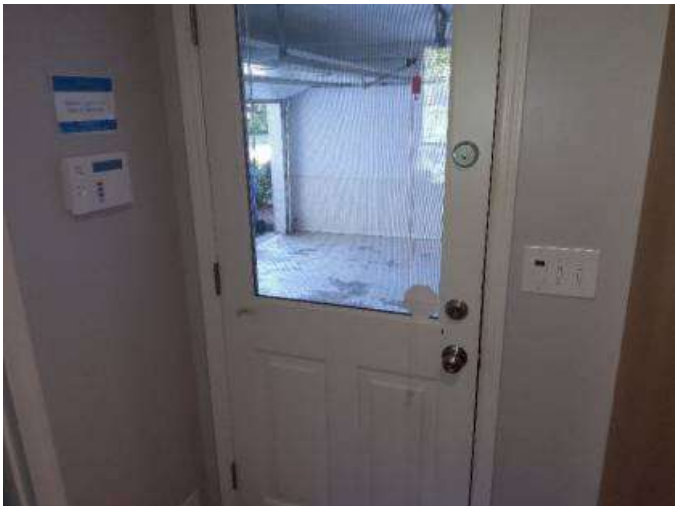
- Type:** Attached two car garage.
- Vehicle Door:** **GOOD NEWS:** The overhead garage door is made of metal, which lasts longer and requires less maintenance than a wood door.
- Vehicle Door Condition:** The overhead garage door is in satisfactory condition and is functional.
- Door Opener:** The automatic door opener and the electronic beam safety reverse system operated properly. The remote controls were not available for testing.
- Door to Home:** **Action** - The door from the garage to the home has a glass window that is too large for the door to be considered a fire rated installation. Over 100" of glass is too large. For safety, recommend replacing the door with a fire rated door.
