Property Address: 1220 Primrose Dr, Roswell, GA 30076

Inspector: Ronnie McCaskill
Company: WIN Home Inspection- Roswell
dba
(770) 650-1601
rmccaskill@wini.com

Standard Full Home Inspection

Service Date: 8/19/2020

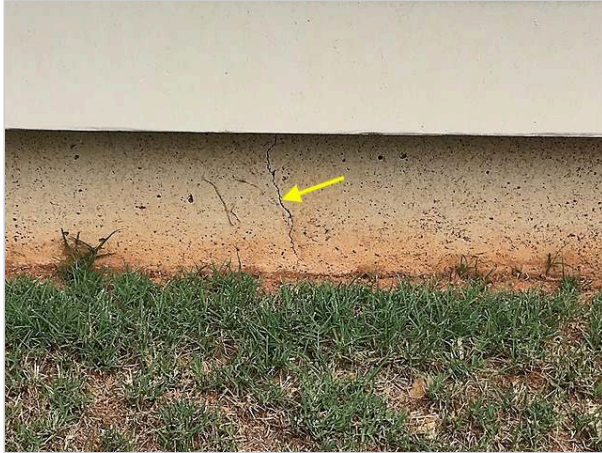
There are small cracks less than 1/8" wide visible in the foundation slabs as pictured below. Small cracks are commonly found on foundations of this type and do not appear to represent a structural issue. The Inspector recommends sealing any cracks to prevent moisture from penetrating through the cracks and to inspect the cracks for widening on an annual basis.

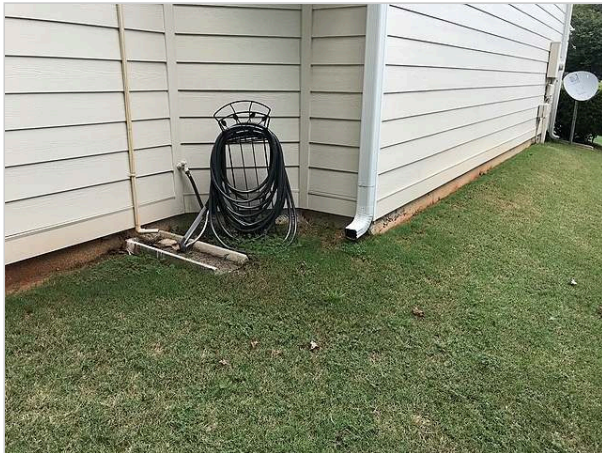
The inspector did not find evidence of past termite treatment (drill holes or bait stations). This inspection does not provide a WDO (wood destroying organism) inspection and we strongly recommend that all buyers have a qualified exterminator inspect the home for termites and other insects during the due diligence period. In addition to ordering a WDO inspection during due diligence the buyer may question the Seller as to the status of past treatment and whether a termite bond has been in force continuously during their ownership.

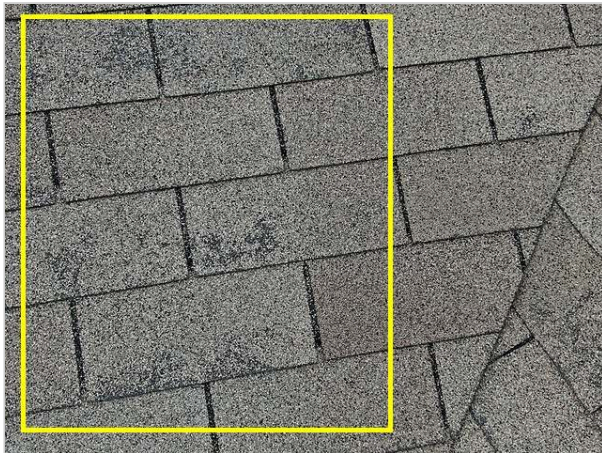
The roofing shingles were inspected and we found some localized moderate granule loss that may be due to workers on the roof when the siding was replaced. Periodic inspection and maintenance of the shingles, vents/ chimneys, and flashing is recommended to prevent leaks and address deficiencies early.

Localized granule loss

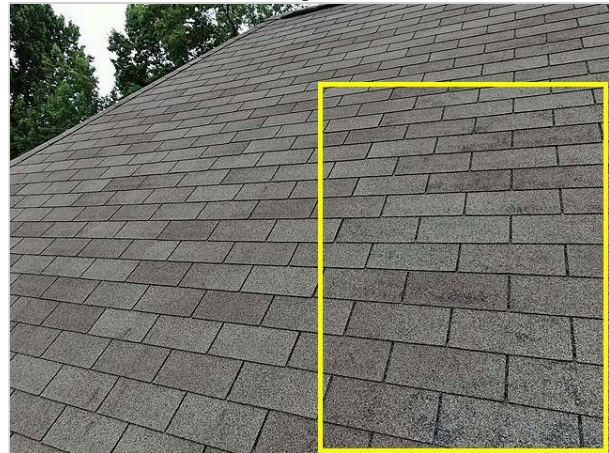
Localized granule loss

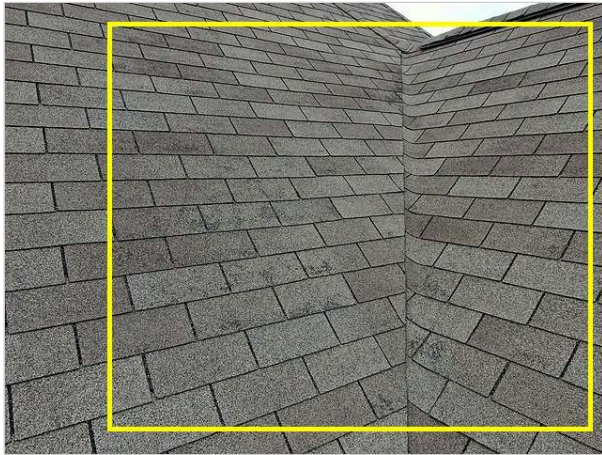
Localized granule loss

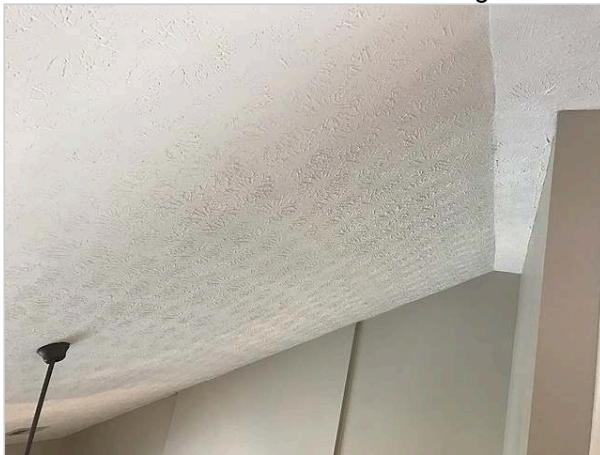
No stains or repairs apparent at family room ceiling

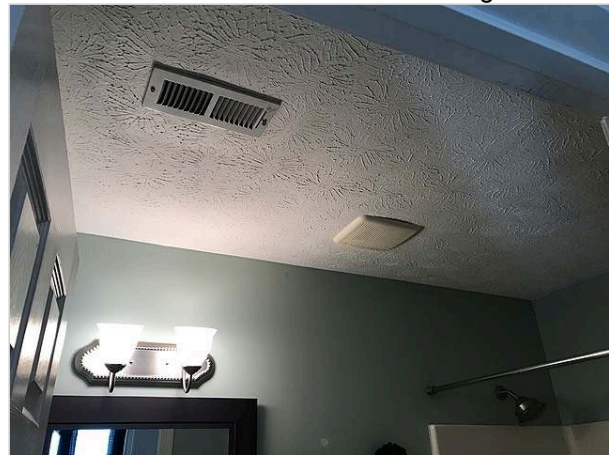
No stains or repairs apparent at bathroom ceiling

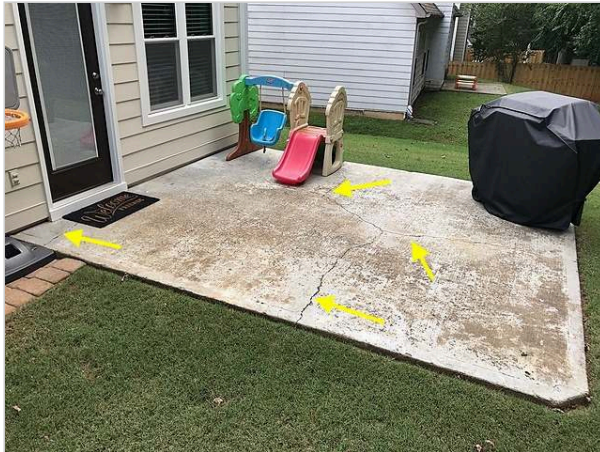
There are concrete shrinkage cracks that are not effecting the functionality of the patio and do not represent a cause for concern at this time. Consideration may be given to sealing these cracks with an epoxy grout or acrylic resin sealant to provide a pleasing appearance and prevent moisture intrusion that could lead to additional damage.

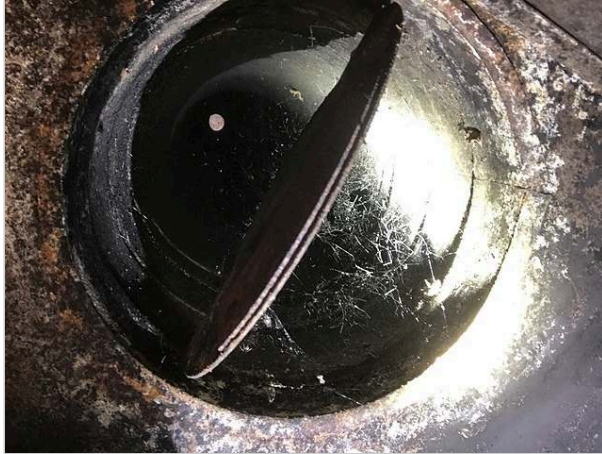
The fireplace flue is housed inside the chimney and is simply the tube that allows smoke and gas to safely exit the home. Defects in the flue can occur for many reasons and home inspectors are not equipped to fully review the chimney flue for defects and cracks that could lead to an unsafe conditions. Review of the flue during this home inspection is limited to access at the firebox using a flashlight and this review will not turn up all defects in the flue.

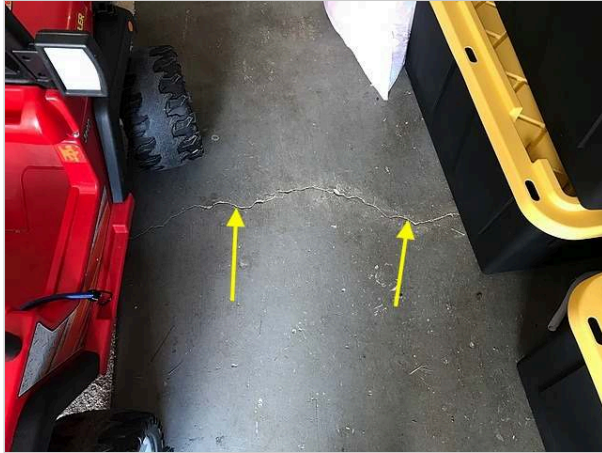
There are concrete shrinkage and/or settlement cracks present in the garage concrete floor slabs that do not appear to be adversely affecting the foundations but are about 1/4" wide. Consideration should be given to sealing the cracks with an epoxy or acrylic resin sealant to provide a smoother transition and prevent insect, moisture or radon gas intrusion. Grinding or selective removal, compaction of the subgrade and replacement of the slab may be desirable to provide a smooth transition between adjacent slabs with more significant damage.

Due to storage entire garage floor could not be evaluated

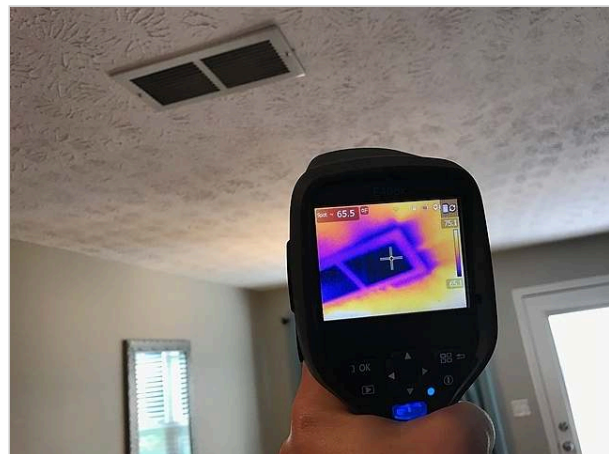
The thermostat controls were used to test the Air Conditioning and we found that the unit servicing the home did not cool effectively on the day of the inspection and is nearing or has exceeded the design life for residential systems. We recommend the Buyer have the Air Conditioning system evaluated by a qualified technician during the Due Diligence period to determine whether repairs or replacement is warranted. The inspector took temperature readings at the supply and return vents. While there may be some cooling capacity to the system (approximately 11 degrees on the day of the inspection), the unit did not maintain a temperature drop of 14-22 degrees between the supply and return vents. The design life of residential Air Conditioning units is 10-15yrs and this unit is 28yrs old.

65.5 supply

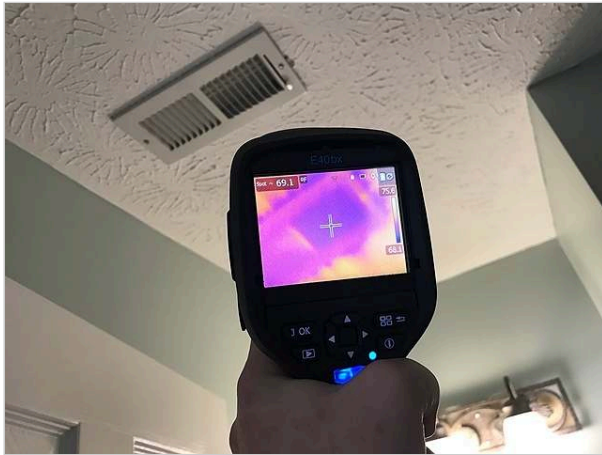
69.1 supply

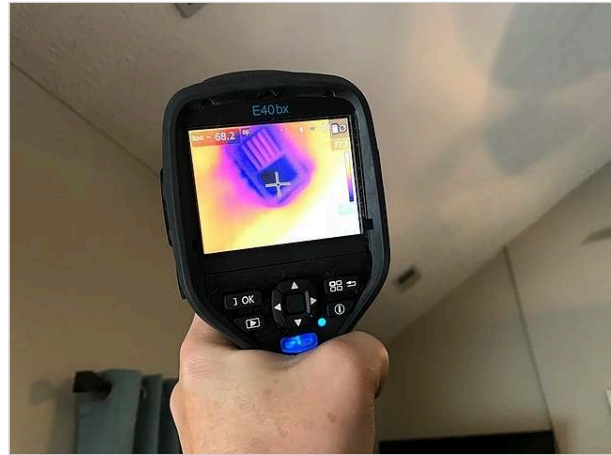
68.2 supply

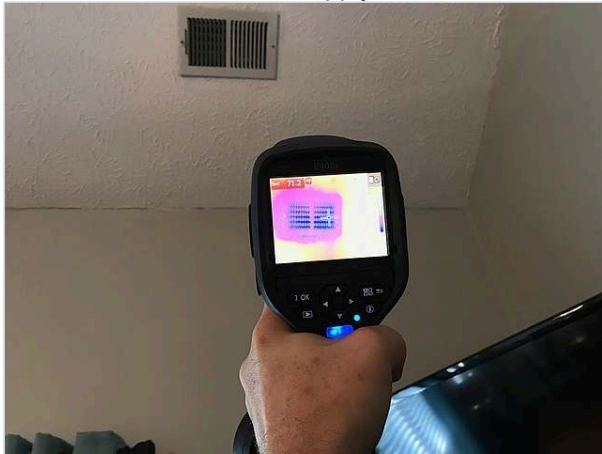
71.2 supply

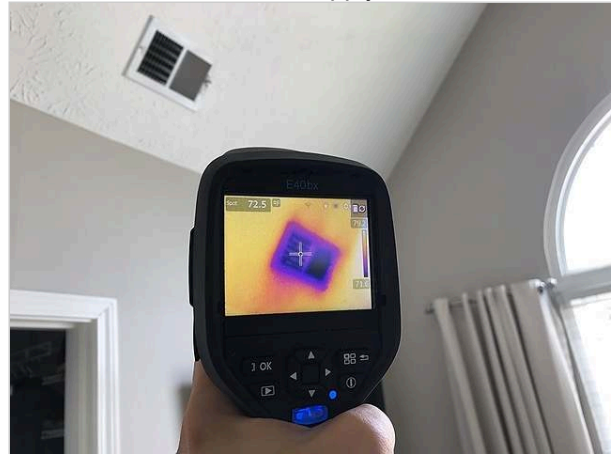
72.5 supply

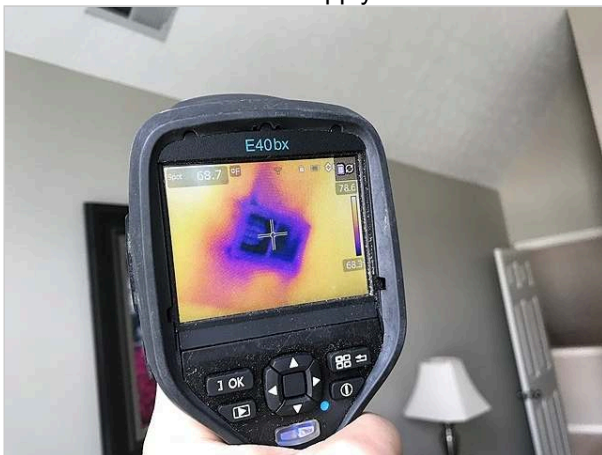
68.7 supply

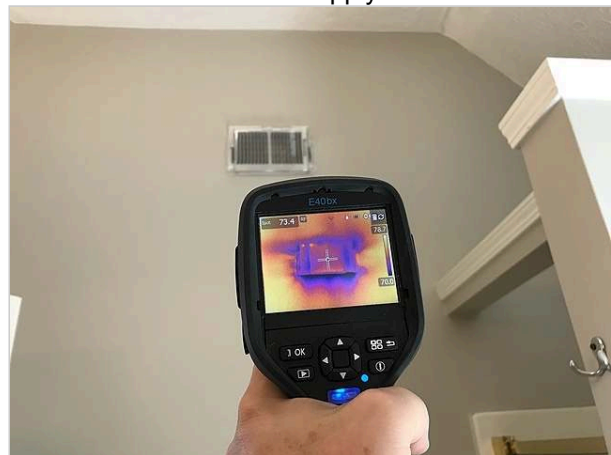
73.4 supply

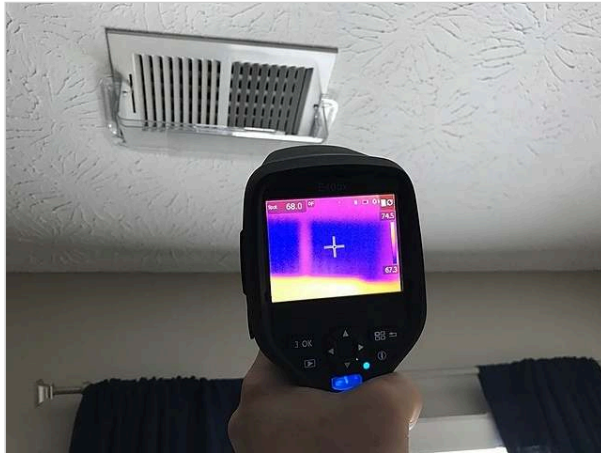
68 supply

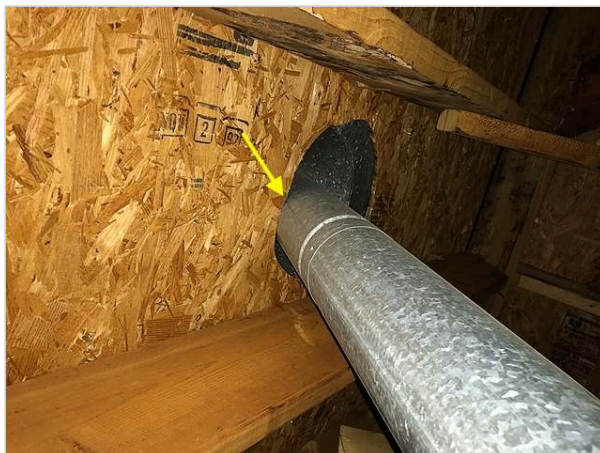
The furnace and/or water heater vent pipe depicted in the photograph below has less than 1 inch clearance to building materials as is currently required by Building Standards and Practices and the UL listing for the duct. The Inspector recommends having a qualified HVAC technician adjust the vent in an approved manner as required to provide a minimum of 1 inch clearance to the combustible materials for proper fire safety. .

Furnace vent in contact with roofing material

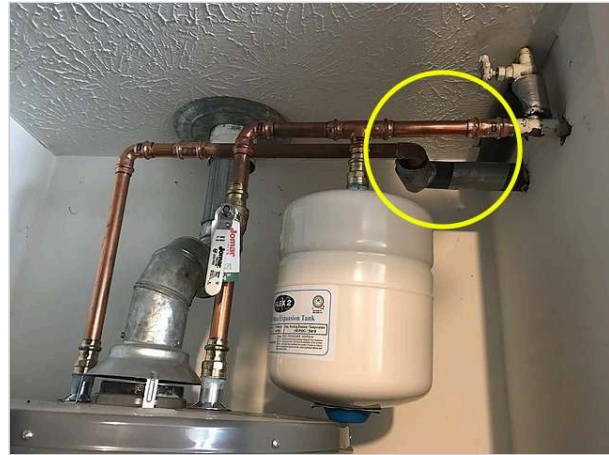
The Inspector noted that there are no bonding jumpers over the pressure reducing valve or at the hot and cold water piping above the water heater. Bonding jumpers should be installed at these locations by a qualified electrician since grounding of the piping and electrical systems could be rendered ineffective by the presence of these fittings and equipment or should a plumber ever be required to remove them for maintenance.

No bonding jumper

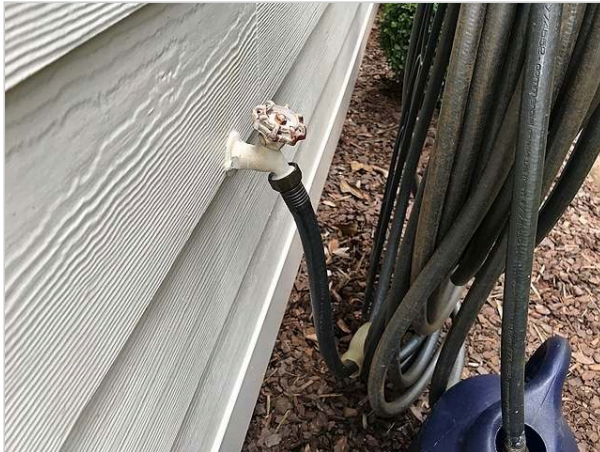
The below noted exterior faucets need back-flow preventers or vacuum breakers to prevent possible contamination of the home's water service. These devices are inexpensive, easily installed by homeowners and may be obtained from your local home improvement center or hardware store.

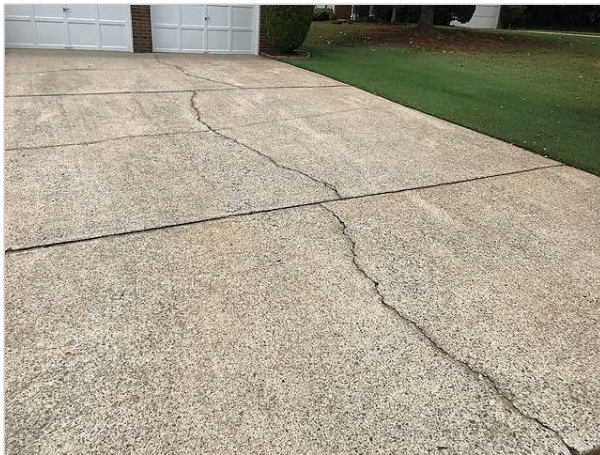
There are concrete shrinkage and settlement cracks and joints present in the driveway and/or sidewalk slabs that have limited effect on the functionality of the pavement, but may present tripping hazards to pedestrians at those locations where the elevations on each side of the crack or joint differ by more than 1/2". Consideration should be given to sealing these cracks with an epoxy grout to prevent moisture intrusion that could contribute to long-term deterioration of the slab. Selective replacement or grinding of the surface may be desirable to provide a smooth transition between adjacent slabs with more significant damage.

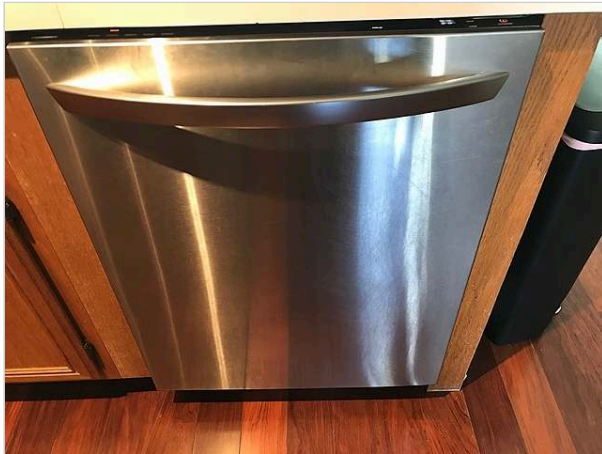
The Inspector noted that the dishwasher drain tube does not loop up to the level of the countertop. There may be enough slack in the line to accomplish this with the current line. We recommend having a qualified handyman or homeowner adjust the drain tube so that a potential backup in the plumbing does not contaminate the dishwasher with bacteria.

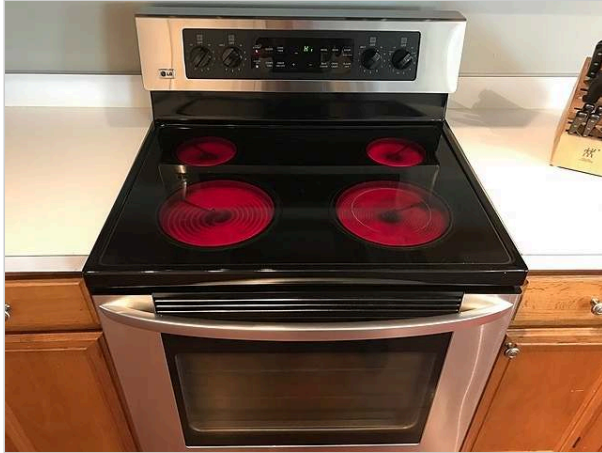
All burners were started and functioned at the time of the inspection. The inspector can not guarantee that a burner will heat to or hold a required temperature.

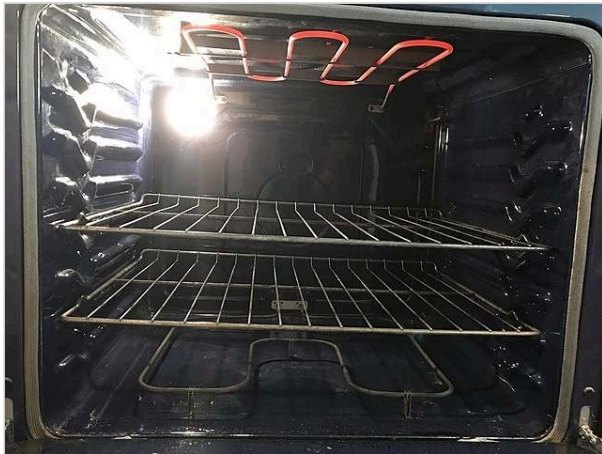
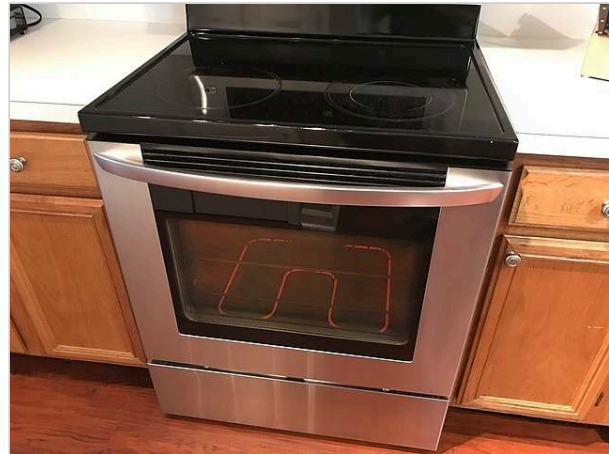
11. Oven

The oven does not have an anti-tip device that would keep it from rocking forward should pressure be applied to the door while it's open. We recommend having a qualified handyman add an anti-tip device for safety especially when there are small children in the home.

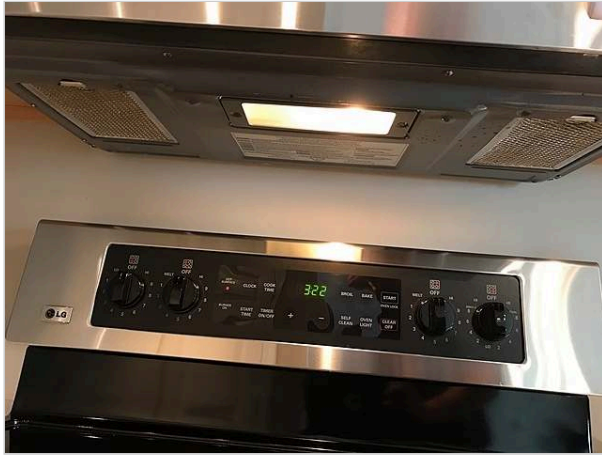
The grease filter for the cook top exhaust fan should be cleaned periodically in the dishwasher to ensure long term service of the fan. Replacement filters are also available at most home improvement stores or at the manufacturers website.

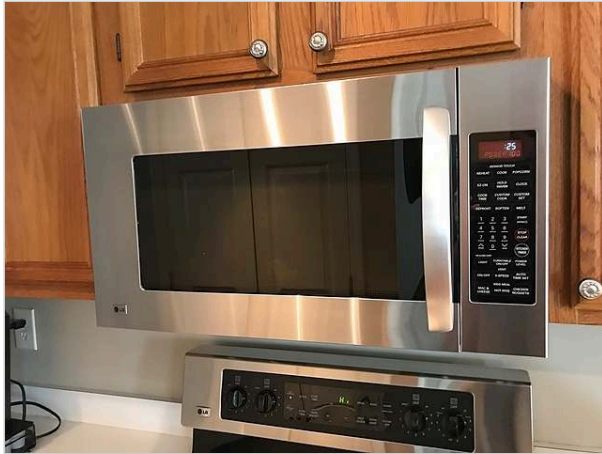
15. Built-in Microwave Operational

The microwave oven was checked for on/off operation and heating a small paper towel which was moistened. This is not a guarantee that the oven will properly heat food or beverages. Microwave ovens have an approximate design life of 9yrs and newer ovens may be more efficient than older units.

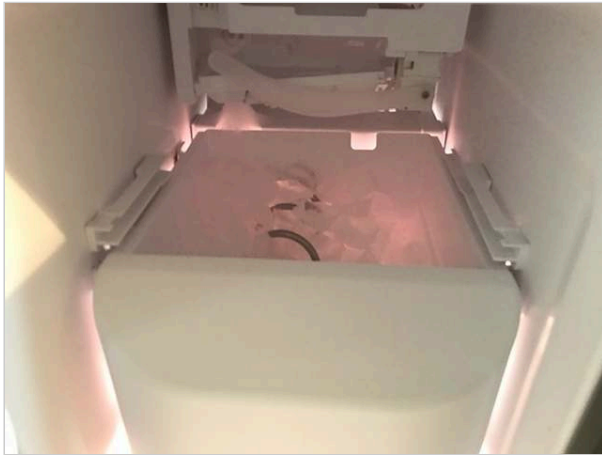
16. Water For Refrigerator

The Inspector noted that there is ice in the freezer and/or water available through the door of the installed refrigerator.

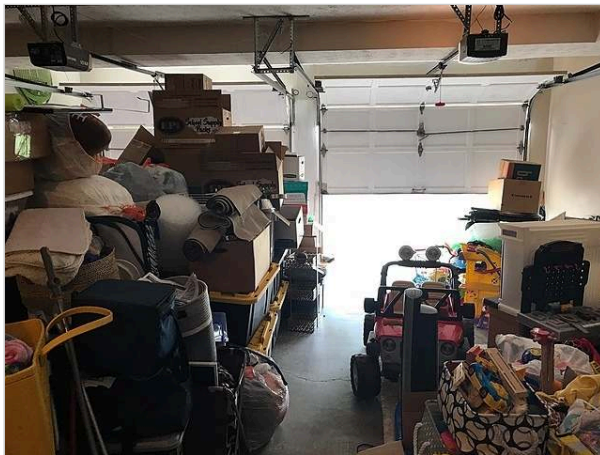
4. Springs/Mount

The springs installed at a garage door on the left side (looking out) did not have containment cables installed. Extension springs should have containment cables installed to help prevent injury or death if a spring should break. The Inspector recommends having a qualified garage door installer add a containment cable to properly tether the springs.

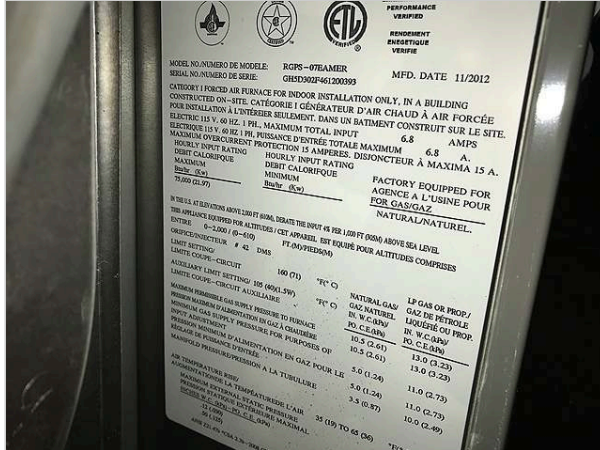
2012 gas furnace

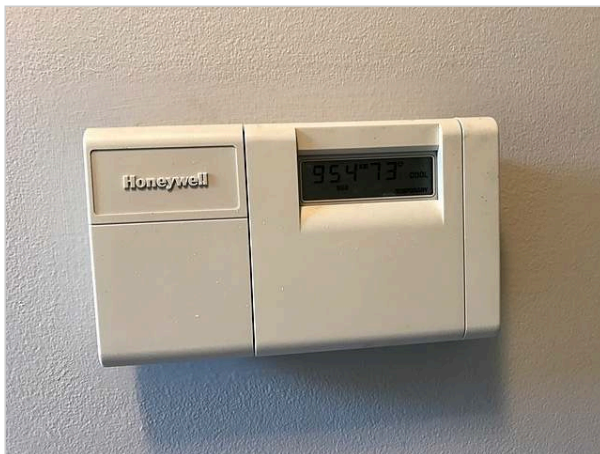
The home has an electronic programmable thermostat that should add to the energy efficiency of the home if it is properly programmed. We recommend consulting the thermostat manufacturers website for details on programming and operating the thermostat.

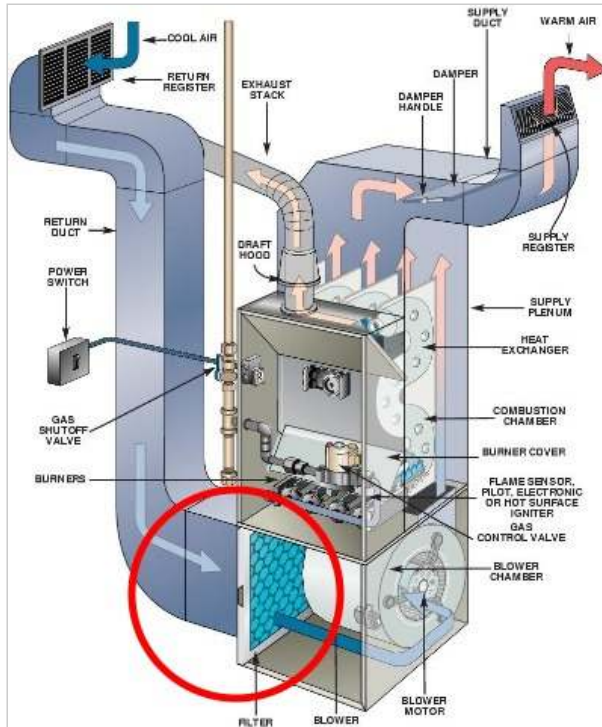
Typical filter location

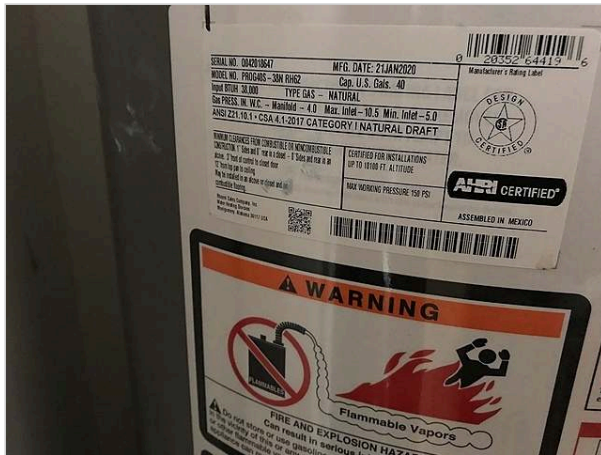
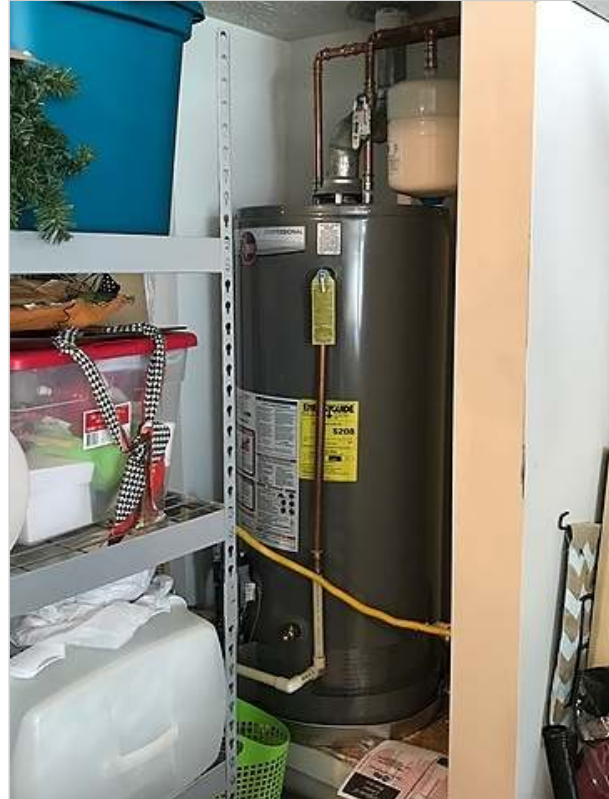
The gas water heater was manufactured in 2020. The life expectancy of a gas water heater is typically 8-12 years from the date of installation, although there are exceptions on both sides.
