BPG Inspection Services

**1357 Westminster Walk Northwest
Atlanta GA 30327**

Client(s): Hamza
Inspection Date: 8/13/2020
Inspector: Kevin Carey ,

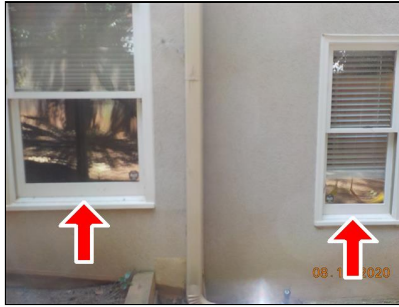
SERVICE / REPAIR: Missing screens noted. Many owners choose to remove screens to enhance the views from the window. Verification of possession by the owner is recommended. Location: **Basement, right side dormer**

Missing screens noted.

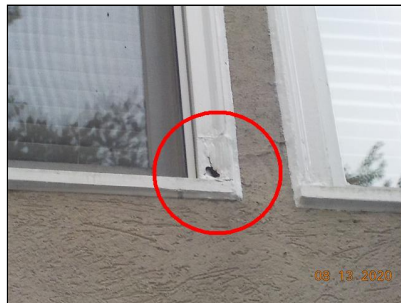
- ❌ 7. **SERVICE / REPAIR:** Wood rot and deterioration are present. Evaluate all areas and replace/repair all wood rot to the extent found to prevent further damage to any area. All replacement wood should be primed on all sides, caulked and painted as required. Any damage on the exterior wall or trim that allows openings into the wall cavity or interior can cause significant water damage over time if not repaired. Location: **Rear window trim/frames.** **Recommend a complete review of all the wood trim elements on the house.**

Wood rot and deterioration are present.

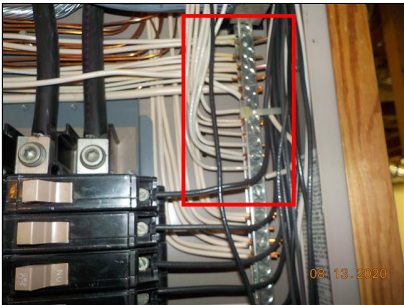
The neutral (white) wires are doubled under the same lugs

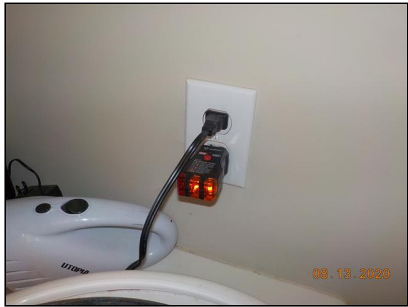
GFCI protection is missing.

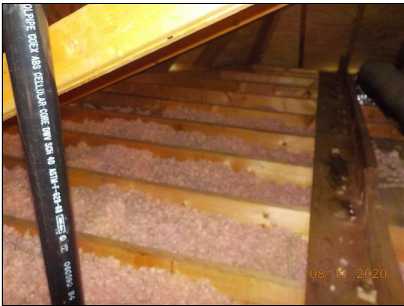
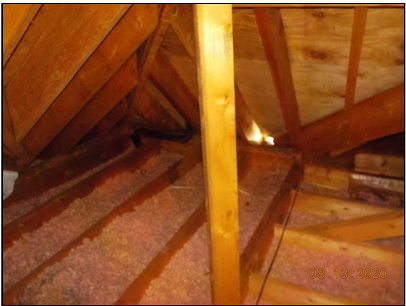
Visible ceiling joists means that thickness is less than 7 1/4 inches.

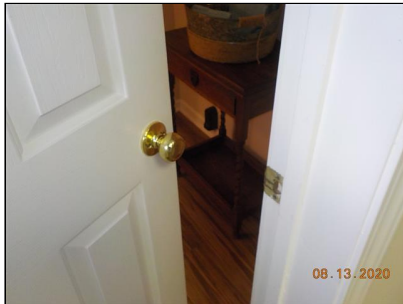
The door sticks when closed.

Adjust or modify door assembly to latch when closed.

- ❌ 36. **SERVICE / REPAIR:** Adjust or modify door assembly to latch when closed. Location: **Basement bathroom**

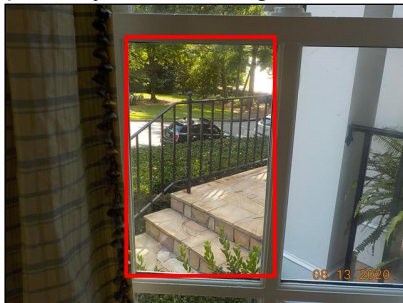
- ❌ 37. **SERVICE / REPAIR:** Condensation and / or hazing was noted between insulated window panes. The thermopane insulated glass has lost its vacuum seal and may eventually completely cloud over. Broken seals also reduce the original insulation value of the window. (Dirty windows should be cleaned to assure that conditions do not exist in other units and were not obvious at time of inspection.) Recommend replacement of all damaged windows listed plus any others throughout house that may be identified by glass service. Location; **Dining room (1)**

Condensation and / or hazing was noted between insulated window panes.

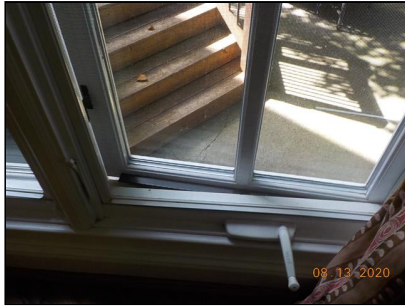
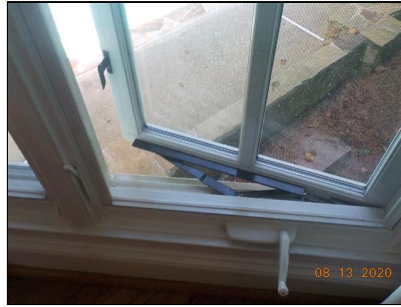
- ❌ 38. **SERVICE / REPAIR:** Windows crank out but do not crank back in. The crank spins and will not pull the window back closed. Recommend further evaluation and repairs made by a qualified window contractor. Location: **Kitchen/ Breakfast room (2)**

Windows crank out but do not crank back in

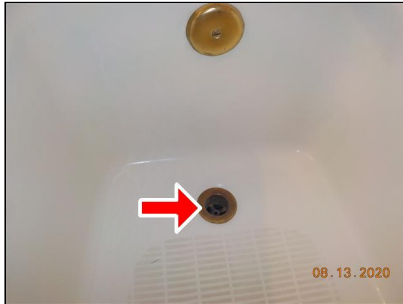
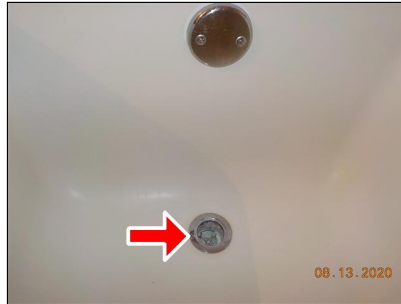
- ❌ 45. **SERVICE / REPAIR:** Tub stopper is missing and should be replaced to allow for taking baths. Location: **Right rear bathroom, basement bathroom**

Tub stopper is missing

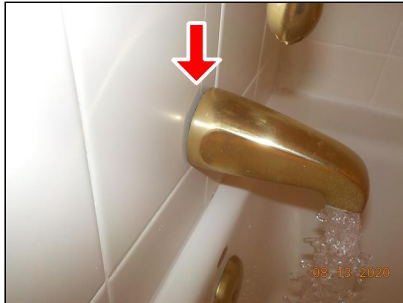
- ❌ 46. **SERVICE / REPAIR:** Fill spout is not tight to the tub wall. Modify and seal to prevent moisture access behind wall assembly. Location: **Right bathroom**

Fill spout is not tight to the tub wall.

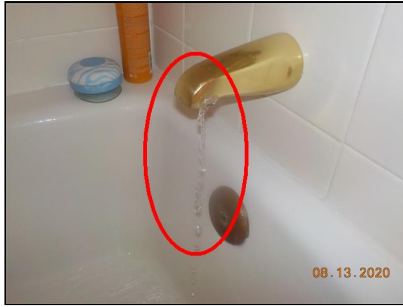
Shower diverter does not seal completely when engaged.

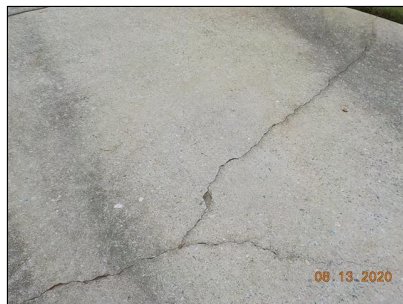
Recommended to seal all open cracks

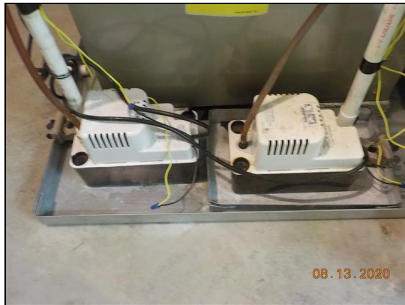
Cleaning the condensate pump reservoir and flushing the line with water is recommended at least twice a year

70. **GENERAL NOTE:** Cleaning the condensate pump reservoir and flushing the line with water is recommended at least twice a year to remove biological growth and reduce the possibility of the drain line becoming clogged.

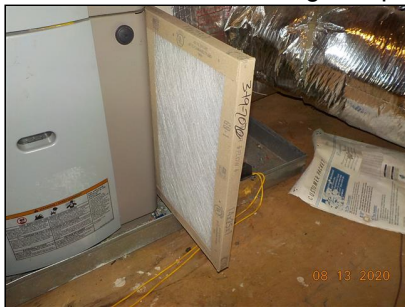
Recommend changing the filter at move-in.

71. **GENERAL NOTE:** Recommend changing the filter at move-in. Recommend changing filter every two to three months thereafter. Use a good quality, pleated filter that is rated MERV-8 or better. The filter size is: 14 x 25 x 1

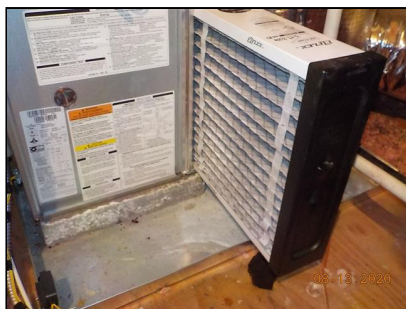
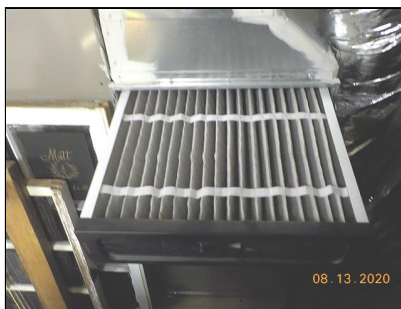
Recommend changing the filter at move-in.

72. **GENERAL NOTE:** Recommend changing the filter at move-in. Recommend changing filter every 10-12 months thereafter. Use a good quality, pleated filter that is rated MERV-8 or better. The filter size is: 16 x 25 x 4, 20 x 25 x 4
