Inspection Report

Property Address:
382 Lofton Rd NW
Atlanta GA 30309

Avalon Home Inspections Inc.

Date: 7/21/2020	Time: 09:30:00 AM	Report ID: 31236JK
Property: 382 Lofton Rd NW Atlanta GA 30309	Customer: Bethany Seewoester	Real Estate Professional: Cathryn Weldon Keller Williams (Atlanta) InTown

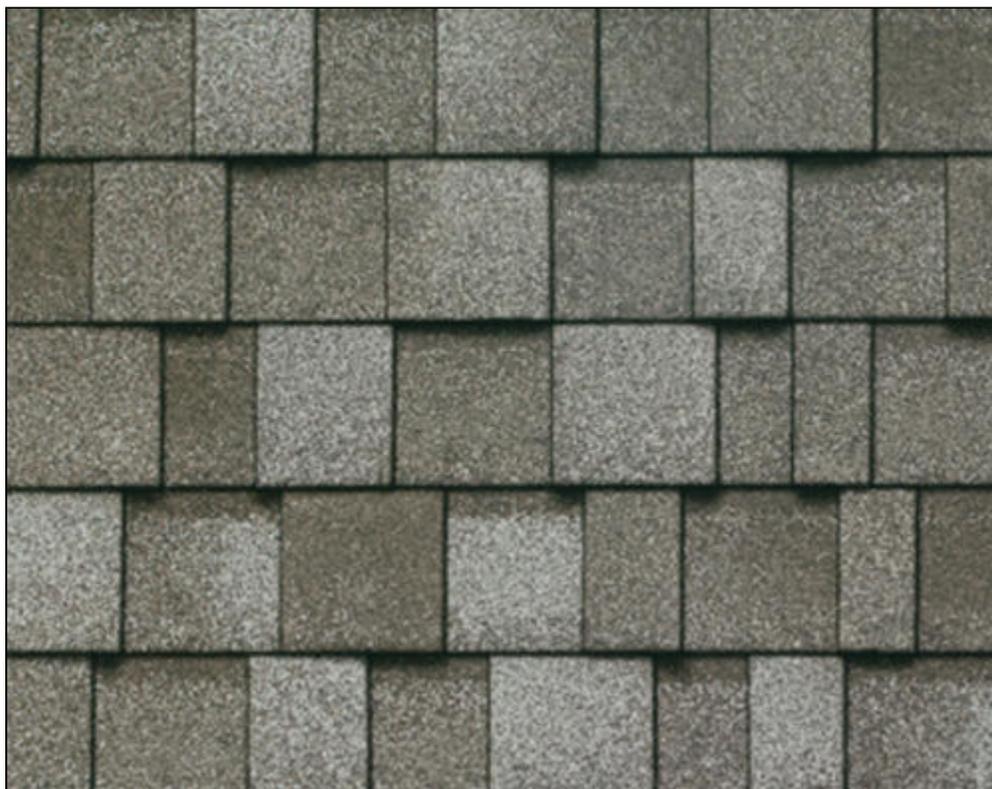
1.0 Item 1(Picture)

- i** (1) Average lifespan of architectural shingles in GA is 25 to 28 Years. Also known as laminated or dimensional shingles, architectural roofing shingles are among the highest quality roofing products made. Traditionally, they are composed of heavy fiber glass material base and ceramic-coated mineral granules that are tightly embedded in carefully refined, water-resistant asphalt.

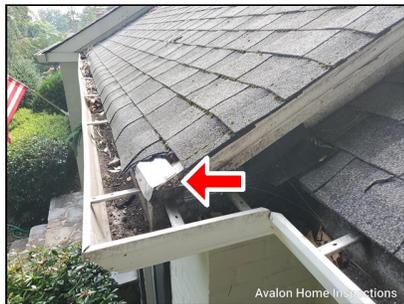
1.0 Item 2(Picture)

🔨 (5) Several roof shingles are damaged at numerous areas of roof. It should be replaced as soon as possible. A qualified contractor should inspect and repair as needed.

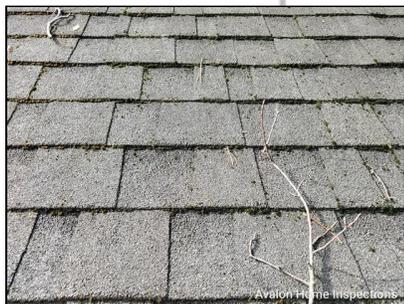
1.0 Item 8(Picture)

🔨 (6) The roof shingles has excessive "moss or algae" growth at the "entire roof". Repairs are needed as moss can shorten lifespan of shingles. A qualified contractor should inspect and treat fungi as needed.

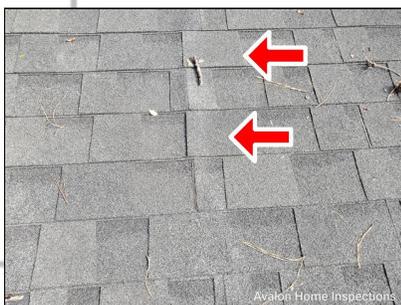
1.0 Item 13(Picture)

Racking can be an improper installation method for many shingle types. It is acceptable for some shingle types, and it is the required method for a few shingle types.

The inspector recommends that, before the expiration of your Inspection Objection Deadline, you have the roof examined by a qualified roofing contractor to determine whether the shingles on your roof have been improperly installed.

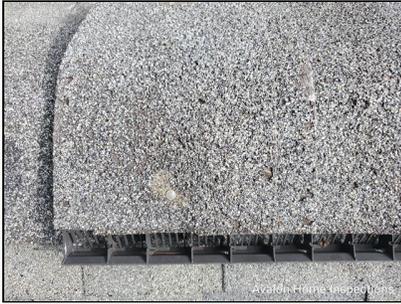
1.0 Item 14(Picture)

🔨 (8) The roof covering shows a mump-like appearance indicating a possible manufacturer defect. These areas will eventually blister and the roof will need replacing.

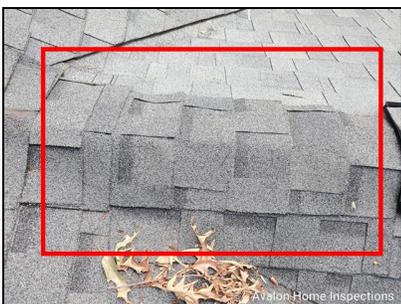
1.0 Item 19(Picture)

🔨 (9) The roof shingles were installed improperly or not according to manufactures specifications at the ridge shingles. The roof is not leaking but will not withstand elements as well as a properly installed shingles. A qualified roofing contractor should inspect and repair/replace as needed.

Ridge shingles must be used at ridge. Architectural shingles cannot be used at ridge cap.

Starter strip is missing around perimeter of home. Repairs are needed by a licensed roofing contractor.

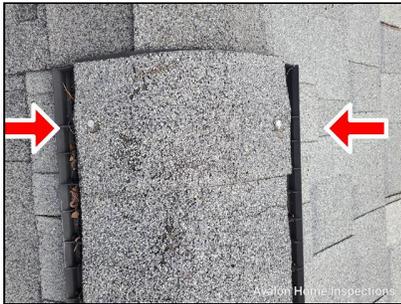
1.0 Item 20(Picture)

- (10) Unsealed visible roof nails should be sealed. This can cause leaks. A qualified person should seal nail holes with tar or silicone.

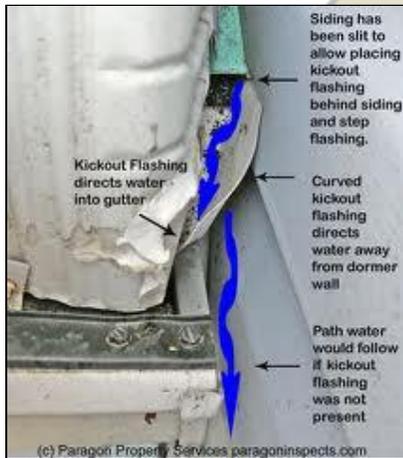
1.1 Item 1(Picture)

- (1) The kick out flashing between cladding and shingles is missing at the front of home. Kick out flashing directs water into gutter or away from home so that runoff water intrusion does not occur into the cavity of wall. A qualified contractor should install as needed.

IRC R703.8

R905.2.8.3 Sidewall flashing.

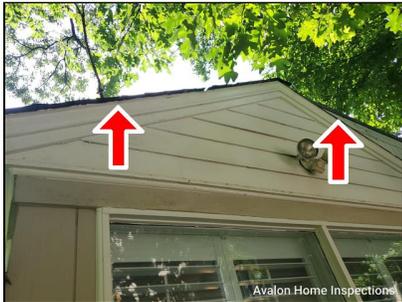
1.1 Item 4(Picture)

(2) The metal drip edge is missing along rake/eaves. Moisture or water could leak in to attic when raining. A qualified roofing contractor should inspect and repair as needed.

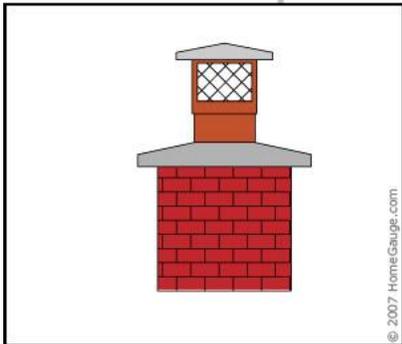
1.2 Item 1(Picture)

(1) Chimney cap is missing. This was common for older homes but is not recommend as rain and pest can enter flue pipe. A qualified contractor should install as needed.

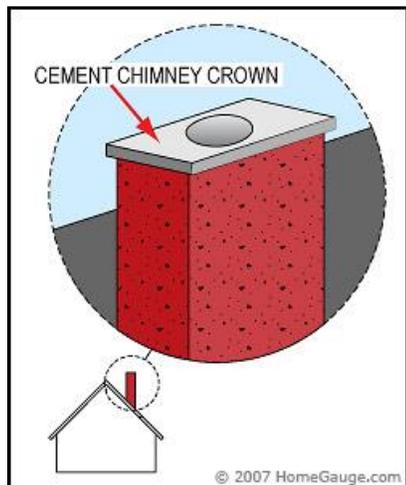
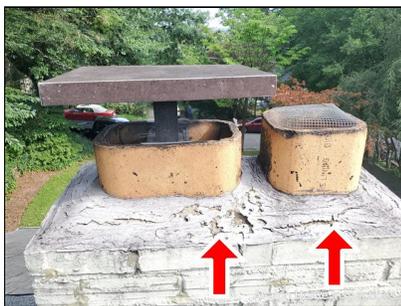
🔨 (2) The cement crown on chimney chase is failing and needs prep and re-coat. Further deterioration may occur if not repaired. A qualified contractor should inspect and repair as needed.

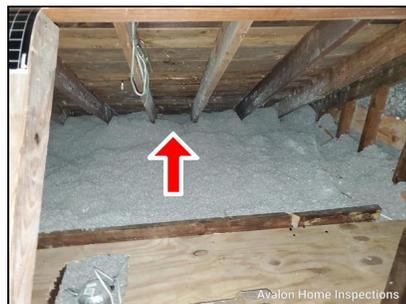
1.3 Item 2(Picture)

🔨 (2) Soffit vent screens are blocked by insulation(missing baffles) at the front of home and rear of home. This is a small but needed repair as proper ventilation of attic will increase roof life and lower energy bills. A qualified contractor should inspect and repair as needed.

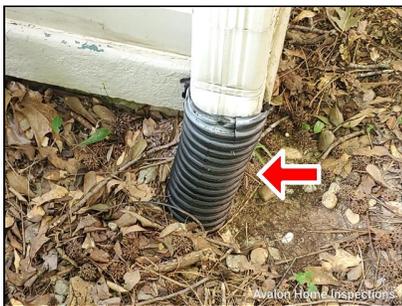
1.4 Item 3(Picture)

- (2) The below ground drain lines for downspouts are old and I am unable to determine if drains will function properly.

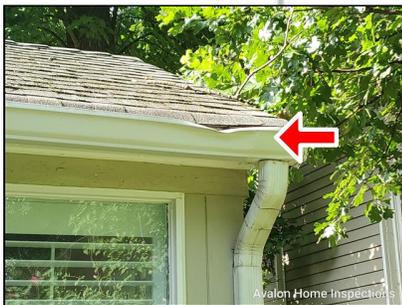
1.4 Item 4(Picture)

- (3) The gutter(s) is damaged at the front of home. Damaged, loose or leaking gutters can cause deterioration of fascia, soffit or roof edge. It can also cause gutters to pull loose and lead to possible water intrusion. A qualified contractor should inspect and repair as needed.

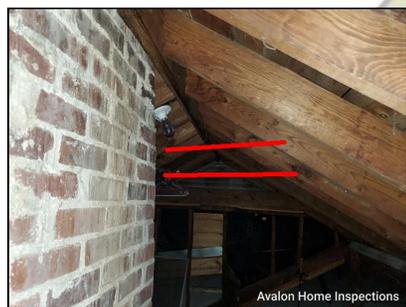
1.5 Item 2(Picture)

(2) The 2x6 rafters are missing collar ties at ridge of roof. Repairs are needed to maintain the stability of roof. A qualified contractor should repair as needed.

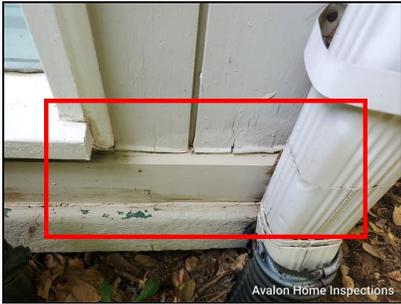
2.0 Item 4(Picture)

- (5) The wood trim at the front, rear and sides of home is beginning to deteriorate along bottom edge. Further deterioration can occur if not corrected. A qualified contractor should inspect and repair as needed.

Pictures shown do not represent all deficiencies, recommend that a qualified contractor evaluate and replace siding as necessary, and/or seal and repaint as necessary.

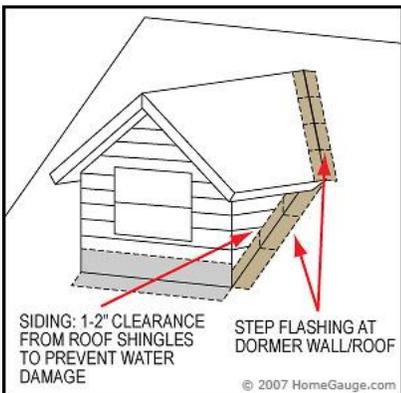
2.0 Item 8(Picture)

- (6) The cladding and trim is beginning to deteriorate at roof line. The siding and trim should be a minimum of 1 inch above shingles to prevent wicking of moisture. Further deterioration can occur if not corrected. A qualified contractor should inspect and repair as needed.

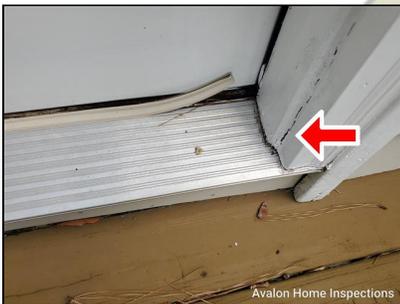
2.1 Item 2(Picture)

🔨 (3) The entry door at the rear of home has deteriorated at brick-mold or trim (exterior). A repair or replacement is needed. A qualified contractor should inspect and repair as needed.

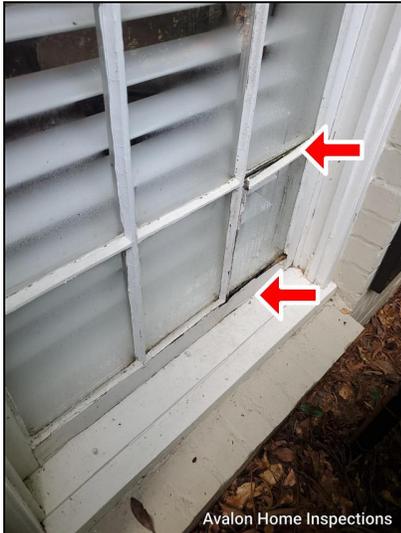
2.2 Item 1(Picture)

- (1) The brick-mold around windows is deteriorated at front of home and left side (facing front). Further deterioration may occur if not repaired. A qualified contractor should inspect and repair as needed.

Pictures shown do not represent all deficiencies, recommend that a qualified contractor evaluate and replace deteriorated trim as necessary, and/or seal and repaint as necessary.

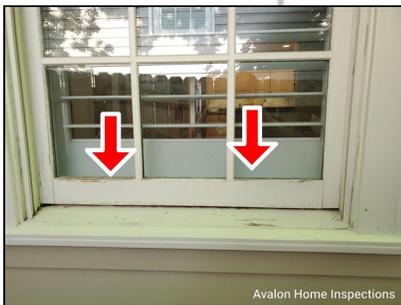
2.2 Item 3(Picture)

- (3) The wood trim is peeling paint at some windows around home. This is a maintenance issue to prevent water intrusion into home. A qualified contractor should prep and paint.

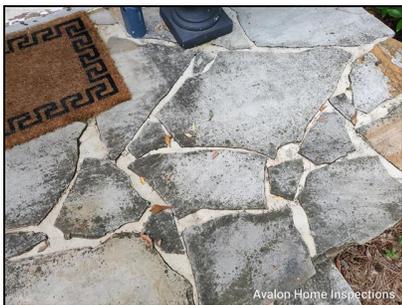
2.3 Item 1(Picture)

- 🔨 (2) The rock on the steps at the front of home is missing and/or has loose mortar. Water can cause further deterioration if not repaired and sealed properly. A qualified contractor should inspect and repoint as needed.

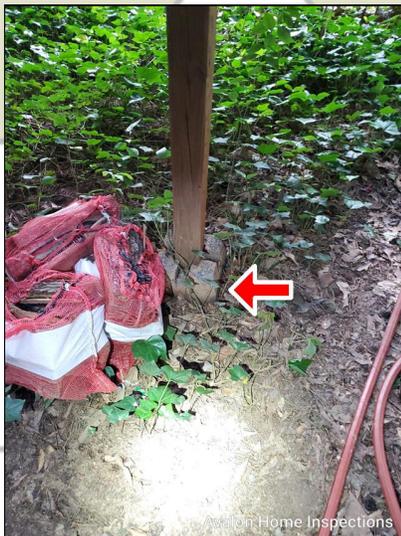
2.3 Item 5(Picture)

- 🔨 (3) The guardrails at steps and deck at the rear of home are loose. An injury could occur if not corrected. A qualified contractor should repair or replace as needed.

- 🔨 (4) The support post(s) for the deck at the rear of home are not sitting on proper footers. Repairs are needed. A qualified contractor should repair or replace as needed.

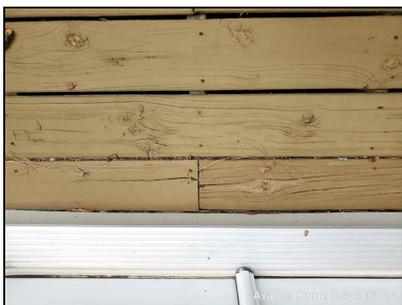
2.3 Item 7(Picture)

- 🔨 (5) The 5/4 decking on the deck at the rear of home has some boards that are deteriorated. A fall or injury can occur if not corrected. A qualified contractor should repair or replace as needed.

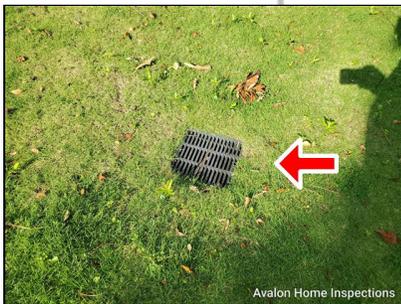
2.4 Item 3(Picture)

(2) The ground drain located at the front of home will need periodical cleaning and maintenance.

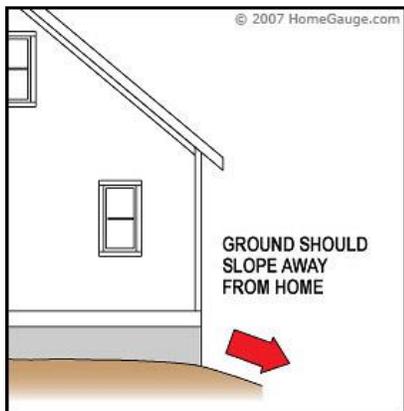
2.4 Item 4(Picture)

- (3) There is a negative slope at the right side (facing front) and can cause or contribute to water intrusion or deterioration. I recommend correcting landscape to drain water away from home.

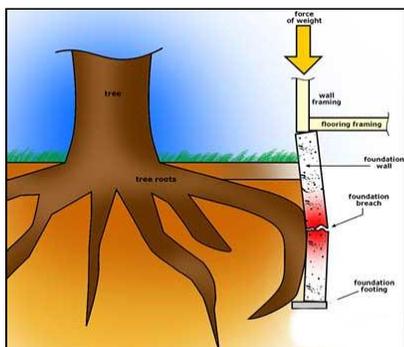
2.4 Item 6(Picture)

- (4) One or more large trees were very close to the foundation. Tree roots can cause significant structural damage to foundations, or may have already caused damage (see other comments in this report). Recommend that a qualified tree service contractor or certified arborist remove trees as necessary to prevent damage to foundations.

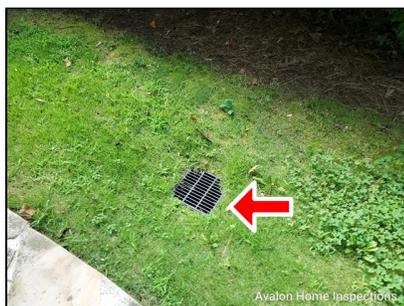
2.4 Item 8(Picture)

- (5) The ground drain located at the front of home will need periodical cleaning and maintenance.

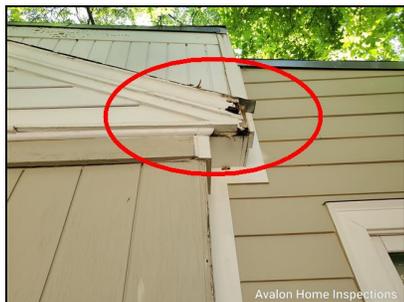
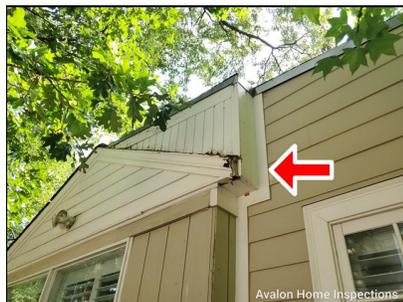
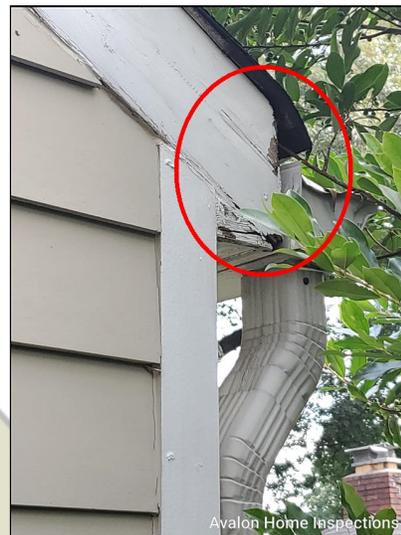
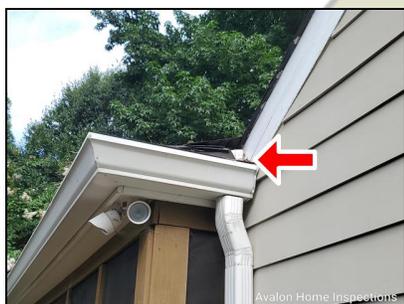
- (1) The paint on eave is failing. I recommend prep and paint at the front, rear and sides of home.

🔨 (2) The wood fascia at eave on the front of home is deteriorated in areas. Further deterioration may occur if not repaired. A qualified contractor should inspect and repair as needed.

Pictures shown do not represent all deficiencies, recommend that a qualified contractor evaluate and replace deteriorated trim as necessary, and/or seal and repaint as necessary.

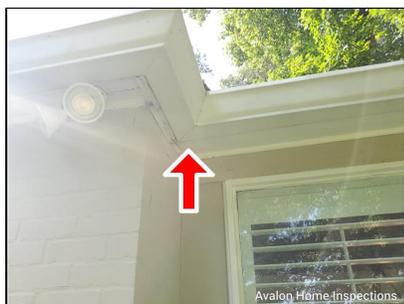
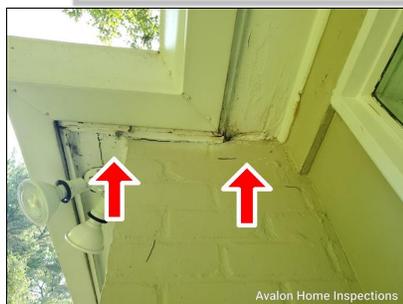
🔨 (3) The soffit panel for eave on the front of home is deteriorated in areas. Further deterioration will occur if not corrected. A qualified contractor should inspect and repair as needed.

Pictures shown do not represent all deficiencies, recommend that a qualified contractor evaluate and replace siding as necessary, and/or seal and repaint as necessary.

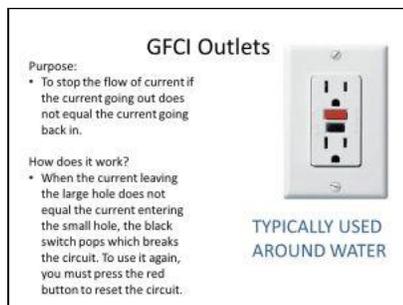
3.8 Item 1(Picture)

At least one GFCI (Ground Fault Circuit Interrupter) outlet at the kitchen is loose in the wall and needs to be secured properly. Electrical issues are considered a hazard until repaired. A qualified licensed electrical contractor should perform repairs that involve wiring.

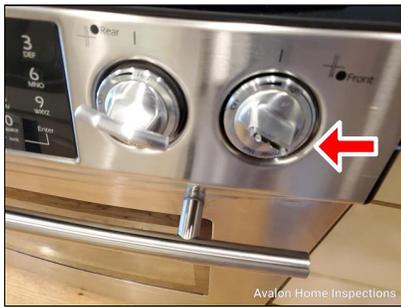
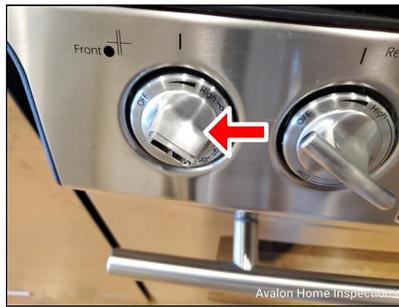
Two knobs are damaged at the range. Repairs are needed.

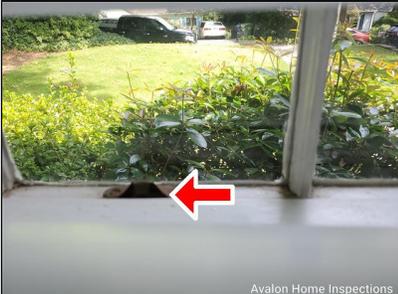
4.5.A Item 1(Picture)

One window is damaged at handle or lock hardware at the living room. This can cause some heat loss in winter and loss of cool air in summer if not corrected. A qualified contractor should inspect and repair as needed.

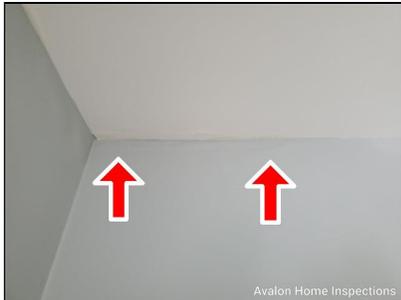
4.0.B Item 1(Picture)

The sheetrock on the ceiling reveals a light stain which appears from a water leak. Stain appears old in the guest bedroom. The moisture meter was used and it did not indicate an active leak. I recommend prep and paint using a qualified contractor.

Keep in mind moisture dries out of finished material(sheetrock, wood, etc.)between attic and stained area quickly due to the heat of an attic. False readings on moisture meters and thermal imaging cameras can occur if lack of adequate rain in the last few days has occurred. Please confirm with seller that leak has been evaluated and/or corrected.

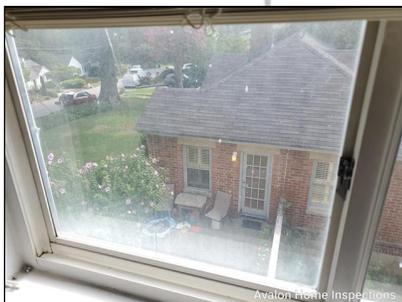
4.5.D Item 1(Picture)

(2) One window is cracked at glass pane at the bonus room. Cracked glass should be replaced to prevent injury or damage. A qualified person should repair or replace as needed.

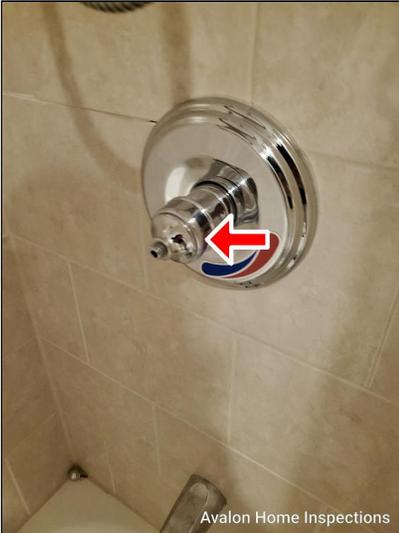
5.5.B Item 1(Picture)

The control knob for shower is missing at the hall bath. Repairs are needed. A qualified licensed plumber should repair or correct as needed.

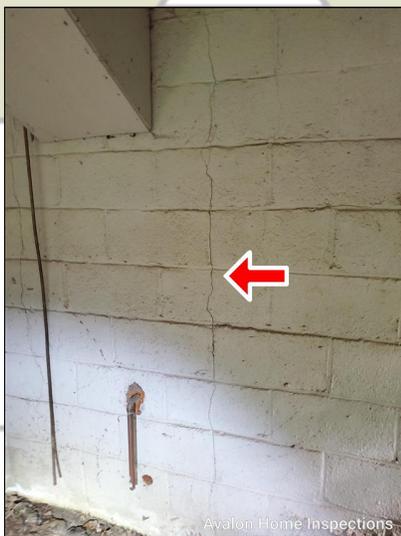
6.0 Item 2(Picture)

Typical shrinkage/expansion cracks at the foundation wall. Typical shrinkage/expansion cracks can be sealed and may need to be re-sealed periodically. This is FYI. Small cracks in masonry will sometimes appear as a house ages. These cracks are not structural in nature and are a result of shrinkage and/or settlement. Cracks should be sealed as a precaution to prevent rainwater penetration. During a prolonged or significant rain this can result in moisture intrusion over time and may not always be visible during the home inspection. Minor preventive maintenance can help to eliminate this.

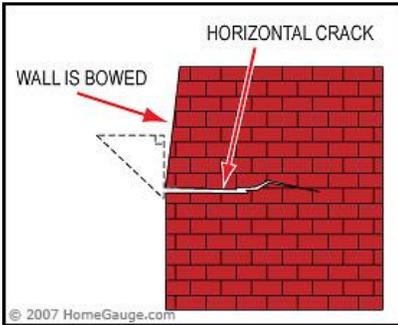
6.1 Item 1(Picture)

- 🔨 Structural crack in wall at the right side (facing front). The appearance of settlement crack is large enough for concern. Recommend a "Structural Engineer" to inspect.

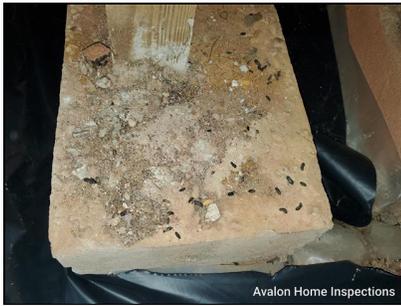
6.2 Item 1(Picture)

- 🔨 (1) Rodent droppings noted in crawlspace. A treatment may be needed. A qualified pest contractor should correct as needed.

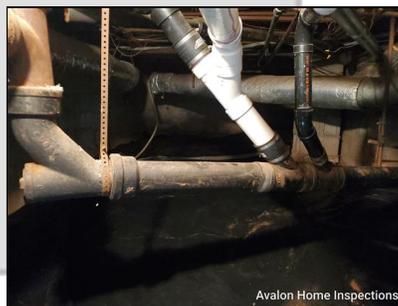
7.0 Item 3(Picture)

🔨 (2) The main soil pipe(waste line) for the home is cast iron. Typical lifespan of this material is 40-50 Years. These pipes rust from the inside out, most of the time with little or no warning. No obstructions or leaks were noted at the time of inspection; however, when solid waste or large volumes of waste are introduced pipes could clog or begin to leak. Recommend a qualified plumber scope waste lines for further inspection to determine the integrity of system. Buyer should budget for replacement.

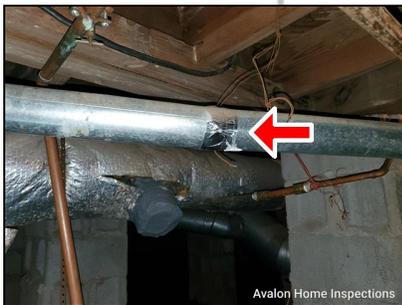
7.2 Item 2(Picture)

(2) The vent pipe for water heater shows evidence of poor venting (white deposits, rust on piping). A more thorough inspection by a qualified contractor is needed. I recommend a qualified licensed heat contractor inspect further and repair as needed.

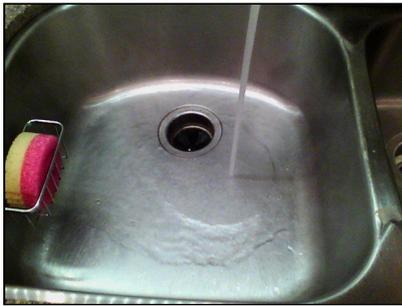
7.2 Item 3(Picture)

(3) The hot water temperature was greater than 125 degrees Fahrenheit. This is a safety hazard due to the risk of scalding. The thermostat should be adjusted so the water temperature doesn't exceed 125 degrees. If the water heater is powered by electricity, a qualified person should perform the adjustment, since covers that expose energized equipment normally need to be removed.

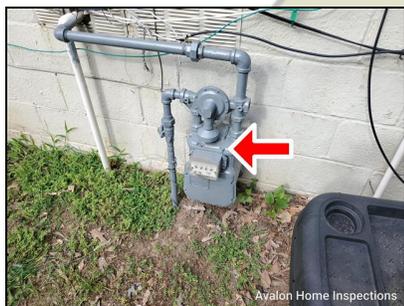
7.5 Item 1(Picture)

i The main fuel shut off is at gas meter outside.

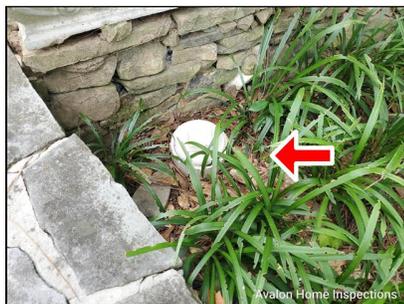
7.7 Item 1(Picture)

i Waste line cleanout is located at the front of home(picture)

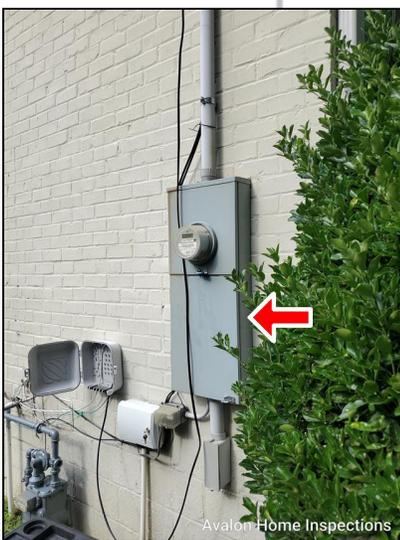
8.6 Item 1(Picture)

🗨 The main panel box is located at the living room. However, the main disconnect (shut-off) is outside at meter base panel (for your information).

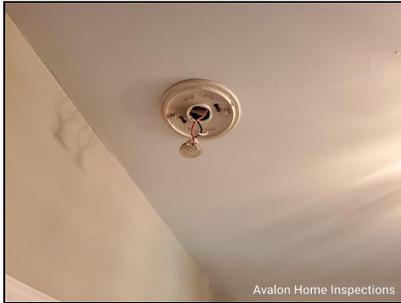
8.7 Item 1(Picture)

(2) The smoke detector has been disconnected intentionally at the common hallway to bedrooms. Without a working smoke detector in your home you have no first alert to a possible fire. I recommend repair or replace as needed using a qualified person.

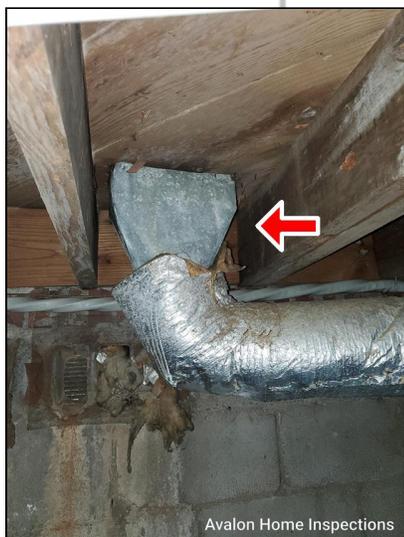
9.3 Item 1(Picture)

- 🔧 (2) The supply duct pipe boots are not insulated to subfloor in the crawlspace. This is causing condensation(sweating). A licensed HVAC contractor should inspect and correct as needed.

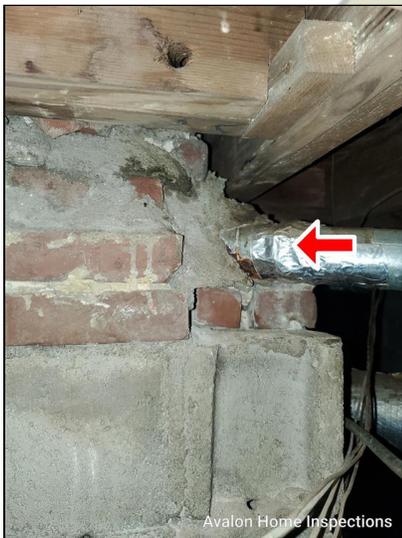
9.6 Item 1(Picture)

The vent pipe for water heater terminates in a clay liner and/or brick chase. This can be safety issue and should be further evaluated by a licensed HVAC contractor. I recommend a qualified licensed heat contractor inspect further and repair as needed.

Chase should be scoped by a qualified heat contractor to determine if liner is safe to use.

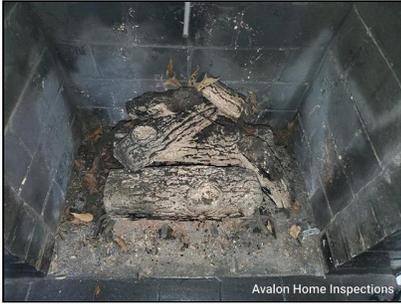
9.8 Item 1(Picture)

The black soot build-up indicates that Gas Fire logs do not appear to be arranged or positioned according to manufacturer's specs. If logs are not positioned correctly, carbon monoxide can be produced.

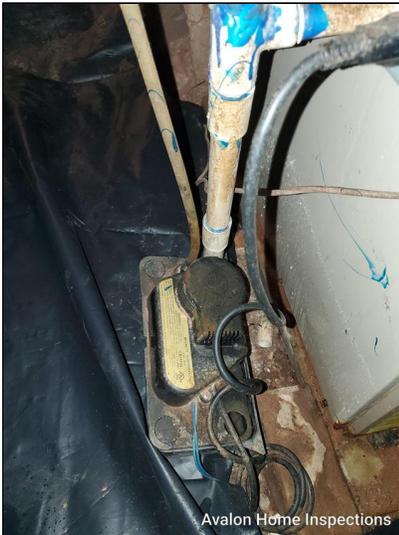
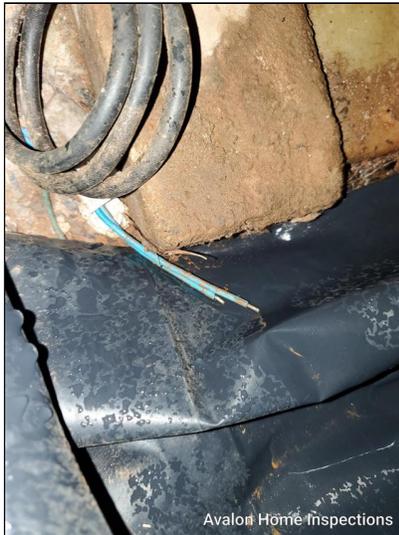
- 🔨 (3) The condensation pump's float switch is not connected to HVAC unit. Leaks can cause damage to unit or home. A qualified HVAC person should inspect further and repair or replace as needed.

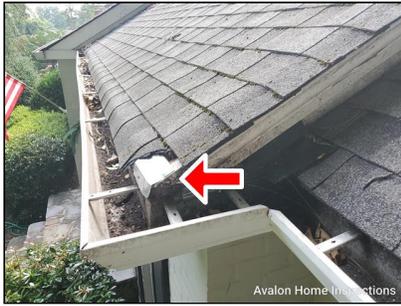
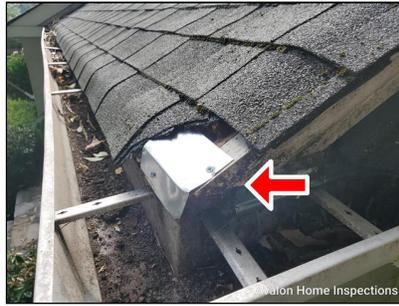
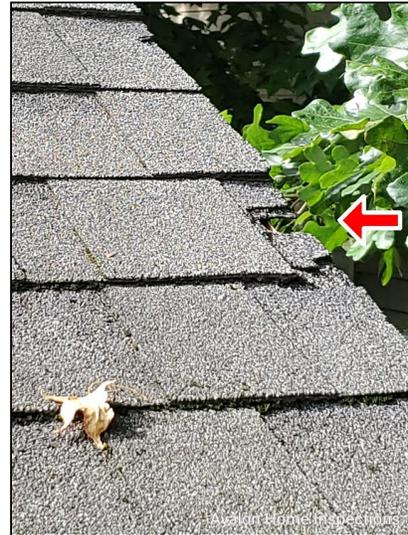
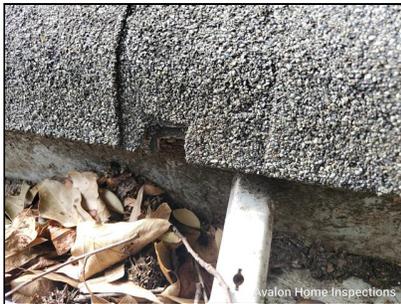
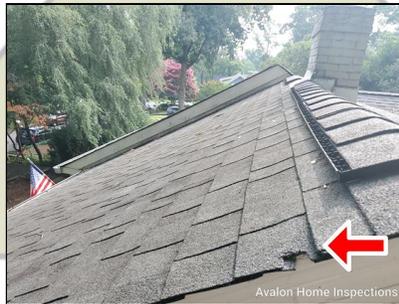
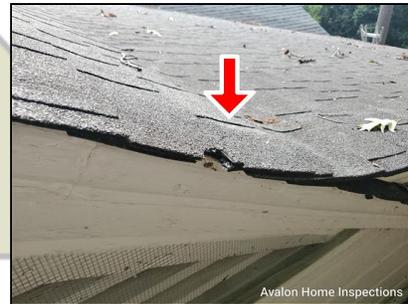
(5) Several roof shingles are damaged at numerous areas of roof. It should be replaced as soon as possible. A qualified contractor should inspect and repair as needed.

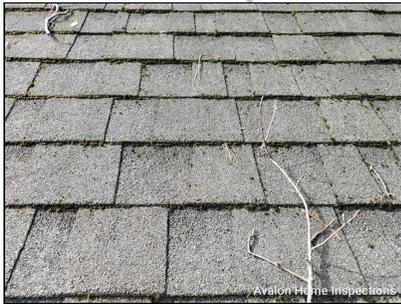
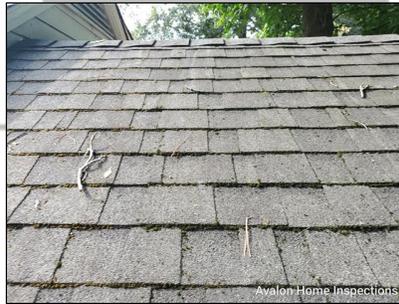
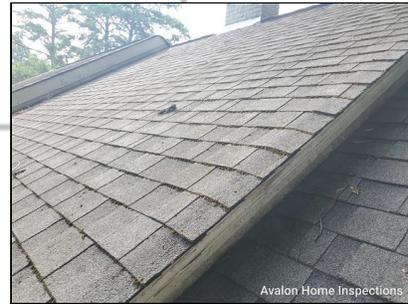
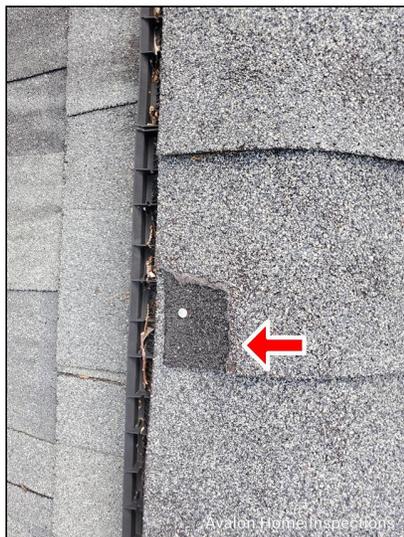
(6) The roof shingles has excessive "moss or algae" growth at the "entire roof". Repairs are needed as moss can shorten lifespan of shingles. A qualified contractor should inspect and treat fungi as needed.

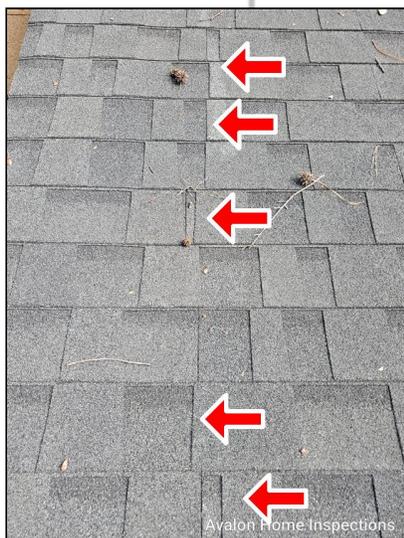
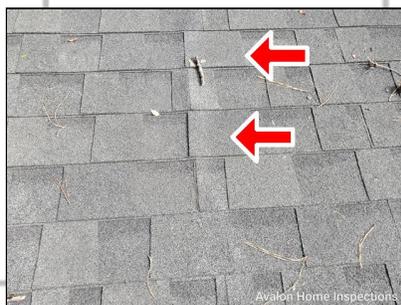
Racking can be an improper installation method for many shingle types. It is acceptable for some shingle types, and it is the required method for a few shingle types.

The inspector recommends that, before the expiration of your Inspection Objection Deadline, you have the roof examined by a qualified roofing contractor to determine whether the shingles on your roof have been improperly installed.

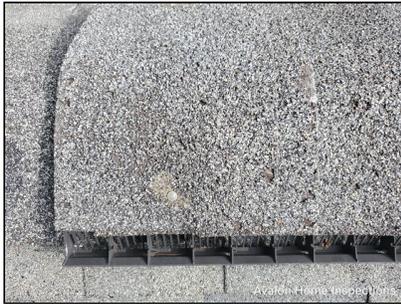
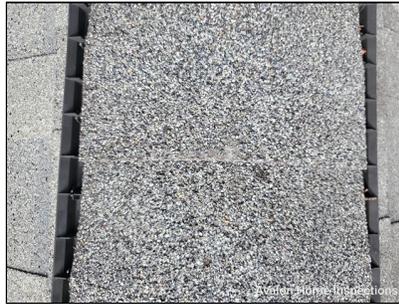
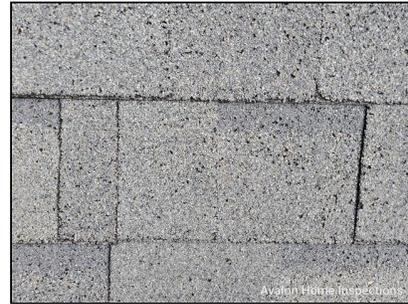
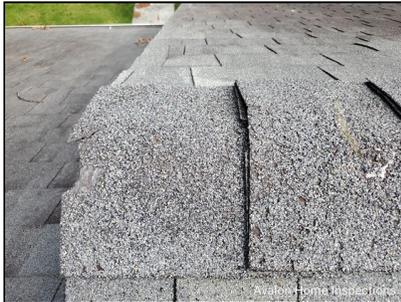
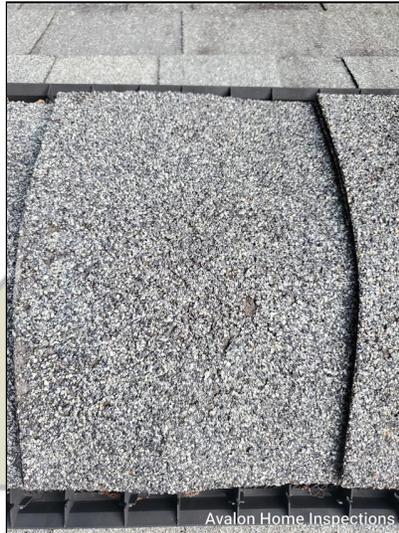
(8) The roof covering shows a mump-like appearance indicating a possible manufacturer defect. These areas will eventually blister and the roof will need replacing.

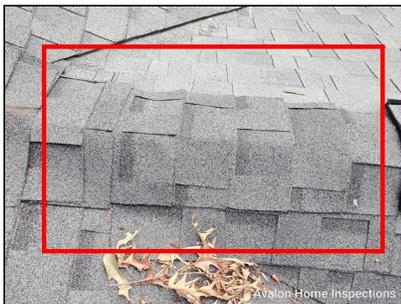
1.0 Item 19(Picture)

(9) The roof shingles were installed improperly or not according to manufactures specifications at the ridge shingles. The roof is not leaking but will not withstand elements as well as a properly installed shingles. A qualified roofing contractor should inspect and repair/replace as needed.

Ridge shingles must be used at ridge. Architectural shingles cannot be used at ridge cap.

Starter strip is missing around perimeter of home. Repairs are needed by a licensed roofing contractor.

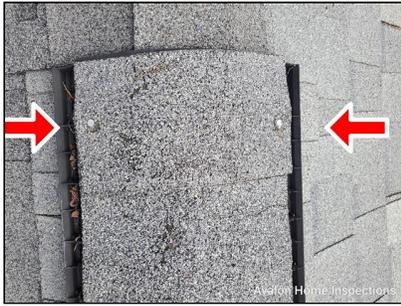
1.0 Item 20(Picture)

(10) Unsealed visible roof nails should be sealed. This can cause leaks. A qualified person should seal nail holes with tar or silicone.

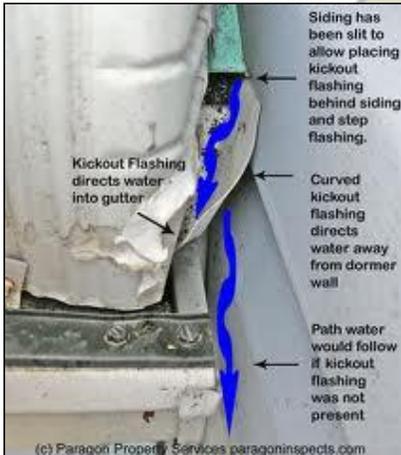
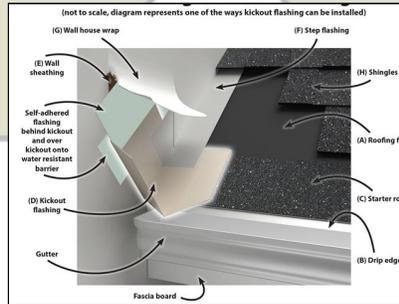
(1) The kick out flashing between cladding and shingles is missing at the front of home. Kick out flashing directs water into gutter or away from home so that runoff water intrusion does not occur into the cavity of wall. A qualified contractor should install as needed.

IRC R703.8

R905.2.8.3 Sidewall flashing.

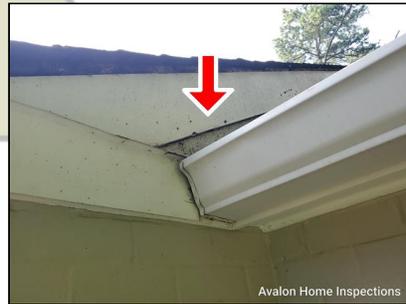
1.1 Item 3(Picture)

(2) The metal drip edge is missing along rake/eaves. Moisture or water could leak in to attic when raining. A qualified roofing contractor should inspect and repair as needed.

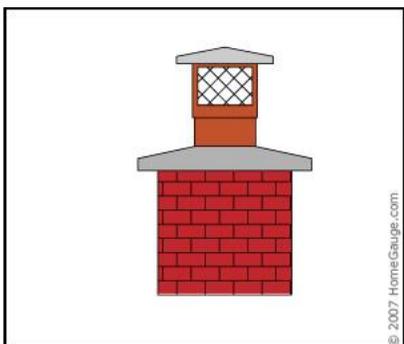
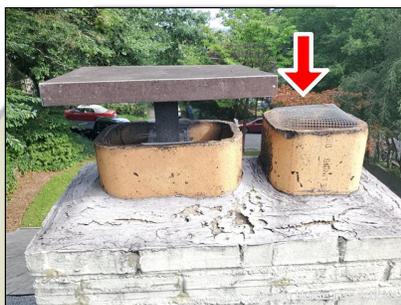
(1) Chimney cap is missing. This was common for older homes but is not recommend as rain and pest can enter flue pipe. A qualified contractor should install as needed.

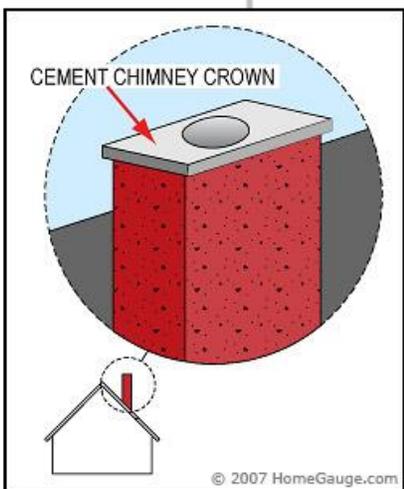
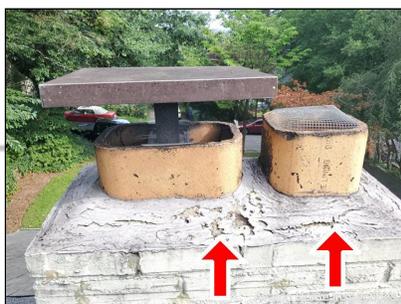
(2) The cement crown on chimney chase is failing and needs prep and re-coat. Further deterioration may occur if not repaired. A qualified contractor should inspect and repair as needed.

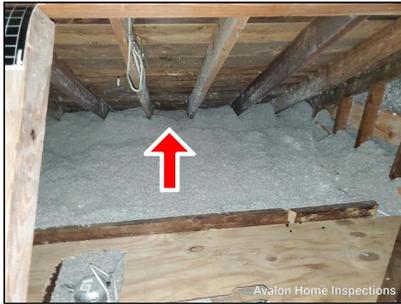
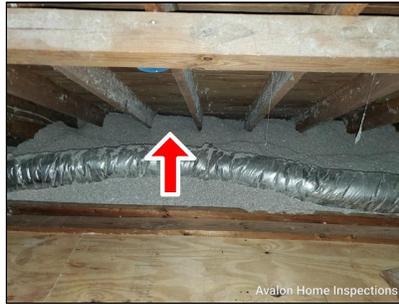
(2) Soffit vent screens are blocked by insulation(missing baffles) at the front of home and rear of home. This is a small but needed repair as proper ventilation of attic will increase roof life and lower energy bills. A qualified contractor should inspect and repair as needed.

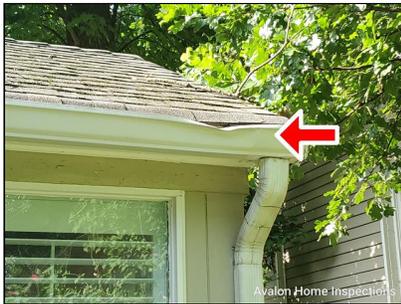
1.4 Item 4(Picture)

(3) The gutter(s) is damaged at the front of home. Damaged, loose or leaking gutters can cause deterioration of fascia, soffit or roof edge. It can also cause gutters to pull loose and lead to possible water intrusion. A qualified contractor should inspect and repair as needed.

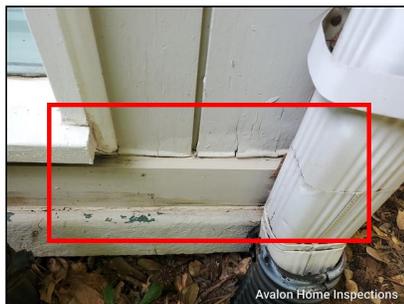
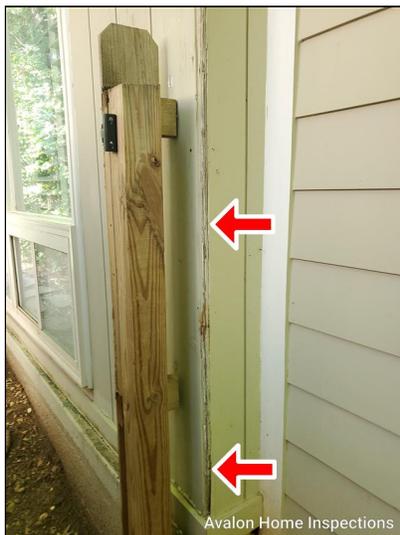
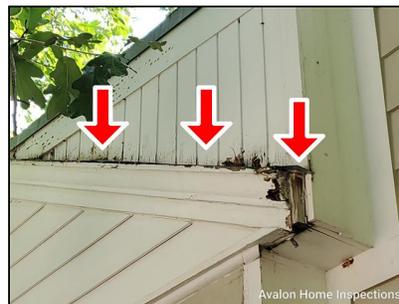
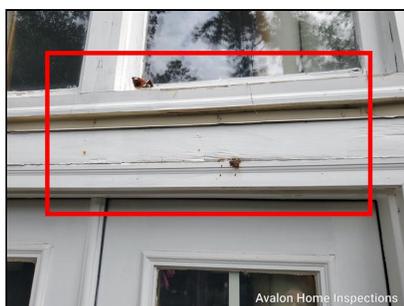
(5) The wood trim at the front, rear and sides of home is beginning to deteriorate along bottom edge. Further deterioration can occur if not corrected. A qualified contractor should inspect and repair as needed.

Pictures shown do not represent all deficiencies, recommend that a qualified contractor evaluate and replace siding as necessary, and/or seal and repaint as necessary.

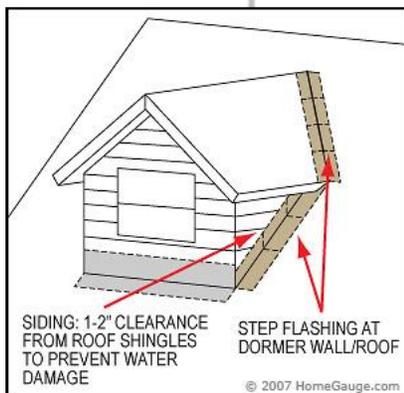
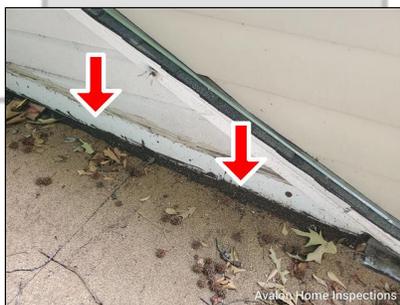
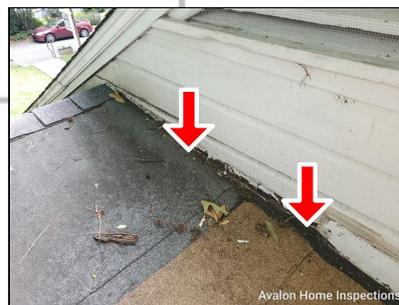
(6) The cladding and trim is beginning to deteriorate at roof line. The siding and trim should be a minimum of 1 inch above shingles to prevent wicking of moisture. Further deterioration can occur if not corrected. A qualified contractor should inspect and repair as needed.

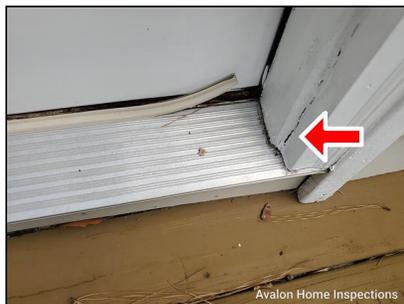
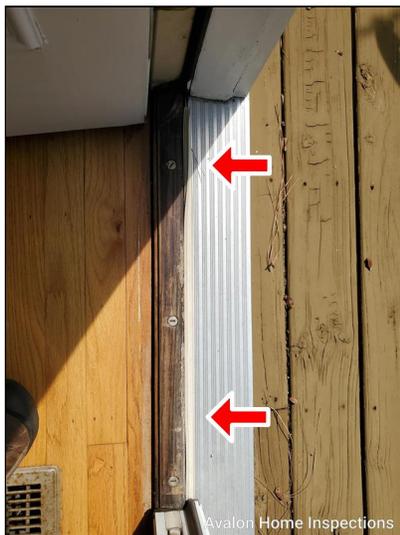
(3) The entry door at the rear of home has deteriorated at brick-mold or trim (exterior). A repair or replacement is needed. A qualified contractor should inspect and repair as needed.

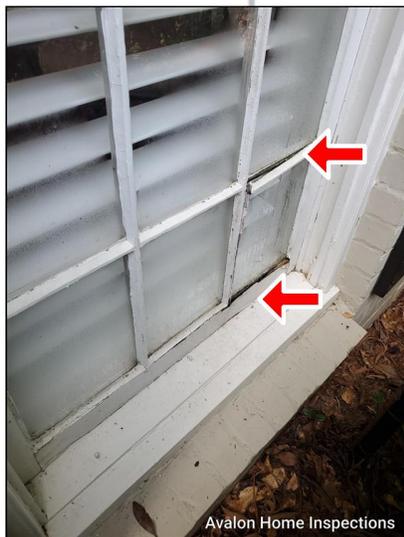
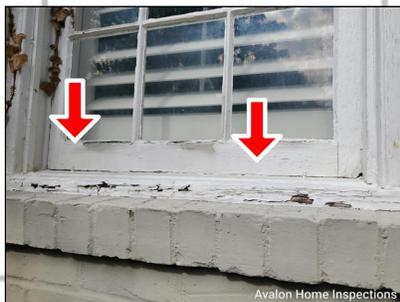
(1) The brick-mold around windows is deteriorated at front of home and left side (facing front). Further deterioration may occur if not repaired. A qualified contractor should inspect and repair as needed.

Pictures shown do not represent all deficiencies, recommend that a qualified contractor evaluate and replace deteriorated trim as necessary, and/or seal and repaint as necessary.

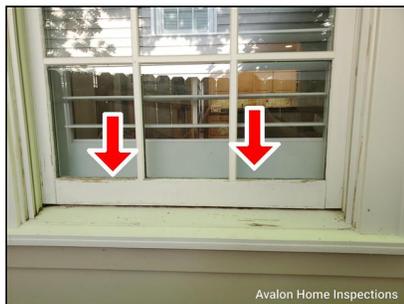
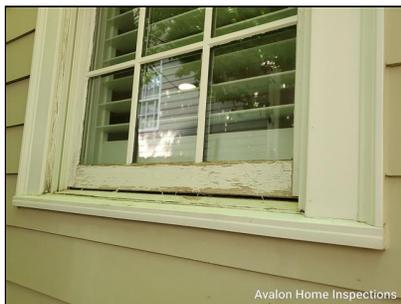
(3) The wood trim is peeling paint at some windows around home. This is a maintenance issue to prevent water intrusion into home. A qualified contractor should prep and paint.

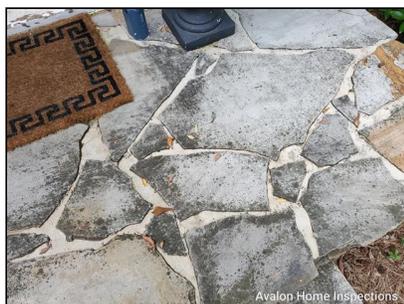
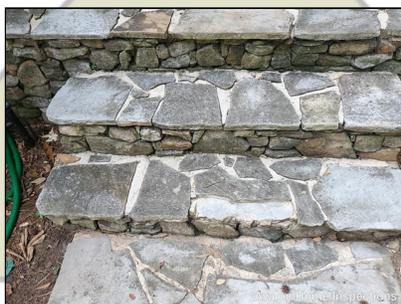
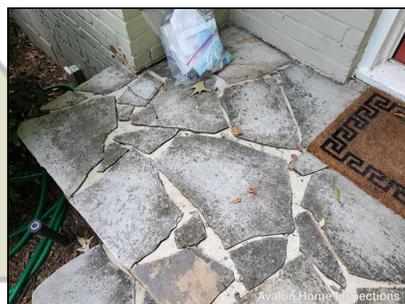
(2) The rock on the steps at the front of home is missing and/or has loose mortar. Water can cause further deterioration if not repaired and sealed properly. A qualified contractor should inspect and repoint as needed.

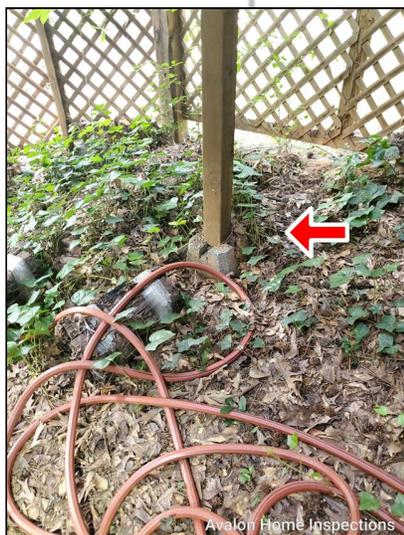
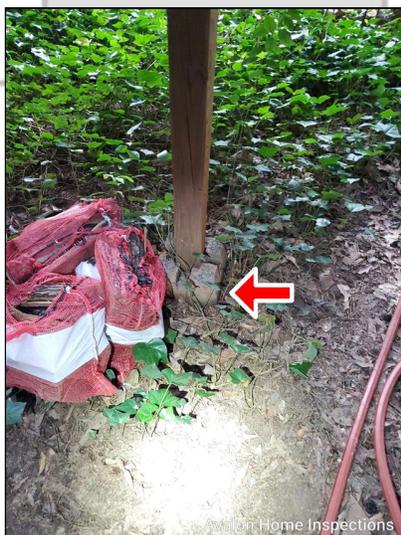
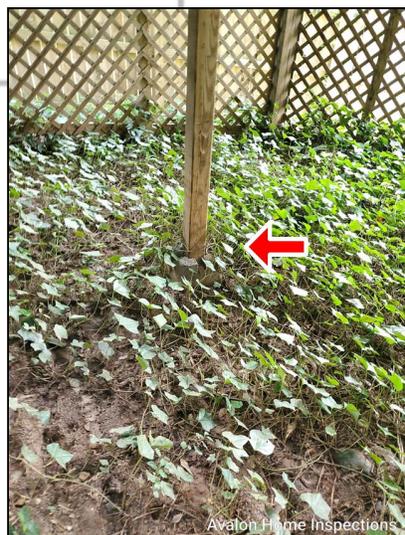
(3) The guardrails at steps and deck at the rear of home are loose. An injury could occur if not corrected. A qualified contractor should repair or replace as needed.

(4) The support post(s) for the deck at the rear of home are not sitting on proper footers. Repairs are needed. A qualified contractor should repair or replace as needed.

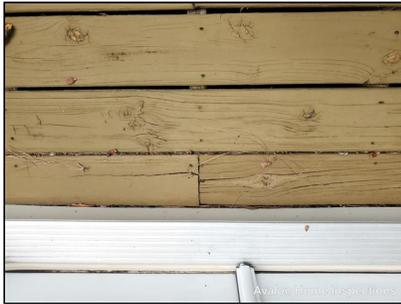
2.3 Item 7(Picture)

(5) The 5/4 decking on the deck at the rear of home has some boards that are deteriorated. A fall or injury can occur if not corrected. A qualified contractor should repair or replace as needed.

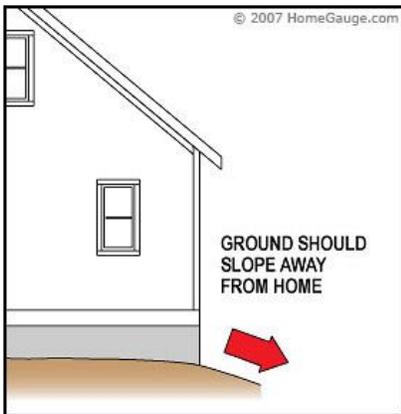
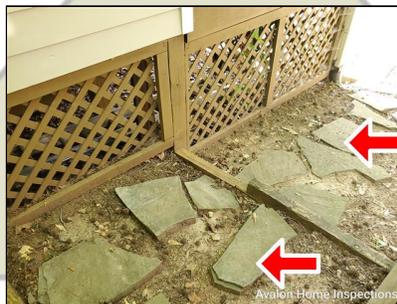
(3) There is a negative slope at the right side (facing front) and can cause or contribute to water intrusion or deterioration. I recommend correcting landscape to drain water away from home.

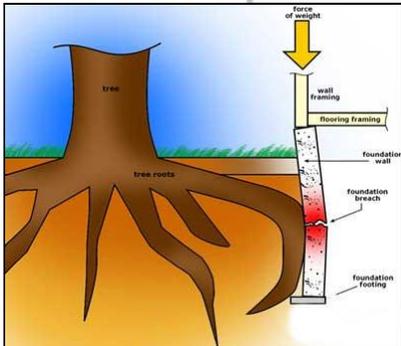
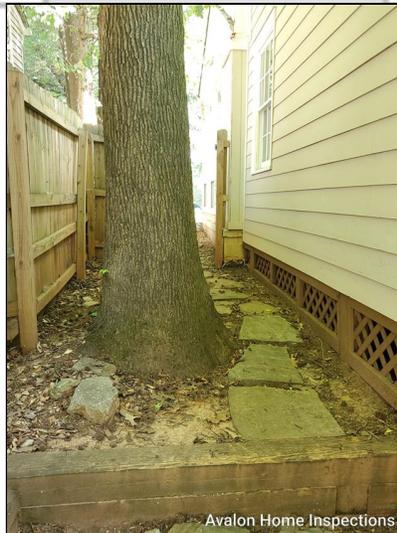
(4) One or more large trees were very close to the foundation. Tree roots can cause significant structural damage to foundations, or may have already caused damage (see other comments in this report). Recommend that a qualified tree service contractor or certified arborist remove trees as necessary to prevent damage to foundations.

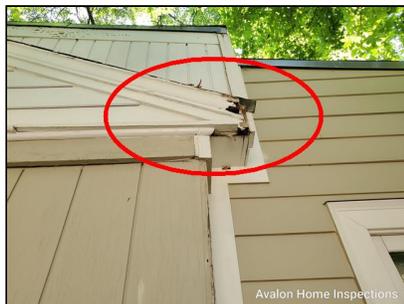
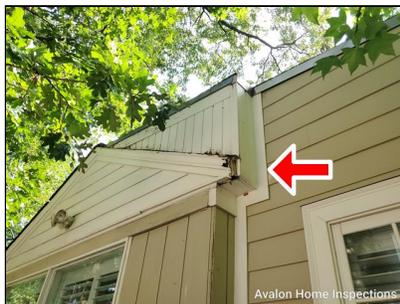
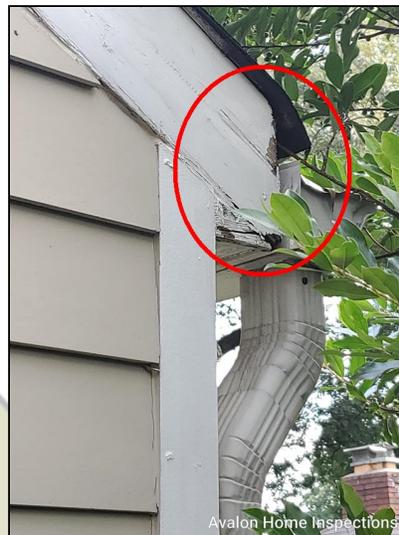
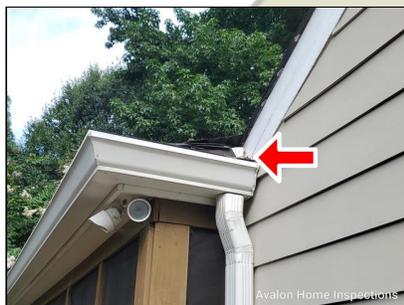
🔨 (1) The paint on eave is failing. I recommend prep and paint at the front, rear and sides of home.

🔨 (2) The wood fascia at eave on the front of home is deteriorated in areas. Further deterioration may occur if not repaired. A qualified contractor should inspect and repair as needed.

Pictures shown do not represent all deficiencies, recommend that a qualified contractor evaluate and replace deteriorated trim as necessary, and/or seal and repaint as necessary.

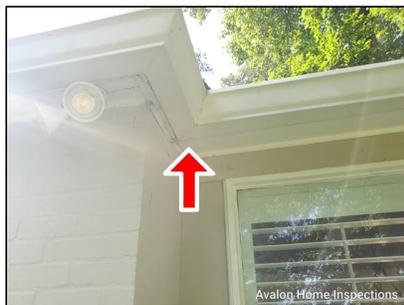
2.5 Item 5(Picture)

🔨 (3) The soffit panel for eave on the front of home is deteriorated in areas. Further deterioration will occur if not corrected. A qualified contractor should inspect and repair as needed.

Pictures shown do not represent all deficiencies, recommend that a qualified contractor evaluate and replace siding as necessary, and/or seal and repaint as necessary.
